## WOOD DESTROYING PESTS AND ORGANISMS INSPECTION REPORT

Building Address: <b>1250 Black Sage Cir., Nipomo, CA 93444</b>		Date of Inspection <b>02/11/2019</b>	Number of Pages <b>7</b>

P.O. Box 1818 Nipomo, CA 93444 Ph: (805) 296-6058 robert@805termite.com		Report # <b>W9075</b>
			Lic. Registration # <b>PR 7553</b>
			Escrow #
Ordered by:	Property Owner and/or Party of Interest:	Report Sent to:	
COMPLETE REPORT <input checked="" type="checkbox"/> LIMITED REPORT <input type="checkbox"/> SUPPLEMENTAL REPORT <input type="checkbox"/> REINSPECTION REPORT <input type="checkbox"/>			
General Description: Single family residence, tile roof, stucco exterior, vacant		Inspection Tag Posted:    Garage	
		Other Tags Posted: None	
An inspection has been made of the structure(s) shown on the diagram in accordance with the Structural Pest Control Act. Detached porches, detached steps, detached decks and any other structures not on the diagram were not inspected.

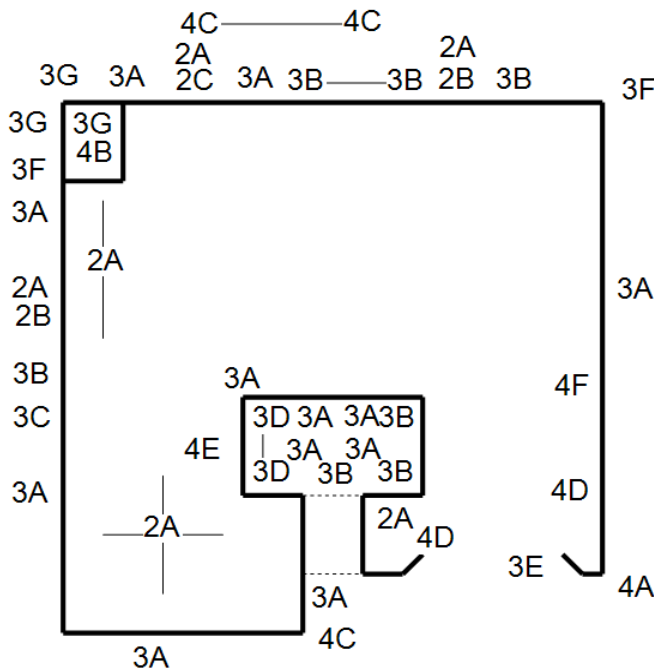
This Diagram is not to scale

- 2A PRICE: \$2,080.00 (Section I)  
FINDINGS: Evidence of drywood termite infestation at the raftertails, garage framing, attic framing and fascia as indicated on the diagram.  
RECOMMENDATION: Vacate the premises and seal the structure for fumigation of drywood termites with Vikane Gas. Remove or cover accessible evidence of infestation. Fumigation guaranteed for FIVE YEARS. Treatment type during guarantee will be the sole judgement of 805 Termite Control. Fumigation awareness notice must be signed prior to fumigation. See fumigation notice for terms and liabilities.

- 2B PRICE: See 3C (Section I)  
FINDINGS: Drywood termite damage was found at the raftertails.  
RECOMMENDATION: Remove and replace or reinforce damage wood members. Painting is included, color may not be an exact match.

- 2C PRICE: See 3A (Section I)  
FINDINGS: Drywood termite damage was found at the fascia.  
RECOMMENDATION: Remove and replace or reinforce damage wood members. Painting is included, color may not be an exact match.

- 3A PRICE: \$2,890.00 (Section I)  
FINDINGS: Fungus damage was noted at the fascia.  
RECOMMENDATION: Remove and replace damaged wood members with new material. Painting is included, color match may not be exact.

- 3B PRICE: \$3,240.00 (Section I)  
FINDINGS: Fungus damage was noted at the roof sheathing.  
RECOMMENDATION: Remove and replace damaged wood members with new material. Painting is included, color match may not be exact.

- 3C PRICE: \$315.00 (Section I)  
FINDINGS: Fungus damage was noted at the blocking and raftertails.  
RECOMMENDATION: Remove and replace damaged wood members with new material. Painting is included, color match may not be exact.

- 3D PRICE: \$1,640.00 (Section I)  
FINDINGS: Fungus damage was noted at the patio rafters.  
RECOMMENDATION: Remove and replace damaged wood members with new material. Painting is included, color match may not be exact.

- 3E PRICE: \$85.00 (Section I)  
FINDINGS: Fungus damage was noted at the garage door jamb.  
RECOMMENDATION: Remove and replace damaged wood members with new material. Painting is included, color match may not be exact.

- 3F PRICE: \$415.00 (Section I)  
FINDINGS: Fungus damage was noted at the corbel.  
RECOMMENDATION: Remove and replace damaged wood members with new material. Painting is included, color match may not be exact.

- 3G PRICE: \$2,630.00 (Section I)  
FINDINGS: Fungus damage was noted at the art room siding, window framing, and wall framing.  
RECOMMENDATION: Remove and replace damaged wood members with new material. Painting is included, color match may not be exact.
