# Duration Plumbing

## Sewer Inspection Report

**522 Avenue F  
Redondo Beach, California 90277**

**Tuesday, July 29, 2025 at 10:45 AM**

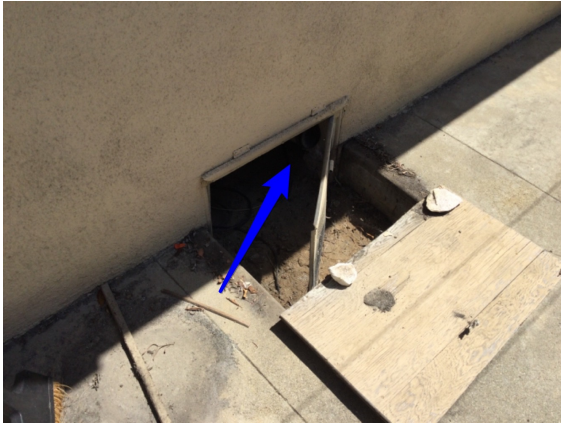
Three inch abs plastic clean out.

Rear unit crawlspace.

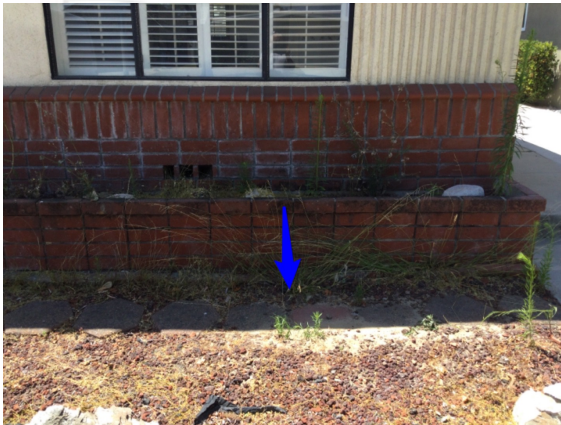
Four inch abs plastic clean out.

Front of house.

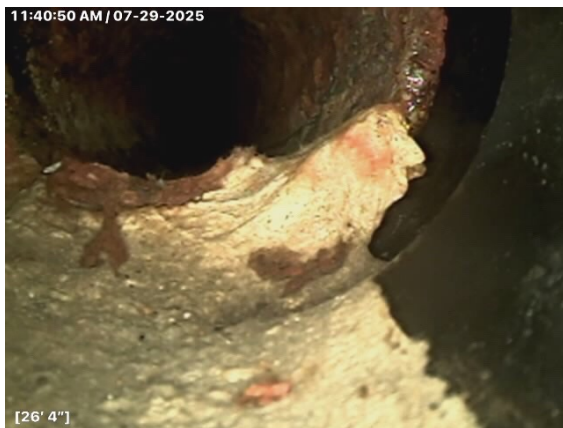
The abs to cast iron transition under the rear unit has a poor connection under the kitchen at the foundation wall.

The abs to cast iron transition under the rear unit should be repaired.
