Confidential Inspection Report

LOCATED AT:
1637 1st st
Manhattan Beach, California 90266

INSPECTED ON:
Tuesday, March 29, 2022

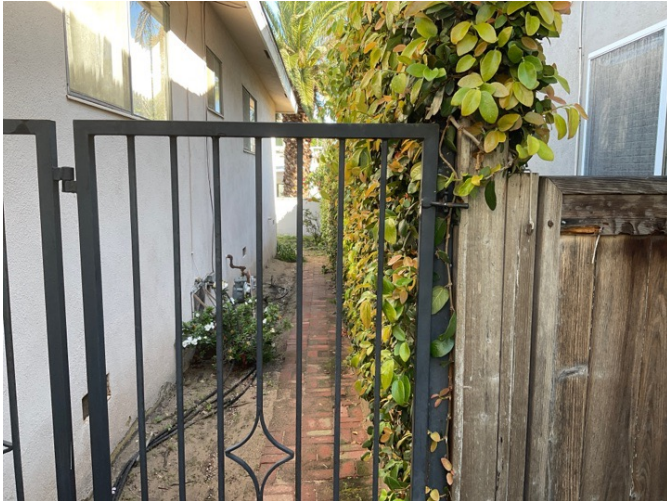
11: The east side gate needs adjustments or repair as it does not easily latch.

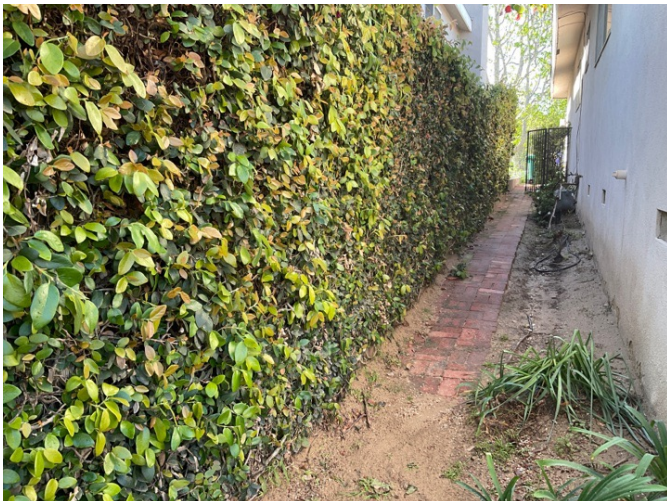
12: Portions of the fences are blocked or covered by foliage that prevent a thorough inspection.

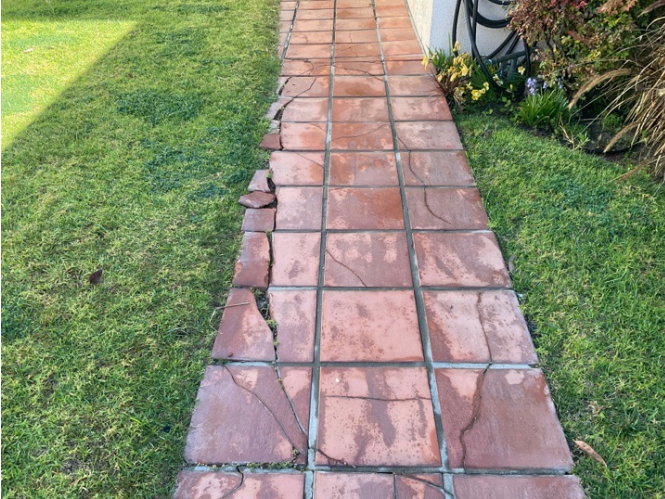
15: There are offsets in the walkways that could be considered a trip potential.

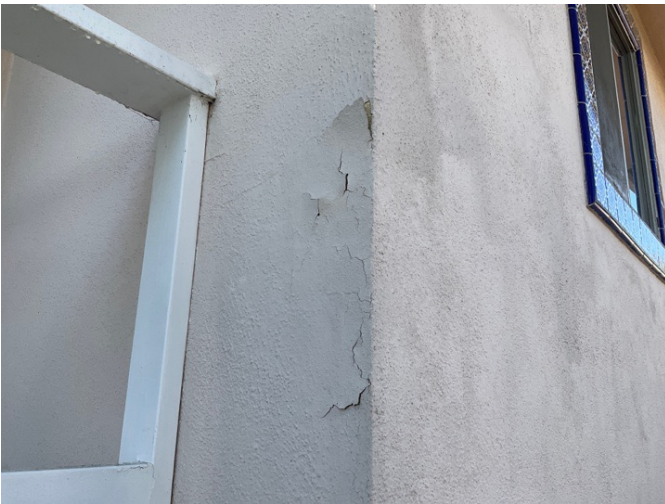
19: The stucco walls have been painted. The paint is older, degraded, and peeling in some areas. It should be evaluated for the cost of repainting in the near term.

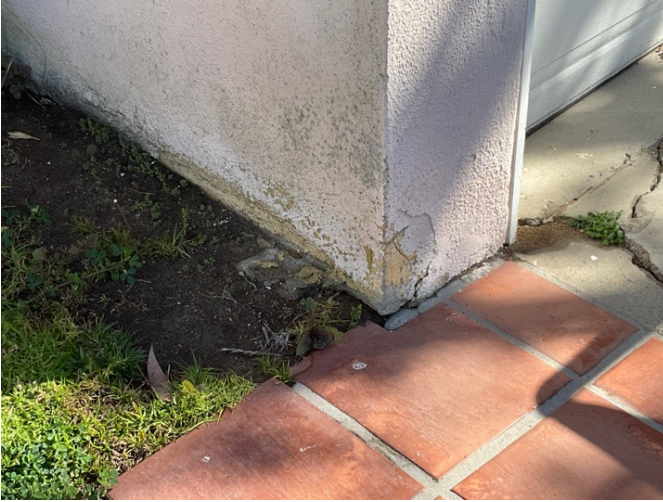
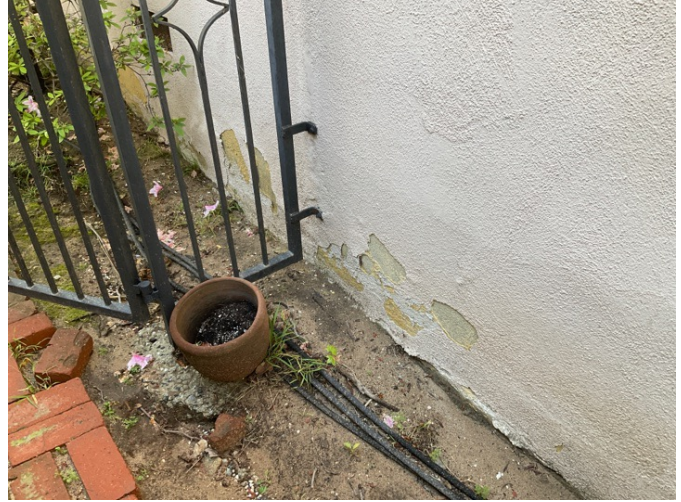
20: At some areas of the lower walls, the stucco and paint is cracked, thin, and degraded. This is likely from exposure to moisture in the soils and/or sprinkler overspray. The condition should be monitored but is currently considered cosmetic.

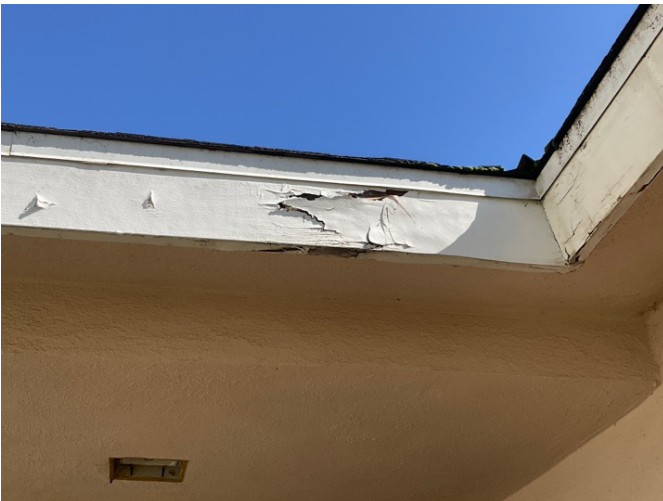
23: Degraded wood was observed at some areas of the fascia boards. A termite inspector should evaluate this further as we are not qualified.

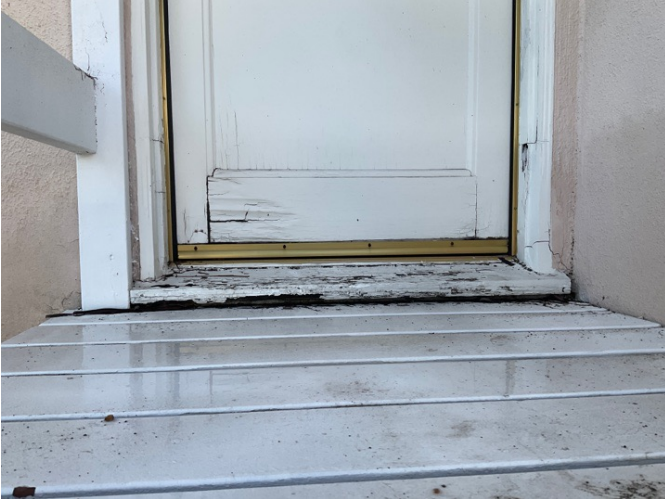
26: The rear door is degraded and in need of service.

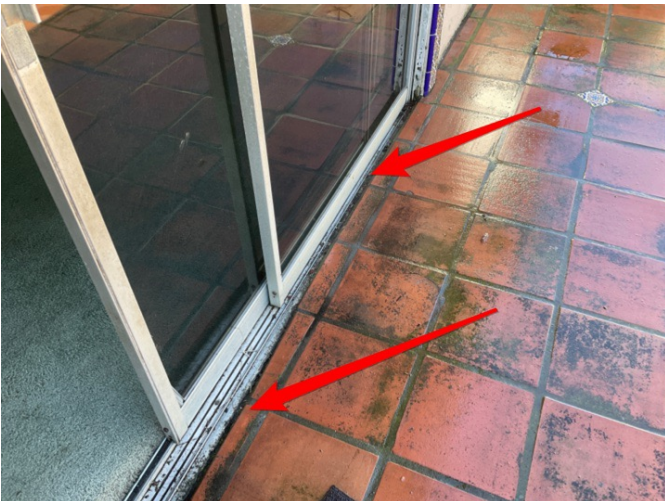
28: The sliding glass door is lower than the adjacent patio which is allowing for water intrusion.

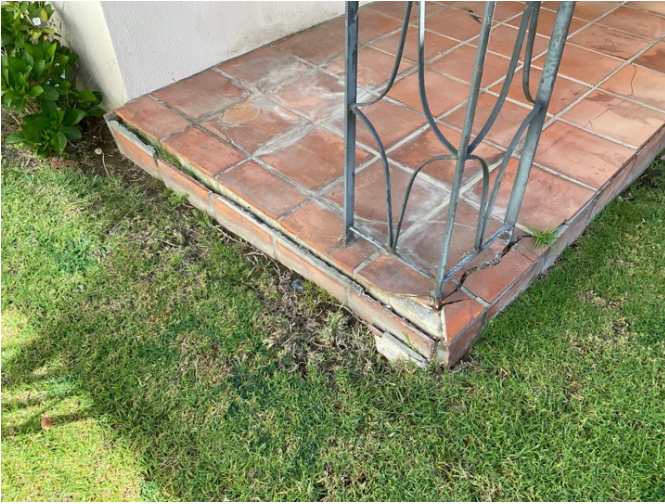
29: There are typical cracks in the front porch. This is a common result from expansive soils, settlement, root movement, or seismic activity. We are not able to determine what caused the movement; however, this is considered to be a cosmetic condition.

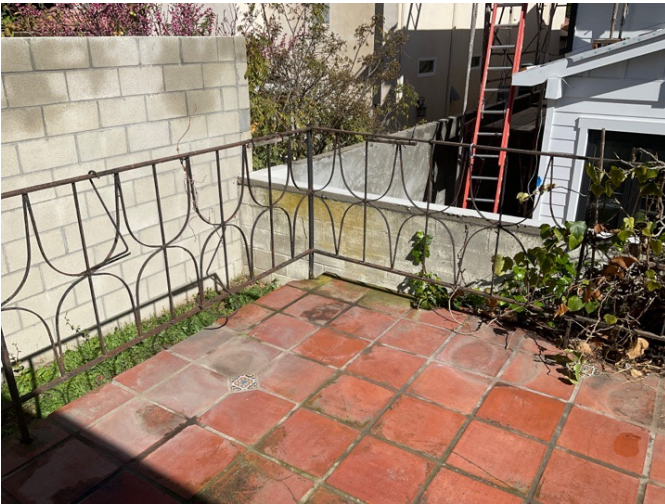
30: The guardrails at the rear patio do not conform to current minimum standards. They should be upgraded if young children will be present.

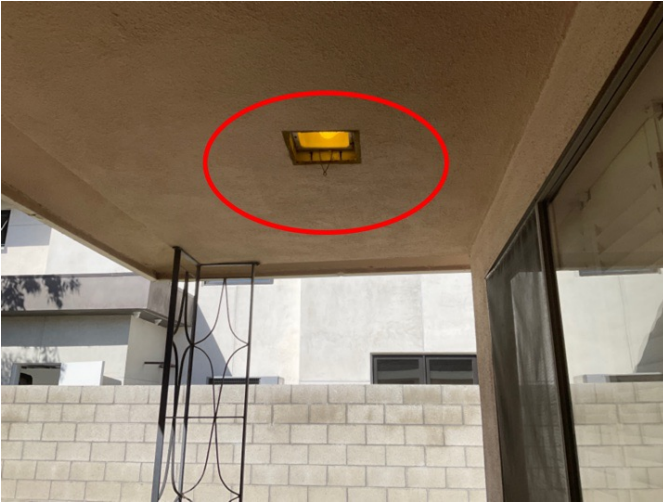
31: The light outside the front door of the residence is functional but missing it's cover.

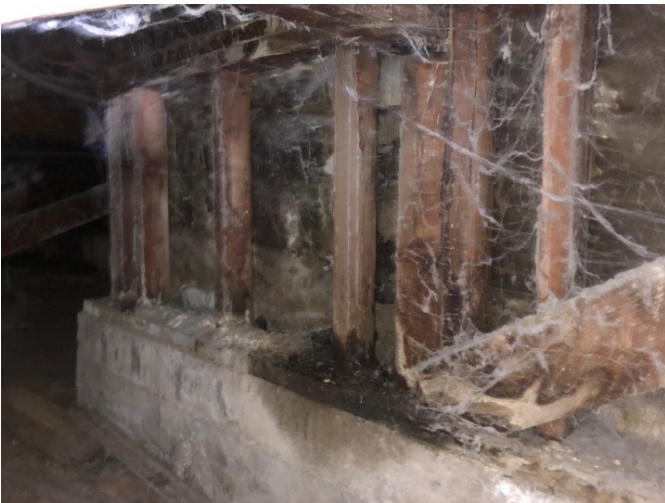
45: The cripple walls are not sheathed. You may wish to upgrade the cripple walls for improved seismic stability. Please consult a foundation retrofit specialist for specific recommendations.

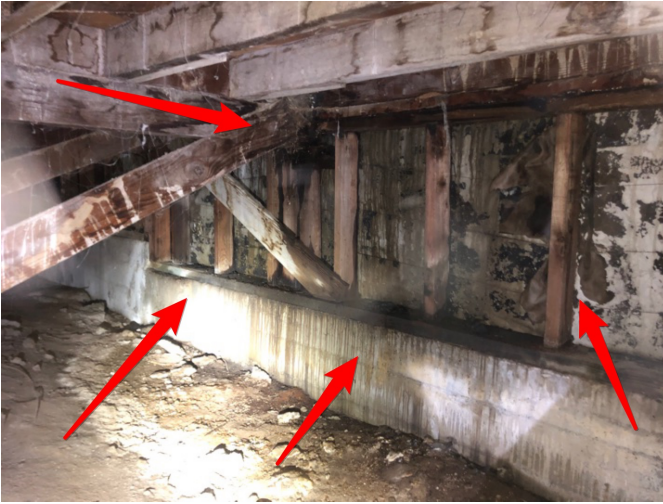
46: Degraded wood was noted under the family room sliding glass door. This should be evaluated by a licensed termite inspector to determine if wood repairs or replacements are needed.

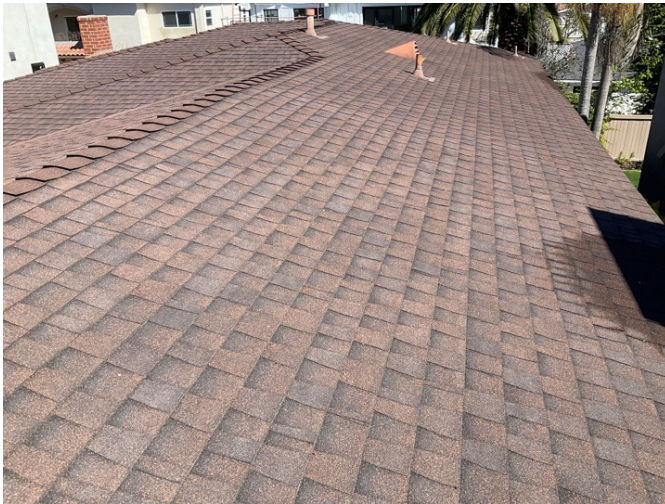
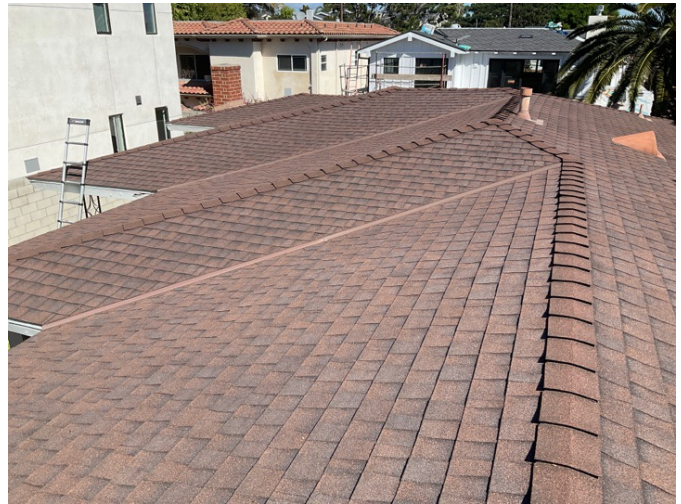
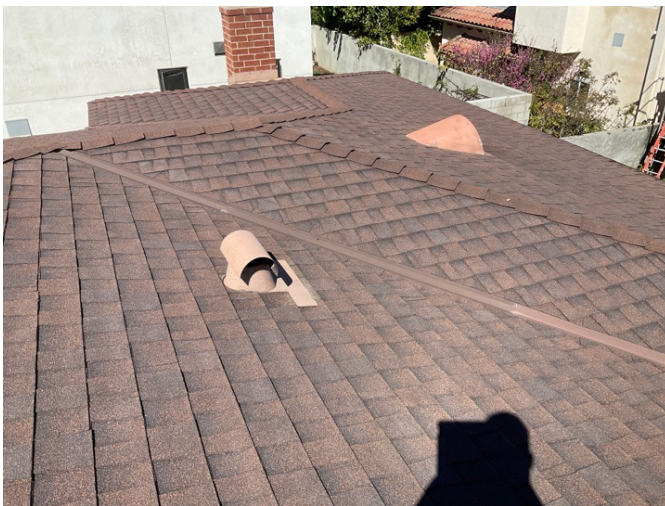
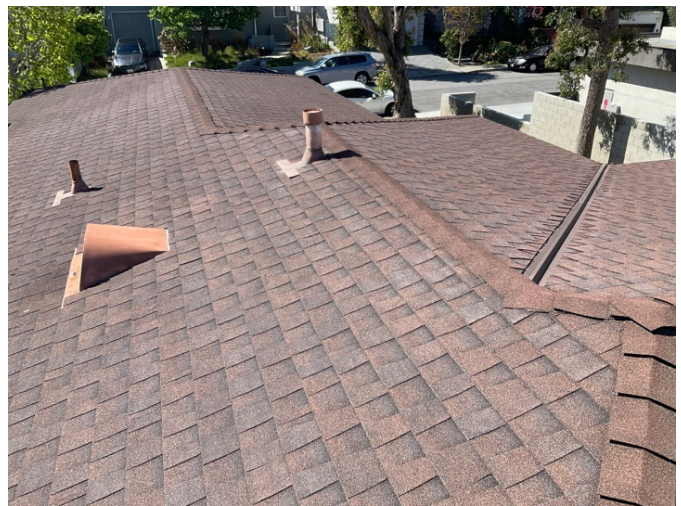
54: The roof coverings are composition shingles. There are a wide variety of composition shingle roofs. This type of roof covering is comprised of asphalt or fiberglass materials that are impregnated with mineral granules. The most common of these roofs are warranted by manufacturers to last from twenty-five to sometimes forty years. Regular maintenance will extend the life of any roof and will usually avert most leaks that only become evident after they have caused other damage. This is important as in accordance with industry standards our inspection does not include a guarantee against leaks. The sellers will generally have the most intimate knowledge of the roof, therefore we recommend consulting them regarding it's history.

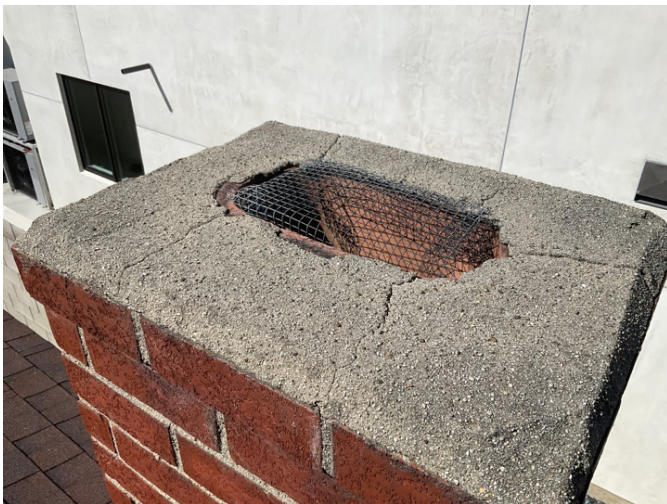
71: The spark arrestor is not a conventional one or an approved type which you may wish to have replaced.

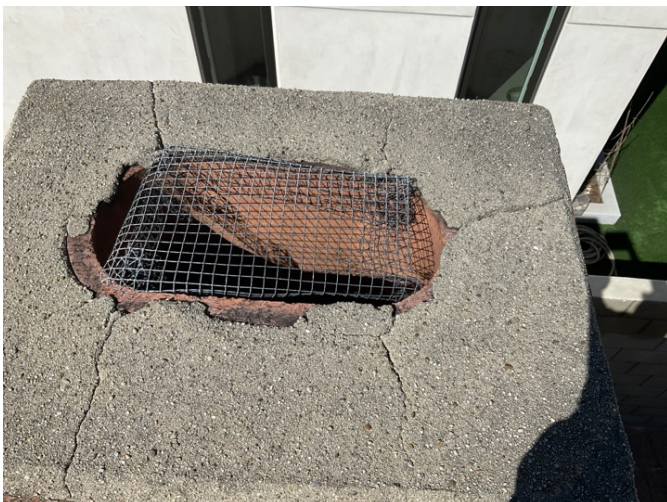
72: The chimney crown, which is designed to seal the chimney wall and shed rainwater, is cracked and should be sealed.

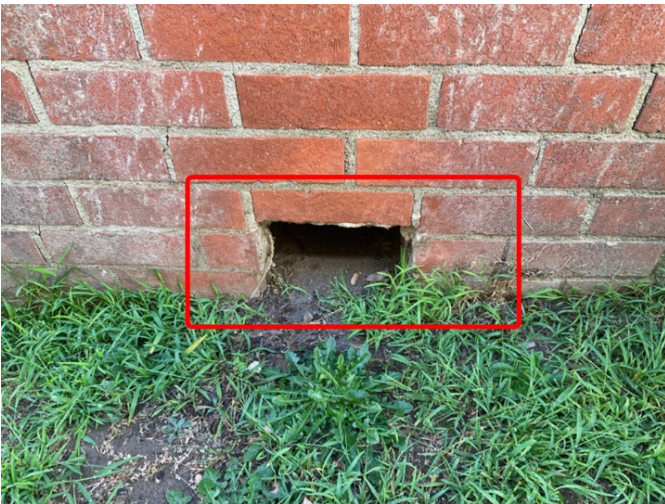
79: The door on the ash box is missing (one should be installed).

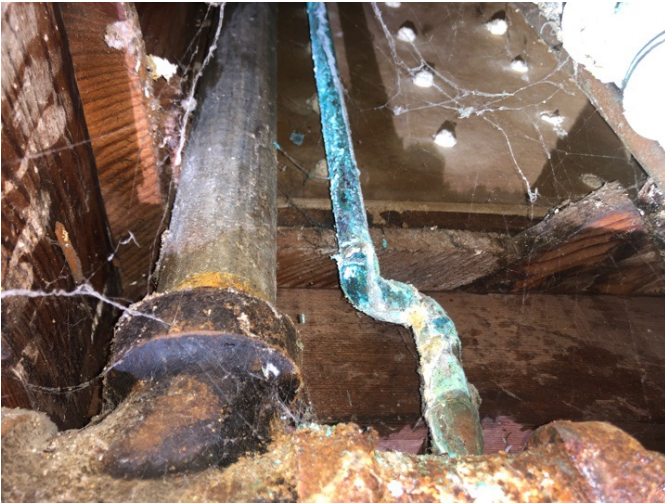
85: The copper water pipes are in acceptable condition, with the exception of a corroded pipe under the bathtub. This should be repaired by a plumber.

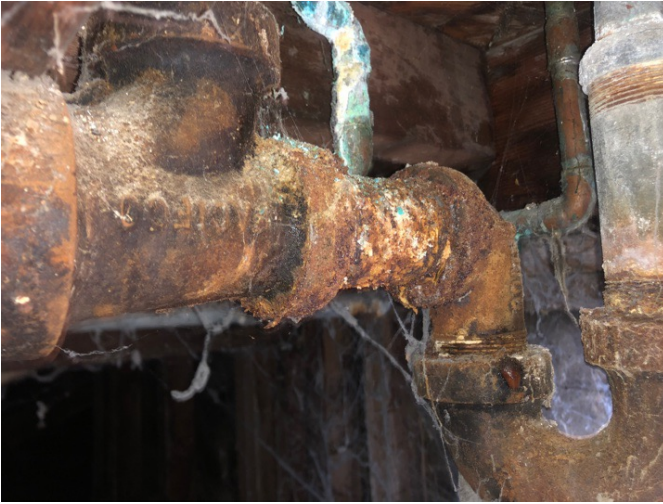
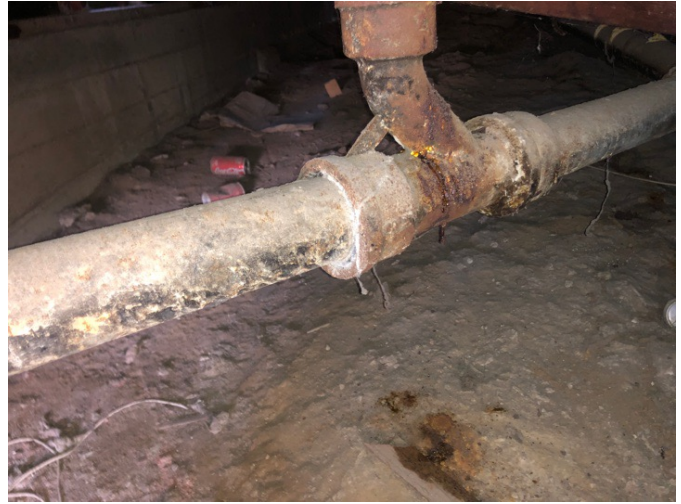
89: There is corrosion on the original drainpipes below the home and active leakage was observed. The pipes are in need of repair but also should be monitored as near term replacement will be needed. The entire drain line system should be thoroughly examined by a licensed plumber to determine the extent of necessary repairs.

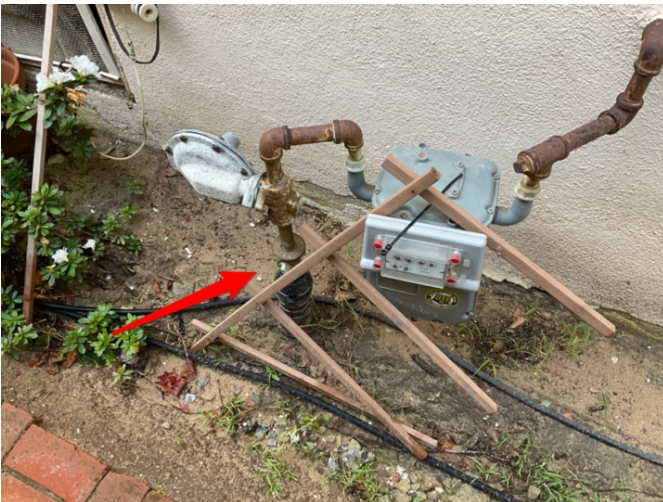
92: The gas main shut-off is located in the east sideyard.

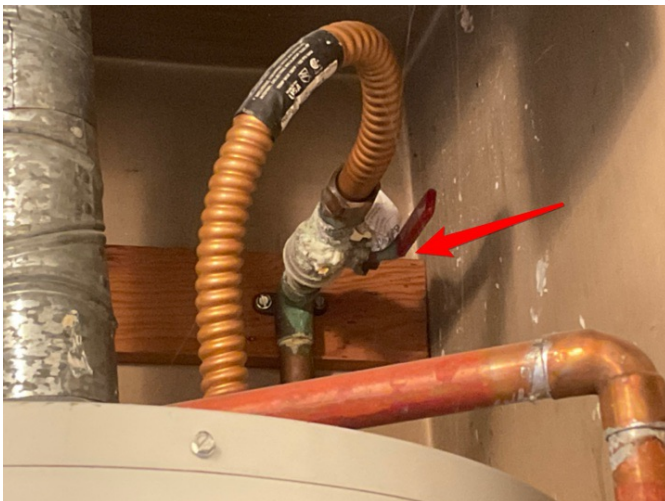
103: The water shut-off valve on the water heater has corrosion, likely due to past leakage. The valve should be monitored for future leakage or replaced.

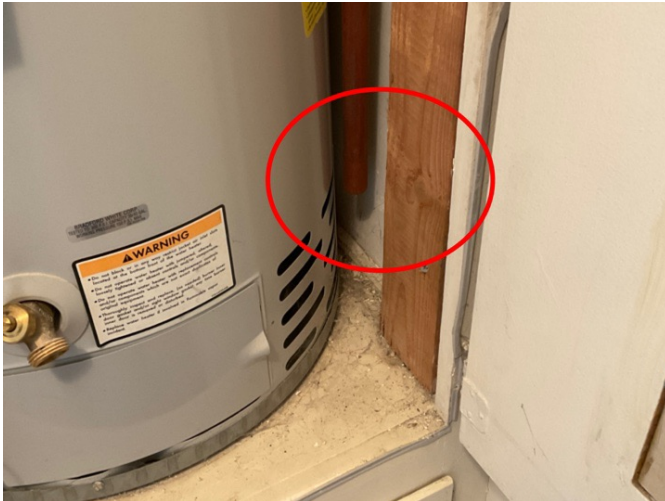
108: The discharge pipe from the pressure relief valve on the water heater must extend to the exterior and terminate at a point no more than 24" above grade and no closer than 6" to it.

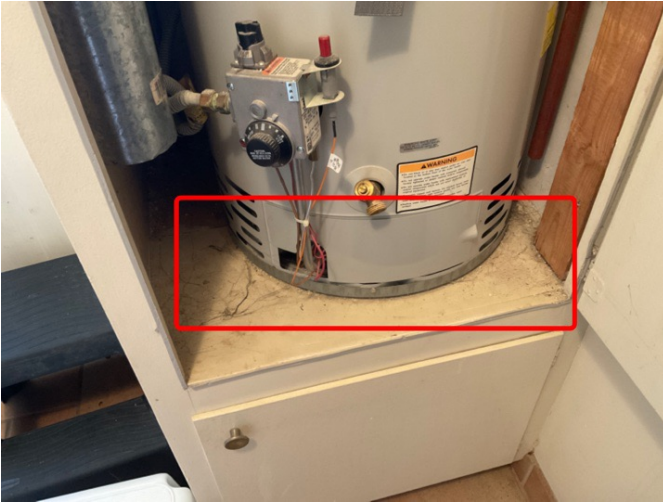
109: The water heater is not equipped with a drip pan or overflow pipe which is designed to minimize water damage from a leak. Although it may not be required, installation is recommended.

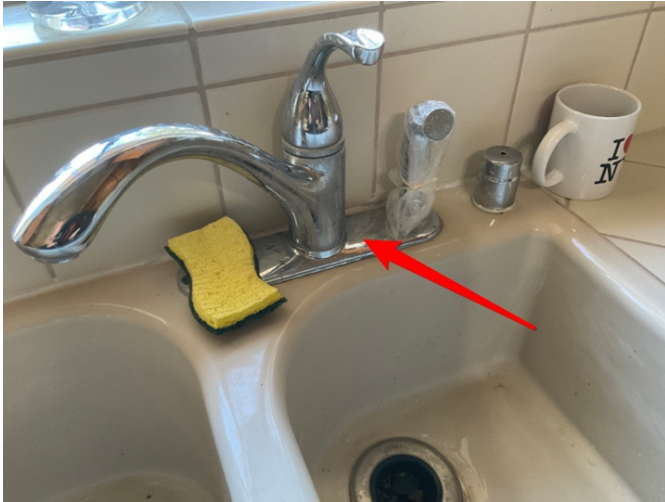
146: The sink faucet leaks around the mixer while in use (service needed). A new cartridge assembly may be required.

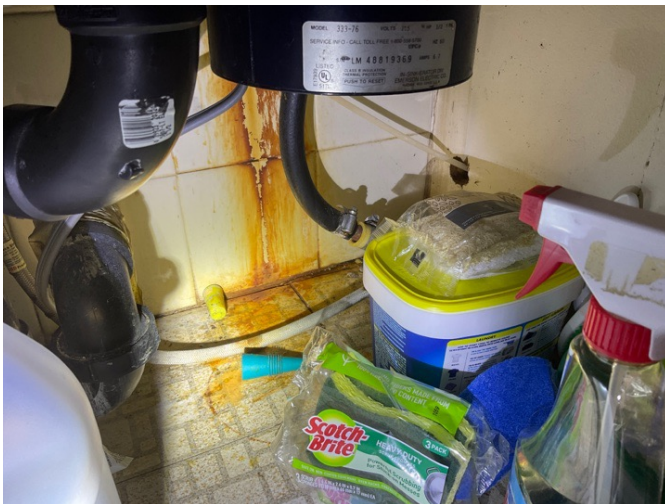
147: The sink faucet is leaking into the cabinet below.

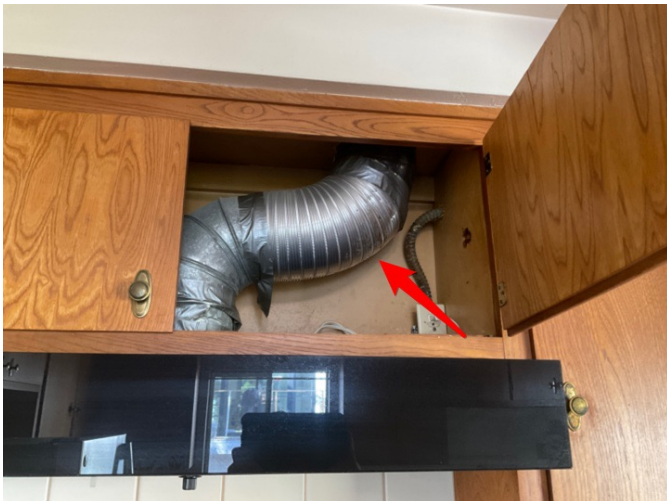
153: The flexible duct at the kitchen exhaust fan is not approved for this use as it may trap grease (potential fire hazard). This duct should be replaced with approved smooth-walled material.

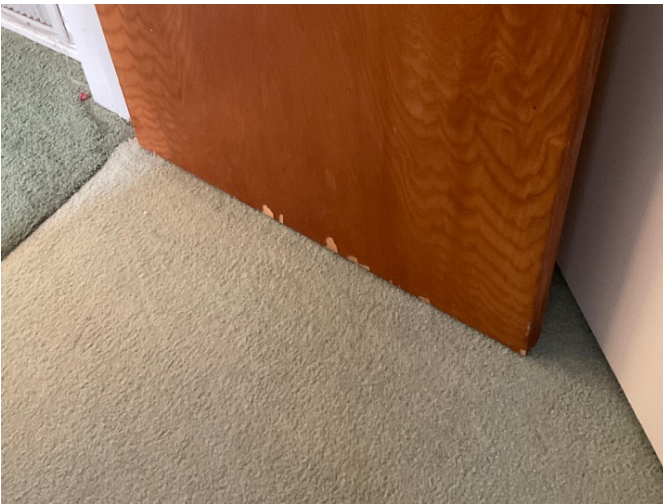
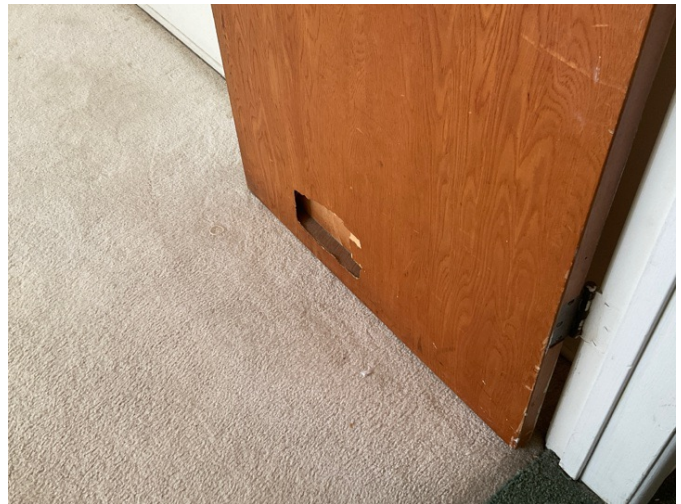
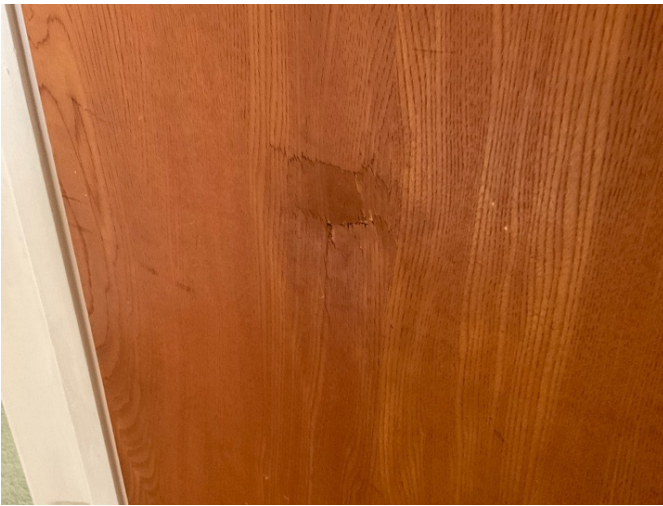
174: The doors were examined and are functional but have cosmetic damage.

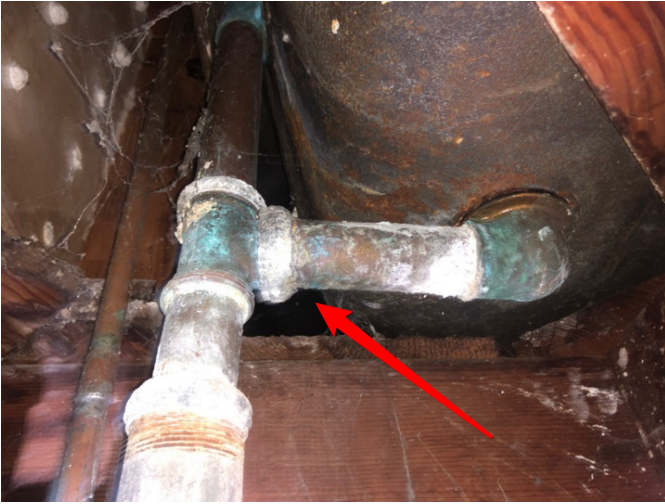
202: There is a drain leak below the bathtub that should be repaired.

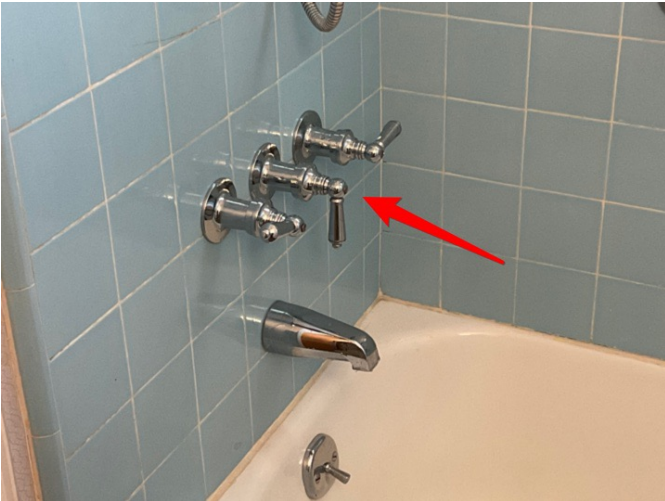
203: The shower diverter valve in the tub-shower is defective (repair or replacement needed).

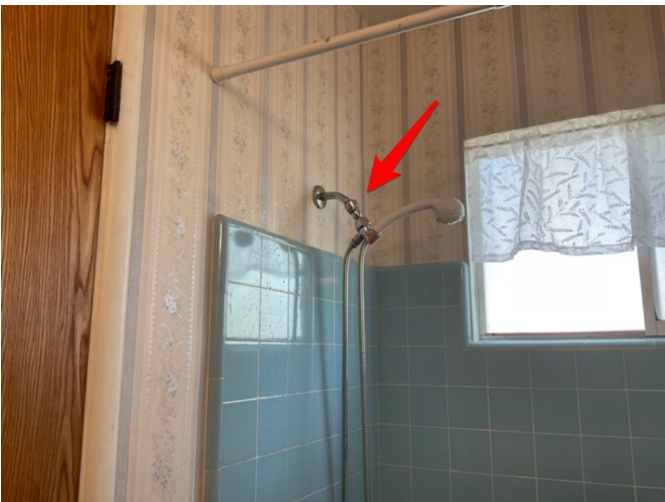
204: The hand sprayer leaks (repairs needed).

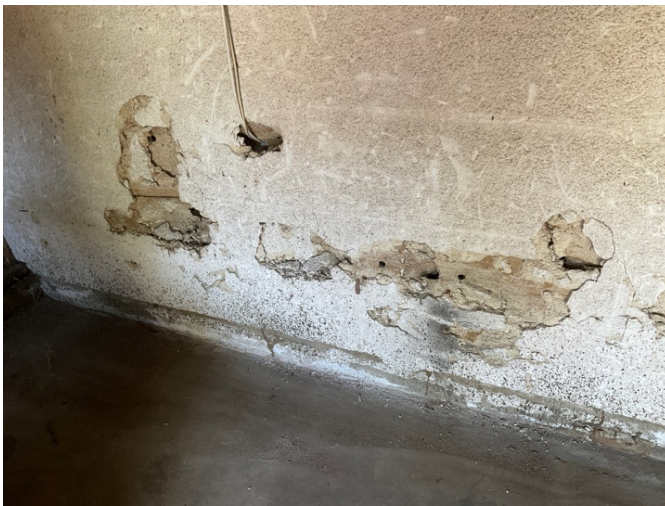
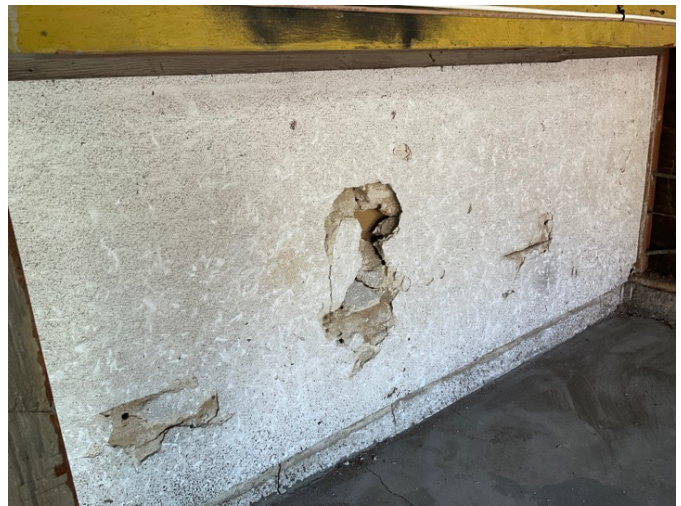
236: The voids in the garage firewall must be repaired with approved 1-hour fire rated material in order to maintain the necessary firewall separation between the garage and the living quarters.

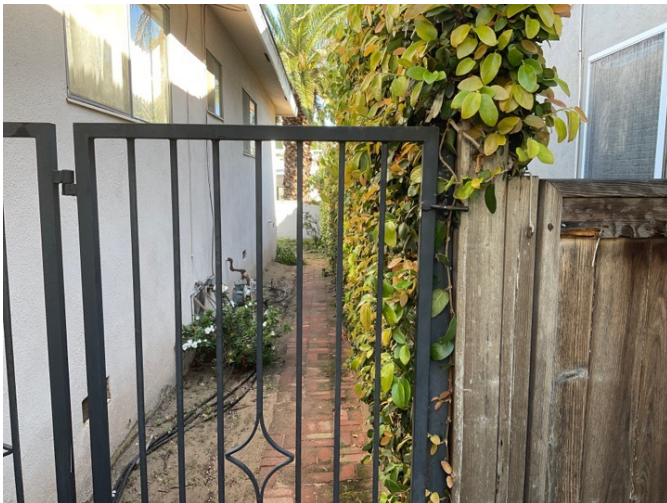
s-11: The east side gate needs adjustments or repair as it does not easily latch.

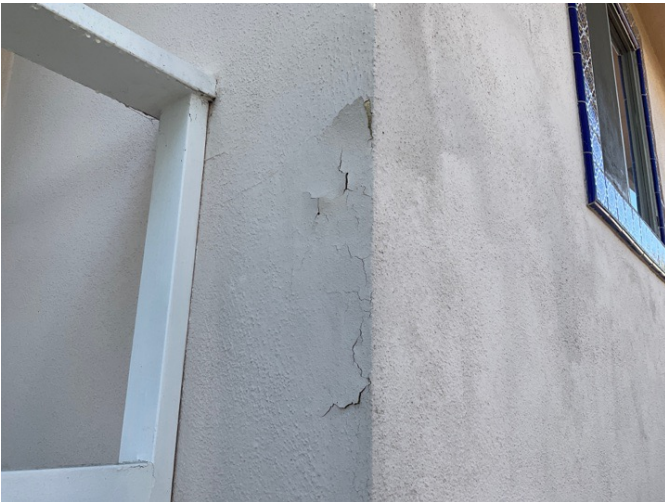
s-19: The stucco walls have been painted. The paint is older, degraded, and peeling in some areas. It should be evaluated for the cost of repainting in the near term.

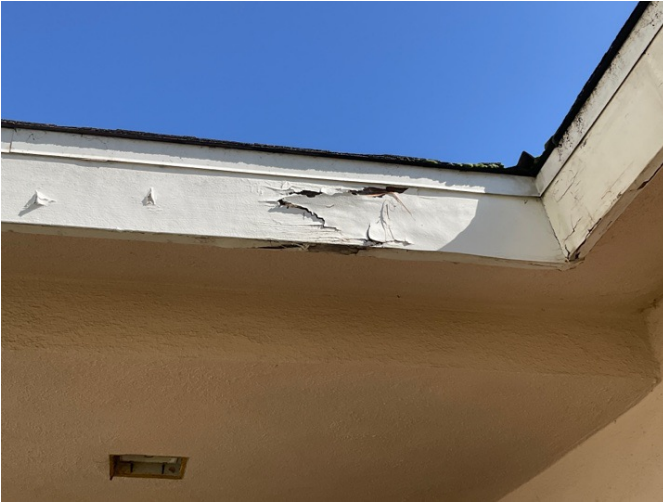
s-23: Degraded wood was observed at some areas of the fascia boards. A termite inspector should evaluate this further as we are not qualified.

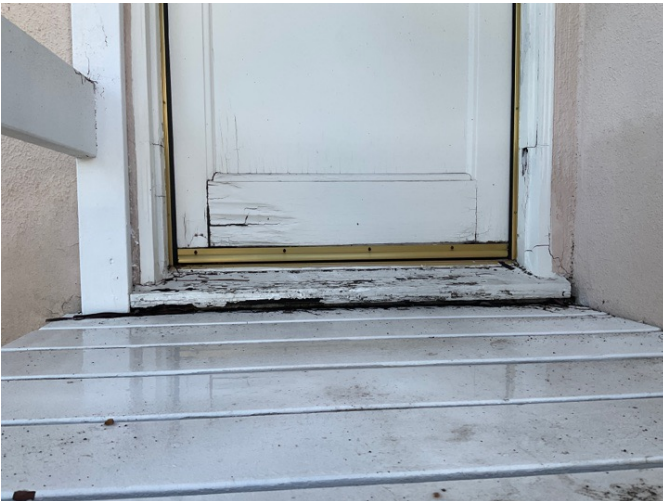
s-26: The rear door is degraded and in need of service.

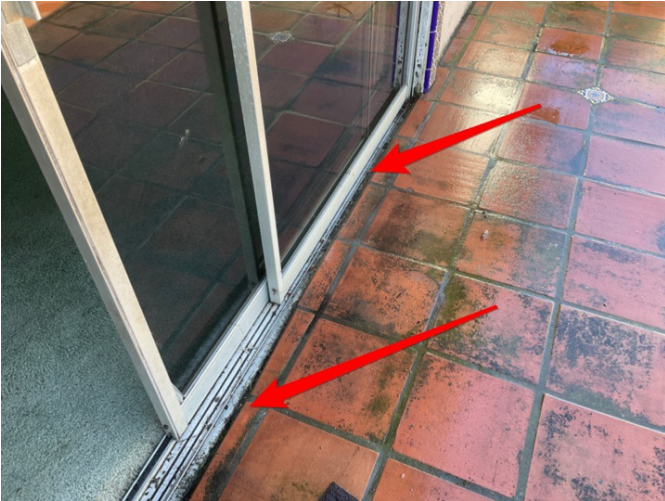
s-28: The sliding glass door is lower than the adjacent patio which is allowing for water intrusion.

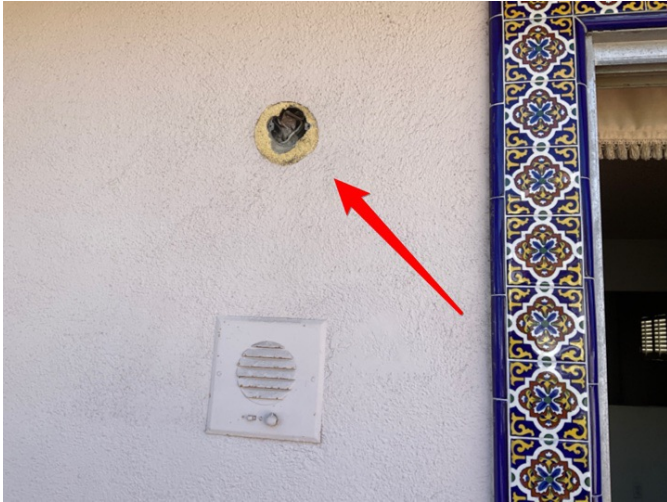
s-32: An approved weather-resistant cover is required at an open junction box located at the rear patio.

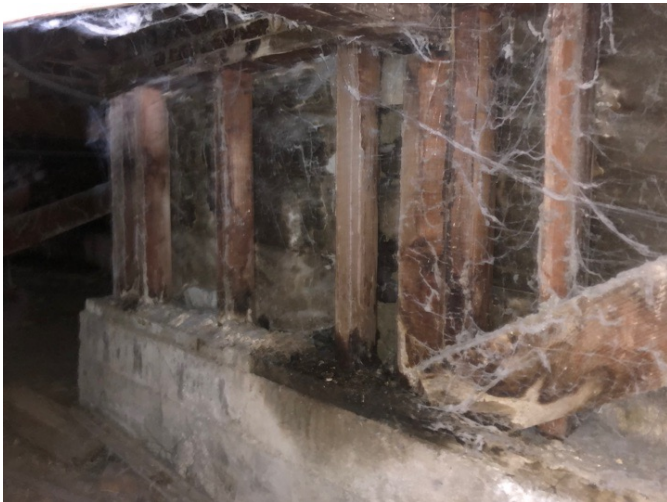
s-45: The cripple walls are not sheathed. You may wish to upgrade the cripple walls for improved seismic stability. Please consult a foundation retrofit specialist for specific recommendations.

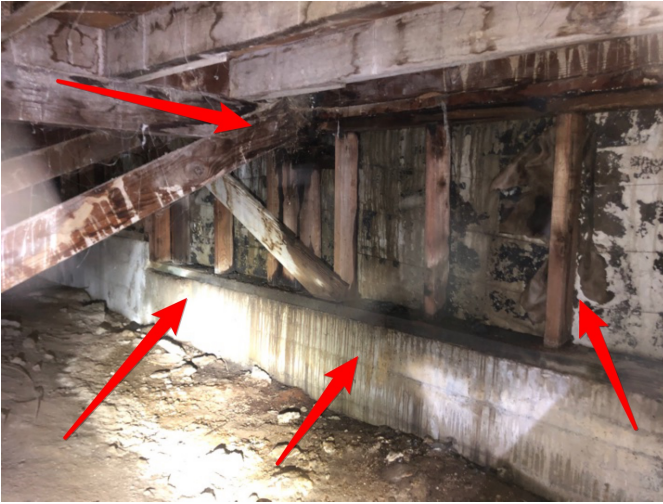
s-46: Degraded wood was noted under the family room sliding glass door. This should be evaluated by a licensed termite inspector to determine if wood repairs or replacements are needed.

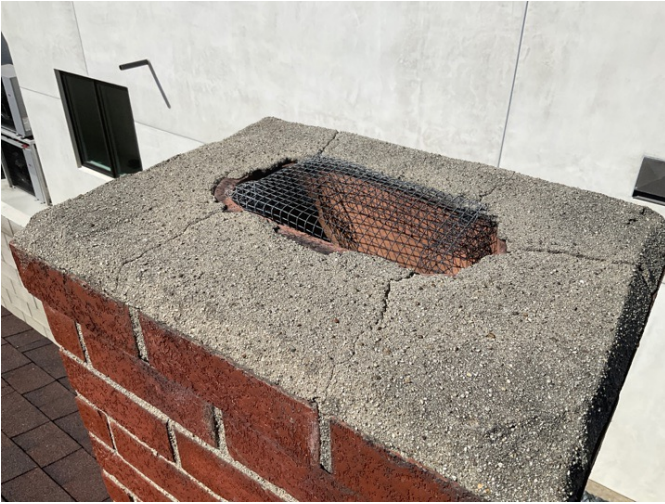
s-71: The spark arrestor is not a conventional one or an approved type which you may wish to have replaced.

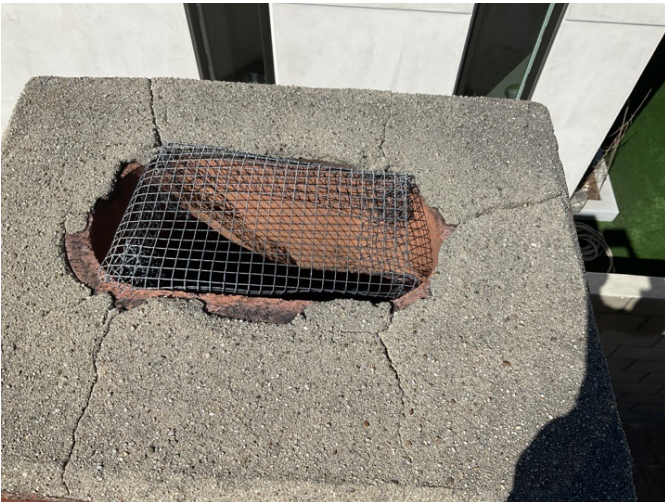
s-72: The chimney crown, which is designed to seal the chimney wall and shed rainwater, is cracked and should be sealed.

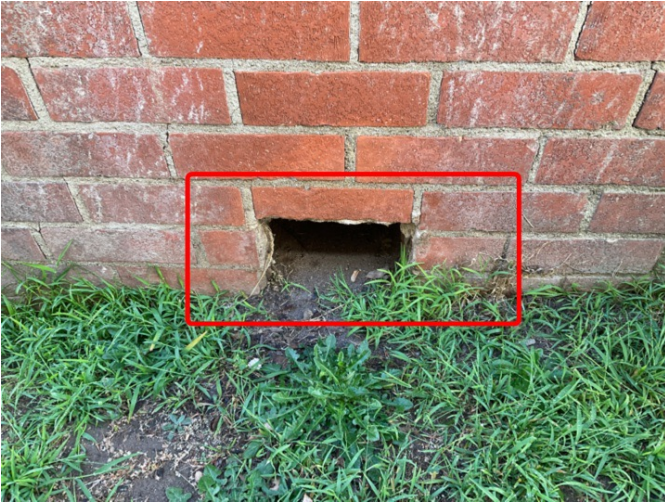
s-79: The door on the ash box is missing (one should be installed).

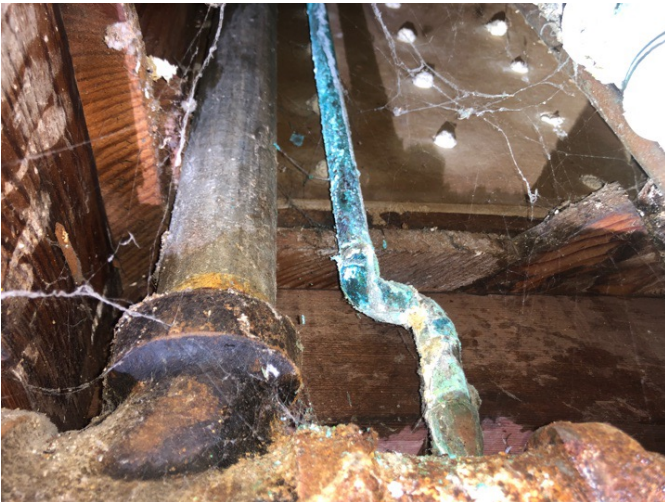
s-85: The copper water pipes are in acceptable condition, with the exception of a corroded pipe under the bathtub. This should be repaired by a plumber.

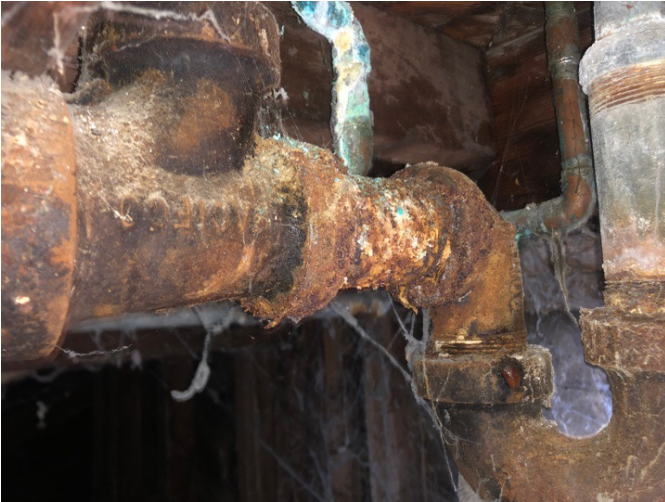
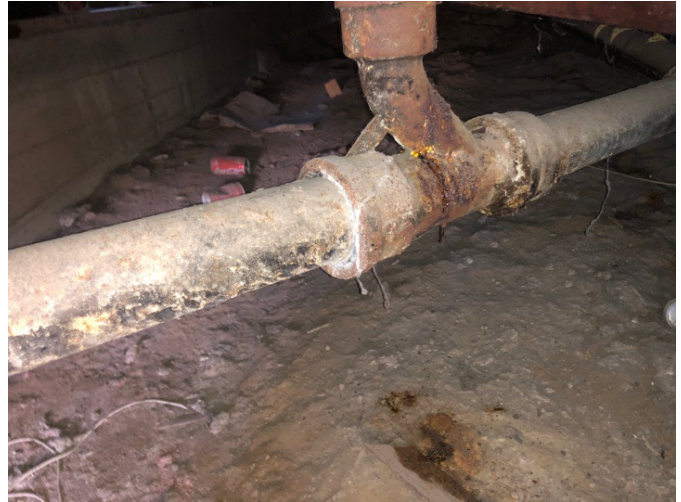
s-89: There is corrosion on the original drainpipes below the home and active leakage was observed. The pipes are in need of repair but also should be monitored as near term replacement will be needed. The entire drain line system should be thoroughly examined by a licensed plumber to determine the extent of necessary repairs.

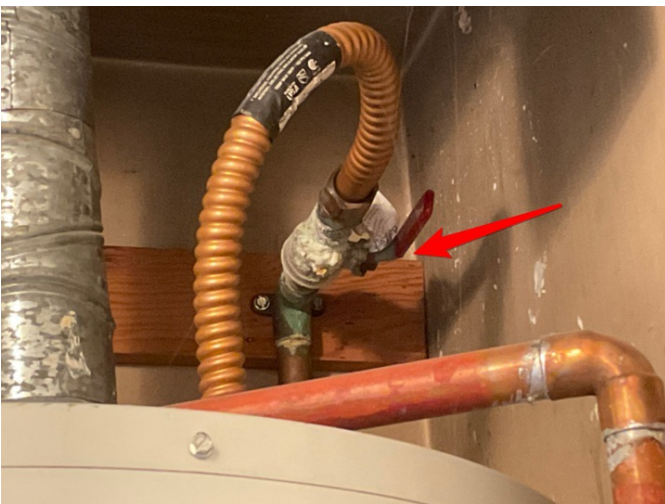
s-103: The water shut-off valve on the water heater has corrosion, likely due to past leakage. The valve should be monitored for future leakage or replaced.

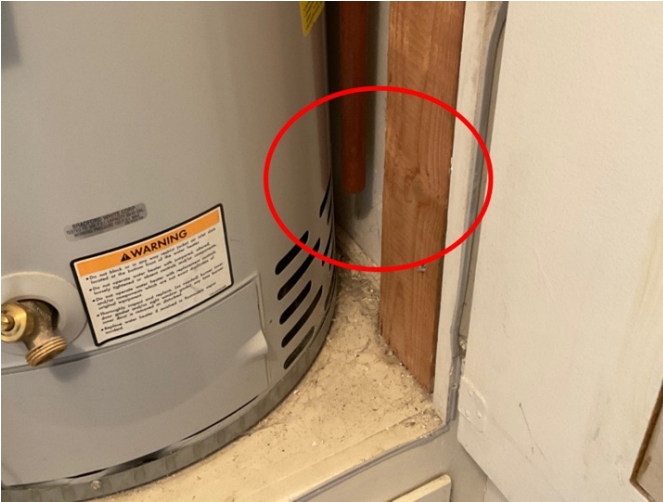
s-108: The discharge pipe from the pressure relief valve on the water heater must extend to the exterior and terminate at a point no more than 24" above grade and no closer than 6" to it.

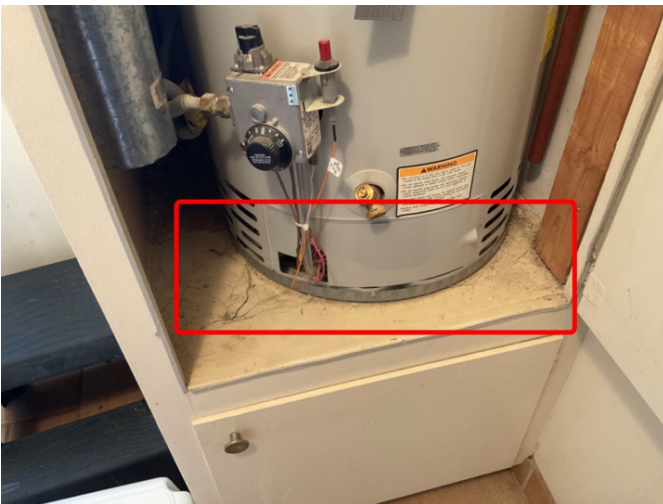
s-109: The water heater is not equipped with a drip pan or overflow pipe which is designed to minimize water damage from a leak. Although it may not be required, installation is recommended.

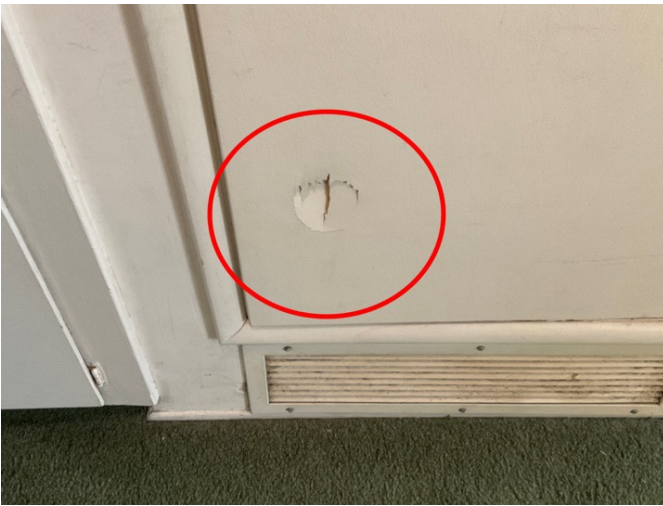
s-129: The heating system closet door is damaged.

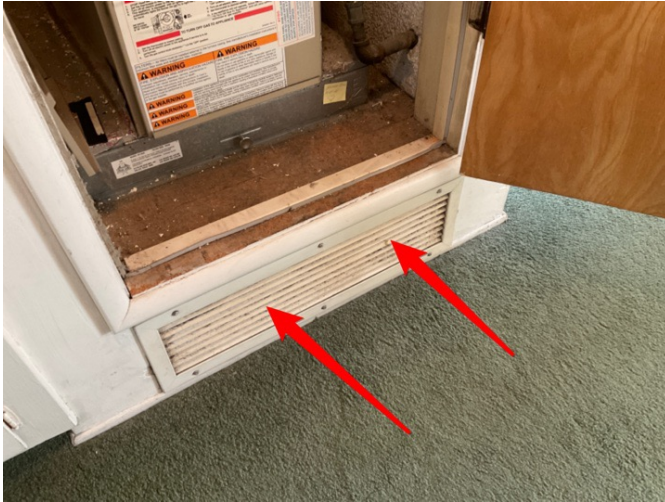
s-133: The return-air intake is located within 10' of the furnace closet. Because the furnace closet is not sealed, this can result in a back-draft where bi-products of combustion are circulated into the home. The closet door should be well sealed when closed.

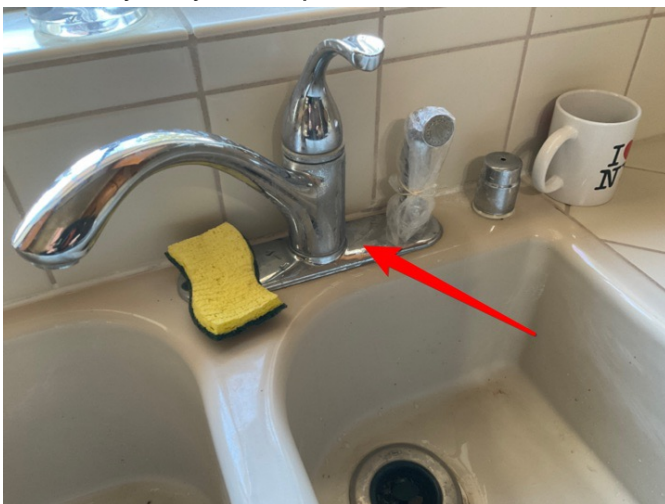
s-146: The sink faucet leaks around the mixer while in use (service needed). A new cartridge assembly may be required.

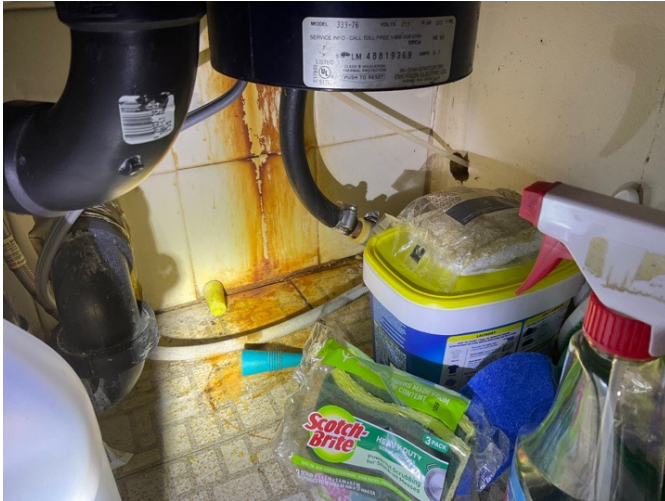
s-147: The sink faucet is leaking into the cabinet below.

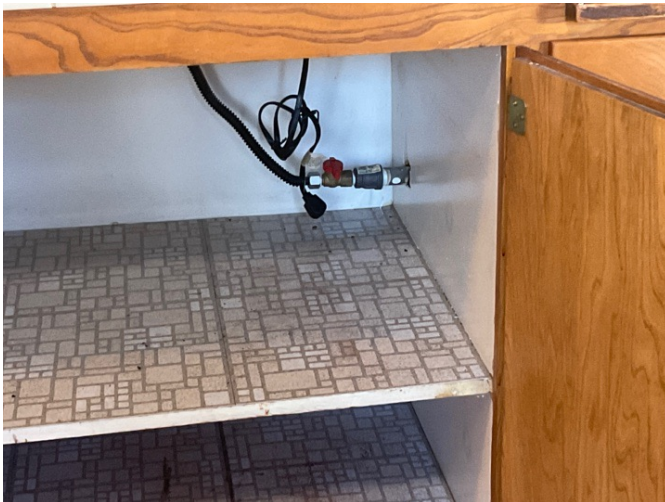
s-150: The gas was off to the cook top and the unit was unplugged. When tested, the igniters did not respond.

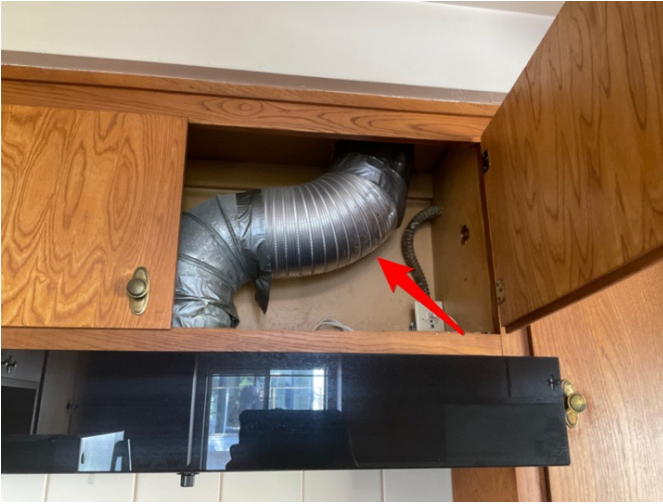
s-153: The flexible duct at the kitchen exhaust fan is not approved for this use as it may trap grease (potential fire hazard). This duct should be replaced with approved smooth-walled material.
