Confidential Inspection Report

LOCATED AT:
1637 1st st
Manhattan Beach, California 90266

INSPECTED ON:
Tuesday, March 29, 2022

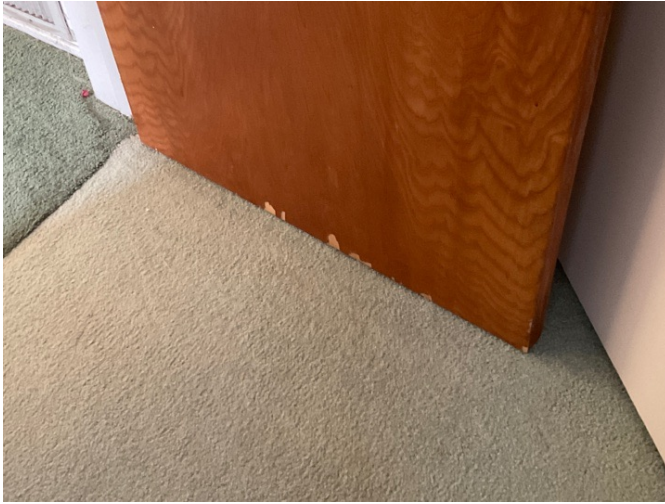
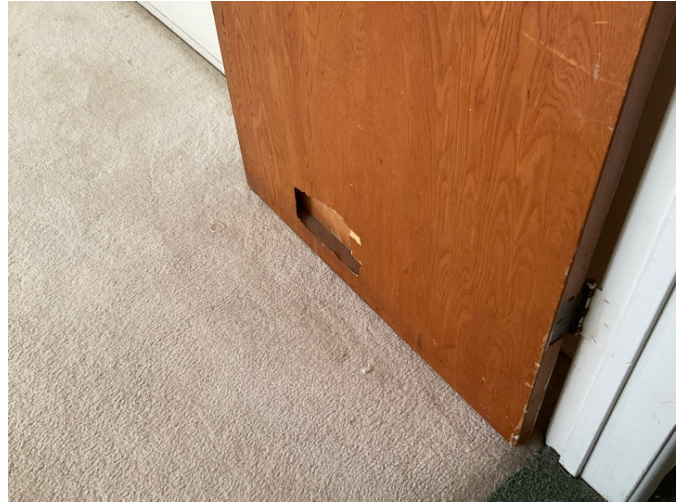
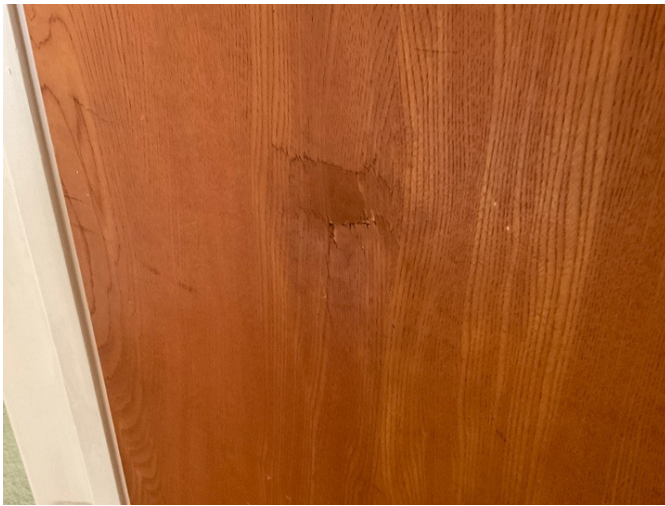
s-174: The doors were examined and are functional but have cosmetic damage.

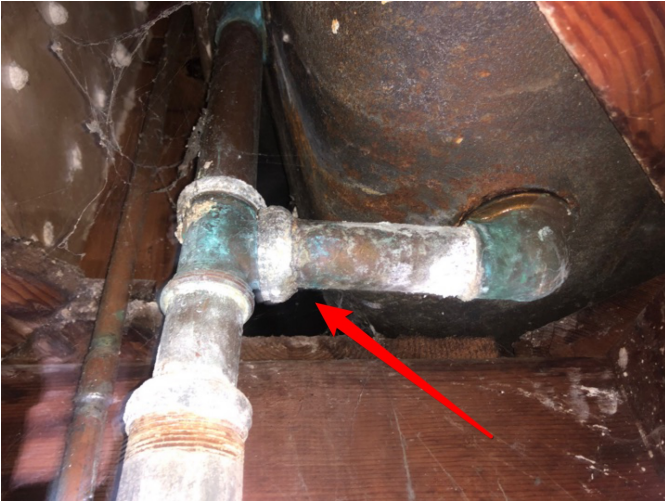
s-202: There is a drain leak below the bathtub that should be repaired.

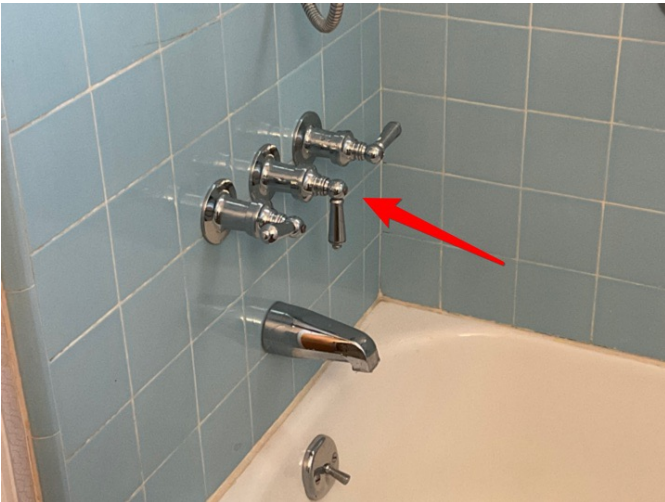
s-203: The shower diverter valve in the tub-shower is defective (repair or replacement needed).

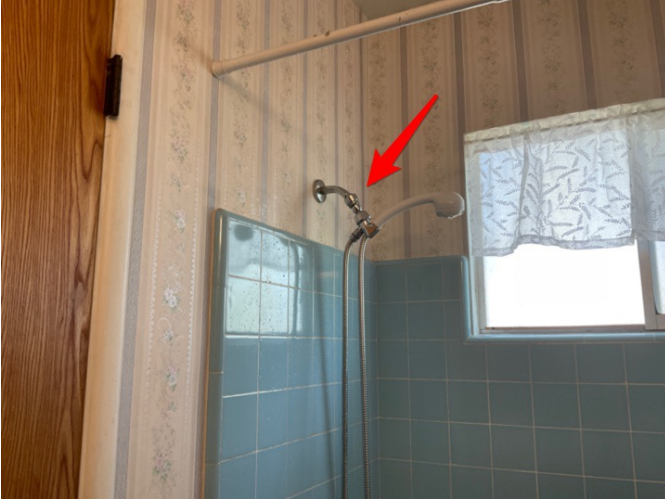
s-204: The hand sprayer leaks (repairs needed).

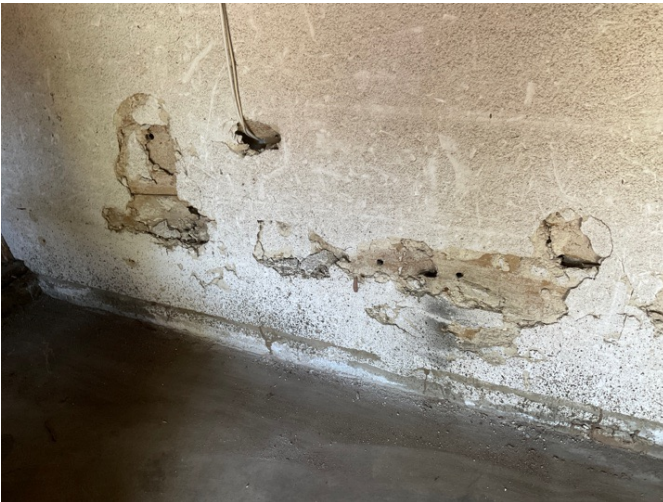
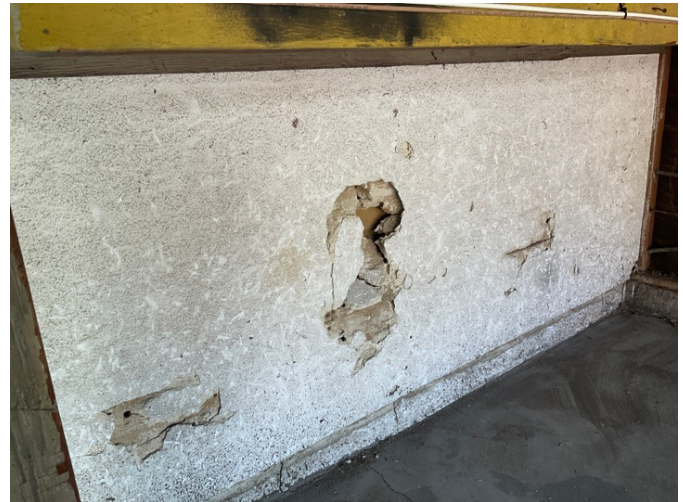
s-236: The voids in the garage firewall must be repaired with approved 1-hour fire rated material in order to maintain the necessary firewall separation between the garage and the living quarters.
