# WOOD DESTROYING PESTS AND ORGANISMS INSPECTION REPORT

#: 20256712

| BUILDING NO.<br><b>522</b> | STREET<br><b>AVENUE F</b> | CITY<br><b>REDONDO BEACH</b> | ZIP<br><b>90277</b> | Date of Inspection<br><b>07/25/2025</b> | NUMBER OF PAGES<br><b>1 of 6</b> |

| GENERAL DESCRIPTION:<br>Single story, duplex with attached garage. It has a composition shingle roof and was vacant at the time of inspection. | Inspection Tag Posted:<br><b>Garage.</b> |

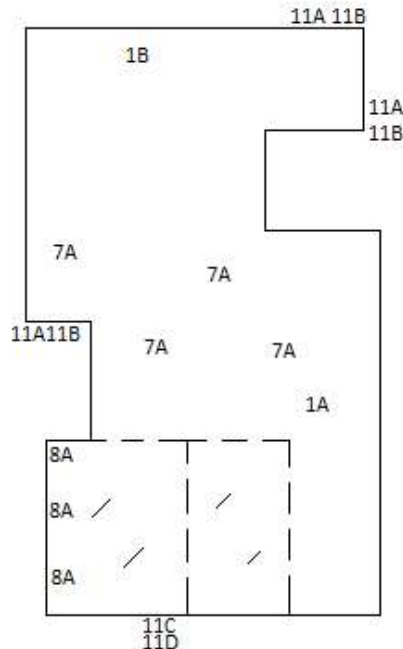
| FINDING AND RECOMMENDATION: 1A | Evidence of a plumbing leak as indicated by 1A on the diagram. Evidence noted in or near: PIPE/DRAIN<br><br>We recommend contacting an appropriate tradesman to correct this condition. |
| FINDING: | FUNGUS DAMAGE indicated by 1B on diagram. The FUNGUS DAMAGE was noted in or near: SUBFLOOR. |

Evidence of DRYWOOD TERMITES as indicated by 7A on the diagram. Evidence noted in or near: ATTIC FRAMING.

Evidence of SUBTERRANEAN TERMITES as indicated by 8A on the diagram. Evidence noted in or near: FRAMING.

Evidence of DRYWOOD TERMITES as indicated by 11A on the diagram. Evidence noted in or near: FASCIA.

DRYWOOD TERMITE DAMAGE as indicated by 11B on diagram. The damage was noted in or near: FASCIA.

| FINDING: | Evidence of DRYWOOD TERMITES as indicated by 11C on the diagram. Evidence noted in or near: GARAGE DOOR JAMB. |
| FINDING: | DRYWOOD TERMITE DAMAGE as indicated by 11D on diagram. The damage was noted in or near: GARAGE DOOR JAMB. |

| RECOMMENDATION: 1B | We recommend scraping or brushing area and treating with a registered fungicide. |

Fumigate the structure with a fumigant lethal to DRYWOOD TERMITES (Sulfuryl Fluoride). See the occupants fumigation notice for further details. This company is not responsible for delays or schedule changes due to inclement weather or other agencies, nor is it responsible for damage to roof or plants as a result of the fumigation. Refer to the occupant's fumigation notice/preparation sheet (sent separately) for additional information.

Drill through concrete slab and inject soil with a termiticide toxic to SUBTERRANEAN TERMITES (NAVIGATOR) in the area of infestation. Fill holes as necessary with a super plugs and fill with a concrete filler and sealant. Remove any evidence of infestation in visible and accessible areas.

Remove and replace damaged wood as necessary with today's available widths and grades.

Scrape out termite damage and repair with appropriate wood filler.

| RECOMMENDATION: 11C | Fumigate the structure with a fumigant lethal to DRYWOOD TERMITES (Sulfuryl Fluoride). See the occupants fumigation notice for further details. This company is not responsible for delays or schedule changes due to inclement weather or other agencies, nor is it responsible for damage to roof or plants as a result of the fumigation. Refer to the occupant's fumigation notice/preparation sheet (sent separately) for additional information. |
| RECOMMENDATION: 11D | Scrape out termite damage and repair with appropriate wood filler. |
