EQUITY BUILDING INSPECTION

RESIDENTIAL BUILDING INSPECTION

27013 Springcreek Rd Rancho Palos Verdes, CA 90275

> Wei Chung Peng 04/11/2024

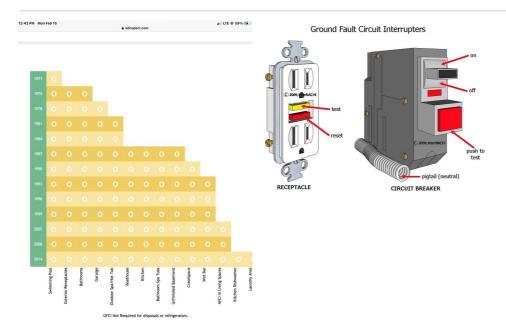
The receptacle(s) was not GFCI protected at the following areas. Although, these receptacles may not have been required at the original time of construction, we highly recommend they be installed in order to protect against electrical shock. Note: Anytime you upgrade or remodel an area, that area shall conform to the current building standard.

Contact a qualified electrical contractor.

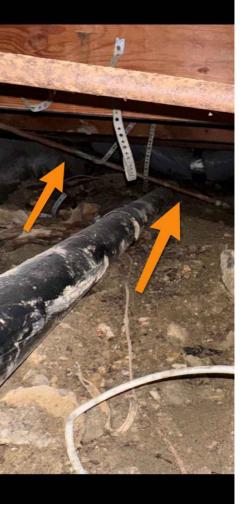
Sections of the visible supply plumbing we not properly supported or attached. We recommend repair to prevent possible damage to the supply plumbing.

Contact a qualified plumbing contractor.

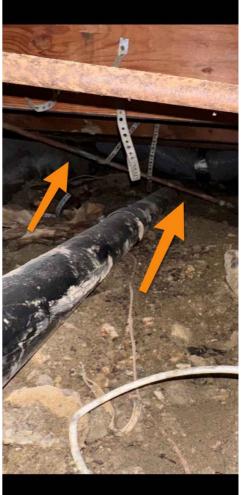
CAST IRON CRAWL WARNING

Some or all of the drain lines and vent pipes are made of cast iron. This material has a useful life span of 50-75+ years depending on conditions. No observable leaks were found at time of inspection but client should plan on budgeting for replacement of drain lines in the future. Periodic checkups in the crawl space should be performed to ensure that waste-water is not leaking into crawlspace areas.

Contact a qualified plumbing contractor.
