WOOD DESTROYING PESTS AND ORGANISMS INSPECTION REPORT

#: 20223708

BUILDING NO. 6632	STREET VERDE RIDGE RD.	CITY RANCHO PALOS VERDES	ZIP 90275	Date of Inspection 10/31/2022	NUMBER OF PAGES 1 of 6
-----------------------------	----------------------------------	------------------------------------	---------------------	---	----------------------------------

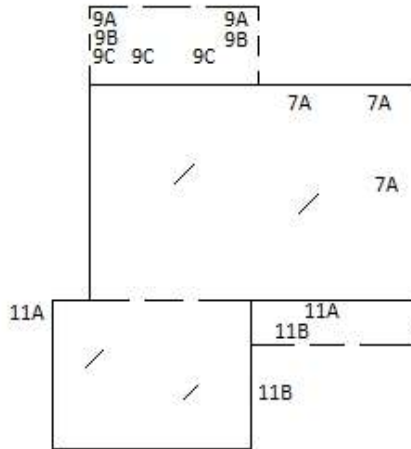
FINDING: Evidence of DRYWOOD TERMITES as indicated by 7A on the diagram. Evidence noted in or near: ATTIC FRAMING.

ITEM NO. 9A (Section 1)
FINDING: Evidence of DRYWOOD TERMITES as indicated by 9A on the diagram. Evidence noted in or near: POSTS.

ITEM NO. 9B (Section 1)
FINDING: DRYWOOD TERMITE DAMAGE as indicated by 9B on diagram. The damage was noted in or near: POSTS.

ITEM NO. 9C (Section 1)
FINDING: FUNGUS DAMAGE indicated by 9C on diagram. The FUNGUS DAMAGE was noted in or near: JOISTS, TRELLIS 2x6x12 (2), 2x4x8 (10).

ITEM NO. 11A (Section 1)
FINDING: FUNGUS DAMAGE indicated by 11A on diagram. The FUNGUS DAMAGE was noted in or near: FASCIA.

ITEM NO. 11B (Section 1)
FINDING: FUNGUS DAMAGE indicated by 11B on diagram. The FUNGUS DAMAGE was noted in or near: BEAMS.

RECOMMENDATION: 7A Fumigate the structure with a fumigant lethal to DRYWOOD TERMITES (Sulfuryl Fluoride). See the occupants fumigation notice for further details. This company is not responsible for delays or schedule changes due to inclement weather or other agencies, nor is it responsible for damage to roof or plants as a result of the fumigation. Refer to the occupant's fumigation notice/preparation sheet (sent separately) for additional information.

RECOMMENDATION: 9A This item included in 7A.

RECOMMENDATION: 9B Cut off termite damage and repair with appropriate wood filler.

RECOMMENDATION: 9C Remove and replace damaged wood as necessary with today's available widths and grades.

RECOMMENDATION: 11A Remove and replace damaged wood as necessary with today's available widths and grades.

RECOMMENDATION: 11B Cut out FUNGUS treat with a wood preservative and repair as necessary.
