# Inspection Report

**Saldivar Trust  
945 Jeanette  
Nipomo, CA 93444**

Report Date: 8/4/2025

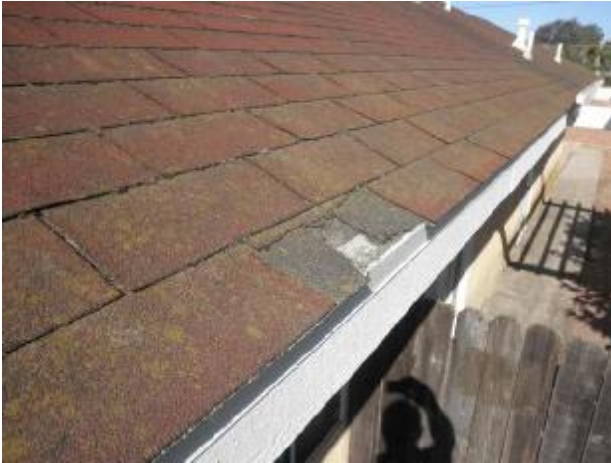
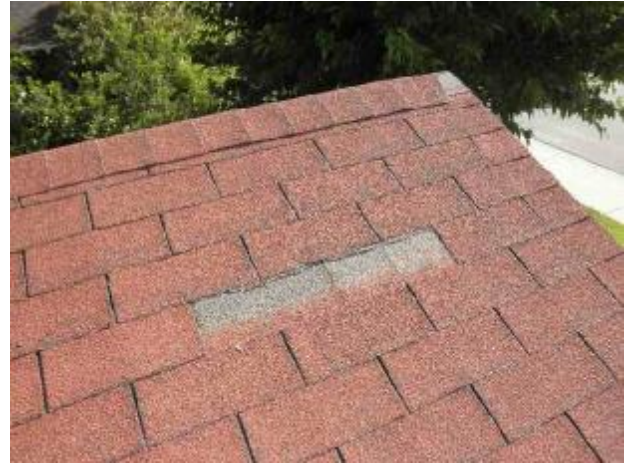
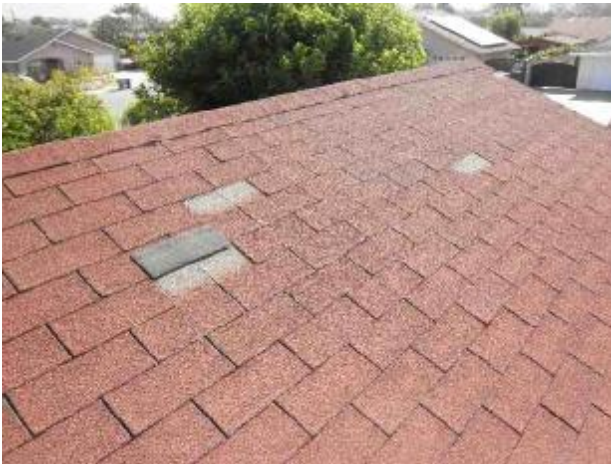
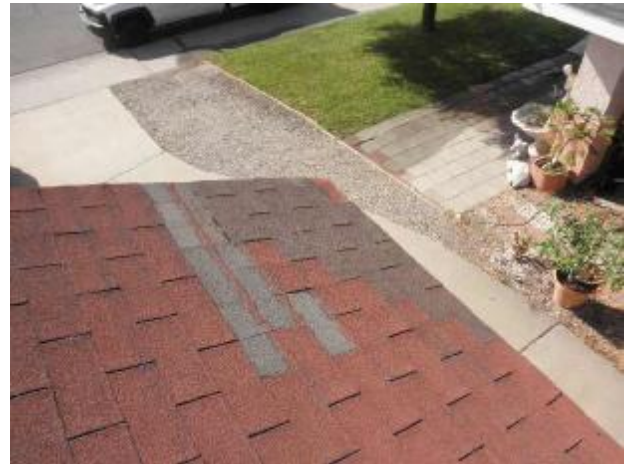
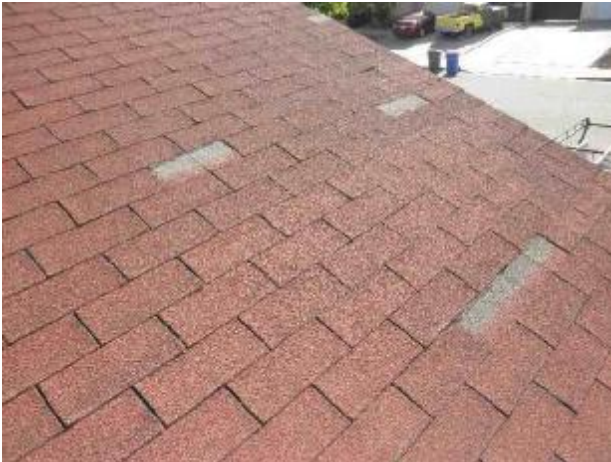
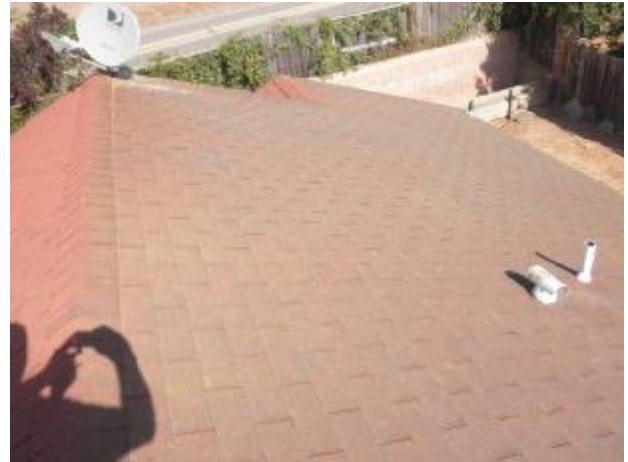
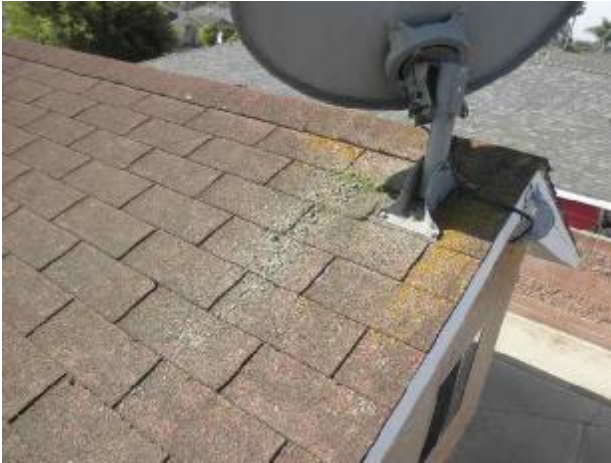
- 1.) The roof shingles have general deterioration due to age. There are multiple blown off shingles, some substandard repairs and evidence of a leak at the water heater exhaust vent flashing. This roof is in need of complete replacement.

Example of the general deterioration and damaged roof shingles.

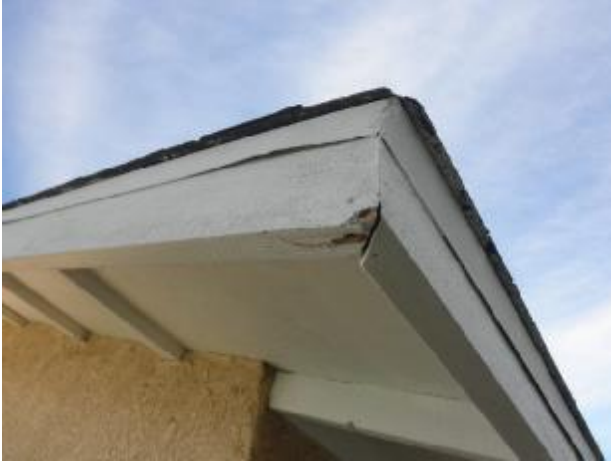
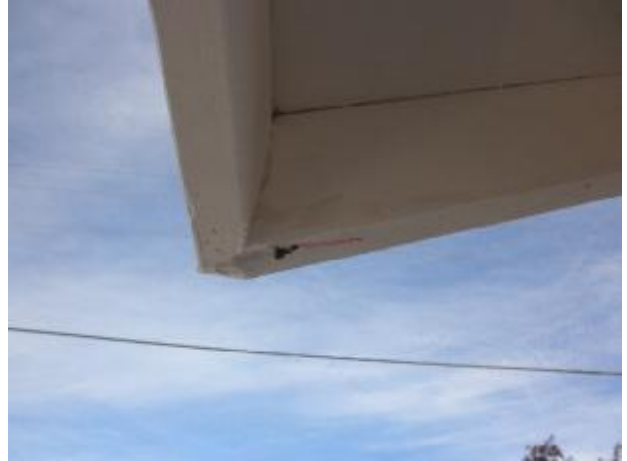
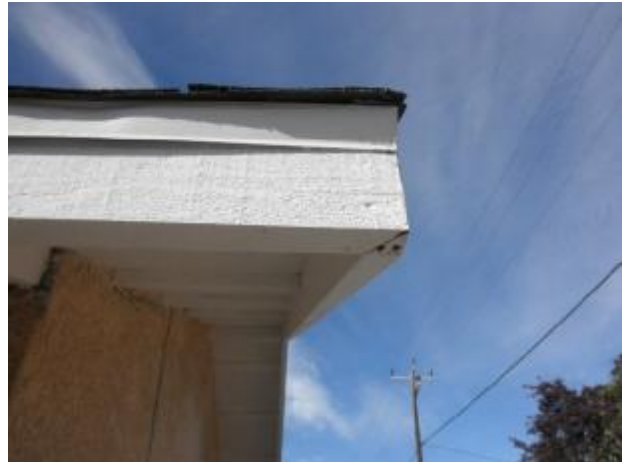
- 16 5.) Moisture damage was observed in the following locations:
- A.) The fascia board at the SE corner of the front entry roof overhang.
  - B.) The fascia board in two locations at the NW corner of the roof.
  - C.) The fascia board at the NE corner and the center east eave.
  - D.) The exterior trim at the water heater closet door.

Moisture damage at the fascia boards.

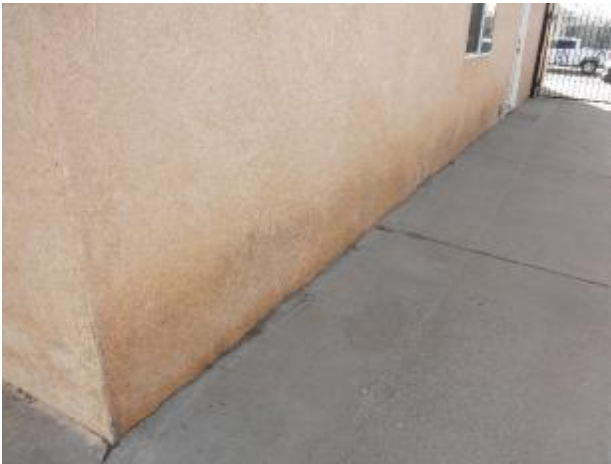
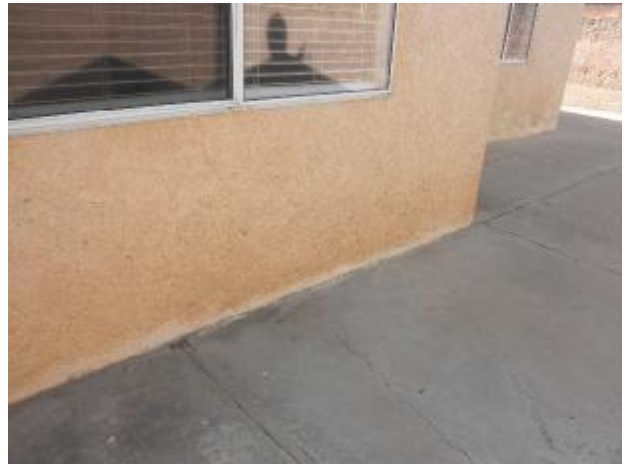
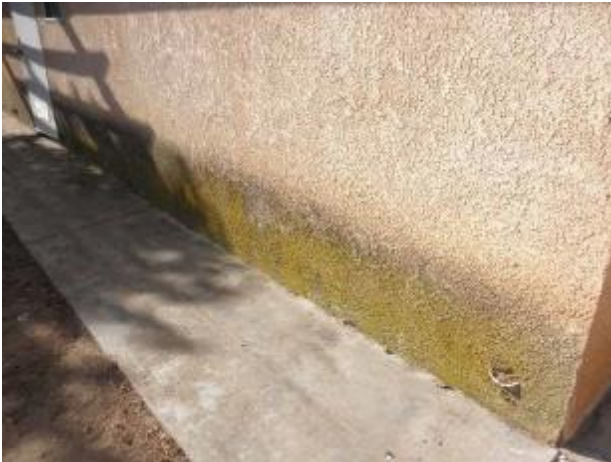
**Drainage Note:** The concrete patios and walkways on the west, north and east sides of the home embeds the weep screed at the base of the stucco walls. This can be a moisture intrusion condition.

The concrete walkways and patios embed the weep screed at the base of the stucco walls.

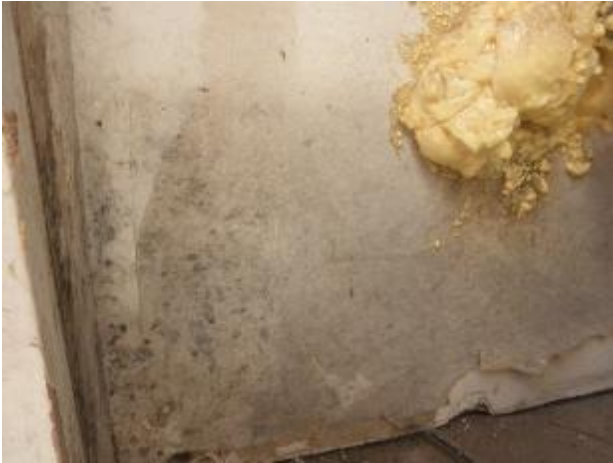
- 3.) Part of the exterior trim is missing at the water heater closet door.
- 4.) There is a black mildew like substance on the drywall inside the water heater closet. (See notes on the Deficiency Summary Report regarding the potential for microbial contamination.)

Black mildew like substance on the drywall inside the water heater closet.

Mold, mildew, fungus and other microbial organisms commonly occur in areas that show evidence of or have the potential for leaking, moisture intrusion and/or inadequate ventilation. The identification of or presence of these organisms is beyond the scope of this inspection. If concerned about this possibility, we recommend further investigation be performed by a Certified Industrial Hygienist to determine if there exists an active (or potential for) infestation or climate for incubation of a microbial contamination prior to close of escrow. (See the Exterior Page)

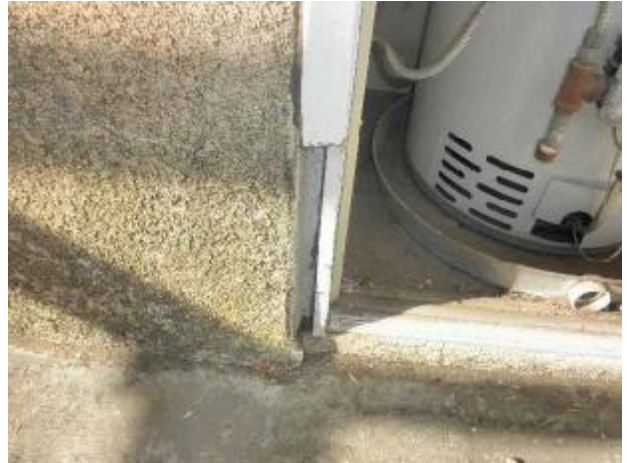
Part of the trim is missing at the water heater closet door.

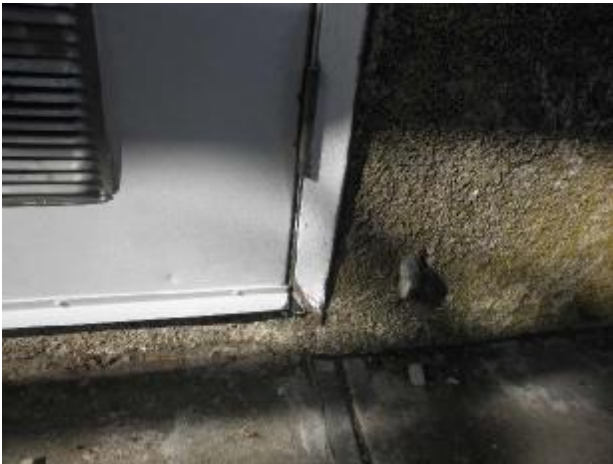
Moisture damage to part of the exterior trim at the water heater closet door.

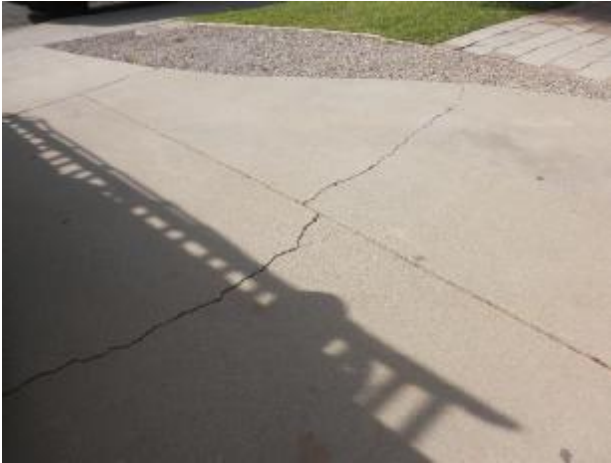
General settlement cracks in the concrete driveway.

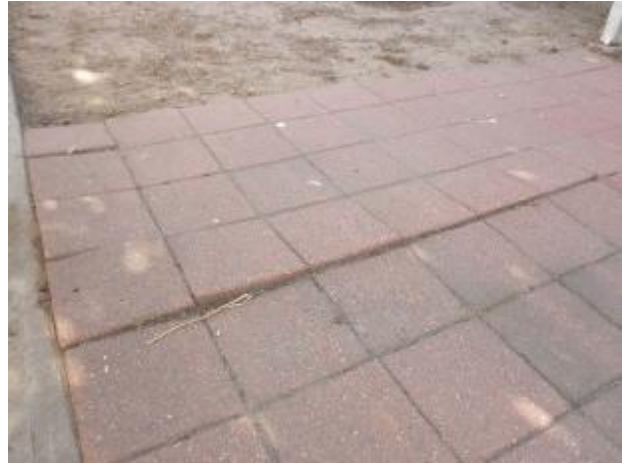
Tripping hazard at the uplifted paver patio.

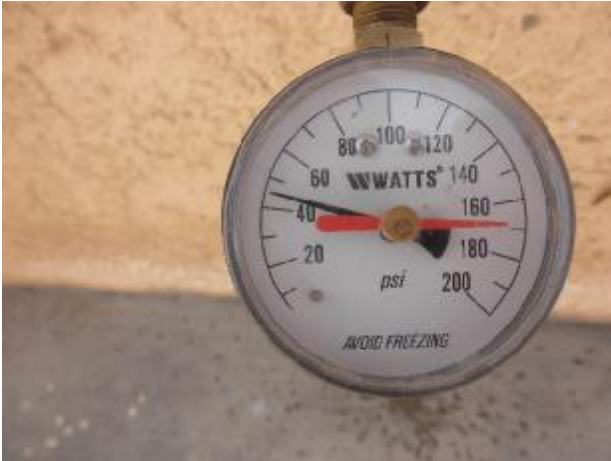
Information Note: The water pressure was measured at 45 psi at the time of inspection. This is within a normal and acceptable range.

The water pressure was measured at 45 psi.

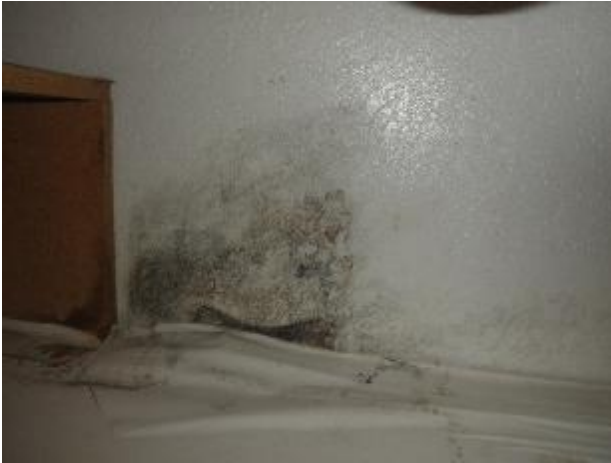
2.) There is black mildew like substance at the drywall below the sink cabinet in the half bathroom. (See notes on the Deficiency Summary page at the end of the report regarding the potential for microbial contamination.)

**Black mildew like substance under the half bathroom sink.**

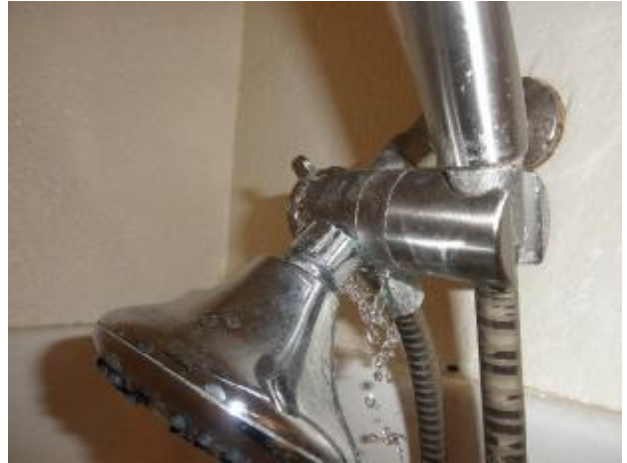
1.) The shower head connection leaks in the hall bathroom.

**Connection at the shower head leaks.**

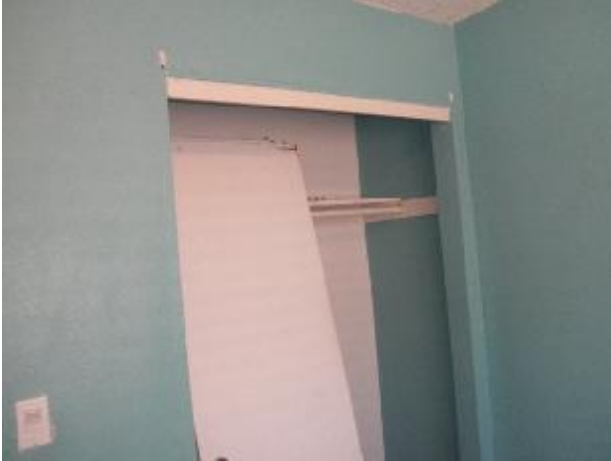
Closet door off the tracks in the west bedroom.

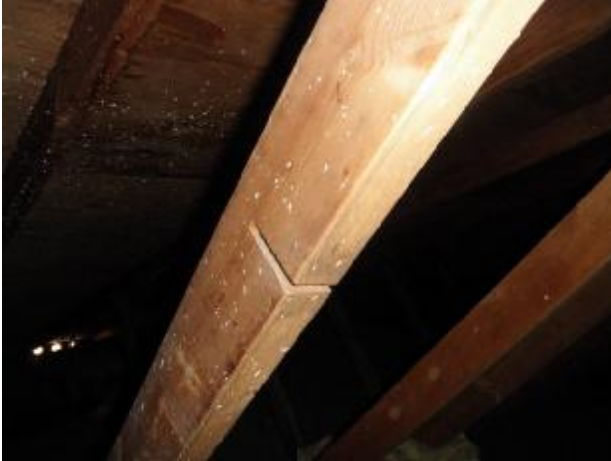
Truss cord cut through in the attic space.
