Property Inspection Report

27608 Saddle Road, Rolling Hills Estates, CA

Inspection date: 05/23/2023

Property Professor, Inc.

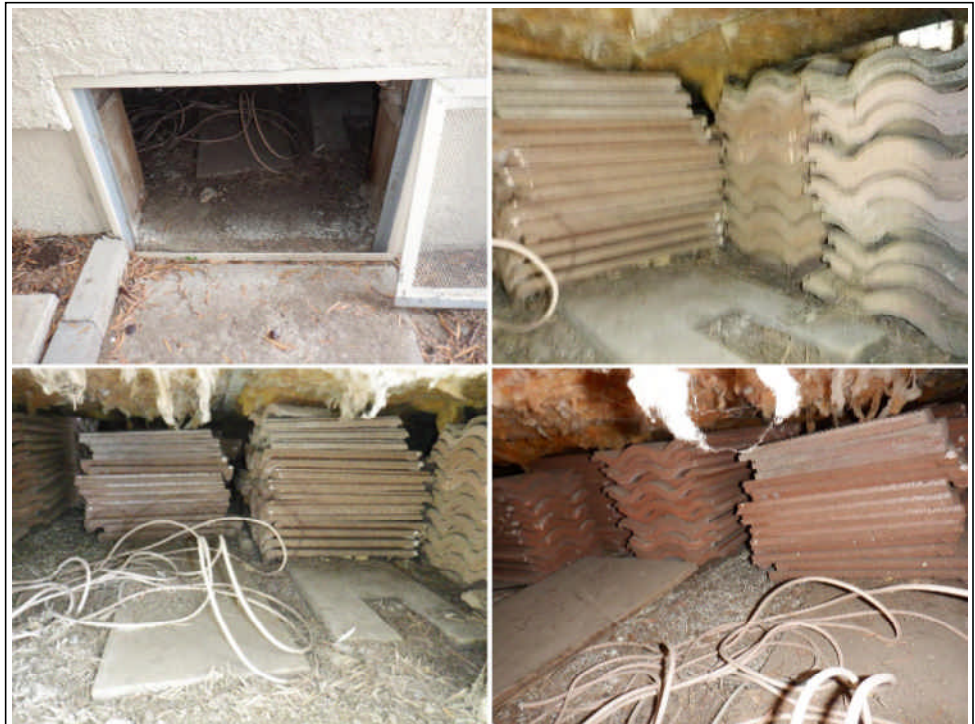
Accessed from the exterior at the right and rear sides of the building.

[CR] The crawl space access under the rear family room addition was limited due to stored concrete roof tiles. This crawl space was viewed from the access opening only. This is a limited inspection. Only the accessible sections were inspected, this is a limited inspection. We recommend access be provided for future inspections, maintenance and/or repairs.

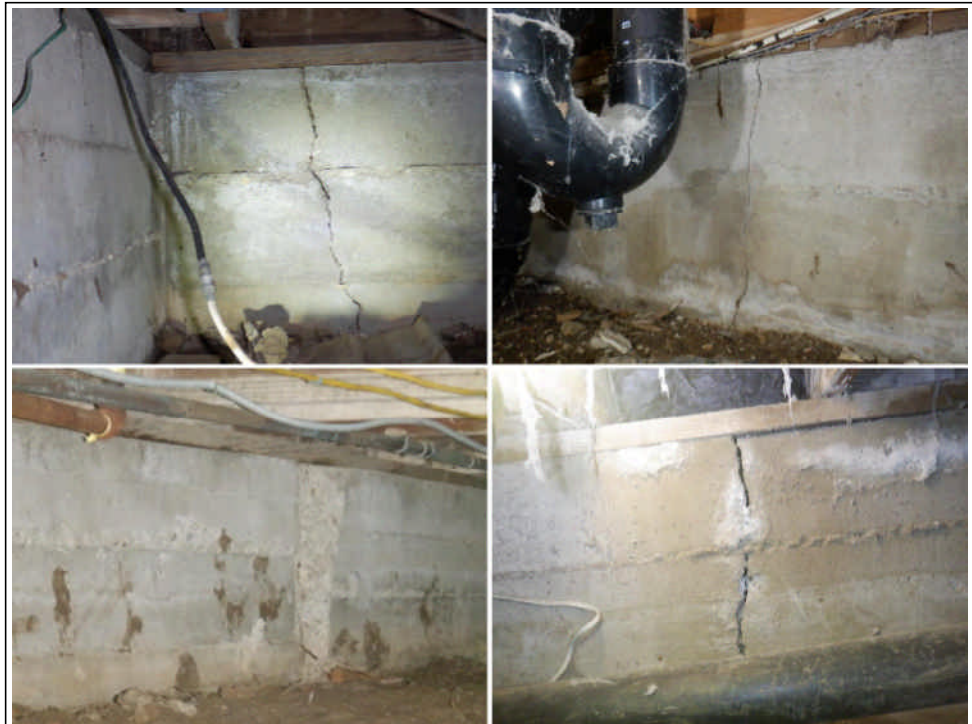
The visible foundation areas of the structure appeared functional, with exceptions noted.
 a. [FE] The original concrete foundation walls at the front and rear had evidence of cracking due to settlement/movement and/or seismic activity. We recommend a full evaluation and/or corrections by a foundation specialist in the appropriate trade.

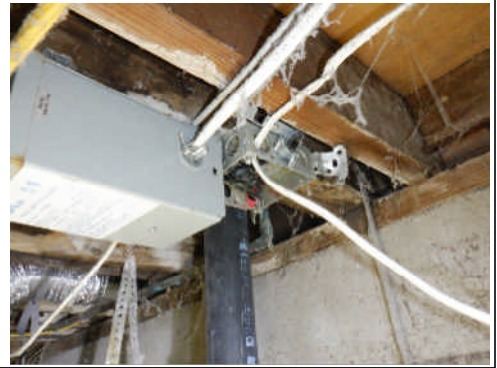
[SC] There was improper wiring in the crawl space in the form of open junction boxes (missing covers) with exposed wire connections. We recommend correcting the condition(s) noted.

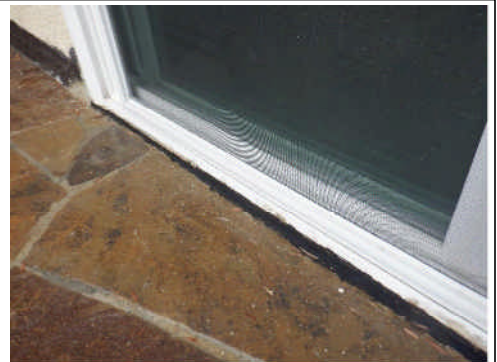
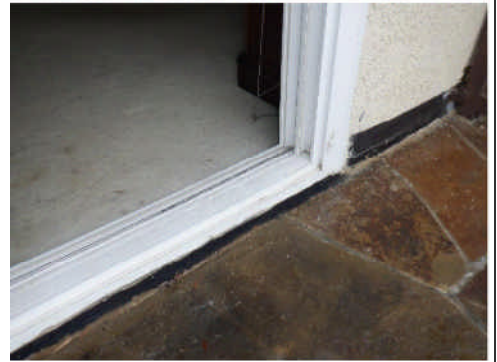
The balcony/deck coating appeared functional, with exceptions noted.
a. [FE] Evidence of patching were noted under the slider door and at the bottom of the exterior wall. This may indicate previous leakage into the structure. We recommend inquiries of the seller regarding any history of leakage, and or a full evaluation and/or corrections by a specialist in the appropriate trade.

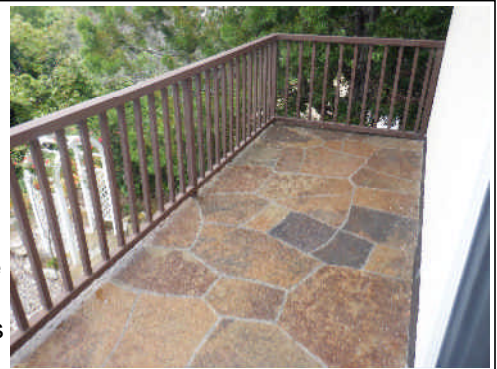
[SC] The guard rail(s) appeared functional and may have met the building standards at the time of construction, however the wide spaces between the balusters are a hazard for small children. Modern construction guidelines typically state that a "4 inch sphere" should not pass between the balusters. While upgrading may not be required, additional measures for child safety like netting or some other means is strongly recommended.

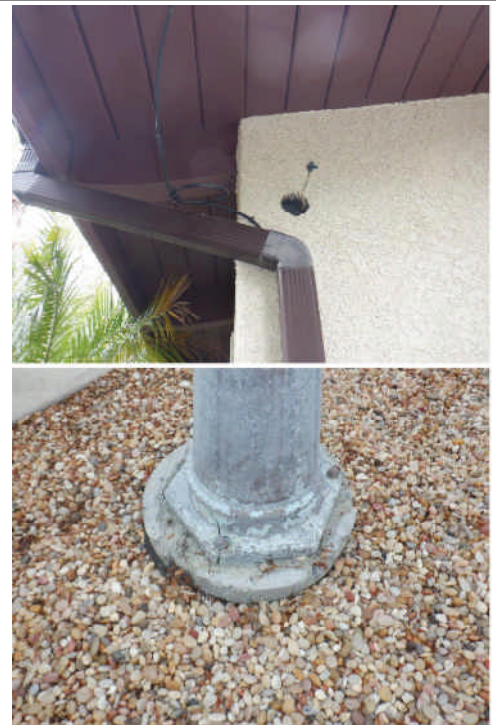
The light(s) were functional, with exceptions noted.
a. **[SC]** There was exposed wiring/ missing light fixture at the right front. We recommend correcting the condition(s) noted.
b. **[CR]** The light post at the front walkway entry was damaged at the base. We recommend correcting the condition(s) noted.

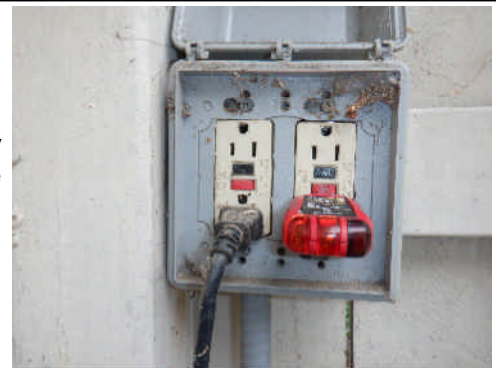
The accessible receptacles were functional, with exceptions noted.
a. **[SC]** Not all of the accessible receptacles were GFCI protected as now required. This condition is a safety hazard. We recommend correcting the condition(s) noted.
b. **[CR]** There was no power at a receptacle at the left front. We recommend correcting the condition(s) noted.

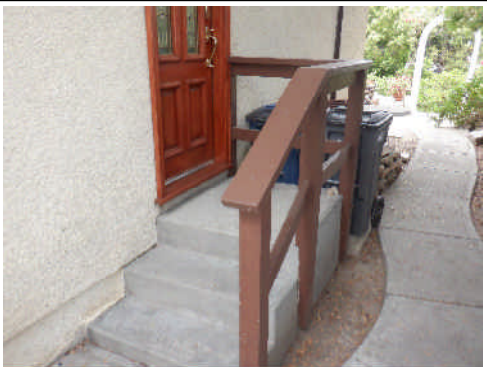
DRIVEWAY(S)	The driveway appeared functional, with some cracks noted.	
WALKWAY(S)	The walkways appeared functional, with some cracks noted.	
HANDRAIL(S)	<p>[SC] The handrail at the right was functional and may have met the standards at the time of construction, however they are not considered to be grippable by today's standards. It was also open and climbable- a child safety issue. We recommend upgrading the handrail(s) to meet today's standards for added safety.</p>

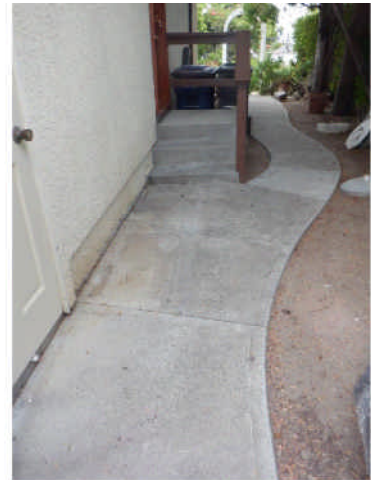
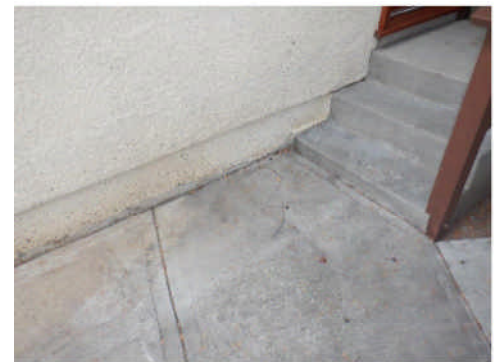
[CR] The concrete entry porch/steps at the right had settled and was sloped toward the building. This condition is a trip hazard and conducive to moisture ponding next to the building. We recommend correcting the condition(s) noted.

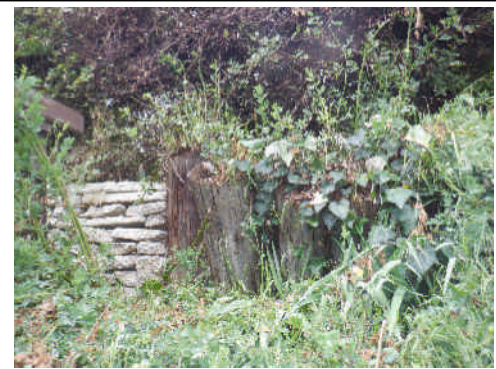
a. [FE] The wood retaining wall at the left side of the backyard was damaged and leaning. We recommend a full evaluation and/or corrections by a specialist in the appropriate trade.

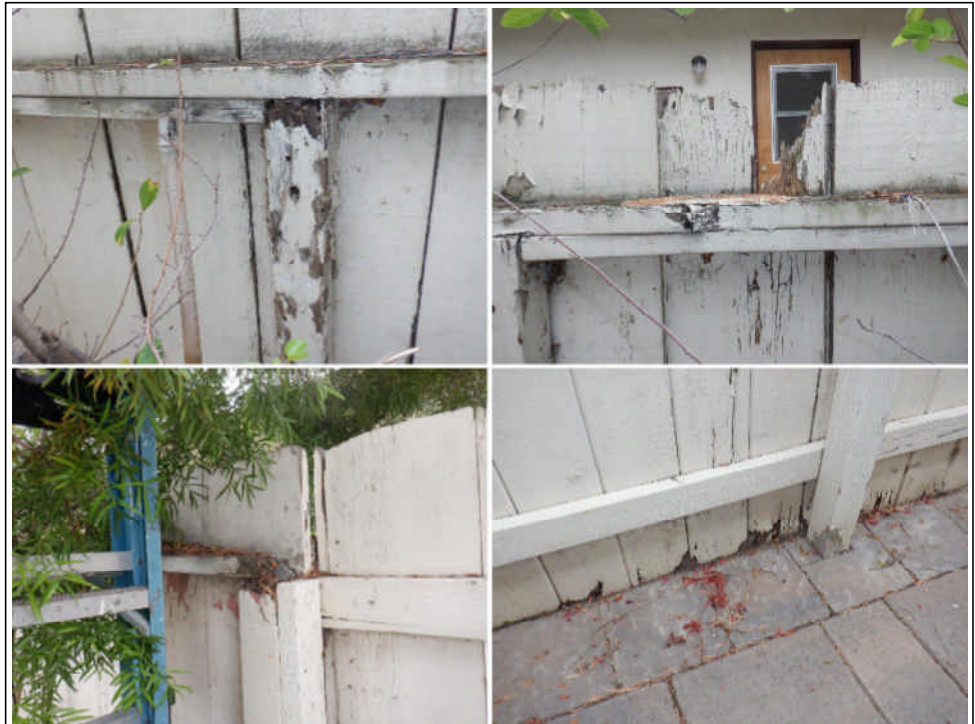
The yard fencing appeared functional, with exceptions noted.
a. [CR] The wood fencing was damaged/deteriorated at the right and left sides. We recommend correcting the condition(s) noted.

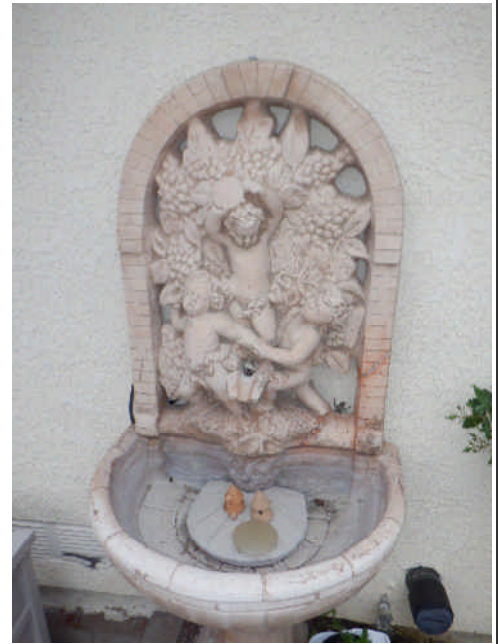
[FE] The fountain was empty of water. These system(s) are outside the scope of the inspection and are not inspected. We recommend consulting with a specialist regarding the operation and maintenance of this system.

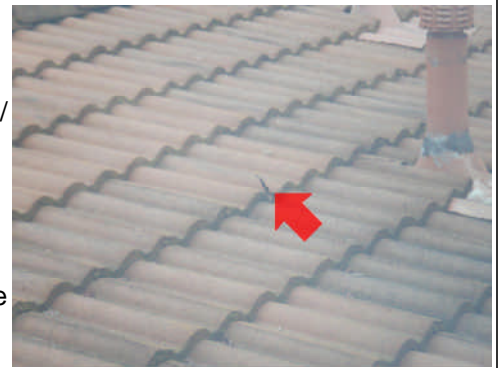
a. [FE] There was one visible cracked/broken tile at the lower roof over living room. These conditions are conducive to roof leaks. We recommend a full evaluation and/or corrections by a roof contractor.

NOTE: A significant number of tile were stored in the crawl space under the family room addition.

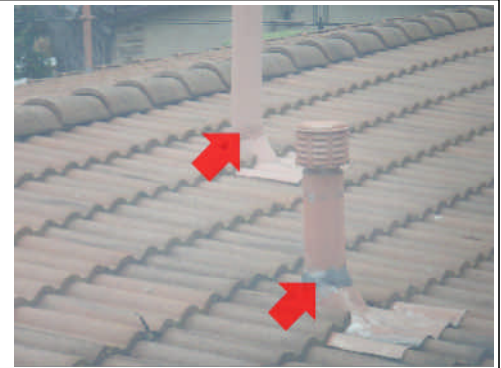
[CR] There were missing flue pipe storm collars. We recommend correcting the condition(s) noted.

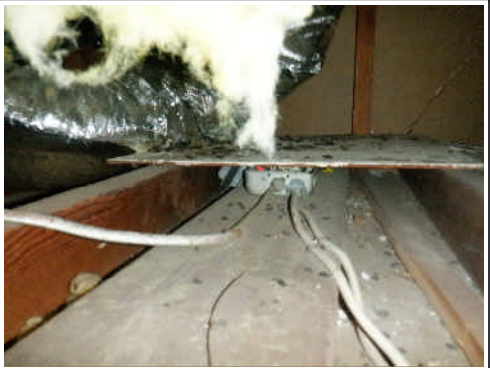
ACCESS(S)	NOTE: The attic examination was conducted from the opening only due to limited access.
FRAMING	The visible areas of the roof framing appeared functional.
CEILING JOIST(S)	The visible areas of the ceiling joists appeared functional.
SHEATHING	The visible areas of the roof sheathing appeared functional.
INSULATION	[CR] There was no visible insulation in the attic. We recommend installing insulation for energy efficiency as an upgrade.
VENTILATION	The visible attic ventilation appeared adequate.
ELECT. WIRING	[SC] There was improper wiring in the attic in the form of open junction boxes with exposed wire connections. We recommend correcting the condition(s) noted.

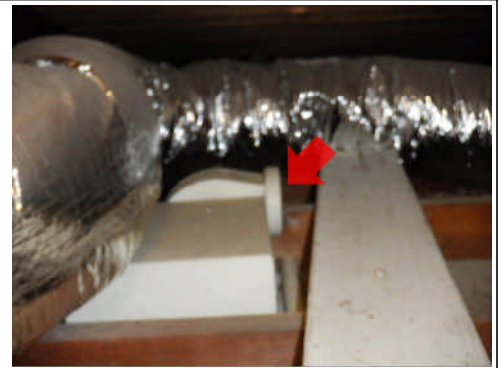
[CR] The bath vent fan(s) are exhausting into the attic. This condition is conducive to moisture build-up and deterioration of the framing or other components. We recommend correcting the condition(s) noted.

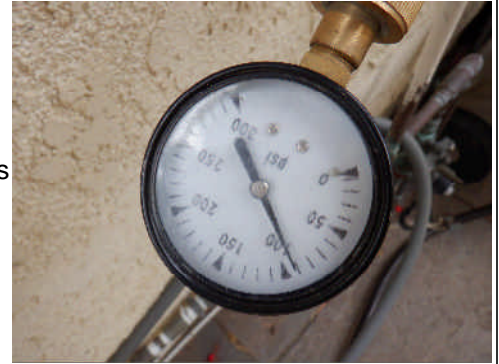
[CR] The pressure regulator installed in the water supply line by the main shutoff valve has allowed the water pressure to rise to 90 PSI, which exceeds the 80 PSI building standard. This is an indication that the regulator is not functioning as designed. We recommend the regulator be adjusted, repaired or replaced.

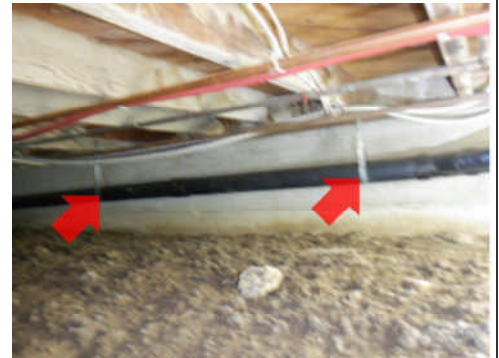
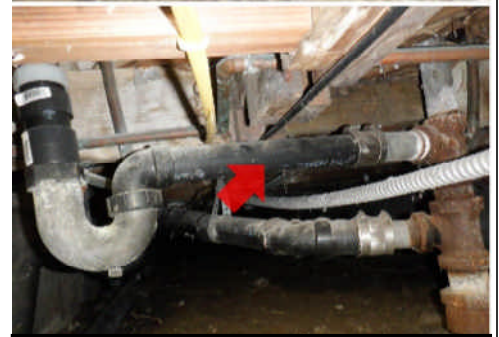
The visible waste piping appeared functional, with exceptions noted.
a. [CR] The metal strapping was in contact with the plastic waste piping in the crawl space. We recommend correcting the condition(s) noted.
b. [CR] The drain line for the lower bathroom(s) had an improper slope to provide for adequate drainage and blockage may result. We recommend correcting the condition(s) noted.

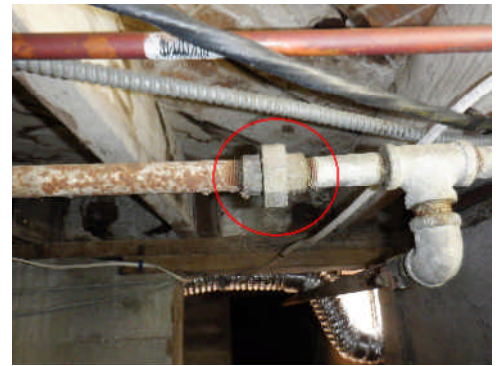
- a. **[SC]** A union fitting was used to connect gas piping in the crawl space. This is an improper location. We recommend correcting the condition(s) noted.

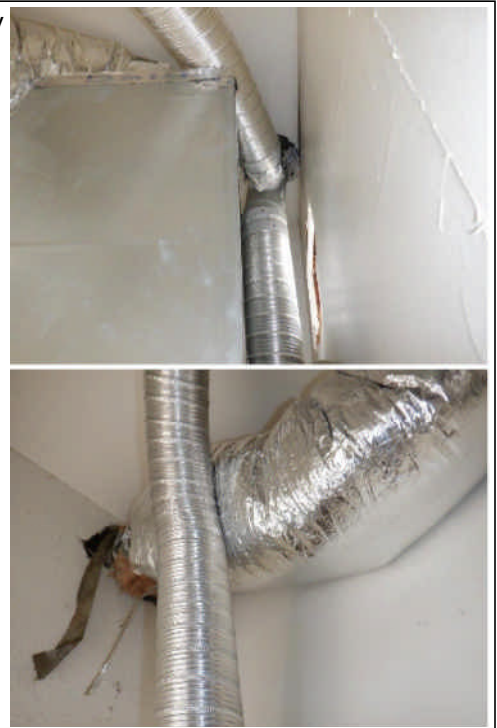
[SC] The flue vent piping was close in contact with a heating duct. This condition is a hazard. We recommend correcting the condition(s) noted.

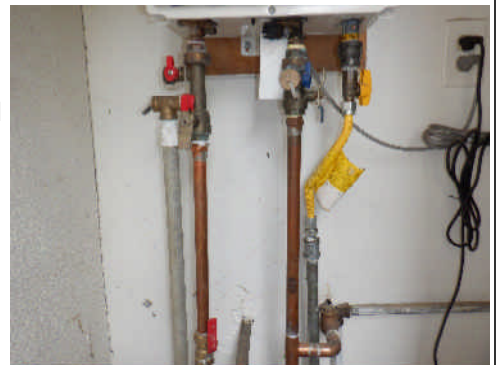
[RU] The shutoff valve and visible water supply connectors appeared functional, but they were not insulated. We recommend insulating the exposed water piping to minimize heat loss.

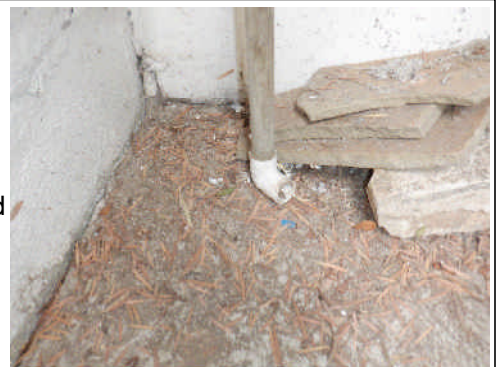
[CR] A temperature and pressure (T&P) relief valve and discharge line were installed as required. The discharge line terminated facing sideways and did not extend to the exterior. We recommend it be extended to the exterior and terminated close to the ground facing downward.

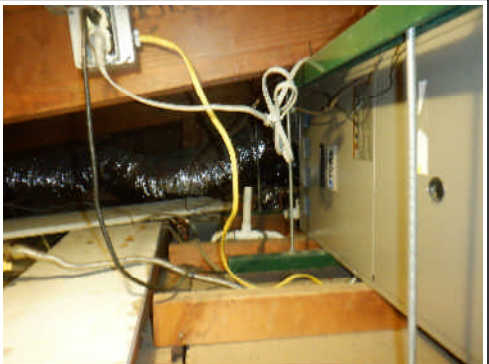
VENTING SYSTEM(S)	The visible areas of the flue vent piping were intact and secured at the connections.	
SUPPLY PLENUM(S)	The supply air plenum appeared functional.	
HEATING UNIT(S)	<p>The furnace was functional.</p> <p>[CR] The access in front of the furnace minimal and restricted by framing. We recommend corrections as possible to provide safe access to the furnace for maintenance or emergency needs.</p> <p>[CR] There was not an adequate work platform in front of the equipment. We recommend correcting the condition(s) noted.</p>

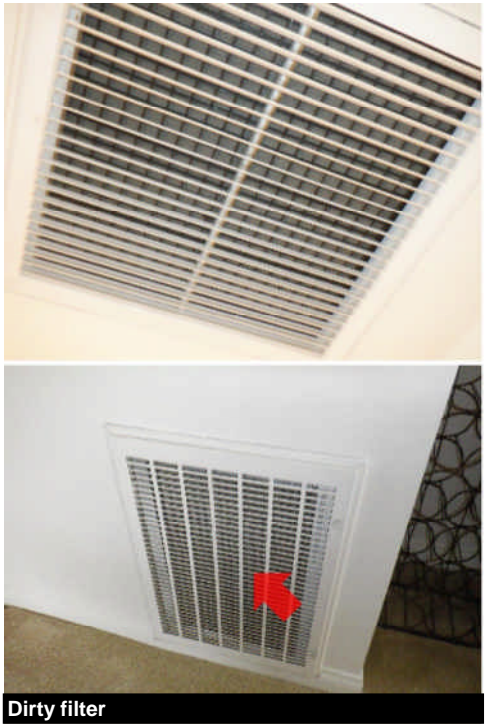
a. **[CR]** The right unit filter was dirty which blocks the air flow. We recommend the filter be cleaned or replaced.

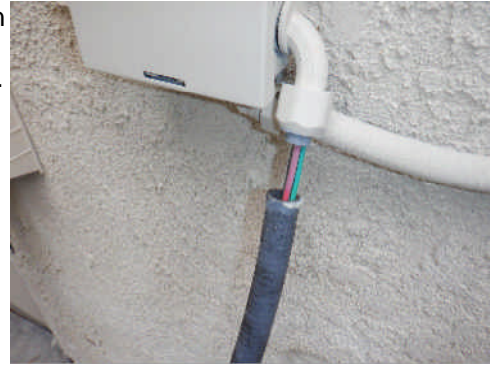
An electrical disconnect was present, in sight of and providing power to the condensing unit, with exceptions noted.
a. [SC] The flex connector/conduit was loose/ disconnected at the electrical disconnect panel. We recommend correcting the condition(s) noted.

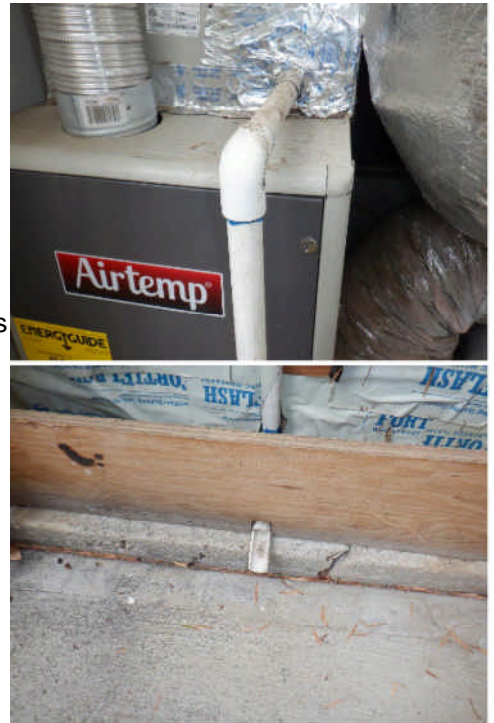
The visible areas of the condensate drain line(s) appeared functional, with exceptions noted.
a. [CR] The interior installation of the cooling system had no secondary condensation drain line to the exterior or cut-off switch. We recommend correcting the condition(s) noted.
b. [SC] The condensate drain line for the right air-conditioning system emptied on a walkway. This condition is a slip and fall safety hazard. We recommend correcting the condition(s) noted.

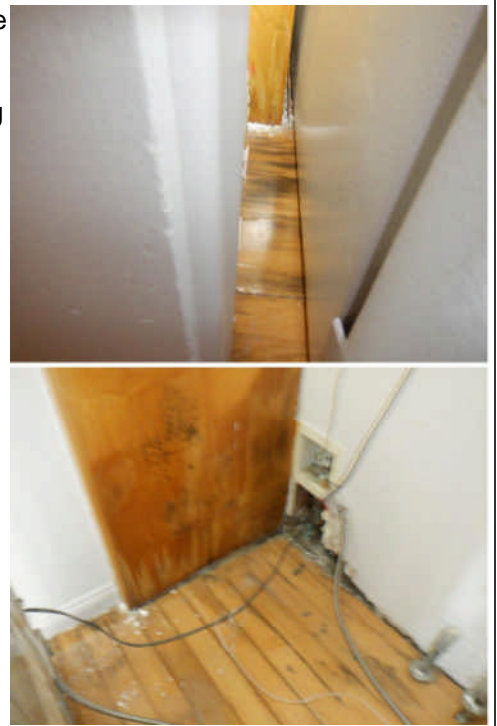
[CR] Moisture stains and damage were noted on the wood flooring. The area appeared dry during the inspection. We recommend locating and correcting the source as well as any damaged materials.

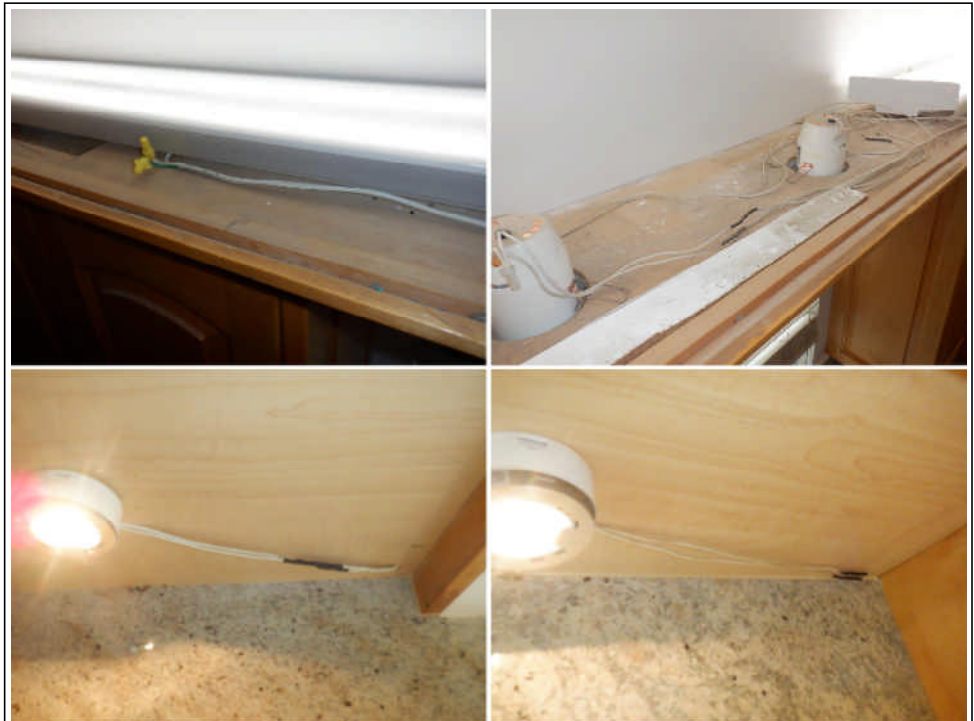
[SC] There was improper wiring installed to the lighting with exposed splices. We recommend correcting the condition(s) noted.

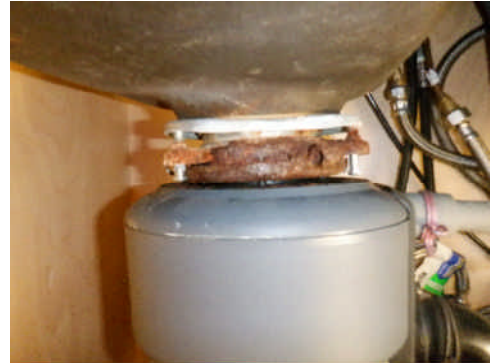
The garbage disposal(s) functioned, with exceptions noted.
a. [CR] The ring holding the disposal to the bottom of the sink was corroded. We recommend correcting the condition(s) noted.

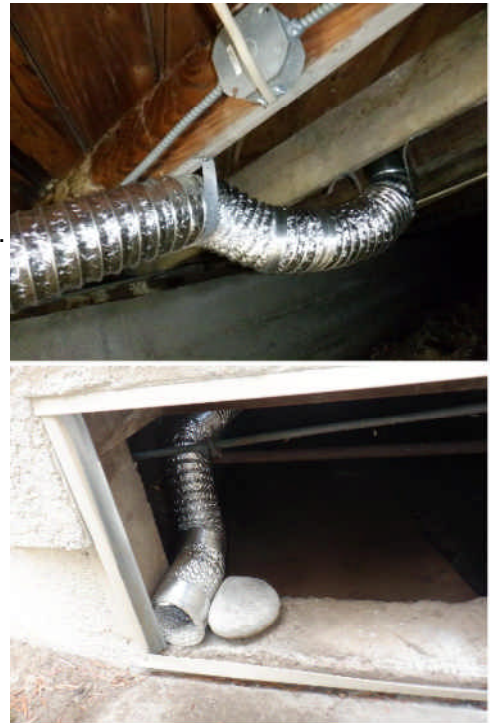
[CR] The fan failed to function. We recommend correcting the condition(s) noted.
[SC] The visible portion of the exhaust vent ducting in the crawl space was a corrugated flexible material that terminated improperly. This material is not approved for kitchen exhaust vents. We recommend correcting the condition(s) noted.

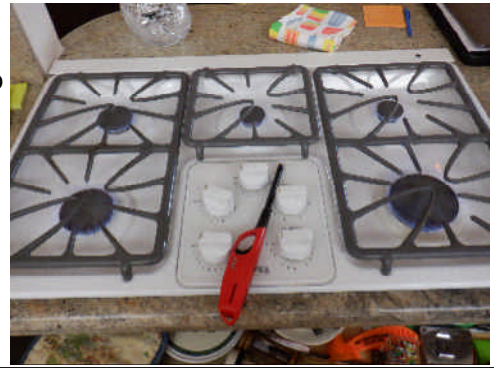
The cooktop/range burners functioned, with exceptions noted.
a. [CR] The electronic ignition failed to function. A lighter was used to ignite the burners. We recommend correcting the condition(s) noted.

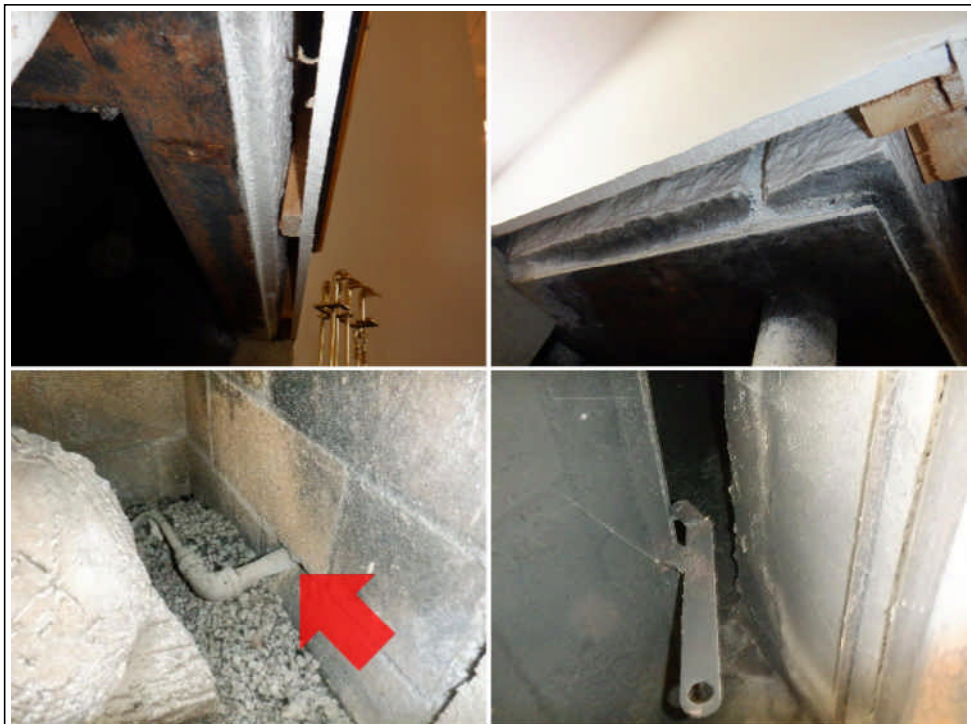
The fireplace and visible areas of the flue appeared functional, with exceptions noted.
 a. [SC] There was wood and other combustible materials too close to the fireplace opening. This condition is a fire safety hazard. We recommend correcting the condition(s) noted.
 b. [FE] There were gaps/voids in the firebox above the opening. These can allow an unsafe transmission of heat. We recommend a full evaluation and/or corrections by a specialist in the appropriate trade.
 c. [SC] The gas line was not sealed at the wall where it entered the firebox.

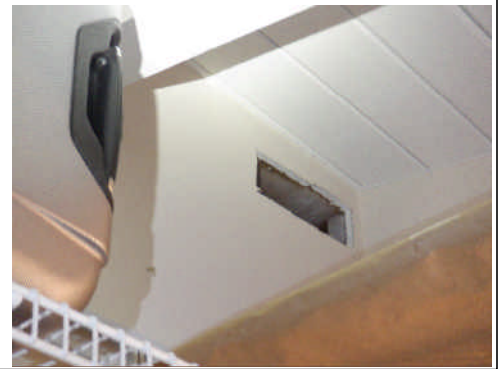
[CR] There was a hole/ opening in the closet wall. We recommend correcting the condition(s) noted.
