Cornerstone Inspection

Property Inspection Report

132 Quail Way, Avila Beach, CA 93424

Date of Inspection: 9/24/2025 Time: 1:30 PM

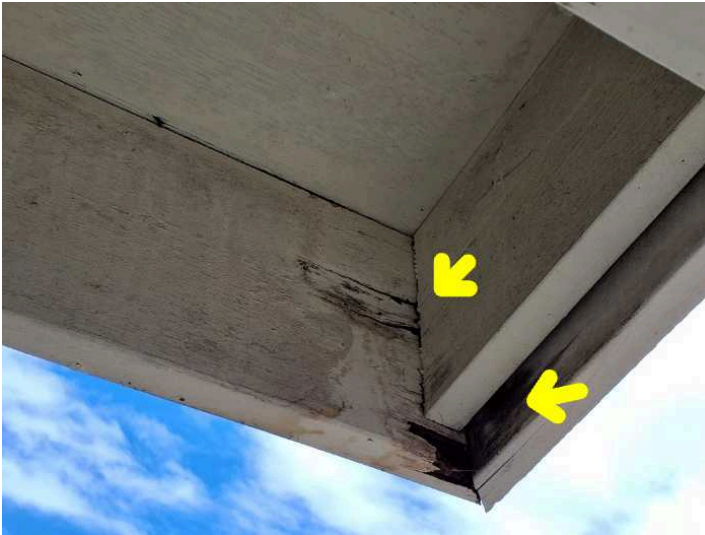
5.2. There is damage to the wood trim, fascia, and/or eaves that should be evaluated by a pest inspector.

There is damage to the wood trim, fascia, and/or eaves that should be evaluated by a pest inspector.

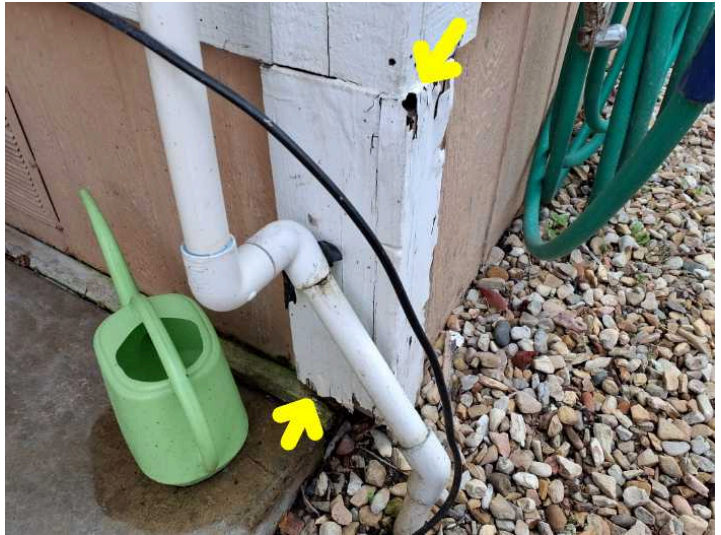
There is damage to the wood trim, fascia, and/or eaves that should be evaluated by a pest inspector.

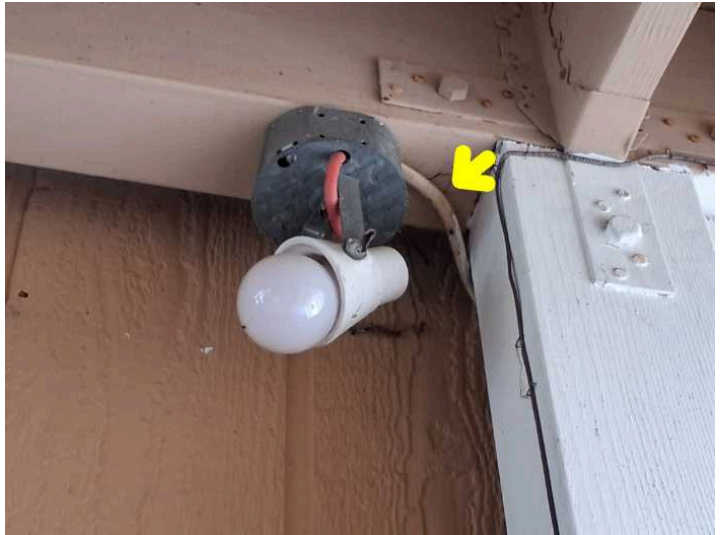
There is exposed romex present, which is a potential safety hazard. We recommend having it evaluated and serviced by a licensed electrician, possibly by installing the romex inside the wall cavity or into conduit.

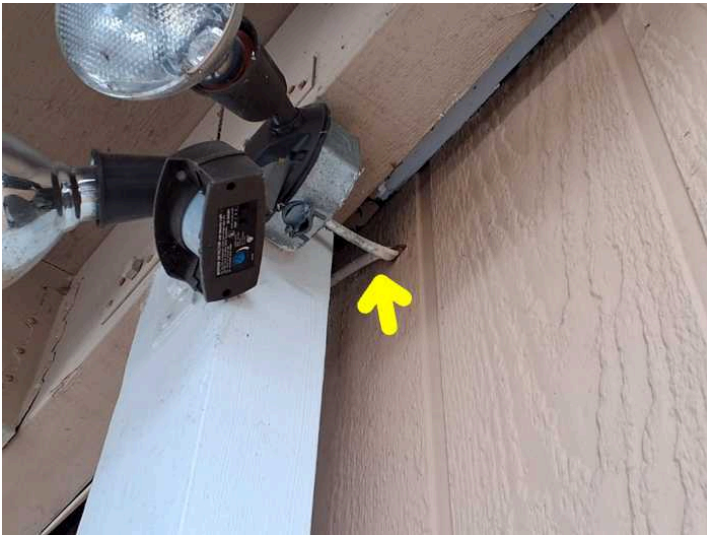
There is exposed romex present, which is a potential safety hazard. We recommend having it evaluated and serviced by a licensed electrician, possibly by installing the romex inside the wall cavity or into conduit.

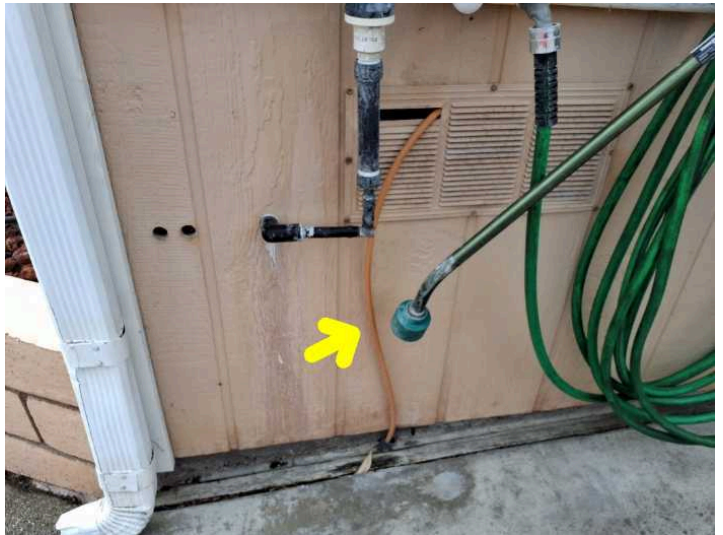
6.7. We have noted that an extension cord is being used for permanent wiring, which is not allowed in most jurisdictions.

We have noted that an extension cord is being used for permanent wiring, which is not allowed in most jurisdictions.

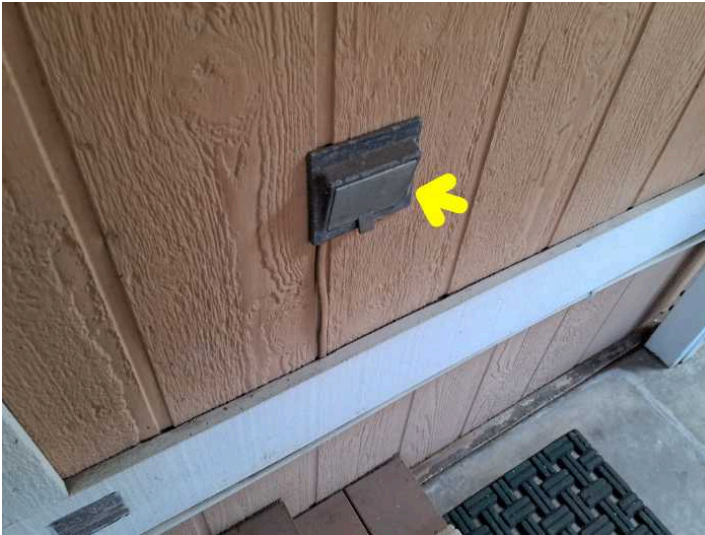
6.2. Some of the exterior electrical outlets do not have a weather rated cover or the cover is damaged and should be serviced.

Some of the exterior electrical outlets do not have a weather rated cover or the cover is damaged and should be serviced.

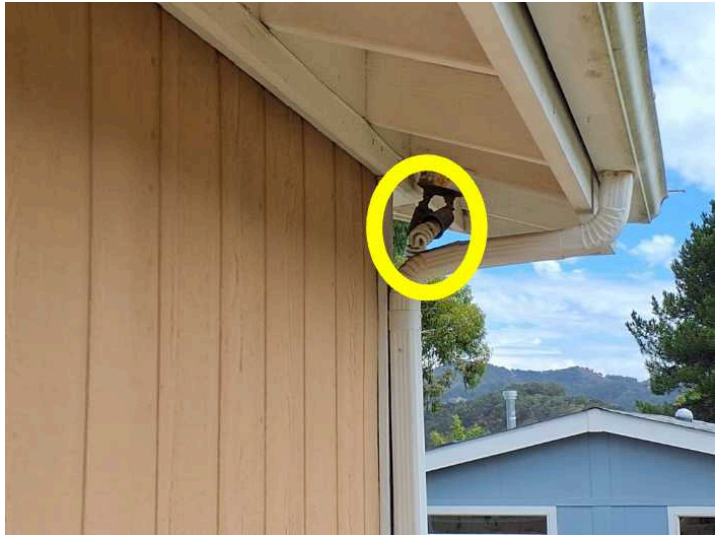
6.4. A light is missing its globe or cover and should be serviced.

A light is missing its globe or cover and should be serviced.

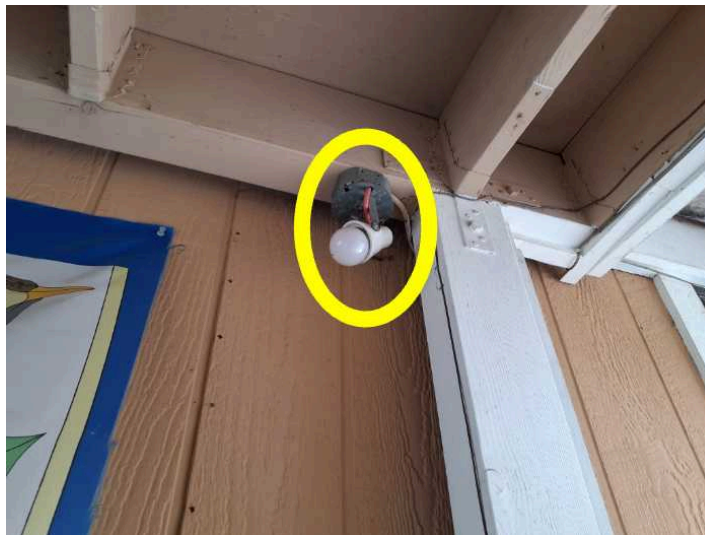
A light is missing its globe or cover and should be serviced.

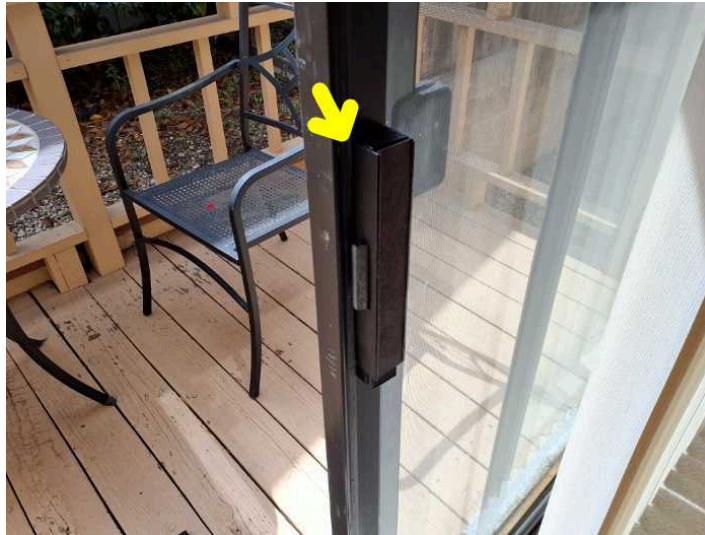
The handle on the sliding glass door is loose or needs service to open and close smoothly.

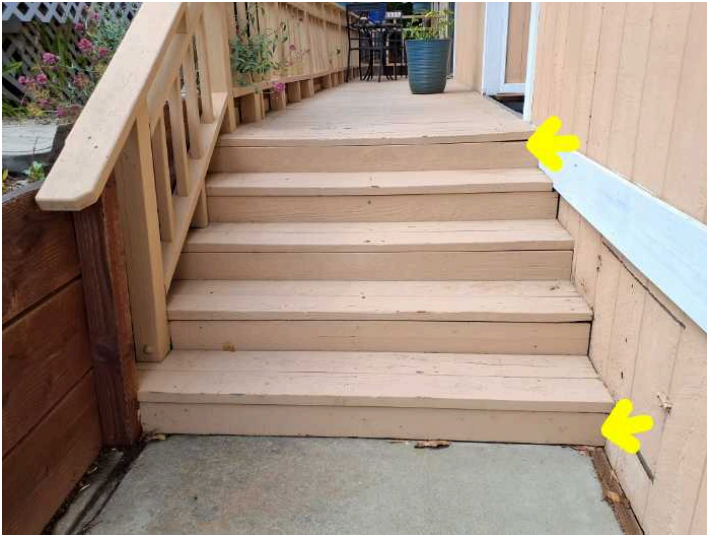
9.2. One or more steps have unequal treads or risers. Steps are required to be uniform to prevent trip-hazards. The rise of any step should be no less than four inches and no greater than seven and three-quarter inches, and the run should be no less than eleven inches. Also, the dimensions of the largest step should not exceed that of the smallest by more than three-eighths of an inch.

One or more steps have unequal treads or risers. Steps are required to be uniform to prevent trip-hazards. The rise of any step should be no less than four inches and no greater than seven and three-quarter inches, and the run should be no less than eleven inches. Also, the dimensions of the largest step should not exceed that of the smallest by more than three-eighths of an inch.

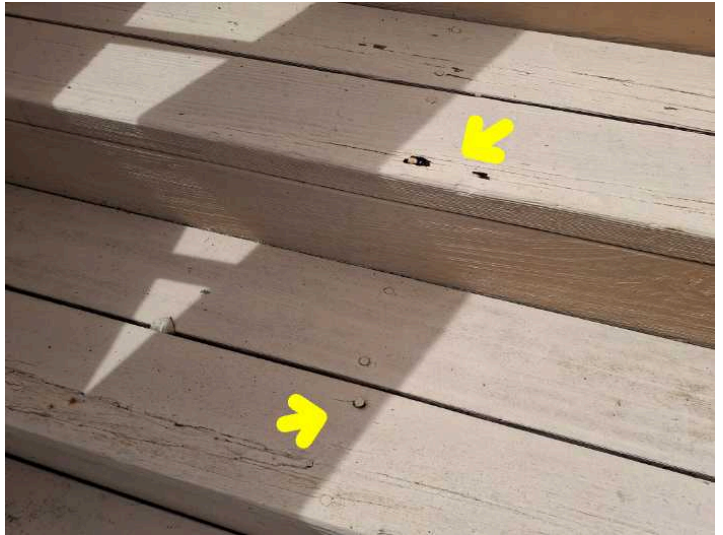
9.3. There is damage to the wooden stairs that should be evaluated by a pest inspector.

There is damage to the wooden stairs that should be evaluated by a pest inspector.

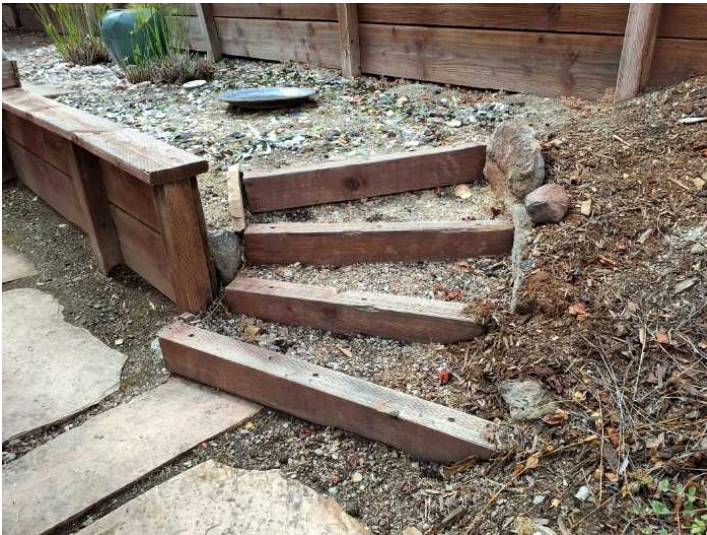
The railroad tie, wooden post, or natural stone steps are landscape components and would not conform to common standards requiring certain dimensions, handrails, guardrails, etcetera.

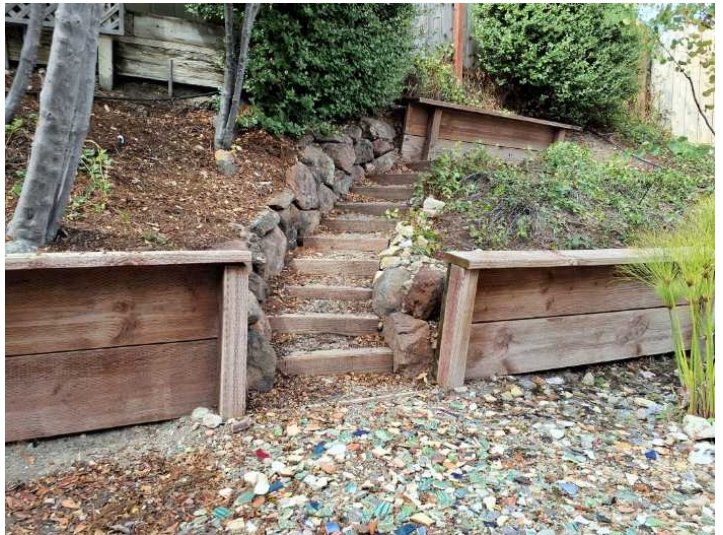
The railroad tie, wooden post, or natural stone steps are landscape components and would not conform to common standards requiring certain dimensions, handrails, guardrails, etcetera.

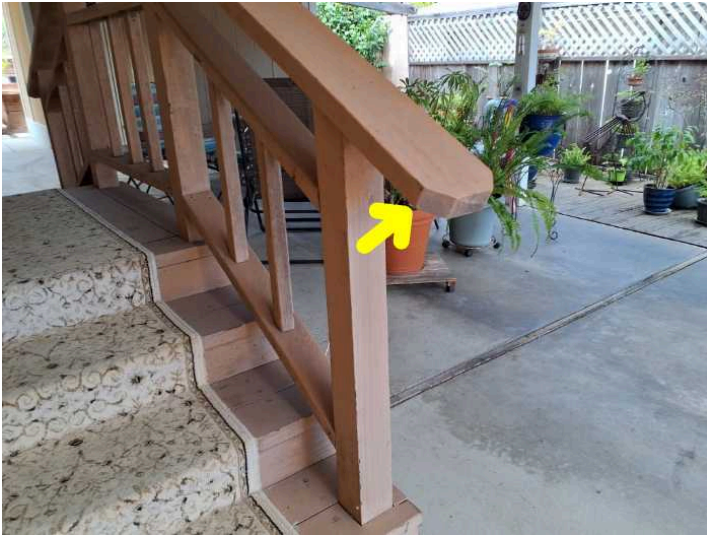
9.5. The handrail does not return, which is required at the top and bottom of the stairs by current building standards. This condition could allow a purse or clothing to initiate a fall.

The handrail does not return, which is required at the top and bottom of the stairs by current building standards. This condition could allow a purse or clothing to initiate a fall.

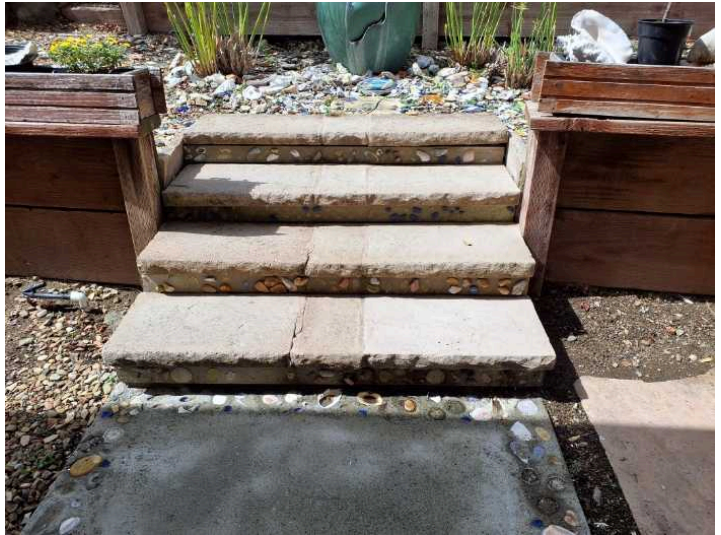
9.6. Current building standards require handrails to be installed on steps which have 4 or more risers, which is particularly important if children or the elderly visit or occupy this property.

Current building standards require handrails to be installed on steps which have 4 or more risers, which is particularly important if children or the elderly visit or occupy this property.

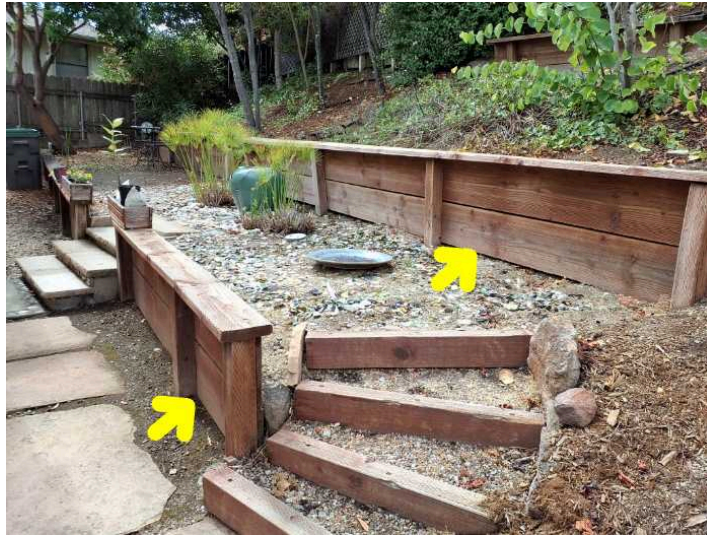
11.3. The wooden planks terracing the slope have no structural value, and are intended to inhibit surface soil movement. They should be periodically monitored for damage and stability.

The wooden planks terracing the slope have no structural value, and are intended to inhibit surface soil movement. They should be periodically monitored for damage and stability.

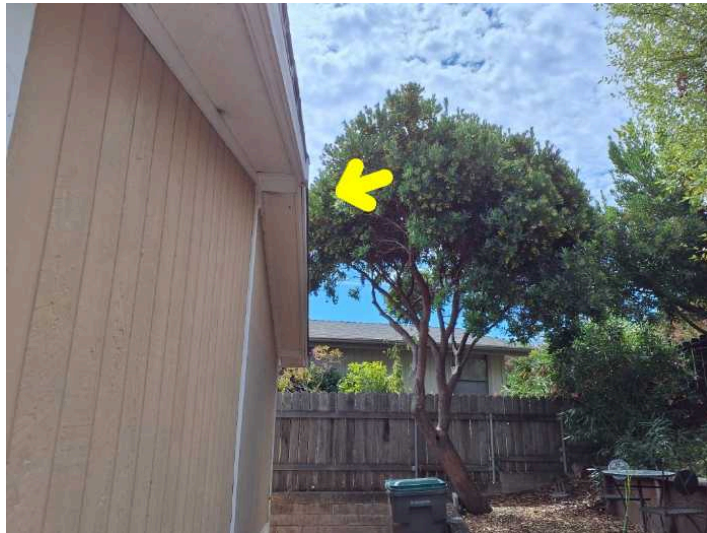
12.2. There are tree limbs over growing the residence that should be trimmed or monitored to ensure that they do not impact or damage the roof or its components.

There are tree limbs over growing the residence that should be trimmed or monitored to ensure that they do not impact or damage the roof or its components.

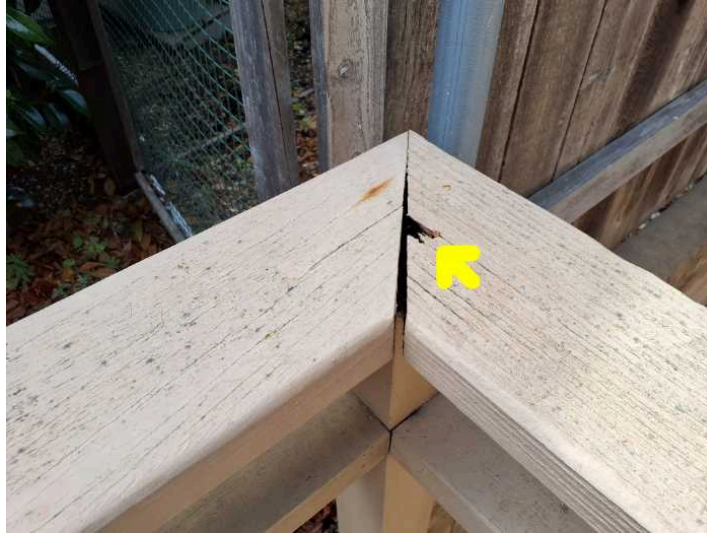
14.2. There is damage to one or more guardrails that should be evaluated by a pest inspector.

There is damage to one or more guardrails that should be evaluated by a pest inspector.

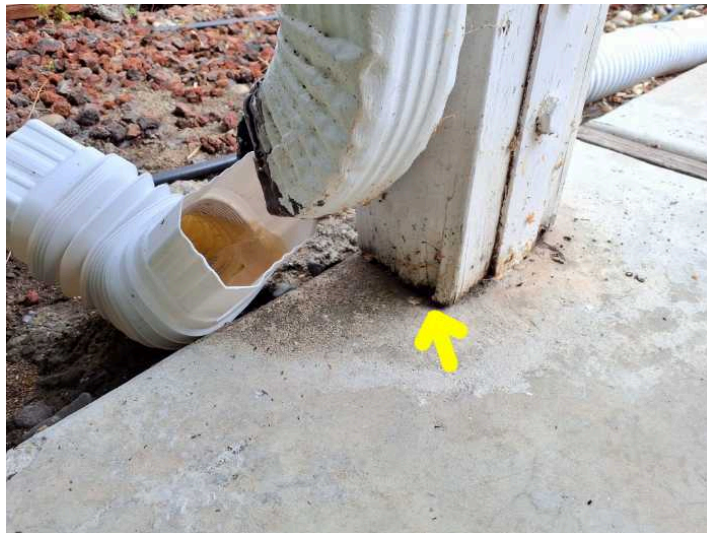
15.1. The carport has damage to one or more of its columns that should be evaluated by a pest inspector.

The carport has damage to one or more of its columns that should be evaluated by a pest inspector.

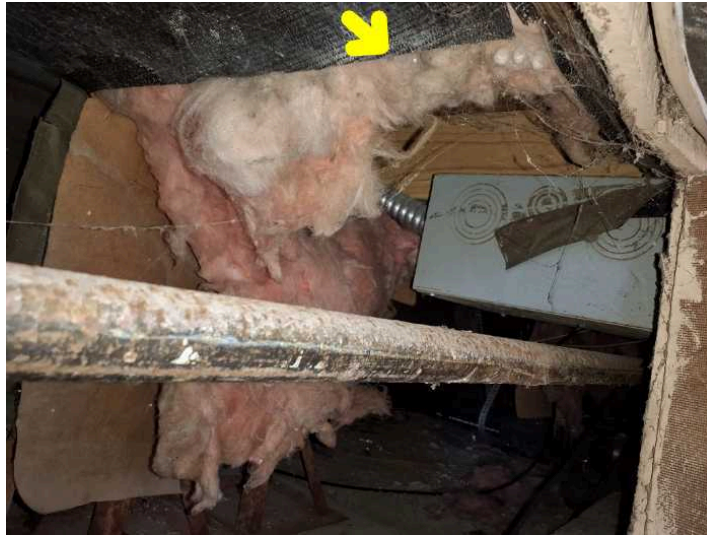
1.6. The rodent barrier has voids or openings that should be sealed. This could also imply that there have been some leaks or plumbing repairs done in the past. You may want to ask the seller regarding this issue.

The rodent barrier has voids or openings that should be sealed. This could also imply that there have been some leaks or plumbing repairs done in the past. You may want to ask the seller regarding this issue.

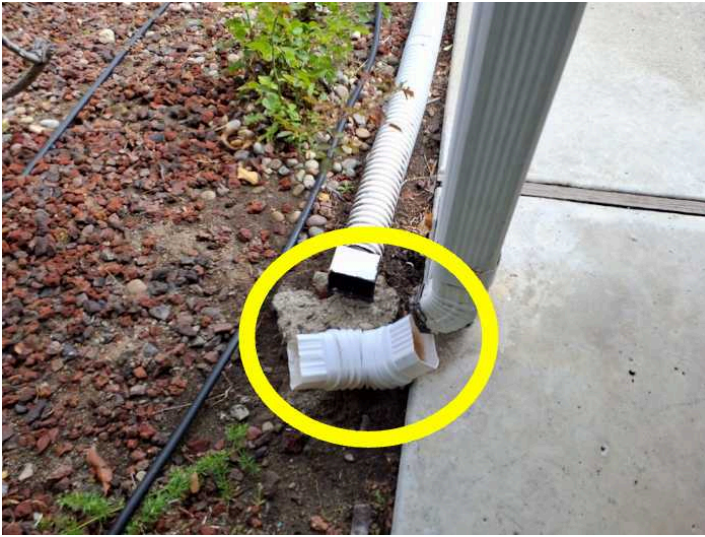
The gutters need to be serviced, such as reconnecting, sealing separated seams, cleaning, or making sure they are secure.

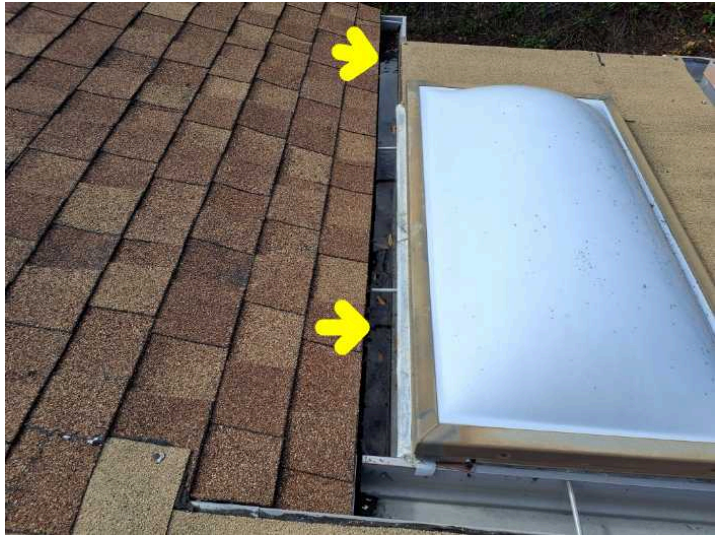
We observed standing water in some sections of the gutters, which implies that they may not be properly sloped and should be evaluated and serviced.

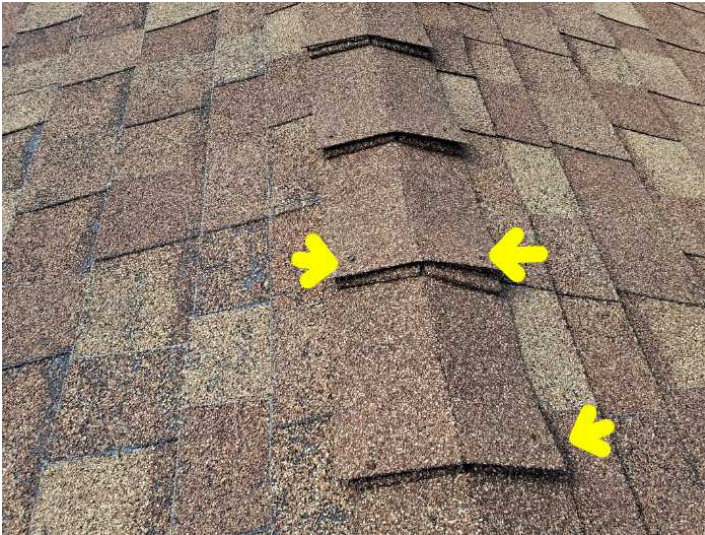
The roofing material has been improperly installed with exposed fasteners and should be monitored closely for leaks.

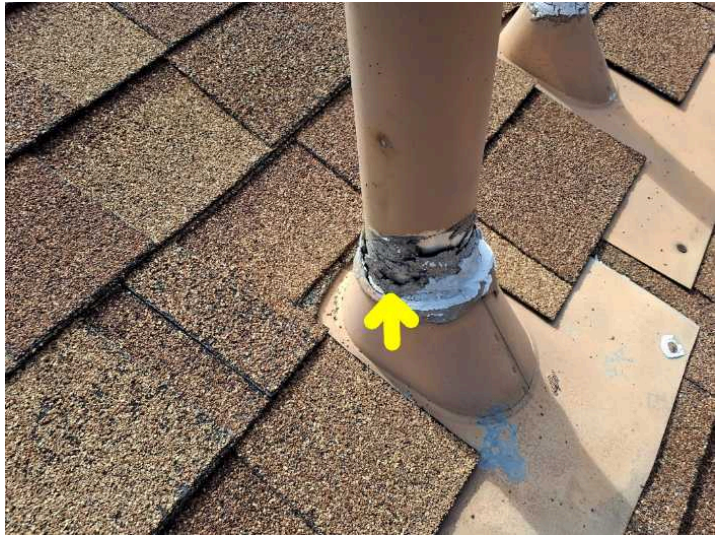
One or more of the roof flashings need to be sealed or serviced. They are comprised of metal that seals valleys, vents, and other roof penetrations, and are the most common point of leaks. This is particularly true of the flashings on a layered roof, which are covered by the roofing material and are even more susceptible to leaks.

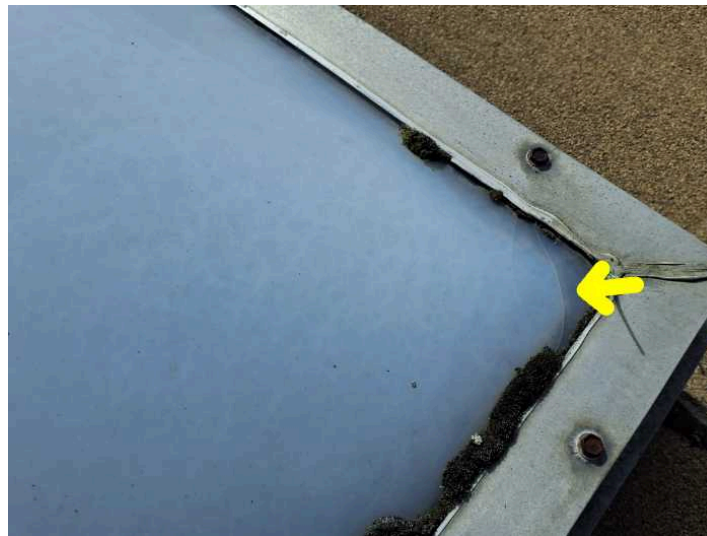
Page 19 Item: 2	Composition Shingle Observations	2.7. The skylight is cracked or broken, and should be evaluated by a qualified specialist.
-----------------	----------------------------------	--

The skylight is cracked or broken, and should be evaluated by a qualified specialist.

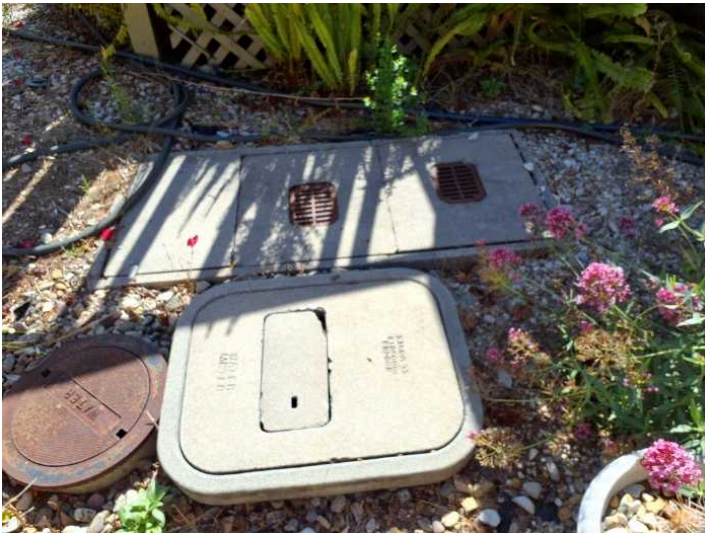
We were unable to determine which shut-off valve is for your unit. It should be identified and disclosed to you, in case there's need for an emergency shut-off of the gas.

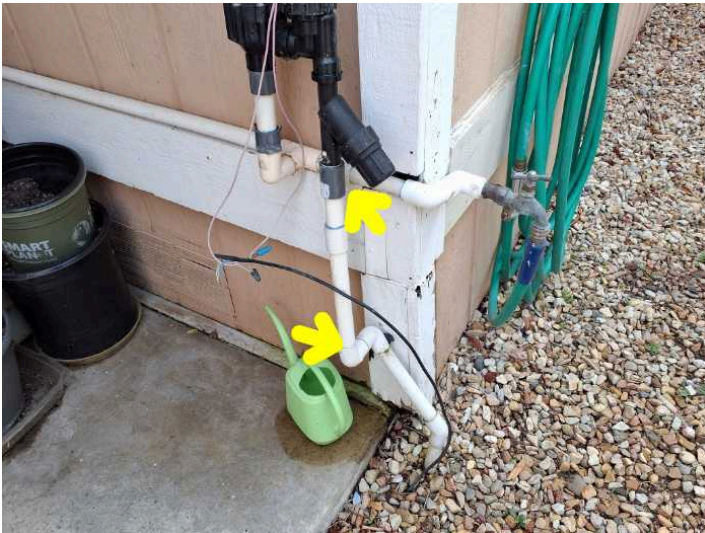
A sprinkler valve, fitting, or pipe located at the right side is leaking and should be repaired by a qualified specialist.

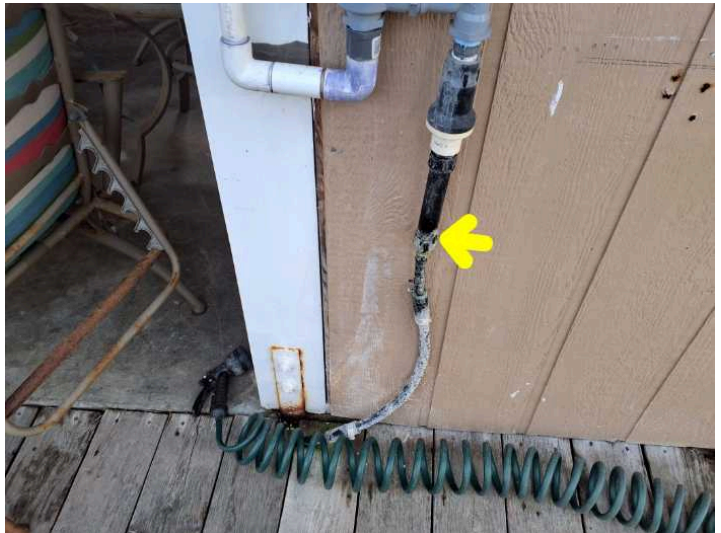
A sprinkler valve, fitting, or pipe located at the right side is leaking and should be repaired by a qualified specialist.

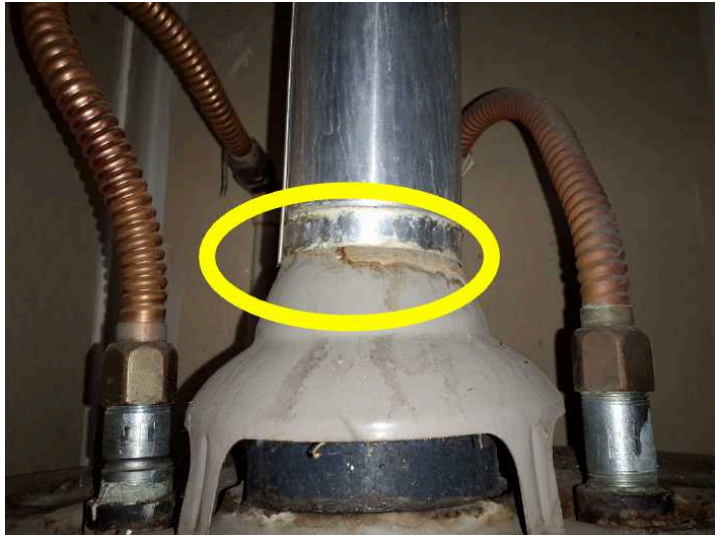
The vent pipe is not properly connected. It is required to have a minimum of 3 fasteners where the pipe connects to the draft hood or other single wall vent pipes.

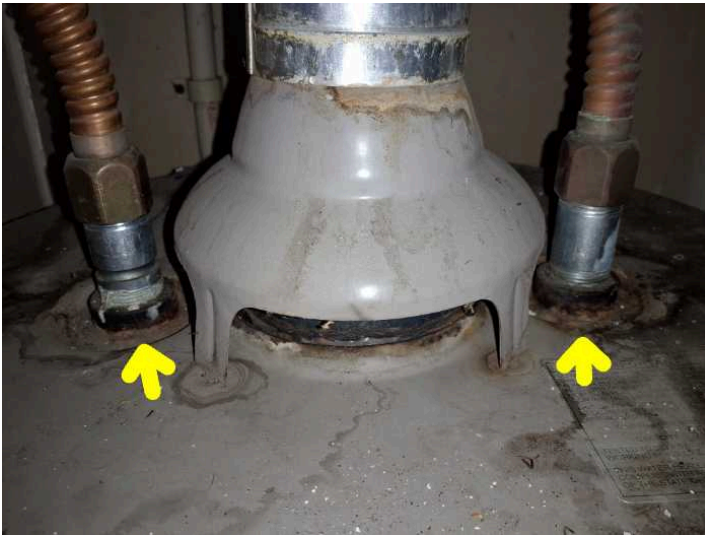
There is rust, corrosion, or mineral encrustation on the fittings of the gas water heater, which should be evaluated and serviced by a qualified plumbing contractor.

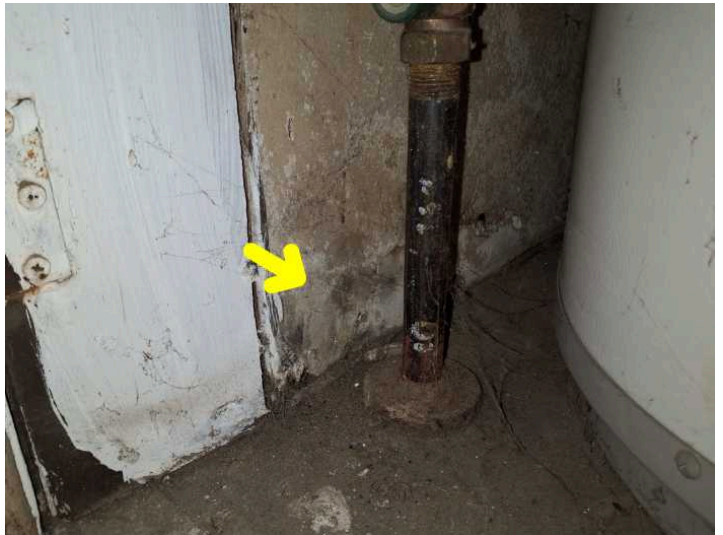
There is a dark staining on the closet wall that should be evaluated by a qualified specialist and cleaned as necessary.

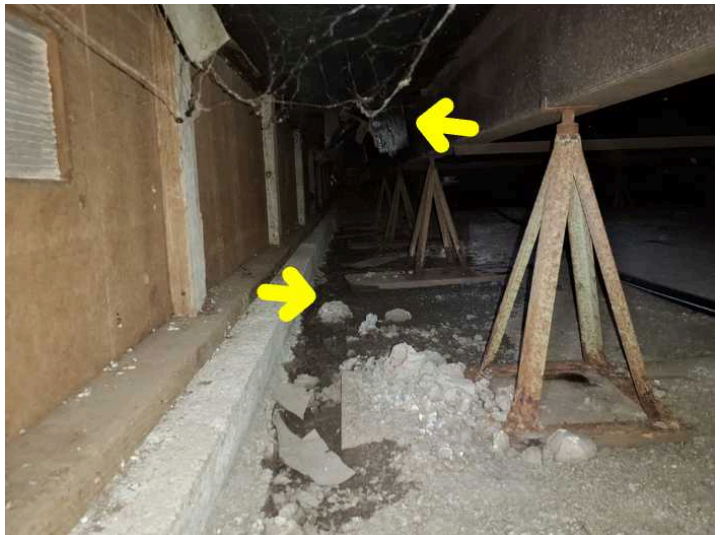
Page 26 Item: 6	Waste and Drain Systems	6.4. There is a drainpipe leak in the foundation area, below the kitchen, which should be repaired by a qualified tradesperson.
-----------------	-------------------------	---

6.4. There is a drainpipe leak in the foundation area, below the kitchen, which should be repaired by a qualified tradesperson.

There is a drainpipe leak in the foundation area, below the kitchen, which should be repaired by a qualified tradesperson.

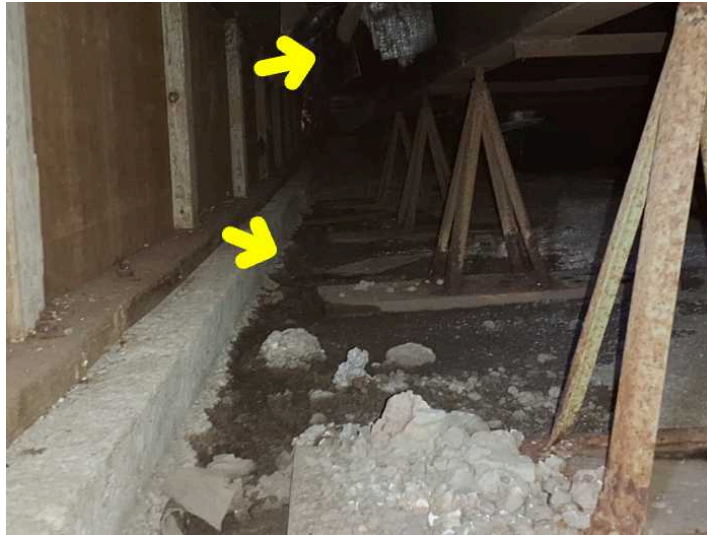
There is a drainpipe leak in the foundation area, below the kitchen, which should be repaired by a qualified tradesperson.

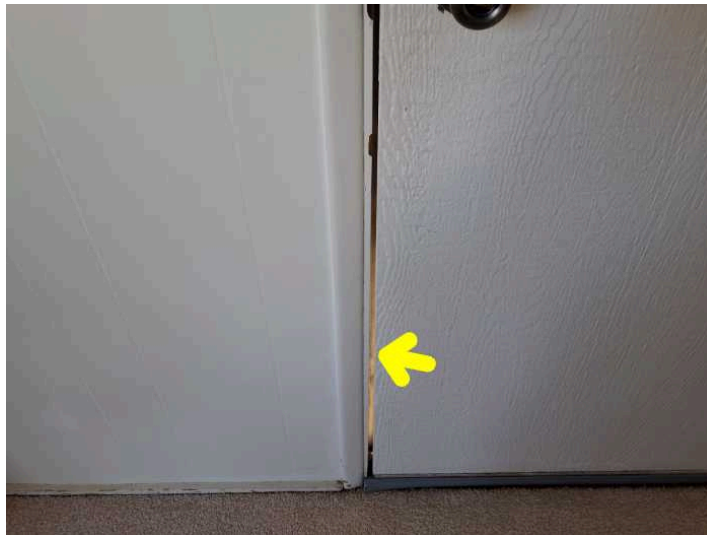
1.1. The front door is functional but not fully weather sealed and could be subject to moisture intrusion especially during wind driven rain.

The front door is functional but not fully weather sealed and could be subject to moisture intrusion especially during wind driven rain.

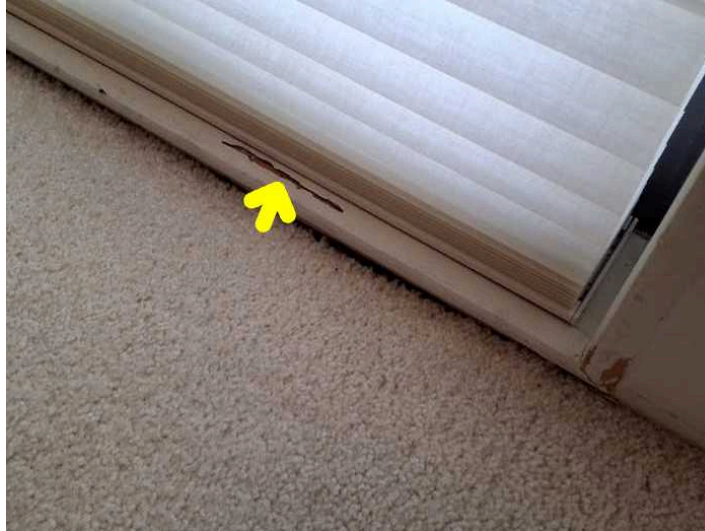
There is damage to a window sill that should be evaluated by a pest inspector.

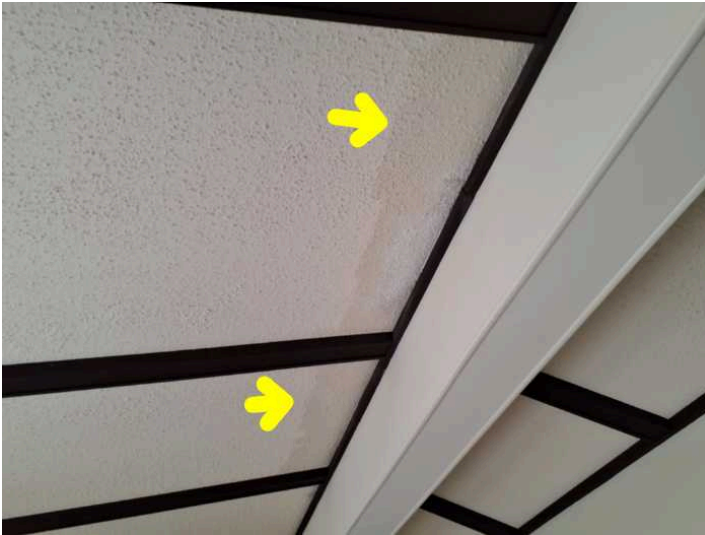
There has been a drywall/plaster repair that should be explained by the seller.

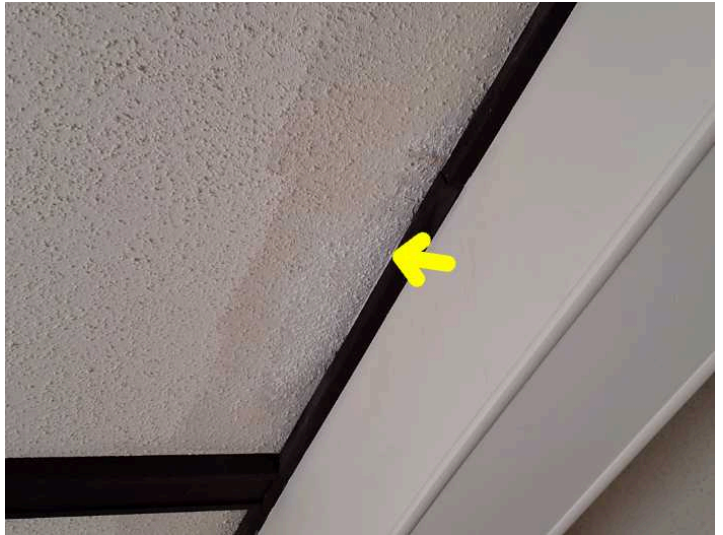
There is a moisture stain on the ceiling that should be explained or explored further.

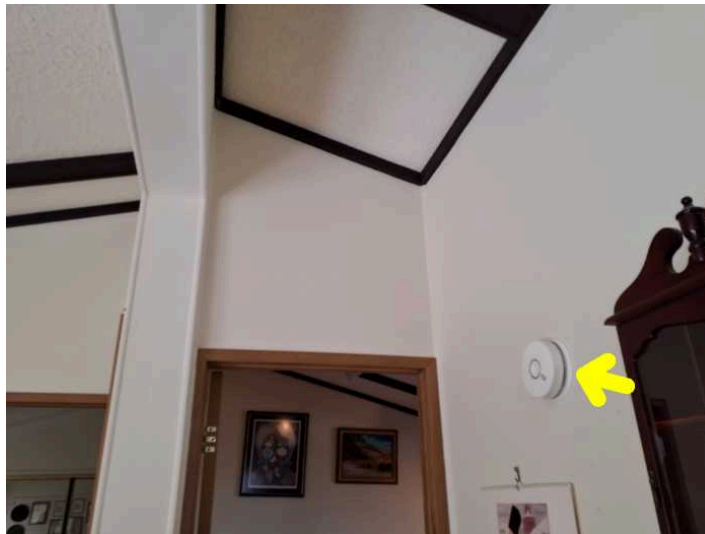
The smoke detector may not be in the location recommended by the manufacturer. We can elaborate but you may wish to verify this.

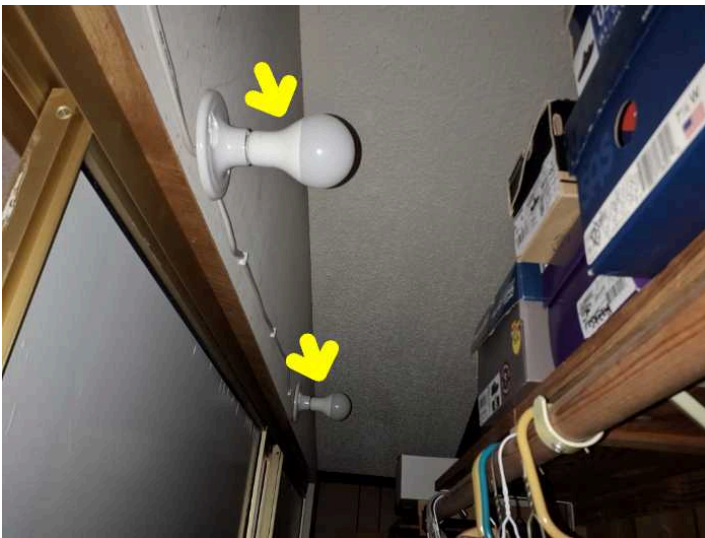
The closet light is missing its globe or cover, which should be installed to improve safety.

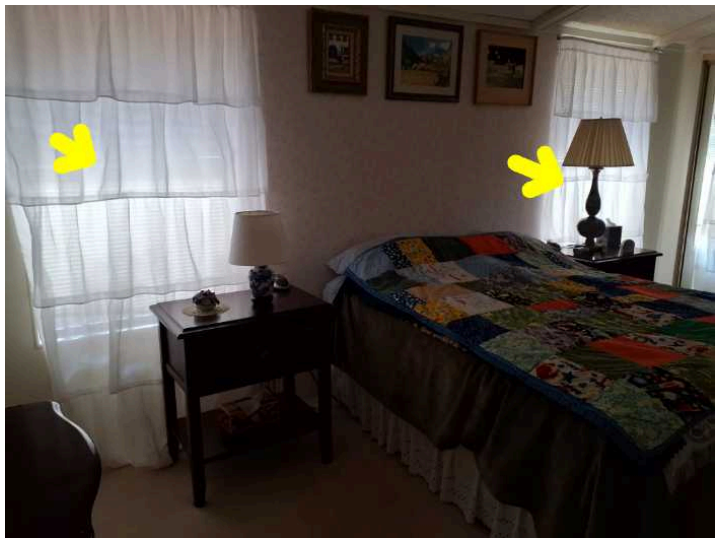
One or more of the single-hung windows will need to have its hardware serviced to properly stay in place when opened. Single-hung windows are typically designed so that the lower panel opens and stays in an open position.

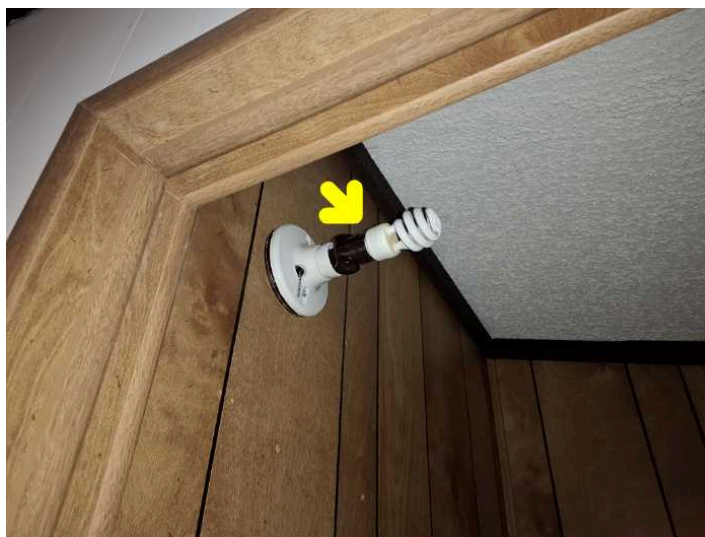
The closet light is missing its globe or cover, which should be installed to improve safety.

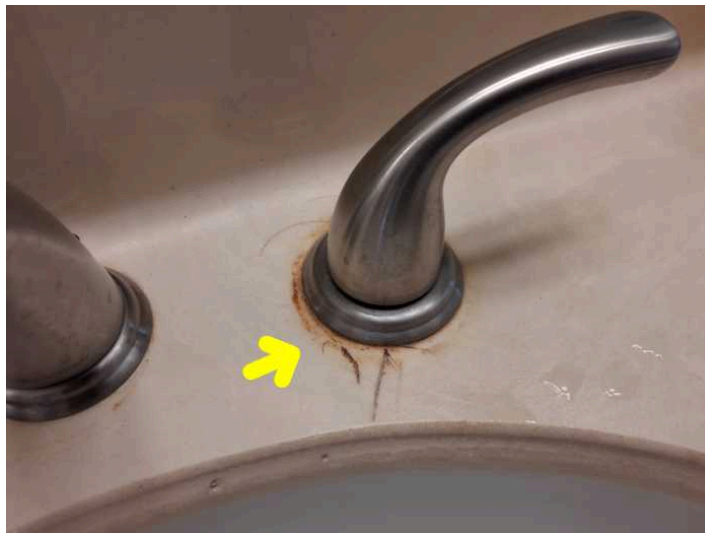
The sink countertop has cosmetic damage you should view for yourself, such as cracks, chips, or missing grout.

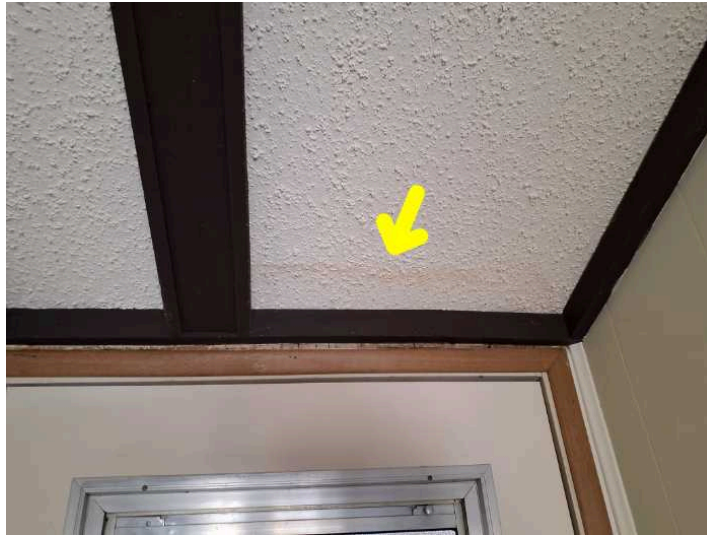
There is a moisture stain on the ceiling that should be explained or explored further.

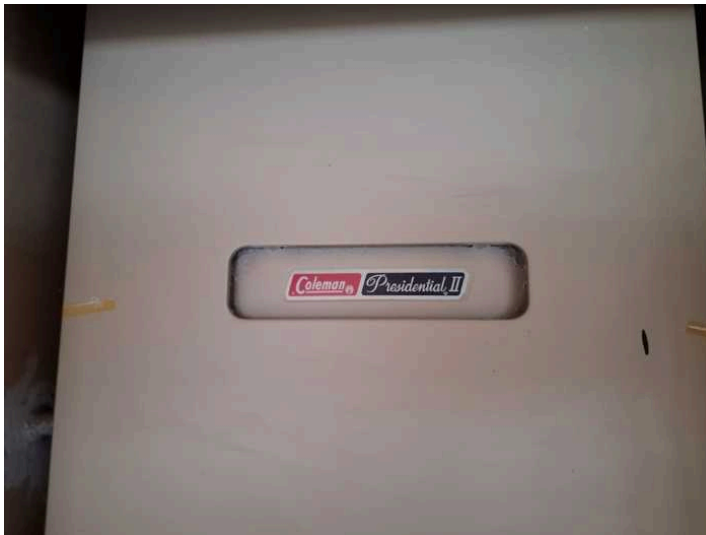
The furnace is functional. However, it is beyond the commonly accepted design life of twenty years, and will need to be monitored more closely for evidence of metal fatigue. We recommend that you have it serviced and evaluated by an HVAC contractor prior to the close of the inspection period.

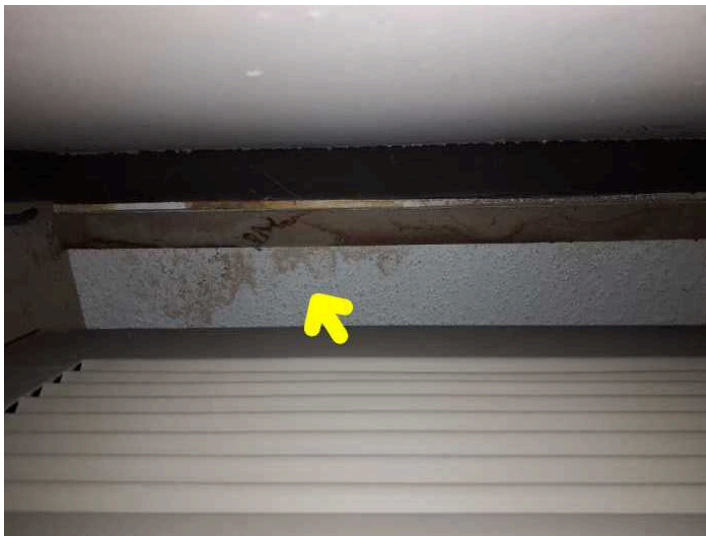
There are moisture stains on the ceiling at the vent pipe which should be explained or further explored. It could indicate the roof vent flashing is not properly sealed.

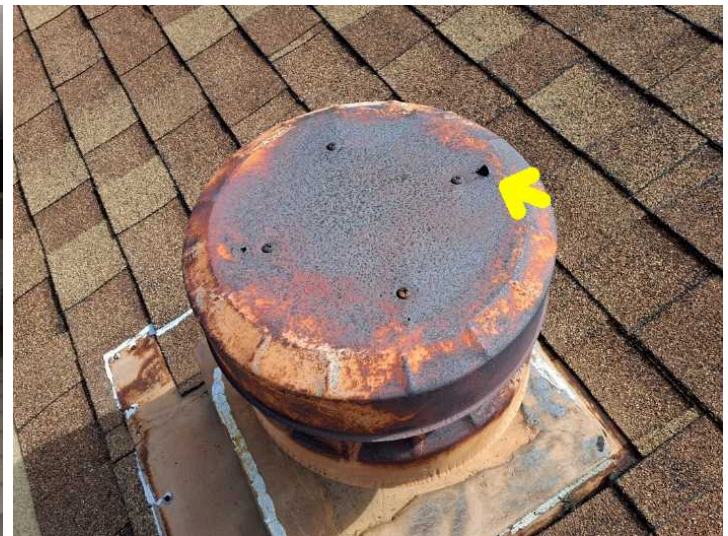
The vent cap on the roof is rusted or deteriorated, and should be replaced before moisture intrusion contaminates the combustion chamber.
