## **Confidential Inspection Report**

LOCATED AT: 22100 Burbank Blvd #350F Woodland Hills, California 91367

INSPECTED ON: Tuesday, November 21, 2023

Inspector, James Huggins Huggs Quality Inspections

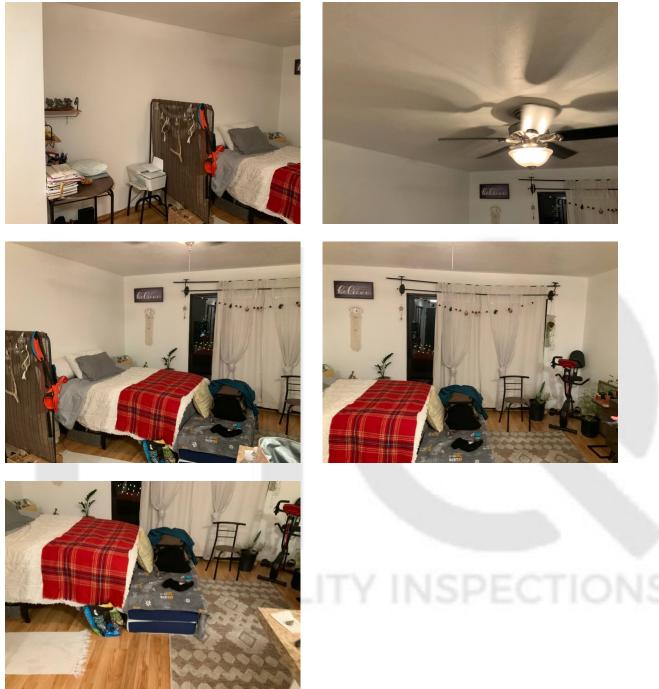
**27:** The interior surfaces, hardware, fixtures, doors and windows appear to be properly installed and generally in serviceable condition, with exceptions noted above.

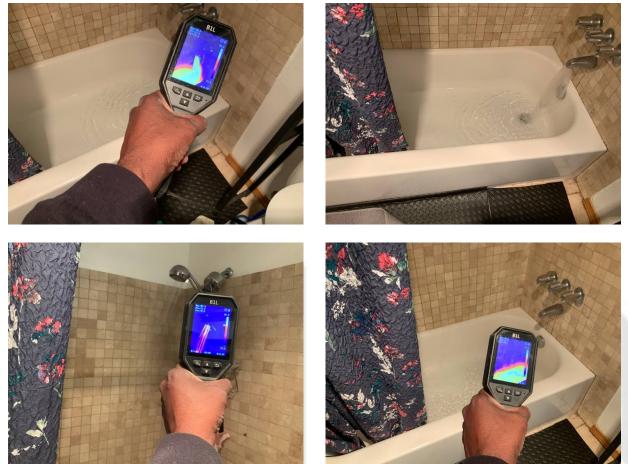
48: The bathtub appears to be properly installed and in serviceable condition.

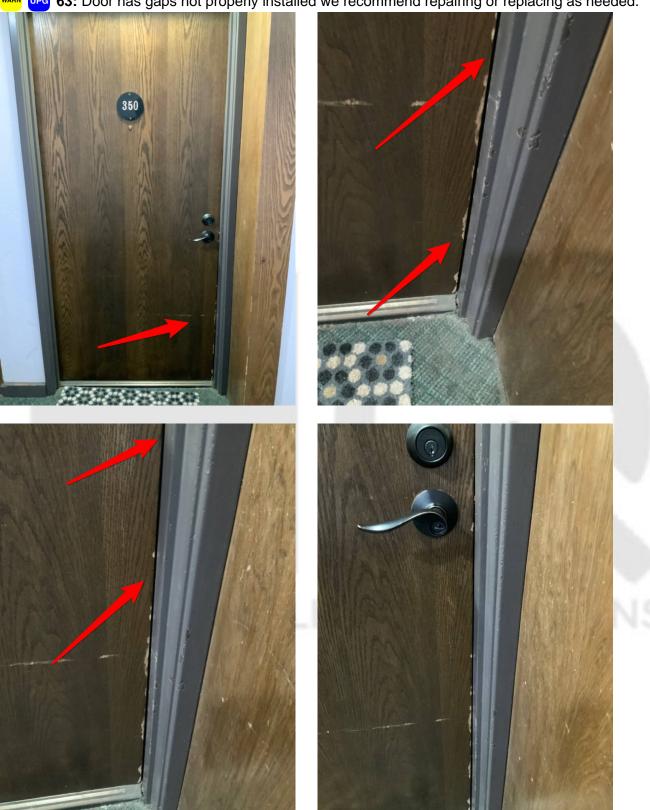
62: Door appears to be scratched maintenance needed.

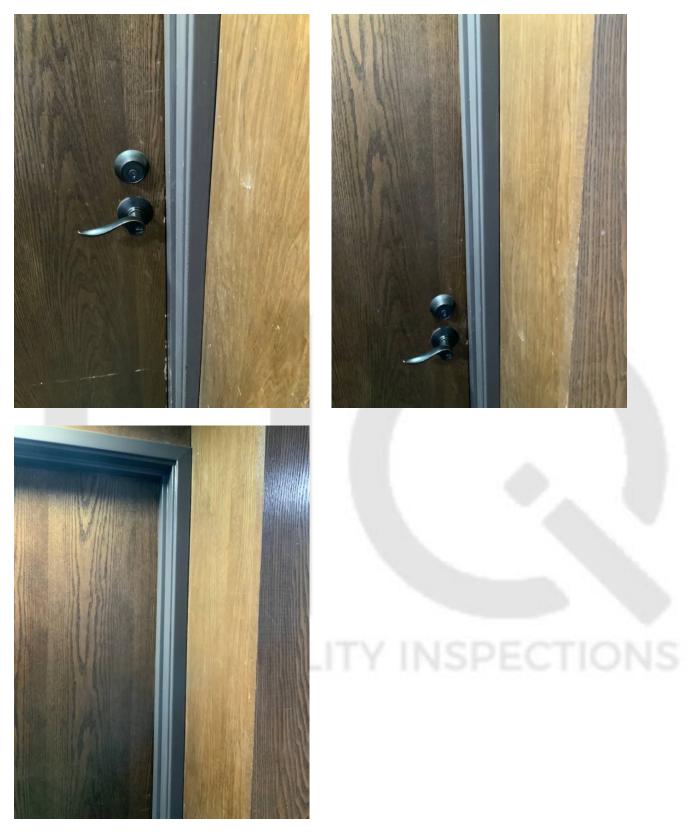
**63:** Door has gaps not properly installed we recommend repairing or replacing as needed. WARN

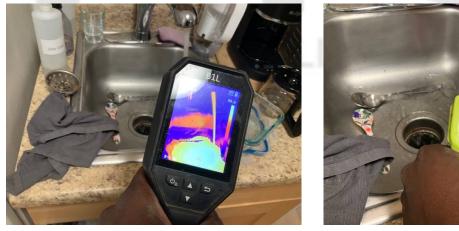
**68:** The sink appears to be properly installed. When operated, it was observed to be fully functional and in serviceable condition.

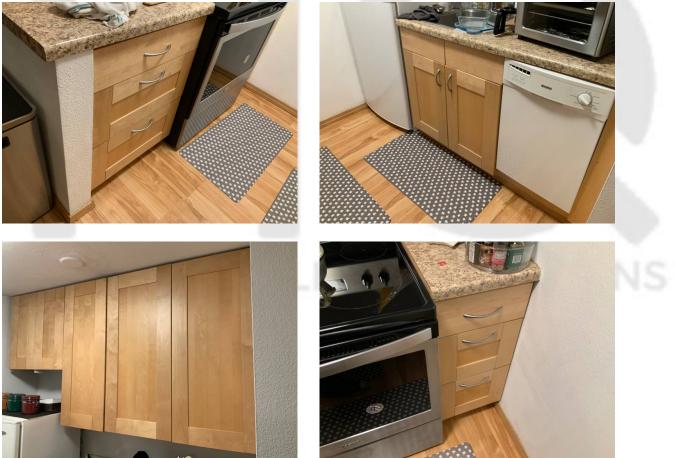
76: Cabinets appear to be in good condition.

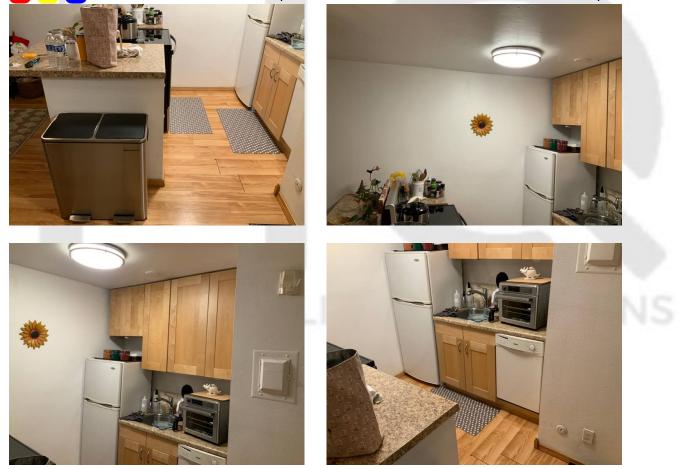
ware ware upg 84: This area is in need of repair as noted above or in other sections of this report.
