File No.: 240024

September 25, 2024

SUBJECT: Site Geologic Reconnaissance Report for Existing Residential Property at # 7
Cinchring Road, Rolling Hills, California

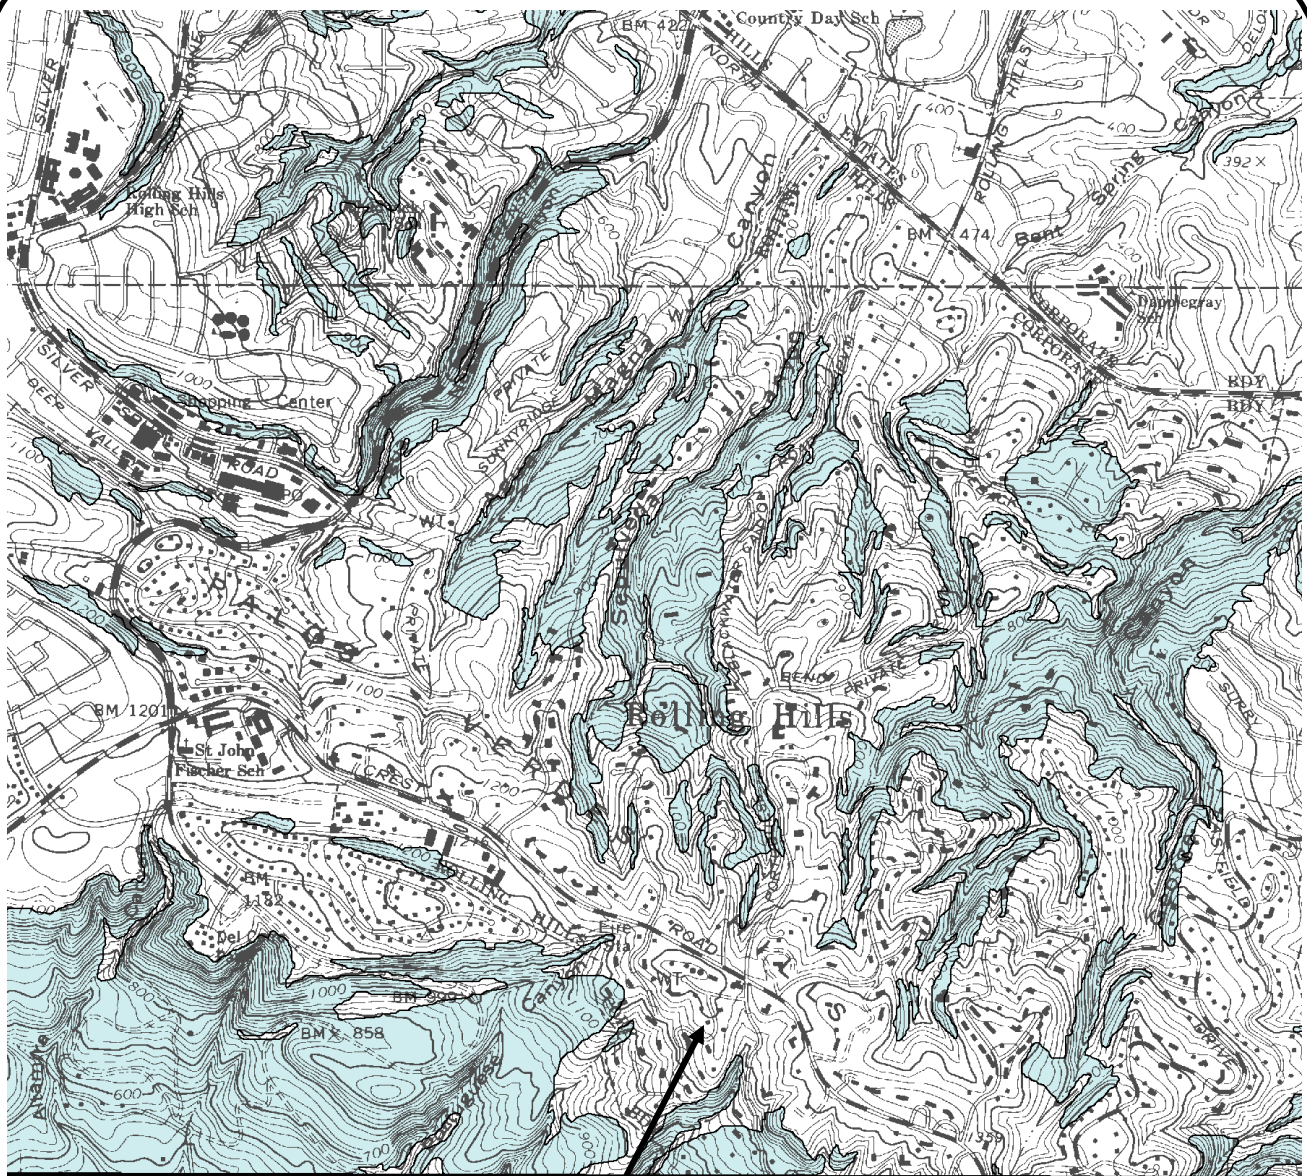
PLATE 2

9. The subject site is not located within the potential seismic hazard zones (liquefaction zones) mapped by the State as shown on Plate 2. The subject site is not located within a seismically-induced landslide hazard zone. The potential of the seismically-induced landslide at the subject site is to be minimal.

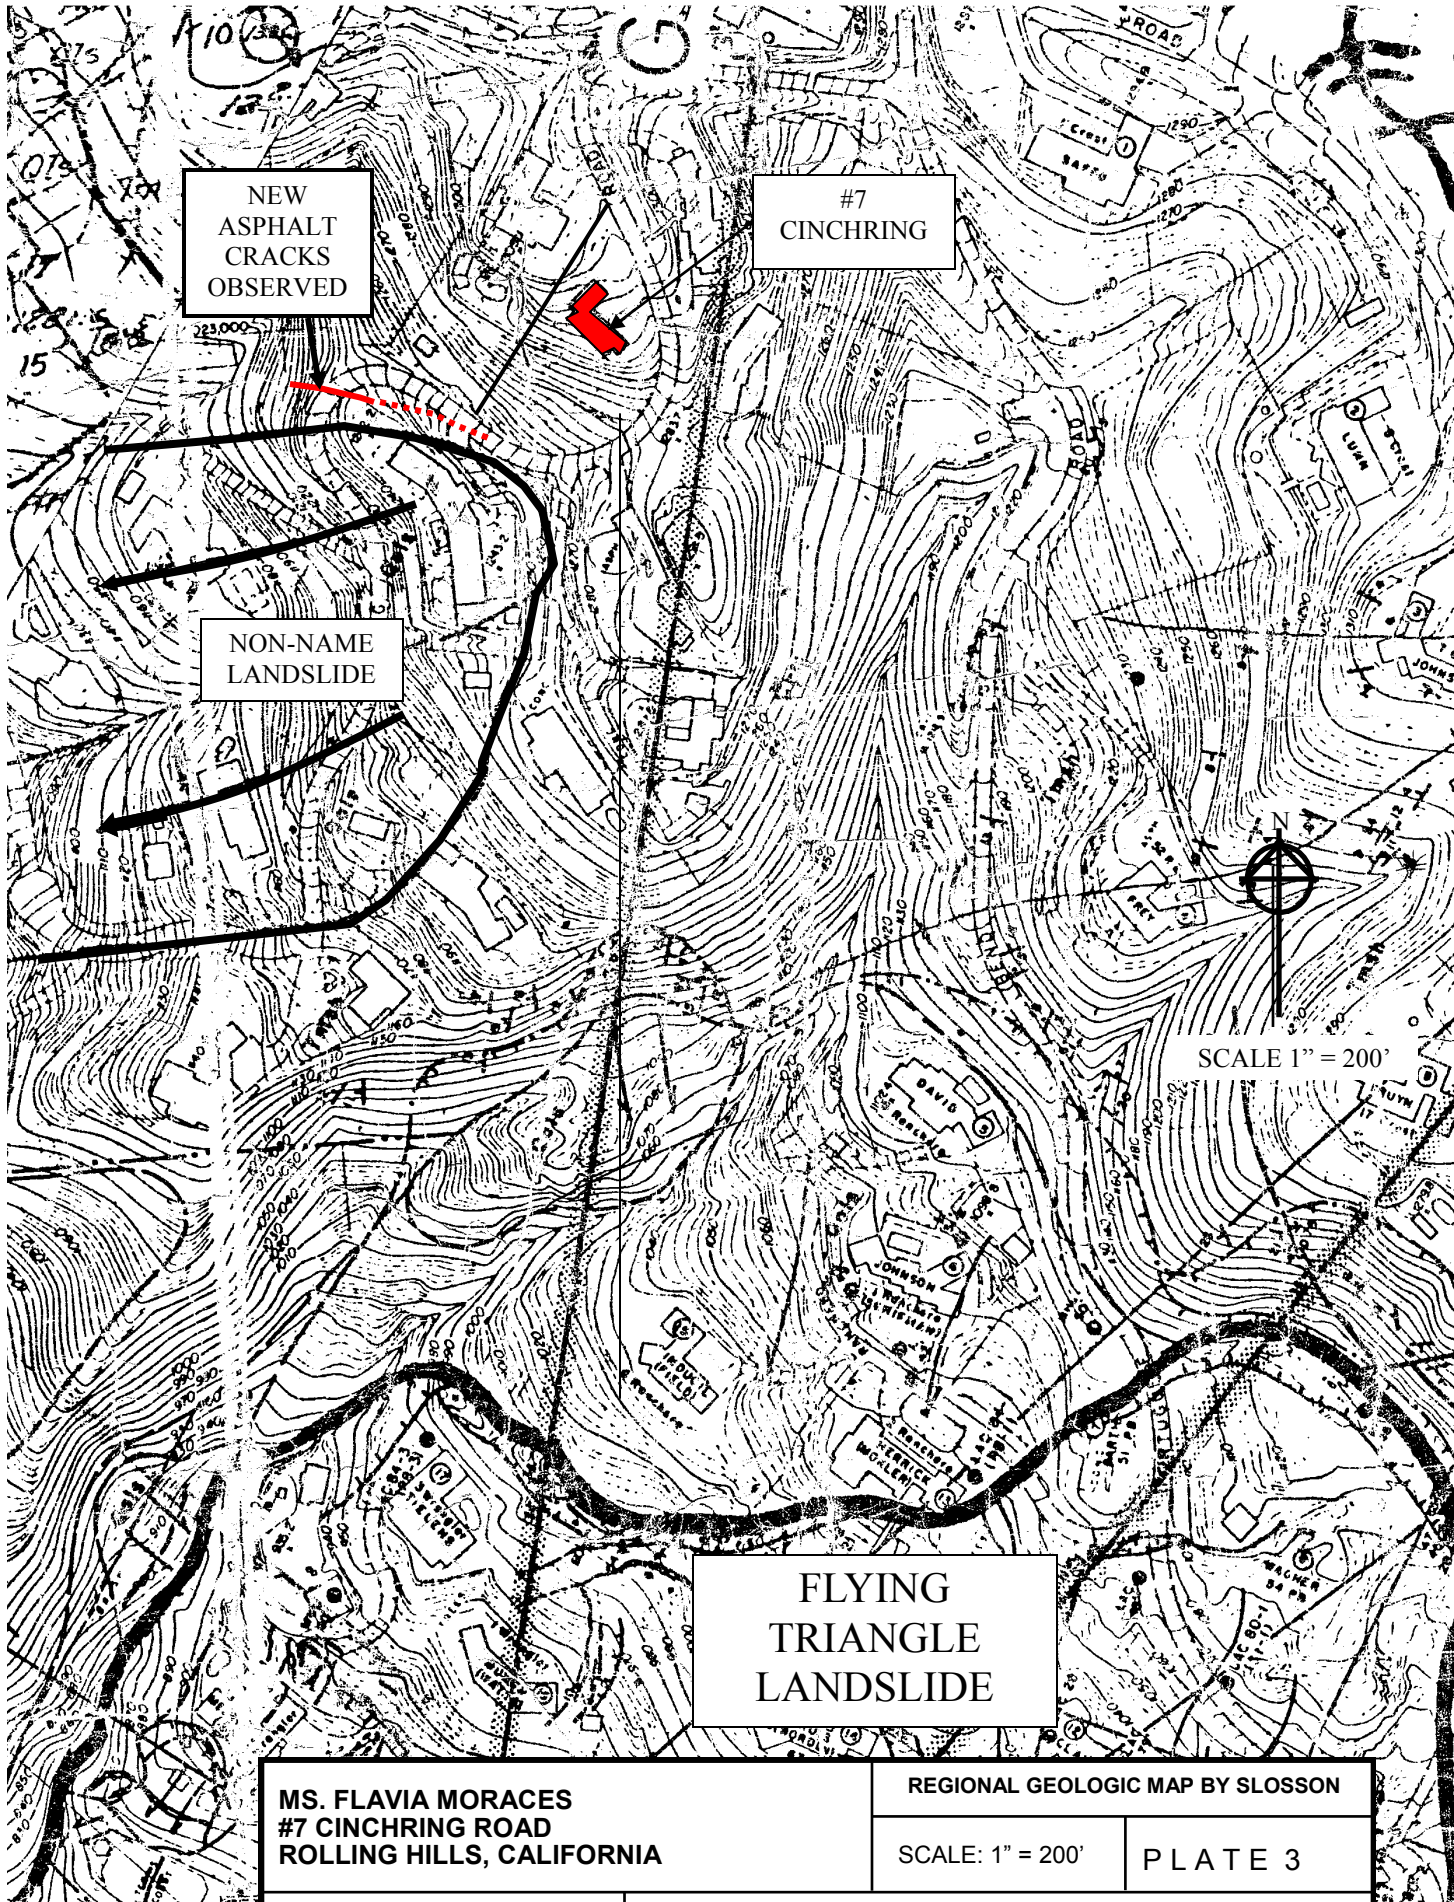
MS. FLAVIA MORACES #7 CINCHRING ROAD ROLLING HILLS, CALIFORNIA		REGIONAL GEOLOGIC MAP BY SLOSSON	
		SCALE: 1" = 200'	PLATE 3
DATE: September 24, 2024	T.I.N. ENGINEERING COMPANY		
JOB NO.: 240024

The subject site is located approximately 1,000 feet northerly of the active Flying Triangle landslide. An un-named landslide is located on the southwesterly side of the subject site. This un-named landslide appears to be reactive. New road cracks/separations were observed on lower Cinchring Drive. The north boundary of the un-named landslide appears to have been expanded northerly approximately 60 feet. Locations of the Flying Triangle landslide, un-named landslide, and new road cracks/separations on lower Cinchring Drive are shown on Regional Geologic Map by Slosson and Associates, Plate 3.
