WOOD DESTROYING PESTS AND ORGANISMS INSPECTION REPORT

325	W. 1st Ave	Chico	CA	95926	
Address of Property Inspec	cted	City	State	ZIP	
10/21/2025	43080				
Date of Inspection	Corresponding	Report No.		Escrow No.

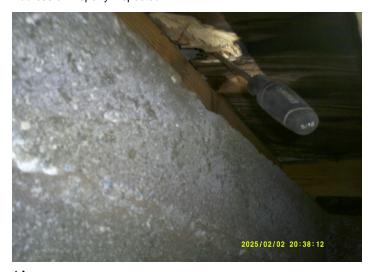
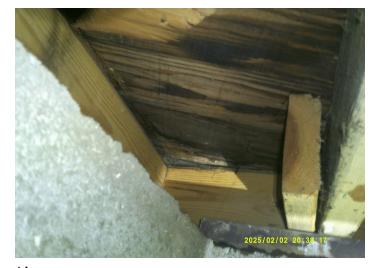
1A 1A

1A - Section I

FINDING: Stains and fungus infection/damage noted at the subfloor. Damage may extend into inaccessible areas.

RECOMMENDATION: Interested parties should engage the services of a licensed contractor to check for leaks and to perform any corrective work needed. Remove the fungus damaged portions of the subfloor. Call for a reinspection of the inaccessible areas. The inaccessible areas will be inspected for a fee if made accessible by the interested parties at his/her expense. A supplemental report will be filed at such time. No opinion is rendered concerning the conditions in the area at this time. Replace with new material.

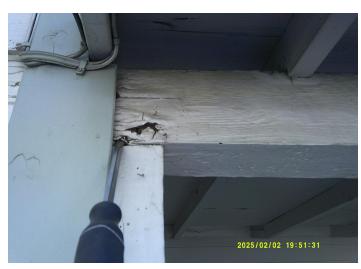
4A - Section I

FINDING: Fungus damage noted at the front porch cover support beam.

RECOMMENDATION: Remove the fungus damaged portions of the support beam and replace with new material.

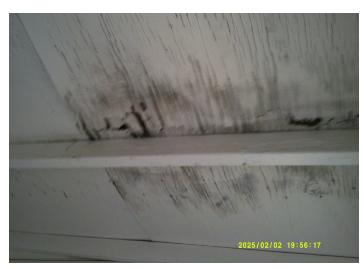
9A - Section I

FINDING: Stains and fungus damage noted at the patio cover roof sheathing and rafters. Damage may extend into inaccessible areas.

RECOMMENDATION: Remove the fungus damaged portions of the roof sheathing and rafters. Call for a reinspection of the inaccessible areas. The inaccessible areas will be inspected for a fee if made accessible by the interested parties at his/her expense. A supplemental report will be filed at such time. No opinion is rendered concerning the conditions in the area at this time. Replace with new material.

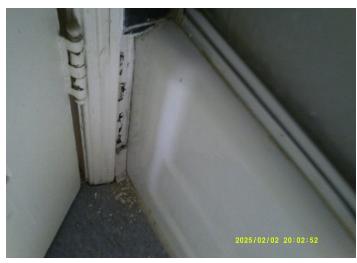
10E - Section II

FINDING: Stains and moisture damage noted at the bathroom sheetrock walls adjacent to the bathtub. Damage may extend into inaccessible areas.

RECOMMENDATION: Interested parties should engage the services of a licensed plumber to check for leaks and to perform any corrective work needed. Remove the moisture damaged portions of the sheetrock walls. Call for a reinspection of the inaccessible areas. The inaccessible areas will be inspected for a fee if made accessible by the interested parties at his/her expense. A supplemental report will be filed at such time. No opinion is rendered concerning the conditions in the area at this time. Replace with new material.

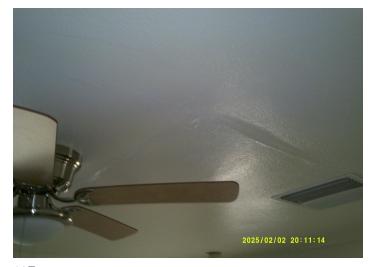
10F - Section II

FINDING: Patching and peeling paint noted at the bedroom ceiling.

RECOMMENDATION: Interested parties should engage the services of a licensed contractor to check for leaks and to perform any corrective work needed.

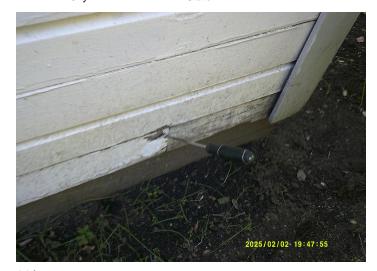
11A - Section I

FINDING: Fungus damage noted at the base of the siding. Damage may extend into inaccessible areas.

RECOMMENDATION: Remove the fungus damaged portions of the siding. Call for a reinspection of the inaccessible areas. The inaccessible areas will be inspected for a fee if made accessible by the interested parties at his/her expense. A supplemental report will be filed at such time. No opinion is rendered concerning the conditions in the area at this time. Replace with new material.

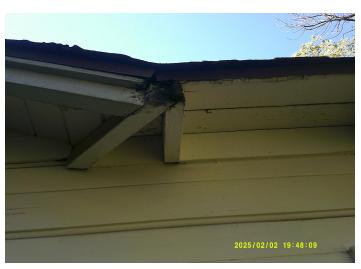
11B - Section I

FINDING: Stains and fungus damage noted at the roof sheathing, rafters, barge rafters and trim at the eaves. Damage may extend into inaccessible areas.

RECOMMENDATION: Interested parties should engage the services of a licensed contractor to check for leaks and to perform any corrective work needed. Remove the fungus damaged portions of the roof sheathing, rafters, barge rafters and trim. Call for a reinspection of the inaccessible areas. The inaccessible areas will be inspected for a fee if made accessible by the interested parties at his/her expense. A supplemental report will be filed at such time. No opinion is rendered concerning the conditions in the area at this time. Replace with new material.

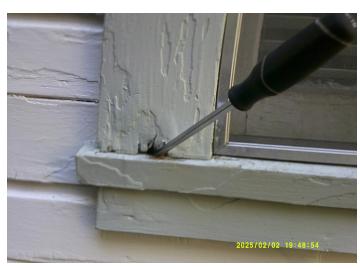
11C - Section I

FINDING: Fungus damage noted at the window sills, frames and trim. Damage may extend into inaccessible areas.

RECOMMENDATION: Remove the fungus damaged portions of the window sills, frames and trim. Call for a reinspection of the inaccessible areas. The inaccessible areas will be inspected for a fee if made accessible by the interested parties at his/her expense. A supplemental report will be filed at such time. No opinion is rendered concerning the conditions in the area at this

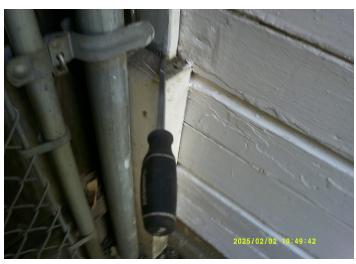
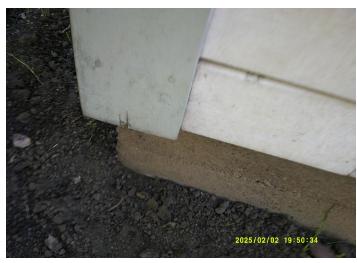
11D 11D

11D - Section I

FINDING: Fungus damage noted at the corner trim. Damage may extend into inaccessible areas.

RECOMMENDATION: Remove the fungus damaged portions of the corner trim. Call for a reinspection of the inaccessible areas. The inaccessible areas will be inspected for a fee if made accessible by the interested parties at his/her expense. A supplemental report will be filed at such time. No opinion is rendered concerning the conditions in the area at this time. Replace with new material.

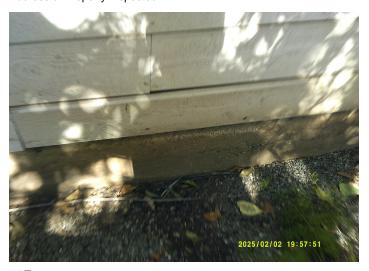
11E - Section II

FINDING: Gaps were noted at the lose siding.

RECOMMENDATION: Repair/replace the gaps in the loose siding as needed to help prevent moisture related problems in this area.

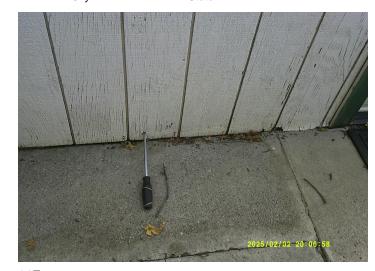
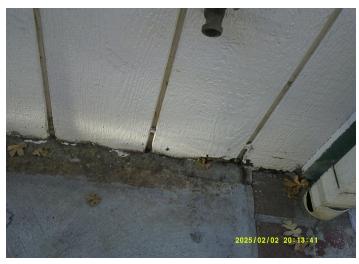
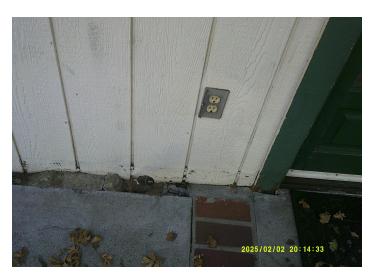
11F - Section I

FINDING: Fungus damage noted at the base of the siding. Damage may extend into inaccessible areas.

RECOMMENDATION: Remove the fungus damaged portions of the siding. Call for a reinspection of the inaccessible areas. The inaccessible areas will be inspected for a fee if made accessible by the interested parties at his/her expense. A supplemental report will be filed at such time. No opinion is rendered concerning the conditions in the area at this time. Replace with new material.

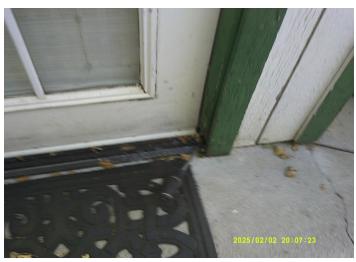
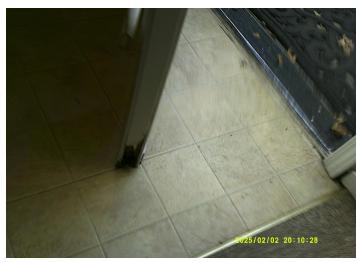
11G 11G

11G - Section I

FINDING: Fungus damage noted at the door, jambs and trim. Damage may extend into inaccessible areas.

RECOMMENDATION: Remove the fungus damaged portions of the door, jambs and trim. Call for a reinspection of the inaccessible areas. The inaccessible areas will be inspected for a fee if made accessible by the interested parties at his/her expense. A supplemental report will be filed at such time. No opinion is rendered concerning the conditions in the area at this time. Replace with new material.

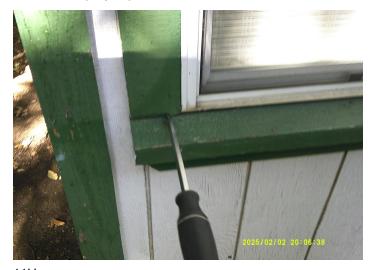
11H - Section I

FINDING: Fungus damage noted at the window sills and trim. Damage may extend into inaccessible areas.

RECOMMENDATION: Remove the fungus damaged portions of the window sills and trim. Call for a reinspection of the inaccessible areas. The inaccessible areas will be inspected for a fee if made accessible by the interested parties at his/her expense. A supplemental report will be filed at such time. No opinion is rendered concerning the conditions in the area at this time. Replace with new material.

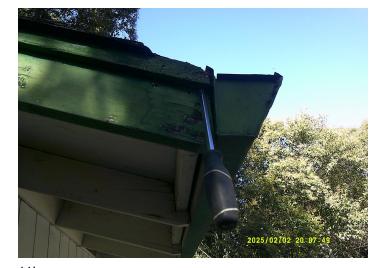
11I - Section I

FINDING: Stains and fungus damage noted at the barge rafters and trim at the eaves. Damage may extend into inaccessible areas.

RECOMMENDATION: Interested parties should engage the services of a licensed contractor to check for leaks and to perform any corrective work needed. Remove the fungus damaged portions of the barge rafters and trim. Call for a reinspection of the inaccessible areas. The inaccessible areas will be inspected for a fee if made accessible by the interested parties at his/her expense. A supplemental report will be filed at such time. No opinion is rendered concerning the conditions in the area at this time. Replace with new material.

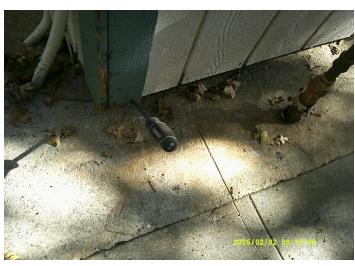
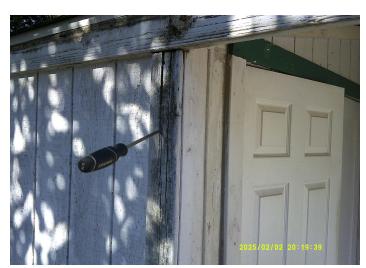
11L - Section I

FINDING: Fungus damage noted at the corner trim. Damage may extend into inaccessible areas.

RECOMMENDATION: Remove the fungus damaged portions of the corner trim. Call for a reinspection of the inaccessible areas. The inaccessible areas will be inspected for a fee if made accessible by the interested parties at his/her expense. A supplemental report will be filed at such time. No opinion is rendered concerning the conditions in the area at this time. Replace with new material.

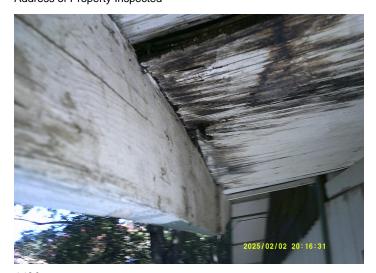
11M - Section I

FINDING: Stains and fungus damage noted at the roof sheathing and barge rafters at the eaves. Damage may extend into inaccessible areas.

RECOMMENDATION: Interested parties should engage the services of a licensed contractor to check for leaks and to perform any corrective work needed. Remove the fungus damaged portions of the roof sheathing and barge rafters. Call for a reinspection of the inaccessible areas. The inaccessible areas will be inspected for a fee if made accessible by the interested parties at his/her expense. A supplemental report will be filed at such time. No opinion is rendered concerning the conditions in the area at this time. Replace with new material.

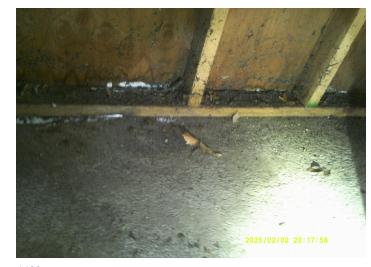
11N - Section I

FINDING: Stains and fungus infection/damage noted at the closet siding, wall studs and sill plate. Damage may extend into inaccessible areas.

RECOMMENDATION: Remove the fungus damaged portions of the siding, wall studs and sill plate. Call for a reinspection of the inaccessible areas. The inaccessible areas will be inspected for a fee if made accessible by the interested parties at his/her expense. A supplemental report will be filed at such time. No opinion is rendered concerning the conditions in the area at this time. Replace with new material.

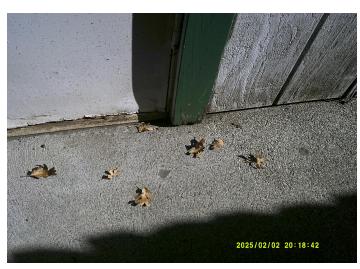
110 - Section I

FINDING: Fungus damage noted at the closet door, jambs and trim. Damage may extend into inaccessible areas.

RECOMMENDATION: Remove the fungus damaged portions of the door, jambs and trim. Call for a reinspection of the inaccessible areas. The inaccessible areas will be inspected for a fee if made accessible by the interested parties at his/her expense. A supplemental report will be filed at such time. No opinion is rendered concerning the conditions in the area at this time. Replace with new material.

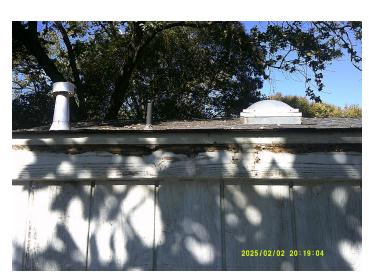
11P - Section I

FINDING: Stains and fungus damage noted at the fascia at the eaves. Damage may extend into inaccessible areas.

RECOMMENDATION: Interested parties should engage the services of a licensed contractor to check for leaks and to perform any corrective work needed. Remove the fungus damaged portions of the fascia. Call for a reinspection of the inaccessible areas. The inaccessible areas will be inspected for a fee if made accessible by the interested parties at his/her expense. A supplemental report will be filed at such time. No opinion is rendered concerning the conditions in the area at this time. Replace with new material.
