General Summary

Ferguson Home Inspections

Kevoork & Susan Toumalan

1608 Cataluna Pl
Palos Verdes Estates CA 90274

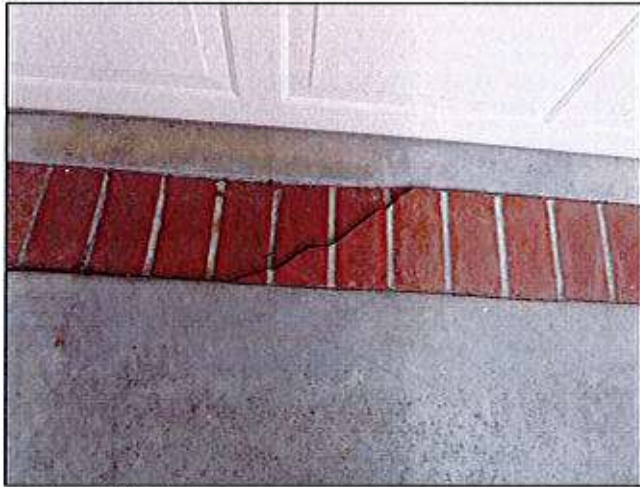
1.0 Item 1 (Picture)

Heaving and expansion cracks noted at the driveway, suggest repairs as needed.

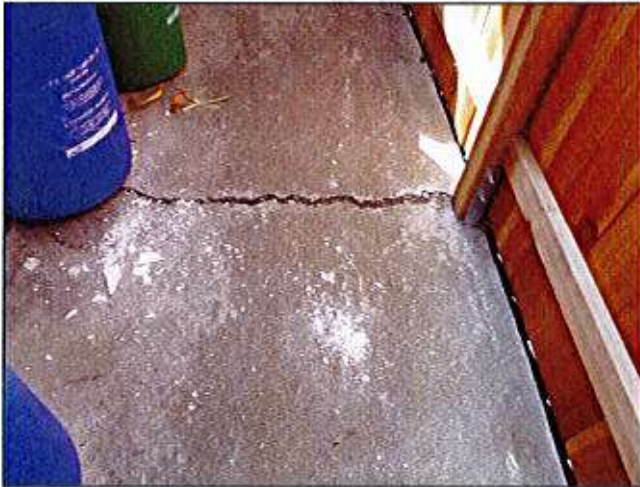
1.1 Item 1 (Picture)

Settling and heaving noted at various areas, this is a potential trip hazard. Suggest review with a licensed contractor for repair/replacement costs as needed.

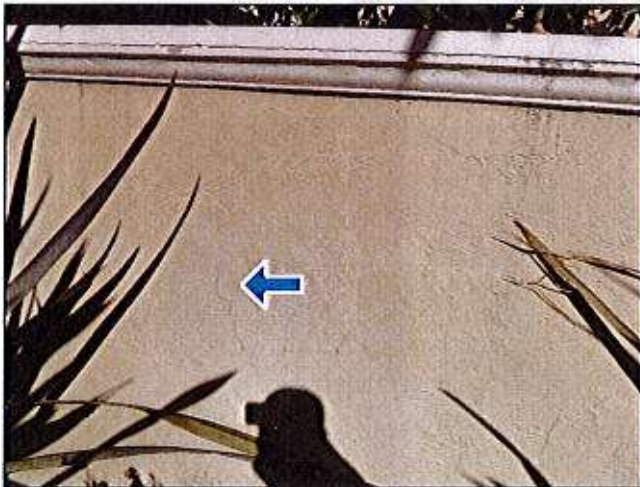
1.2 Item 2 (Picture)

(2) Minor cracks noted at the stucco fences, areas stable at the time of the inspection. Suggest repairs/maintenance as needed.

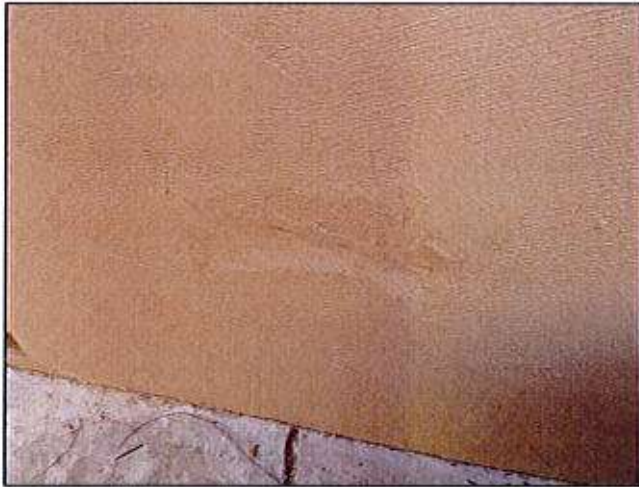
1.3 Item 1 (Picture)

(1) Various areas of the siding have been patched, suggest review with the seller on the cause and any repairs needed.

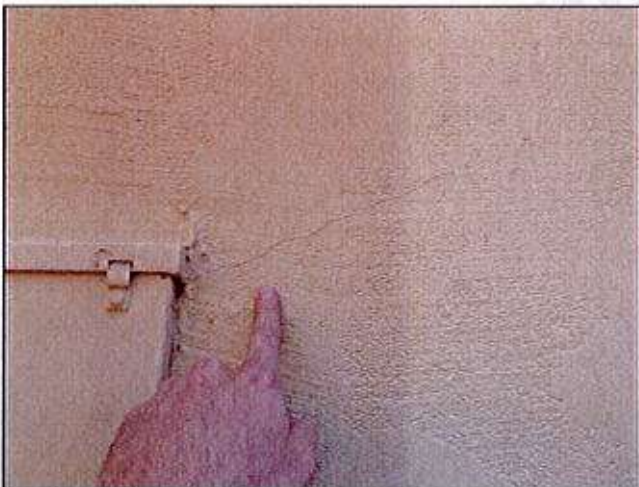
1.3 Item 3 (Picture)

(2) Settling cracks noted at various areas of the stucco siding, suggest maintenance as needed.

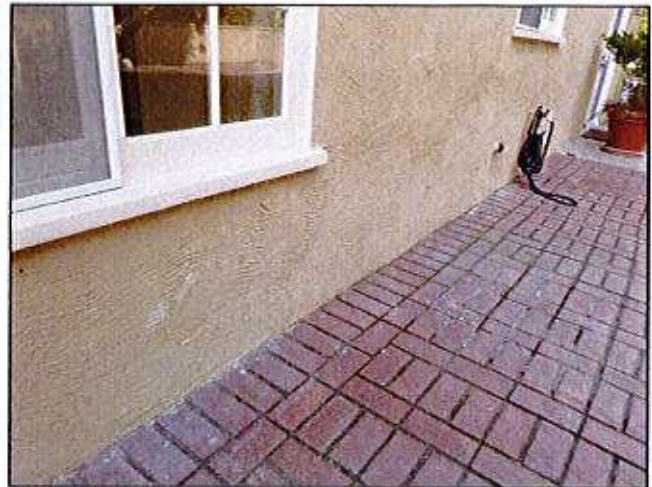
1.3 Item 7 (Picture)

(3) Minor deterioration and blistering stucco noted at various areas. See the Lot/Drainage comments and review with a licensed contractor to repair as needed and divert water away from the foundation areas.

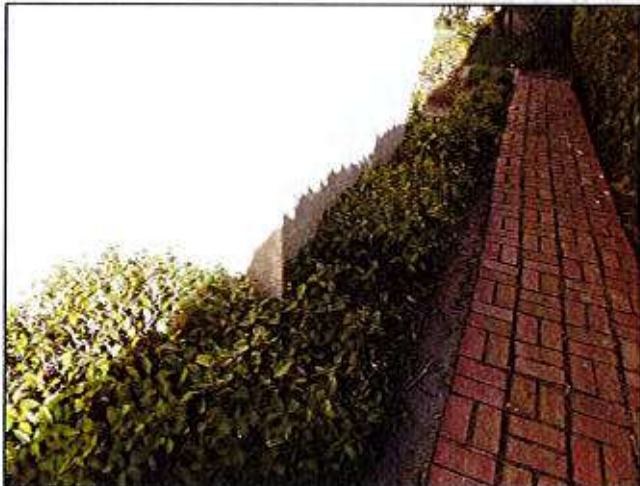
1.3 Item 8 (Picture)

(4) Multiple trees and bushes are in contact with the siding. Suggest trimming them away from the siding to prevent any future damage.

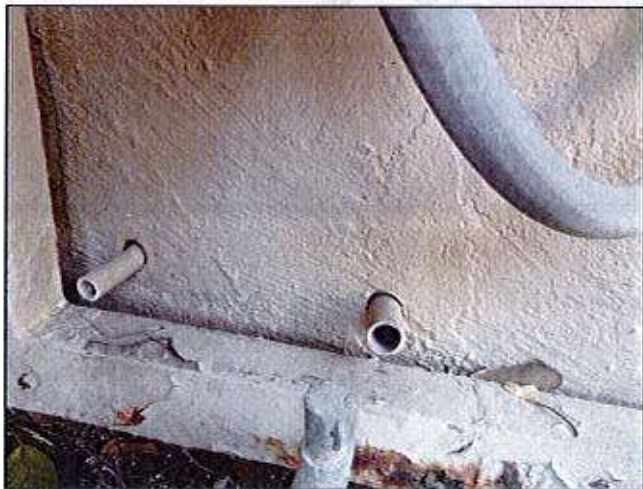
1.3 Item 10 (Picture)

(5) Suggest sealing around the siding penetration's to prevent future water/insect/rodent intrusion at these areas.

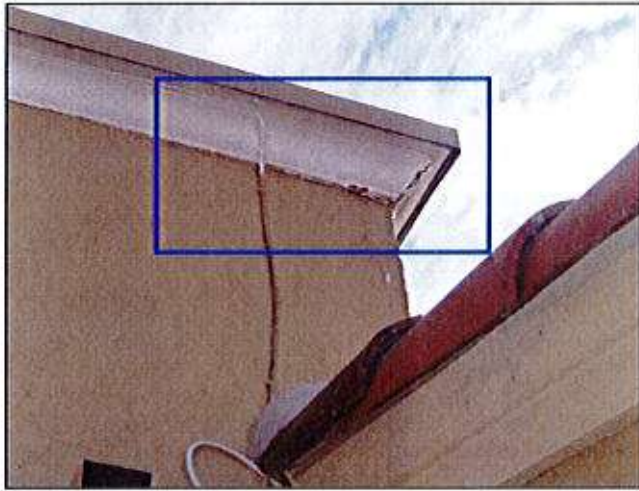
1.4 Item 1 (Picture)

Wood deterioration noted at various trim areas. Suggest review with termite company and/or a licensed contractor

and repair/replace as needed.

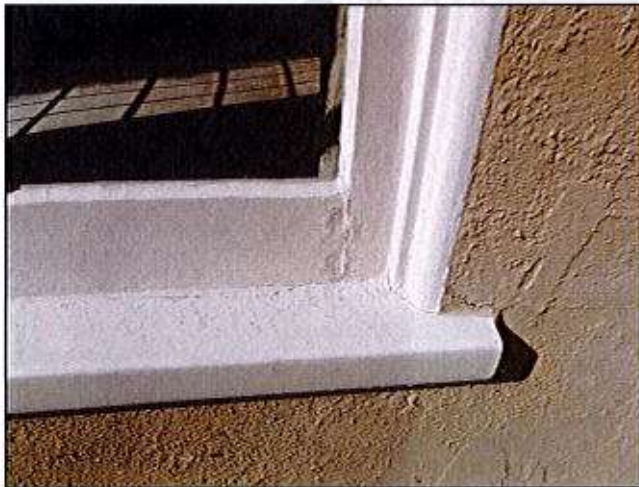
1.5 Item 1 (Picture)

The wood trim/frames are peeling paint at various windows, further deterioration may occur if not repaired. Suggest review by a licensed contractor and repair/replace as needed.

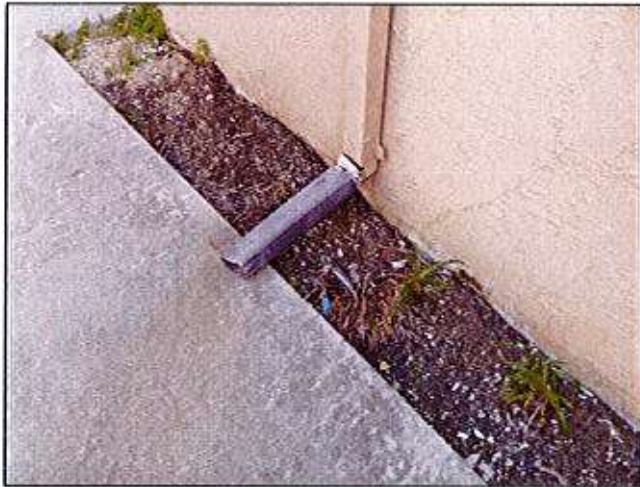
1.8 Item 1 (Picture)

(1) The gutters/downspouts are damaged, rusted and deteriorated at various areas, suggest replacing the gutters/downspouts as needed.

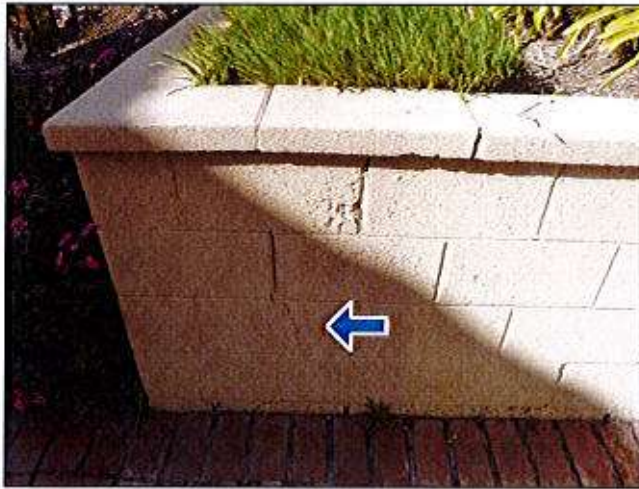
1.9 Item 1 (Picture)

(1) The retaining wall at the rear shows some settlement and movement cracks, but appears stable. Suggest review with a licensed contractor for repair/replacement costs as needed.

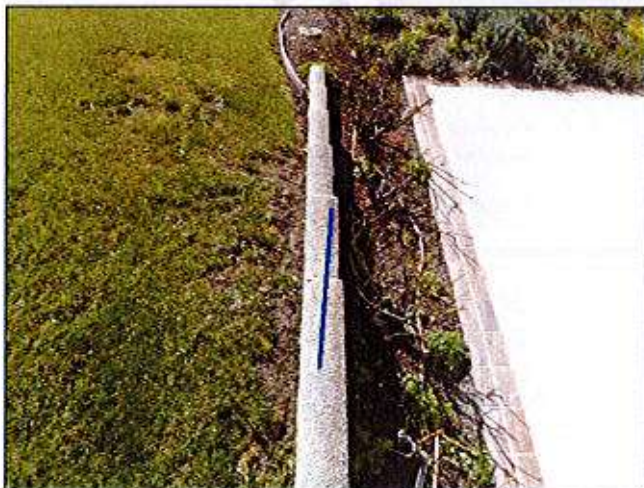
1.9 Item 4 (Picture)

(2) The retaining wall at the front left shows some minor settlement and movement, but appears stable. Suggest review with a licensed contractor for repair/replacement costs as needed.

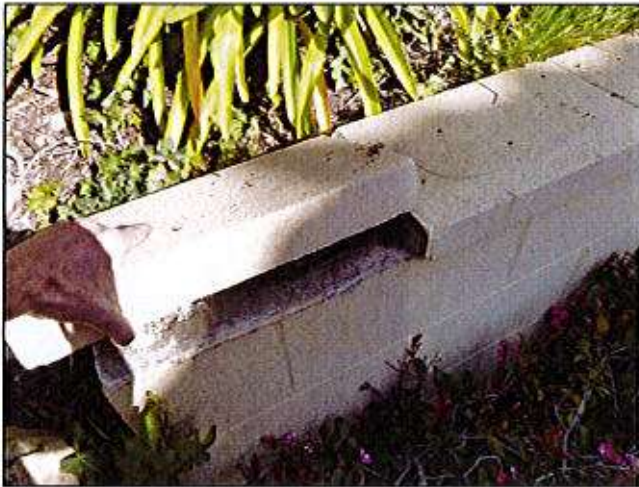
1.9 Item 5 (Picture)

(3) Various top caps were loose at the rear retaining wall, suggest repairs as needed.

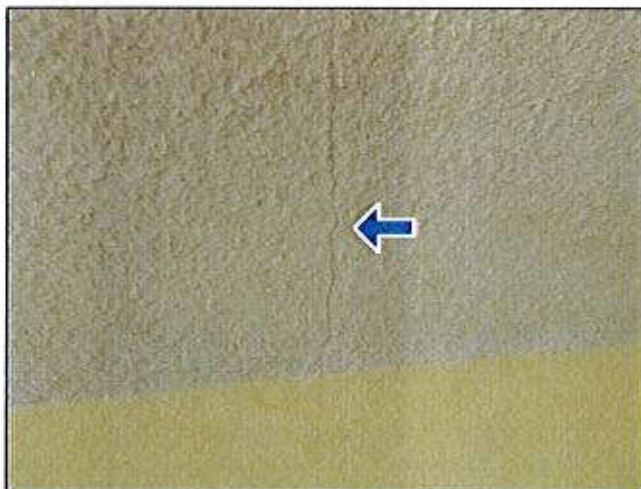
3.0 Item 1 (Picture)

(1) Settling was observed at the front right section of the structure. Suggest review with a licensed foundation contractor and/or a soil/geo-technical engineer and make any repairs as needed.

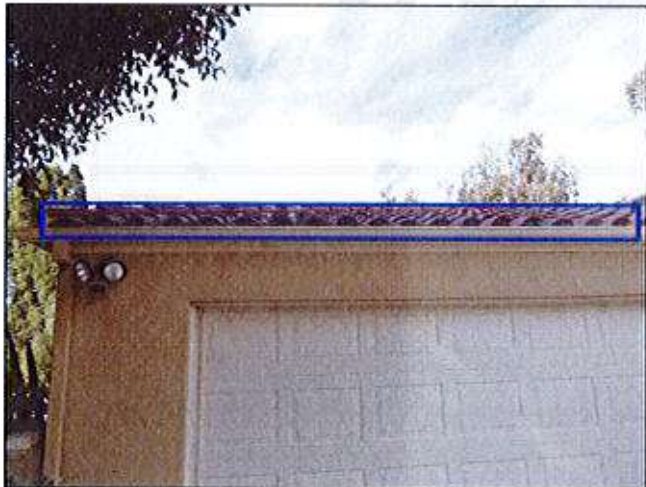
4.0 Item 5 (Picture)

(2) The tile bird stops were missing at various areas, suggest review with a licensed roofer for installation costs as needed.

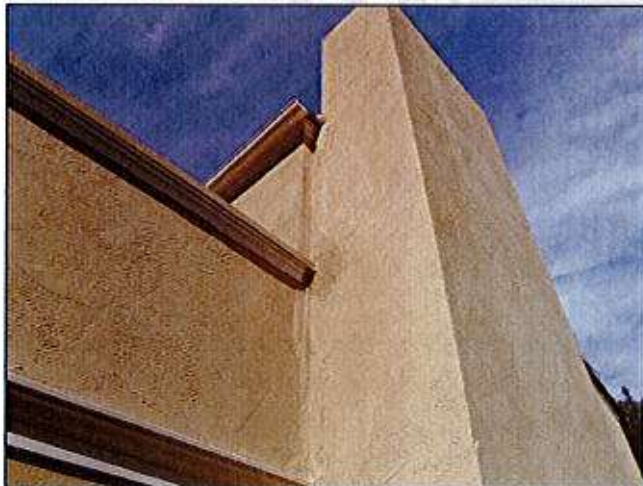
4.2 Item 1 (Picture)

(1) Excessive stucco patching was noted at the chimney structure. The stucco patches are separating/failing, indicating that the chimney structure is settling at different rate(s) than the dwelling. Suggest review by a licensed chimney contractor and a licensed contractor to make repairs as needed to reduce/eliminate the settling of both the chimney structure and dwelling and to repair the exterior stucco to prevent water intrusion as needed.

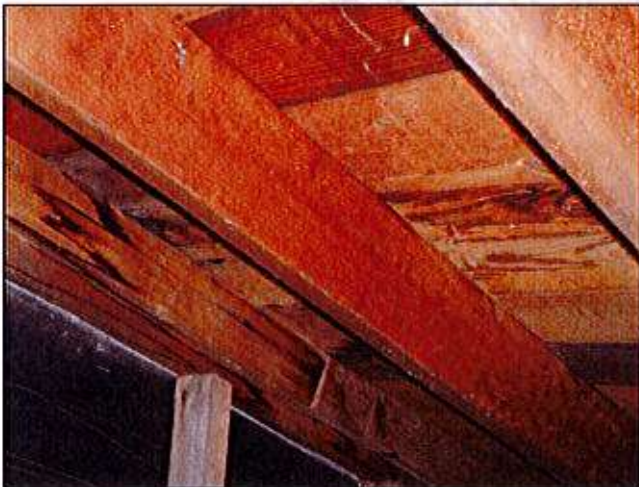
5.0 Item 1 (Picture)

(1) Moisture stains noted at various areas of the attic sheathing/framing, see roof comments and repair as needed.

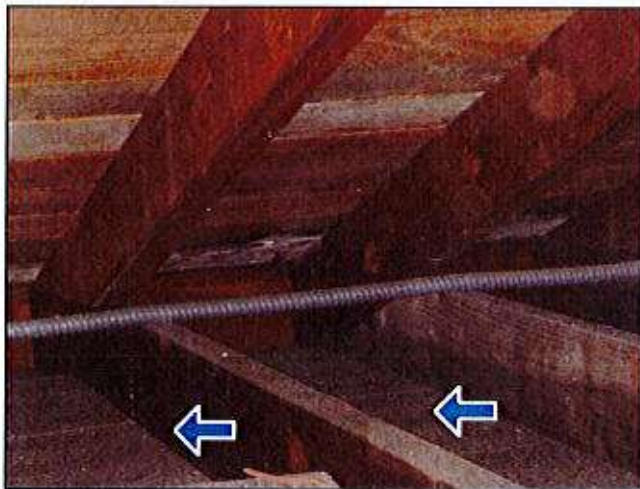
5.1 Item 1 (Picture)

No insulation installed at the attic area, this is common for the original age of the home. Suggest review by a licensed contractor for installation costs as an upgrade.

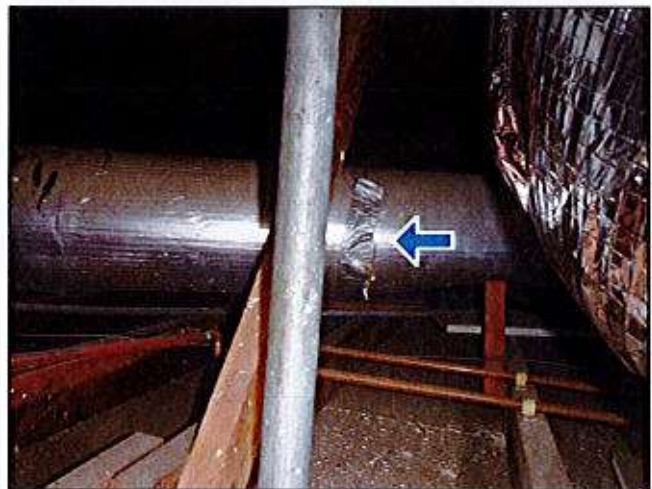
5.4 Item 4 (Picture)

(1) Possible asbestos like ducting material, tape and wrap noted at ducting and joints. Tape and wrap, torn and loose in the several areas, suggest review by licensed contractor for repairs/replacement or removing material or encapsulating the damaged areas.

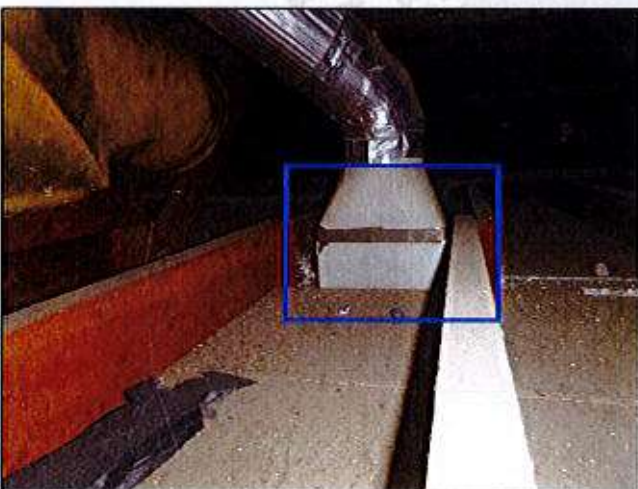
5.4 Item 5 (Picture)

(2) Possible asbestos wrapped ducting noted at the heating registers. Suggest review with a licensed heating company and/or the city on the installation of a new heating system without the complete removal and/or encapsulation of the remaining asbestos material. Suggest repair/replace/encapsulate as needed.

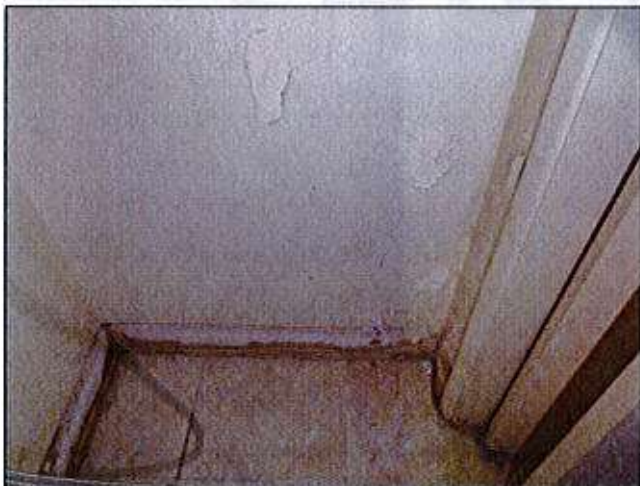
6.1 Item 1 (Picture)

Old water stains noted at the walls. Areas tested with moisture meter did not show any indication of excessive moisture or active leak(s) at the time of the inspection. Suggest maintenance and repairs as needed.

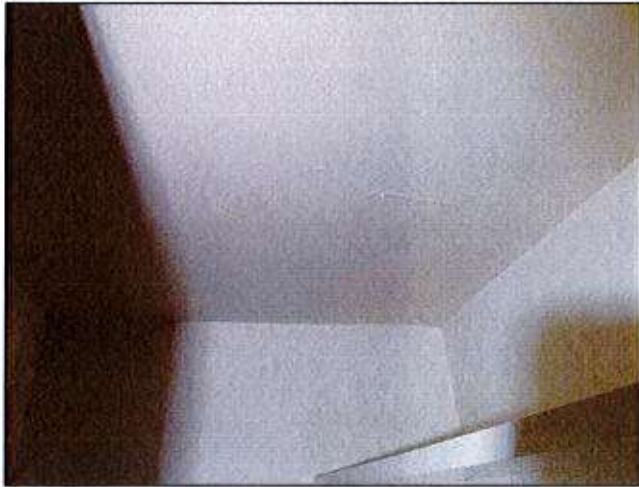
6.2 Item 1 (Picture)

Patched and uneven areas of the ceiling noted, suggest review with the seller on the cause and any repairs needed. Suggest repair as needed.

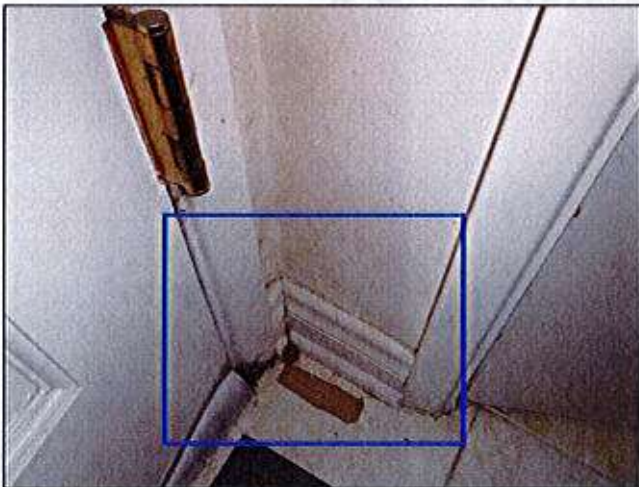
6.3 Item 1 (Picture)

(1) Evidence of previous and possible on-going water intrusion was noted at the door(s) to the exterior. Suggest review with a licensed contractor for repair/replacement costs as needed.

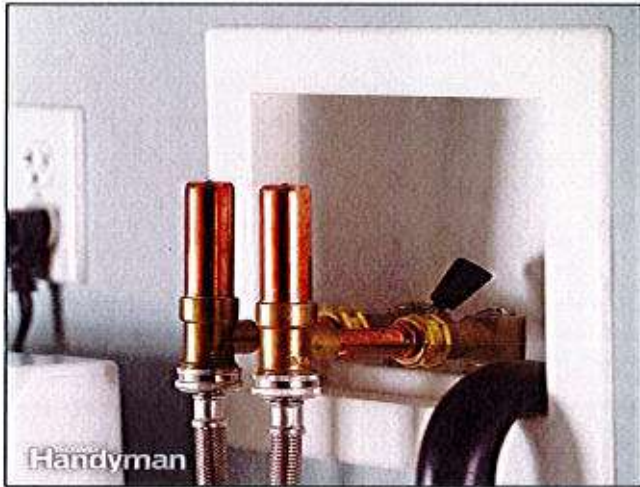
6.5 Item 1 (Picture) HV

(1) Suggest upgrading with 'hammer valve' plumbing supply systems if a water sensor/efficient/smart washing machine is to be installed at this area.

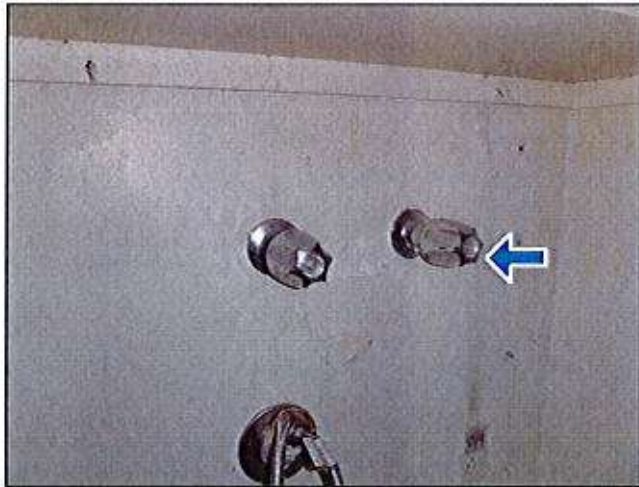
6.5 Item 4 (Picture)

(2) The handles/valves are deteriorated, suggest replacement as needed.

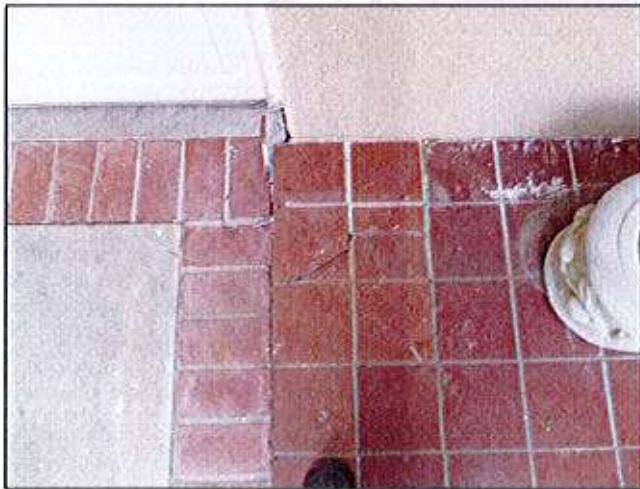
7.1 Item 1 (Picture)

The decking is cracked and deteriorated. Suggest review by a licensed decking contractor for repair/replacement costs as needed.

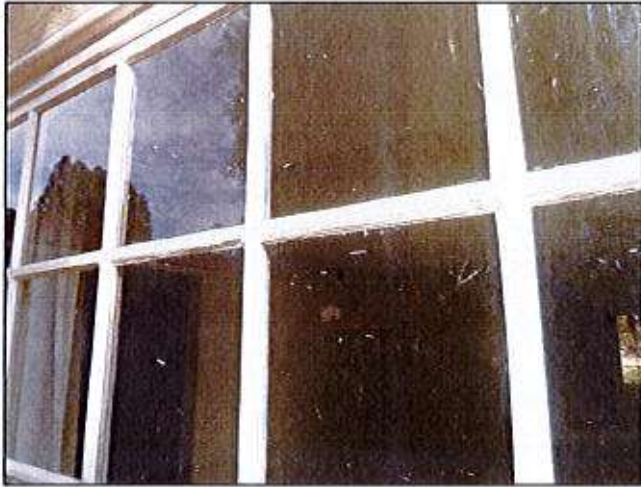
7.3 Item 1 (Picture)

Wood deterioration noted at various windows (temporary silicone repairs were noted at this area). Suggest review with termite company and/or a licensed contractor and repair/replace as needed.

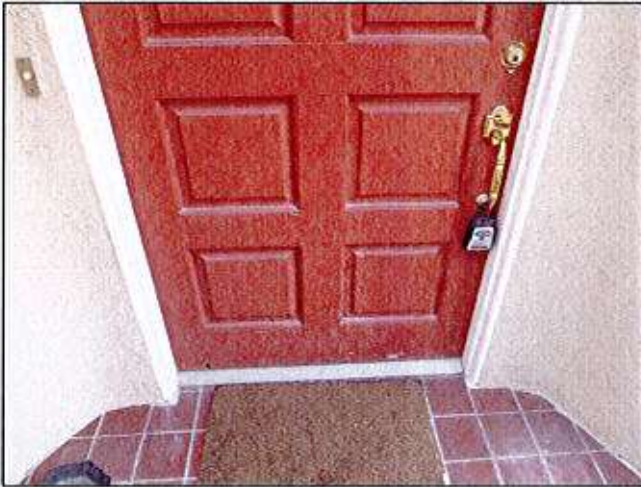
7.4 Item 1 (Picture)

The door is weathered and deteriorated, suggest maintenance and repairs as needed.

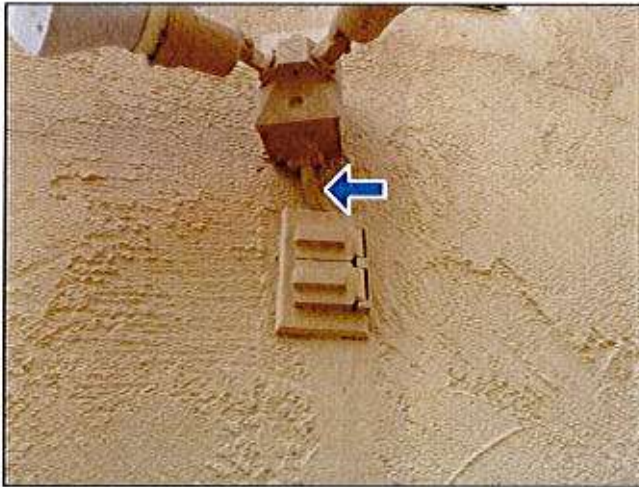
9.1 Item 1 (Picture)

(1) Exposed romex wiring located in accessible areas. This is a safety concern as it could be subject to physical damage. Romex wiring is allowed in inaccessible areas such as attics, crawl spaces and within walls provided that all proper protective materials and required tie-downs are in place. Suggest review by a licensed electrician for repair/replacement costs as needed.

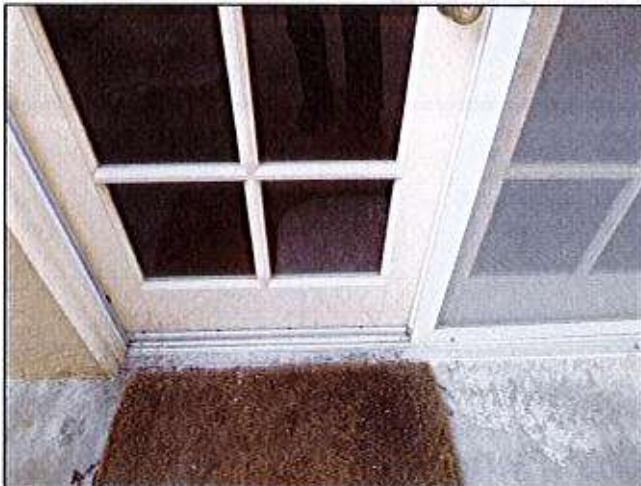
9.3 Item 1 (Picture)

Wood deterioration noted at the doors and frame. Suggest review by a licensed contractor for repair/replacement costs as needed.

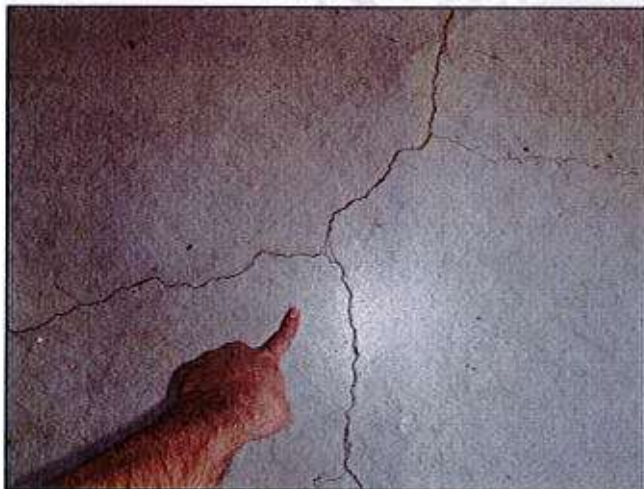
11.0 Item 1 (Picture)

A large expansion crack was noted at the garage slab. This is common for the age of the structure due to the expansion soil and generally there was no steel installed at the garage slab. Suggest review with a licensed contractor for repair/replacement costs as needed.

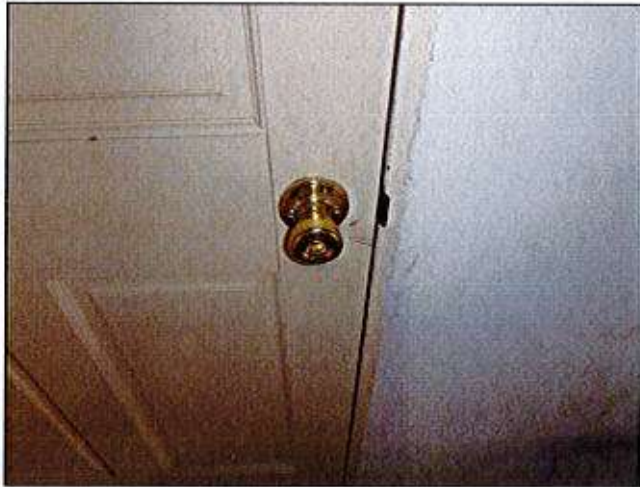
11.5 Item 1 (Picture)

The rear access door does not lock, suggest repair/replacement of the locking hardware as needed.

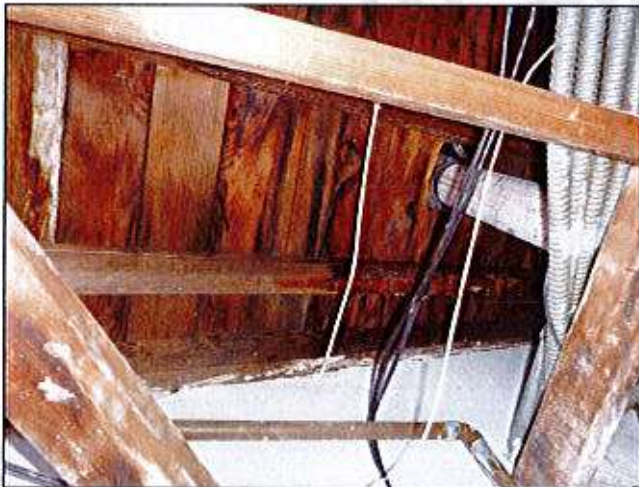
11.6 Item 1 (Picture)

(1) Water stains and deterioration noted at the ceiling, see the roof comments and repair/replace as needed.

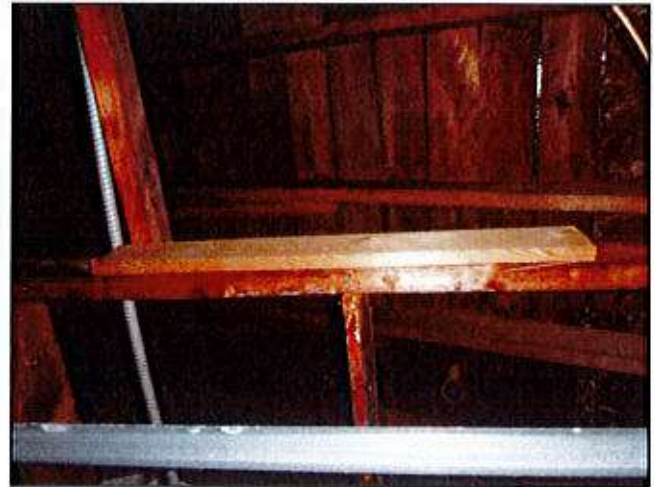
11.6 Item 5 (Picture)

(2) Various areas of the garage framing were incorrectly cut and/or damaged, suggest review with a licensed contractor for repairs as needed.

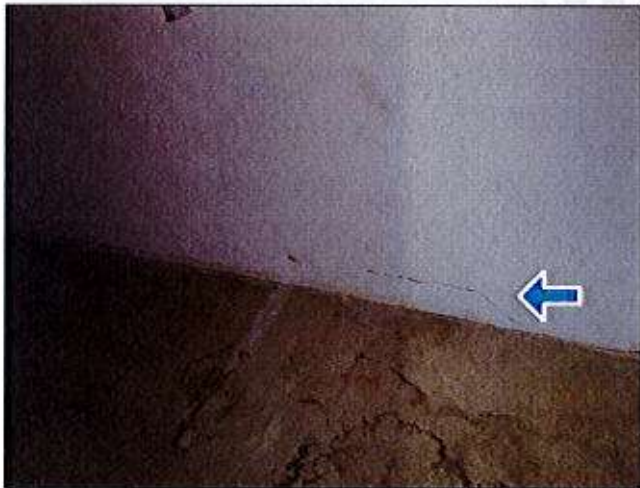
11.6 Item 6 (Picture)

(3) Settling cracks and patching noted, suggest repair as needed.

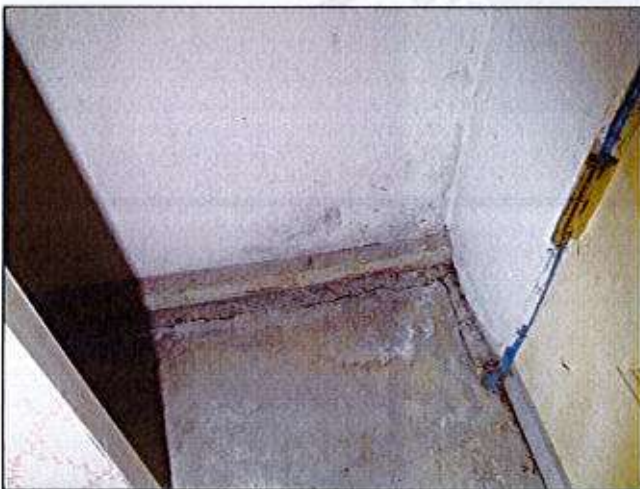
11.6 Item 7 (Picture)

(4) Minor staining and efflorescence noted at the rear wall/slab, see the lot/grade and drainage comments and add perimeter barriers/regrade the walkways to divert the water away from the garage structure.

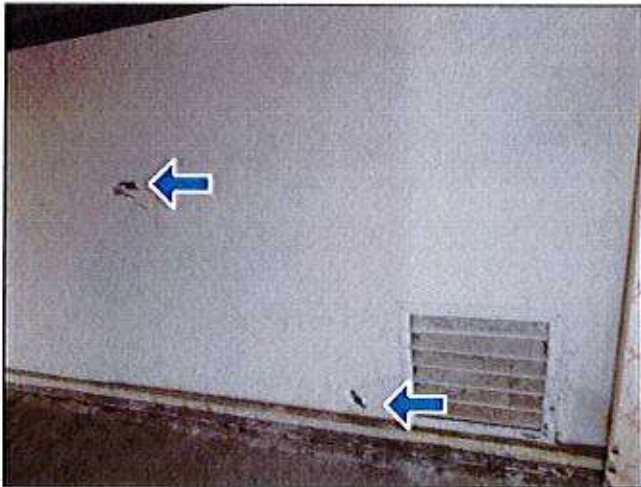
11.6 Item 8 (Picture)

(5) Minor holes were noted at the walls, suggest repairs as needed.

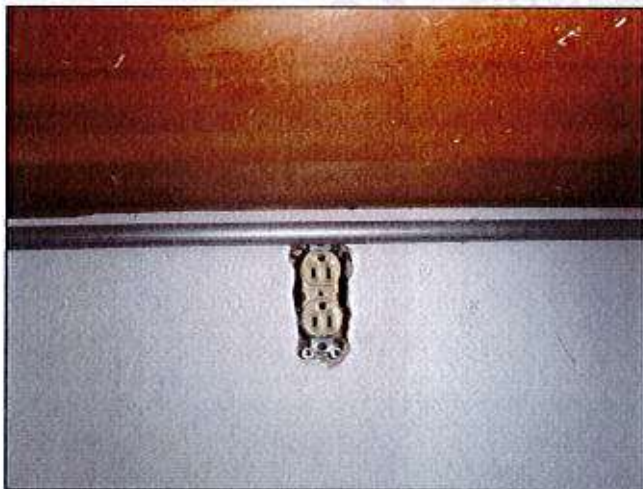
11.7 Item 1 (Picture)

- (1) Various light fixtures were inoperable, possible bulbs out. Suggest replacing the bulbs as needed.
- (2) Various outlet cover(s) are missing, suggest installation for safety.

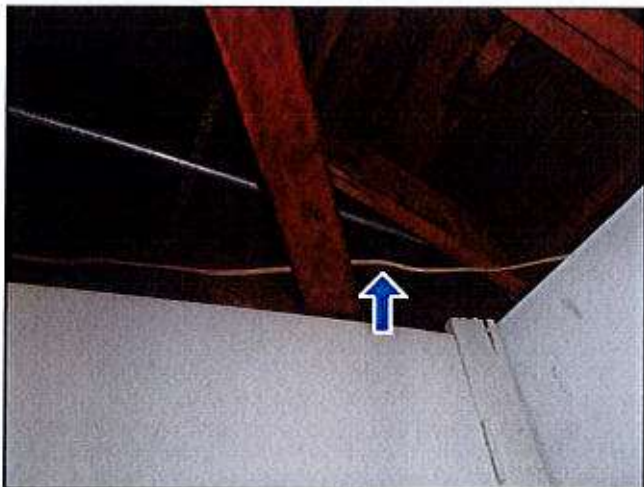
11.7 Item 2 (Picture)

- (3) Exposed romex wiring located in accessible areas. This is a safety concern as it could be subject to physical damage. Romex wiring is allowed in inaccessible areas such as attics, crawl spaces and within walls provided that all proper protective materials and required tie-downs are in place. Suggest review by a licensed electrician for repair/replacement costs as needed.

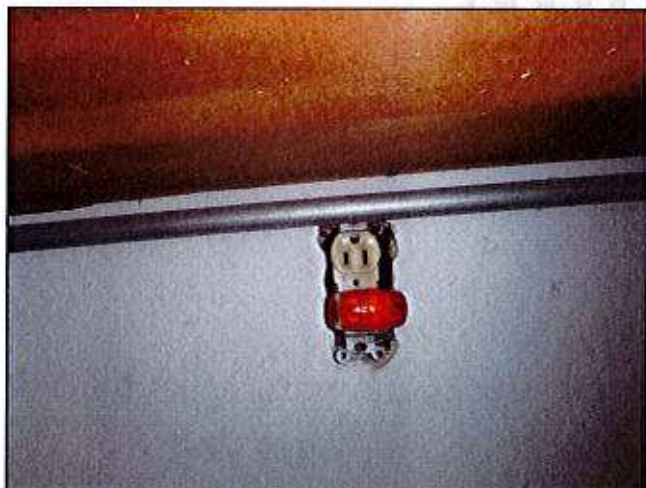
11.7 Item 3 (Picture)

(4) Ungrounded three prong outlets noted at this area. Suggest review with a licensed electrician for costs to ground the outlets as needed as an upgrade and/or protect the outlet(s) on a GFCI circuit where recommended.

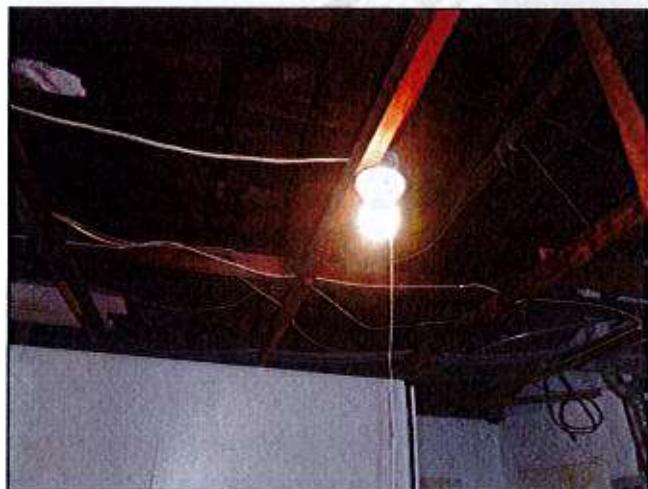
11.7 Item 4 (Picture)

(5) A light fixture was stuck in the 'On' position, suggest repairs as needed.

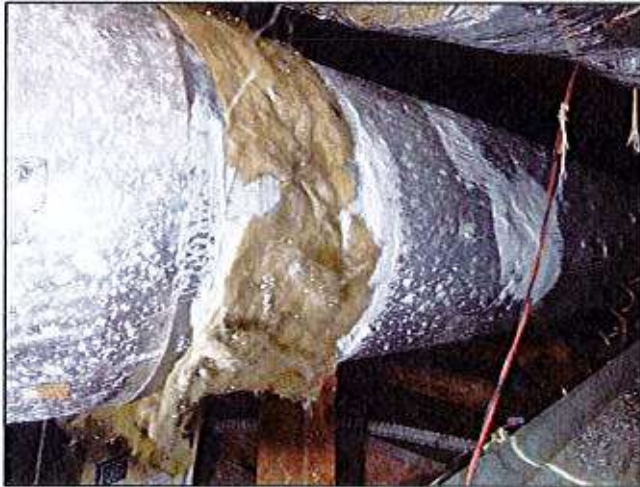
12.3 Item 1 (Picture)

(1) Possible asbestos like ducting material, tape and wrap noted at ducting and joints. Tape and wrap, torn and loose in the several areas, suggest review by licensed contractor for repairs/replacement or removing material or encapsulating the damaged areas.

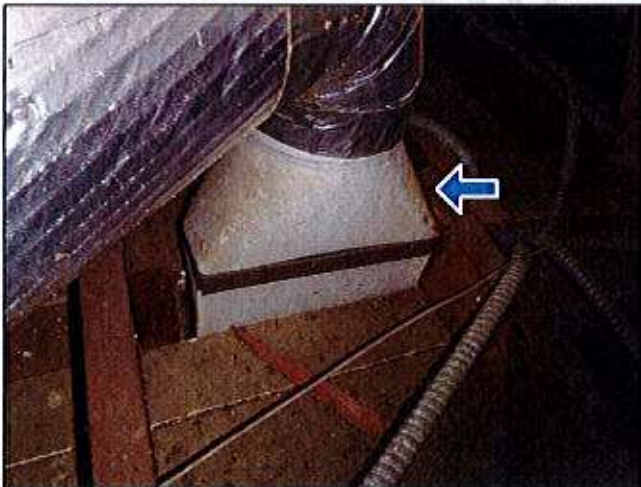
12.3 Item 5 (Picture)

(2) Possible asbestos wrapped ducting noted at the heating registers. Suggest review with a licensed heating company and/or the city on the installation of a new heating system without the complete removal and/or encapsulation of the remaining asbestos material. Suggest repair/replace/encapsulate as needed.

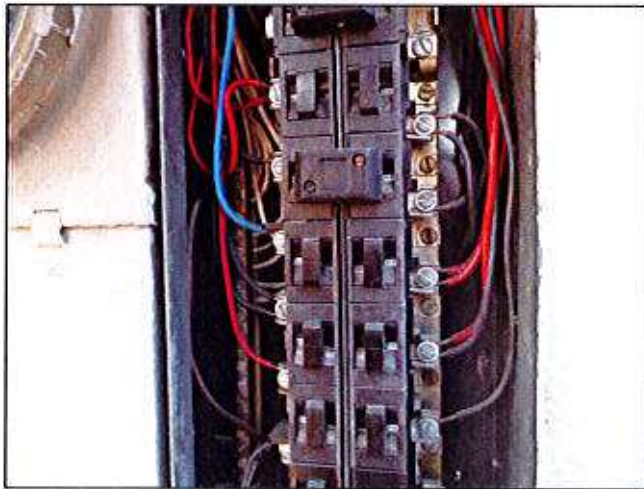
13.1 Item 3 (Picture)

(1) The electrical panel(s) are a Bulldog breaker system. Problems with this style panel include circuit breakers (depending on the vintage) with a dismal performance record and the possibility of unbalanced multi-wire circuits. Also, please be aware that various insurance companies will not insure homes with this style of electrical panel. Suggest review by a licensed electrician for replacement costs as needed.

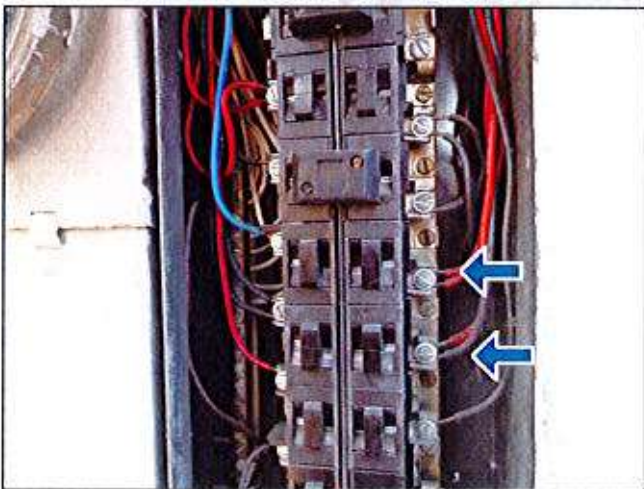
13.1 Item 4 (Picture)

- (2) Due to the age and size of this system (100 Amps) suggest review with a licensed electrician for replacement cost to upgrade the electrical panel and install additional circuits to the interior of the dwelling as needed.
- (3) Double lugged circuit(s) noted in the main panel. This condition can add to the load of the affected electrical circuits causing a possible overload and tripping the breakers. Ideally, circuits should be independently protected, suggest review by a licensed electrician for repair/replacement costs as required for safety.

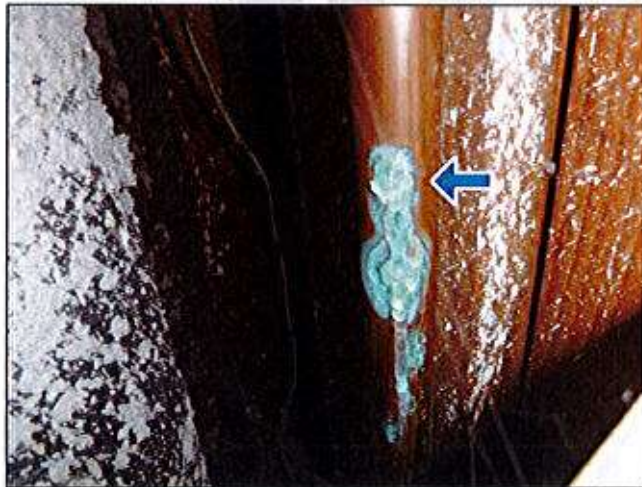
14.0 Item 1 (Picture)

(1) Corroded plumbing and fittings noted at various areas within the dwelling. Suggest further review by a licensed plumber for repair/replacement costs as needed to prevent future leakage, pin hole leaks and possible stains/damage to the interior of the dwelling.

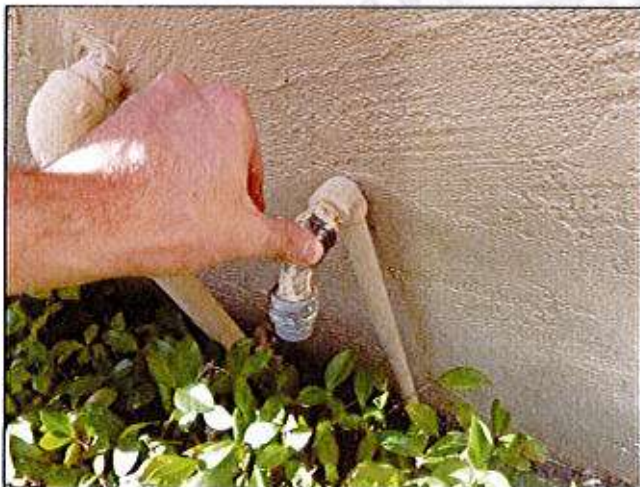
14.0 Item 4 (Picture)

(3) The exterior hose bib on the right side is inoperable, suggest repairs as needed.

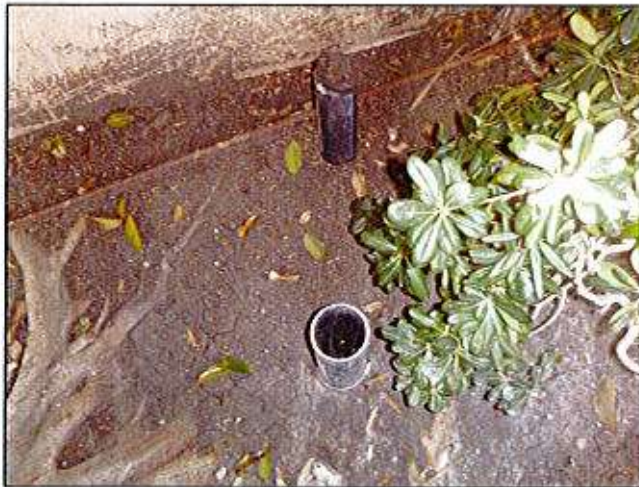
15.0 Item 1 (Picture)

(3) An open sewer drain cleanout was noted at the front of the dwelling, suggest installation of a cap as needed.

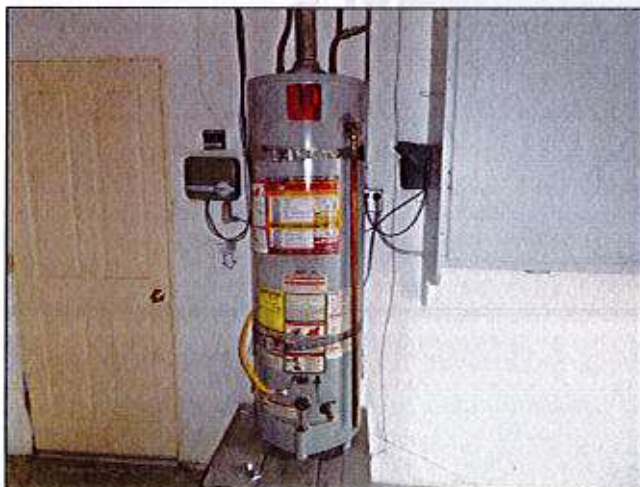
16.0 Item 1 (Picture)

(1) Due to the age of this unit, suggest review with a licensed plumber for replacement costs as it is nearing the end of it's intended life span (12-15 years).

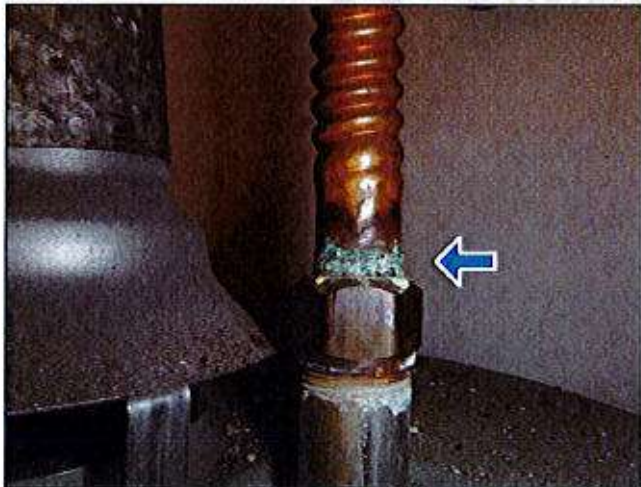
16.0 Item 4 (Picture)

(4) Rusted and corroded riser connection(s) noted, no leaking was visible at the time of the inspection. Suggest review by a licensed plumber for repair/replacement costs as needed.

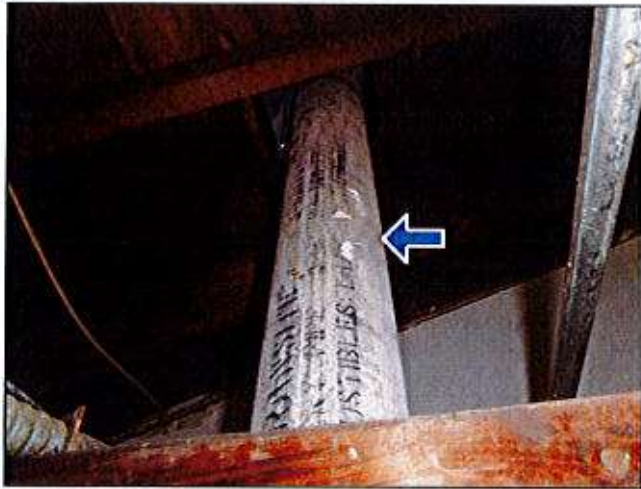
16.1 Item 1 (Picture)

(1) Asbestos-like material transit pipe/vent noted. Common for the age of the dwelling. No damage visible at the transit pipe at the time of the inspection.

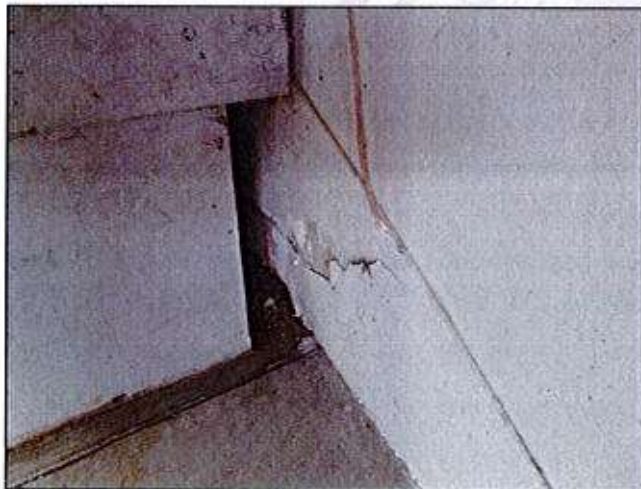
16.2 Item 1 (Picture)

(1) Stains and patching noted at the water heater area walls, these areas tested dry at the time of the inspection. Suggest review with the seller on the cause and any repairs needed, suggest repair as needed.

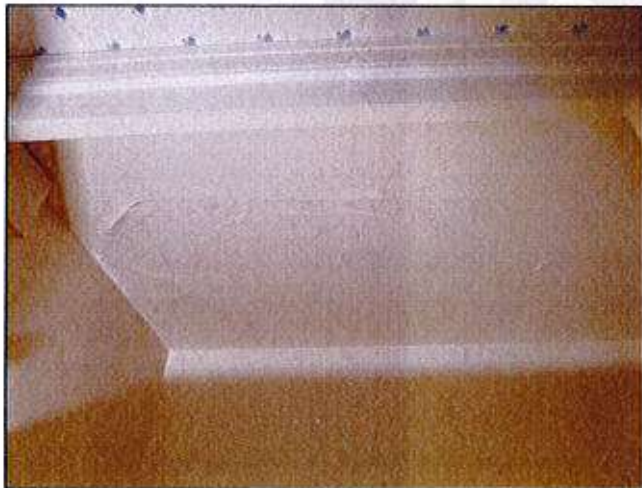
17.2 Item 1 (Picture)

Water stains and deterioration noted at the ceiling, suggest review with the seller and a licensed contractor to determine the cause and for repairs as needed.

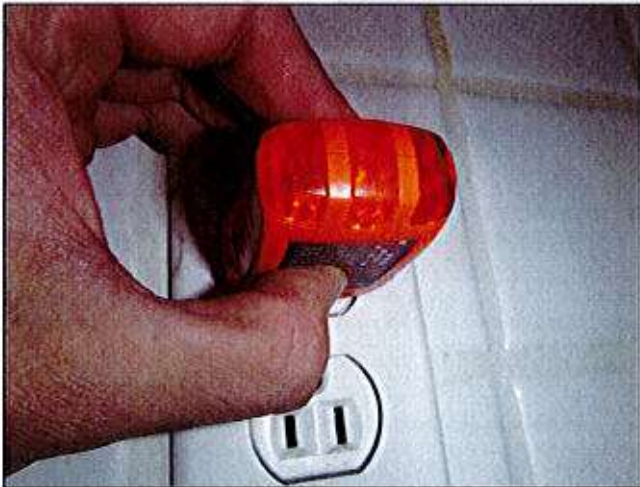
17.8 Item 1 (Picture)

(1) Various countertop outlets are not GFCI protected as required. Countertop GFCI outlet(s)/protection has been required within six feet of the sink since 1987 and all countertop outlets since 1996. Suggest review by a licensed electrician for installation costs as required for safety.

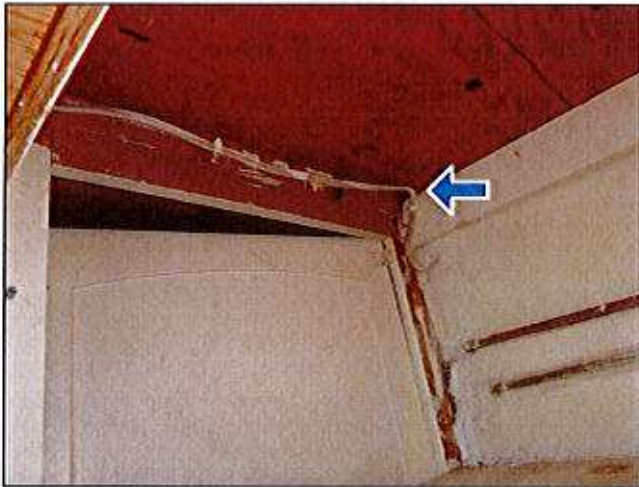
17.8 Item 2 (Picture)

(2) Exposed romex wiring located in accessible areas. This is a safety concern as it could be subject to physical damage. Romex wiring is allowed in inaccessible areas such as attics, crawl spaces and within walls provided that all proper protective materials and required tie-downs are in place. Suggest review by a licensed electrician for repair/replacement costs as needed.

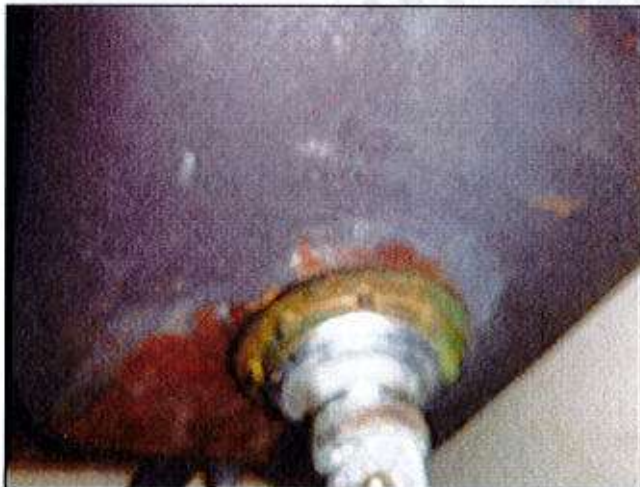
17.9 Item 1 (Picture)

Excessive rusting and deteriorated areas of the sink was noted, suggest repair/replace as needed.

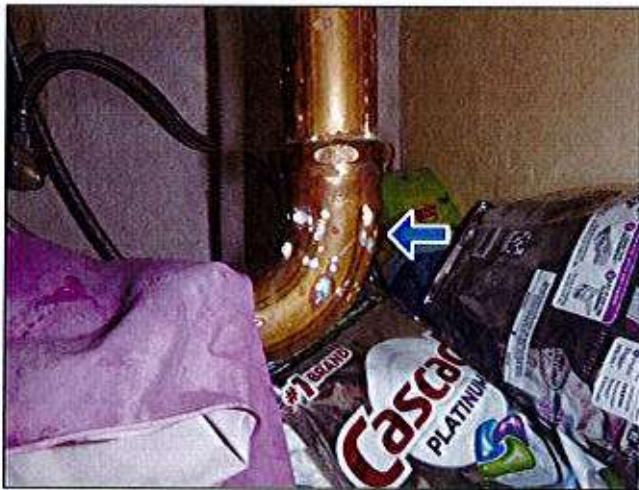
17.11 Item 1 (Picture)

Corrosion noted at the sink drain(s), no leaking noted at the time of the inspection. Suggest review with a licensed plumber and repair/replace as needed.

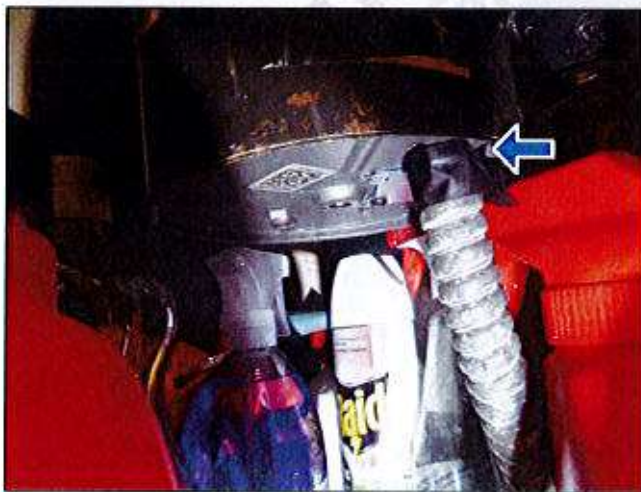
17.13 Item 1 (Picture)

The food disposal wiring is missing the romex/conduit connector (anti-strain device) and the wiring is exposed, this is a potential safety hazard. Suggest review with a licensed plumber for repair/replacement costs as needed for safety.
