Inspection Report

11725 209th St
Lakewood CA 90715

CR Home Inspections

Date: 12/10/2024	Time: 08:10 AM	Report ID: Vu11725
Property: 11725 209th St Lakewood CA 90715	Customer: Alish Vu	Real Estate Professional: Jean Che

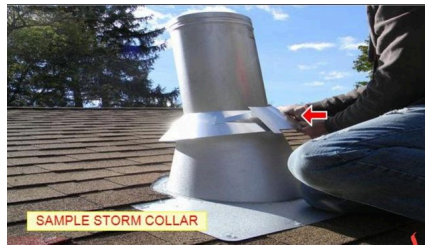
1.2 Item 1(Picture)

(1) Exhaust vent is missing a storm collar. A storm collar is a circular piece of metal that fits on the round pipe of a prefabricated chimney or metal exhaust vent just above the flashing system. It serves the

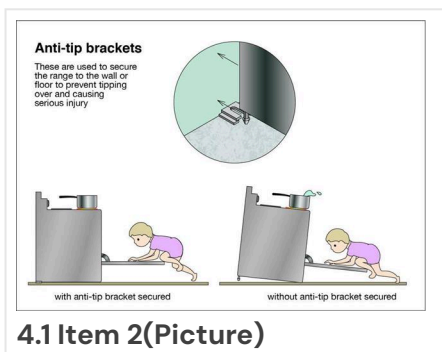
4.1 Item 2(Picture)

(2) Stove is missing it's anti trip brackets.

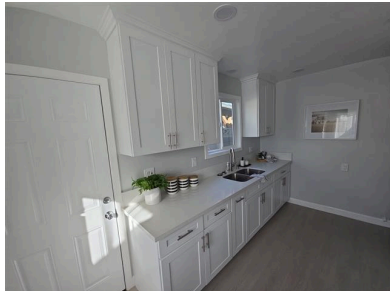
5.3 Item 1(Picture)

(1) All kitchen drawers and doors opened and closed properly. Some interior cabinet areas not visible for inspection due to personal storage(if present).

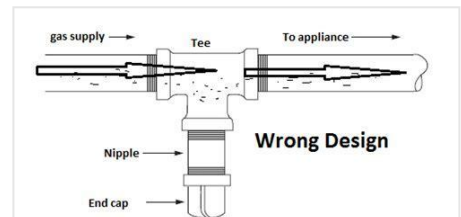
8.3 Item 3(Picture)

(2) I recommend installing a sediment trap at the gas line to the water heater. Sediment traps are intentionally installed to help prevent sediment in the gas piping from getting into the gas valve or burner area of an appliance and fouling things up. May not have been required at the time of the inspection but we recommend that one be installed.

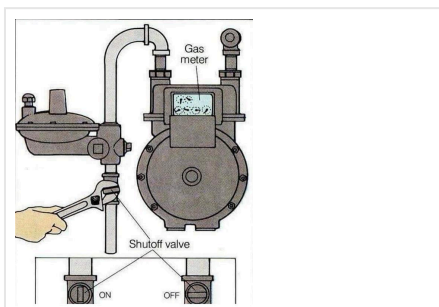
8.6 Item 1(Picture)

I recommend that all exterior gas lines be properly painted to prevent corrosion from the elements.

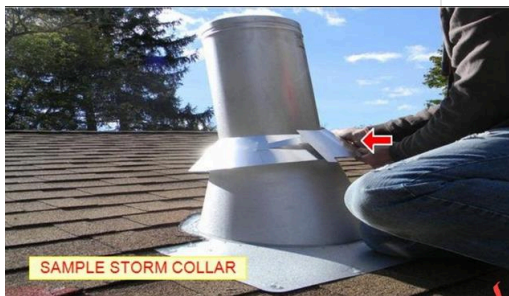
1.2 Item 1(Picture)

(1) Exhaust vent is missing a storm collar. A storm collar is a circular piece of metal that fits on the round pipe of a prefabricated chimney or metal exhaust vent just above the flashing system. It serves the important purpose of keeping rain water from being able to enter through the opening where the pipe comes out of the flashing system.

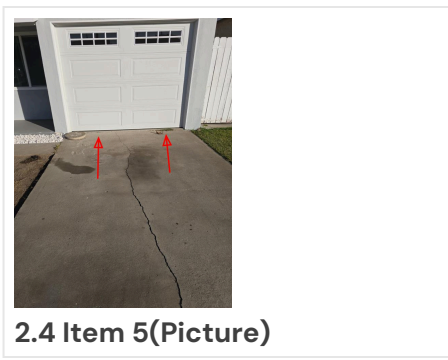
(2) There is a negative slope at the garage and can cause or contribute to water intrusion or deterioration. I recommend correcting landscape to drain water away from home.

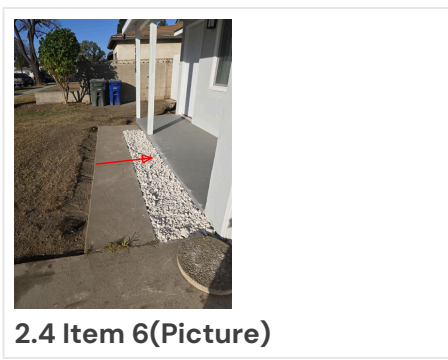
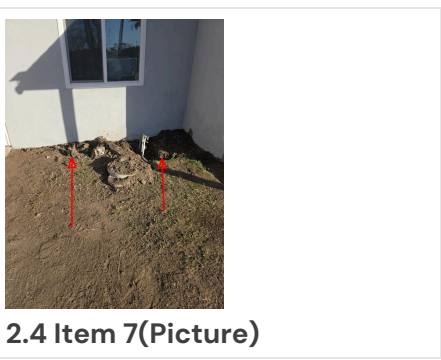
(3) There is a negative slope at the front of home and can cause or contribute to water intrusion or deterioration. I recommend correcting landscape to drain water away from home.

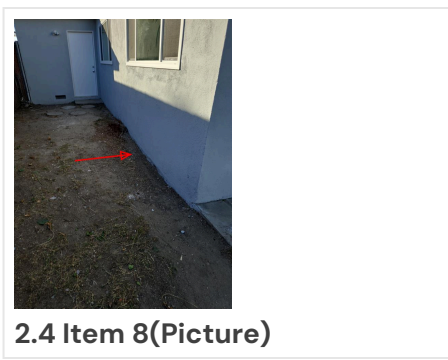
(4) There is a negative slope at the right side (facing front) and can cause or contribute to water intrusion or deterioration. I recommend correcting landscape to drain water away from home.

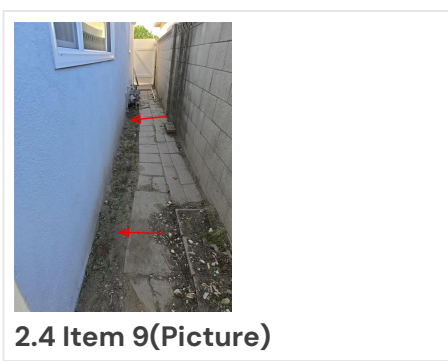
(5) There is a negative slope at the left side (facing front) and can cause or contribute to water intrusion or deterioration. I recommend correcting landscape to drain water away from home.

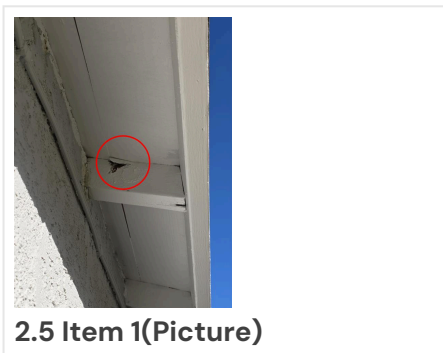
(1) I recommend that all exterior eave trim be properly sealed, primed and painted to prevent deterioration from the elements.

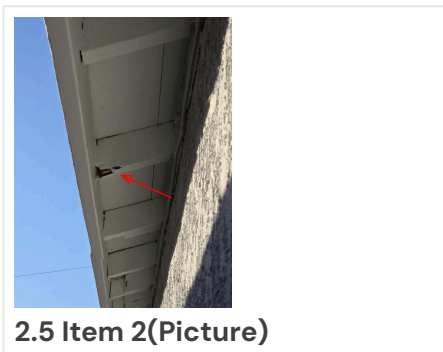
(2) There are signs of termites. I recommend consulting with a qualified professional for further evaluation and repairs.

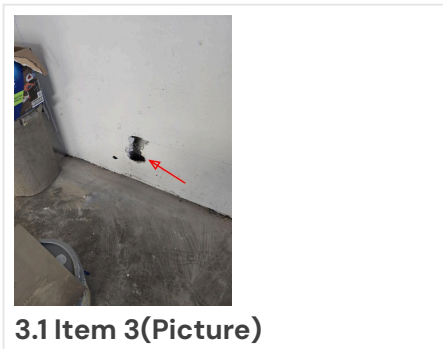
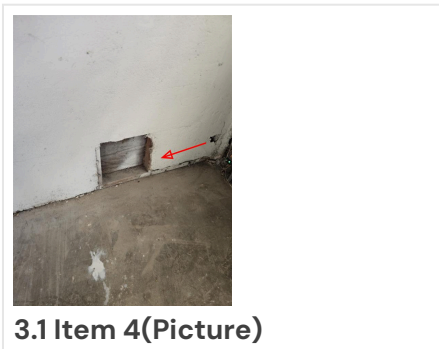
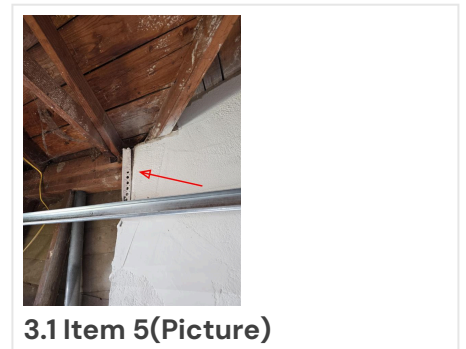
(2) Damaged drywall was observed

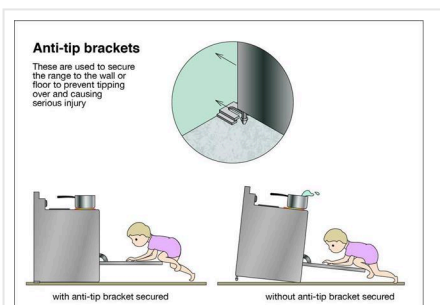
4.1 Item 2(Picture)

(2) Stove is missing it's anti trip brackets.

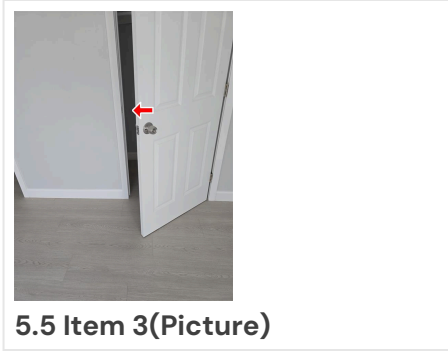
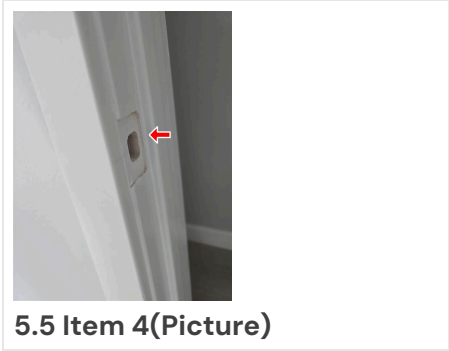
(2) Bedroom closet- Strike plate is missing.

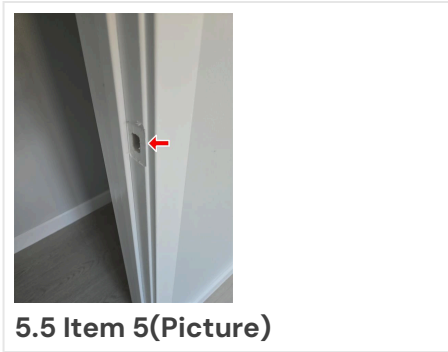
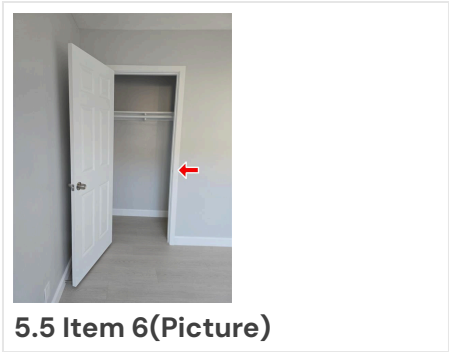
(3) Bedroom closet- **Strike plate is missing.**

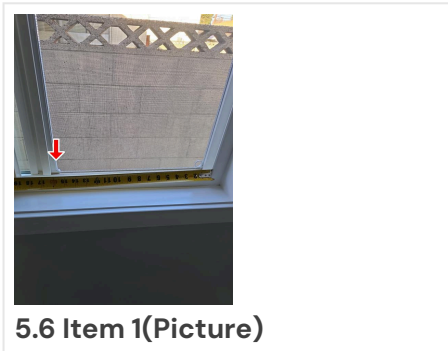
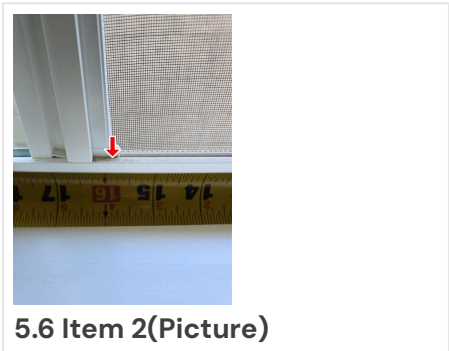
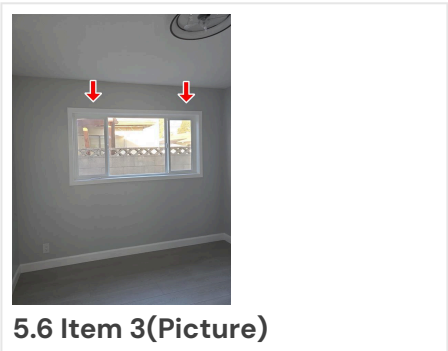
All bedrooms- **Window does not appear to meet Egress requirements. Building Code advises that every bedroom must contain at least one egress window. It must be at least 5.7 square feet, 20 inches wide by 24 inches high, with an opening no higher than 44 inches from the floor. Egress windows are large openings that offer a secondary exit in case of an emergency.**

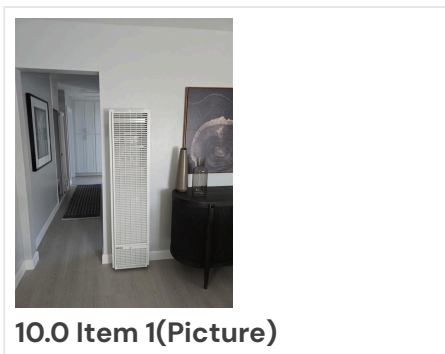
Wall furnace did not turn on at the time of the inspection.
