Inspection reference: 25029

## Confidential Inspection Report

16428 Estella Ave  
Cerritos CA 90703

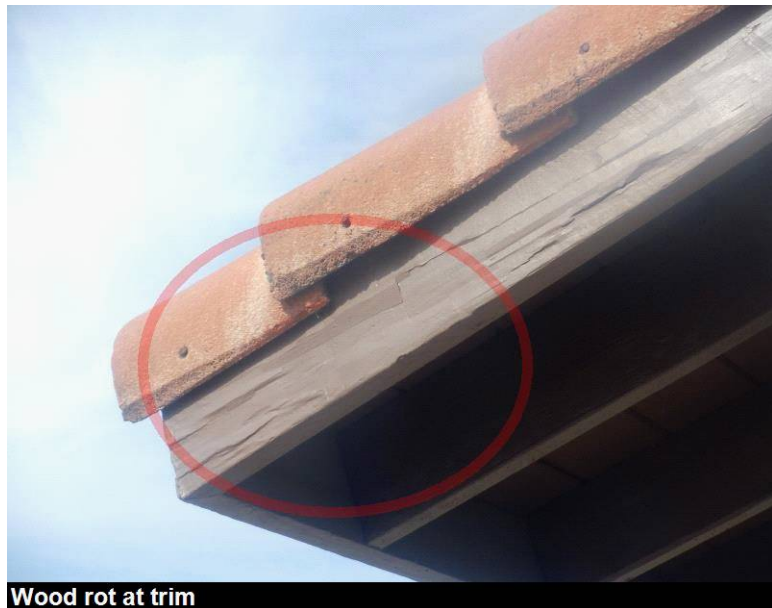
Wood; Foam; The termite inspection report should be reviewed as deteriorated wood was visible at exterior trim ( such as fascia boards, rafter tails, starter boards, window and door casings). Licensed pest control company will determine repair method and whether fumigation is necessary.

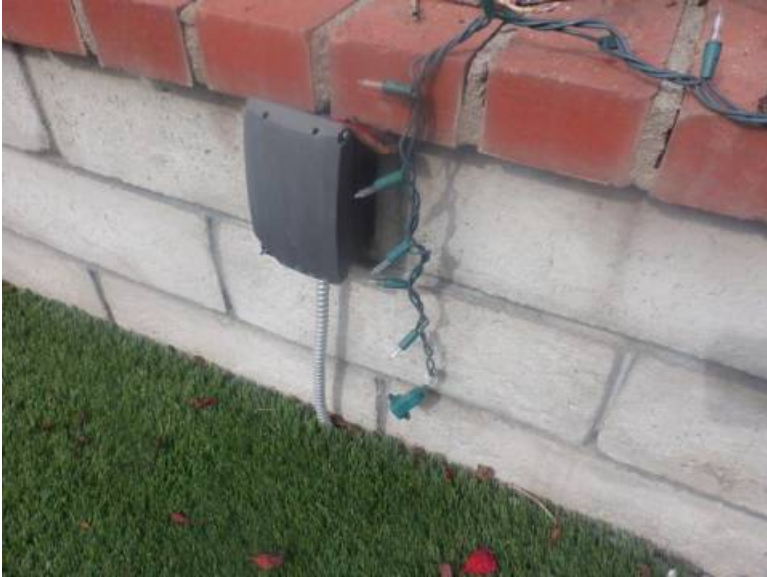
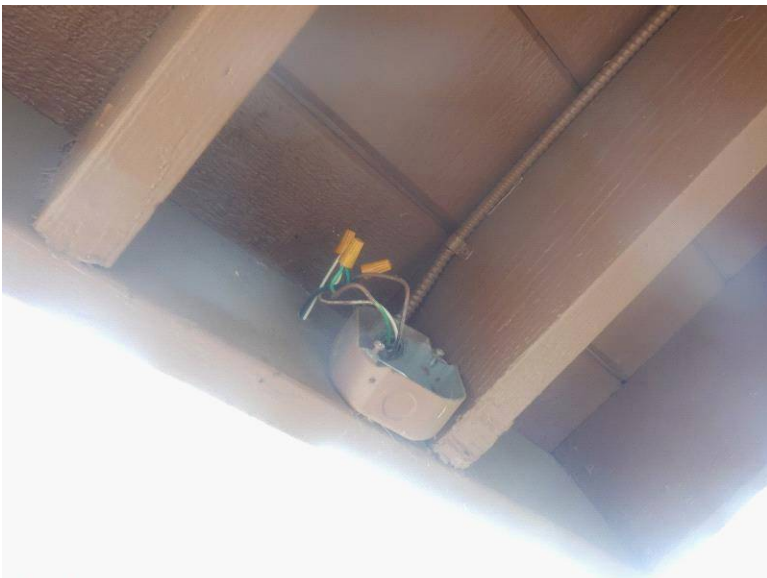
Secure electrical conduit to rear left yard electrical outlet (secure to wall).

Open box

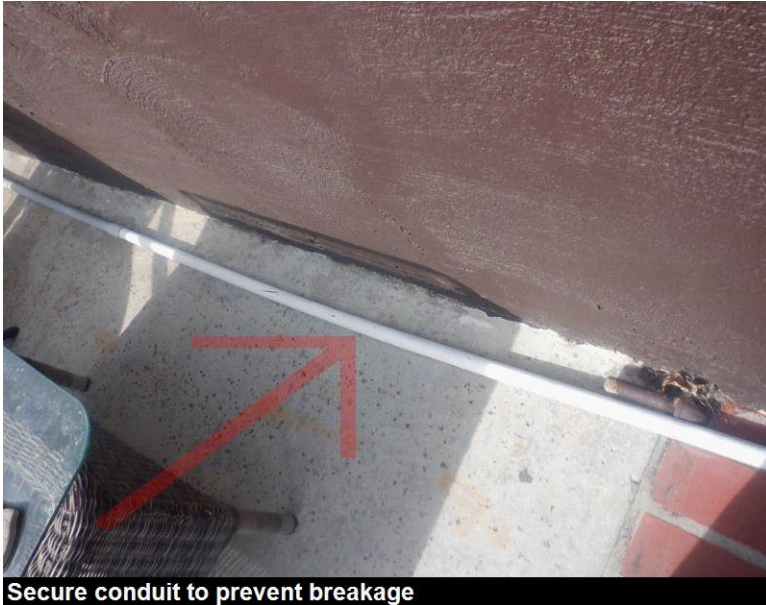
Secure conduit to prevent breakage

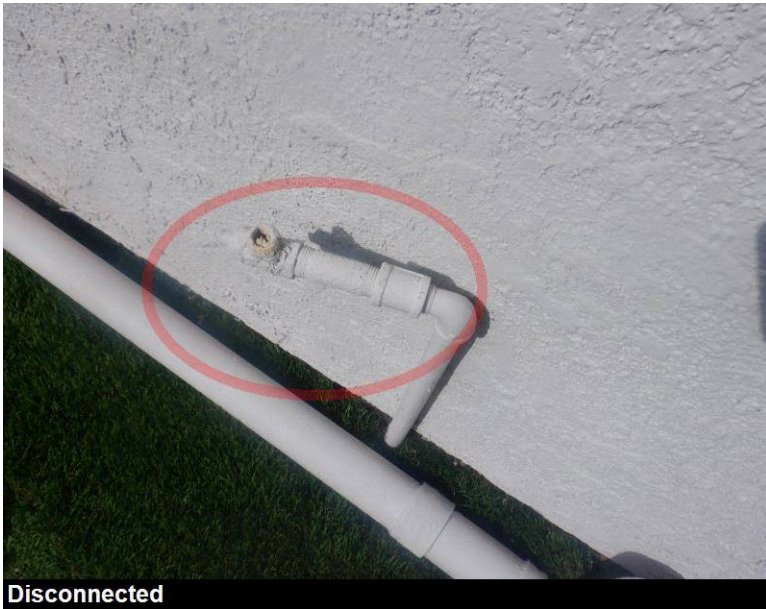
Disconnected

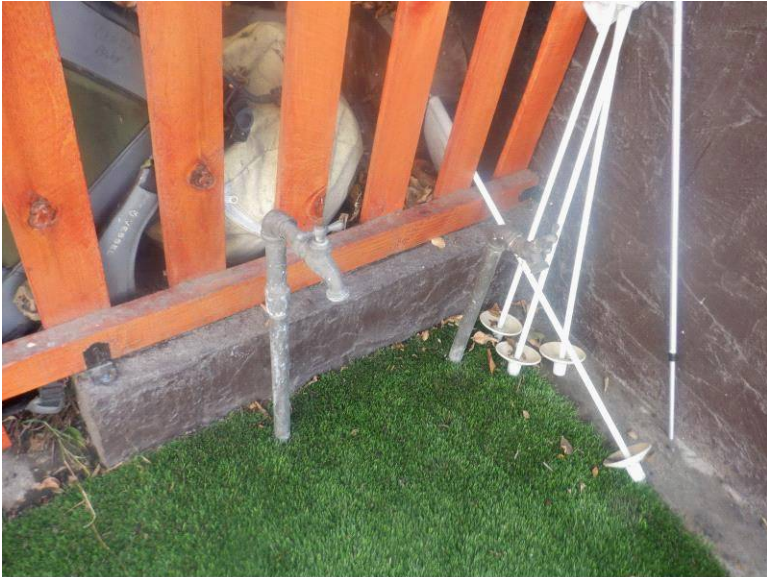
Disconnected

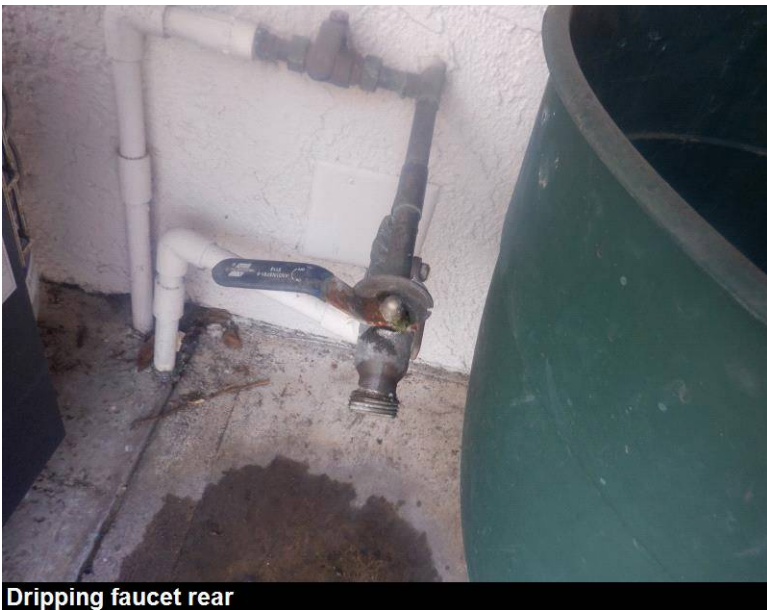
Dripping hose faucets were noted at rear of this structure. A leaky hose and a leaky hose bib are not only annoyances; they can also waste quite a bit of water. They can be caused by several things (problem with the O rings, valve seats, washers, etc.). Maintenance is needed.

Dripping faucet rear

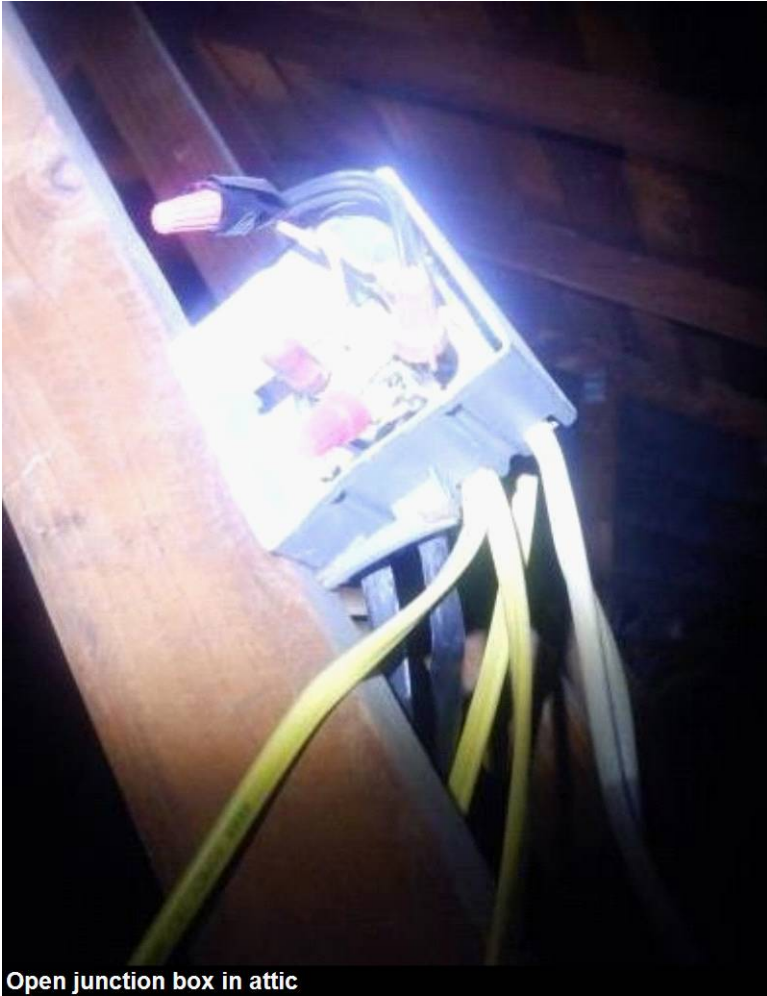
Any electrical junctions (wire splicing) within reach of attic access opening are required to be in a proper box with a cover, contact licensed contractor for repair.

Open junction box in attic

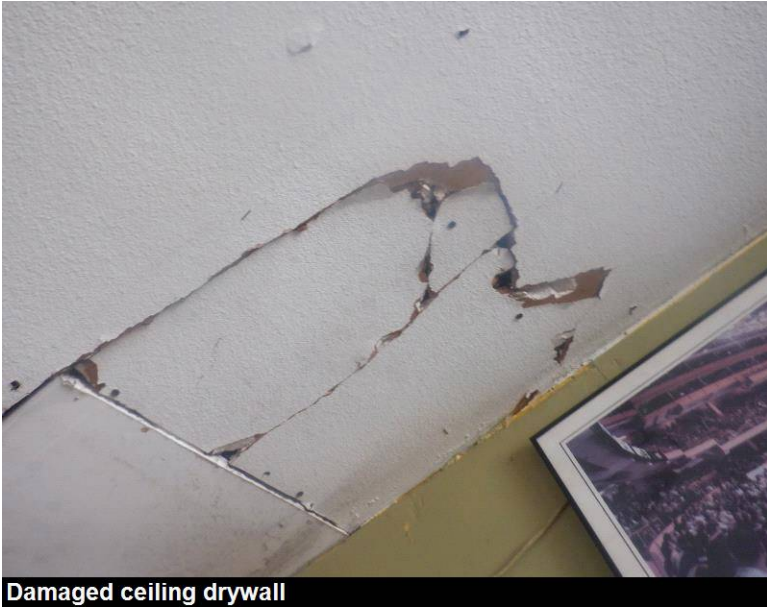
**Damaged ceiling drywall**

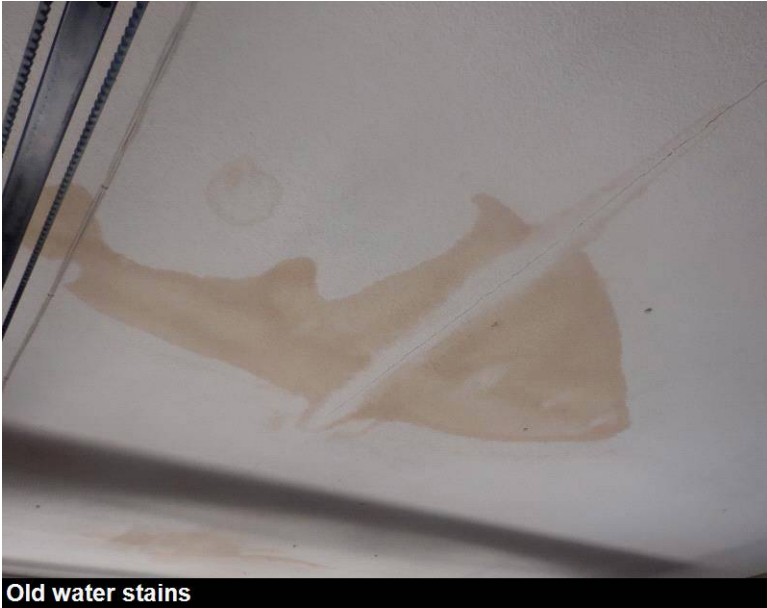
There is visible water staining on the garage ceiling, it appears to be old. Visible cosmetic wear and tear to garage ceiling finishes (discoloration, small holes, hairline cracking, etc.).

**Old water stains**

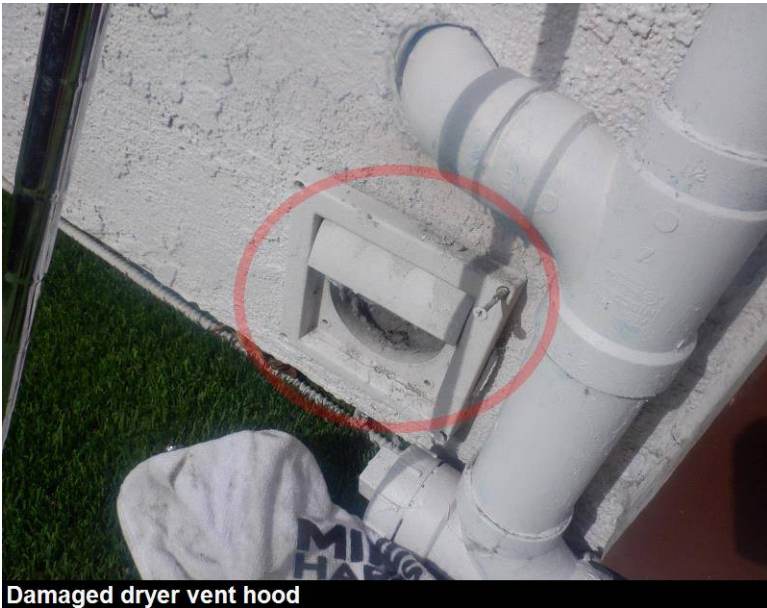
There is a gas line present for the dryer hook-up. Damaged dryer vent hood (right side exterior wall)

**Damaged dryer vent hood**

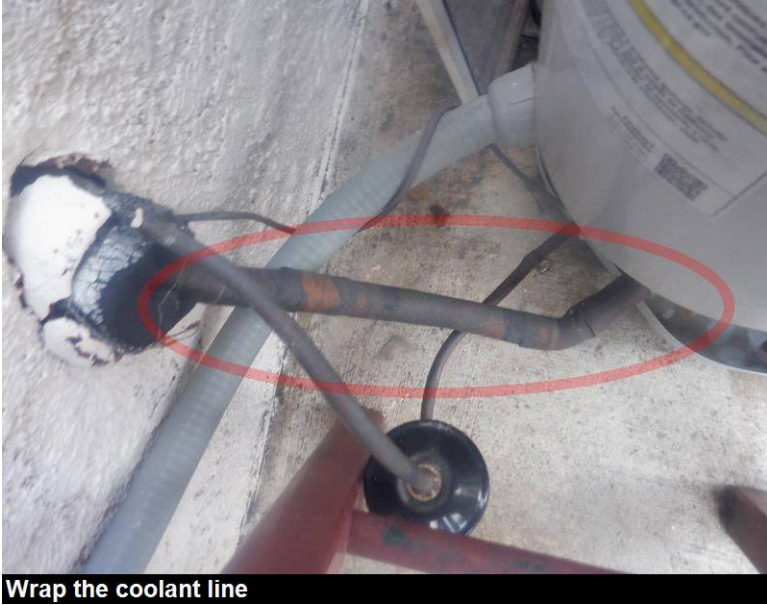
reasons. First, it prevents condensation forming on the pipe. Condensation could drip from the pipe and cause damage to building materials, or create a slip hazard on the floor. The other reason to insulate the suction line, is to prevent the refrigerant in the line from picking up additional heat. The warmer the refrigerant is, the harder the compressor and condenser have to work. Minimizing the temperature of the refrigerant in the suction line, helps the condensing unit work more effectively.

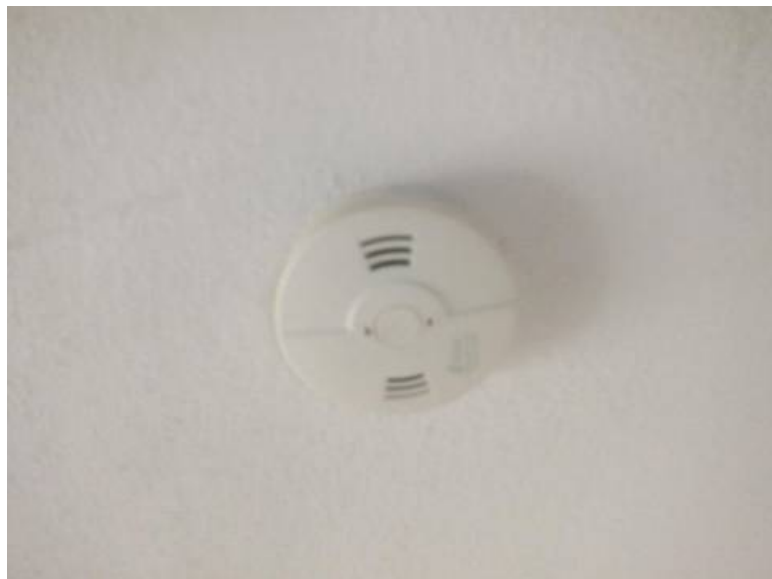
As of July 1, 2011, it became state law in California for carbon monoxide detectors to be installed on each level of living space. CO detectors are only required for houses that have either an attached garage, fireplace or gas heater or appliance. Carbon monoxide detectors can get the best reading of your home's air when they are placed five feet from the ground. The structure is not currently compliant, installation of detectors is required downstairs.

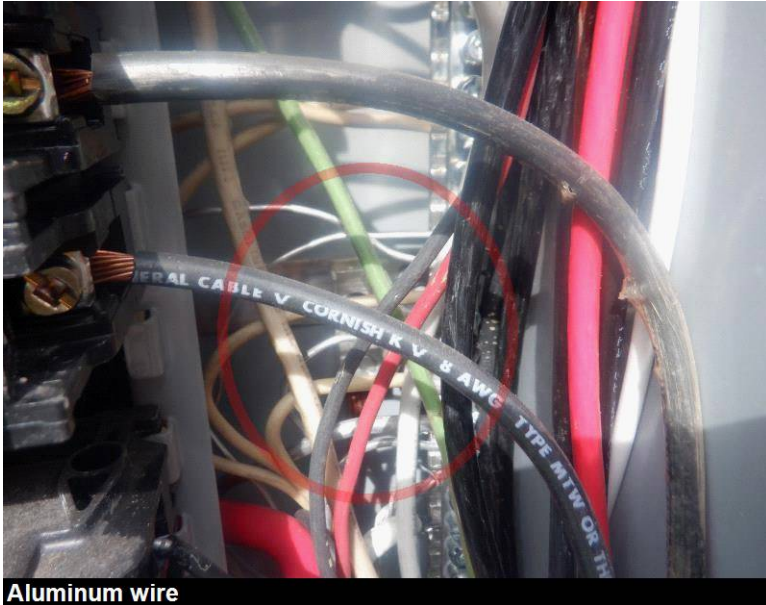
2. Use copalum crimps. The crimp connector repair consists of attaching a piece of copper wire to the existing aluminum wire branch circuit with a specially designed metal sleeve and powered crimping tool. The sampled outlets showed the wires had been pigtailed, this was a common practice prior to the invention of copalum adapters to address aluminum wire issues by attaching a piece of copper wire to the aluminum, then attaching the copper to the fixture. This remains an acceptable form of adaptation. Not all outlets were inspected, look for wire nuts inside the junction as indicator they have been pigtailed.

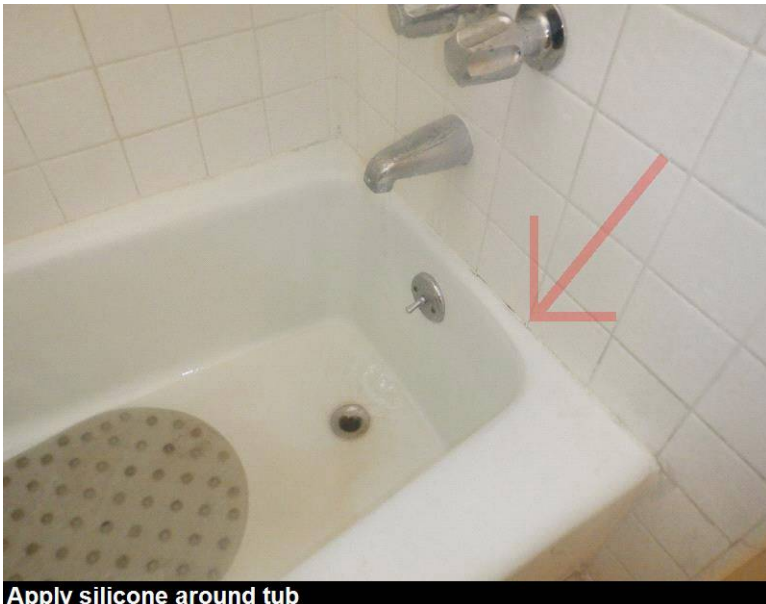
Apply silicone around tub

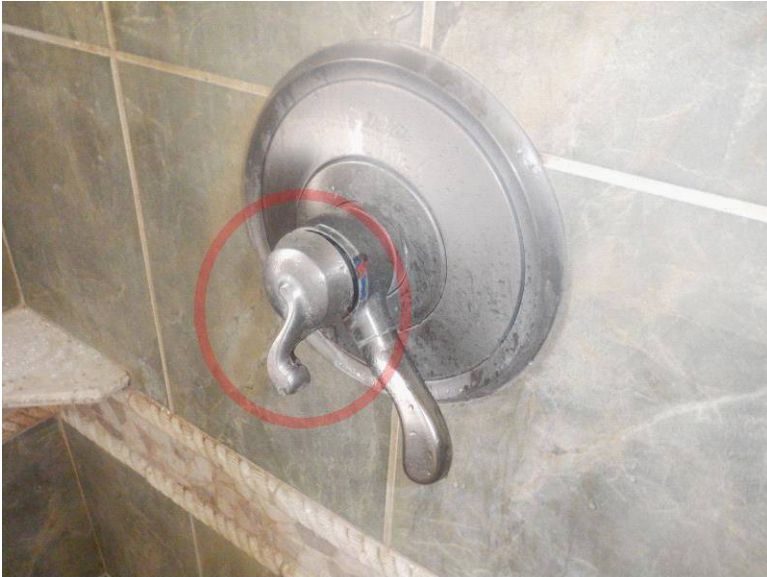
Master; The shower mixer is not operating properly, repair or replace. The spa tub is inoperable. The tub temperature control knob is not operating properly. Torn screen at the bathroom window. The toilet handle sticks.

Mixer not operating properly

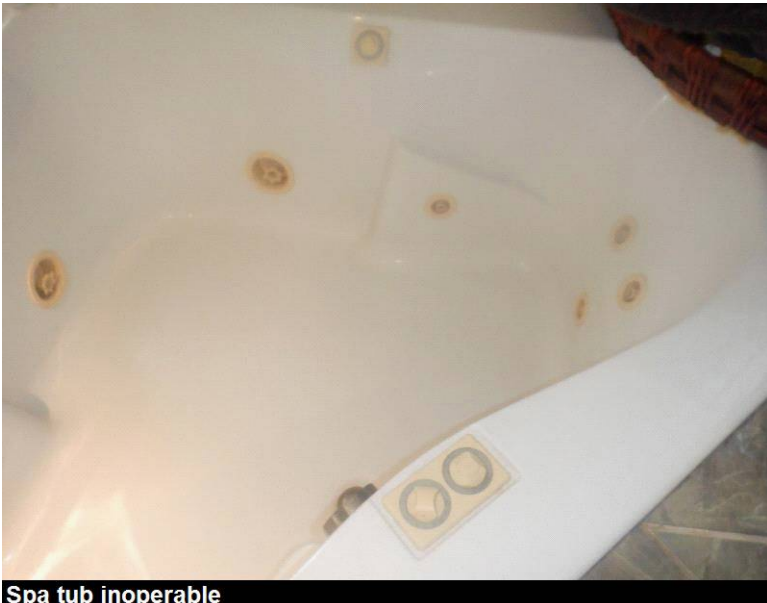
Spa tub inoperable

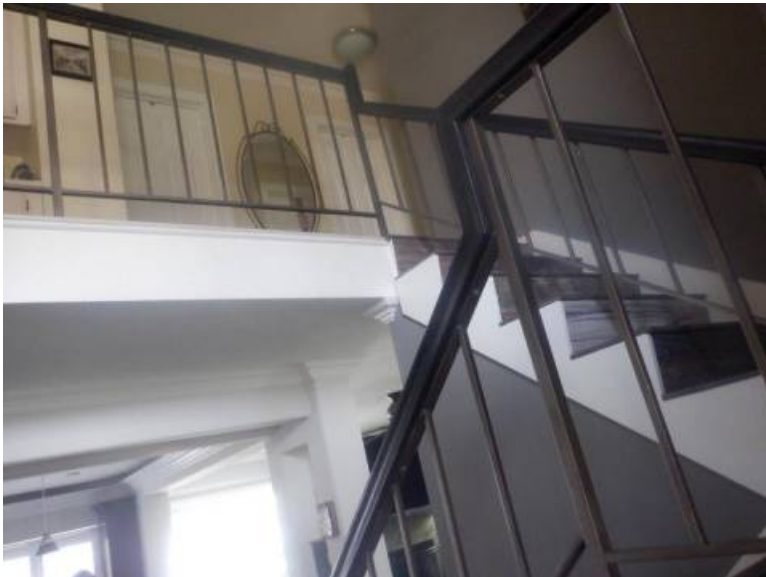
The gaps at the stairway railings and/ or treads are larger than allowed by current building standards. The maximum distance between balusters or between a post and baluster, in the California building code, is 4 inches. The space between the finished floor and the bottom rail must not exceed 4 inches. In addition, the minimum balustrade height is 42 inches. Though replacement of railings are not required to transfer title of property, any newly installed railings must meet current standards.

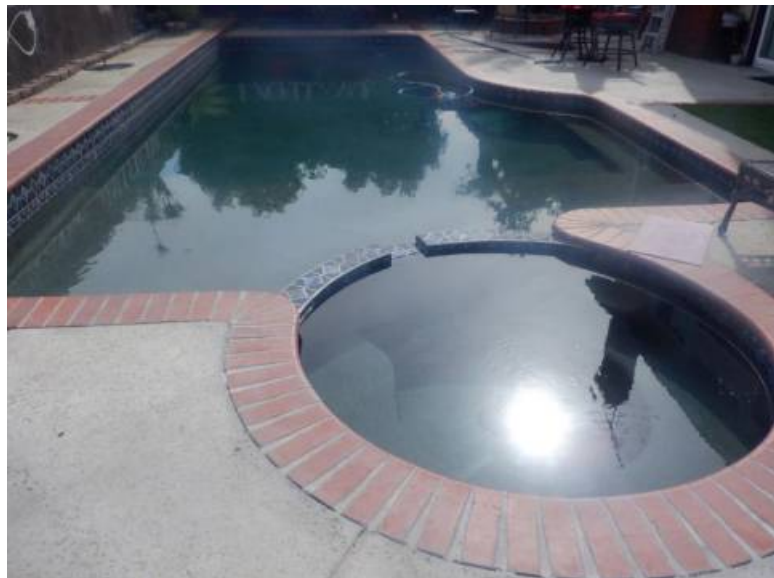
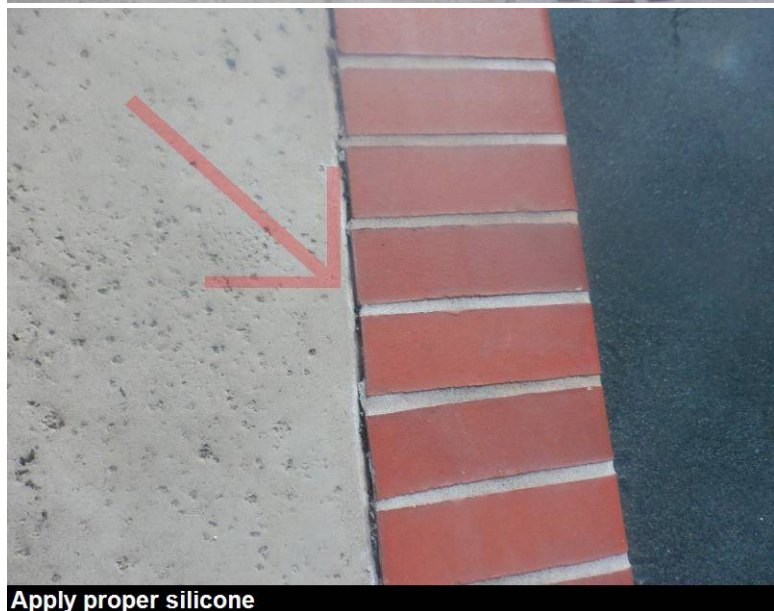
The silicone at the coping expansion joint needs to be periodically applied as pool maintenance. Caulking the expansion joint around the pool (between the pool coping and pool deck) is important to prevent water and debris from entering joint which may loosen the coping stones over time. The caulk used for pools should be an elastomeric sealant, suitable for outdoor use.

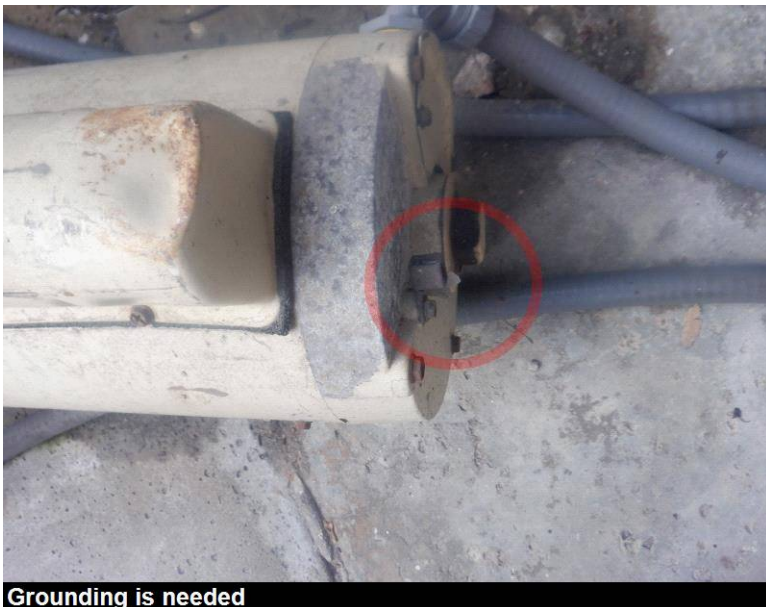
The pool or spa motor is required to be electrically grounded for safety, most motors have a ground clamp attached for convenience. Contact a licensed contractor or pool technician for installation.

**Grounding is needed**
