# Inspection Report

**Property Address:**  
56 Los Verdes Dr  
San Luis Obispo CA 93401

10/29/2025

**Harper Homes: Home Inspection Services**

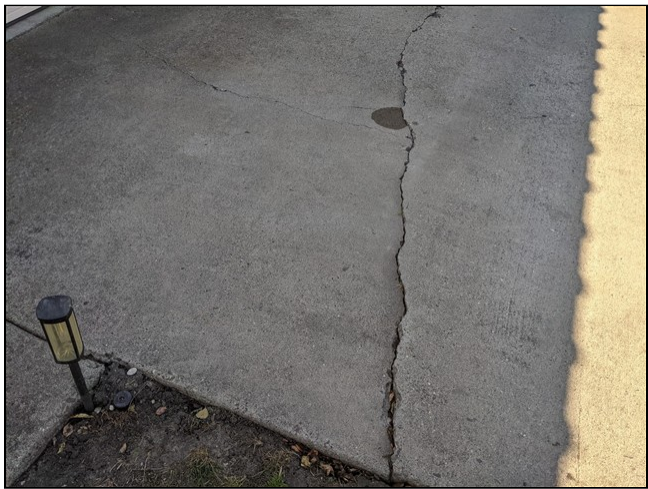
1.2 Item 1(Picture)

(1) ALTERATION NEEDED  
Uneven walkways noted at various areas of the home, creating possible trip hazards. Any variance in walkway height more than 3/4" needs properly ground down or filled in to improve the safety of the walkways.

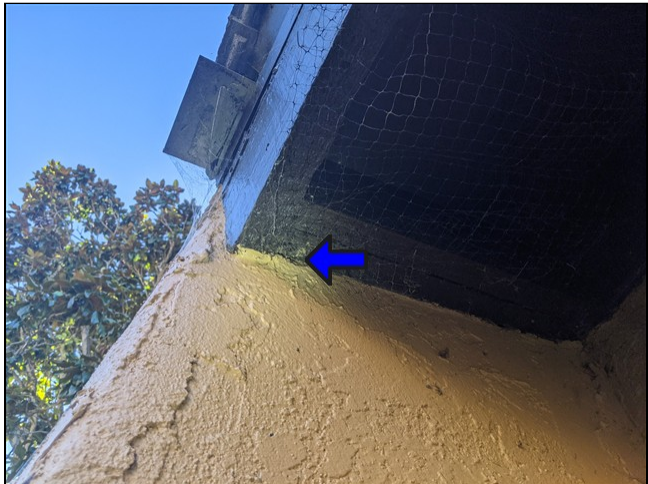
2.0 Item 1(Picture)

Moisture damage noted at the end of the rafters extending from the roofing at the various locations. Refer to the pest report for further details and make repairs as prescribed.

Due to the age of the roof and various signs of moisture intrusion at the interior ceiling, it is recommended that the roof and all roofing components be further evaluated by a qualified roofing contractor to better understand the extent of repairs needed, remaining life, and cost to repair/replace. Signs of leaking were noted at the scupper drains at the interior of the home as well as a soft section of plywood near the rear left scupper drain.

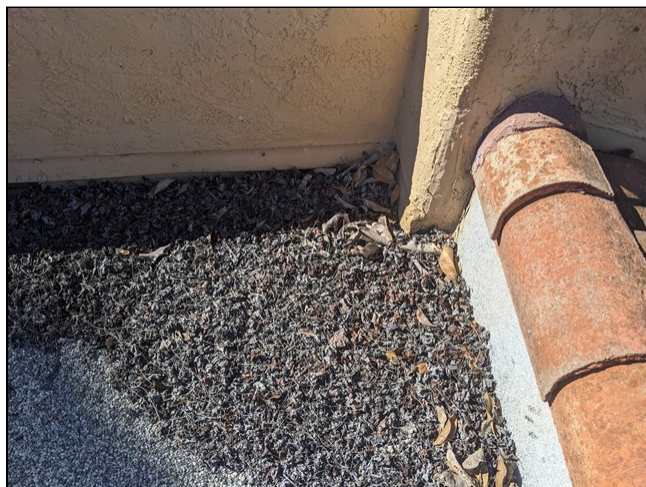
2.0 Item 2(Picture)

Leaves and debris need removed from the roof and an annual maintenance routine established. The trees need trimmed back to prevent contact with the roof and limit the amount of seasonal debris.

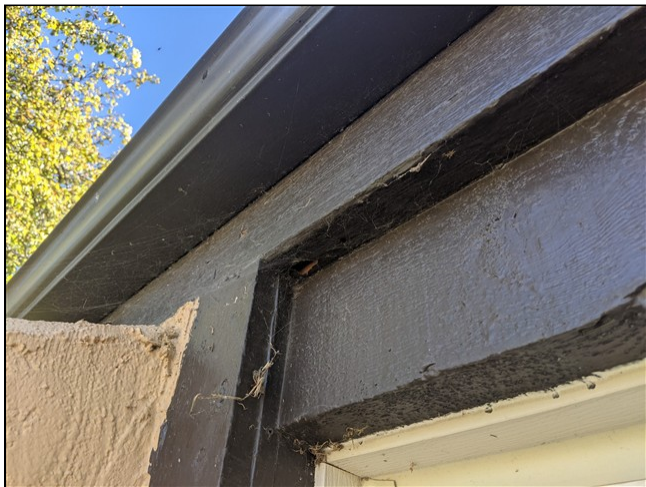
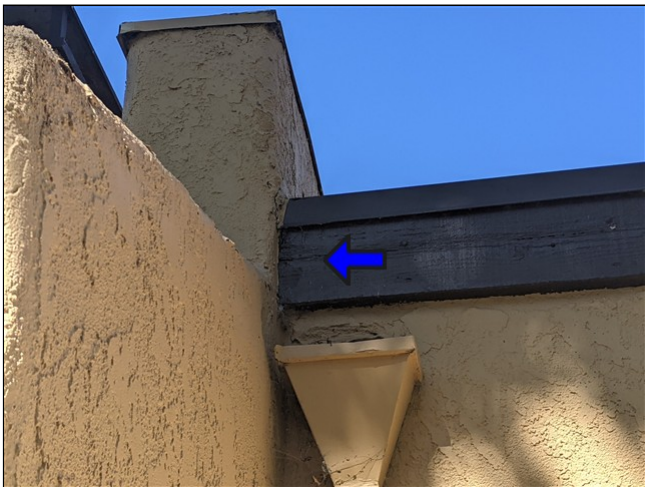
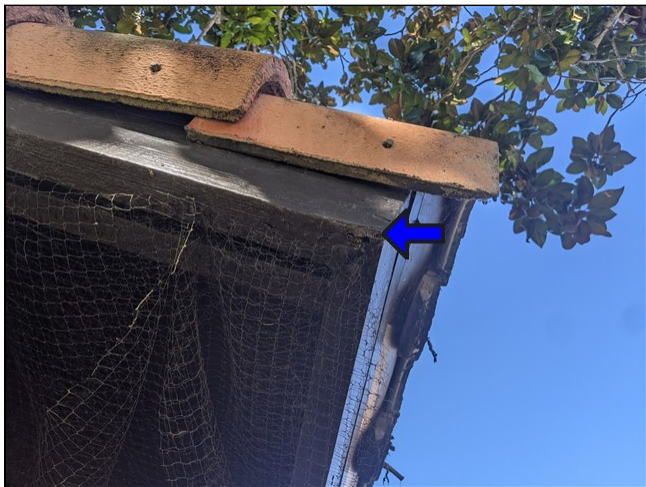
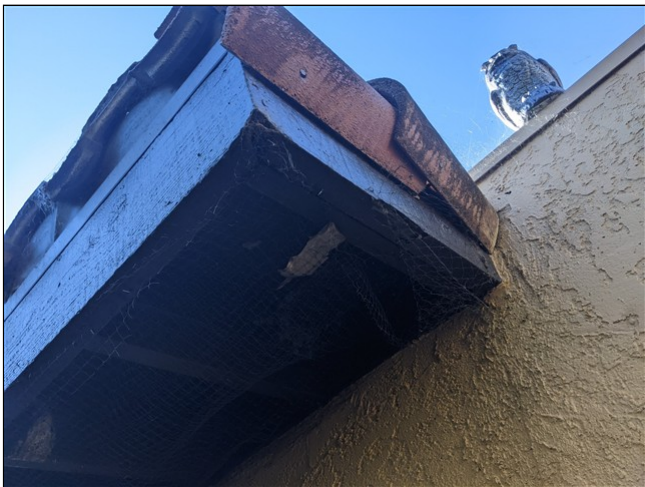
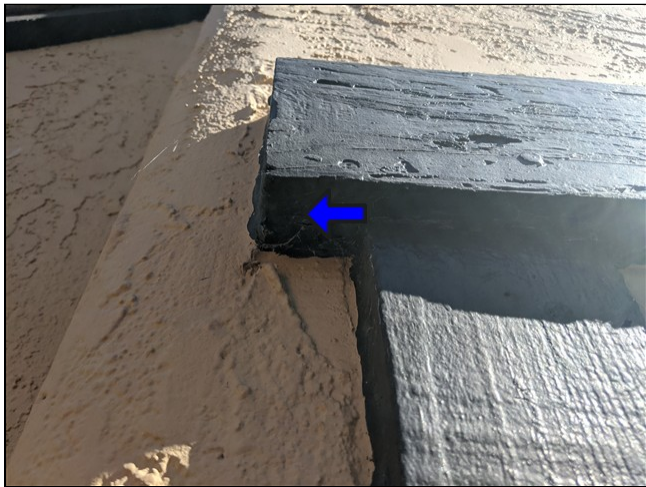
Areas of the fascia and trim contain moisture damage. Refer to the pest report for further information on this condition and make repairs as prescribed.

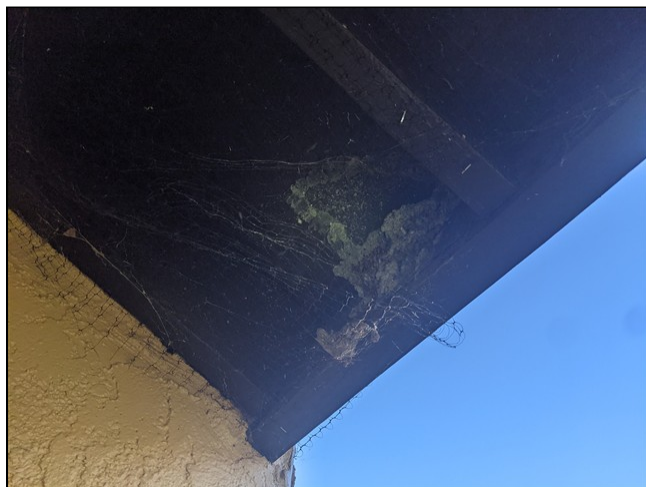
2.4 Item 6(Picture)

Bird nesting noted against the siding under the eave at left exterior. Recommend organic material be properly removed to prevent moisture and pest intrusion.

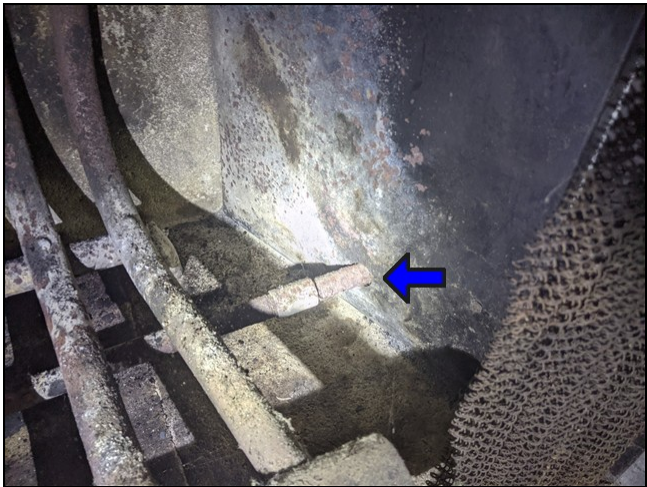
3.1 Item 1(Picture)

Fire rated sealant should be installed where the gas log lighter enters the fireplace to ensure smoke and heat are properly contained to the fireplace.

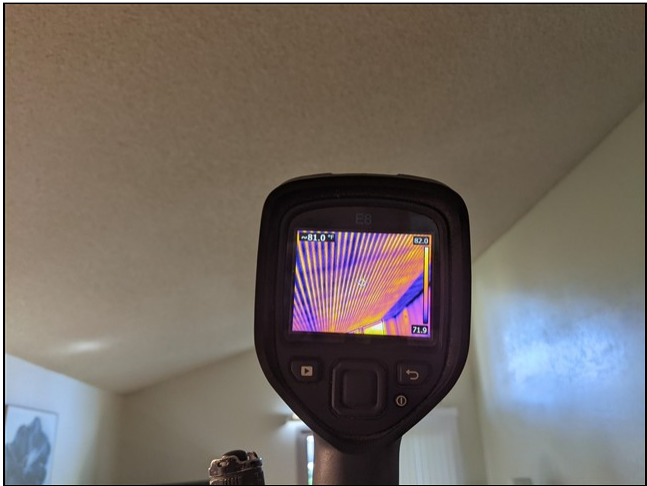
4.0 Item 1(Picture)

The heating system for the home is electric radiant heat located in the ceiling which was tested and functional at the time of the inspection.

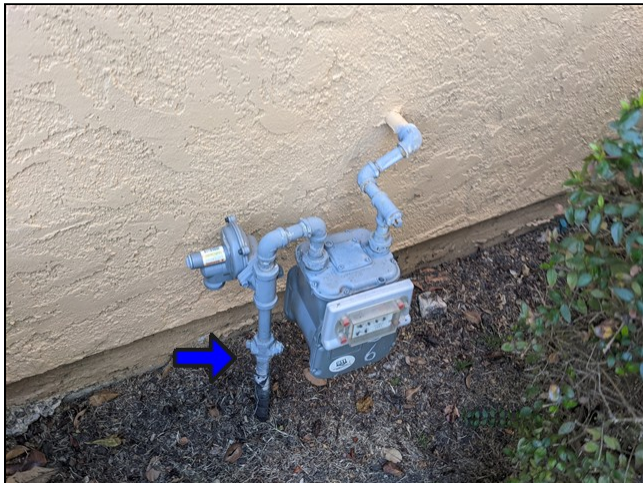
5.3 Item 1(Picture)

Recommend gas meter wrench permanently located near the gas meter. This upgrade will improve safety in the event of an emergency.

Gas line sediment trap not installed near the water heater and furnace, and should be installed to help prevent the possibility of gas line debris from entering the gas appliances.

The gas shutoff is located at the left exterior of the home. To turn the gas off turn the valve perpendicular to the piping.

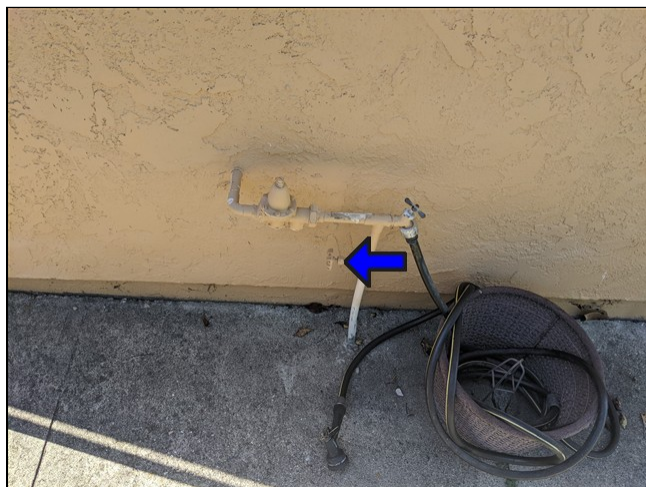
5.4 Item 1(Picture)

The water shutoff is located at the front exterior of the home. To turn the water off turn the handle clockwise.

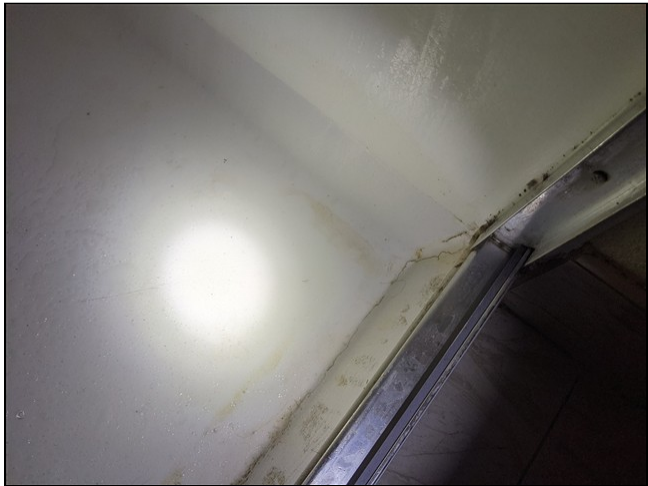
7.0.A Item 1(Picture)

Gel coat chipped or damaged slightly in the tub in a few areas. This can be typical with age and regular use, and proper repair of the fiberglass gel coat material can help extend the life of the tub. Recommend repair and replacement as needed.

REPAIR NEEDED  
Gel coat chipped or damaged sightly in the tub in a few areas. This can be typical with age and regular use, and proper repair of the fiberglass gel coat material can help extend the life of the tub. Recommend repair and replacement as needed.

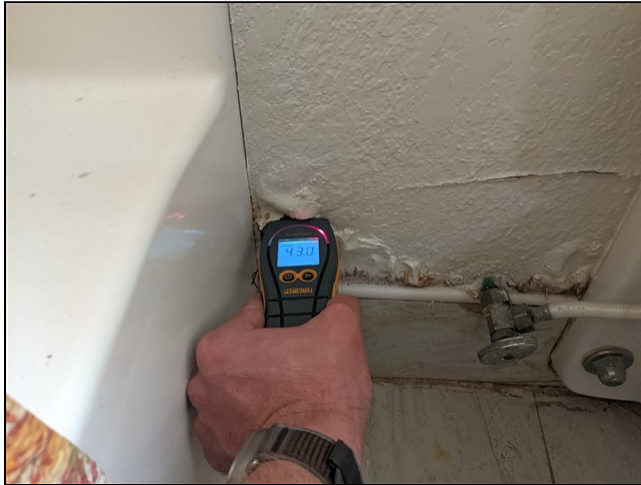
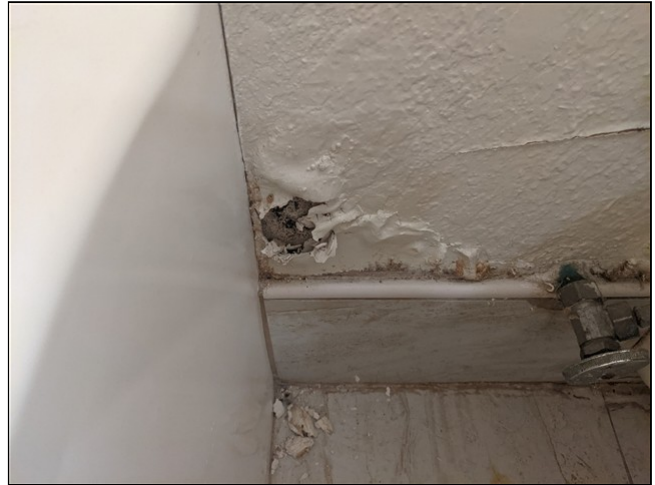
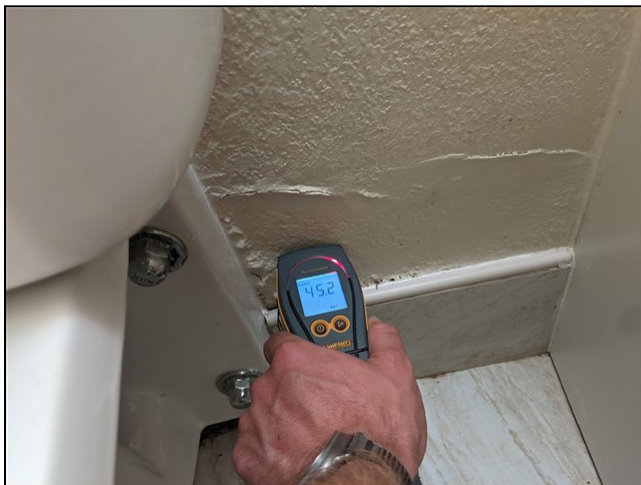
Moisture damage was noted near the toilet and shower and possible microbial growth was noted. This area should be further evaluated and repairs made to the damaged sections of drywall material.

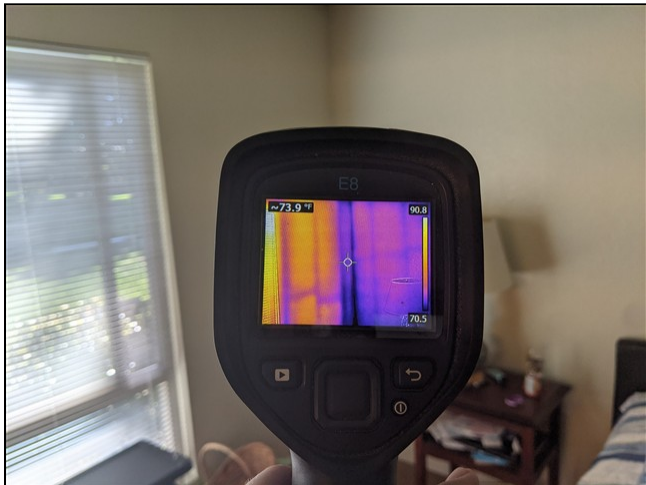
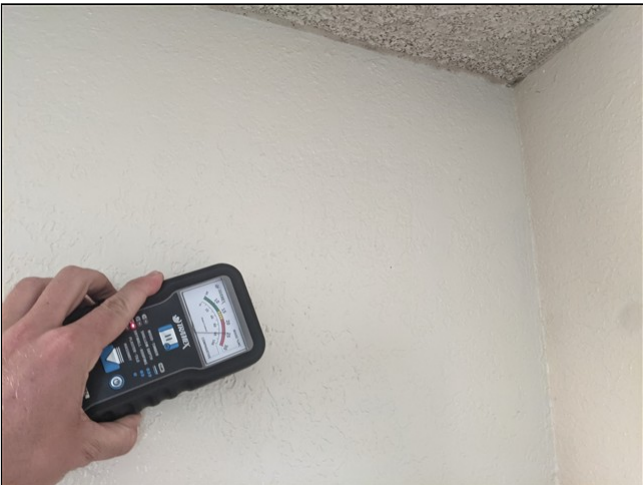
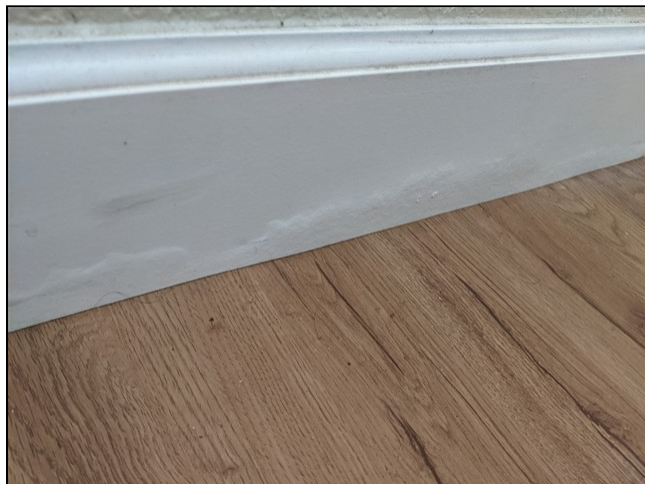
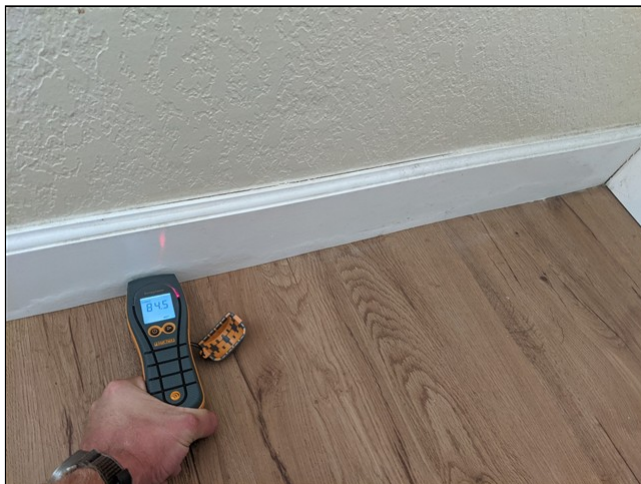
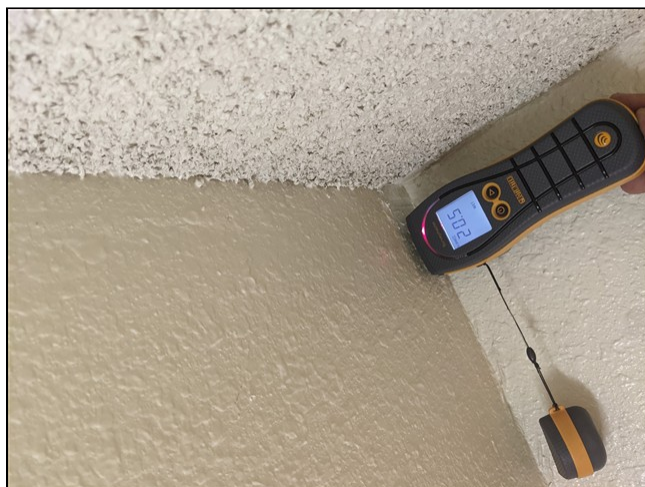
Moisture stains noted on the ceiling and walls left corner and the closet of the master bedroom. Large amounts of moisture was detected using a moisture meter. Recommend the roof and flashings be further evaluated in these areas to determine the cause and remedy of this moisture intrusion. The wall material should be further evaluated and repairs/ remediation performed for possible microbial growth.

Moisture stains noted on the ceiling and walls left corner and the closet of the master bedroom. Large amounts of moisture was detected using a moisture meter. Recommend the roof and flashings be further evaluated in these areas to determine the cause and remedy of this moisture intrusion. The wall material should be further evaluated and repairs/remediation performed for possible microbial growth.

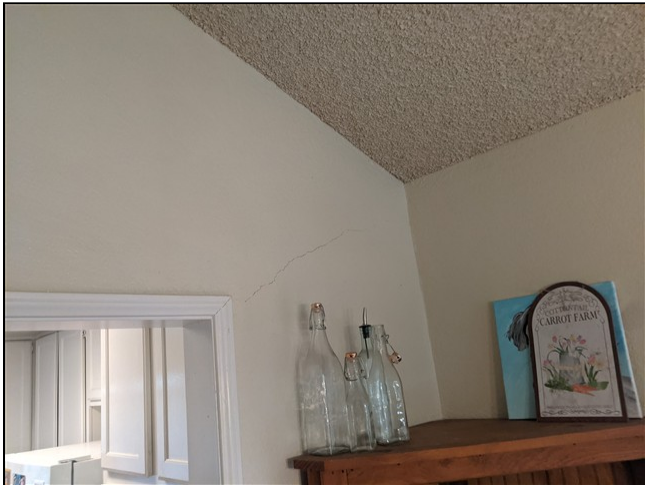
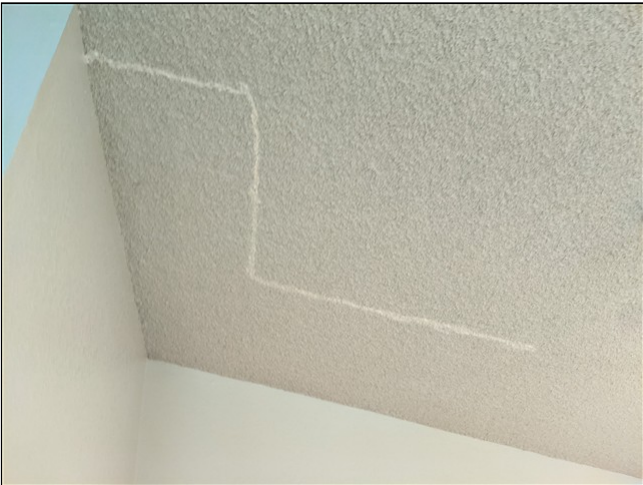
Drywall cracking noted in a few areas indicating some movement of the slab foundation. While this may be typical for the area, it is recommended that the drainage be improved to prevent moisture saturation at the foundation to minimize the slab movement. Recommend further evaluation, as needed, by a qualified engineering contractor.
