## **Property Inspection Report**

***249 Country Club Dr, San Luis Obispo, CA 93405***

***Date of Inspection: 9/4/2025 Time: 9:00 AM***

***Inspector: Peter Ruiz***

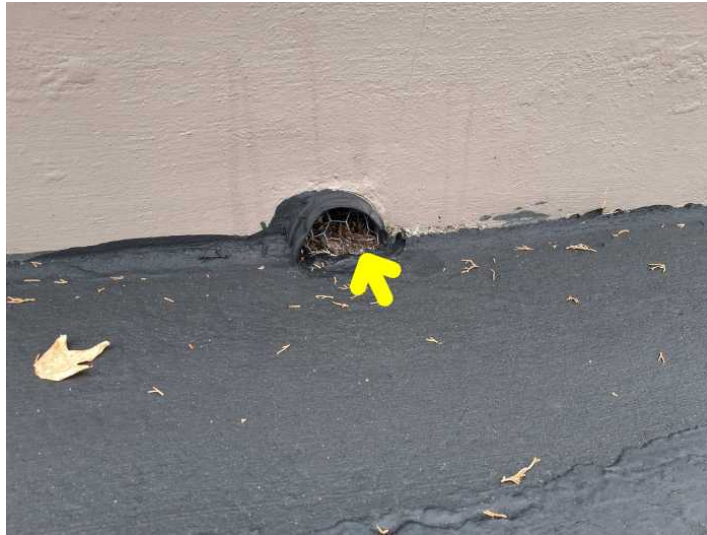
2.5. There is an accumulation of silt and debris in some of the catch basins/area drains, that should be removed. If the silt and debris is left to accumulate and builds to the level of the drain lines, it could pass into them, harden during the summer months, impede drainage, and lead to blockages. Therefore, the drain lines should be flushed through to the street or to their termination point.

There is an accumulation of silt and debris in some of the catch basins/area drains, that should be removed. If the silt and debris is left to accumulate and builds to the level of the drain lines, it could pass into them, harden during the summer months, impede drainage, and lead to blockages. Therefore, the drain lines should be flushed through to the street or to their termination point.

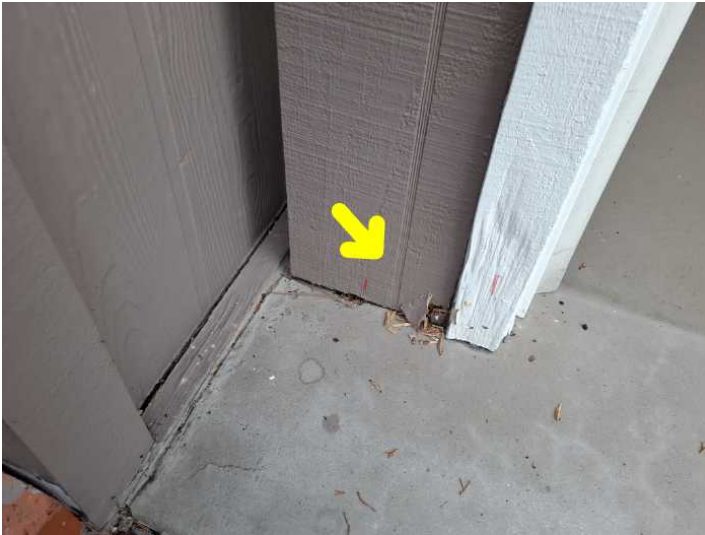
3.4. Portions of the siding have dry rot or are moisture damaged, and should be evaluated by a pest inspector.

Portions of the siding have dry rot or are moisture damaged, and should be evaluated by a pest inspector.

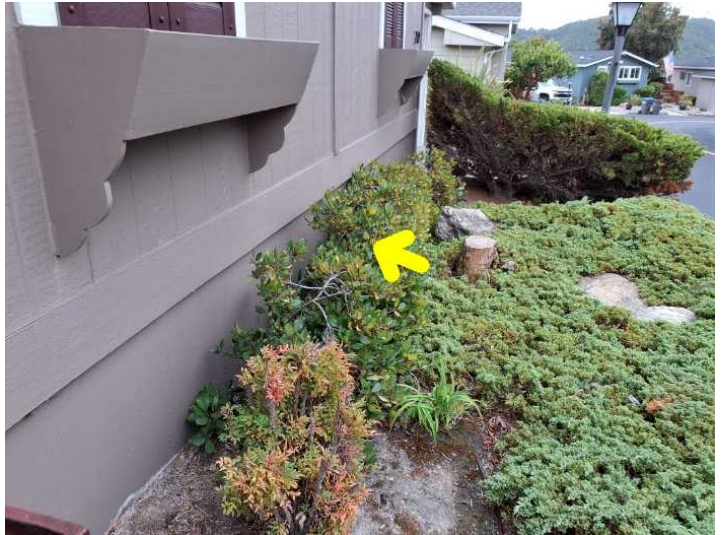
3.2. Vines, shrubs or bushes are growing on the house walls and although they are attractive they can introduce pests and rodents and accelerate deterioration. Therefore, you may wish to consider having them removed or cut back to 12 inches (30 cm) away from the home.

Vines, shrubs or bushes are growing on the house walls and although they are attractive they can introduce pests and rodents and accelerate deterioration. Therefore, you may wish to consider having them removed or cut back to 12 inches (30 cm) away from the home.

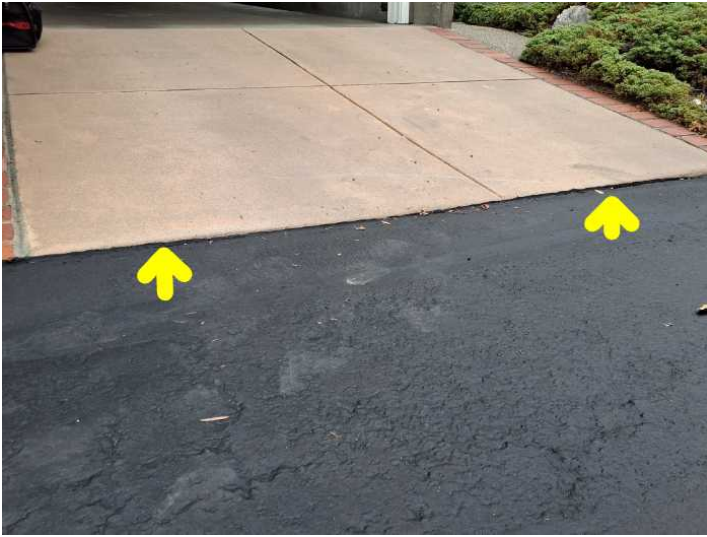
There are one or more offsets in the driveway that could prove to be trip-hazards.

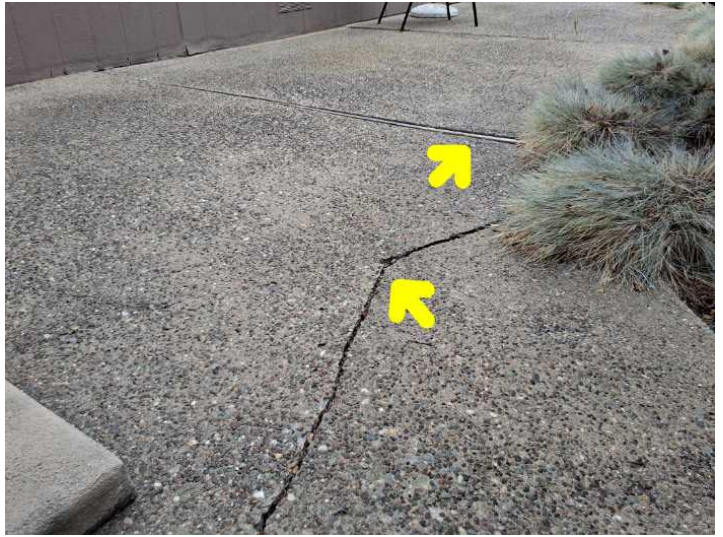
There are one or more offsets in the walkways or patio that could prove to be trip-hazards.

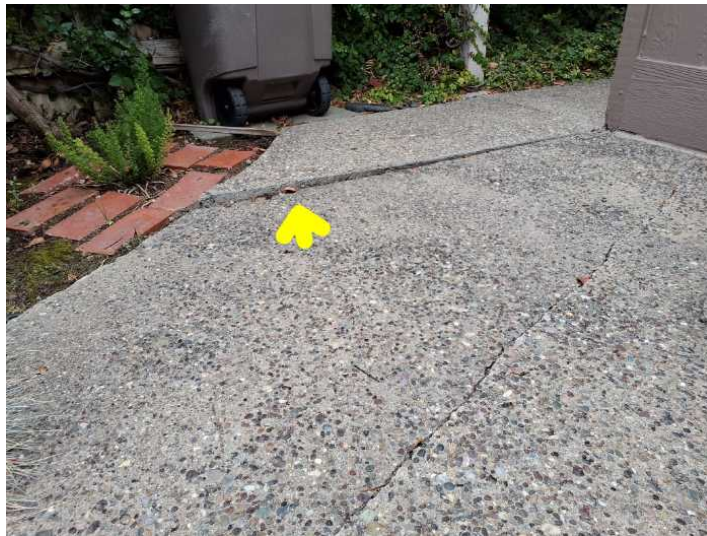
There are one or more offsets in the walkways or patio that could prove to be trip-hazards.

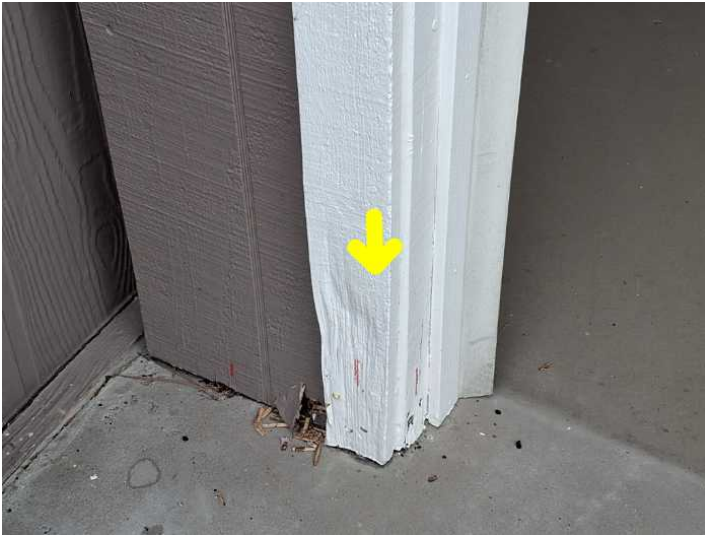
The pest inspector report should confirm moisture, dry rot, or insect damage to the wood trim, fascia boards, and/or eaves.

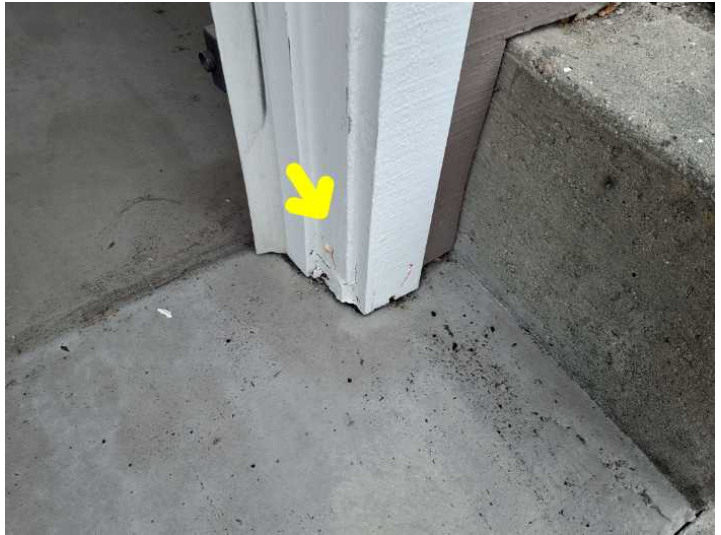
The pest inspector report should confirm moisture, dry rot, or insect damage to the wood trim, fascia boards, and/or eaves.

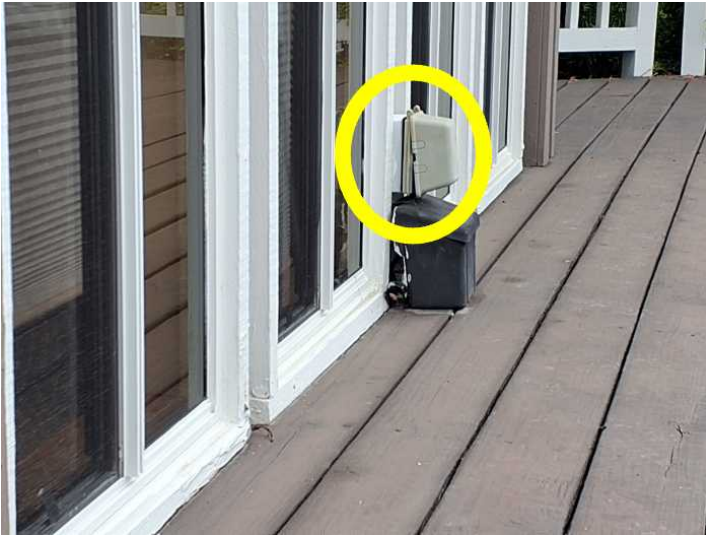
Some of the exterior outlets do not have ground-fault protection, and should be upgraded to include this important safety feature.

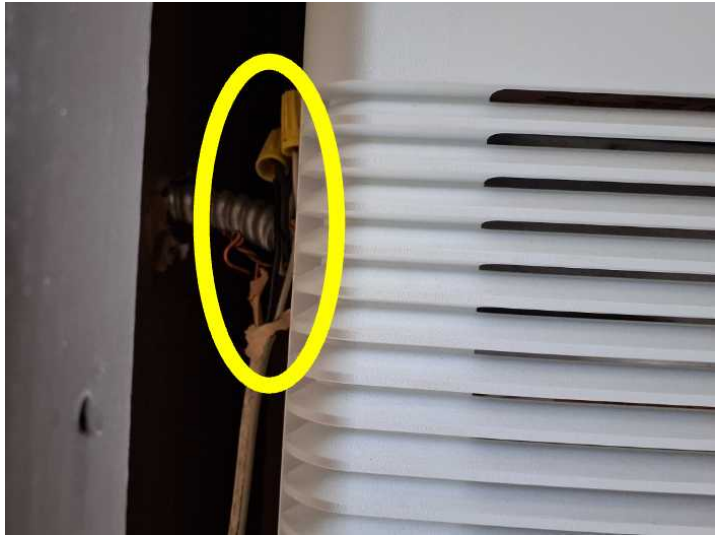
An electrical connection has been incorrectly made outside of a junction box, which should be evaluated by a qualified tradesperson and serviced as necessary.

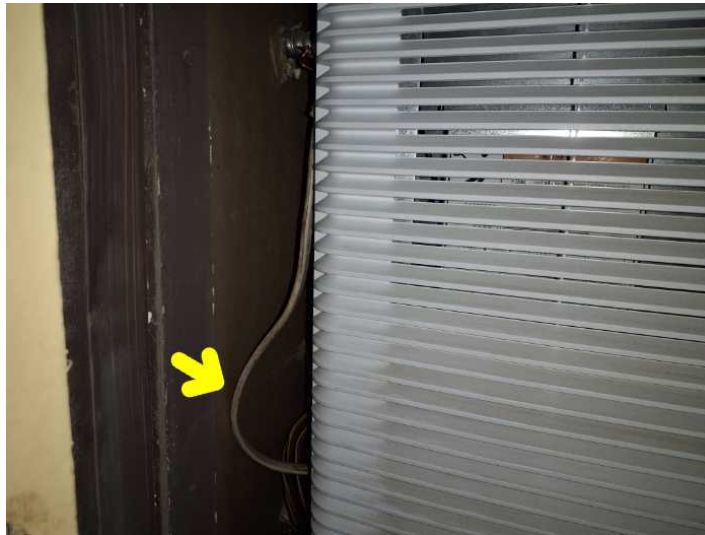
6.6. There is exposed romex present, which is a potential safety hazard. We recommend having it evaluated and serviced by a licensed electrician, possibly by installing the romex inside the wall cavity or into conduit.

There is exposed romex present, which is a potential safety hazard. We recommend having it evaluated and serviced by a licensed electrician, possibly by installing the romex inside the wall cavity or into conduit.

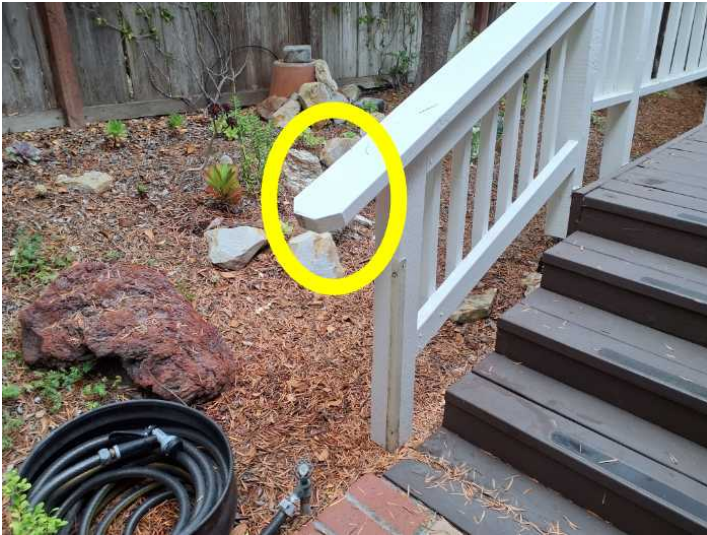
The handrail does not return, which is required at the top and bottom of the stairs by current building standards. This condition could allow a purse or clothing to initiate a fall.

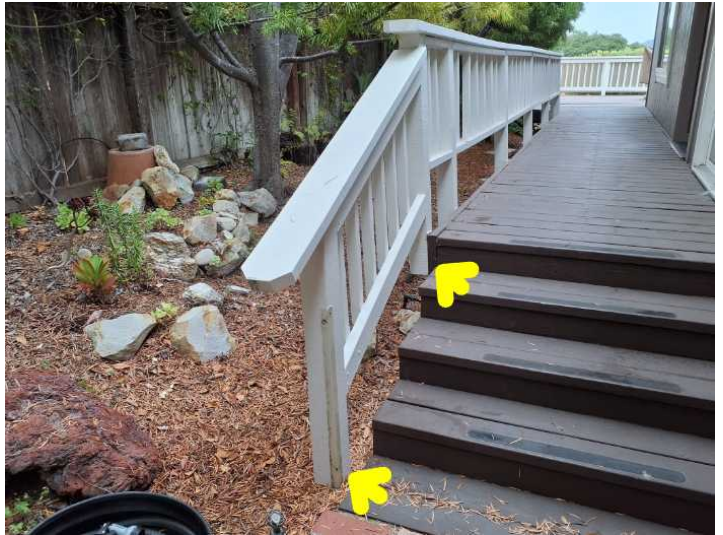
One or more handrails are not secure and should be serviced for optimal safety.

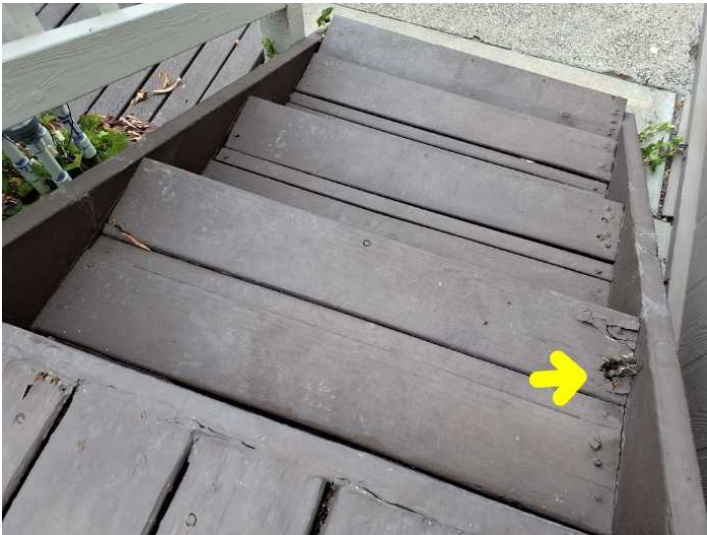
9.3. There is damage to the wooden stairs that should be evaluated by a pest inspector.

There is damage to the wooden stairs that should be evaluated by a pest inspector.

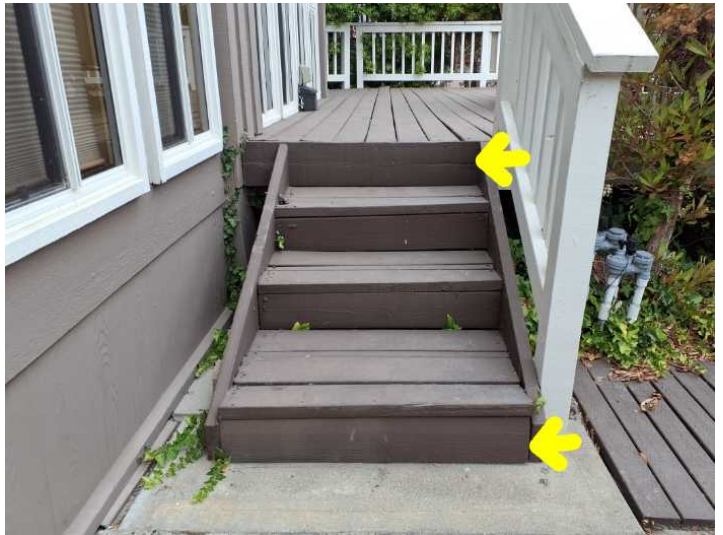
9.2. One or more steps have unequal treads or risers. Steps are required to be uniform to prevent trip-hazards. The rise of any step should be no less than four inches and no greater than seven and three-quarter inches, and the run should be no less than eleven inches. Also, the dimensions of the largest step should not exceed that of the smallest by more than three-eighths of an inch.

One or more steps have unequal treads or risers. Steps are required to be uniform to prevent trip-hazards. The rise of any step should be no less than four inches and no greater than seven and three-quarter inches, and the run should be no less than eleven inches. Also, the dimensions of the largest step should not exceed that of the smallest by more than three-eighths of an inch.

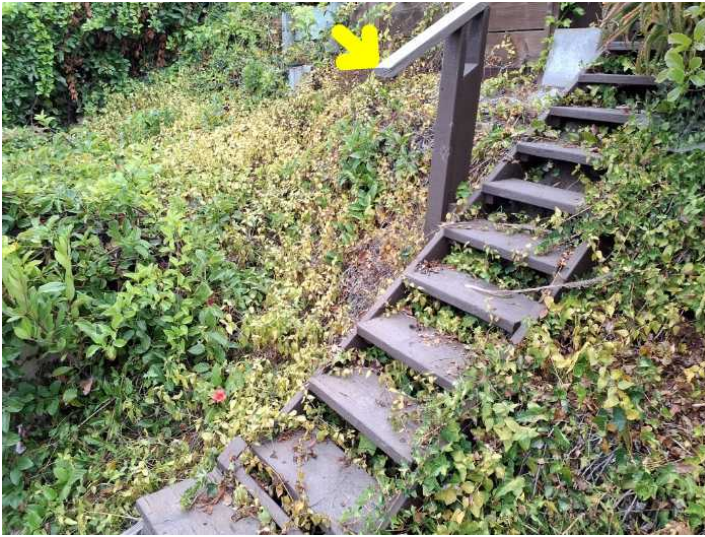
The handrail does not fully extend to the bottom of the rear stairs, which should be serviced for optimal safety.

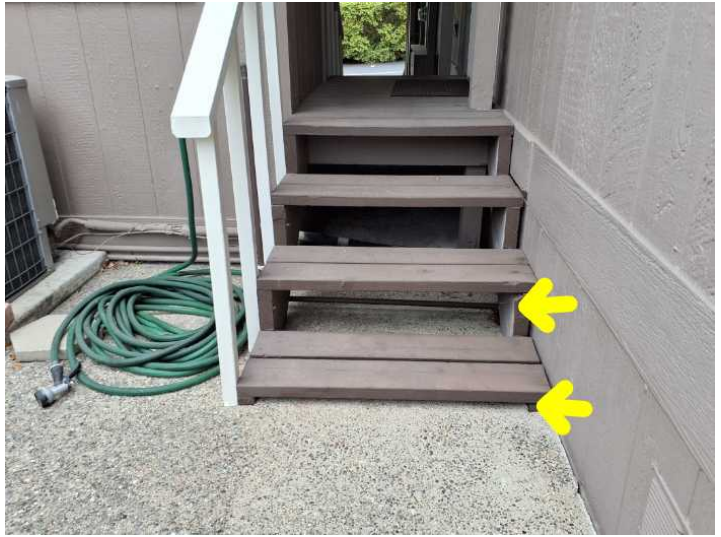
One or more steps have unequal treads or risers. Steps are required to be uniform to prevent trip-hazards. The rise of any step should be no less than four inches and no greater than seven and three-quarter inches, and the run should be no less than eleven inches. Also, the dimensions of the largest step should not exceed that of the smallest by more than three-eighths of an inch.

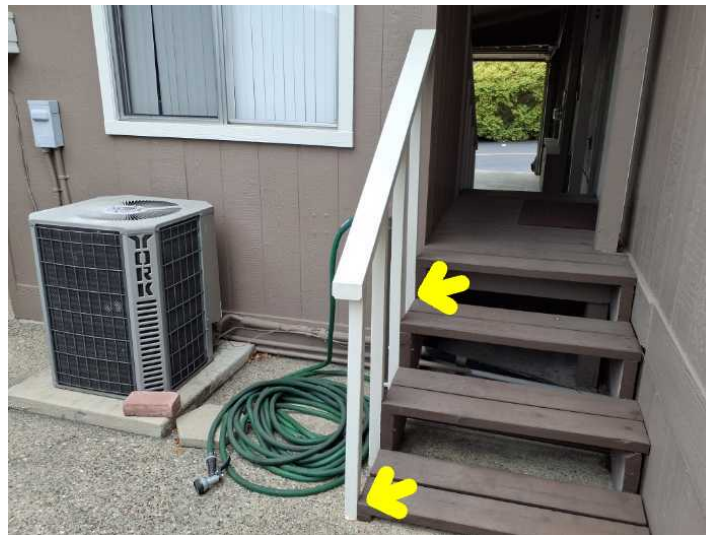
One or more handrails are not secure and should be serviced for optimal safety.

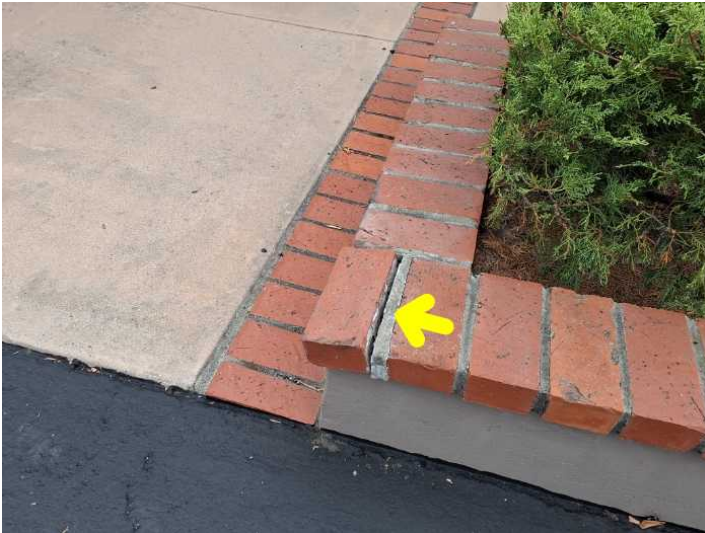
11.2. One or more yard wall caps are loose or missing and should be serviced.

One or more yard wall caps are loose or missing and should be serviced.

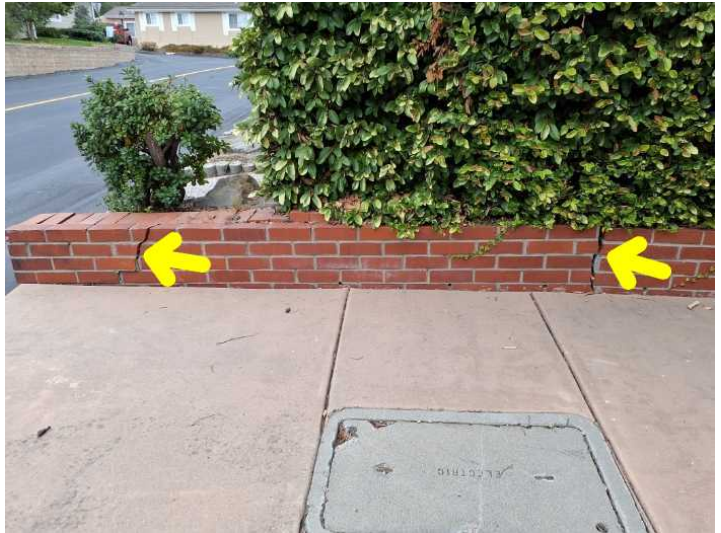
11.3. There are typical stress fractures or grout joint separations in the brick yard walls, but they are reasonably firm and do not appear to be in danger of falling at this time.

There are typical stress fractures or grout joint separations in the brick yard walls, but they are reasonably firm and do not appear to be in danger of falling at this time.

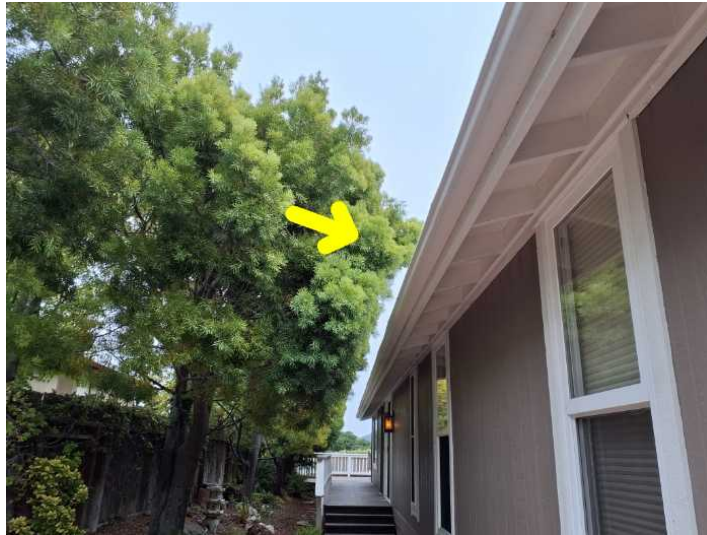
There are tree limbs over growing the residence that should be trimmed or monitored to ensure that they do not impact or damage the roof or its components.

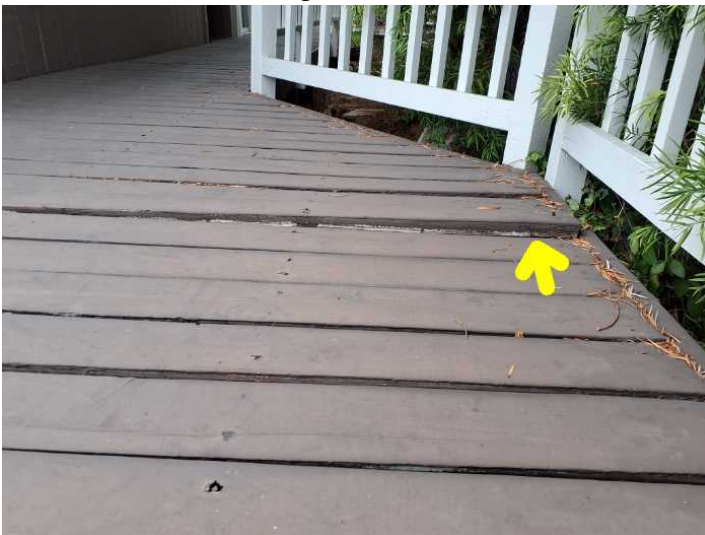
13.2. There is damage to one or more decks that should be evaluated by the pest inspector.

There is damage to one or more decks that should be evaluated by the pest inspector.

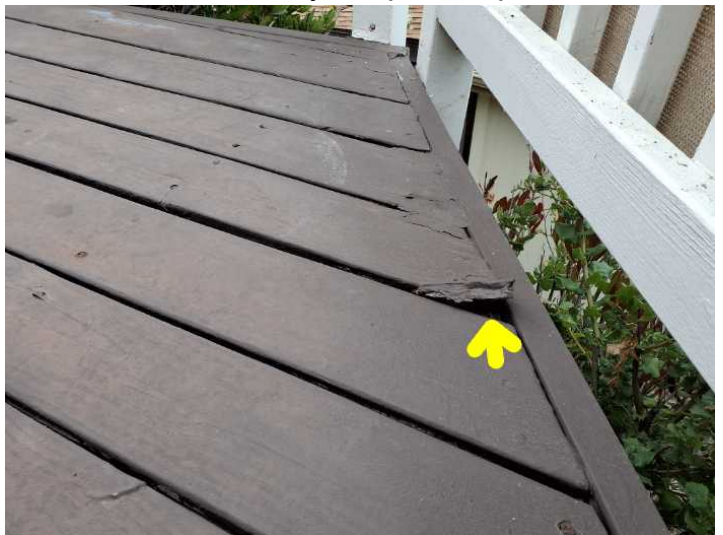
There is damage to one or more decks that should be evaluated by the pest inspector.

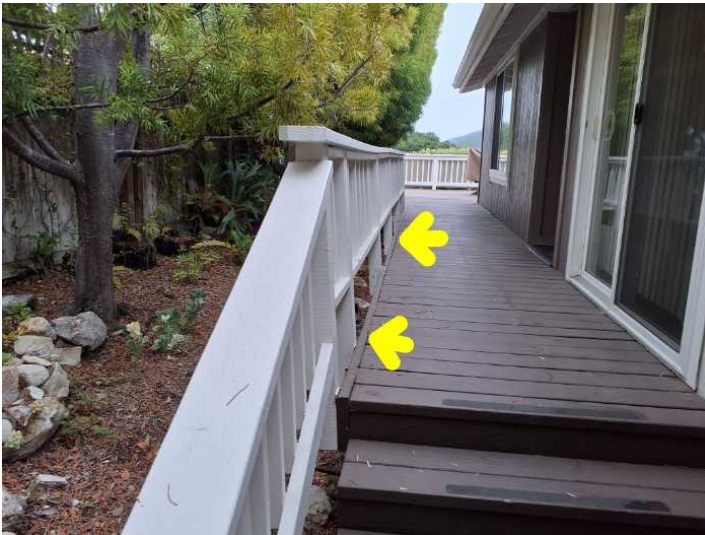
14.3. One or more guardrails are not secure, and should be serviced by a qualified specialist.

One or more guardrails are not secure, and should be serviced by a qualified specialist.

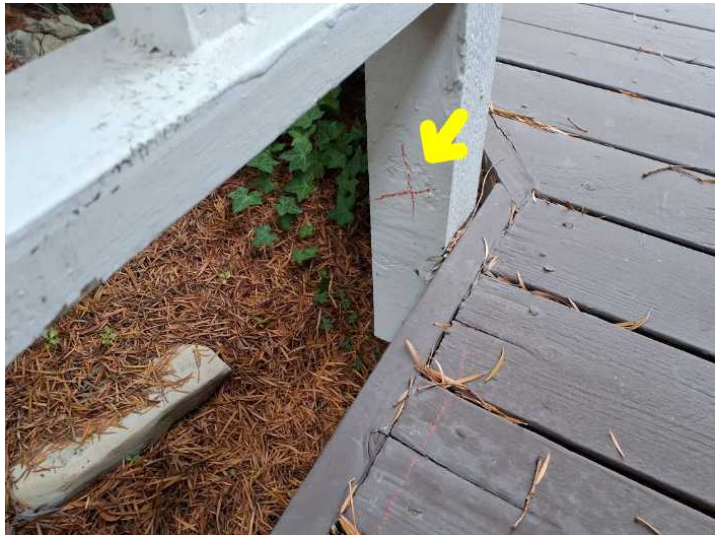
There is damage to one or more guardrails that should be evaluated by a pest inspector.

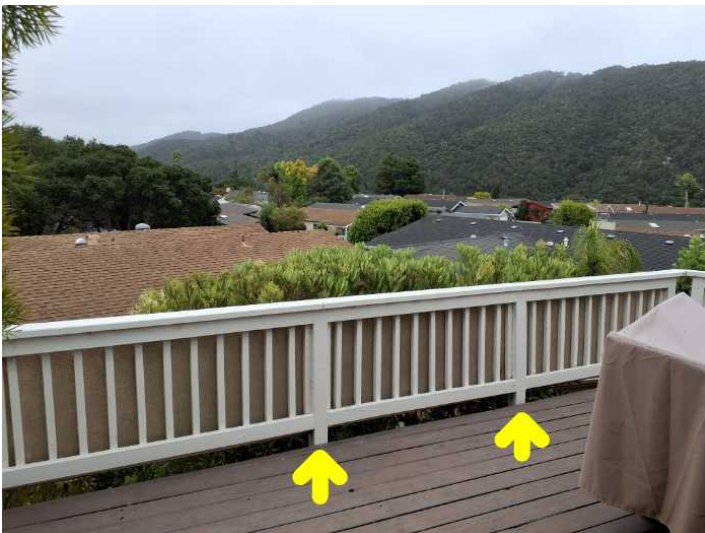
One or more guardrails are not secure, and should be serviced by a qualified specialist.

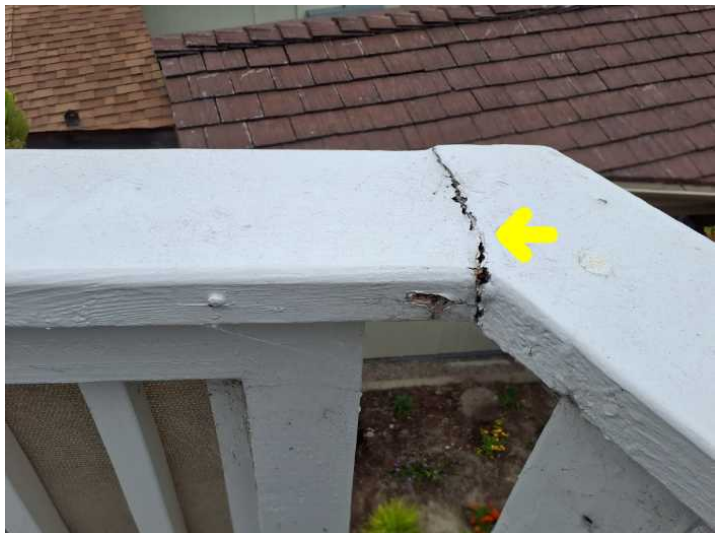
There is damage to one or more guardrails that should be evaluated by a pest inspector.

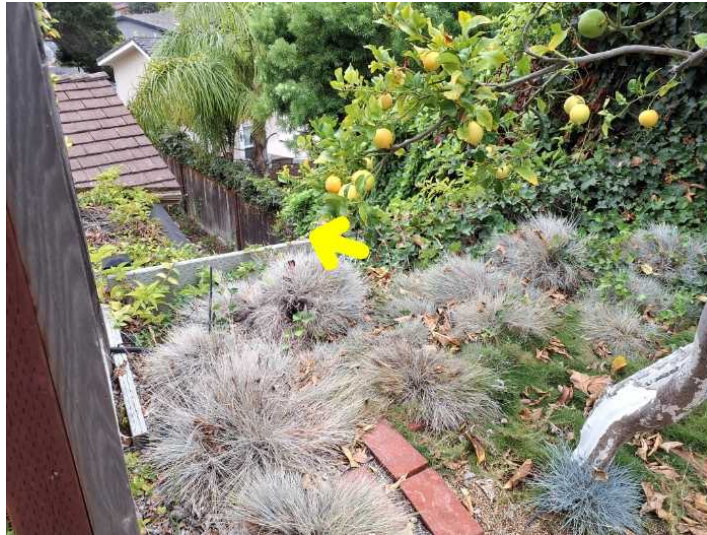
There are areas of this property that do not have guardrails, which are required for walk-offs greater than thirty inches, and appropriate precautions should be taken to safeguard children and the elderly.

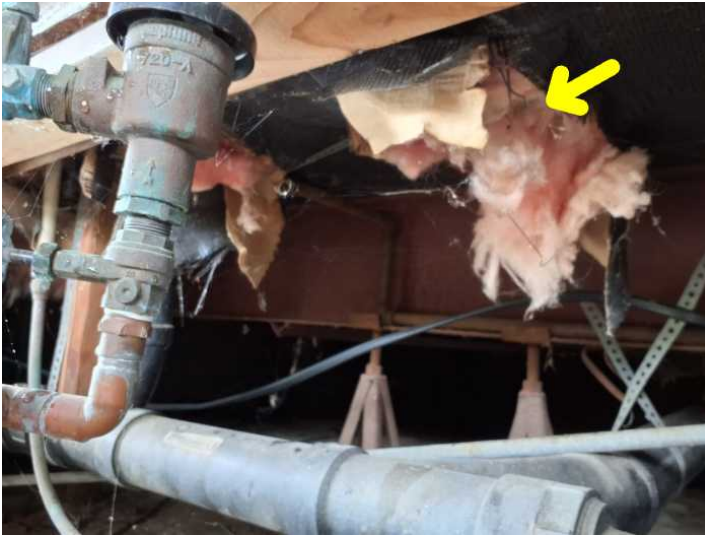
The rodent barrier has voids or openings that should be sealed. This could also imply that there have been some leaks or plumbing repairs done in the past. You may want to ask the seller regarding this issue.

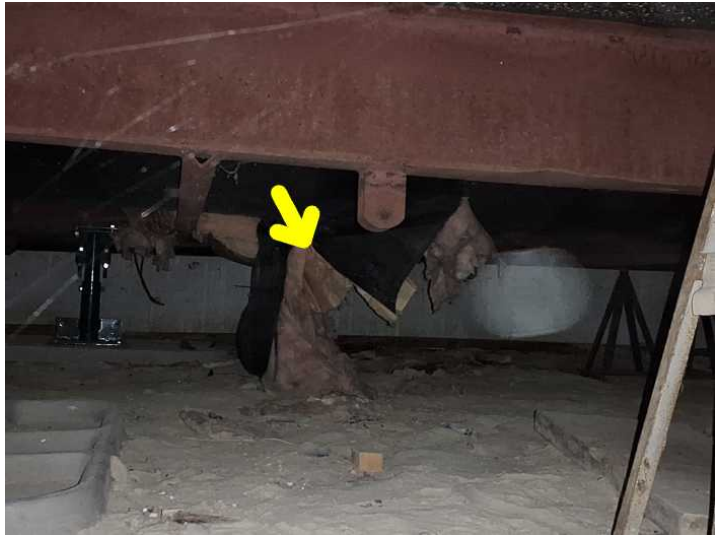
The rodent barrier has voids or openings that should be sealed. This could also imply that there have been some leaks or plumbing repairs done in the past. You may want to ask the seller regarding this issue.

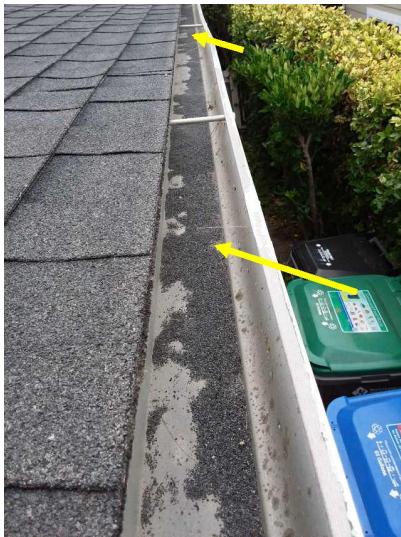
Some of the gutters need to be cleaned to drain properly.

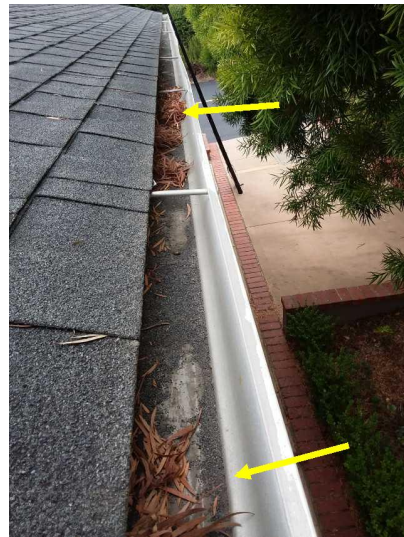
Some of the gutters need to be cleaned to drain properly.

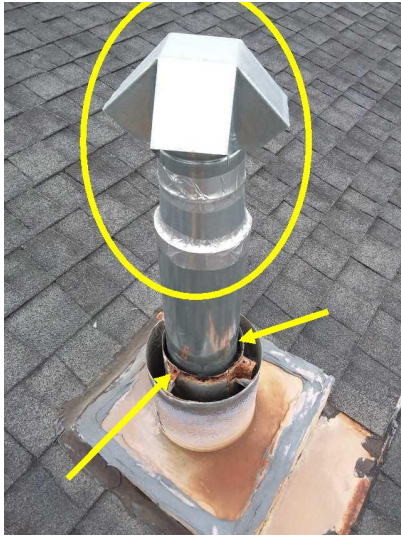
Some of the roof flashing need to be sealed or serviced. They are comprised of metal that seals valleys and vents and other roof penetrations, and are the most common point of leaks. This is particularly true of the flashing on a layered roof, which are covered by the roofing material and which are even more susceptible to leaks.

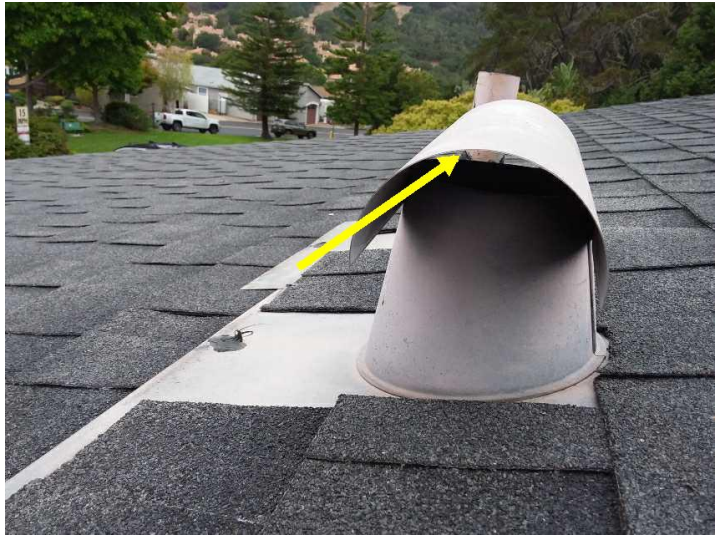
Some of the roof flashing need to be sealed or serviced. They are comprised of metal that seals valleys and vents and other roof penetrations, and are the most common point of leaks. This is particularly true of the flashing on a layered roof, which are covered by the roofing material and which are even more susceptible to leaks.

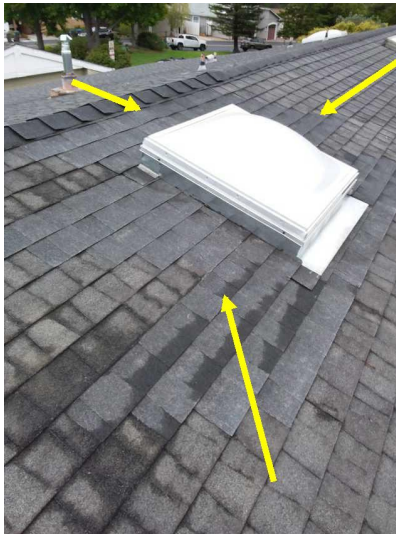
We observed repairs done to the roof that should be explained by the sellers as to why these repairs were needed.

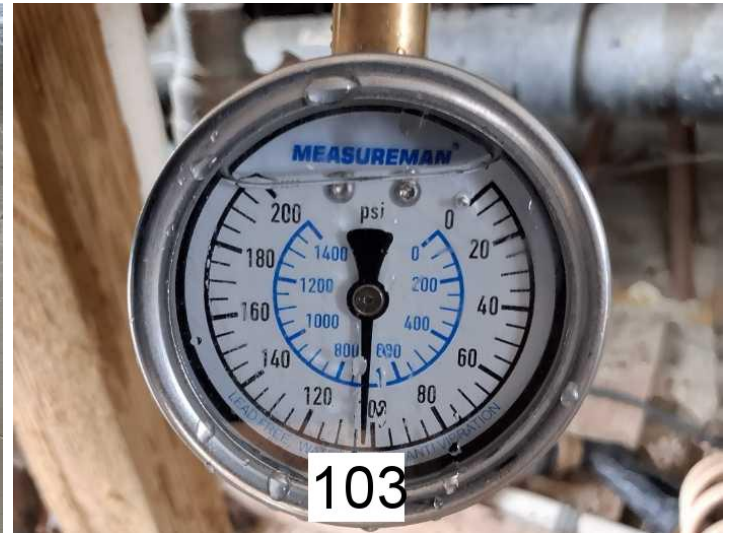
| Page 25 Item: 1 | Water Supply Comments | <p>1.4. The pressure inside the residence exceeds 80 PSI, which is too strong and will stress components of the system. We recommend a regulator should be installed by a licensed plumbing contractor. Most regulators come factory preset at 60 PSI.</p> |

1.4. The pressure inside the residence exceeds 80 PSI, which is too strong and will stress components of the system. We recommend a regulator should be installed by a licensed plumbing contractor. Most regulators come factory preset at 60 PSI.

The pressure inside the residence exceeds 80 PSI, which is too strong and will stress components of the system. We recommend a regulator should be installed by a licensed plumbing contractor. Most regulators come factory preset at 60 PSI.

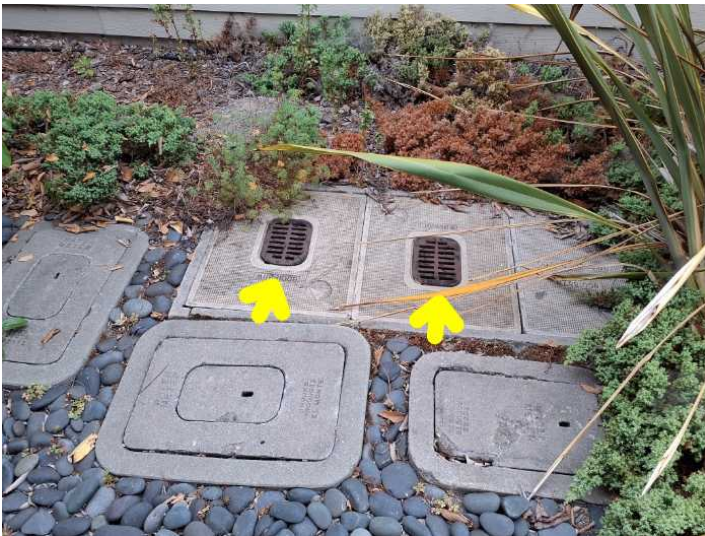
We were unable to determine which shut-off valve is for your unit. It should be identified and disclosed to you, in case there's need for an emergency shut-off of the gas.

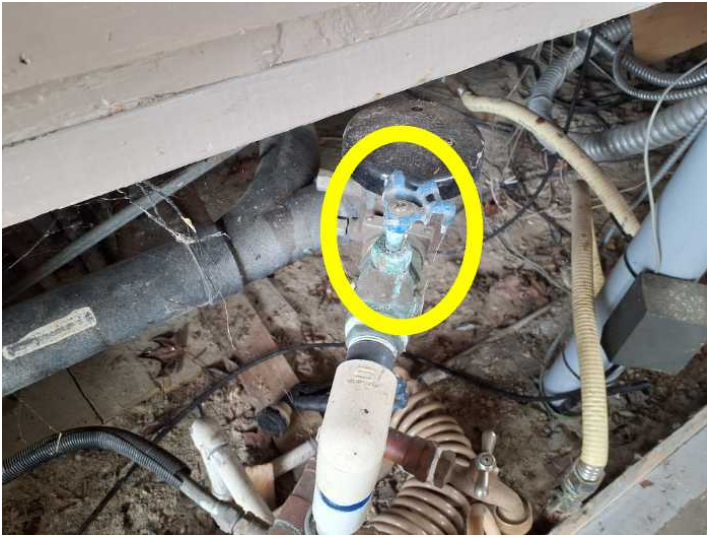
A hose bib at the right side has a missing or broken handle, which should be serviced by a qualified plumbing contractor.

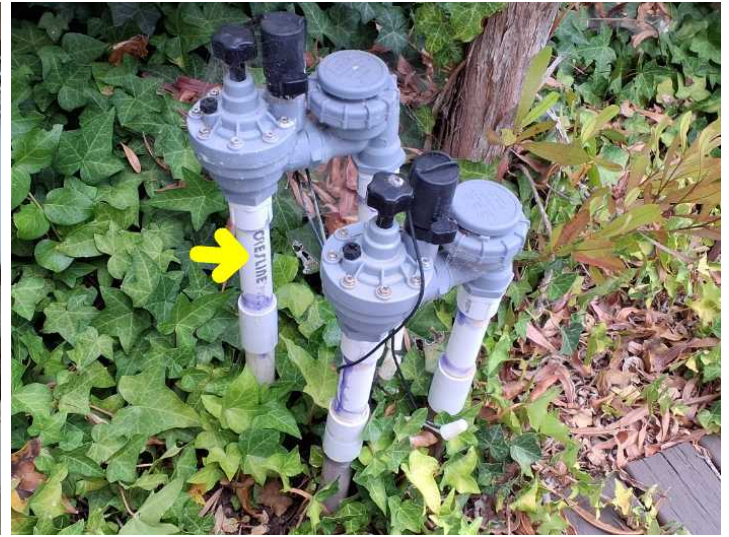
We have observed exposed PVC pipes on the exterior, which may become brittle when exposed to the sun's ultraviolet light. These pipes can become subject to breaking or leaking. We recommend painting the PVC pipes to block the UV rays and protect the pipe.

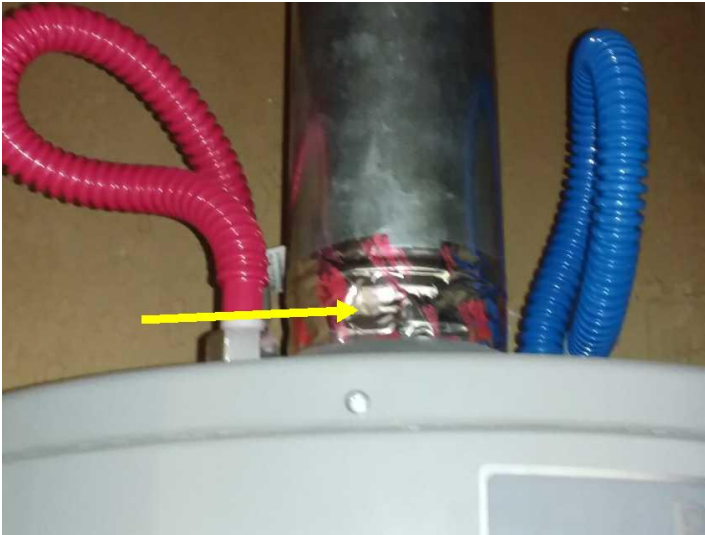
The vent pipe is not properly connected. It is required to have a minimum of 3 fasteners where the pipe connects to the draft hood or other single wall vent pipes.

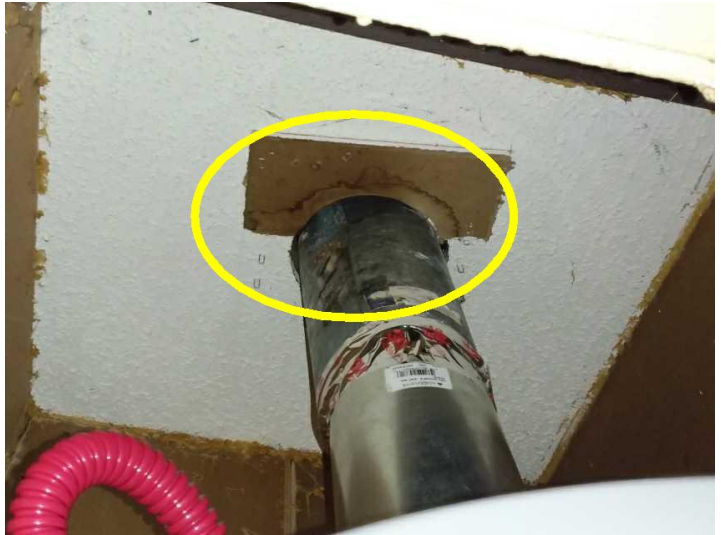
The vent pipe is too close to combustible material, and should be serviced before the close of escrow. A single-walled vent pipe should be six inches away from any combustible material, and a double-walled vent pipe should be one inch away.

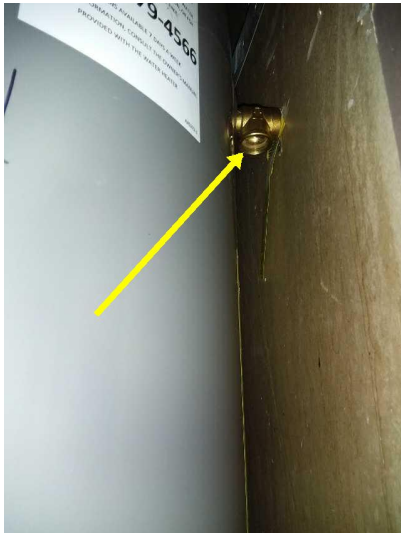
The pressure relief valve on the water heater does not have a discharge pipe. One should be installed to terminate no more than 24 inches above grade and no closer than 6 inches to it and be directed down towards the ground.

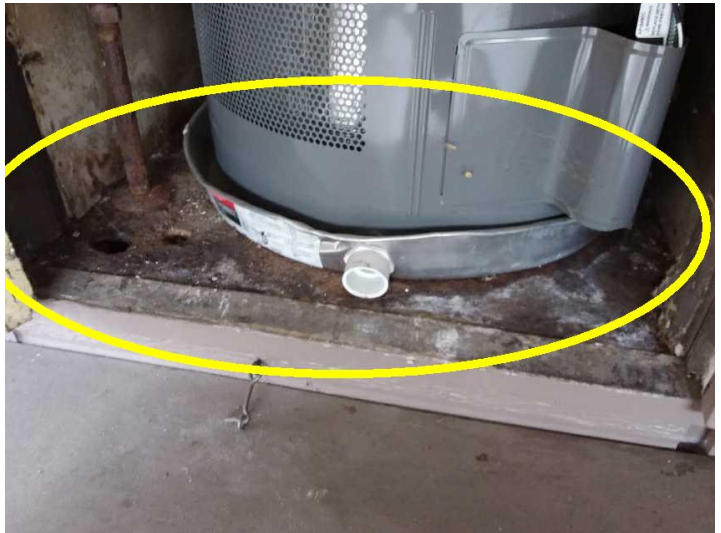
There is a moisture stain on the wall, floor, or ceiling that should be explained or explored further.

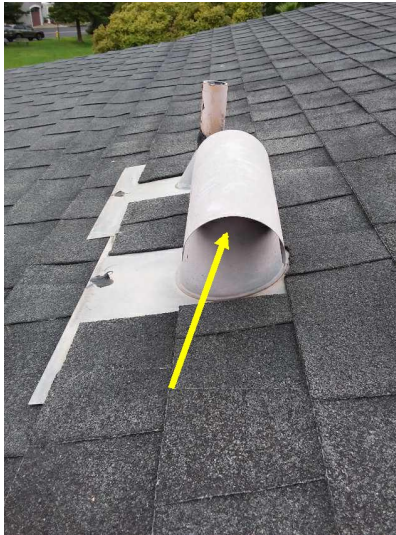
The vent pipe termination cap is not an approved type. A qualified Plumber or HVAC Contractor should evaluate and service as required.

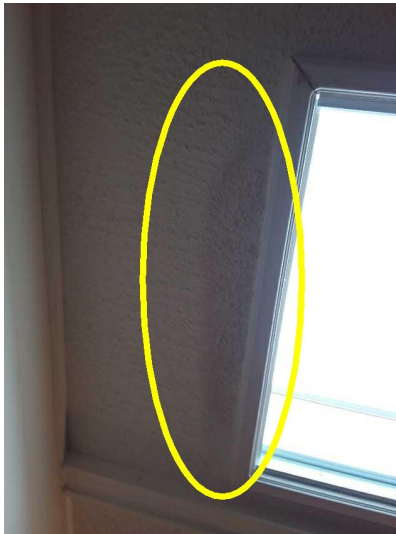
There is a moisture stain on the ceiling that should be explained or explored further.

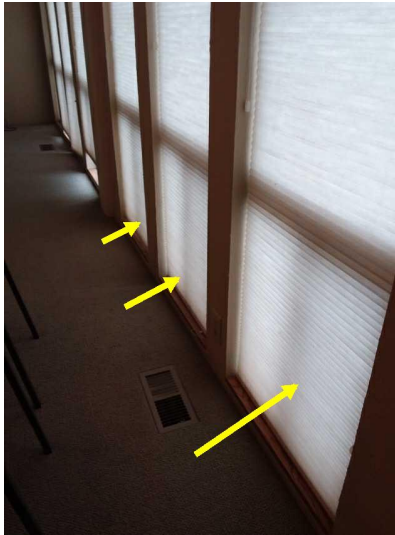
There's one or more windows installed within 18 inches of the finished floor that current standards require such windows to be tempered or safety glass.

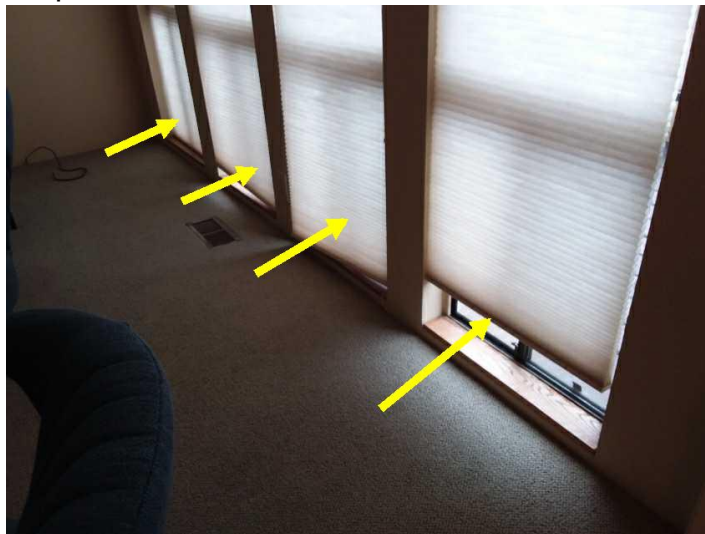
There's one or more windows installed within 18 inches of the finished floor that current standards require such windows to be tempered or safety glass.

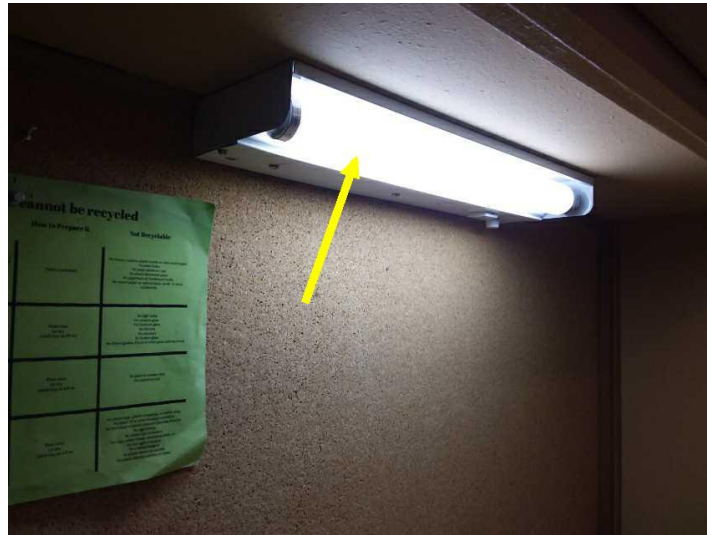
A light is missing its globe or cover and should be serviced.

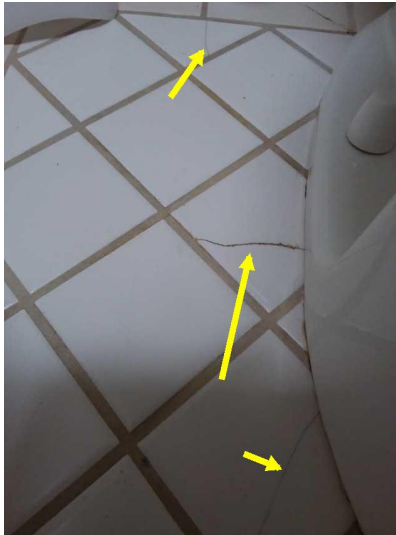
There are cracks in the tiles, which you should view for yourself. They are likely to have been caused by movement or an insubstantial mortar base, but you may wish to seek the opinion of a specialist.

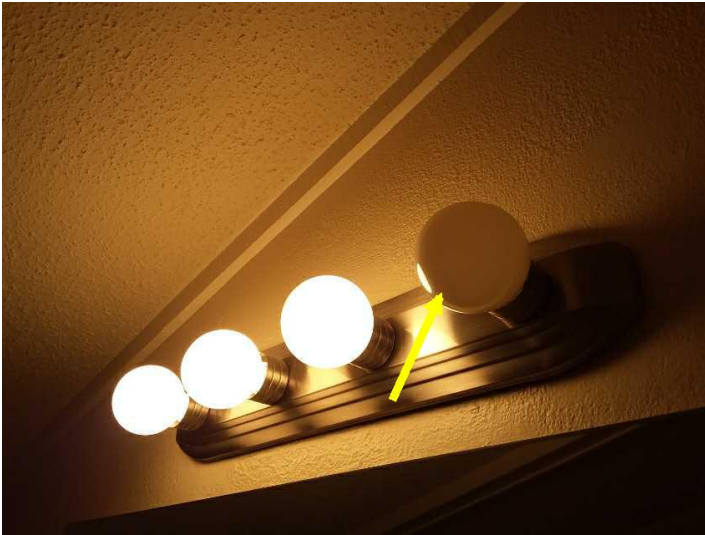
The wall light does not respond and should be serviced.

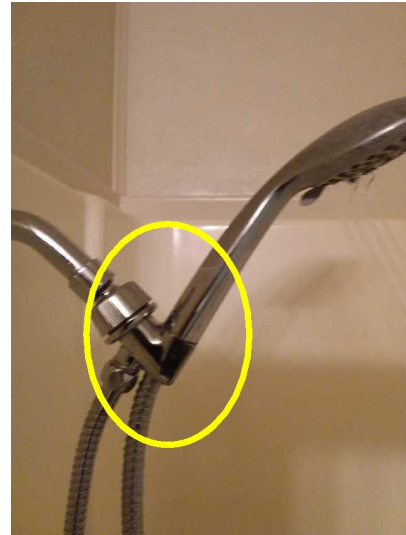
The showerhead leaks and should be serviced/repaired, which may be as simple as tightening it.

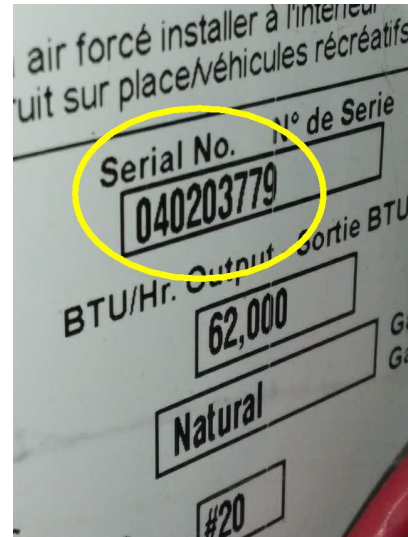
| Page 44 Item: 1 | Forced Air Furnace | <p>1.13. The furnace is functional. However, it is beyond the commonly accepted design life of twenty years, and will need to be monitored more closely for evidence of metal fatigue. We recommend that you have it serviced and evaluated by an HVAC contractor prior to the close of the inspection period.</p> |

Serial number 040203779 - manufactured 2004

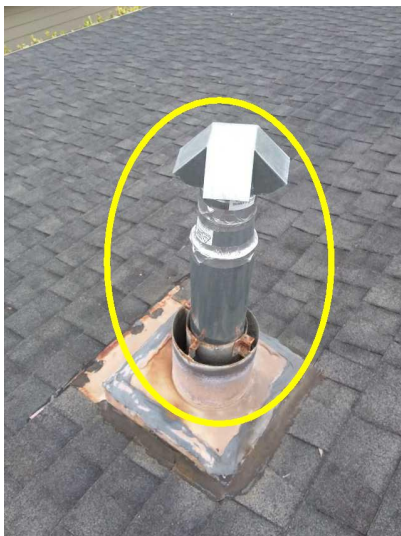
The vent cap on the roof may not be an approved type and should be evaluated and serviced as needed.

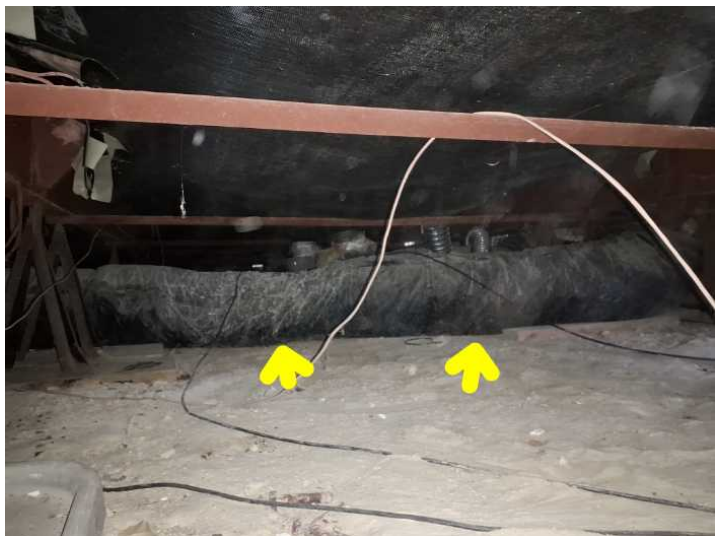
The flexible ducts in the crawlspace are in contact with the soil and should be a minimum of 4" off the ground. The plastic covering will deteriorate when in contact with the soil.

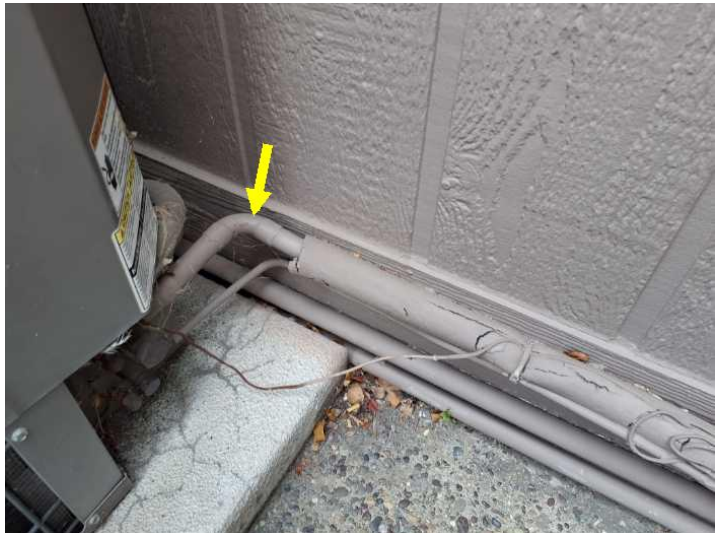
2.7. Insulation is missing from the refrigerant lines at the evaporator coil, which will allow condensation to form and drip, and should be installed.

Insulation is missing from the refrigerant lines at the evaporator coil, which will allow condensation to form and drip, and should be installed.
