## Sewer Lateral Inspection Report

**1844 W. 39th Street, Los Angeles**

**Brian Morrison**  
June 12, 2026

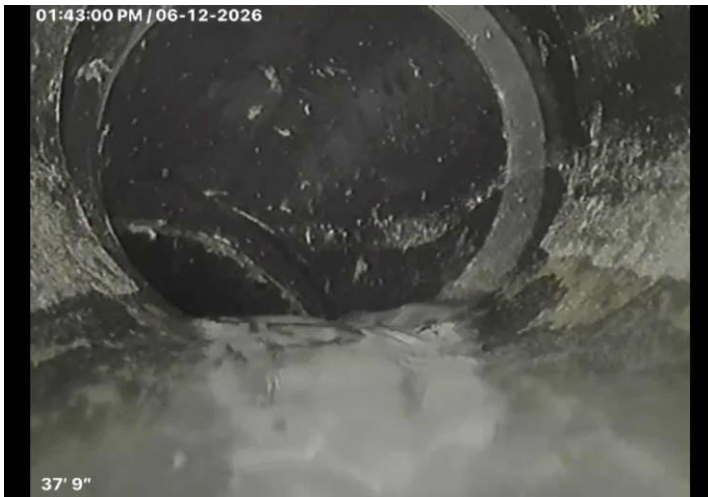
Photo 1

| Distance | Code | Remarks | Photo |
|---|---|---|---|
| 43 feet | FI | Excessive bends | 1,2 |

1. At 43 feet the inspection was terminated due to excessive bends in the lateral pipe. The camera system can get stuck within the pipe if there are too many bends greater than 45 degrees are present, therefore the inspection was abandoned. (See Photo 1) (See Photo 2)

We could not complete the sewer lateral inspection; further inspection is required. We could not complete the inspection due to the following condition(s): Excessive bends.

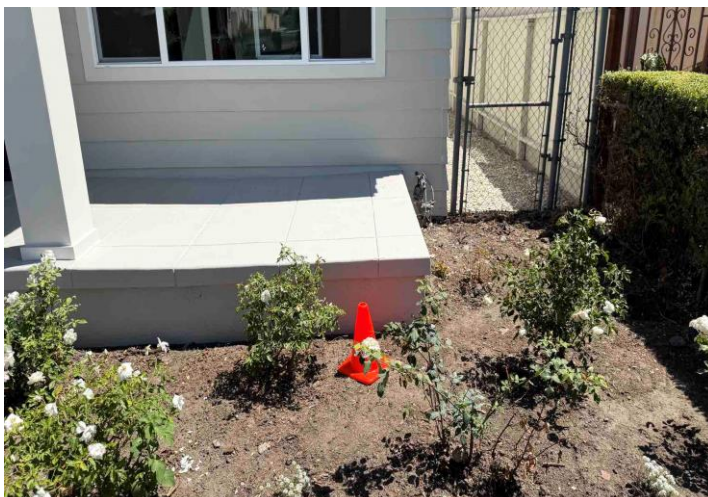
Photo 3

| Distance | Code | Remarks | Photo |
|---|---|---|---|
| 3 feet | | Install proper clean out | 3 |

Installation of a sewer lateral cleanout at the building is recommended. We will excavate the soil to a depth of 3-4 feet and remove a small section of the existing pipe to install a cleanout with a riser to grade level and cap. All soil removed during excavation will be backfilled and compacted. The cost of the recommended repair are \$4,667.00.
