# Inspection Report

**Susan Madrid**  
1291 W Newport Street  
San Luis Obispo, CA 93405

Report Date: 3/30/2023

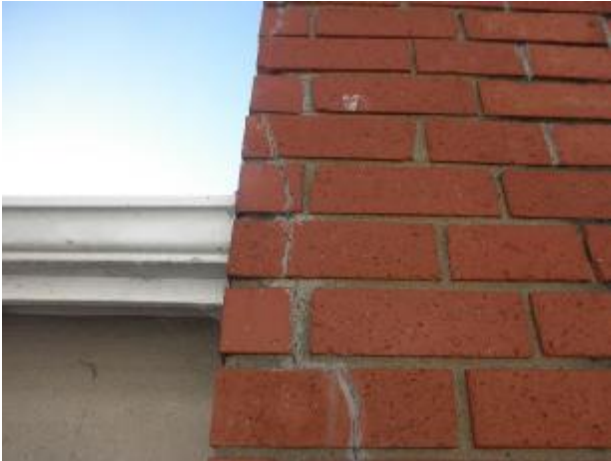
**Roof # R**

1.) There is thermal cracking on the outside brick wall of the chimney.

**Thermal cracking on the outside brick wall of the chimney.**

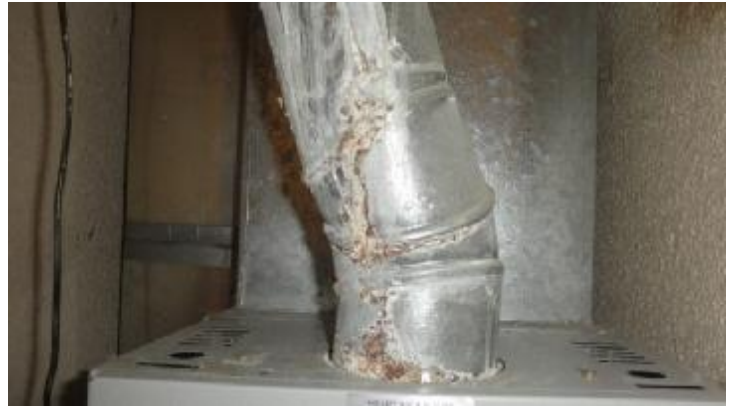
**Roof # R**

2.) The storm collar is missing at the furnace exhaust flue and there is evidence of leaks at the furnace exhaust flue.

**Evidence of leak at the furnace flashing.**

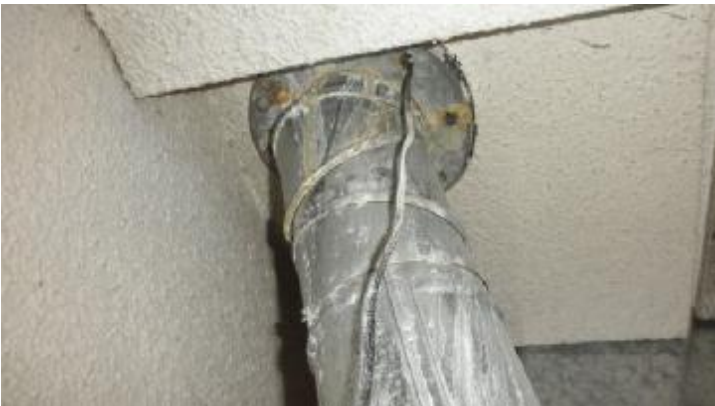
**Roof # R**

**Evidence of leak at the furnace flashing.**

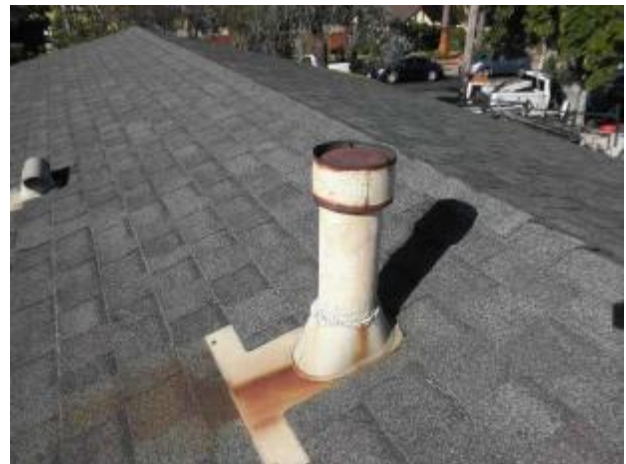
**Roof # R**

**Missing storm collar the furnace exhaust.**

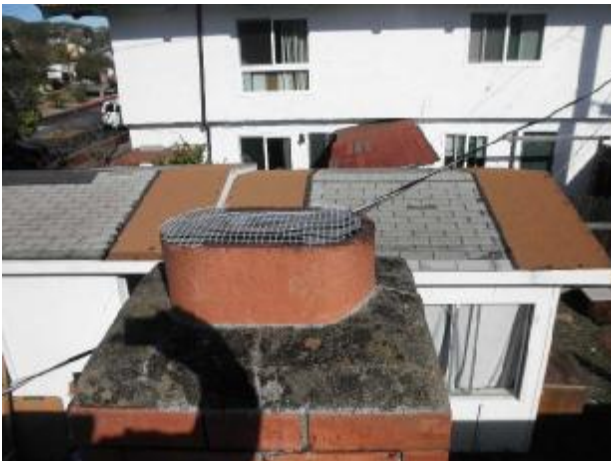
**Roof # R**

**Substandard spark arrester at the chimney.**

**Fire Safety Upgrade Note:** The spark arrestor on top of the chimney(s) is substandard. Recommend installing a four sided spark arrestor with a rain cap at the top of the chimney.

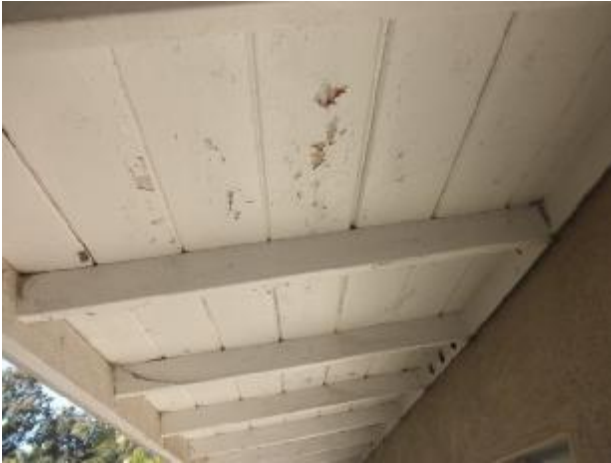
# EX

The eaves need to be painted.

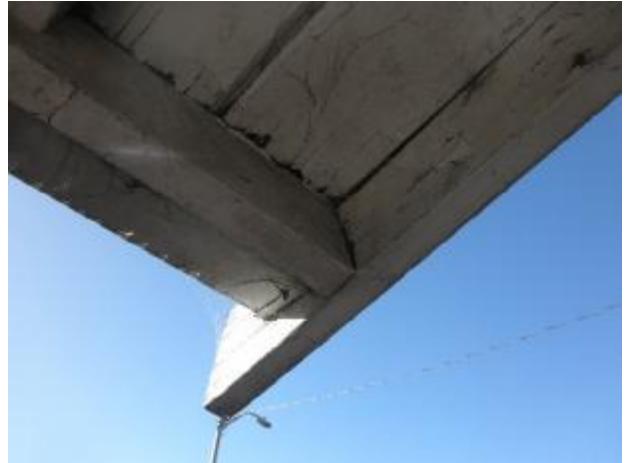
# EX

Moisture damage at the SW eave.

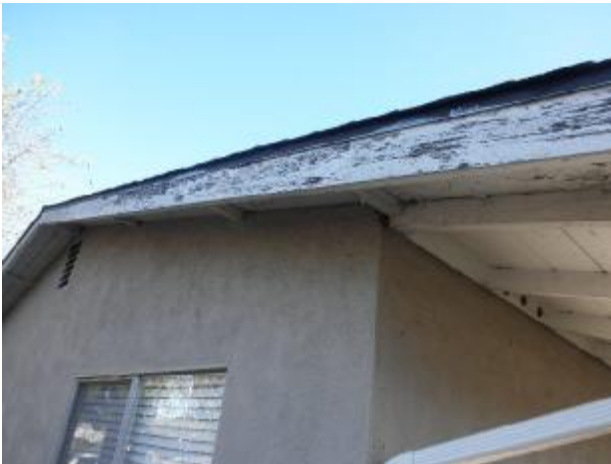
# EX

The eaves need to be painted.

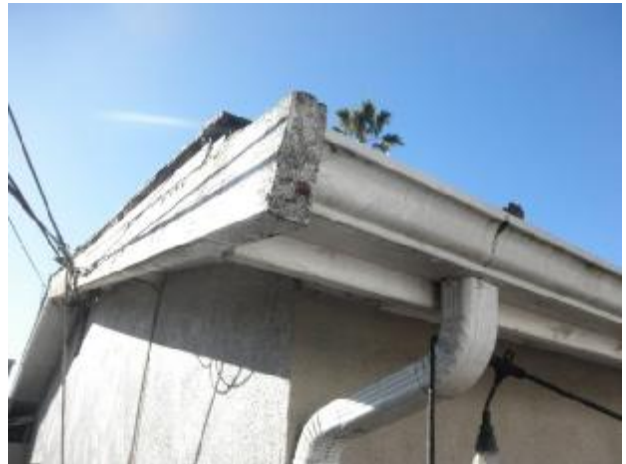
# EX

Moisture damage at the NE fascia.

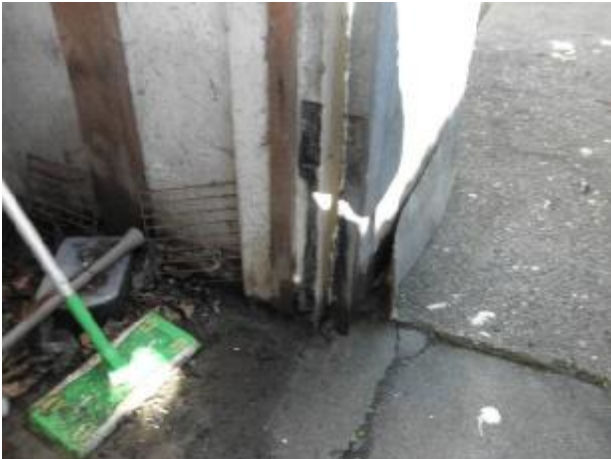
# EX

Moisture damage at the water heater closet door.

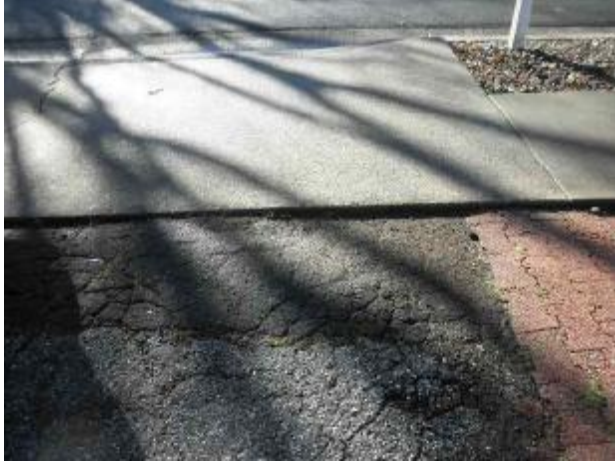
**Grounds & Drainage # GD**

**Safety Hazard Note:** There are tripping hazards at the interface of the asphalt driveway and the city sidewalk, at the interface of the front paver walkway to the concrete driveway and at the front entry concrete landing.

**Tripping hazard at the driveway and sidewalk.**

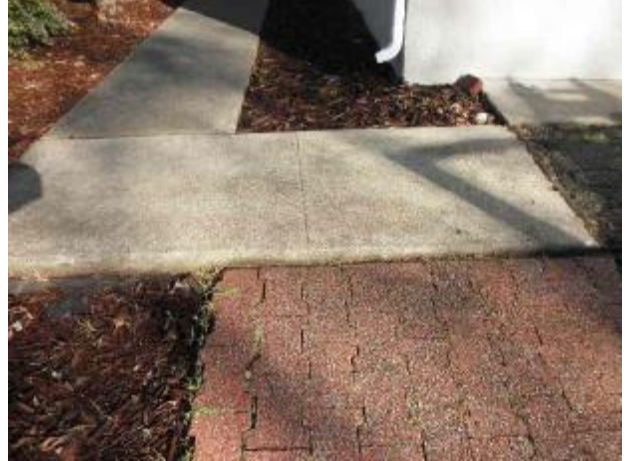
**Grounds & Drainage # GD**

**Tripping hazard at the front walkway.**

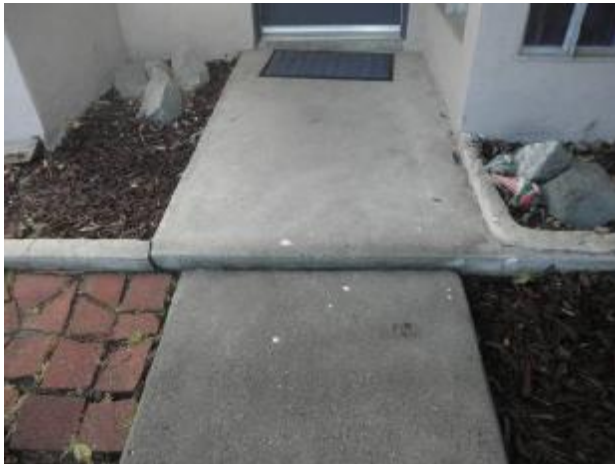
**Grounds & Drainage # GD**

**Tripping hazard at the front walkway.**

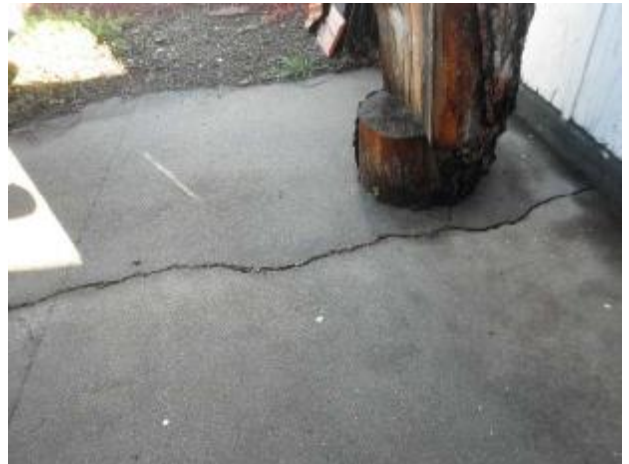
**Grounds & Drainage # GD**

**General settlement crack in the concrete driveway at the NW corner of the property.**

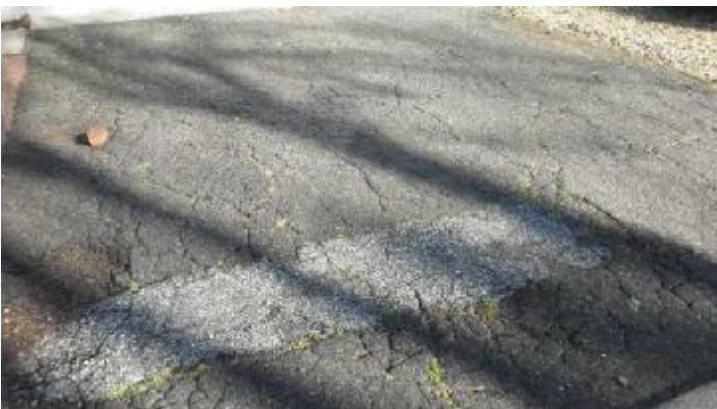
**Grounds & Drainage # GD**

**Maintenance Note:** The asphalt driveway appears to be in poor condition. Cracks, tree root damage and general deterioration were observed.

**The asphalt driveway needs to be resealed.**

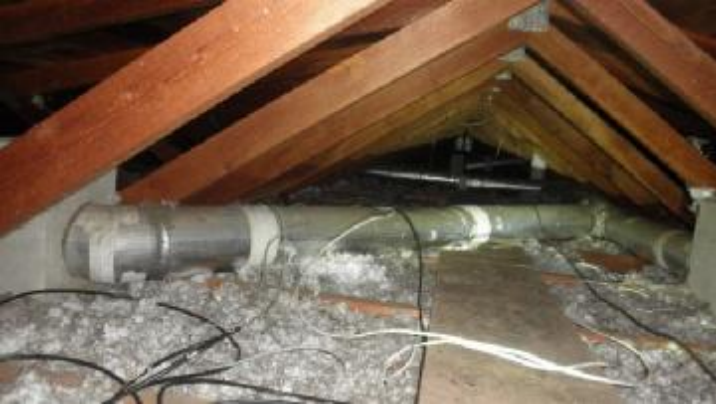
# HC

Insulation around the ducting may be asbestos.

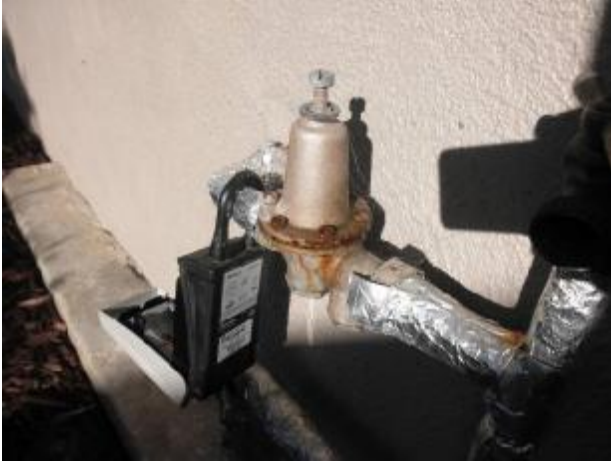
# P

1.) There is an active leak at the pressure regulator at the main water riser.

Leak at the pressure regulator at the main water shut off.

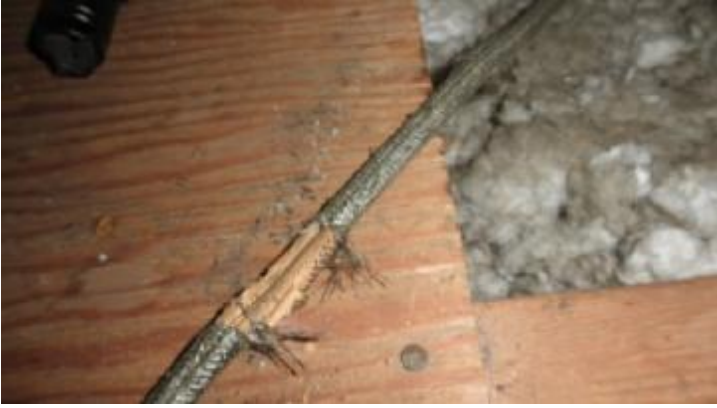
# EL

**Safety Hazard Note:** There is a frayed Romex wire with exposed single conductors in the attic space adjacent to the access opening.

Frayed electrical romex wiring in the attic.

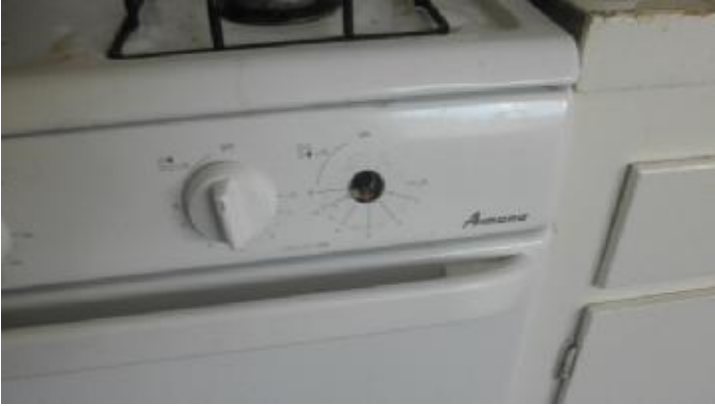
# K

1.) One of the control knobs for the range is broken.

Control knob broken at the range.

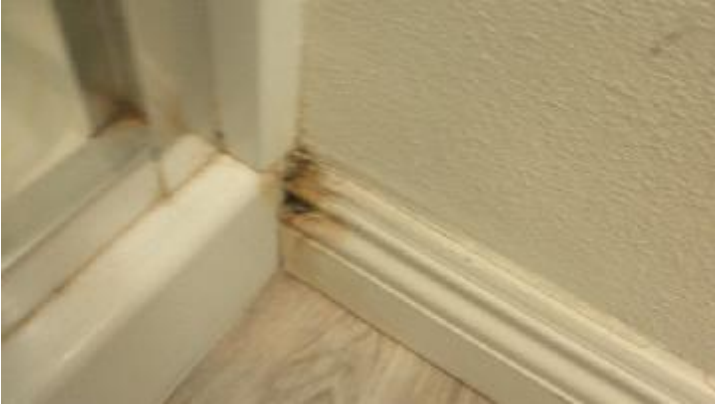
# B

- 1.) There is a slow drain at the sink in the master bathroom.
- 2.) There is moisture damage to the drywall at both sides of the master shower due to over splash. This has caused a black mildew like substance. (See notes on the Deficiency Summary page at the end of the report regarding the potential for microbial contamination.)

Moisture damage and black mildew like substance at the edge of the master shower.

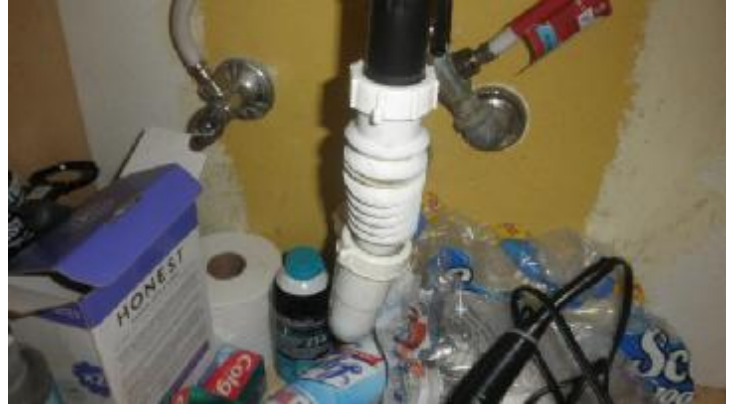
# B

Corrugated piping at the hall bathroom sink.

**Repair Note: The drain line for the hall bathroom sink has been installed with corrugated piping. This subjects the drain line to clogs and is recommended to be replaced with smooth wall piping.**

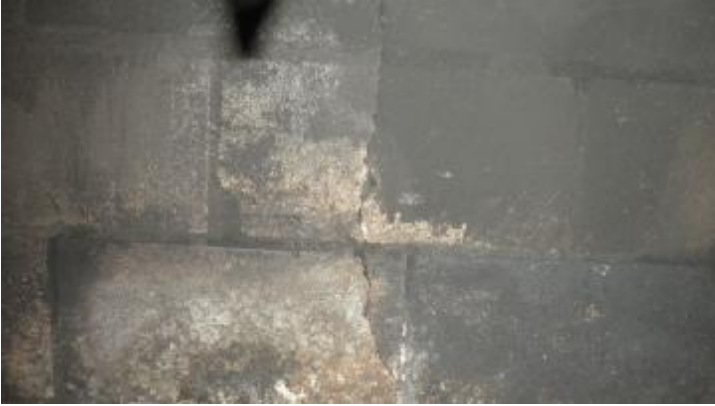
**# IR**

**Cracks in the firebox.**

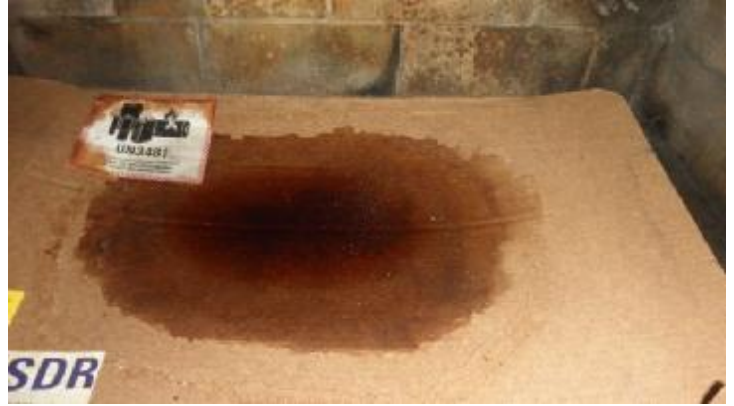
**# IR**

**Water leak inside the fireplace.**

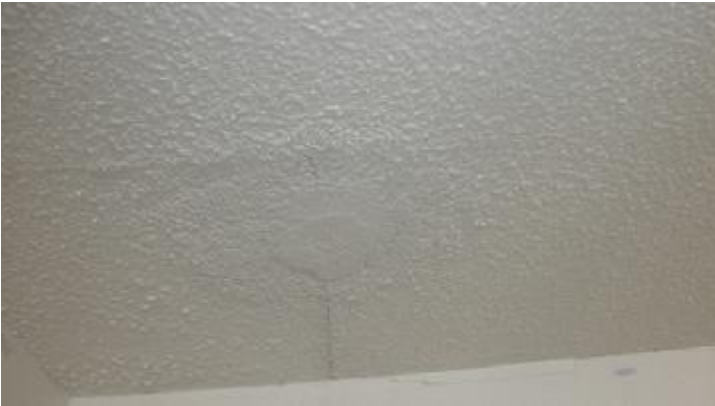
**# IR**

**Example of patches at the living room ceiling.**

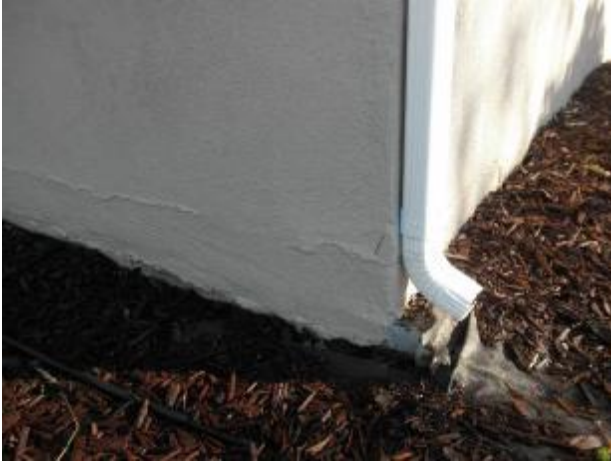
# F

**Information Note:** The concrete foundation slab on grade is not visible due to the finish flooring in the home. There were no secondary visible observations of problems throughout the home which would indicate a significant structural deficiency with the slab. There is some settlement cracks with patching at the SW corner of the home. Having a manometer survey is recommended.

Settlement crack with patching at the SW corner.
