Inspection Report

Property Address:
4410 Upper Lopez Canyon
Arroyo Grande CA 93420

8/7/2024

Harper Homes: Home Inspection Services

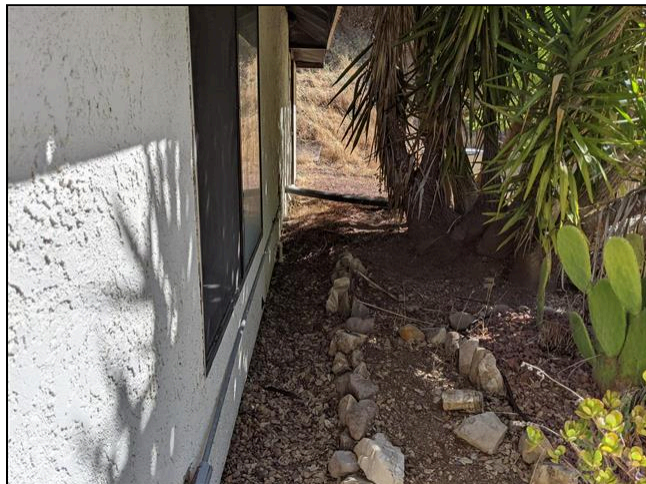
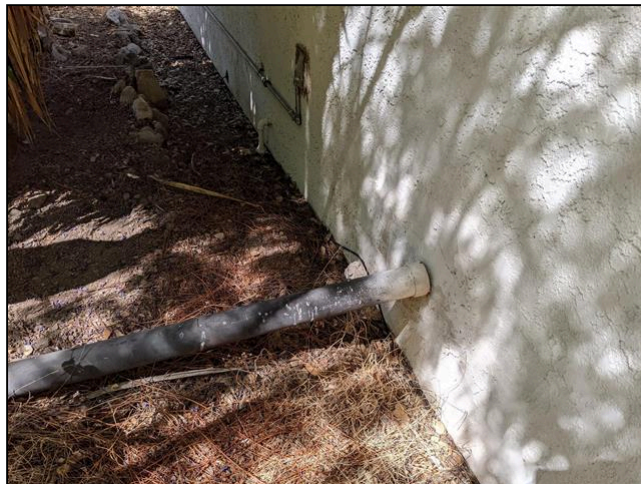
Grade / drainage needs improved at the perimeter of the home. Recommend the soil be sloped away from the home and all surface water be channeled or directed away from the foundation to promote functional drainage.

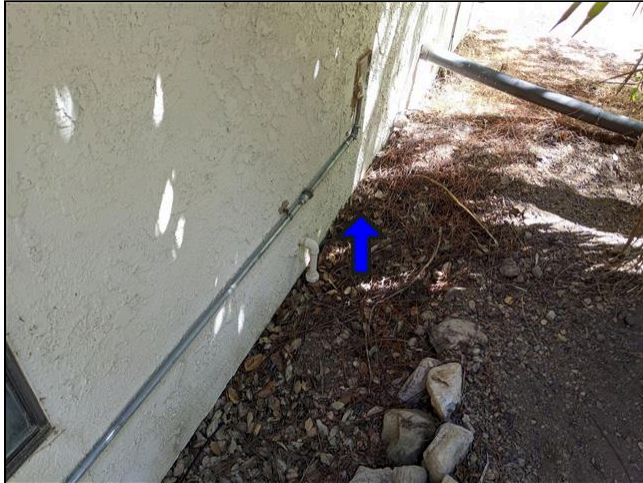
1.0 Item 3(Picture)

Soil or landscape materials are pushed up against the stucco siding at various areas around the home. Landscape maintenance is needed to remove material from holding moisture at the siding while maintaining functional drainage away from the foundation.

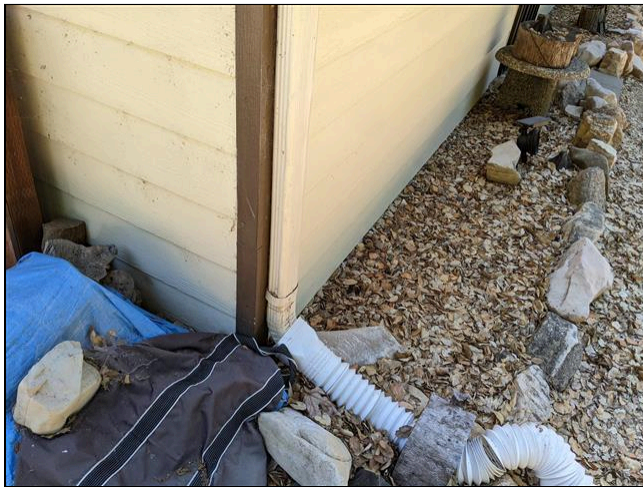
1.0 Item 4(Picture)

Soil or landscape materials pushed up against the siding at various locations. Refer to the pest report for more information on this condition and have material removed to prevent earth to wood contact while allowing drainage to remain effective.

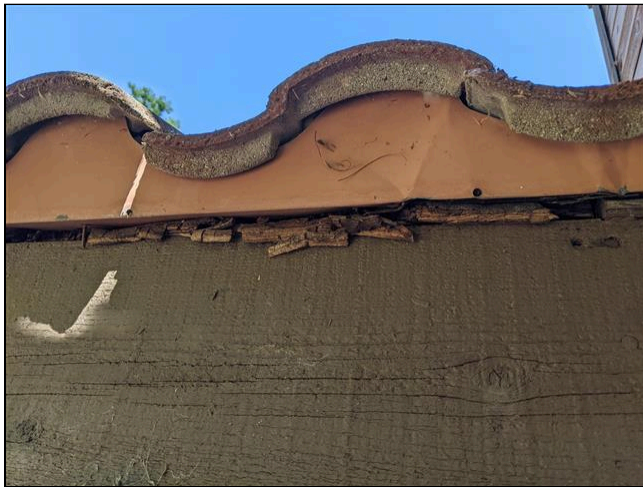
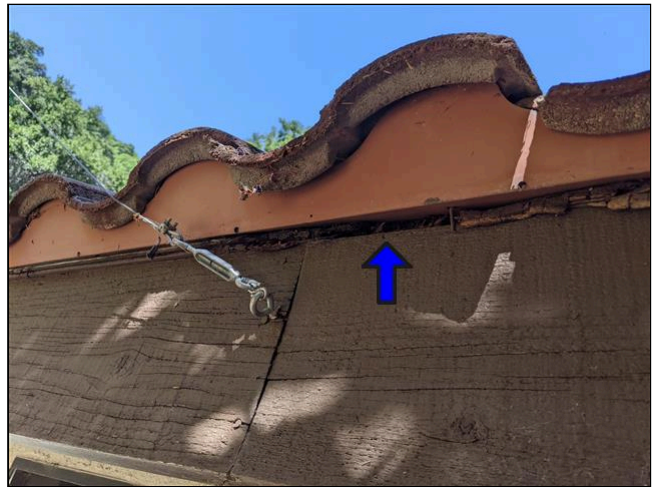
Roof sheathing contains moisture damage under the eave at the right side of the home. Refer to the pest report for further information on this condition and make repairs as prescribed. Roofing materials should be further evaluated and repaired in these areas to prevent continued deterioration.

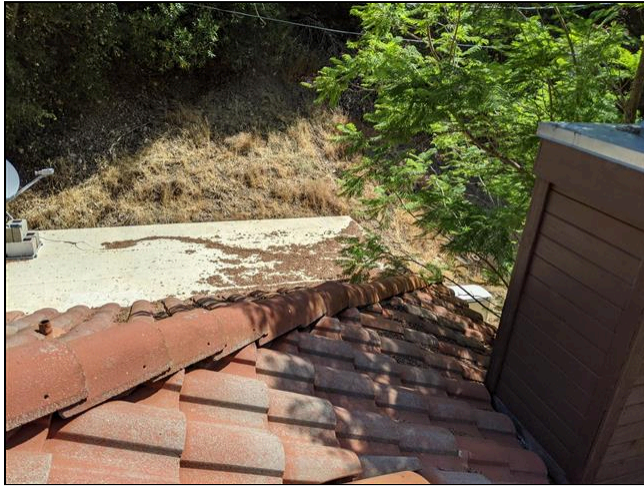
2.0 Item 3(Picture)

Debris on the roof should be removed and an annual maintenance schedule established. This will greatly extend the life expectancy of the roof in these areas.

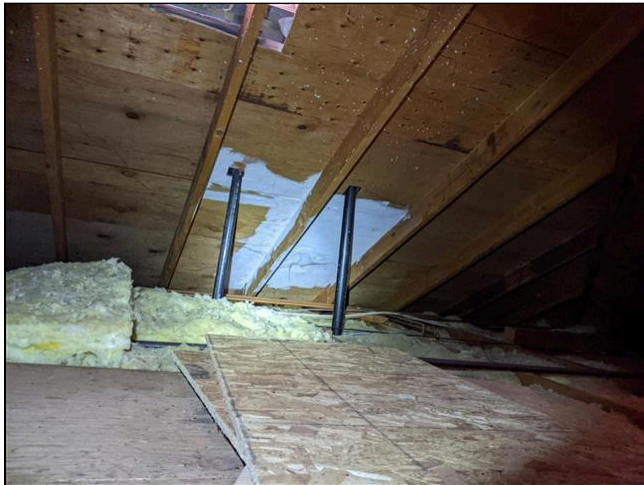
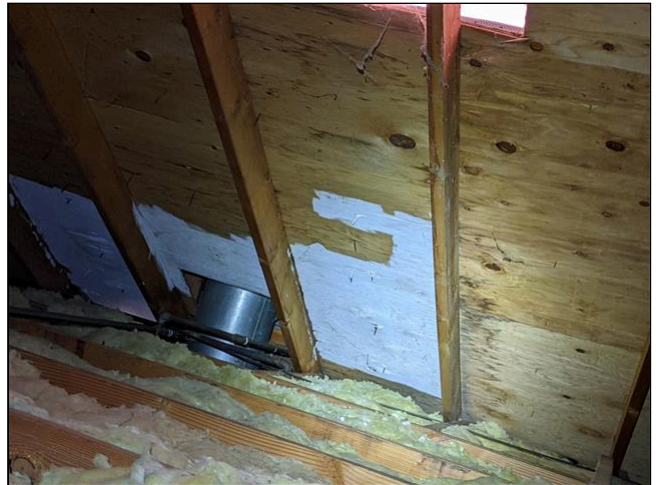
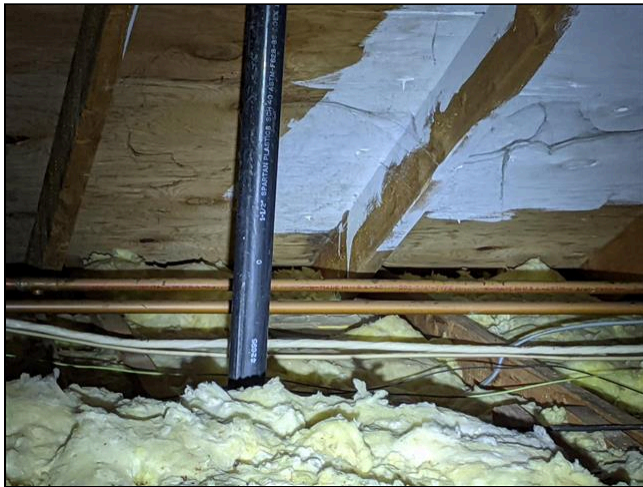
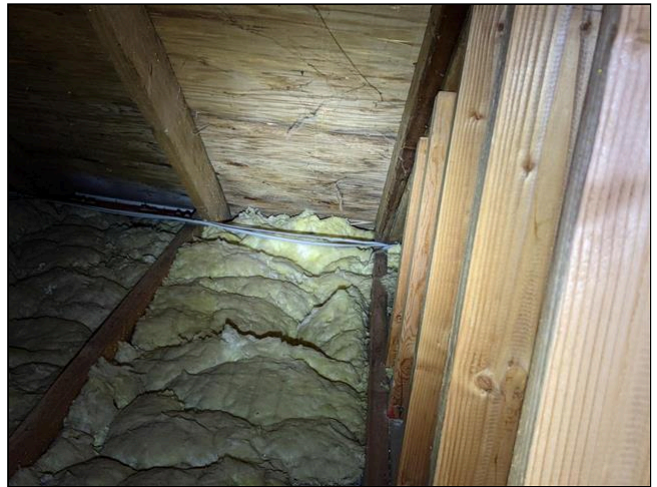
Due to the age of the roof and various signs of moisture intrusion in the attic it is recommended that the roof and all roofing components be further evaluated by a qualified roofing contractor to better understand the extent of repairs needed, remaining life, and cost to repair/replace.

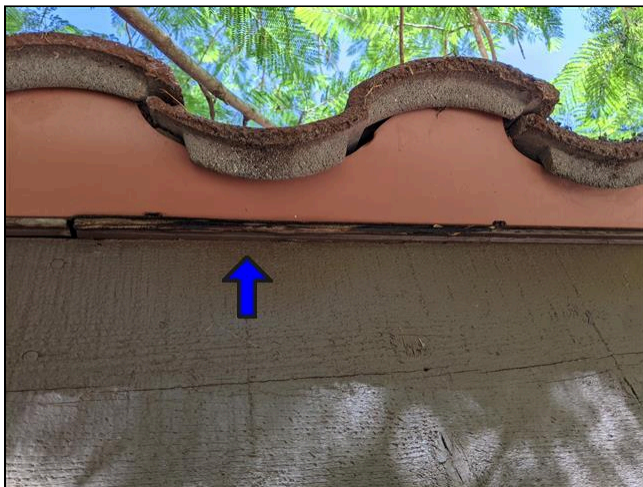
2.1 Item 1(Picture)

No drip edge was present on the roof. While this might have been acceptable at the time of construction, recommend roof drip edge installed to prevent moisture intrusion to the roof sheathing and fascia.

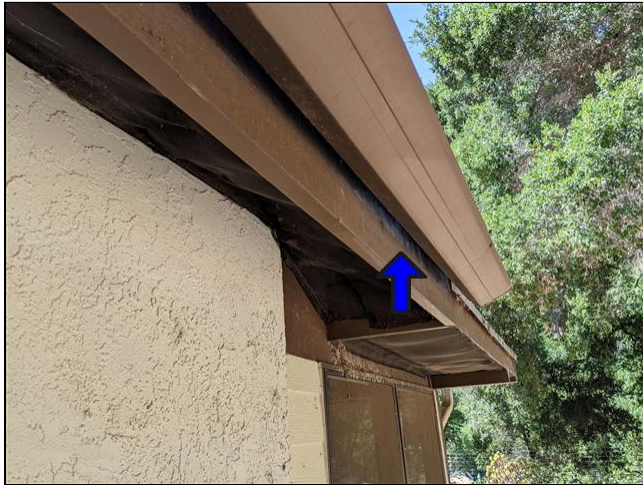
2.3 Item 1(Picture)

Gutter damaged at the left side of the home and repairs should be made to insure proper drainage at this area.

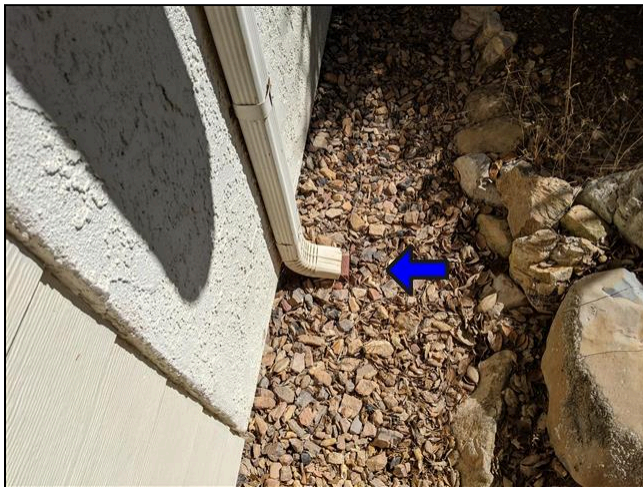
2.3 Item 2(Picture)

Downspout extension needed at the right exterior to channel rain water away from the foundation and help promote functional drainage.

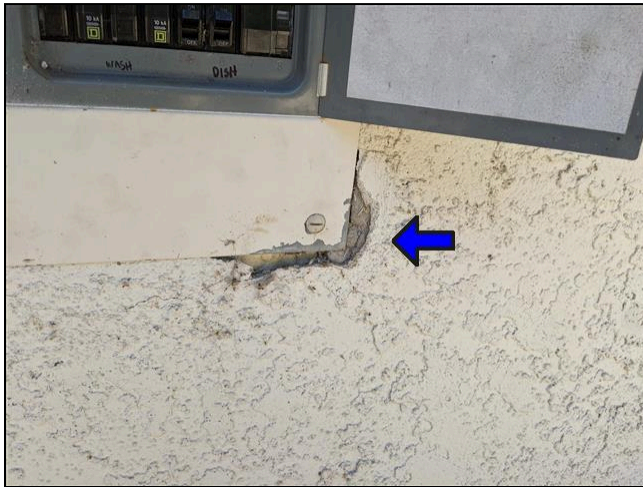
2.4 Item 1(Picture)

Perforations in the siding at the left exterior should be patched or repaired to prevent pest or moisture intrusion.

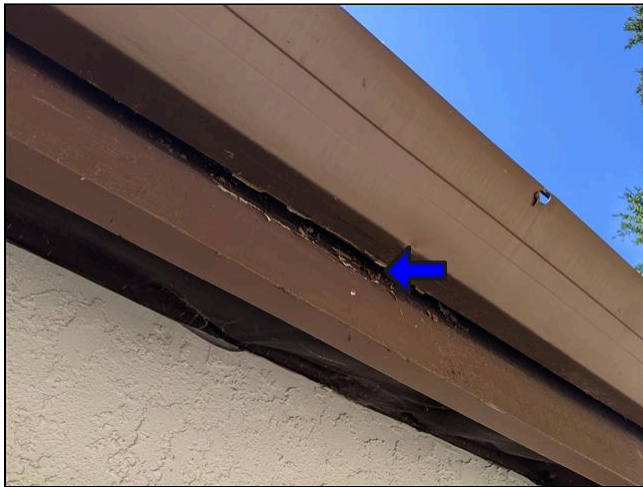
2.4 Item 2(Picture)

Moisture damage noted at the fascia. Recommend further evaluation by a structural pest control operator and make repairs as prescribed.

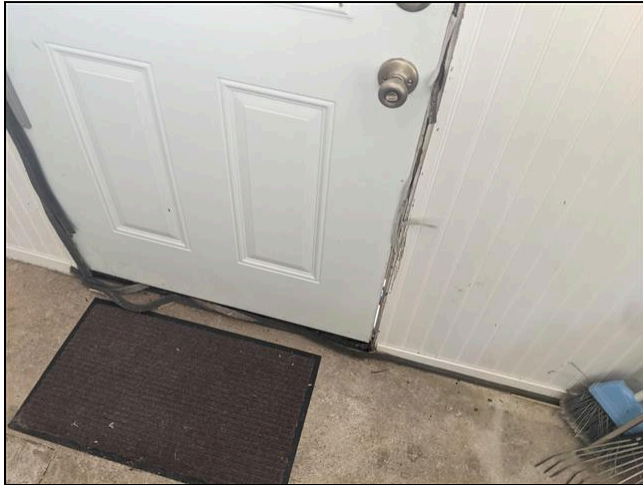
2.5 Item 1(Picture)

Weather stripping needs improved at the rear left patio door to insure maximum efficiency of the home.

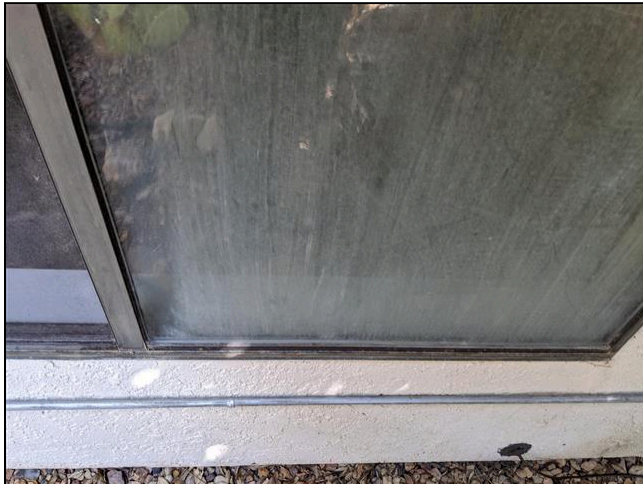
2.6 Item 1(Picture)

Failed seals in dual pane windows, noted at the right living room window and condensation build up or stains were noted within the window. Recommend windows repaired or replaced to ensure full insulation capabilities and improve aesthetics.

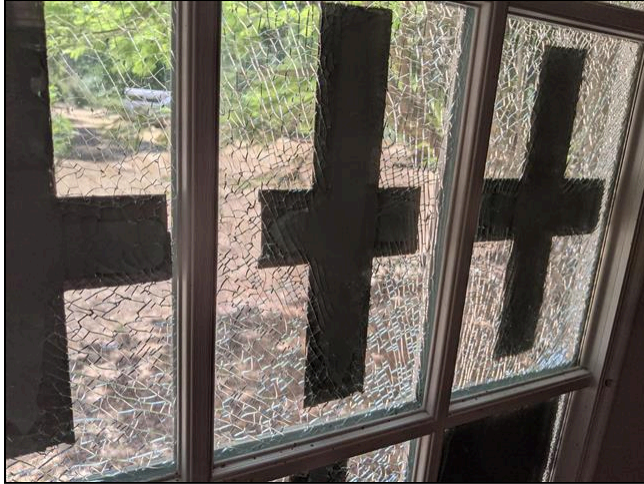
2.6 Item 2(Picture)

Cracked window noted at the rear patio door and needs repaired.

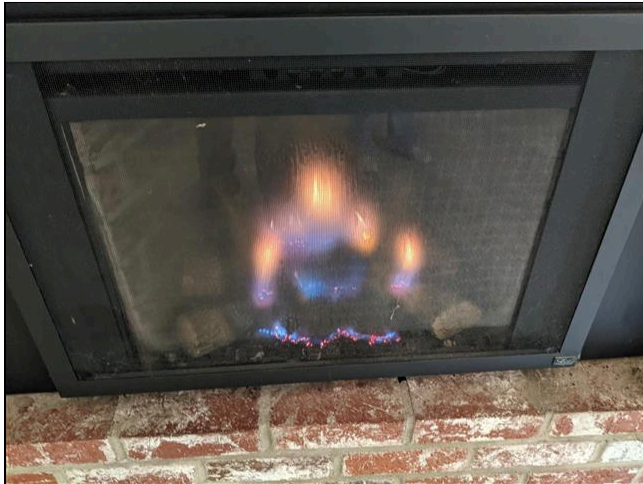
3.1 Item 1(Picture)

The gas fireplace was tested and functional at the time of the inspection.

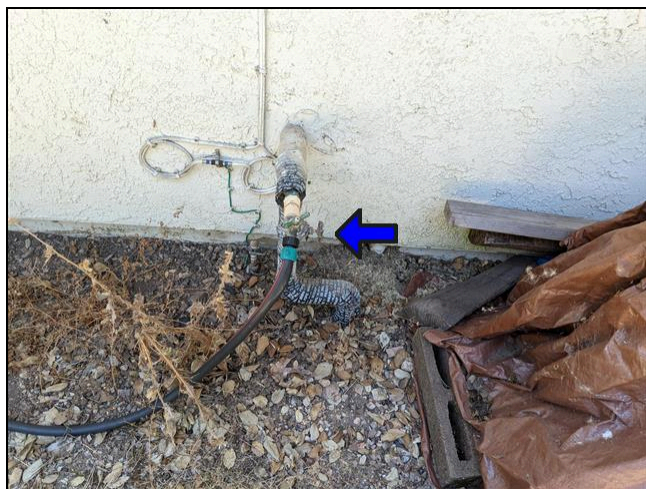
5.4 Item 1(Picture)

The water shutoff is located at the left exterior of the home. To turn the water off turn the handle clockwise.

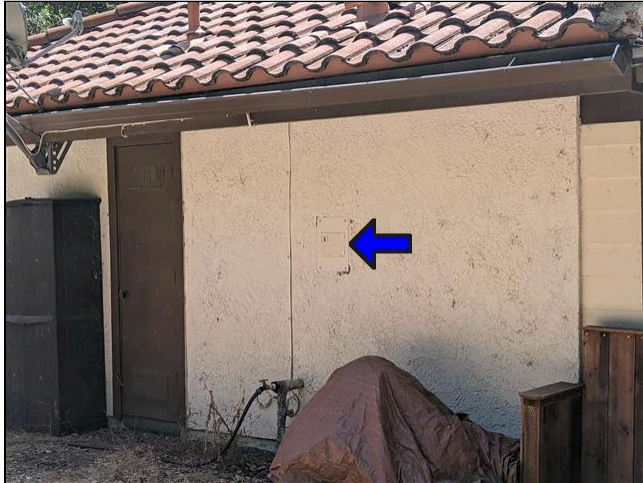
6.1 Item 1(Picture)

The exterior sub panel observed during the inspection does not appear to be rated for outdoor use. Exterior-rated panels are designed to withstand environmental conditions such as moisture and temperature fluctuations. The use of an interior-rated panel in an outdoor location may lead to potential

issues such as moisture ingress and reduced safety. We recommend consulting a licensed electrician to evaluate the panel's suitability, and if necessary, replace it with a properly rated exterior panel to ensure compliance with safety standards and proper protection.

The exterior sub panel observed during the inspection does not appear to be rated for outdoor use. Exterior-rated panels are designed to withstand environmental conditions such as moisture and temperature fluctuations. The use of an interior-rated panel in an outdoor location may lead to potential issues such as moisture ingress and reduced safety. We recommend consulting a licensed electrician to evaluate the panel's suitability, and if necessary, replace it with a properly rated exterior panel to ensure compliance with safety standards and proper protection.

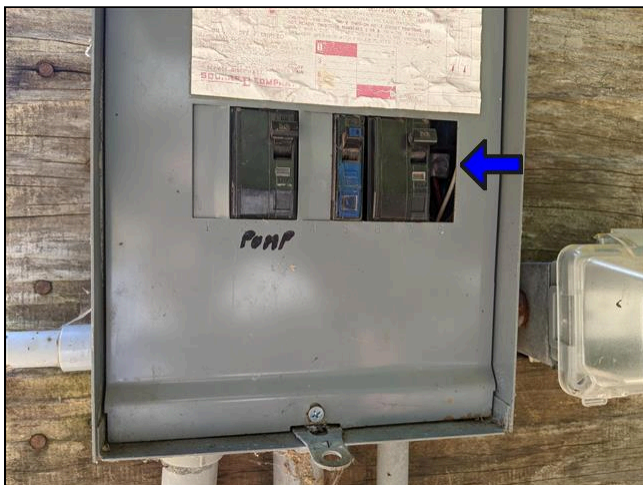
6.1 Item 2(Picture)

Unused breaker slot remains exposed at the well sub panel and needs the appropriate breaker slot cover installed.

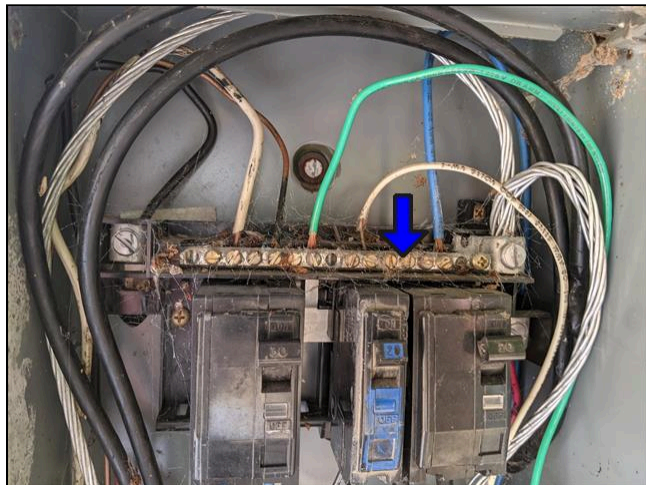
6.1 Item 3(Picture)

Neutral and grounding conductors improperly bonded in the well sub-panel. While this can be typical for well equipment installations, it is technically incorrect and should be repaired or improved by a qualified licensed electrician.

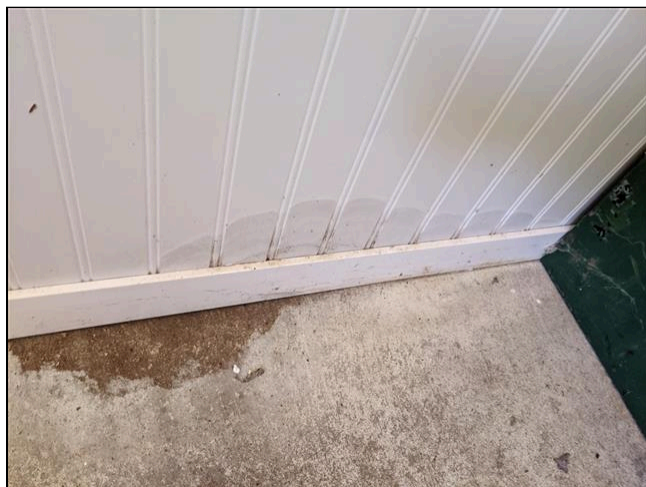
8.0 Item 1(Picture)

Moisture stains noted on the walls at the rear patio. Recommend the siding and flashings be further evaluated in these areas to determine the cause and remedy of this moisture intrusion.

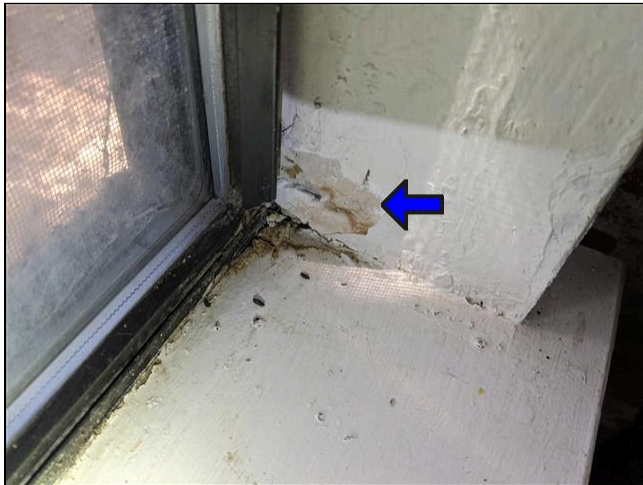
8.3 Item 1(Picture)

Moisture intrusion noted at the window sills and walls due to probable moisture intrusion from the metal frame windows. This can be common with metal framed windows and can be improved by caulking the interior corner seams in the frames, or replaced, as needed.

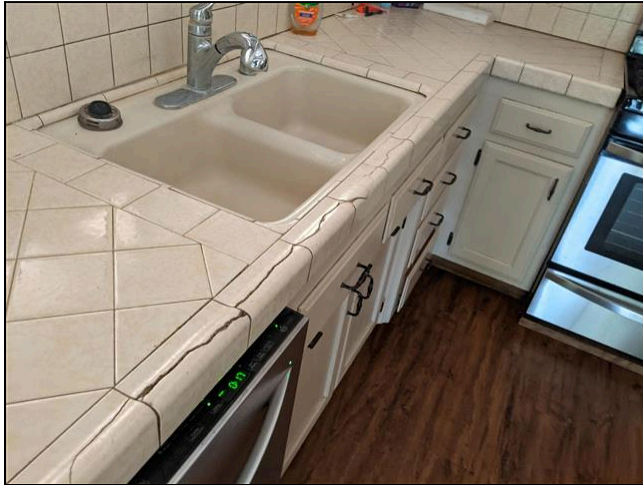
9.3 Item 1(Picture)

A few cracked tiles noted on the kitchen counter. Tiles remain attached to the mortar and appear stable. Recommend repairs made as needed.

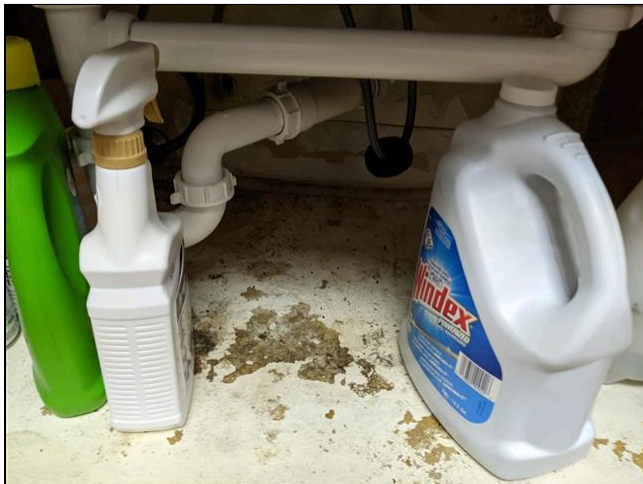
9.3 Item 2(Picture)

Moisture damage and mildew or microbial growth build up was noted on the wall and/or cabinet material under the sink. It is likely the damage extends into enclosed areas. Recommend removal of the damaged sections of wall and cabinet material and complete evaluation of the adjacent walls and cabinets. All affected areas should be properly sterilized or replaced.
