### *Inspection Report*

Address: 267 Montana Way Los Osos, CA 93402

10/05/2026

Inspector: Taylor Vreeken, CCI

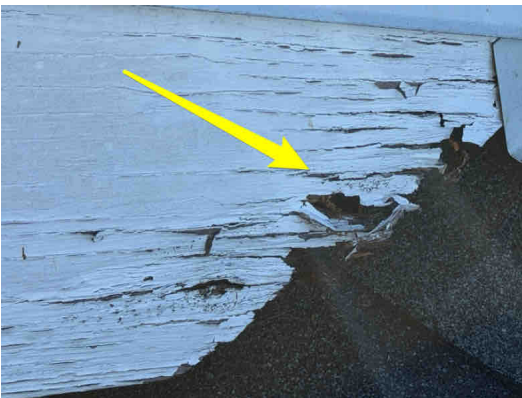
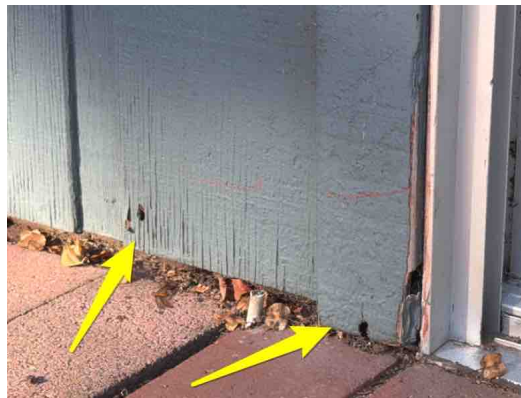
**E&C** 27: Some moisture and/or bug-type damage and deterioration found at areas of the exterior wood siding and/or trim. Refer to the termite report for additional comments, recommendations, locations and extent.

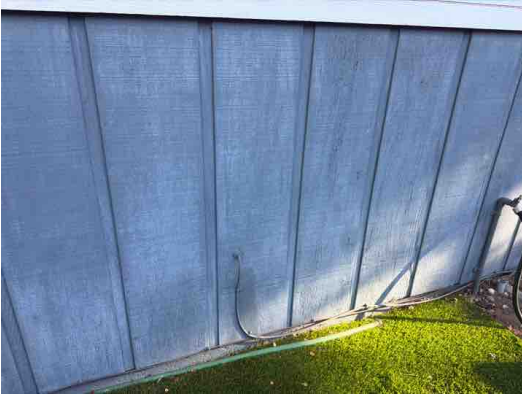
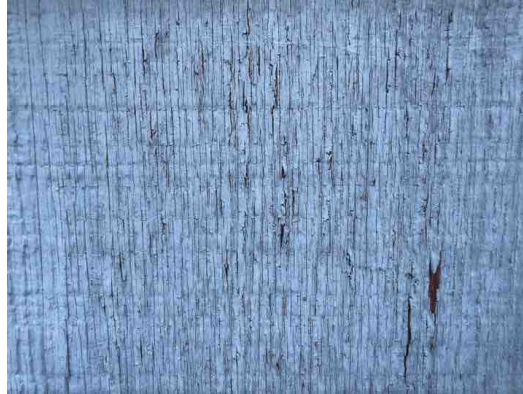
**MR 28:** Deteriorated paint at areas of the exterior.

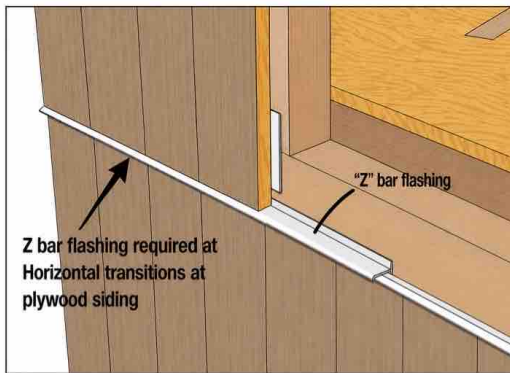
**FI 29: Disclosure:** No visible water shed / "Z" bar flashing at areas of some past exterior plywood wood siding repairs. Areas will need to be sealed and maintained regularly or removed and replaced with appropriate Z-bar flashing to help ensure water tightness.

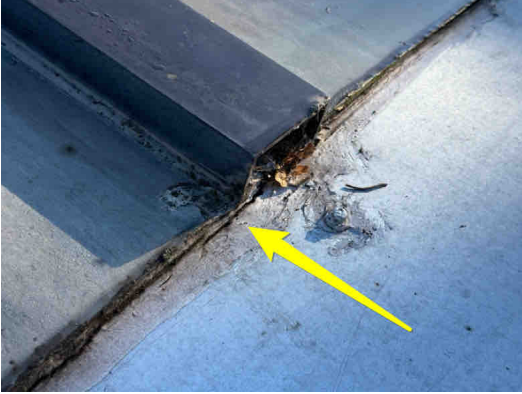
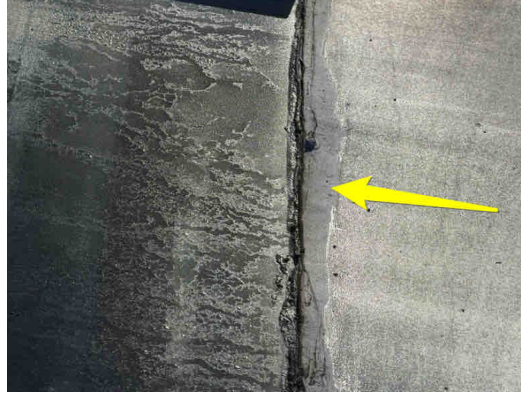
**MR 35:** Recommend sealing/ resealing around roof panels, skylights, and seams on and around the sunroom as part of typical maintenance.

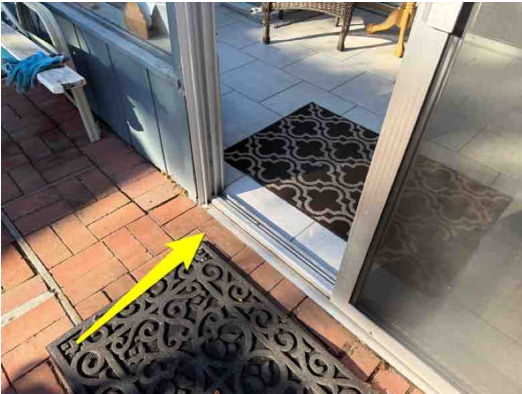
**FI DS 36:** The Backyard enclosed patio was installed on a grade level slab with no footings or waterproofing where the wood framing meets the concrete. This style of construction is not intended to be waterproof and may allow for seasonal moisture intrusion.

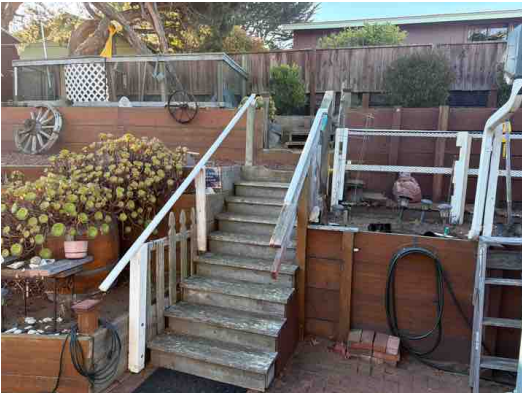
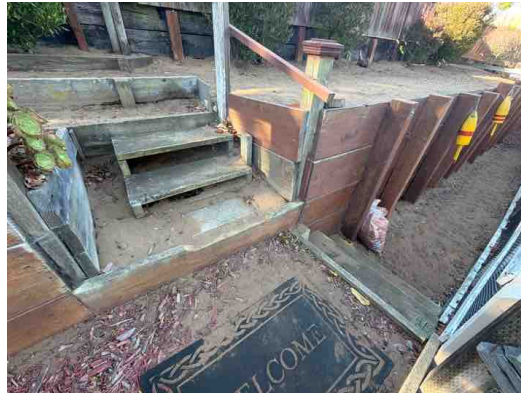
**E&C SC 37:** Disclosure- Exterior landscaping steps/stairs do not meet minimum construction standards and may be a potential trip hazard.

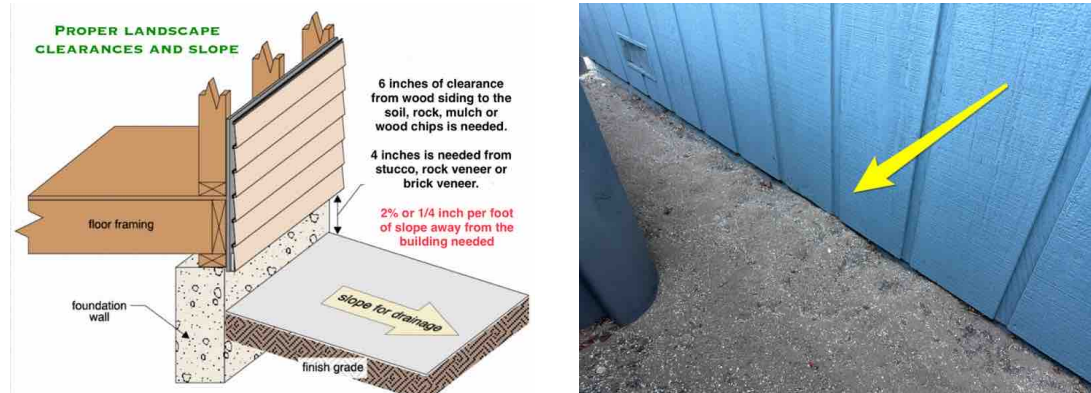
**MR 41:** Soil level found high along areas of the perimeter of the foundation and exterior siding (recommend 6 inches from the bottom of the exterior siding to dirt, rock, mulch or wood chips).

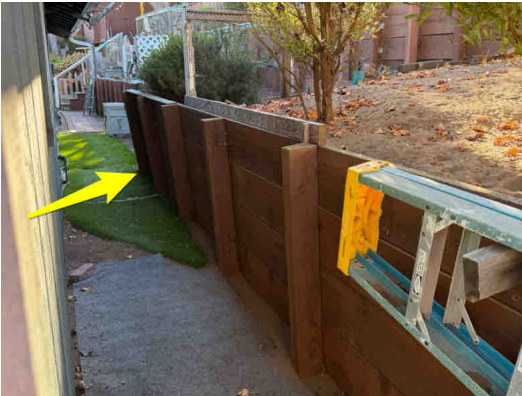
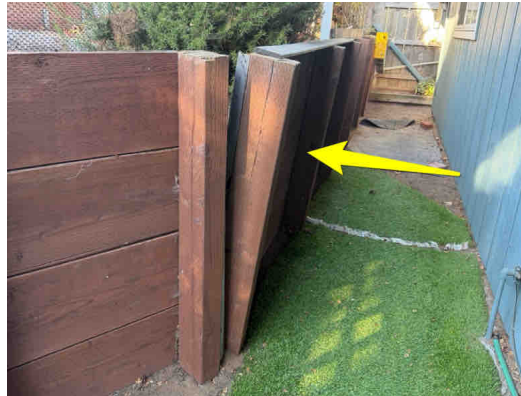
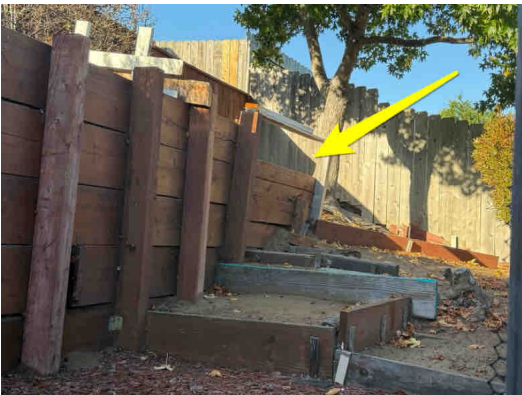
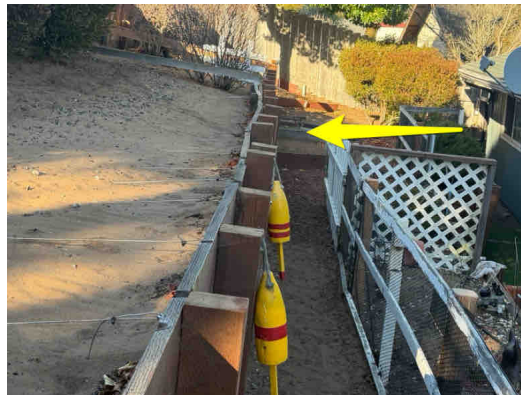
**E&C 42:** Portions of the wood retaining wall have a moderate lean/ out of plumb. The degree of leaning indicates movement and may affect the wall's ability to adequately retain the adjacent soil. Recommend evaluation and repair or reinforcement as necessary by a qualified contractor.

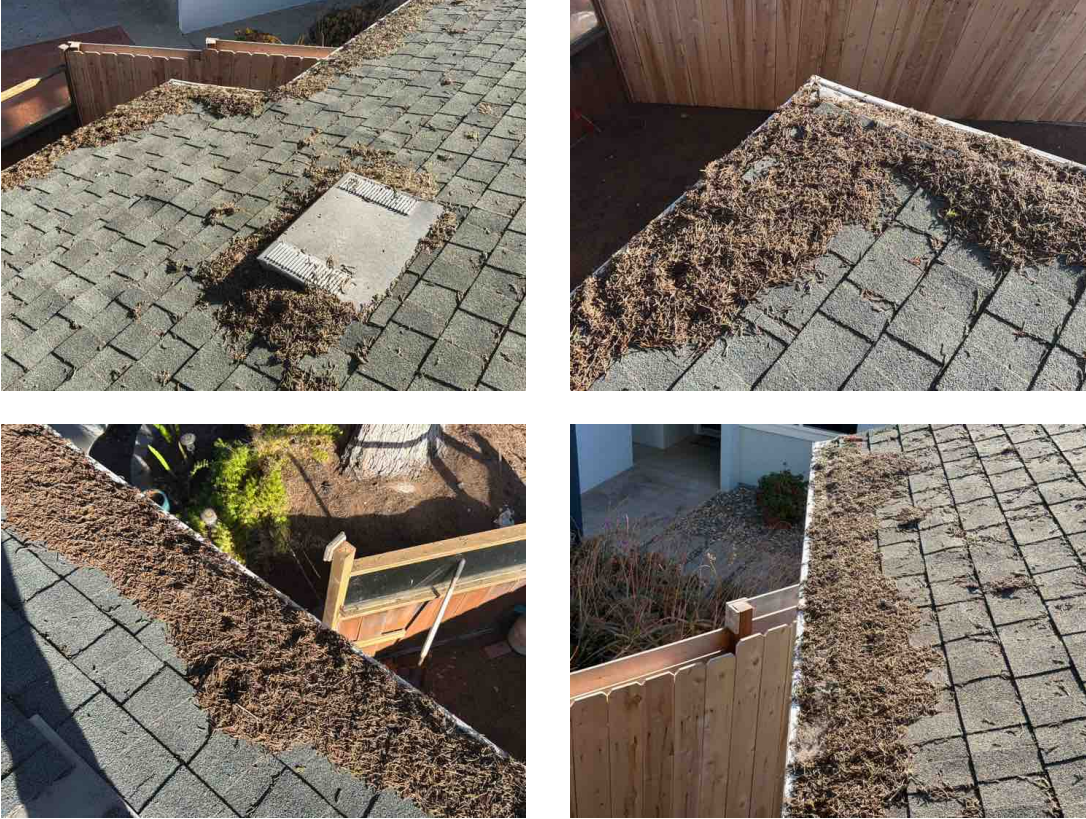
**MR 50:** Debris covers portions of the roof and/or roof flashings. This may cause deterioration and/or a roof leak. Areas of the roof are not fully visible. Clean and inspect regularly.

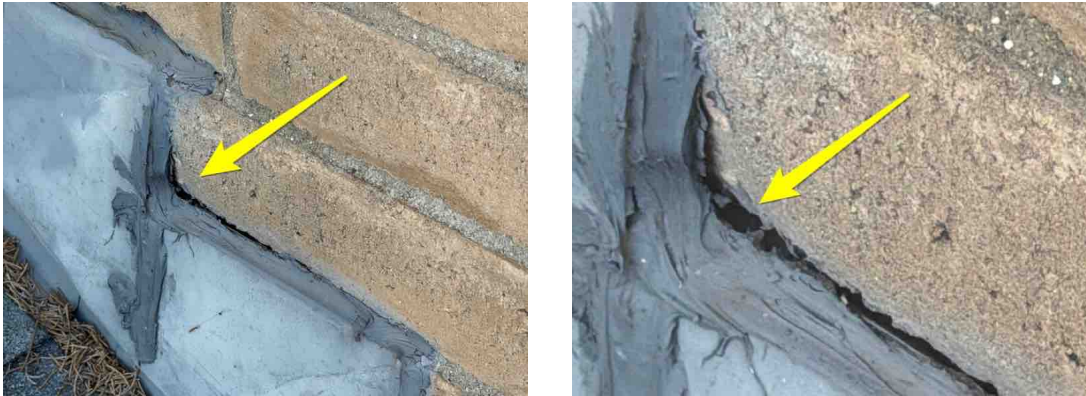
**52:** A void/separation was observed at the chimney flashing. The opening may allow moisture intrusion behind the flashing and into the roof/chimney assembly. Recommend proper repair of the flashing by a qualified roofing professional rather than reliance on surface-applied sealant.

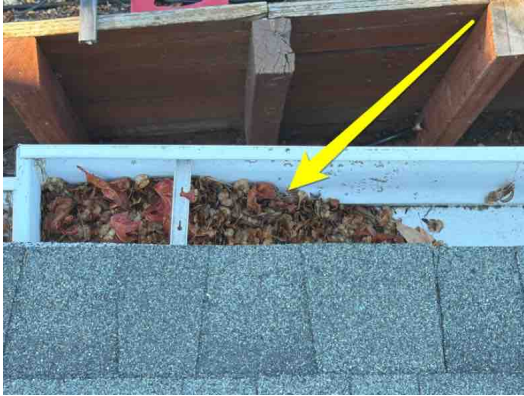
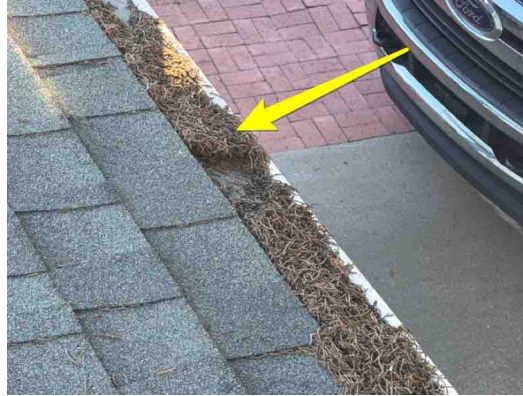
**MR 56:** Recommend some typical rain gutter maintenance. This should at minimum consist of cleaning, sealing, and re-fascinating and repairing of loose or damaged gutters and downspouts.

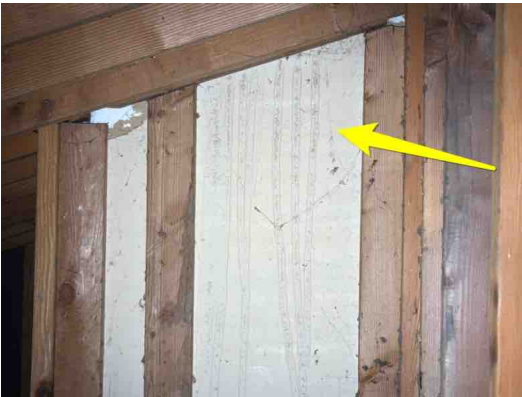
**FI DS** 64: Some minor and typical moisture stains noted in areas throughout the attic. All water stains should be investigated by a licensed roofer. Refer to termite report for additional comments and/or recommendations.

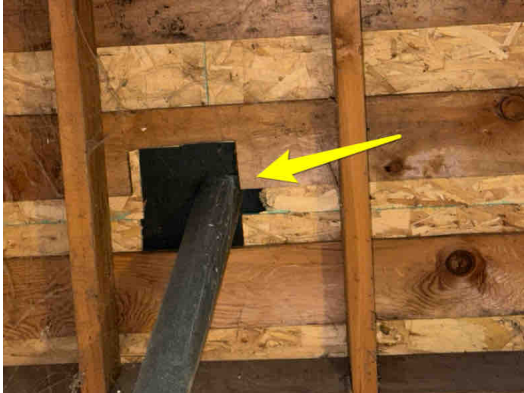
**E&C 82:** The water heater vent pipe is improperly installed. Improper use of single-wall vent pipe through the roof plywood. Water heater vent pipe is too close to combustibles (6 inches of clearance is required for single-wall vent connector pipe). Recommend the proper installation of a double-wall vent pipe where it passes through the roof.

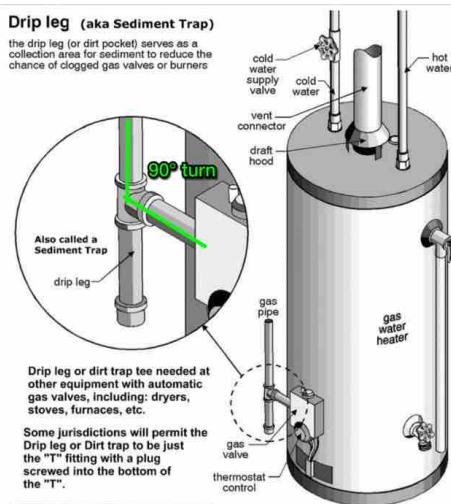
**SU 87:** Recommend the installation of the missing sediment trap / drip leg at the WATER HEATER gas piping at flex connection by a certified or licensed plumbing professional familiar with minimum requirements. [CPC 1212.8]

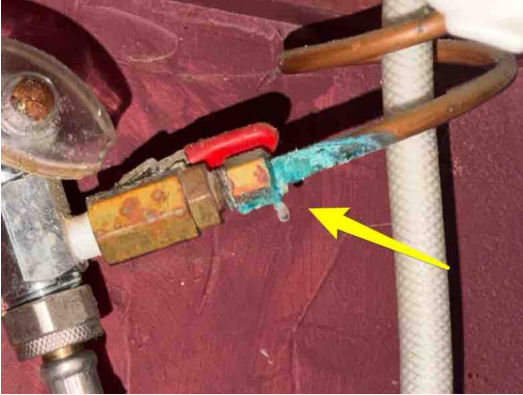
**FI 98:** Some corrosion found at the water supply shutoff valves under the Kitchen sink / evidence of past leaking. Client should investigate further until satisfied as to the cause, condition and potential future issues. Correction Recommended.

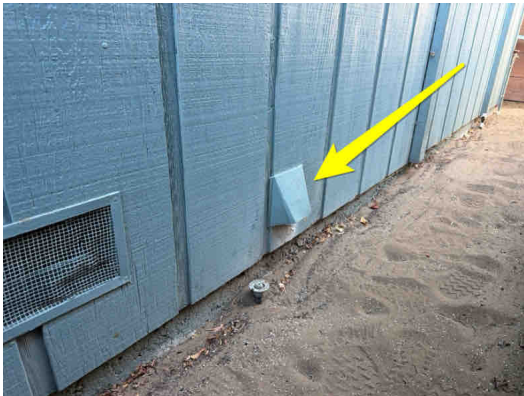
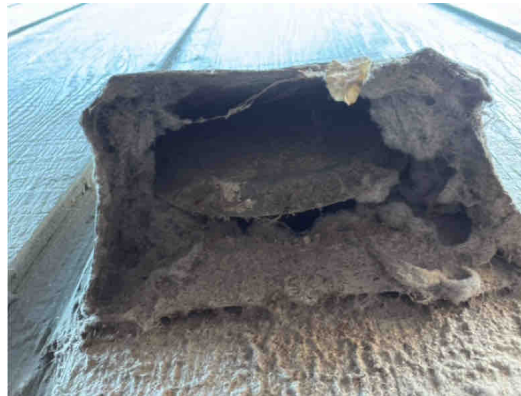
**MR 123:** Recommend cleaning and servicing the laundry dryer vent system, pipe and cap, for safety as part of typical ongoing maintenance.

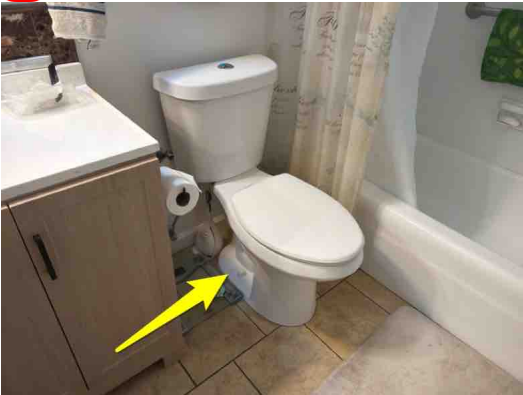
**E&C 128:** Toilet loose at floor: PRIMARY BEDROOM BATHROOM

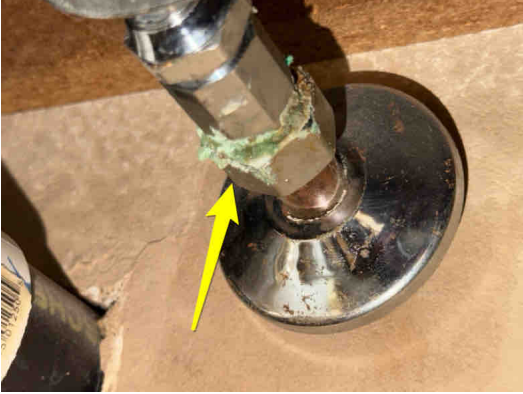
**FI 130:** Some corrosion found at water supply piping and waste piping connections under the bathroom sinks / evidence of past leaking.

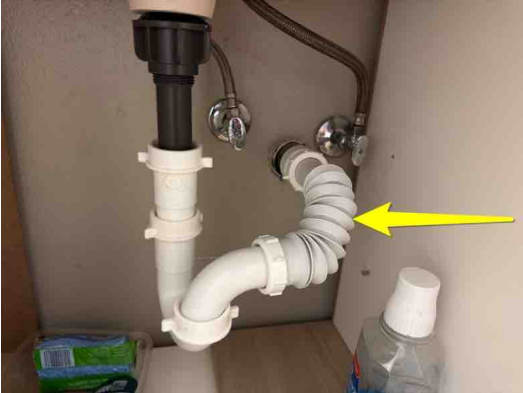
**E&C 133:** Improper drain piping under bathroom sink: PRIMARY BEDROOM BATHROOM. Recommend additional review and repairs by licensed plumbing contractor.

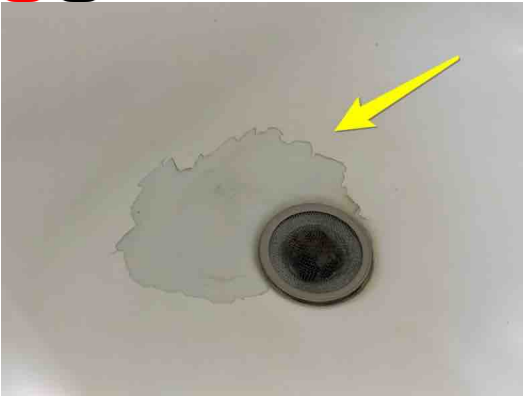
**FI DS 137:** Deteriorated finish or re-finish material at the PRIMARY BEDROOM BATHROOM tub.

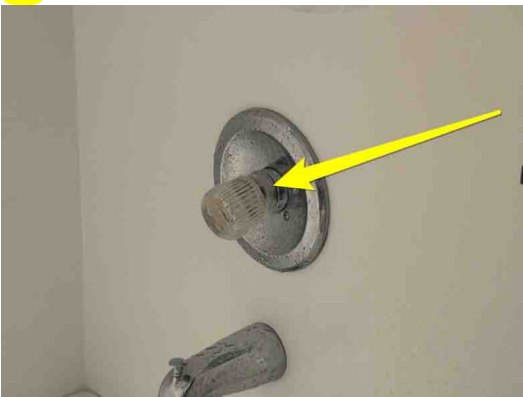
**SU 140:** Hot & cold reversed at the shower faucet: HALLWAY BATHROOM

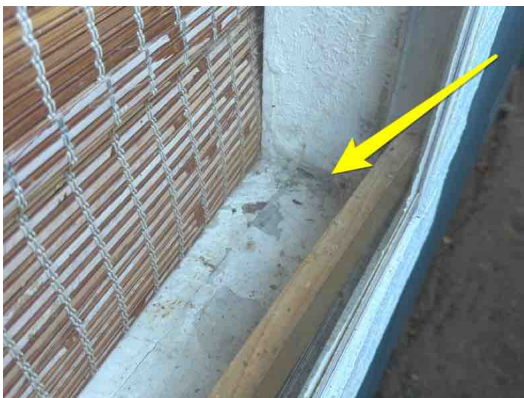
**FI 153:** Moisture stains and/or damage on the inside at some window sills. Refer to the termite report for additional comments and recommendations.

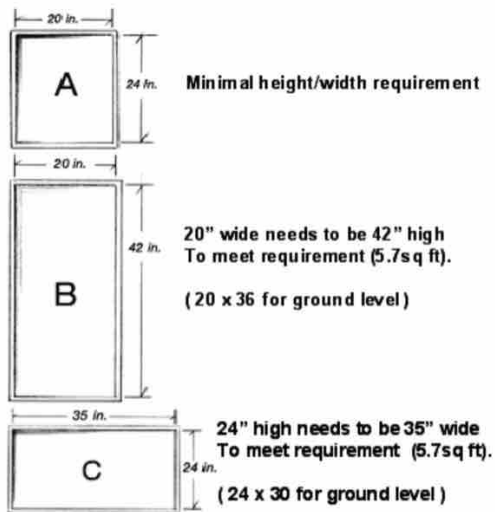
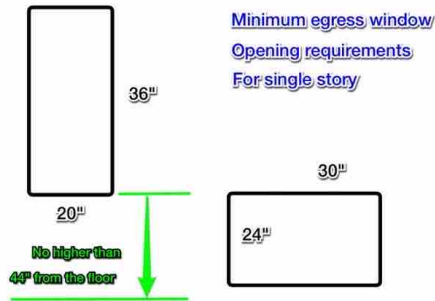
**SC 155:** Windows in the the PRIMARY BEDROOM do not meet the current minimum fire egress standards.

Total window area needs to be 5.7 sq ft  
(5.0 for ground level)

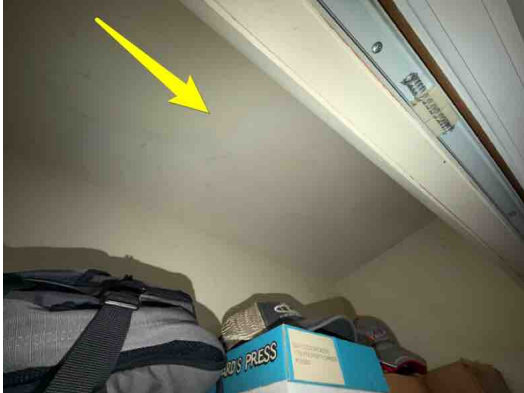
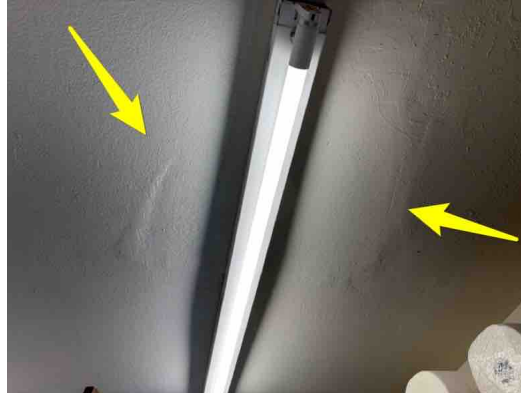
**FI DS 166:** Evidence of past ceiling and wall repairs and/ or alterations found throughout. Client should investigate further to satisfy themselves as to the cause and current conditions.

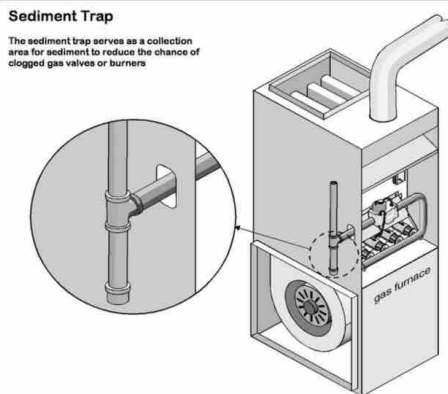
**UPG 170:** Missing the required installation of the sediment trap at the furnace gas piping at flex connection. Correction should be performed by a certified or licensed HVAC professional familiar with minimum requirements.

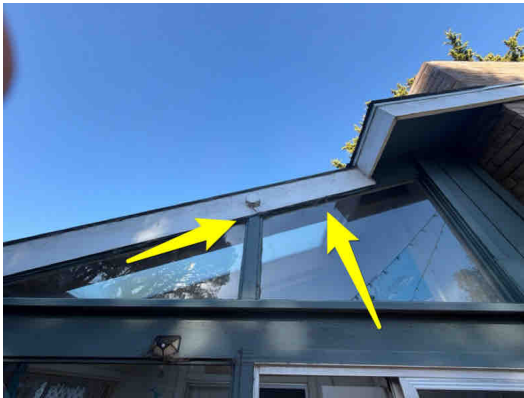
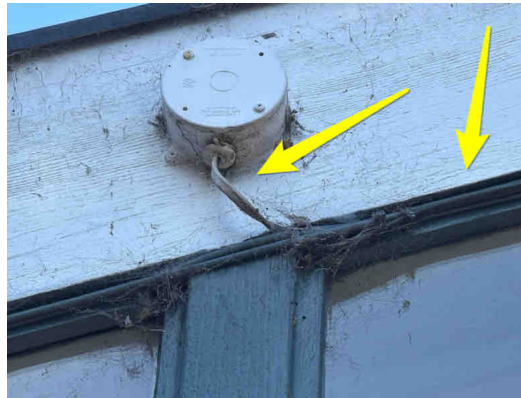
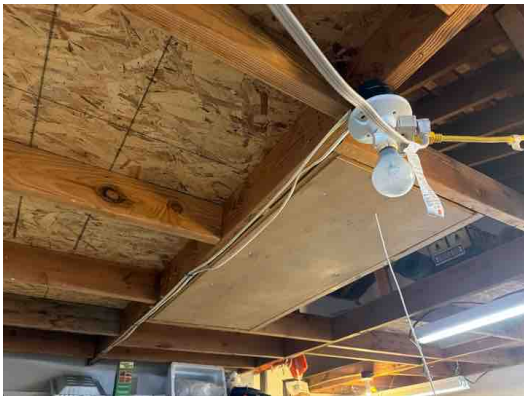
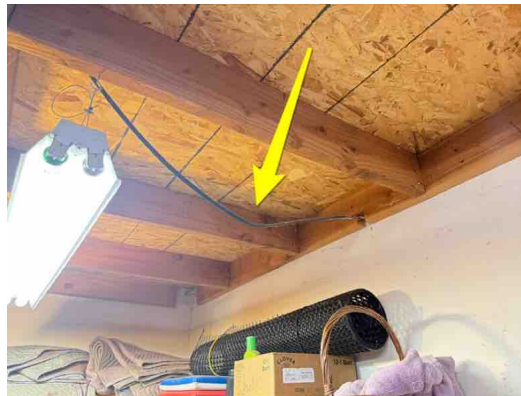
**SC 182:** Improper exposed electrical wiring, "Romex" improperly installed subject to physical damage, not in a conduit or raceway per standards: SOUTHEAST EXTERIOR and GARAGE  
NEC 334.15(B)  
NEC 300.4

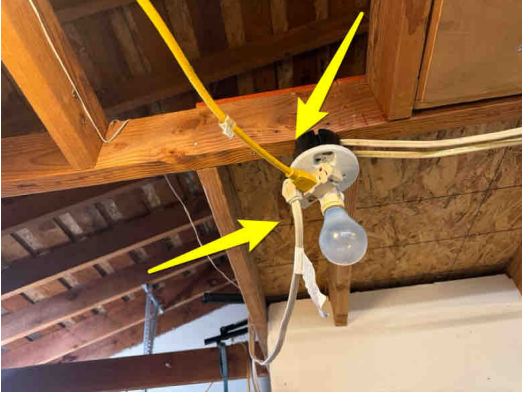
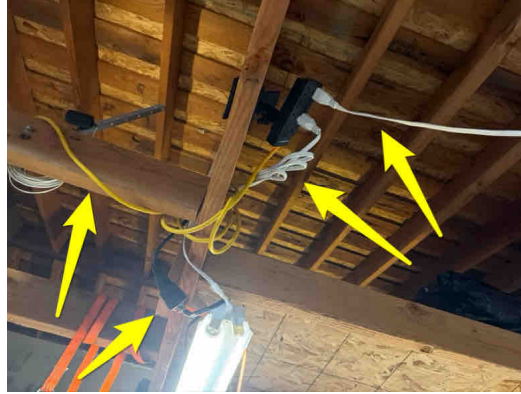
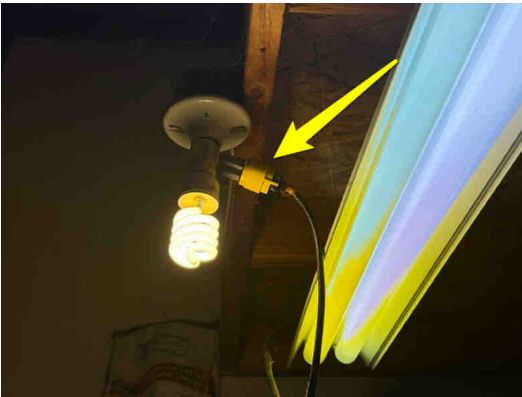
**SU 183:** Extension cord improperly used as permanent electrical wiring: MULTIPLE LOCATIONS IN THE GARAGE

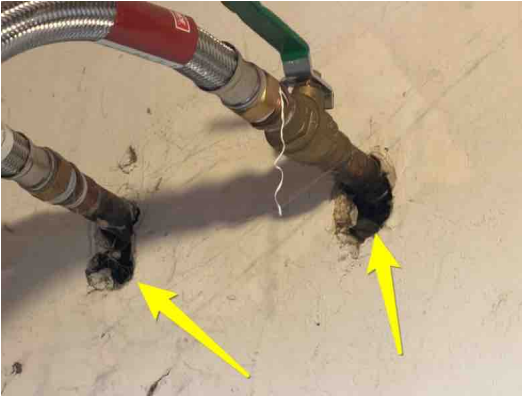
**SC FI 198:** Some holes or openings found in the garage firewall. Corrections are warranted for fire safety. Contact an appropriate contractor to review the entire garage repair as needed.

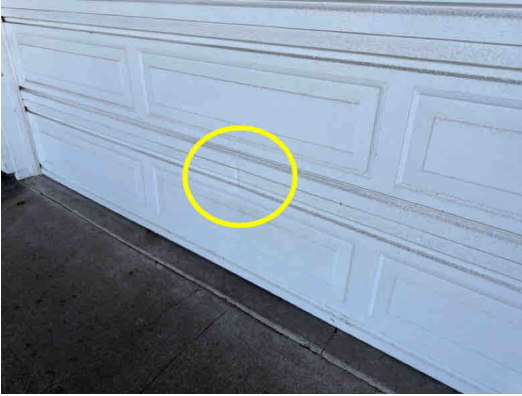
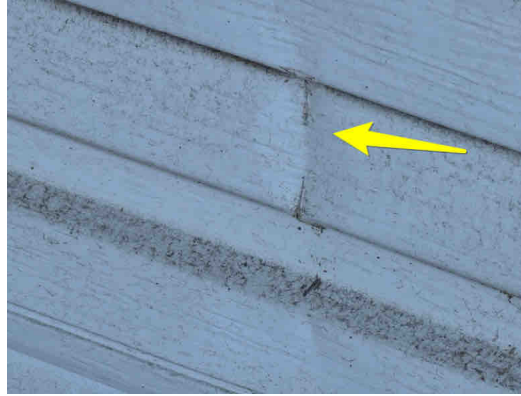
**E&C** 206: Disclosure: Some dented panel(s) at garage vehicle roll-up door.

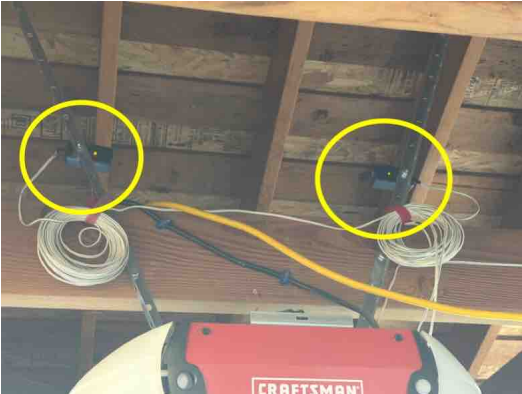
**SC** 209: Improper installation of the garage vehicle door auto opener safety reverse electric eye system. The electronic auto reverse sensors were improperly installed in an inappropriate area. Correction warranted for safety.

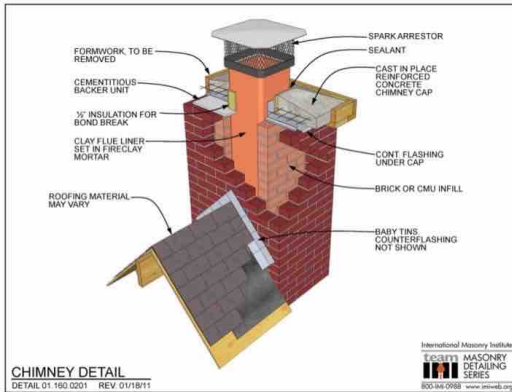
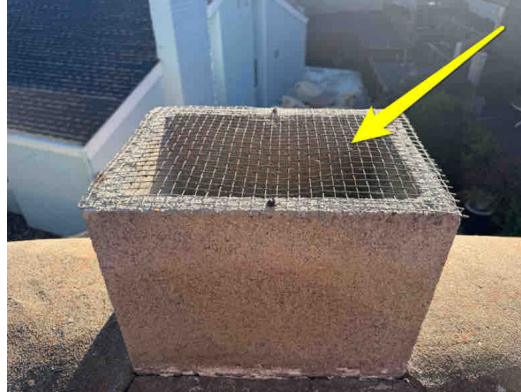
**SC 215:** An improper and unsafe use of a flat screen atop the fireplace chimney. Recommend the installation of a proper screen chimney cap for safety per standards.

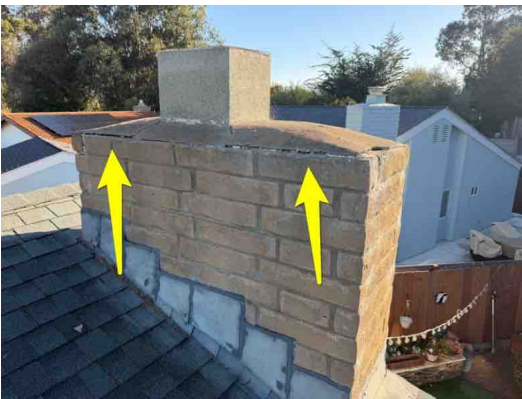
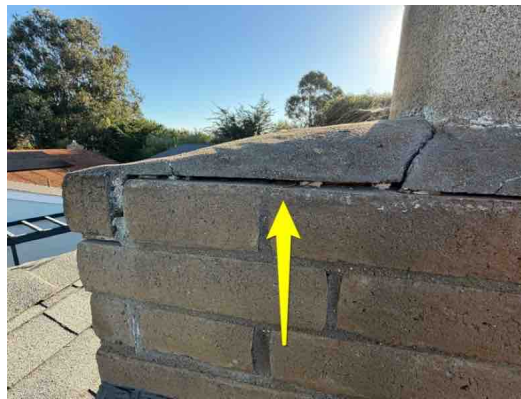
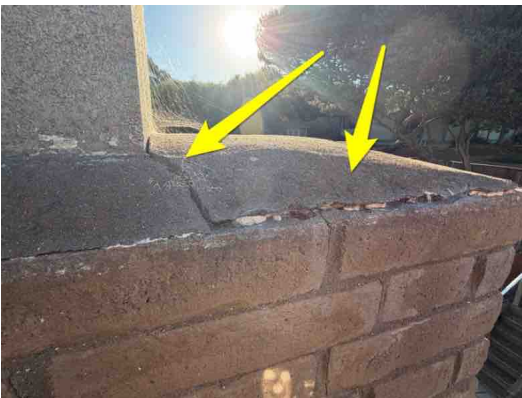
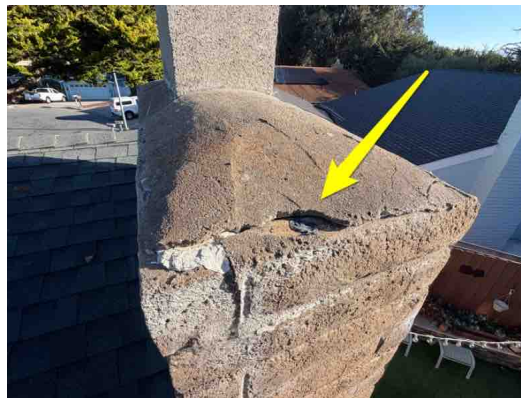
**E&C 216:** The mortar crown at the masonry chimney is significantly deteriorated, with cracking, separation/lifting, missing material, and evidence of multiple past repairs. These conditions can allow moisture intrusion and continued deterioration of the chimney masonry. Recommend evaluation and proper repair or replacement of the chimney crown by a qualified masonry/chimney professional.
