Shawn Foster Inspections

Confidential Inspection Report 3844 E. 15th St. Long Beach CA 90804

February 29, 2024

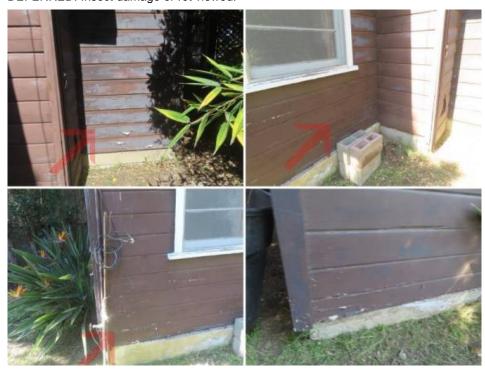
Siding

MAINTENANCE: Some loose or peeling paint viewed. We recommend painting at this time to protect the wood from further deterioration and to enhance its appearance. DEFERRED: Insect damage or rot viewed.

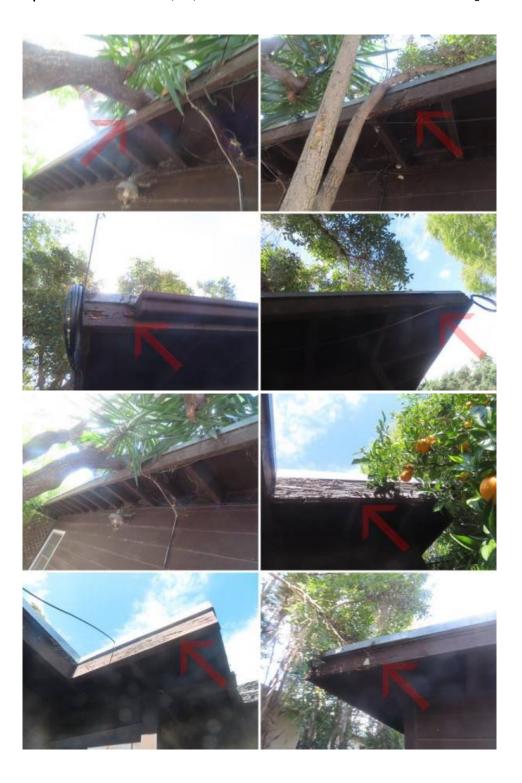
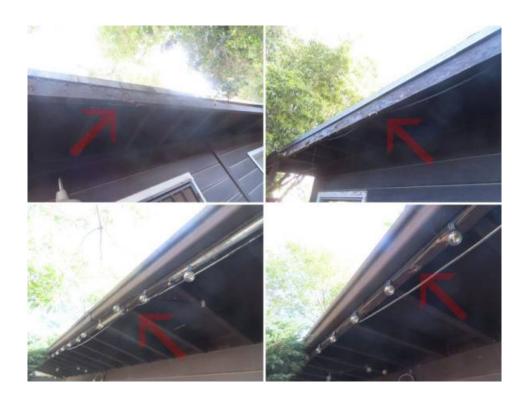
TRIM AND EAVES

DEFERRED: Rot/insect damage viewed one or more locations.

MAINTENANCE: Paint is deteriorated, loose or peeling. We recommend painting at this time to protect the wood from further deterioration and to enhance its appearance.

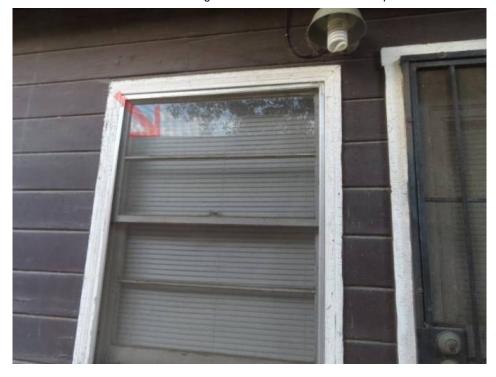
WINDOWS

MAINTENANCE: Screen was damaged at one or more windows sampled.

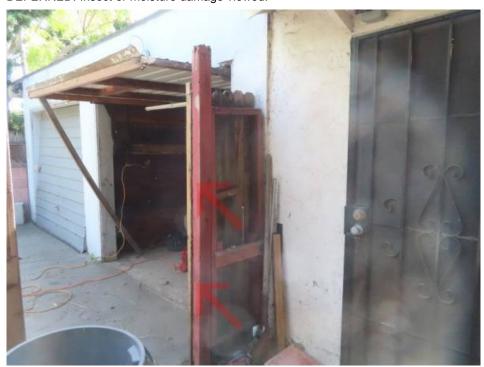
Gates

DEFECTIVE: Gate is in deteriorated condition and needs repair or replacement. DEFERRED: Insect or moisture damage viewed.

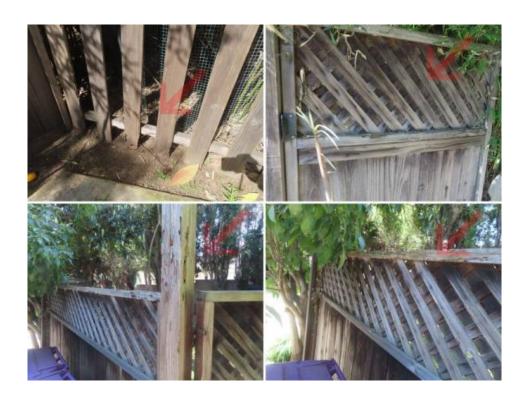
Wooden fences

DEFERRED: Insect or moisture damage viewed.

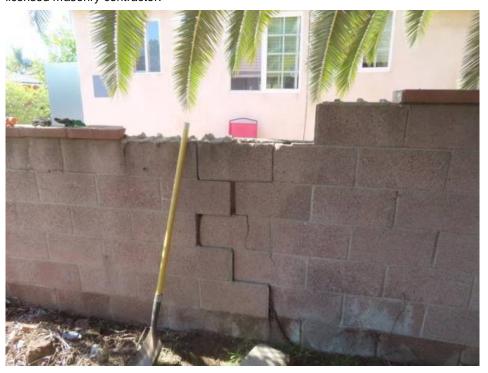
Concrete block fences

DEFERRED: Settlement/soil movement cracks.

DEFECTIVE: Large cracks. We recommend further evaluation and corrections by a licensed masonry contractor.

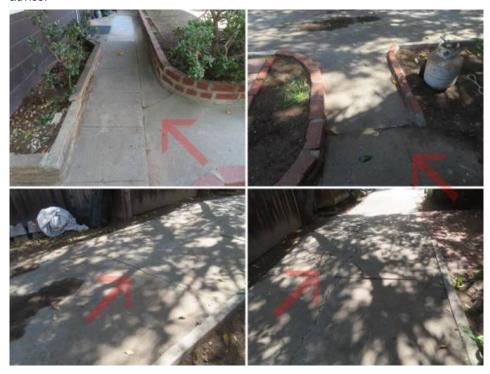
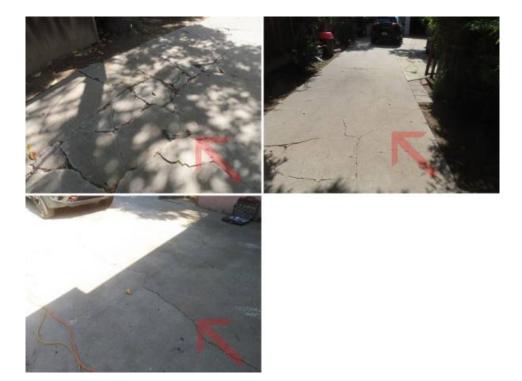
MONITOR: Moderate size and amount of cracks viewed in the paving appear to be typical of settlement or shrinkage in areas of expansive soil. We suggest monitoring cracks from time to time. Change in the size or number of cracks may be symptomatic of other conditions such as defective drainage, settlement or soil movement and should be further evaluated by a licensed masonry contractor.

MAINTENANCE: Vertical displacement viewed appears to be caused by tree roots. We recommend consulting with a licensed landscaping contractor or arborist for remedial advice.

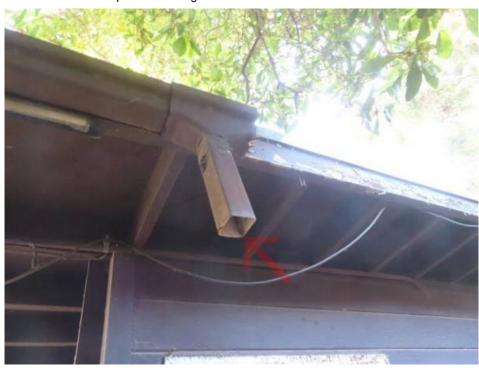
Downspouts

DEFECTIVE: Downspout is missing at one or more locations.

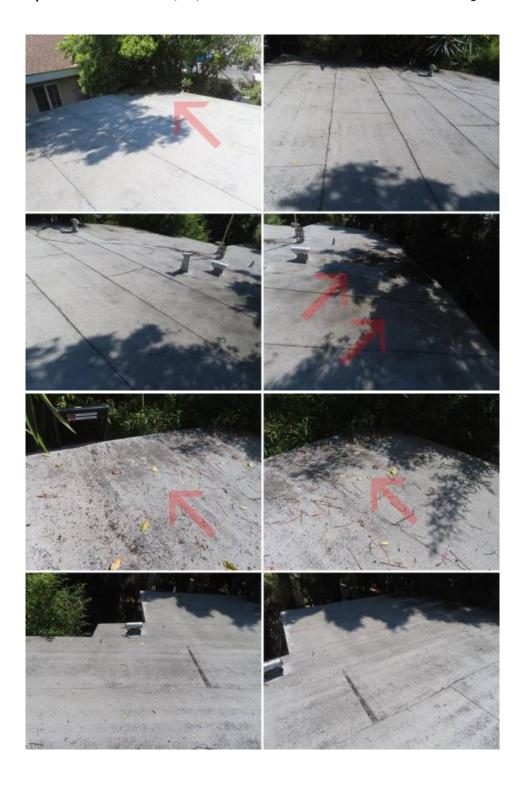
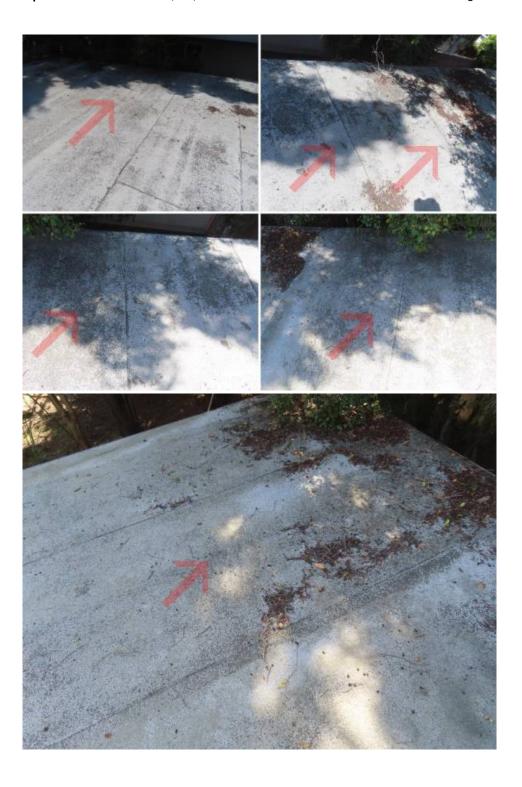
MONITOR: Older roof, at or near the end of its design life. We suggest budgeting for a new roof in the near future.

MAINTENANCE: Vegetation near or touching the roof surface. We recommend maintaining vegetation growth from reaching the roof as needed to prevent damage to the roofing materials.

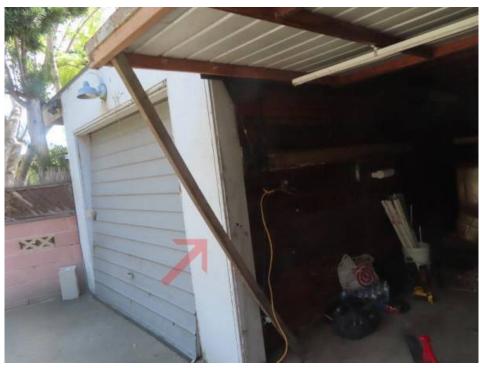
Tilt-up

DEFERRED: Support needed to keep right door open. Recommend repairs for safety reasons.

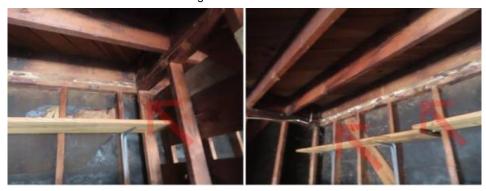
Framing

DEFERRED: Insect/moisture damage.

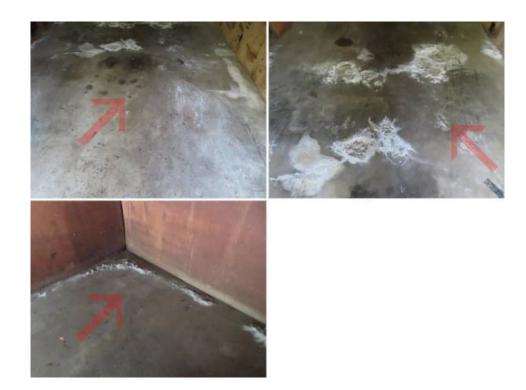
Floor

MONITOR: Small cracks observed. These appear to be typical settlement/shrinkage cracks and generally do not have structural significance. We suggest monitoring them from time to time. If any changes are observed we recommend further evaluation by a licensed concrete contractor.

DEFERRED: Pitted, corroded or damage to floor. Efflorescence noted.

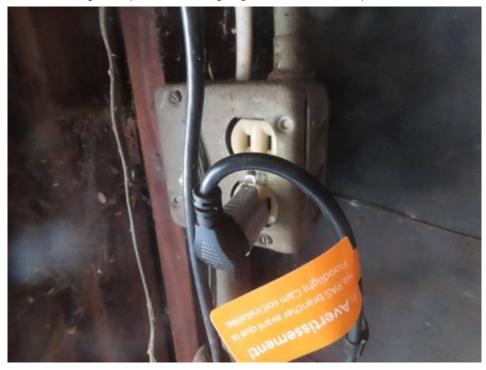
Ground Fault Circuit Interrupters (GFCI)

SAFETY: One or more receptacles are not GFCI protected. We recommend installing and maintaining GFCI protection at all garage and work area receptacles.

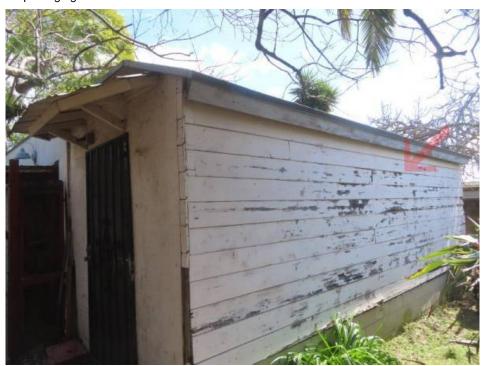
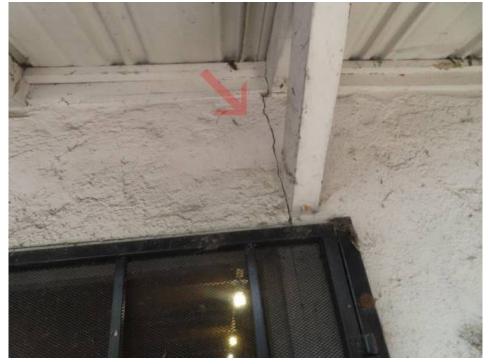
Stucco

MAINTENANCE: Small cracks viewed. These cracks appear to be typical of settlement/shrinkage or seismic racking and are usually patched when painting.

MAINTENANCE: Some loose or peeling paint viewed. We recommend painting at this time to protect the wood from further deterioration and to enhance its appearance. Tarp hanging over the back.

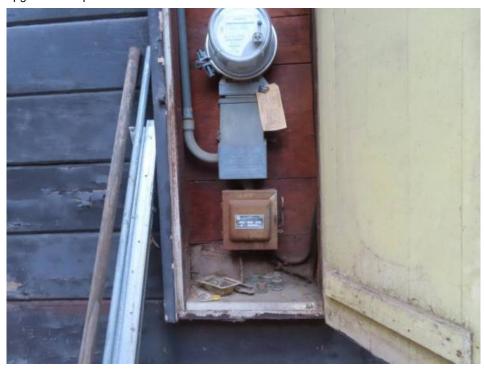
Panel observations, exterior

DEFERRED: Electrical panel is outdated by today's standards and will likely need to be upgraded if expanded.

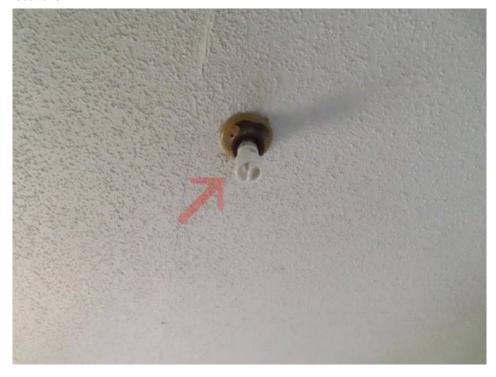
Lights and switches

DEFECTIVE: Light fixture is broken, missing the globe, or is not installed at one or more locations.

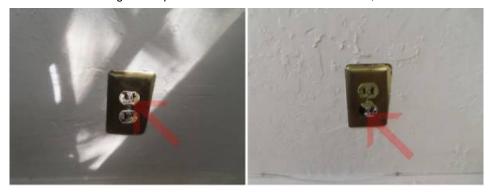
Electrical outlets

SAFETY: Some two-pronged receptacles viewed. This type of system is common with similar structures of this age. Some plug-in devices, such as lamps and televisions, etc., may not require a grounded receptacle. However, we recommend upgrading to properly grounded three-pronged receptacles where needed,

DEFECTIVE: Receptacle sampled was painted at one or more locations. Painting receptacles can block the openings or otherwise compromise the connection at the receptacle. We recommend having all painted receptacles replaced by a licensed electrician. especially at receptacles for appliances, tools and electronic equipment including refrigerators, laundry machines, computers, and for all other appliances and equipment that are supplied with a three-prong grounded plug.

DEFECTIVE: 3-prong grounded type receptacle sampled at one or more locations was not properly grounded.

DEFECTIVE: Damaged receptacle viewed at one or more locations, risk of shock.

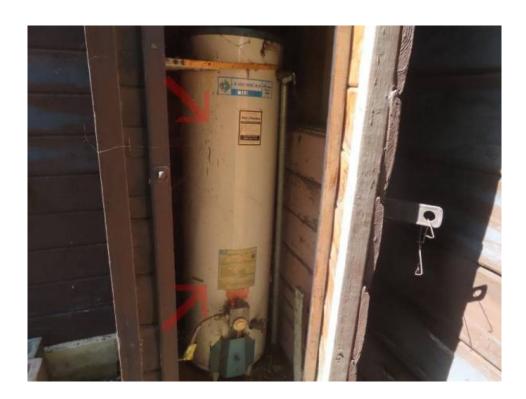
DEFECTIVE: Not braced, anchored or strapped to resist toppling or horizontal displacement due to earthquake motion. Minimum requirements for water heaters to 50 gallons capacity are two approved straps properly located and anchored with minimum 1/4" X 3" lag bolts into the studs (or the structural equivalent where stud attachment is not an option).

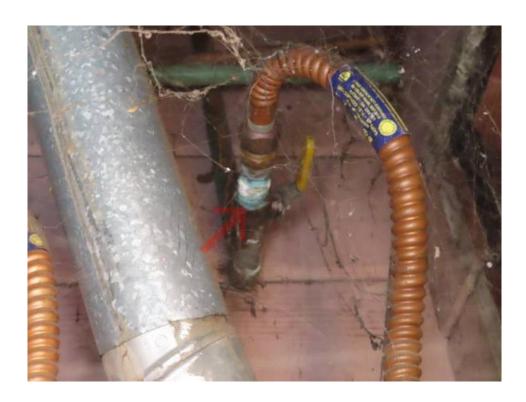
SAFETY: Transite vent pipe(s) observed. Transite is known to contain asbestos and will need special handling if removed or repaired.

MAINTENANCE: Shutoff valve or connectors are corroded. We recommend replacing corroded components when observed as preventative maintenance.

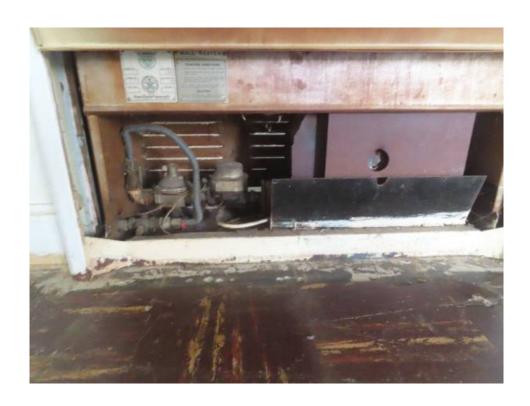
Burner

DEFERRED: Pilot or gas was off and the burner was not operated.

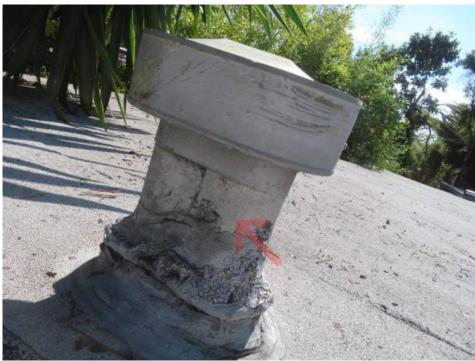
SAFETY: Transite vent pipe(s) observed. Transite is known to contain asbestos and will need special handling if removed or repaired.

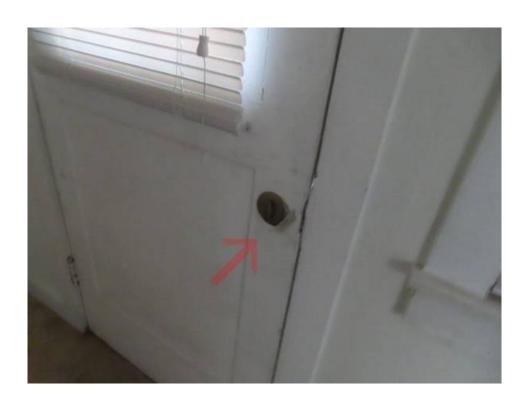
Exterior doors

DEFERRED: No handle present, only deadbolt. Recommend adding a handle.

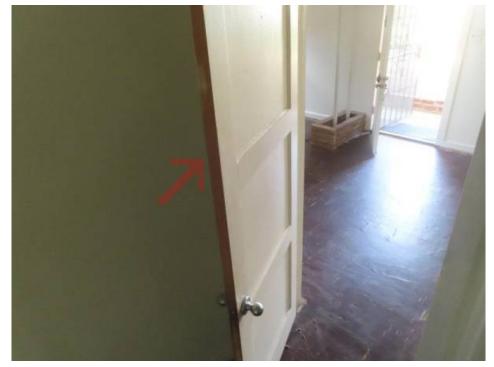
Interior doors

MAINTENANCE: Door rubs.

SERVICEABLE.
MAINTENANCE: Recommend paint.

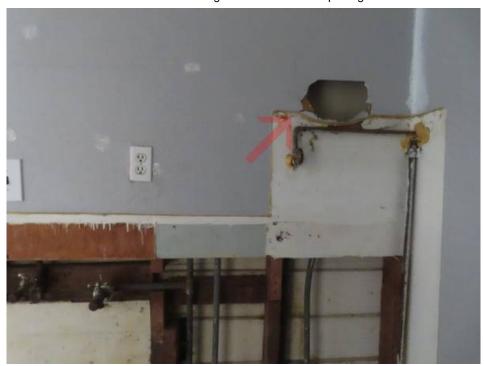
Plaster

MAINTENANCE: Some holes or damaged viewed needs repairing.

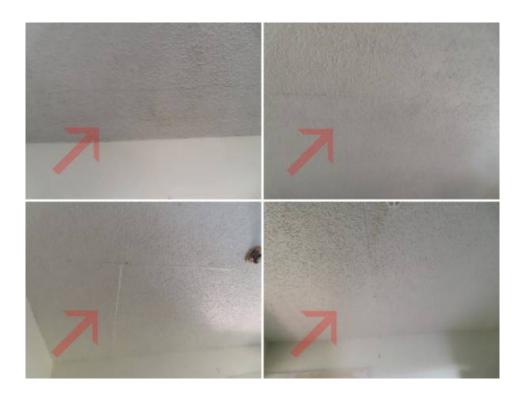
Interior walls/ceiling

SAFETY: Acoustic ceilings viewed may contain asbestos. Positive identification of asbestos can only be made by a certified laboratory. The acoustic ceilings appear to be in good condition. Removal or encapsulation is not generally recommended unless the material is damaged and/or in friable condition. Asbestos was widely used in building materials prior to 1983. This material if present can pose health risks and will require special handling if disturbed. Your real estate agent may be able to provide you with the pamphlet "Asbestos In The Home" (CPSC Document #453) or you may obtain one yourself from the Consumer Products Safety Commission by calling them at (800) 638-CPSC, or it can be found at their web site: www.cpsc.gov. We also have that document available as a .pdf file, which we will e-mailed to you upon request.

MONITOR: Some cracks in the walls and ceilings viewed at various locations likely indicate moderate settlement/movement or seismic racking. We suggest monitoring and if any changes are observed we recommend further evaluation by a structural engineer.

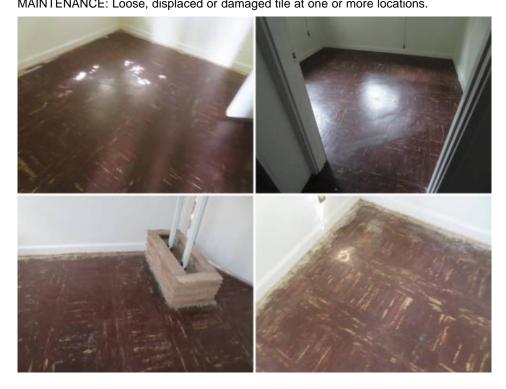
FLOORING Vinyl Flooring

DEFERRED: Older tiles may possibly contain asbestos. Recommend further inspection by a licensed asbestos company.

MAINTENANCE: Loose, displaced or damaged tile at one or more locations.

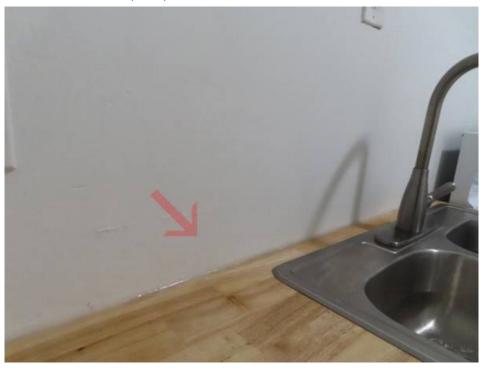
Counter tops

Formica or plastic laminate. DEFERRED: No back splash present.

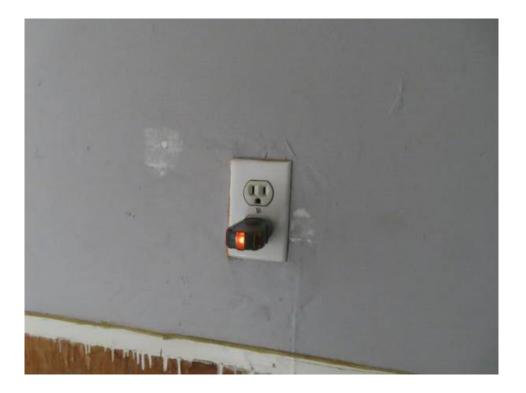
Observations

DEFECTIVE: Active drip leak in line. Recommend repairs at this time. SAFETY: 120 volt electrical outlet is an non grounded type receptacle. We recommend installing a grounded receptacle at this location or properly grounding the washer and dryer to the cold water pipes as per the appliance manufacturer's instructions to protect against electric shock or electrocution.

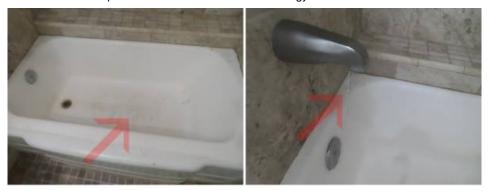
Bathtub Glaze is worn.

SERVICEABLE. Finish is chipped, peeling or possibly stained.

MAINTENANCE: Shower diverter valve does not fully divert water to the shower head.

We recommend repairs as needed for water and energy conservation.
