Inspection Report

Jay & Amber Ford
210 Foxtail Lane
Templeton, CA 93465

Report Date: 2/23/2023

Customer File # 19123
:
: Jay & Amber Ford

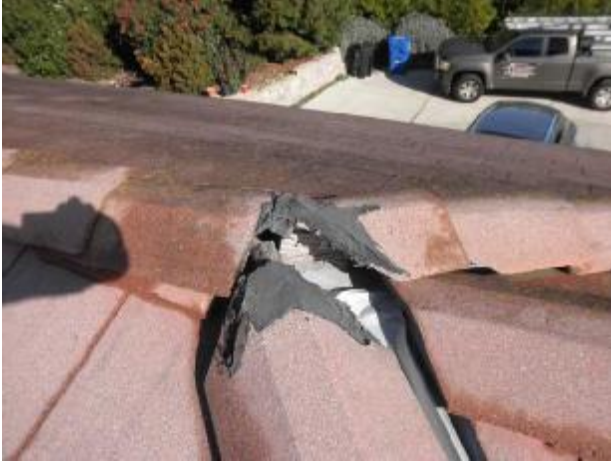
1.) The sealant needs to be reapplied at the top of the hip above the garage.

Deteriorated sealant at the top of the hip above the garage.

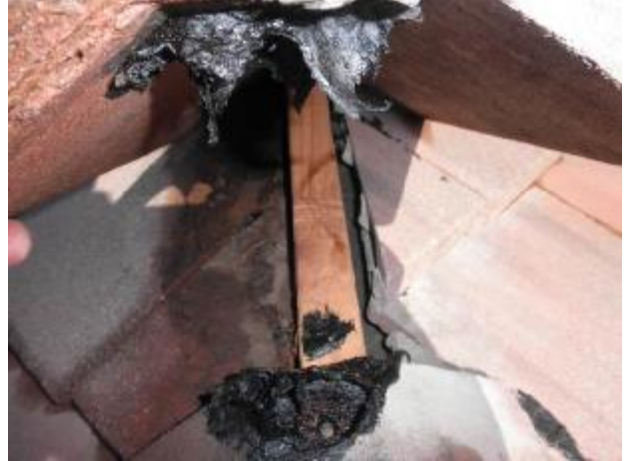
Information Note: There is no water proofing fabric installed below the hip tiles. Although some roofing contractors argue that this is not technically required, many roofers consider this installation to be standard practice. (Note: Technically this was not required until 2003)

No water proof fabric below the hip and ridge roof tiles.
