# Inspection Report

**Property Address:**  
1642 Havemeyer Ln  
Redondo Beach CA 90278

## Professional Inspection Network

<b>Property Address</b> 1642 Havemeyer Ln Redondo Beach CA 90278	<b>Date of Inspection</b> 11/4/2022	<b>Report ID</b> 20221104-1642-Havemeyer-Ln
<b>Customer(s)</b> Sylvia Pulido Richard Colin	<b>Time of Inspection</b> 09:00 AM	<b>Real Estate Agent</b> Joe Safranek Beach City Brokers
<b>Inspection Details</b>		
<b>In Attendance:</b> Seller and Seller's Agent	<b>Type of building:</b> Single Family (2 story)	<b>Approximate age of building(s):</b> 55 Years Old
<b>Building(s) Faces:</b> North	<b>Temperature:</b> Over 60 (F) = 15.5 (C)	<b>Weather:</b> Clear
<b>Ground/Soil surface condition:</b> Dry	<b>Rain in last 3 days:</b> No	<b>Radon Test:</b> No
<b>Water Test:</b> No

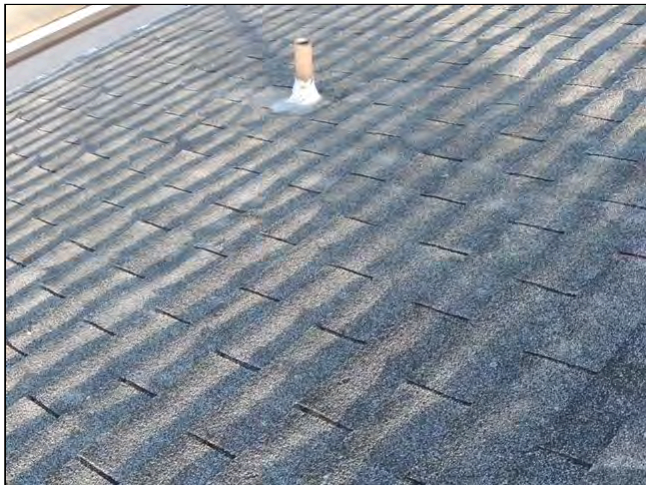
Item 1 - Item 7(Picture) Roofing

1. (1) **Major Concern:** The composition shingle roofing is wearing at uneven rates. The sides of the roofing that are more exposed to the sun's light are wearing more quickly than other areas. Also, there are missing/torn shingles in many locations. The composition asphalt shingle roof is at the end of its service life. It is in need of replacement. Suggest further review by a qualified roofing contractor to provide replacement options and cost.

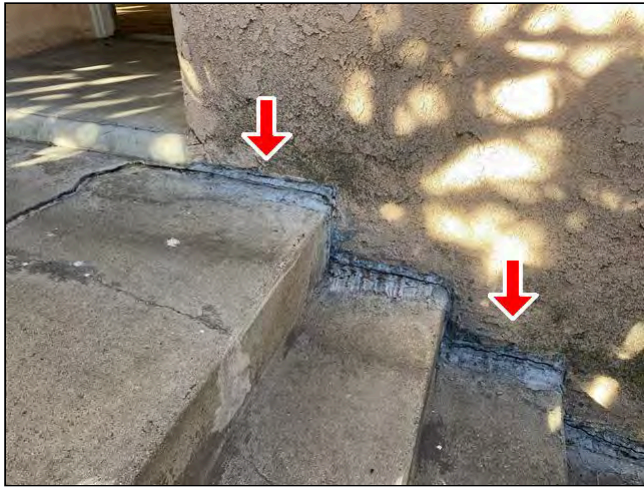
Item 6 - Item 1(Picture) Exterior

6. (2) **Repair or Replace:** The steps at the East exterior wall of the home have been installed directly to the exterior wall. No visible flashing was observed between the exterior wall and steps. Possible seepage can occur. This area shows signs of settlement and previous repair. This would suggest that water and/or moisture has entered the home and structure. Recommend further evaluation and repairs by a qualified contractor.

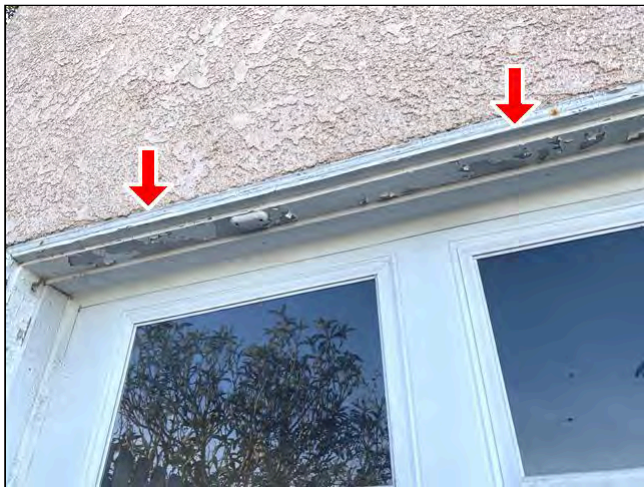
Item 7 - Item 1(Picture) Exterior

7. (3) **Repair or Replace:** The exterior wooden elements throughout the exterior of the home have not been maintained for some time. The wooden trims, doors, fascia boards, eaves, rafters and etc require (in various degrees) repair, replacement, sanding and painting. Suggest further evaluation by a qualified trades person determination, evaluation and or corrective repairs and replacement.

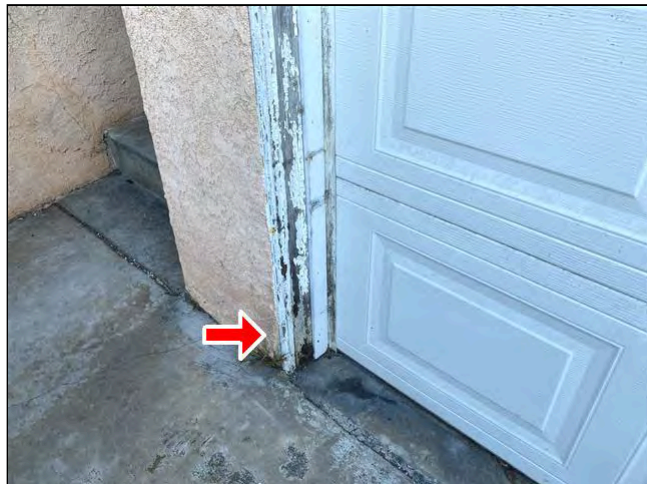
Item 8 - Item 2(Picture) Exterior

8. (4) **Repair or Replace:** Wood deterioration was observed at the base of the garage overhead door frame. The wood frame is in contact with the ground. This configuration is prone to rot and insect activity. If the home inspection reveals signs of damage you should have a pest control company inspect further for activity and possible hidden damage. Suggest repair/replacement of all deteriorated wood by a licensed contractor.

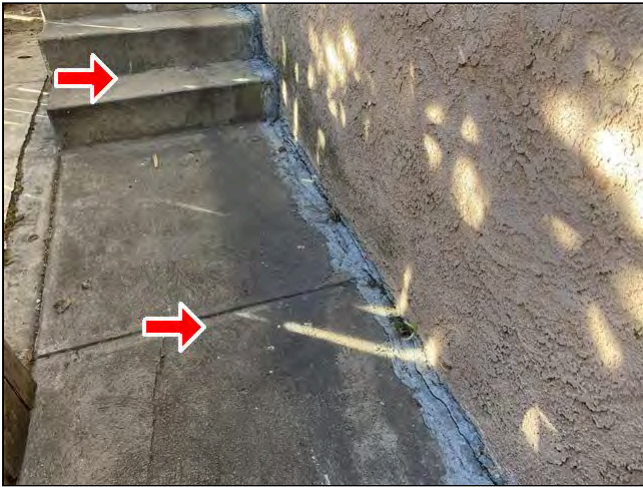
Item 11 - Item 1(Picture) Exterior

11. (1) **Repair or Replace:** The steps and walkway at the East wall of the home have settled away from the home. This settlement has created an opening allowing water to enter the home. There are signs of water intrusion on the interior side of the foundation, wall or slab. Protection against the penetration of water into the building envelope is strongly urged. Suggest further review by a qualified contractor to provide replacement options and cost.

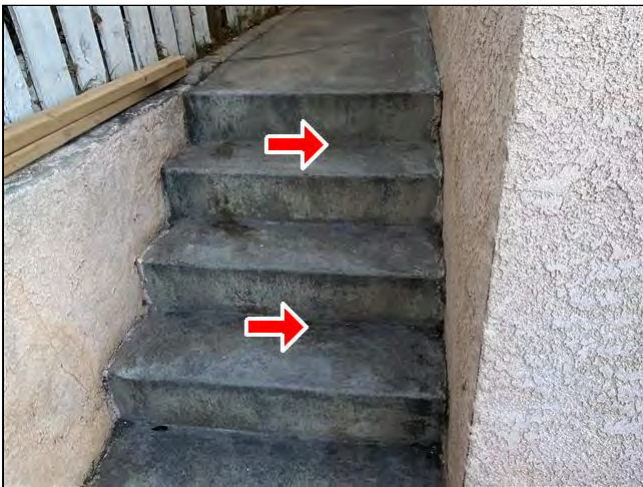
Item 12 - Item 1(Picture) Exterior

12. (2) **Repair or Replace:** There is a negative slope towards the home at the front East wall. This configuration can cause or contribute to water intrusion or deterioration of the foundation. Water can be detrimental to the integrity of the foundation of the house. It is important to prevent or minimize standing water around the house. Recommend further evaluation by a qualified grading contractor to determine corrections needed.

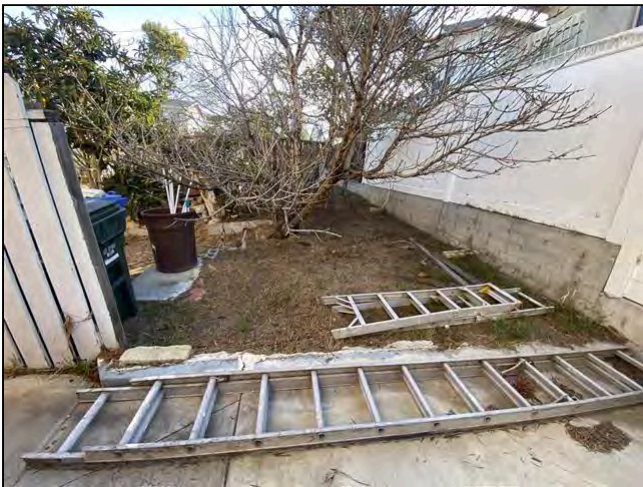
Item 15 - Item 1(Picture) Exterior

15. **Repair or Replace:** The wood fence throughout the East side of the property is deteriorated, leaning and/or missing. The fence is in need of replacement.

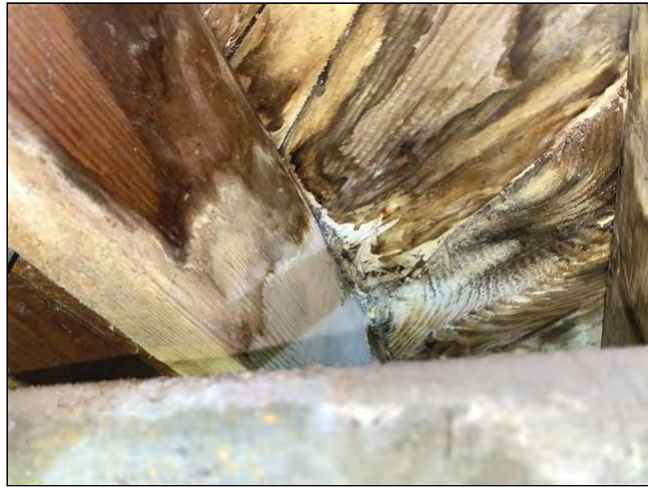
Item 16 - Item 2(Picture) Structural Components

16. (1) **Repair or Replace:** Water staining, wood deterioration and possible fungus was observed at the first floor bathroom subfloor. It is suggested that the subfloor below bathrooms be further evaluated by a qualified contractor to determine if wood subfloors or in need of repair and or replacement.

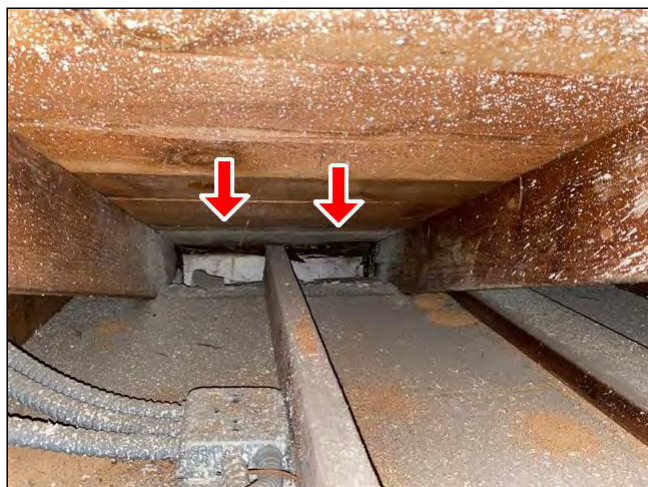
Item 19 - Item 2(Picture) Structural Components

19. (2) **Repair or Replace:** Wood deterioration was observed on the underside of the roof sheathing along the edge of the roof. Deterioration is possible due to the current condition of the roofing materials. If the home inspection reveals signs of damage you should have a pest control company inspect further for activity and possible hidden damage. Suggest repair/replacement of all deteriorated wood by a licensed contractor.

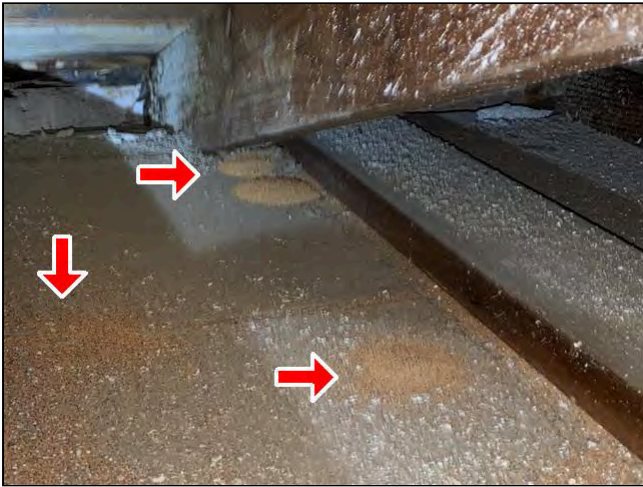
Item 20 - Item 1(Picture)

20. (4) **Monitor:** Signs of insect activity (possible wood destroying) was observed at the attic space of the home in many locations.

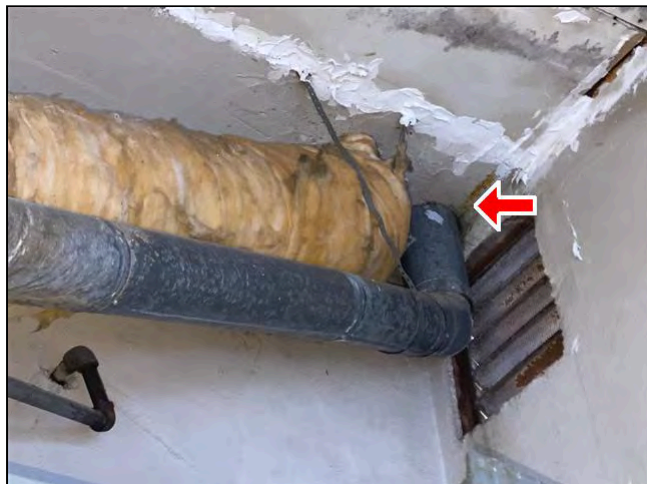
Item 23 - Item 1(Picture) Heating/Central Air

23. (2) **Safety Issue:** The forced air heater vent passes through a ceiling or wall without the use of an approved thimble or spacer. This could be a fire hazard. We suggest a qualified technician should install an approved, listed thimble or spacer.

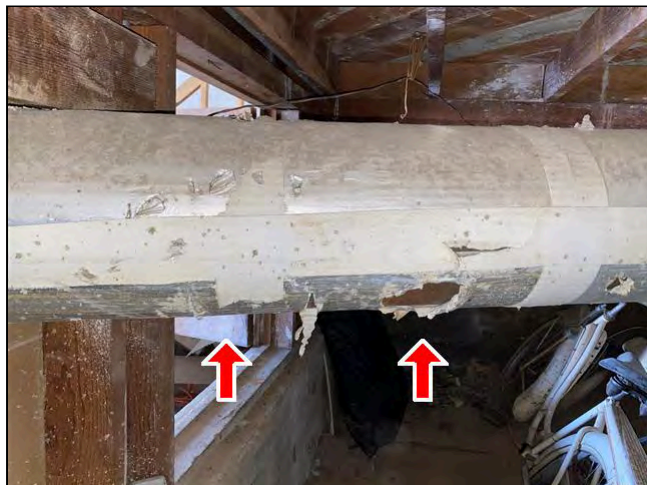
Item 24 - Item 1(Picture) Heating/Central Air

24. **Safety Issue:** The ducting for the forced air heater appears to be asbestos. The identification of Asbestos is outside the scope of this inspection. We suggest a qualified environmental specialist should be retained to evaluate the ducting and make further recommendations. Testing and remediation of Asbestos can only be accomplished by a qualified environmental specialist. If strict protocol is not followed, Asbestos can be released into the interior of the building and may create a health hazard. The ducting material shows signs of deterioration in many locations. The Environmental Protection Agency (E.P.A.) reports that asbestos represents a health hazard if "friable" (damaged, crumbling, or in any state that allows the release of fibers). Suggest further review, testing and removal by a qualified professional.

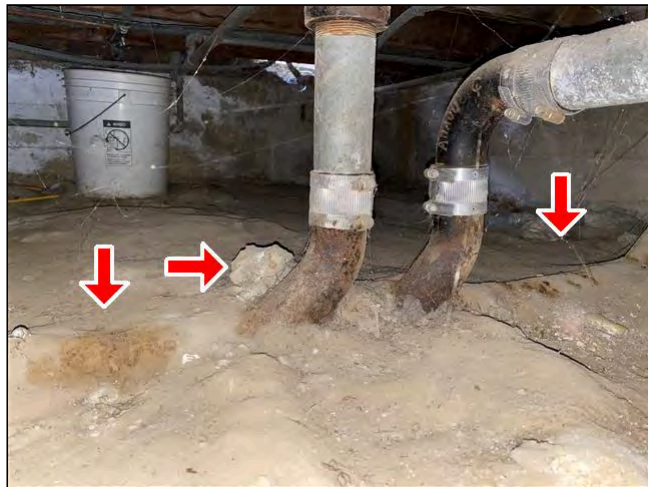
Item 25 - Item 2(Picture) Plumbing System

25. (1) **Repair or Replace:** The cast iron drain pipes at the rear area of the crawl space are corroded and leaking. The drain pipes are in need of replacement. Suggest further review and replacement by a qualified plumber.

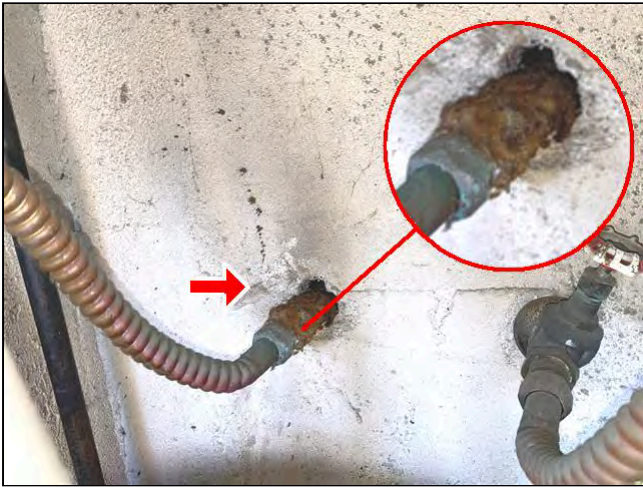
Item 29 - Item 1(Picture) Plumbing System

29. (2) **Repair or Replace:** The water supply pipe at the rear wall the water heater is corroded. Although the valve is not leaking it is suggested that it be replaced by a qualified professional.

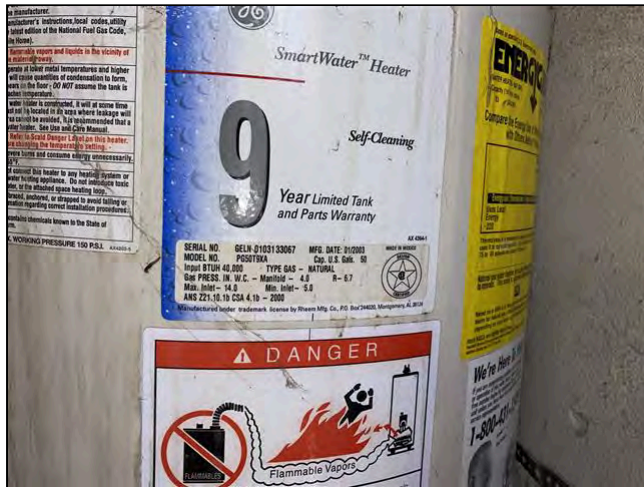
Item 34 - Item 1(Picture)

34. (3) **Repair/Replace:** The water heater is an older unit. The water heater is at the end of its service life. Typical life expectancy of water heaters is 7 to 12 years. The existing unit is 20 years old. Suggest replacement of the water heater by a licensed and qualified plumber.

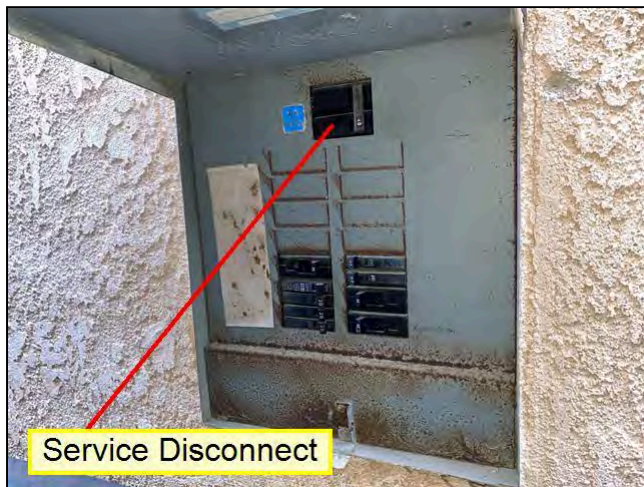
Item 35 - Item 1(Picture) Electrical System

35. (1) **Improve/Monitor:** The size of the electrical service supplied to the home (40-Amps) may not be sufficient depending on the lifestyle of the occupants. Most older homes were constructed with a generic 100-amp electrical panel that could provide all of the home's electricity, but as times have changed, so have homes and their electrical needs. Today, a 40-amp electrical panel will struggle or fail to get the job done and you will have to upgrade to a larger service/panel. Calculate your homes wattage needs to determine exactly what size your home requires. Look out for a few common and obvious signs such as your lights flickering, appliances that aren't performing to their full potential, using multiple appliances in your home will trip the breakers, or the panel has begun to simply malfunction. Having an old or undersized electrical panel in your home can not only cause quite the inconvenience but it can also become dangerous. It's important to know the signs to look out for when your panel has become insufficient for your home's wattage needs. A qualified electrician can inspect the system and provide you with replacement options and costs within the inspection contingency period.

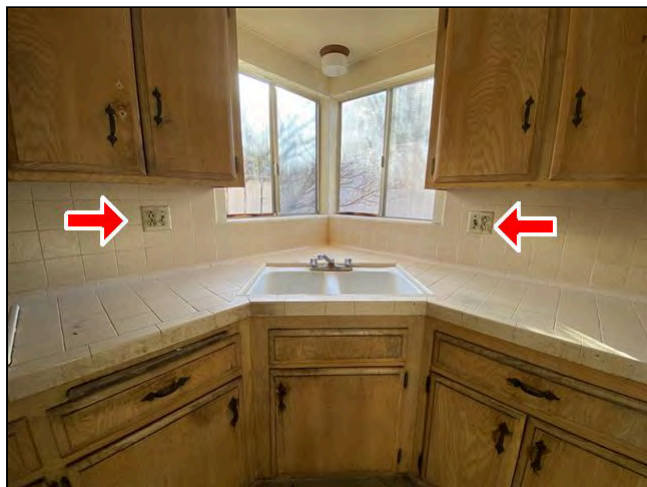
Item 36 - Item 1(Picture) Electrical System

36. (1) **Safety Issue:** The installation of ground fault circuit interrupter (GFCI) devices is advisable at all kitchen outlets within 3 to 6- feet of the sink. GFCI's are strongly recommended at the disposal unit & dishwasher. A ground fault circuit interrupter (GFCI) offers protection from shock or electrocution; suggest repairs by a licensed electrical contractor

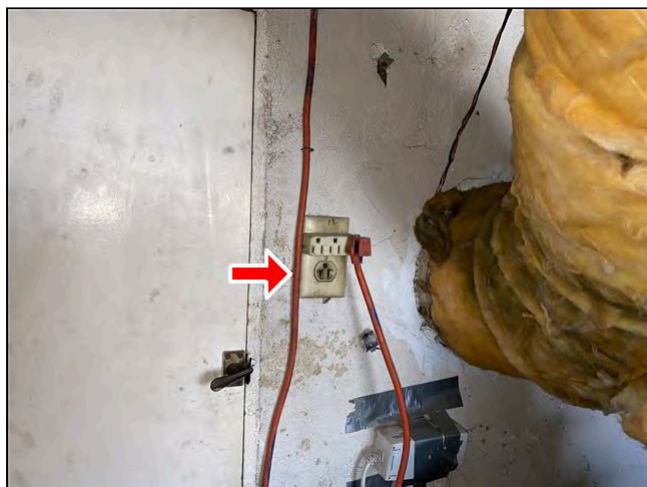
Item 38 - Item 1(Picture) Electrical System

37. (2) **Repair or Replace:** It is suggested that the electrical outlets throughout the subject property be replaced by a qualified electrician.
38. (3) **Safety Issue:** The installation of ground fault circuit interrupter (GFCI) devices is advisable at all exterior and garage outlets. GFCI's are strongly recommended. A ground fault circuit interrupter (GFCI) offers protection from shock or electrocution; suggest repairs by a licensed electrical contractor.

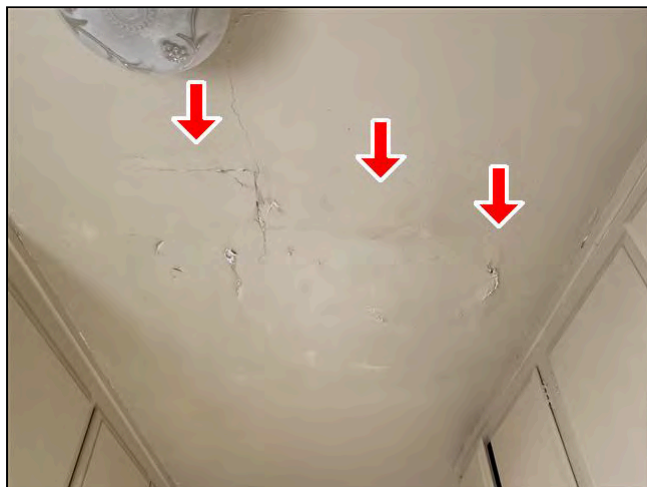
Item 39 - Item 1(Picture) Interiors

39. (1) **Major Concern:** Evidence of water damage was observed at the laundry room ceiling. A bathroom is located above this area. This damage would suggest that an active leak(s) is present in this location. Areas of past and present moisture are favorable for growing many fungal like organisms. There is an extra risk of hidden damage/fungus/mold to be present in this location. The identification of molds, fungus and other microbial organisms is outside the scope of this inspection. We suggest a qualified environmental specialist should be retained to evaluate the surfaces and make further recommendations. Testing and remediation of mold growth can only be accomplished by a qualified environmental specialist. If strict protocol is not followed, spores can be released into the interior of the building and may create a health hazard for those with low tolerances to such organisms. Suggest further investigations and repairs by a qualified contractor.

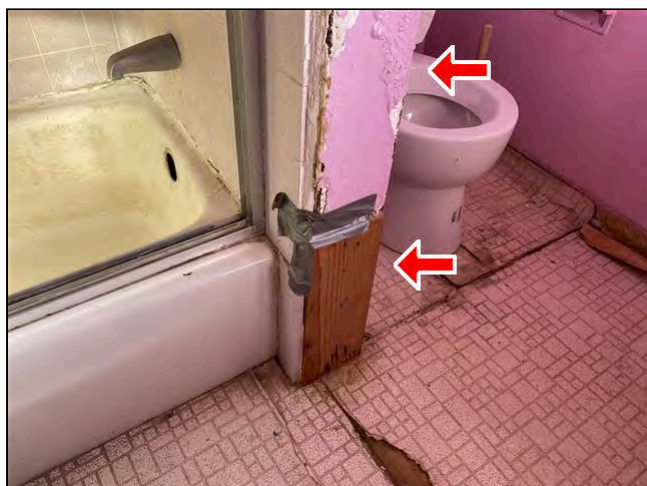
Item 40 - Item 1(Picture) Interiors

40. (2) **Major Concern:** Water damage was observed at the interior walls in the second floor bathroom. Areas of past and present moisture are favorable for growing many fungal like organisms. There is an extra risk of hidden damage/fungus/mold to be present in this location. The identification of molds, fungus and other microbial organisms is outside the scope of this inspection. We suggest a qualified environmental specialist should be retained to evaluate the surfaces and make further recommendations. Testing and remediation of mold growth can only be accomplished by a qualified environmental specialist. If strict protocol is not followed, spores can be released into the interior of the building and may create a health hazard for those with low tolerances to such organisms. Suggest further investigations and repairs by a qualified contractor.

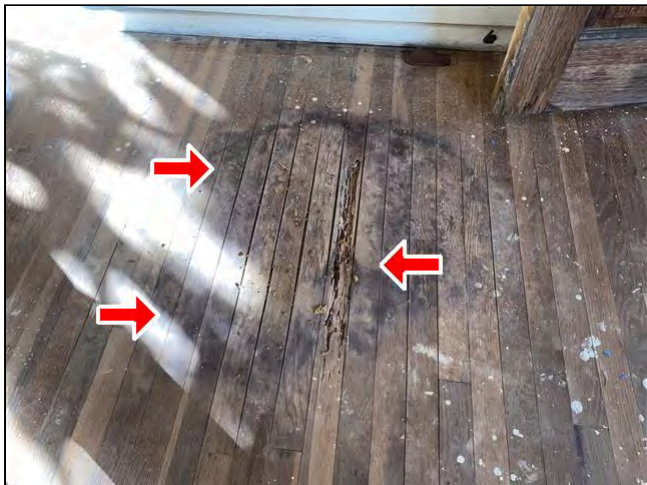
Item 43 - Item 1(Picture) Interiors

43. (1) **Repair or Replace:** Wood deterioration was observed at the living room floor boards in various locations. If the home inspection reveals signs of damage you should have a pest control company inspect further for activity and possible hidden damage. Suggest repair/replacement of all deteriorated wood by a licensed contractor.

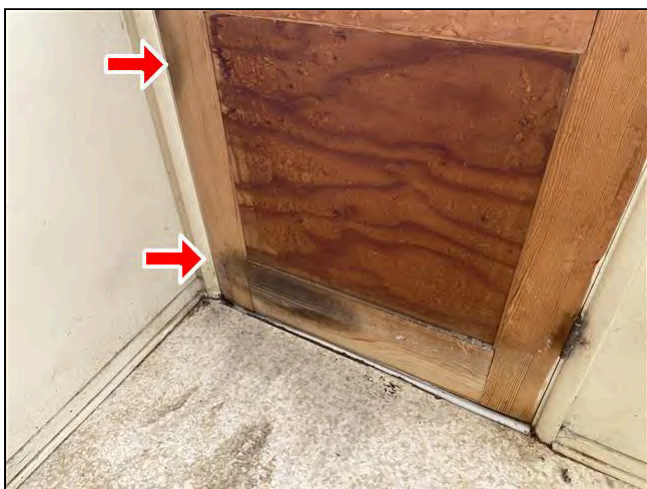
Item 45 - Item 1(Picture) Interiors

45. **Repair or Replace:** The laundry room rear wall door is in need of replacement.

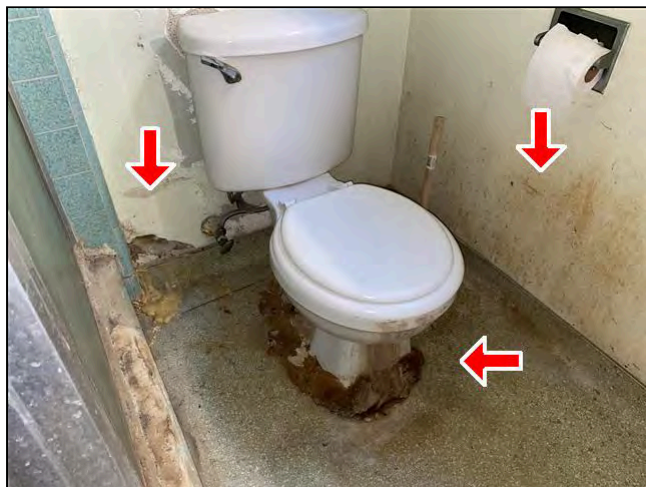
Item 47 - Item 1(Picture) Interiors

47. (1) **Safety Issue:** There is surface growth and fungal like growth observed at the first floor bathroom in many locations. This may indicate the presence of mold, fungus or other microbial organisms. Areas of past and present moisture are favorable for growing many fungal like organisms. The identification of molds, fungus and other microbial organisms is outside the scope of this inspection. We suggest a qualified environmental specialist should be retained to evaluate the surfaces and make further recommendations. Testing and remediation of mold growth can only be accomplished by a qualified environmental specialist. If strict protocol is not followed, spores can be released into the interior of the building and may create a health hazard for those with low tolerances to such organisms.

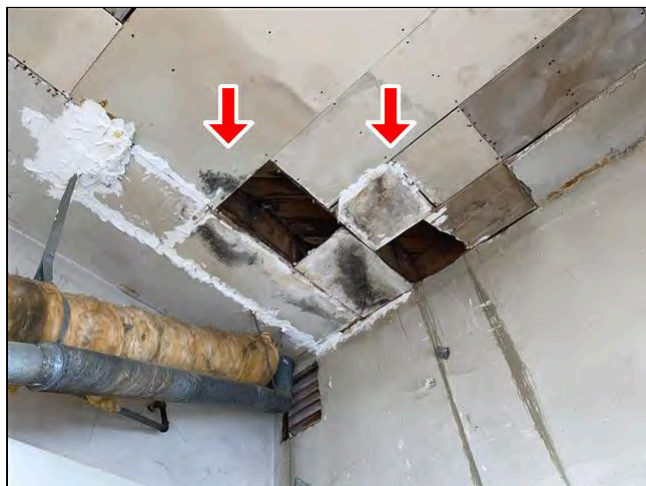
Item 48 - Item 1(Picture) Garage

48. (1) **Safety Issue:** There is surface growth at the garage ceiling. This may indicate the presence of mold, fungus or other microbial organisms. The identification of molds, fungus and other microbial organisms is outside the scope of this inspection. We suggest a qualified environmental specialist be retained to evaluate the surfaces and make further recommendations. Testing and remediation of mold growth can only be accomplished by a qualified environmental specialist. If strict protocol is not followed, spores can be released into the interior of the building and may create a health hazard for those with low tolerances to such organisms.

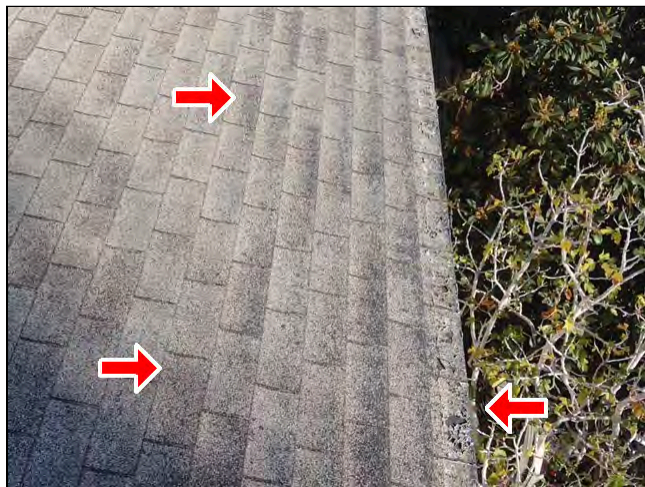
1.0 Item 1(Picture) Roofing

(1) **Major Concern:** The composition shingle roofing is wearing at uneven rates. The sides of the roofing that are more exposed to the sun's light are wearing more quickly than other areas. Also, there are missing/torn shingles in many locations. The composition asphalt shingle roof is at the end of its service life. It is in need of replacement. Suggest further review by a qualified roofing contractor to provide replacement options and cost.

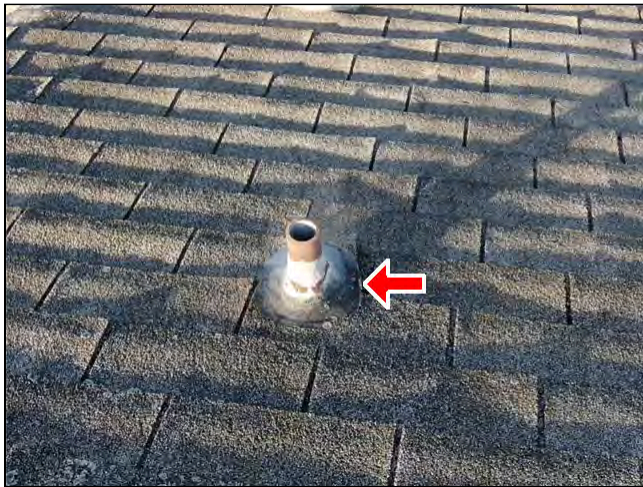
1.1 Item 1(Picture) Roofing

**Repair or Replace:** The mastic at all rooftop vents and penetrations is weathered and cracked. It is suggested that all vent and penetrations be examined and sealed with approved material by a qualified professional.

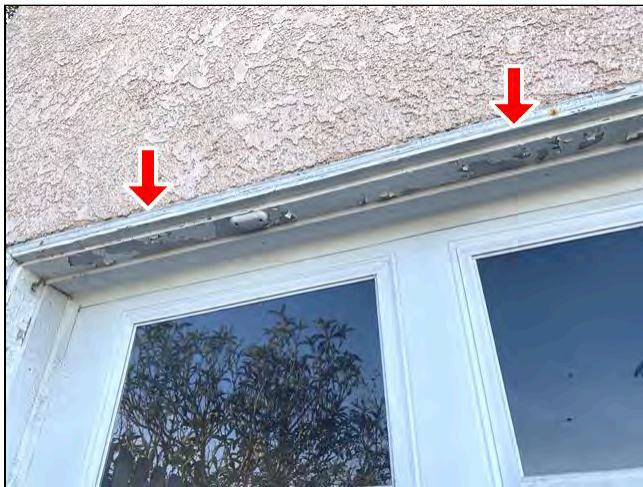
2.0 Item 7(Picture) Exterior

(3) **Repair or Replace:** The exterior wooden elements throughout the exterior of the home have not been maintained for some time. The wooden trims, doors, fascia boards, eaves, rafters and etc require (in various degrees) repair, replacement, sanding and painting. Suggest further evaluation by a qualified trades person determination, evaluation and or corrective repairs and replacement.

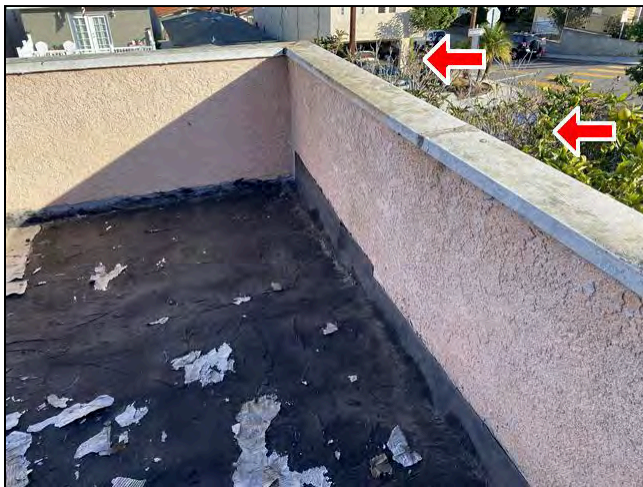
2.0 Item 11(Picture) Exterior

(6) **Safety Issue:** The height of the front wall balcony rail/wall does not comply with today's building standards. We suggest the wall should be repaired or replaced by a qualified technician to conform to standard trade practices.

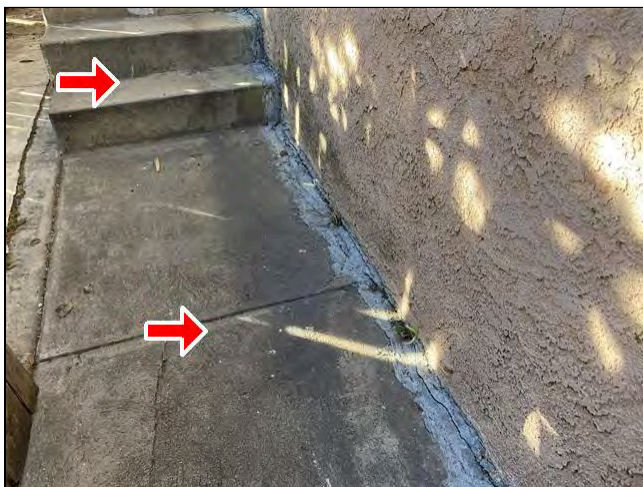
2.4 Item 1(Picture) Exterior

(1) **Repair or Replace:** The steps and walkway at the East wall of the home have settled away from the home. This settlement has created an opening allowing water to enter the home. There are signs of water intrusion on the interior side of the foundation, wall or slab. Protection against the penetration of water into the building envelope is strongly urged. Suggest further review by a qualified contractor to provide replacement options and cost.

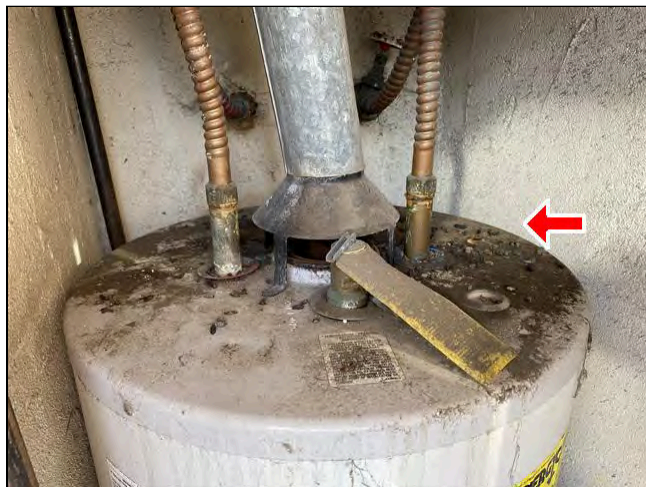
2.5 Item 1(Picture) Exterior

**Safety Issue:** Evidence of rodents was found in the form of feces was observed at the water heater. A qualified person should make repairs to seal openings in the structure, set traps, and clean rodent waste as necessary. Future costs could be incurred from prior rodent damage not visible at time of inspection.

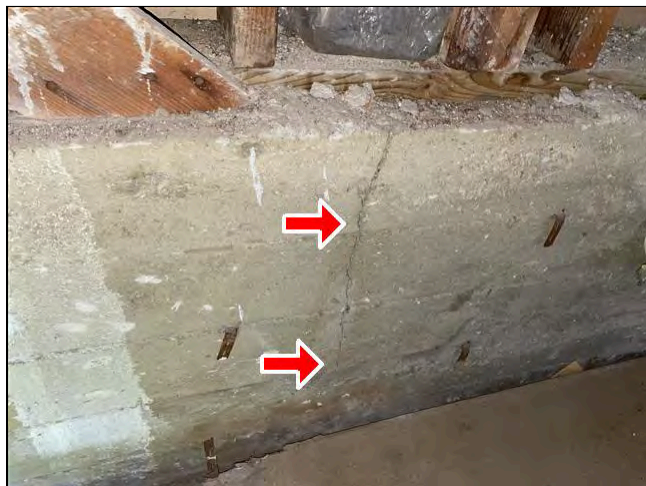
3.0 Item 1(Picture) Structural Components

(2) **Repair or Replace:** Signs of cracking and movement were visible in portions of the foundation at more than one location. Although the cracking is isolated to these areas, we feel this could affect the performance of the entire foundation, especially during seismic activity. We suggest a qualified foundation contractor or structural engineer should evaluate the foundation, and determine what repairs are needed.

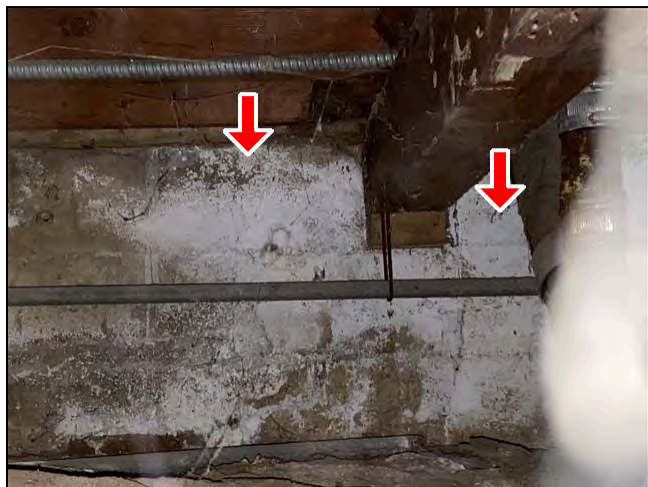
3.0 Item 4(Picture) Structural Components

(3) **Improve/Monitor:** A condition known as efflorescence is evident on portions of the concrete foundation walls or slab. This whitish, fuzzy material is a mineral deposit left when moisture in the concrete evaporates. The presence of efflorescence often indicates an occasional surplus of moisture on the outside of the foundation. We suggest to keep the exterior moisture to a minimum, exterior surface drainage, including downspout water, should be directed as far away from the building as possible. Landscape watering should always be directed away from the building and limited to short durations.

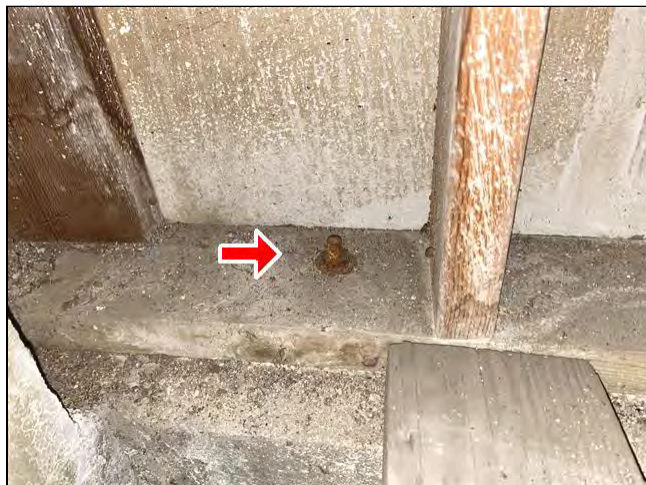
3.0 Item 8(Picture) Structural Components

(6) **Monitor:** The original building is anchored to the foundation using older technology. The original configuration appears to have performed adequately to date. Consider upgrades as part of any future modernization and/or remodeling.

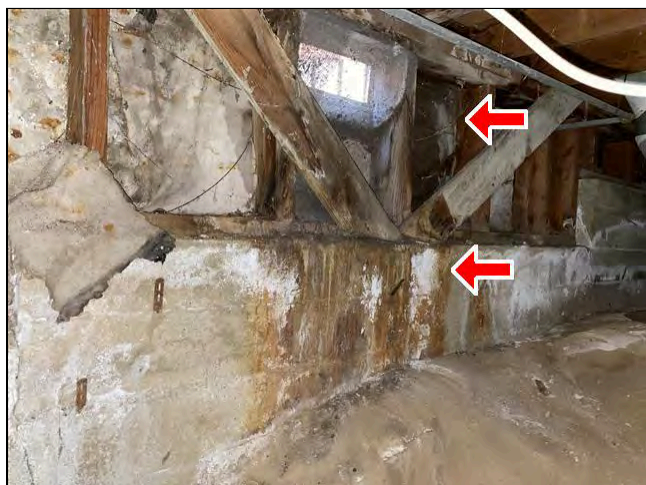
3.0 Item 9(Picture) Structural Components

(7) **Improve/Monitor:** Water staining/intrusion was observed at the East area of the crawl space. Water intrusion can lead to more costly repairs and increase damage if not corrected. Water intrusion can cause deterioration and excessive moisture on building components if not corrected. Exterior drainage improvements are recommended.

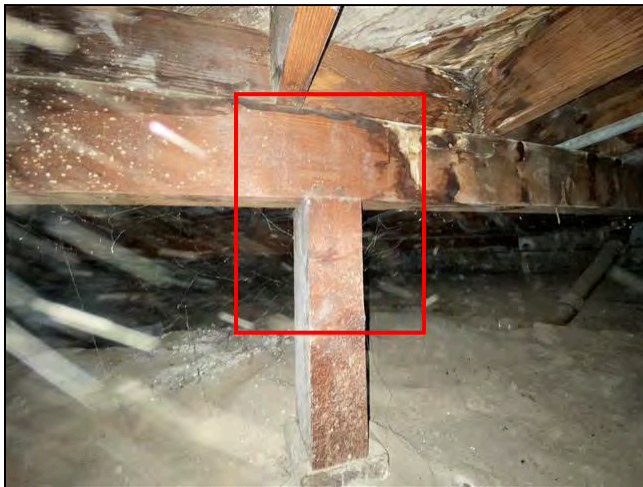
3.2 Item 3(Picture) Structural Components

(2) **Improve/Monitor:** The girder and post connections are not reinforced according to modern standard building practice. No adverse effects resulting from this condition are noted. We suggest as an up-grading these connections would be considered optional.

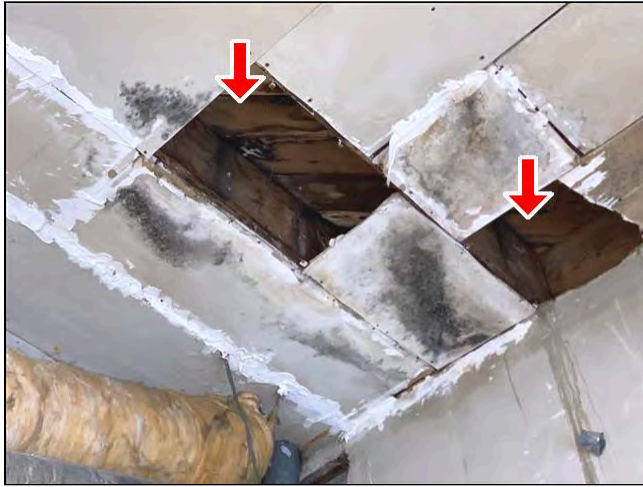
3.5 Item 1(Picture) Structural Components

(1) **Major Concern:** A significant amount water damage was observed at the exposed structure at the garage ceiling. The balcony deck above this location appears to have been leaking for sometime causing a considerable amount damage to the structure. There is an extra risk of hidden damage at areas beyond view. Suggest further review by a qualified contractor and structural engineer to provide repair/replacement options and cost.

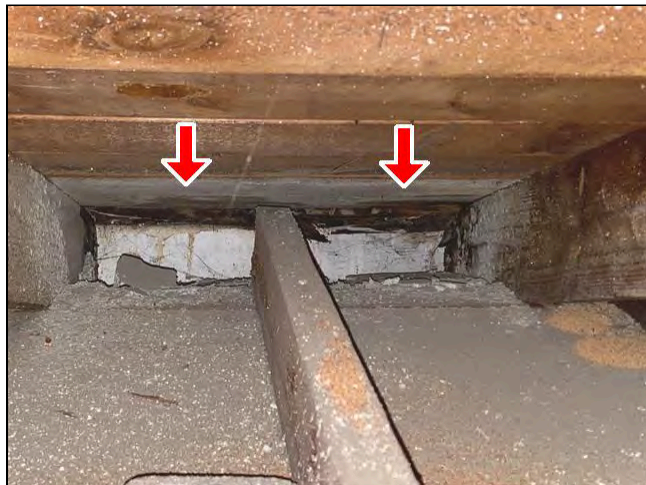
3.5 Item 6(Picture) Structural Components

(2) **Repair or Replace:** Wood deterioration was observed on the underside of the roof sheathing along the edge of the roof. Deterioration is possible due to the current condition of the roofing materials. If the home inspection reveals signs of damage you should have a pest control company inspect further for activity and possible hidden damage. Suggest repair/replacement of all deteriorated wood by a licensed contractor.

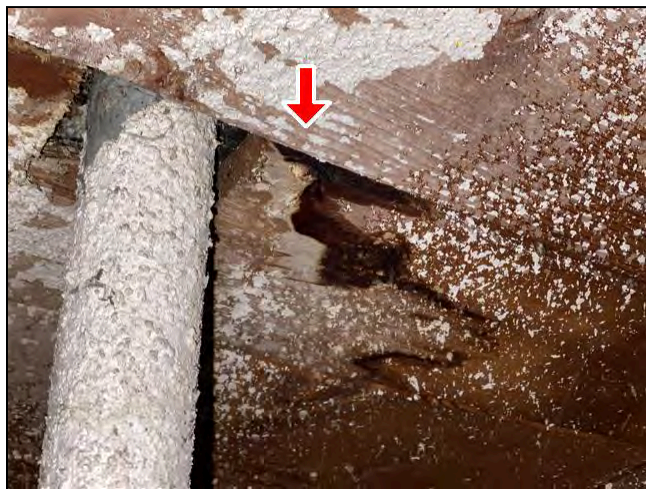
3.5 Item 8(Picture) Structural Components

(3) **Monitor:** Water staining was observed on the underside of the roof sheathing and structure in various locations. The source of the leak(s) should be identified and repairs performed as necessary.

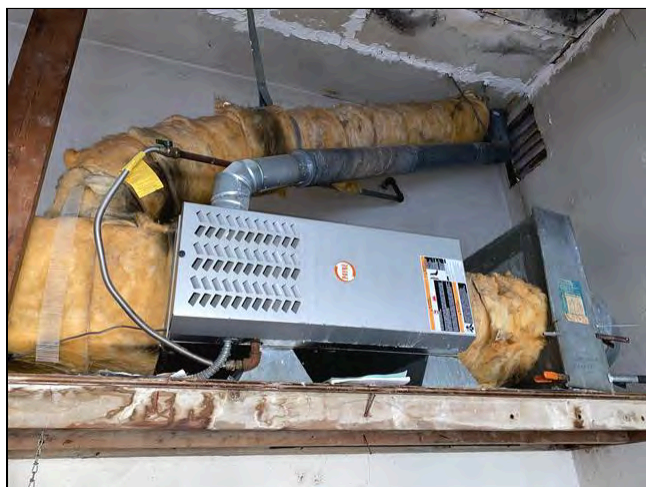
4.0 Item 1(Picture) Heating/Central Air

**Monitor:** The thermostat for the forced air heater is inoperative. Unable to test and operate the forced air heater during the inspection. Because of this, we recommend further evaluation/safety check be performed by the local gas company before the end of your contingency period.
