WOOD DESTROYING PESTS AND ORGANISMS INSPECTION REPORT

Building No. 1431	Street Heather Circle	City Chico	ZIP 95926	Date of Inspection 03/28/2023	Number of Pages 5
----------------------	--------------------------	---------------	--------------	----------------------------------	----------------------

Report # : 40689
Registration # : PR3779
Escrow # :
 CORRECTED REPORT

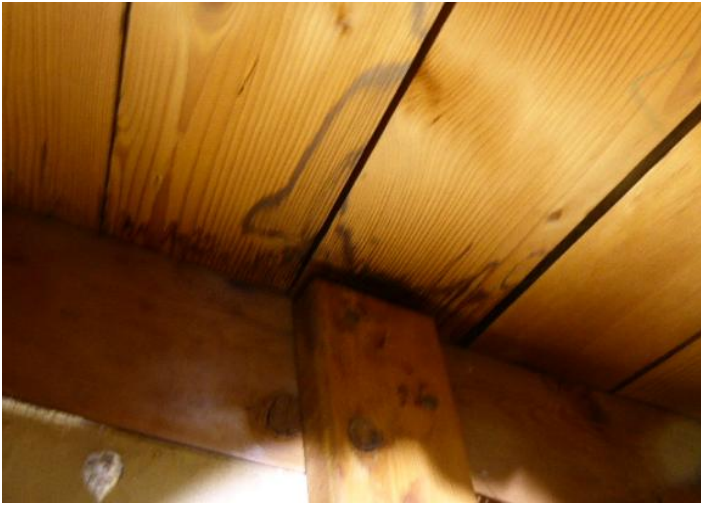
7A

FINDING: Stains were noted at the attic wood members as viewed from the access opening. Unable to determine if stains are active or passive.

RECOMMENDATION: Interested parties should engage the services of a licensed contractor to check for leaks and to perform any corrective work needed.

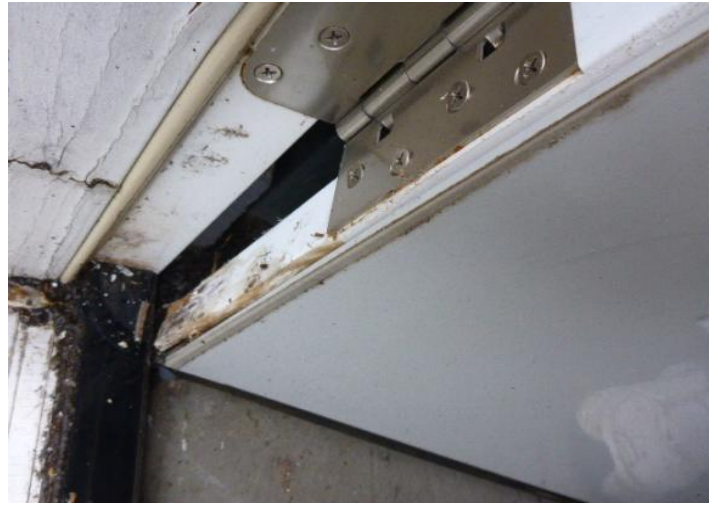
8A

FINDING: Wet stains and fungus damage noted at the garage door, jambs and trim. Damage may extend into inaccessible areas.

RECOMMENDATION - Interested parties should engage the services of a licensed contractor to check for leaks and to perform any corrective work needed. Remove the fungus damaged portions of the door, jambs and trim. Call for a reinspection of the inaccessible areas. The inaccessible areas will be inspected for a fee if made accessible by the interested parties at his/her expense. A supplemental report will be filed at such time. No opinion is rendered concerning the conditions in the area at this time. Replace with new material.

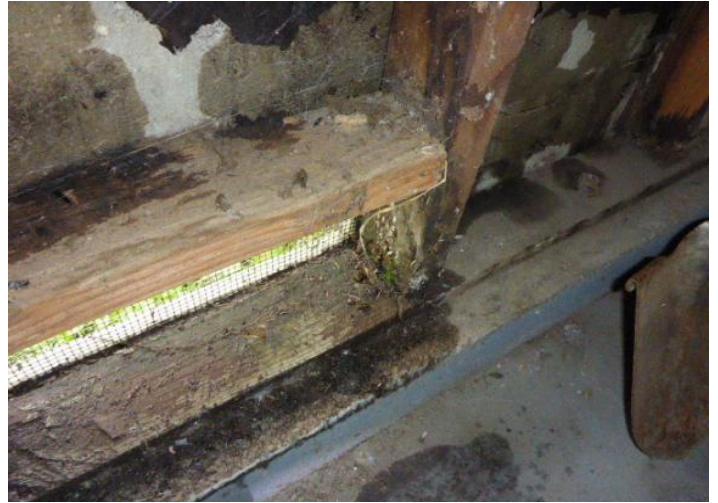
8B

FINDING: Wet stains and fungus infection/damage noted at the garage wall studs and sill plate. Damage may extend into

inaccessible areas.

RECOMMENDATION: Remove the fungus damaged portions of the wall studs and sill plate. Call for a reinspection of the inaccessible areas. The inaccessible areas will be inspected for a fee if made accessible by the interested parties at his/her expense. A supplemental report will be filed at such time. No opinion is rendered concerning the conditions in the area at this time. Replace with new material.

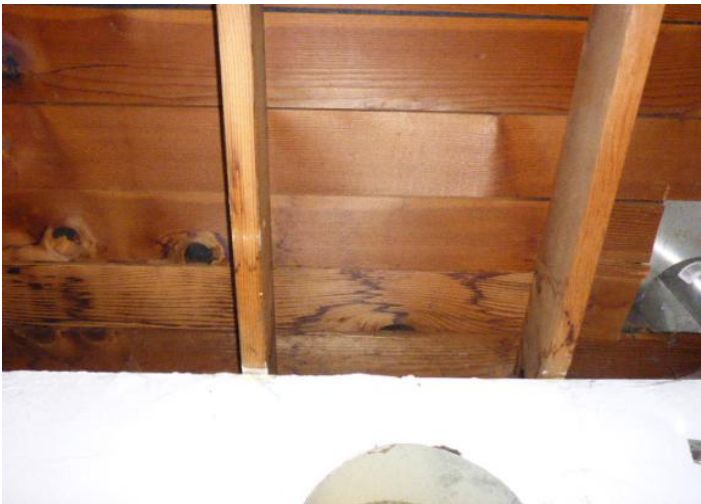
8C

FINDING: Stains were noted at the garage roof sheathing, rafters and upper wall wood members. Unable to determine if stains are active or passive.

RECOMMENDATION: Interested parties should engage the services of a licensed contractor to check for leaks and to perform any corrective work needed.

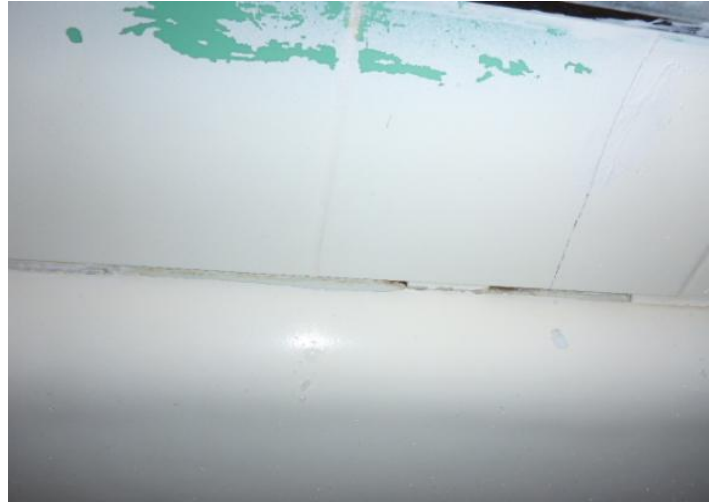
10A

FINDING: Toilet stool is loose at the master bathroom location indicated by "10A" on the diagram.

RECOMMENDATION: Re-set the toilet stool as needed.
