Mold Assessment Performed on 07/14/2023  
Report Finalized on 07/17/2023

**Project #JL-33021**

**1208 Bloomwood Road  
Rancho Palos Verdes, CA 90275**

**JLM Environmental was contracted to perform a limited microbial investigation of the subject property.**

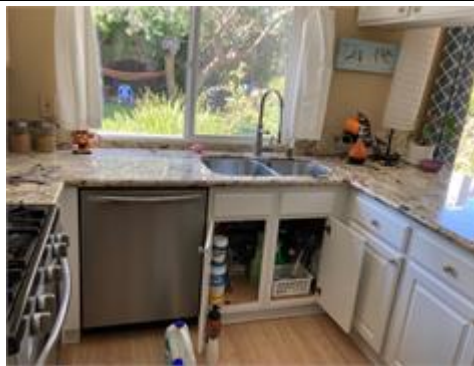
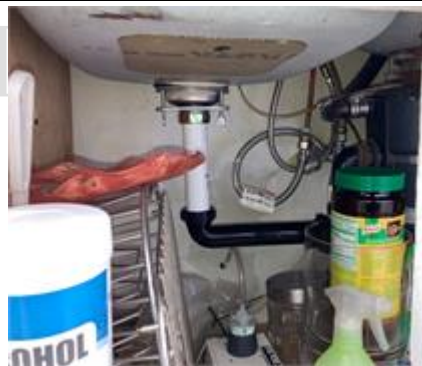
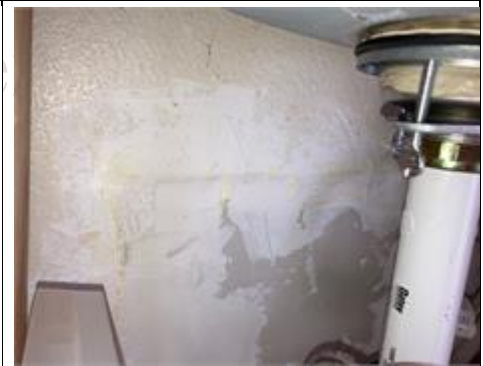
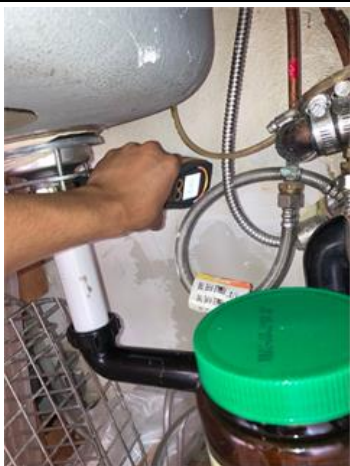
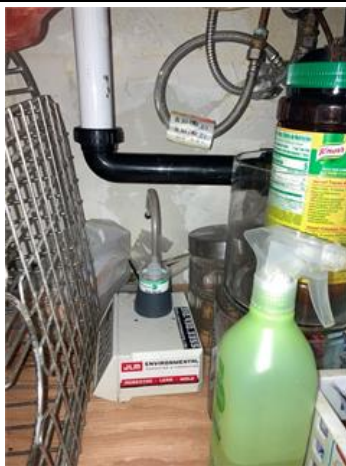
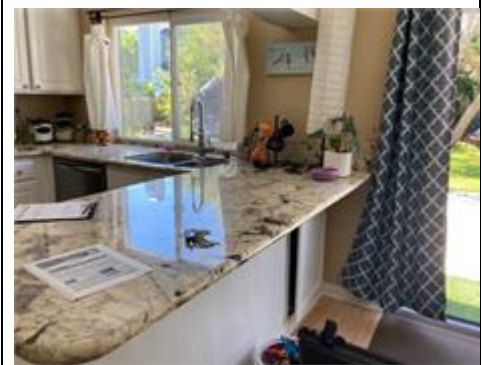
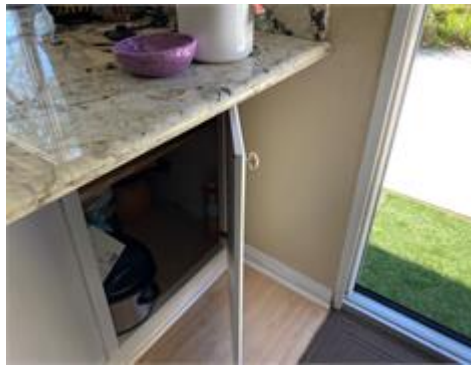
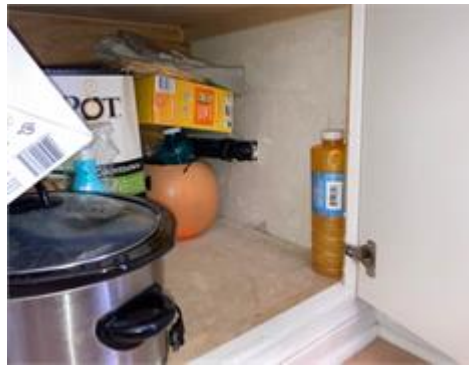
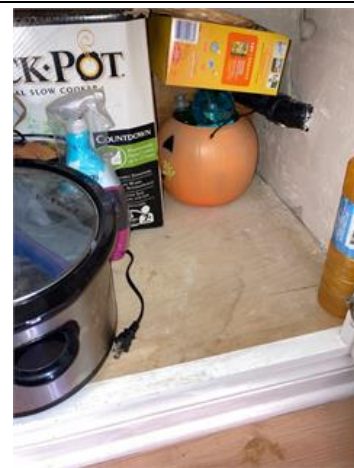
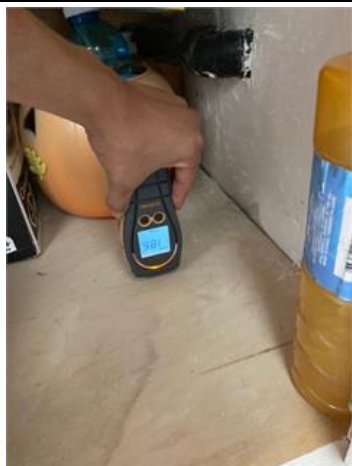
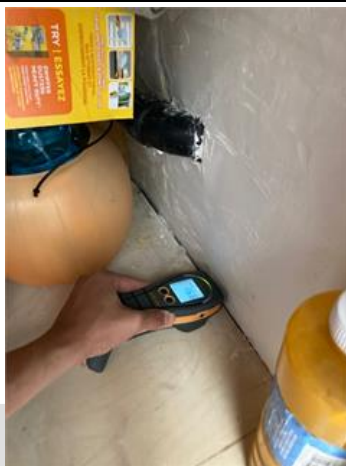
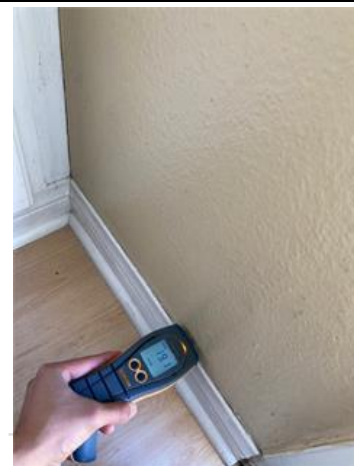
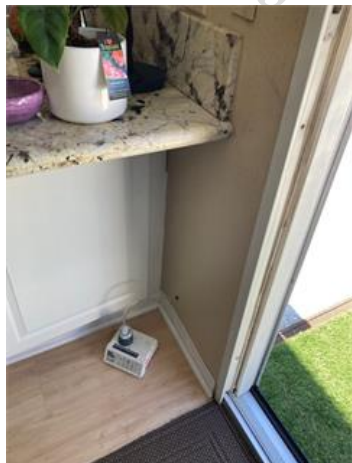
## Interior

Location:	Kitchen
Visible signs of water staining, water damage or suspect fungal presence observed in the accessible areas:	Yes - Recent patching on wall below sink and in cabinetry off sliding door were observed at time of survey.
Humidity (%):	50
Elevated moisture levels conducive to fungal growth were detected:	Yes - On south wall below sink and on cabinet platform (off the sliding door); additional elevated moisture levels detected in lower portion of wall adjacent to sliding door

<b>Plumbing Corrosion Observed:</b>	No
<b>Musty odors detected upon entry to the area?</b>	Yes
<b>Visible growth observed:</b>	No
<b>Visible stain observed:</b>	Yes - On platform below sink

**Cavity Sample Collection:** **Sample 01 - South Wall (Below Sink)**  
 Although no elevated levels are currently detected, it can be expected that the spore counts at this location may continue to change due to the current conditions observed; response actions are recommended.

**Cavity Sample Collection:** **Sample 02 - South Wall (Off Sliding Door)**  
 Sample results indicated the presence of elevated spore counts of allergenic mold types identified: **Aspergillus/Penicillium; response actions are recommended.**

**Interior Notes:**  
 A recent plumbing leak has occurred, affecting the wall below sink; evidence of recent patching and elevated moisture levels were detected in this area at time of survey. A cavity sample (Sample 01) was collected from this area to assess the current conditions within the concealed cavity.

Evidence of inadequate drainage along the adjacent side of the south wall was observed in the backyard. Elevated moisture levels were also detected in the lower south wall extending from the kitchen cabinets to the sliding door casing. A cavity sample (Sample 02) was collected from this area to assess the current conditions within the concealed cavity.

- Consult with a contractor to evaluate plumbing and exterior drainage
- Set up a containment accompanied with negative air pressure to completely isolate the work area from the rest of the property where remediation will take place.
- Post warning signs at all locations of ingress and egress to the decontamination locations. Access to this area will only be permitted for properly trained and certified personnel.
- Be certain to seal all air vents, windows, exhaust fans, etc. with proper tape and polyethylene sheeting. Negative air pressure must be maintained throughout the duration of the entire remediation project.
- Remove: Lower cabinetry on south wall extending west of sink

- Remove: Lower 24" of drywall from south wall extending from sink to sliding glass door jamb
- Dry all building materials using dehumidification to industry standard of 15% or less.

- Remove and dispose of insulation and any debris found within exposed cavities. Removal of affected materials should extend 2 feet beyond all visibly impacted areas.

- Exposed wooden structural members exhibiting staining should be sanded, wire, brushed, HEPA vacuumed and damp wiped with a fungicide.
- HEPA vacuum all horizontal and vertical surfaces that may be impacted by aerosolized spores inside of the containment area.

- Encapsulate all exposed cavities.
- Fog the containment.
- Containment and critical barriers must be maintained until JLM Environmental can issue final clearance.

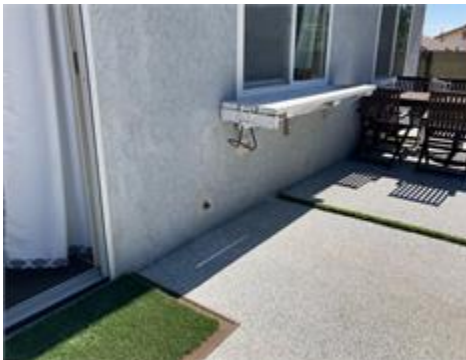
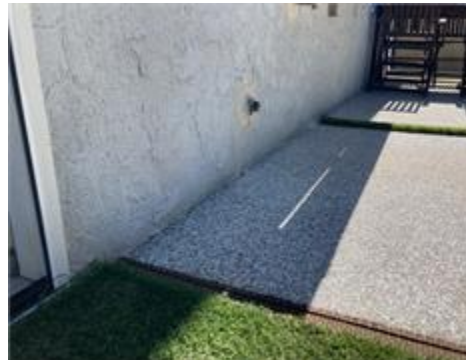
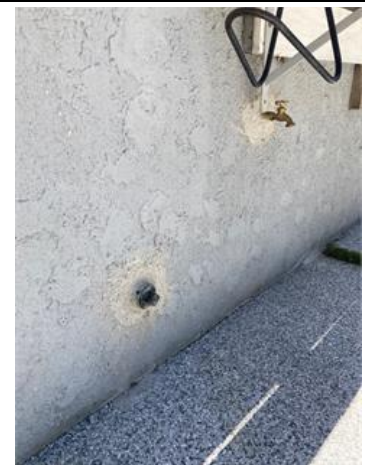
**Location:** Backyard (Adjacent to Kitchen)

Visible patching of stucco was observed along the kitchen exterior wall (where plumbing repairs have been performed). The backyard has poured concrete with epoxy running along the kitchen's south wall; the concrete and epoxy were observed to run at the height of the stucco wall's weep screed. It is believed that inadequate drainage along the wall has resulted in the conditions detected on the opposite side of the wall.

- Consult with a contractor to evaluate plumbing and exterior drainage
