# Premier Home Inspection, Inc.

**Kelly Bowers  
2953 Floral Ave., Riverside CA**

**Date: 01/12/2024**

**Report # 2240106**

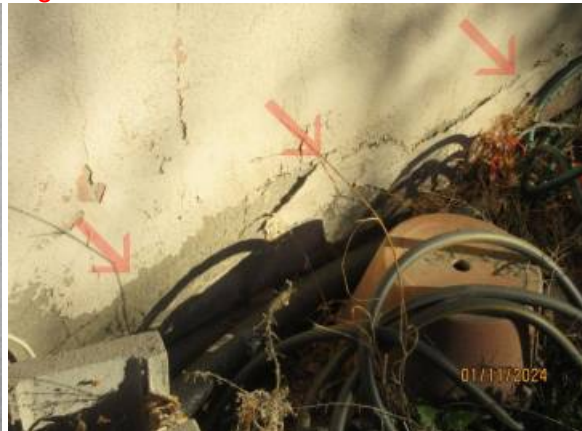
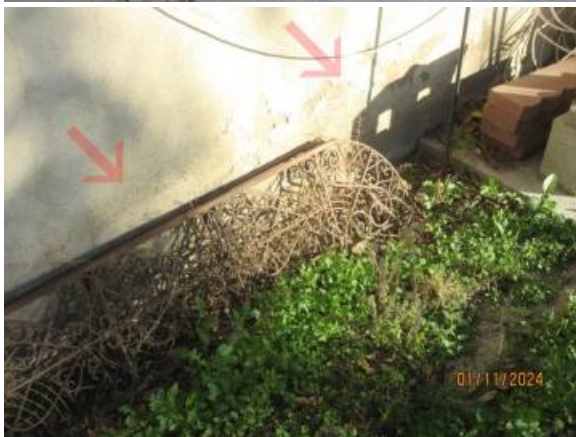
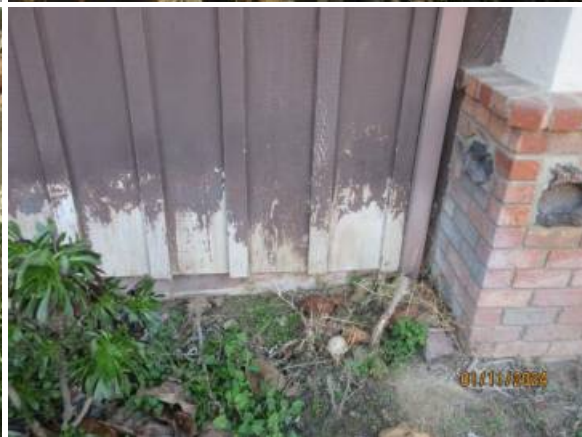
The stucco around the house is deteriorated and damaged in several areas around the house. We recommend it be removed and replaced in all of the affected areas as needed. There is damaged or deteriorated wood siding noted in several areas. We recommend repair or replacement as needed. The exterior surfaces are in fair condition due to weathering and age. We recommend repainting and/or refinishing in the near future to maximize the service.

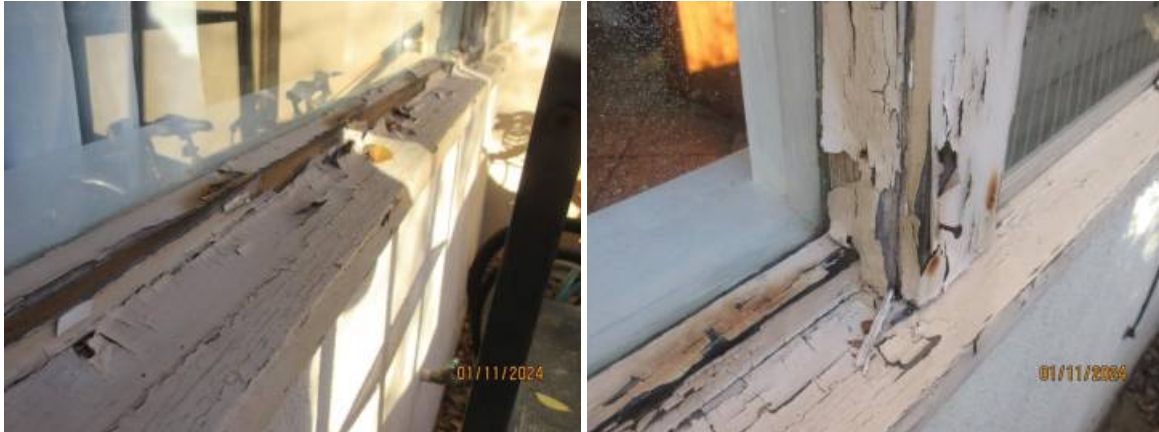
Wood. Damaged wood trim was observed at the window and door trim areas around the house. We recommend review of the pest inspection report regarding repairs. Repair or replace all of the damaged wood around the house as needed. The trim surfaces are weathered and require paint/refinishing to maximize their service life.

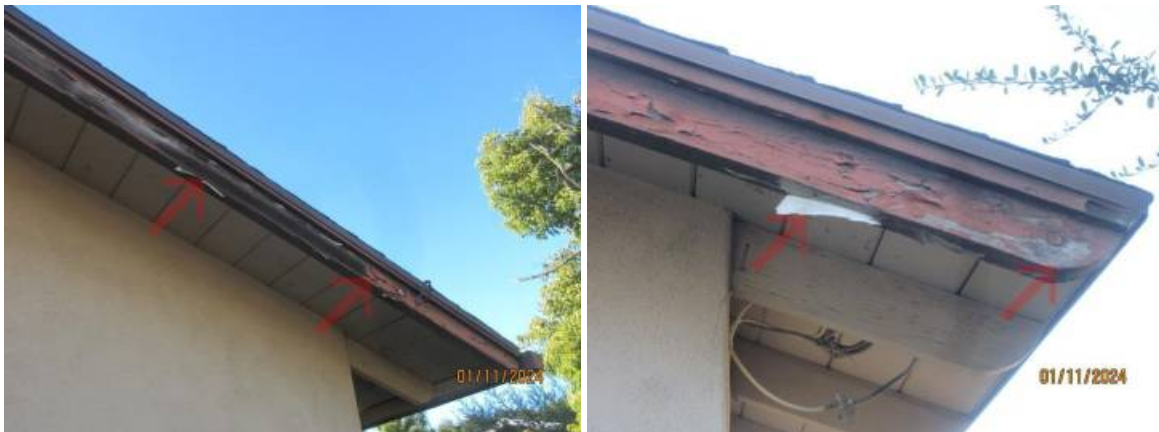
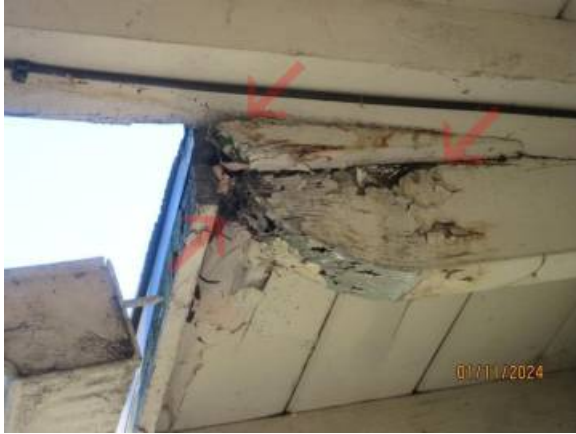
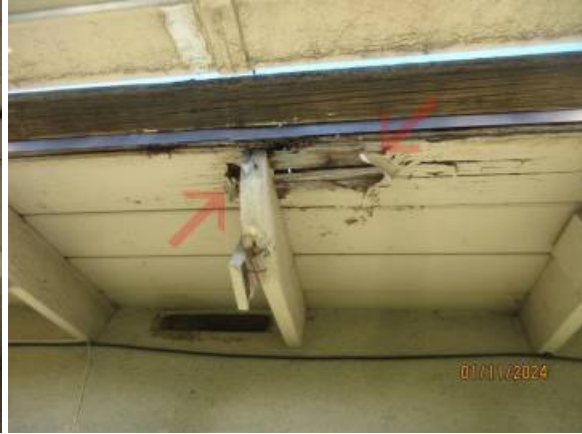
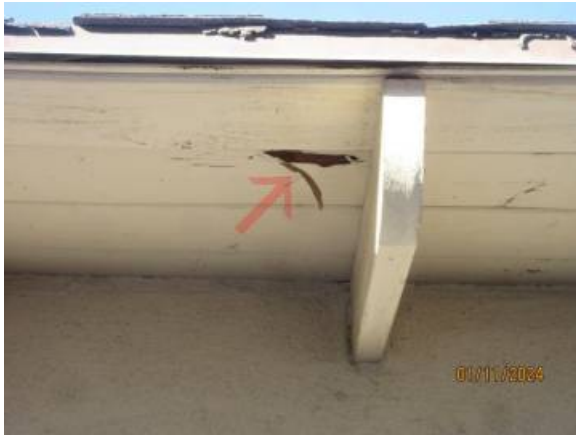
There is damaged deteriorated wood noted in many areas around the house under the eaves and at the fascia boards and rafter tail areas of the house. Repair or replace all of the damaged wood as needed. Check the termite report for all damaged wood around the house and repair or replace the wood in these areas as needed. The areas under the eaves are weathered in many areas around the house. Check the wood in all areas for any damage and repair or replace the damaged wood as needed. The wood also needs to be painted to protect the wood in these areas of the house and to add life to the wood.

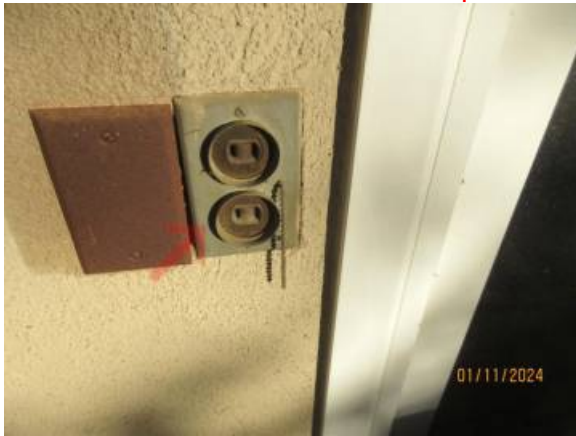
The exterior receptacle(s) is improper located in relation to the pool/spa. No outlets are permitted within 10 ft off the waters edge. We recommend it be relocated and GFCI protected or removed. There is a missing weather proof cover over the exterior receptacle and/or switch at the outside of the house. Repair and properly cover the electrical in this area as needed.

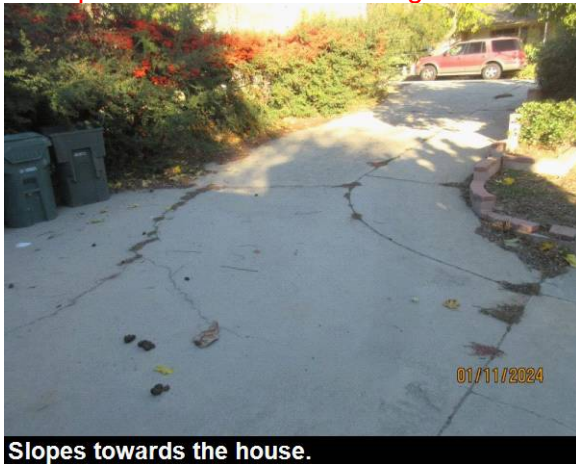
Concrete. The driveway drainage is sloped toward the house and garage. We recommend this condition be monitored and if necessary, a drainage system be installed to ensure surface water does not flow into the building. There is not any drainage visible in this area. There are large cracks and heaving or settling of the driveway. While vehicles can still be driven over it, replacement should be budgeted for and the trip hazards corrected.

Slopes towards the house.

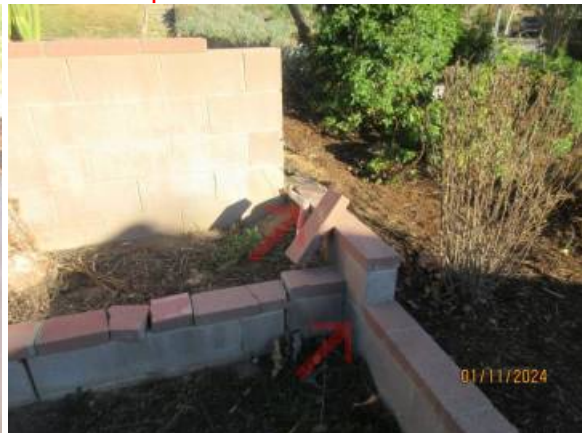
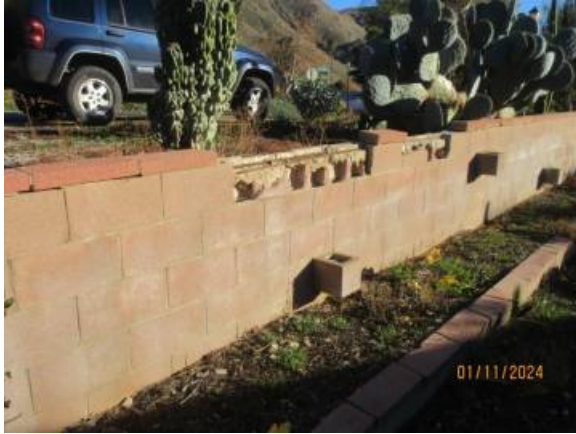
The retaining walls have developed major cracks and/or leaning. This is on the left side of the house and in the front yard area as well. There are missing blocks and loose blocks in several areas. The rebar is exposed and not properly installed in these areas. While the walls are still standing, in our opinion they have failed as intended and should be removed and replaced. There are no weep holes or drains at the base of the retaining wall to aid in the drainage behind the wall. This should be corrected to prevent excessive pressures against the wall and allow for drainage to occur through these areas. Repair and add as needed.

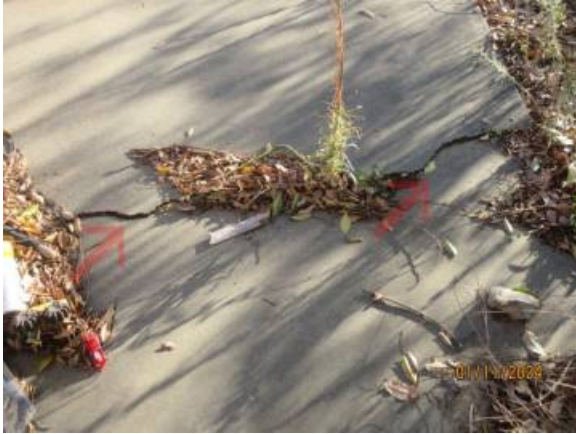
There are moderate cracks in the patio. These indicate movement of the soil and/or poor preparation of the substrate, and over time may develop into trip hazards. Repair as needed.

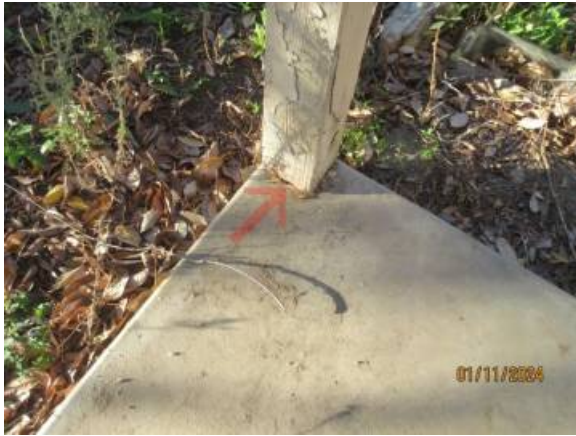
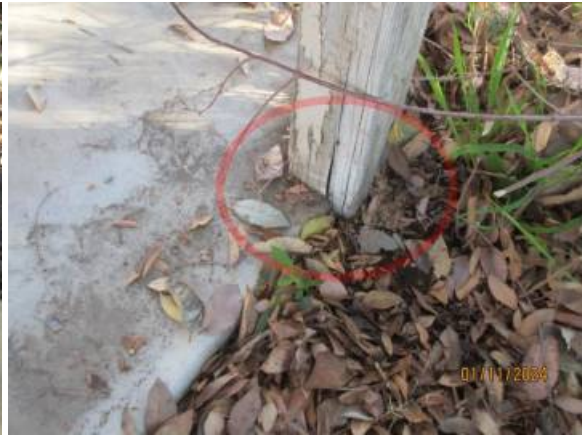
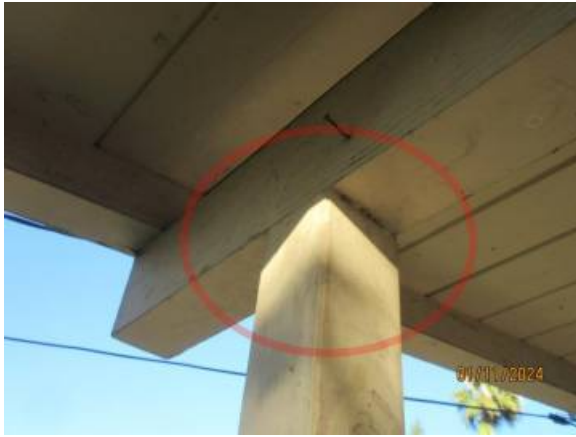
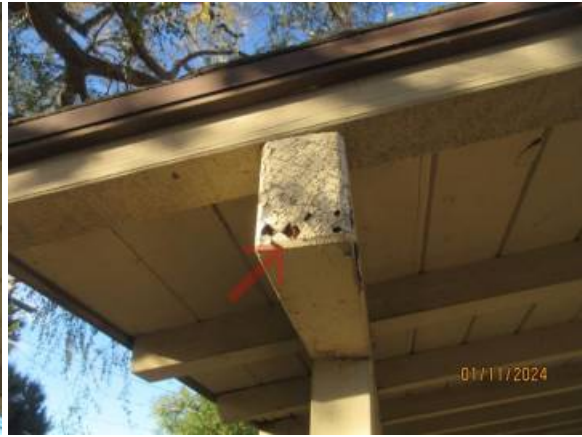
There is damaged wood to the beams and posts in several areas. Repair the damaged wood as needed. Check the termite report for all damaged wood to this structure and repair or replace the damaged wood in these areas as needed. The posts are not properly secured and supported in these areas. There are not any brackets and footings to properly support the posts in these areas. One post is leaning and off of the concrete slab in this area. The posts also need to be properly secured and strapped to the header beam as well. Repairs needed to the structure as needed. Patio cover is not stable as it is currently installed. Additional support and repairs needed to the patio cover structure for proper support of structure. This structure appears to have been an addition done to the property. Check for signed off permits on this addition.

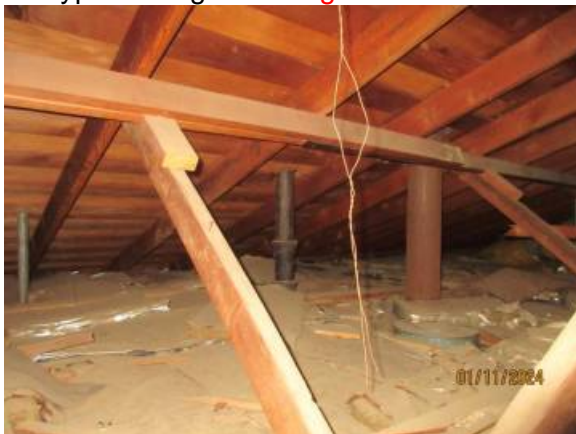
Where visible the roof structure appears to be constructed in a manner typical of houses of this type and age. **The light fixture in this area did not operate. Check the bulb first.**

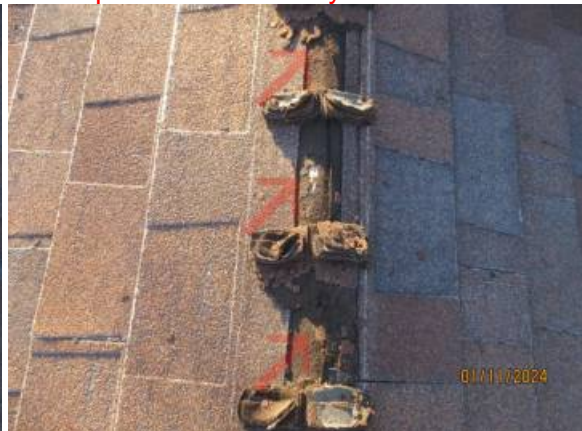
The roof shingles have extensive granulation loss, erosion and cracking throughout the shingled surface. The nail fasteners are exposed in many areas. There is also exposed felt paper on the roofs surface as well. These conditions indicate the end of the useful life of this type of roofing. This cannot be repaired and replacement is needed. The ridge cap shingles are damaged and deteriorated in many areas of the roof and need to be replaced. There is debris accumulating on the roof. This is likely to cause roof damage and drain blockages. We recommend the debris be removed and the roof inspected regularly to keep the drains clear. Portions of the shingles have been installed over a surface with a pitch of less than 2 in 12 and is subject to leakage due to poor drainage for the roof over the patio cover area. The surface should be monitored for signs of leakage and repaired if necessary.

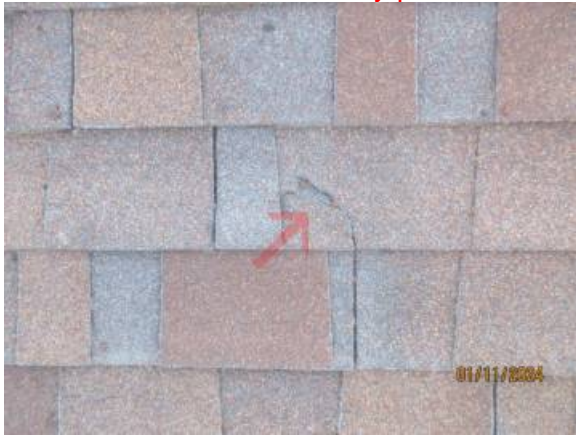
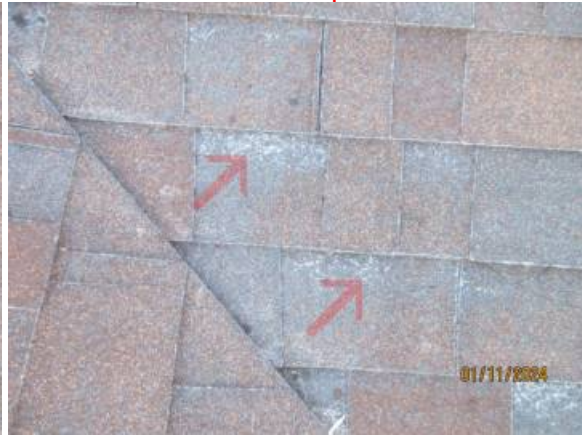
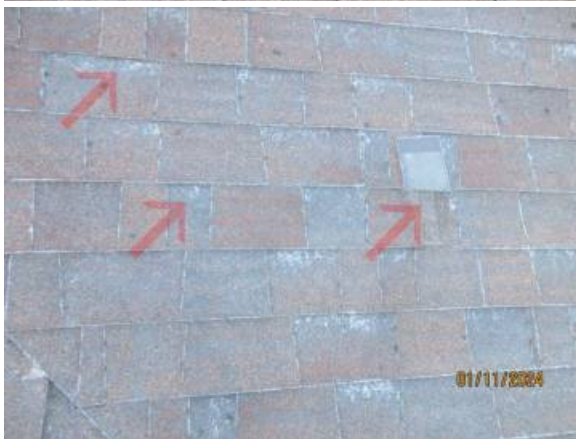
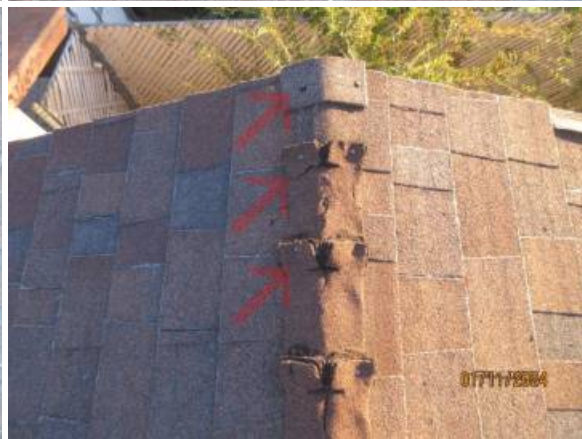
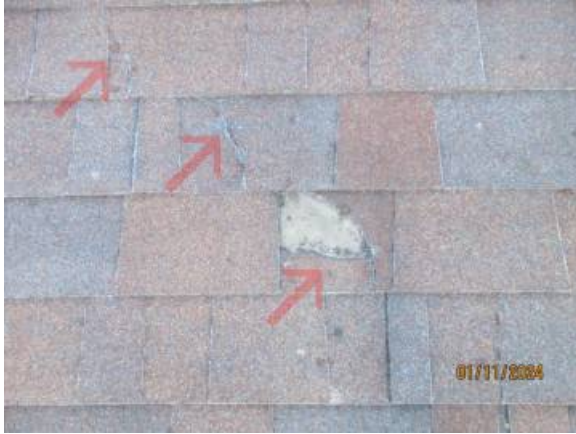
The roof is in poor condition. The conditions noted create the opportunity for leakage, and the roof can not be effectively patched. We recommend the roof be replaced.

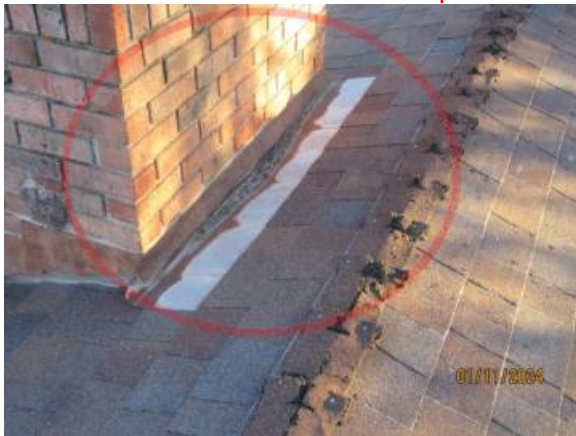
Metal. There is not a proper cricket flashing on the area in front of the chimney. When the surface area of the chimney is over 48" a cricket is needed to divert the water properly away from this area of the roof and prevent any leaks in the roof in these areas.

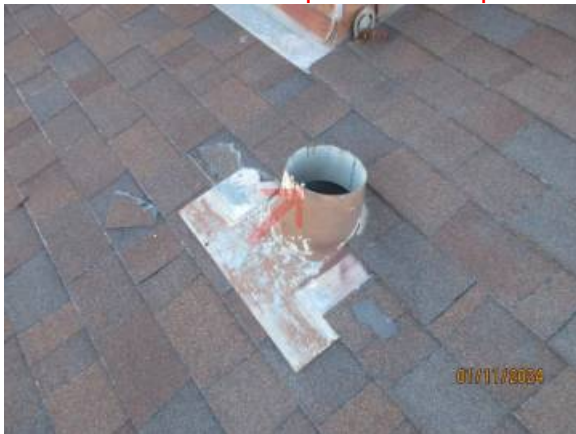
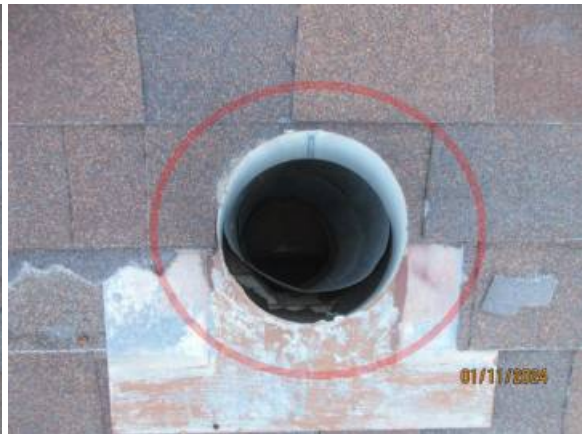
The flue cap(s) is missing. This appears to be for the kitchen hood vent fan unit. We recommend it be replaced to keep out rain and debris.

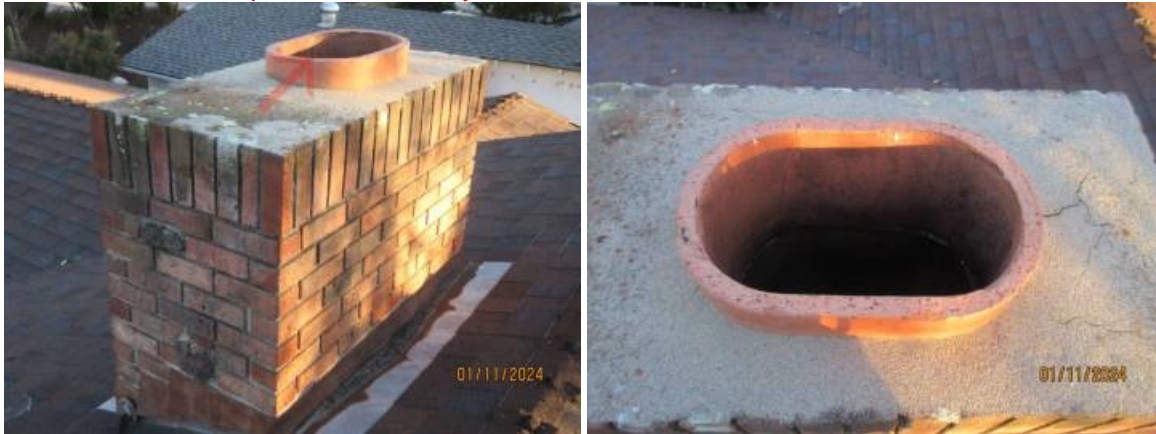
The chimney appears serviceable and no major problems were observed that would affect the operation of the fireplace. A proper spark arrester rain cap is needed for safety and to prevent water entry into the flue. There is a screen unit lying on the roof, yet this is not a proper spark arrester rain cap for the chimney structure.

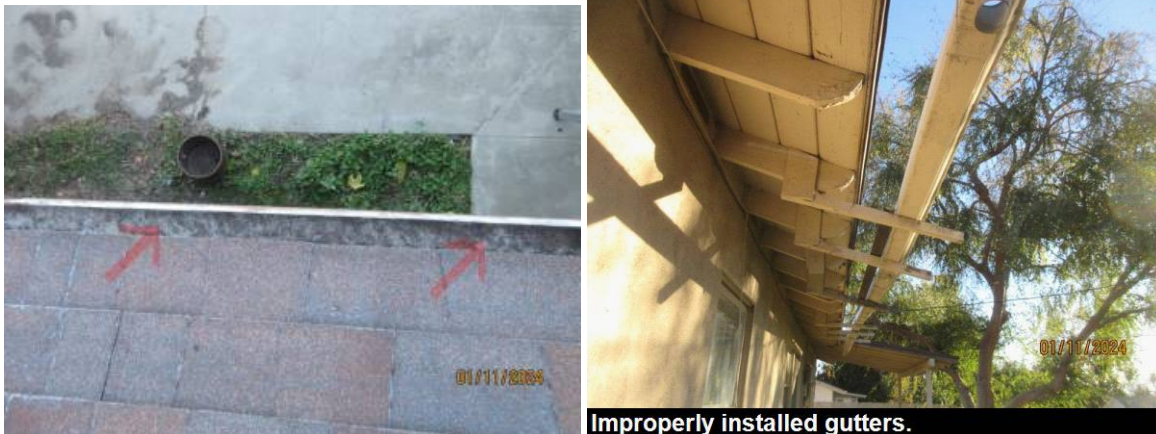
The gutters are filled with debris. We recommend all debris be removed to ensure proper drainage. The trough at the back of the house is not properly installed under the roof edge areas. Repair or replace as needed.

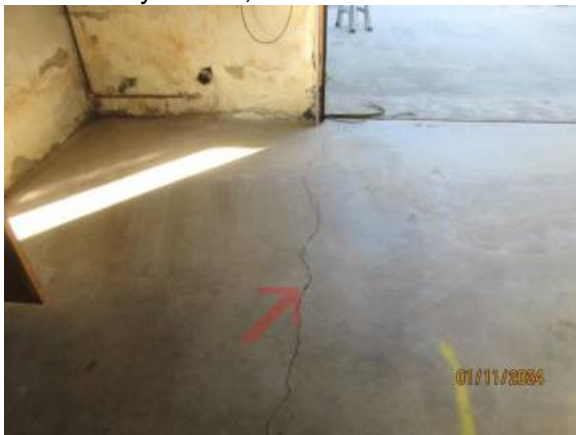
Typical concrete cracks noted. There are uneven areas in the slab floor of garage. Floor is not fully visible, due to stored items blocking view of this area.

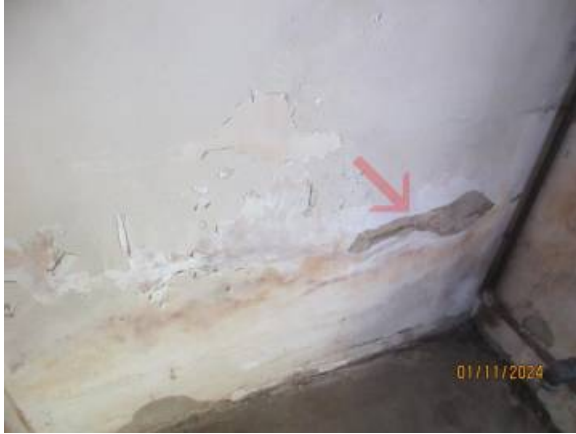
There are holes or openings in the fire resistive wall between the garage and living space. Repair any openings with approved materials to restore its fire rating for safety. The fire wall is not completely visible or accessible due to the items blocking view and access to this area.

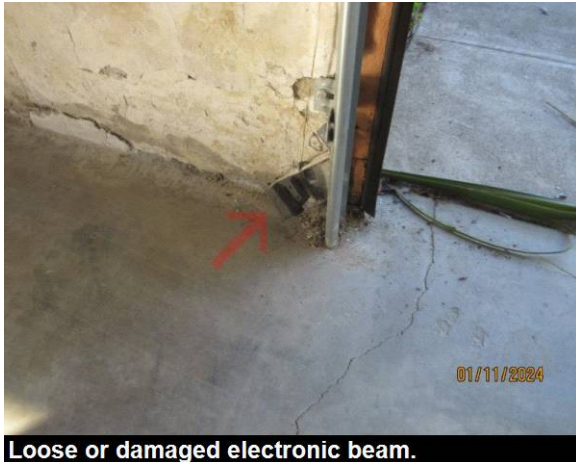
The garage door opener does not operate and function properly. The electronic beam is damaged and not properly installed. Repair this opener as needed. Automatic reverse feature cannot be tested or operated until the opener is operational. Repair as needed. The garage door openers are required to have a battery back-up power to the opener(s) on all newer garage door openers installed. This could not be properly verified at this time. Recommend further review as needed.

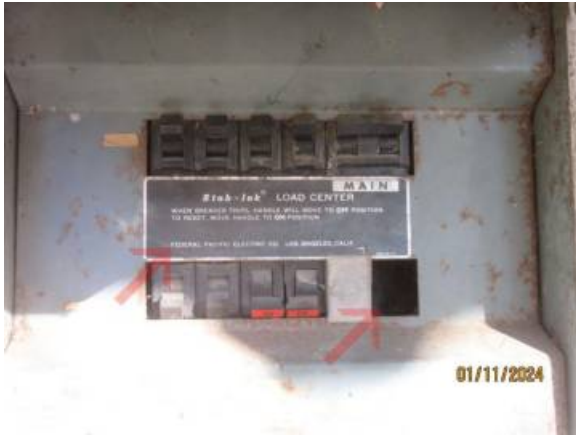
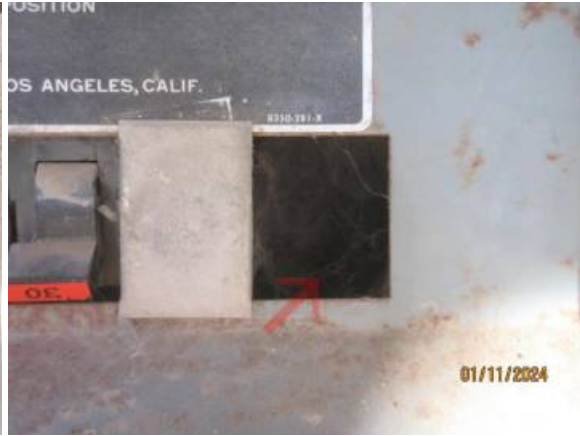
**This is a Federal Pacific electrical panel. This type of electrical panel has had problems with the breakers and circuits fusing to the buss bar and causing fires and unsafe conditions to the electrical panel. These breakers throw in opposite directions and can cause the breakers to turn off or trip when the panel cover is removed. Caution is needed with this panel and circuits. Recommend further review to this panel and system by a qualified electrician for safety and functional use. The circuit breakers are not labeled as required. We recommend labeling to allow individual circuits to be shut off rather than all circuits, if electrical repairs are needed. The panel cover screws are missing or improper type. We recommend proper blunt end screws installed. Twist-outs are missing (unused breaker slots) at the panel. This increases the likelihood of persons contacting the "live" electrical components within the panel, we recommend the slots be sealed with approved filler plates or knockouts.**

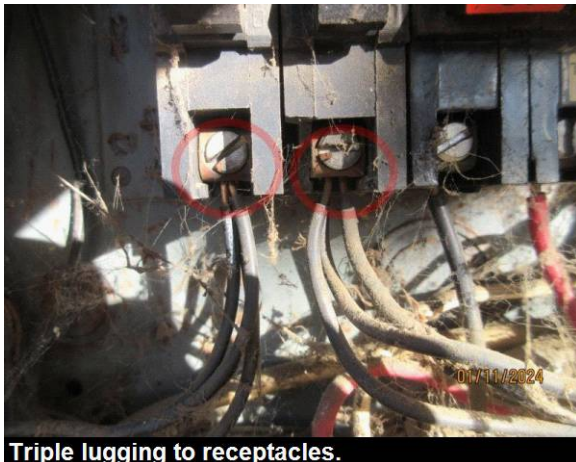
Multiple wires are connected to a single lug on several circuit breakers where only one wire should be connected. This "double lugging" and "triple lugging" is not permitted because a positive connection for all wires is not assured. We recommend the circuitry be reconfigured and additional breakers be installed as needed. Have a licensed electrician make further evaluation and corrections as needed.

Triple lugging to receptacles.

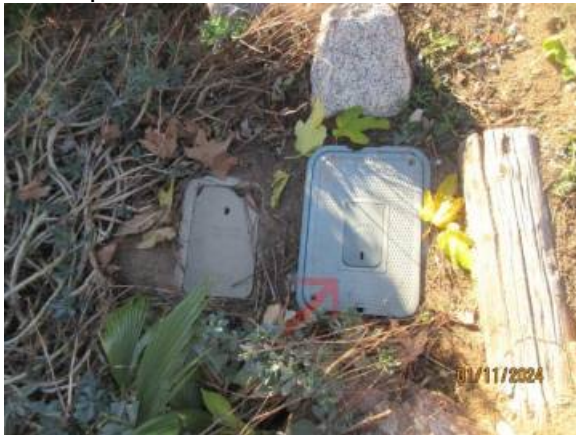
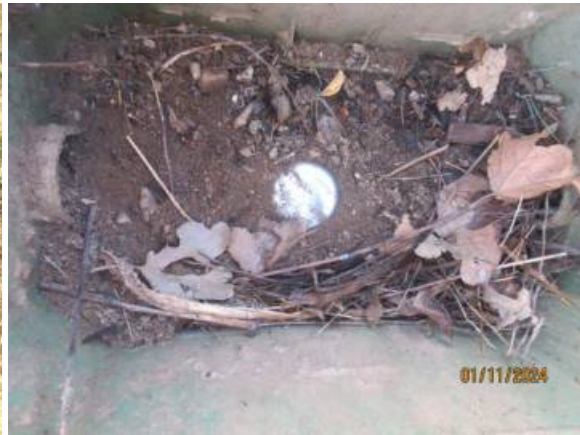
Copper in the visible areas. The water meter is located in a vault at the street on the left side of the property. **The water meter vault is filled with dirt and the main water shut off valve, at the meter area, is buried and not visible to inspector. Remove the dirt to inspect the condition of this valve for proper and functional use as needed.** The water meter is dry at the time of the inspection.

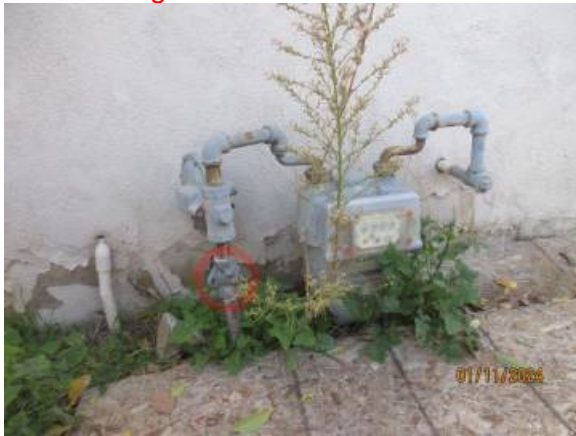
Meter located at left side of the building. The gas meter appears in serviceable condition. There is no meter wrench attached to the meter. We recommend purchasing a wrench or installing a seismic automatic shut off valve for safety.

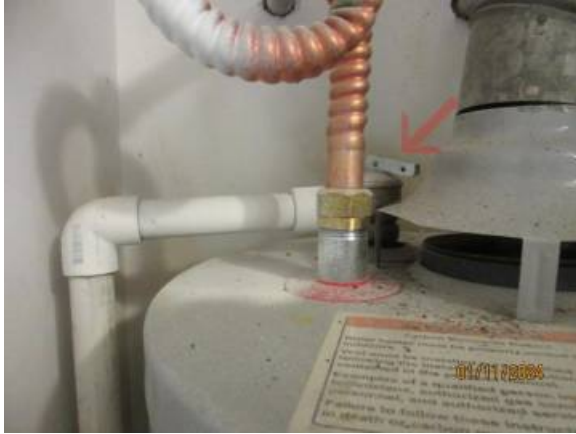
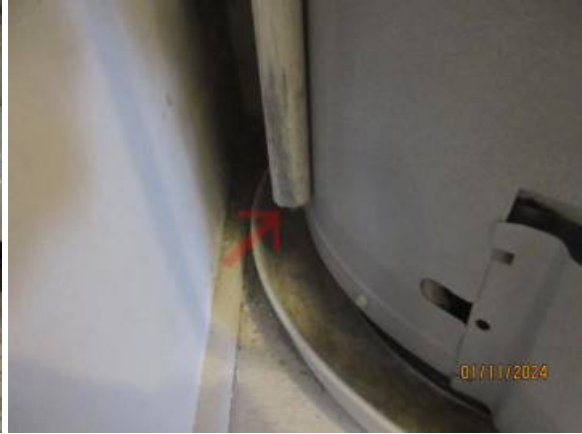
A temperature pressure relief valve is installed as required, it was not tested and it should not be altered or blocked off, if leakage occurs it should be replaced. The temperature/pressure relief valve drain line is missing or ends prematurely. This is a safety hazard and indicates a non professional installation. We recommend this drain line be extended to a safe location.

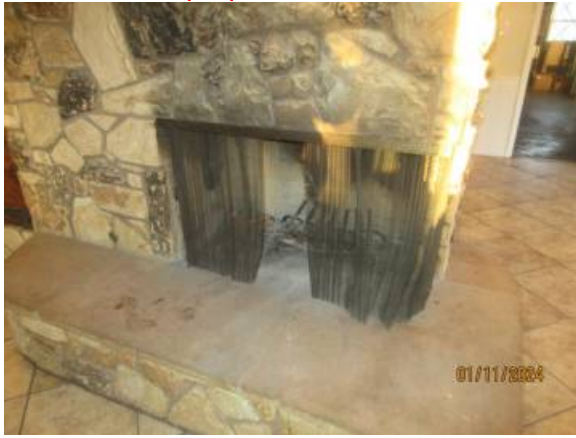
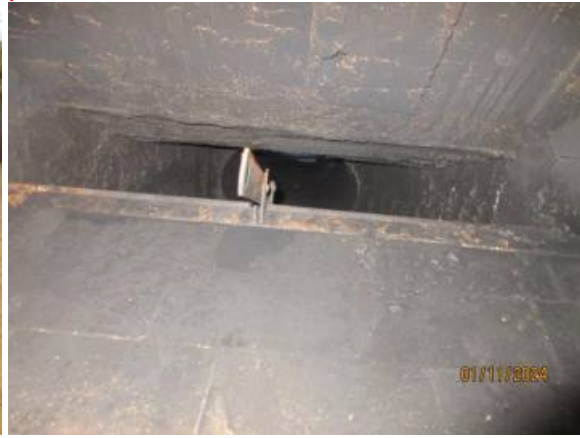
Mortar joints are intact. Damper is operational. **The gas line is capped off and it is not in use. Check for proper use and function and repair as needed.**

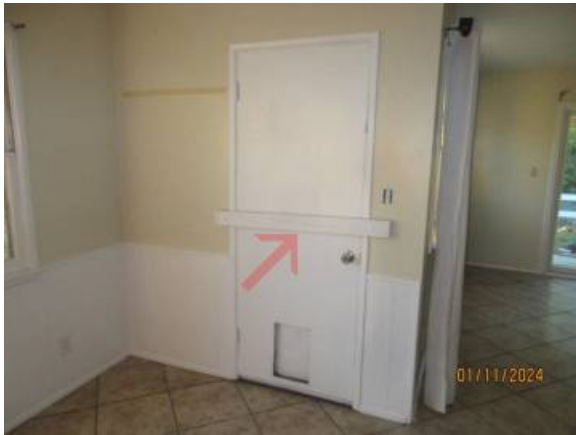
The door to the outside is secured closed and it is not in use. Repair or replace as needed.

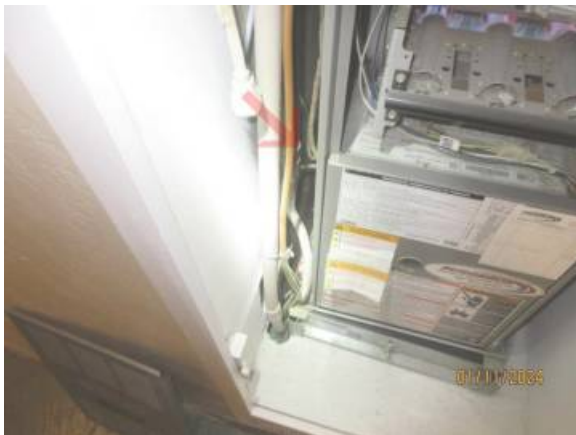
Natural Gas. The gas valve is installed but not tested. An approved flexible gas connected is installed. **There is not a gas sediment trap on the gas line at the gas valve area. Repair and add as needed.**

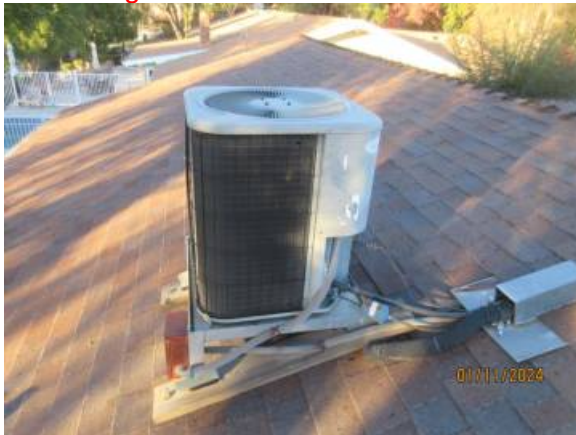
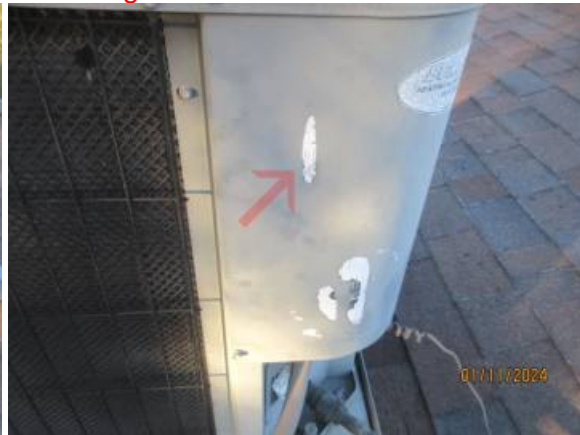
Gas heat with air conditioning combined. This unit is located on top of the roof. **The label is not legible and could not determine the size and age of this unit.**

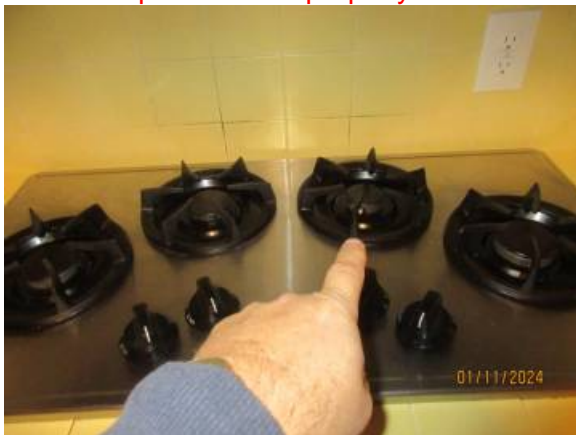
Gas. Separate cook top from the oven. The oven responded to normal operating controls at the time of the inspection and appear serviceable. **One of the back middle burners on the cooktop did not lite properly when tested. Repair as needed.**

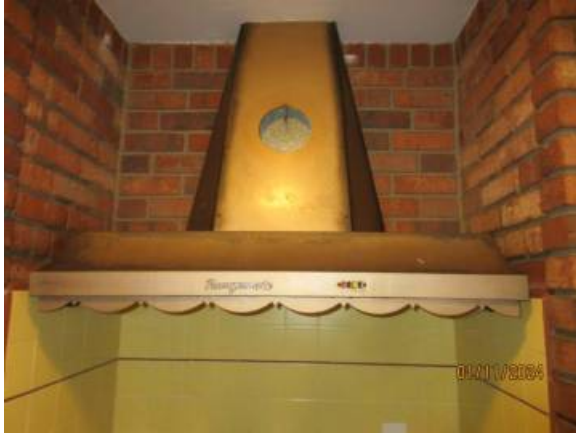
**Fan/Hood was not operational. We recommend it be repaired or replaced as needed. Check for proper power to this unit. Lights are inoperative when tested. Check the bulb and repair as needed.**

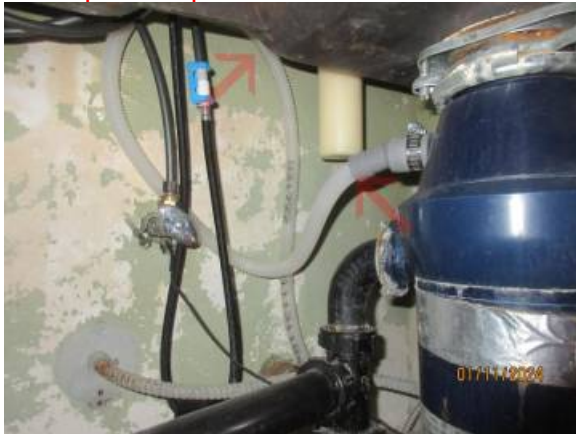
The dishwasher was turned on and operated to normal operating controls. It is in serviceable condition for its age. **We recommend installing an air-gap device on the drain line as required to prevent possible contamination of the dishwasher if plumbing backups occur.**

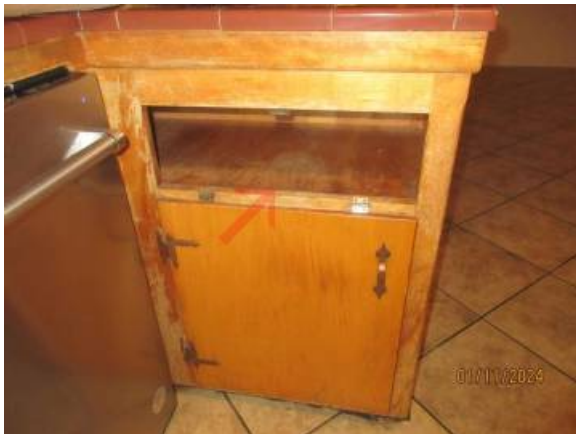
The countertops show typical minor wear or cracking. The cabinets and drawers show moderate to heavy wear. We recommend repair and/or refinishing to maximize their service life. The cabinets have minor wear and need minor adjustment of the hinges. Missing or damaged drawer front in one area as well. The sink base cabinet shelf is damaged from moisture. We recommend it be replaced or repaired as needed.

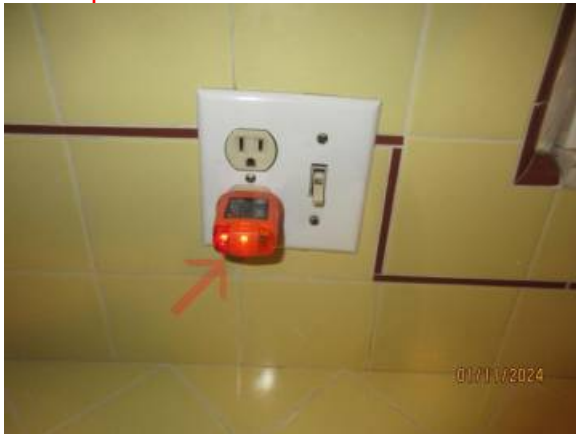
Incorrect wiring to one or more receptacles was observed. The receptacles on both sides of the sink have reverse polarity. We recommend the receptacles be properly wired with correct polarity as needed. Receptacles within 6 feet of the sink are not GFCI protected. Upgrading is not required but we recommend it for safety. There are a minimal number of electrical receptacles in this area. We recommend additional receptacles be added to prevent the use of extension cords. There needs to be GFCI protection for all counter top receptacles for safety and functional use, by today's standards. Repair and add as needed. Some lights are inoperative when tested. Check the bulbs first.

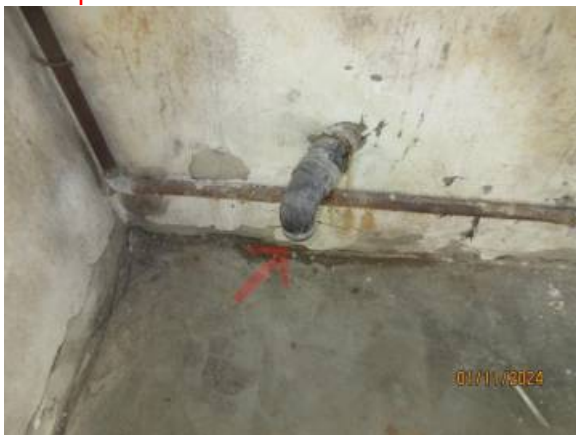
There is not a stand pipe installed in this area. Check for proper drainage in this area and repair as needed.

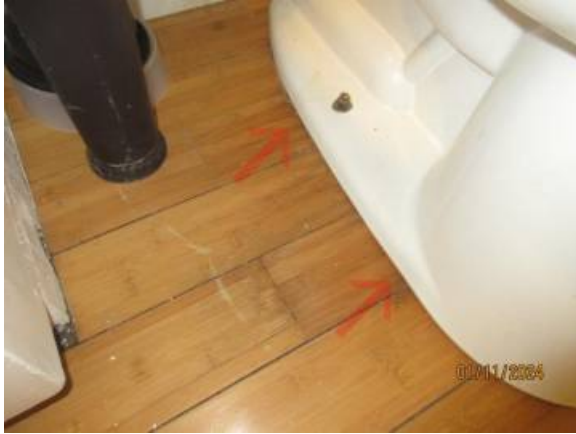
The following item(s) were noted at the toilet: There is leaking in the toilet when flushed. Moisture is detected at surrounding floor. We recommend the source of moisture be determined and corrected. Repair as needed. This toilet has a low flow rating of 1.6 gpf or a lower rating on the toilet. This can not be verified, only to determine it is rated as such.

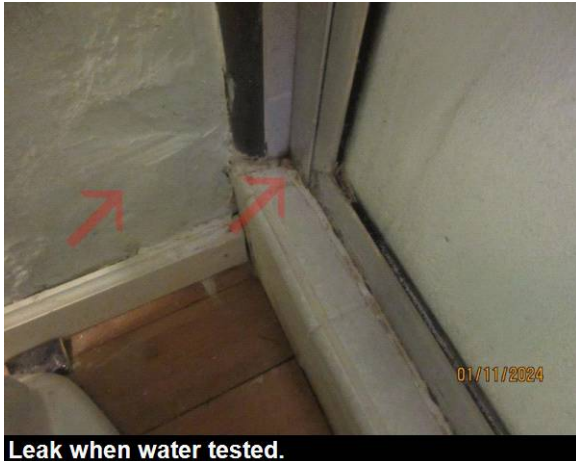
Enclosure appears properly installed, serviceable and has the required safety glass. The shower enclosure leaks in the lower corners and damage may result. We recommend it be properly repaired or replaced.

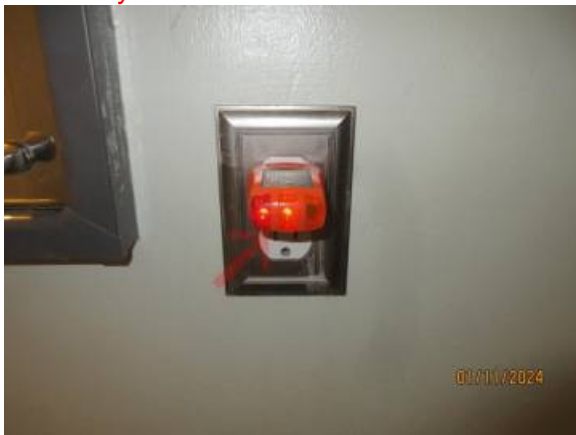
The receptacle was observed to be wired backwards, or in reverse polarity. Under some circumstances, this can be a shock hazard and/or damage electronic equipment. It is easy to correct this condition and we recommend repairs. There is not a GFCI circuit for this outlet. This was not required when the property was originally built. This would be a good upgrade for safety.

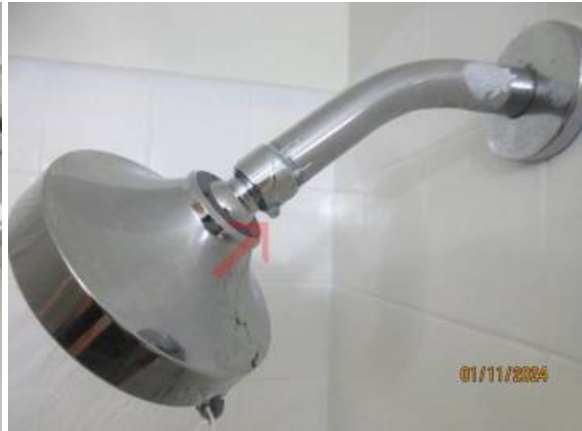
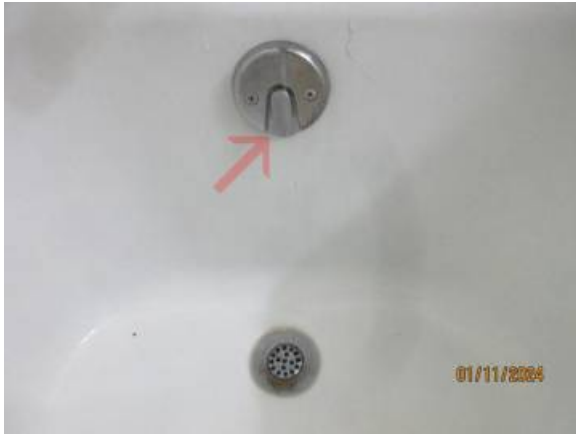
**Minor leakage is noted at faucet handles and/or the tub diverter. We recommend new valve stems be installed or faucets be replaced. The shower head leaks or sprays improperly. We recommend it be replaced. The following item(s) were noted at the tub/shower drain: Mechanical drain stopper is not operational at tub.** This shower head has a low flow rating of 2.5 gallons per minute or less. This is indicated by the label rating on the faucet. This is not verified only to determine the faucet has this rating on it. The drain appears serviceable and emptied in a reasonable amount of time.

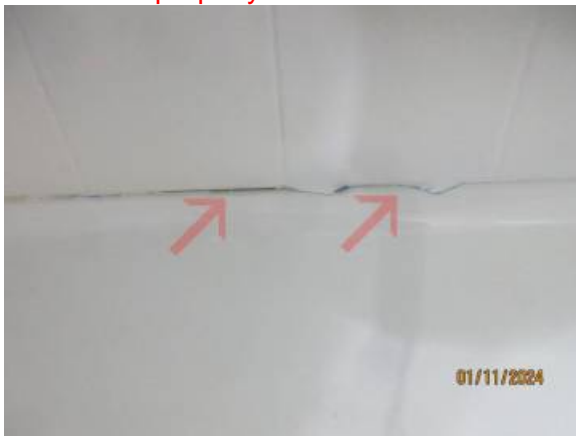
Caulking and/or re-grouting is needed to prevent water intrusion in these areas. Repair and seal off properly as needed.
