# WOOD DESTROYING PESTS AND ORGANISMS INSPECTION REPORT

| Building Address:<br><b>326 S. Parkwood Ave., Pasadena, CA 91107</b> | | Date of Inspection<br><b>05/07/2019</b> | Number of Pages<br><b>7</b> |
| <br><b>Del Rio Termite &amp; Pest Control</b><br>1508 Highland Ave. Duarte, CA 91010<br>Phone: (626) 930-8722 Fax: (626) 930-8723 | <br>NAT-84206-1 | | Report #<br><b>W18306</b> |

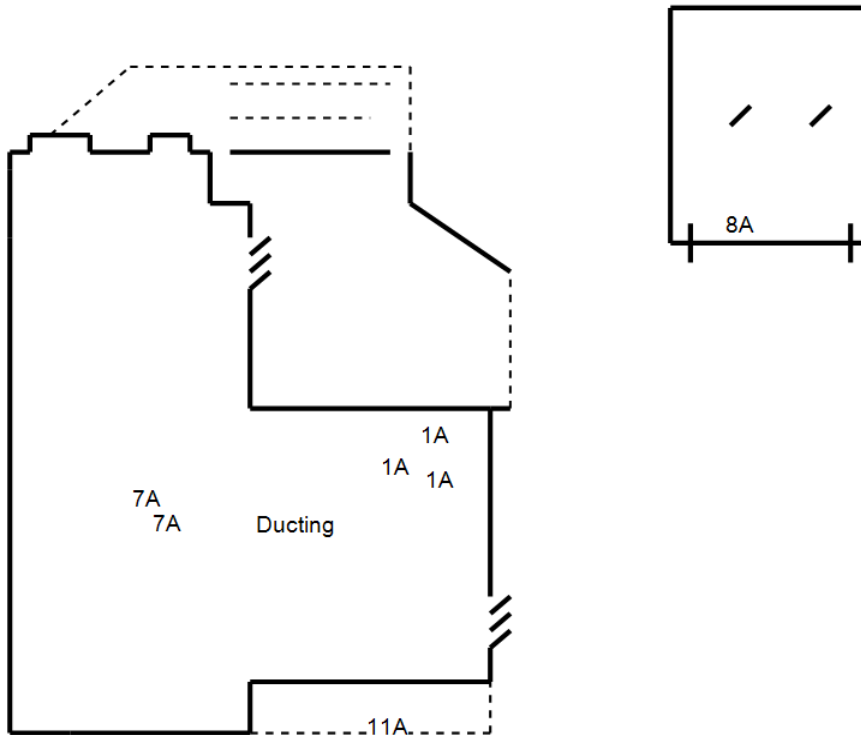
This Diagram is not to scale

FINDINGS: Evidence of drywood termite infestations at sub area.

7A PRICE: \$280.00 (Section I)  
FINDINGS: Evidence of drywood termite infestations at attic.  
RECOMMENDATION: Chemically treat visible and accessible infestations. Liquid solutions may be applied in the form of mist spray to exposed framing. Liquid solution may also be injected into termites galleries where infestations are accessible. Remove or cover all accessible pellets and frass of wood-destroying pests. NOTE: LOCAL TREATMENT IS NOT INTENDED TO BE AN ENTIRE STRUCTURE TREATMENT METHOD. IF INFESTATIONS OF WOOD DESTROYING PESTS EXTEND OR EXIST BEYOND THE AREA (S) OF LOCAL TREATMENT THEY MAY NOT BE EXTERMINATED. ONE YEAR LIMITED GUARANTEE ON ALL TREATMENTS DONE BY THIS COMPANY.

8A PRICE: \$120.00 (Section I)  
FINDINGS: Evidence of termite damaged wood members noted at garage top plate and cripple at time of inspection.  
RECOMMENDATION: Replace/Repair damaged wood members as necessary. If additional adverse conditions are uncovered during repairs, further inspection will be recommended and a supplemental report will be issued indicating any infection, or additional repairs.

11A PRICE: \$90.00 (Section I)  
FINDINGS: Fungus condition visible at exterior rafter end at time of inspection.  
RECOMMENDATION: Scrape and Chisle out damages, Chemically treat Fungus condition with an EPA registered Fungicide. Patch with approved wood filler and or repair as necessary. Paint to match as necessary.

RECOMMENDATION: Chemically treat visible and accessible infestations. Liquid solutions may be applied in the form of mist spray to exposed framing. Liquid solution may also be injected into termites galleries where infestations are accessible. Remove or cover all accessible pellets and frass of wood-destroying pests. NOTE: LOCAL TREATMENT IS NOT INTENDED TO BE AN ENTIRE STRUCTURE TREATMENT METHOD. IF INFESTATIONS OF WOOD DESTROYING PESTS EXTEND OR EXIST BEYOND THE AREA (S) OF LOCAL TREATMENT THEY MAY NOT BE EXTERMINATED. ONE YEAR LIMITED GUARANTEE ON ALL TREATMENTS DONE BY THIS COMPANY.
