### Inspection/Certification

Inspection Address: **2015 Calle Pattito, Templeton CA 93465**

Brian Padgett – Alliance Septic Service

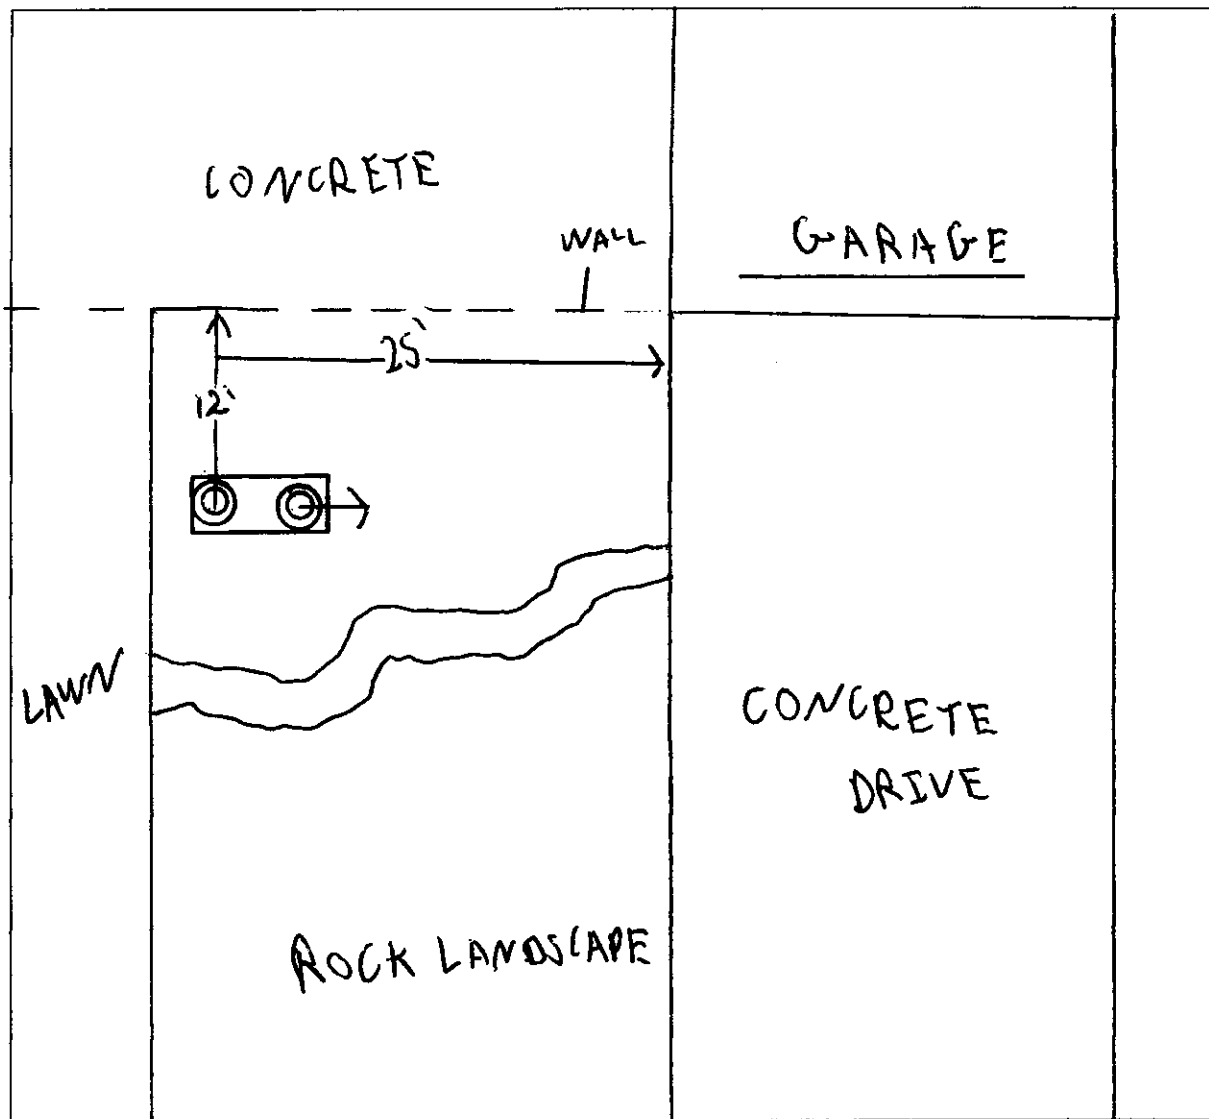
Comments: 1500 GALLON CONCRETE TANK  
UNDER LANDSCAPE

Y Full Diameter Access Risers to Grade      Depth From Top of Tank to Grade 40"
