# **Cornerstone Inspection**

## **Property Inspection Report**

**1556 Gulf St, San Luis Obispo, CA 93405**

**Date of Inspection: 10/7/2025 Time: 1:00 PM**

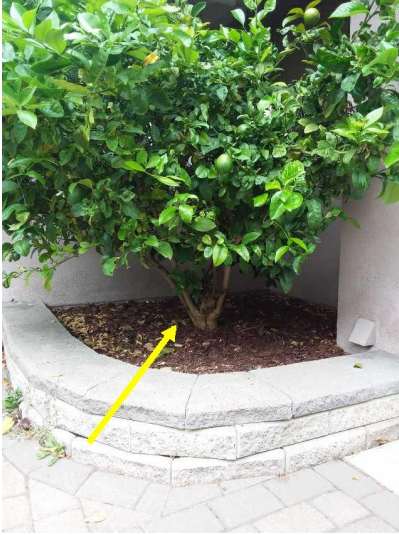
2.7. There are planter beds that will trap water against the walls of the residence which can never be sensibly approved. This condition may allow the possibility of moisture intrusion into the residence. If they are to remain, they should be retrofitted to have several one-inch weep holes at their base. It would be prudent to periodically monitor the adjacent interior walls.

There are planter beds that will trap water against the walls of the residence which can never be sensibly approved. This condition may allow the possibility of moisture intrusion into the residence. If they are to remain, they should be retrofitted to have several one-inch weep holes at their base. It would be prudent to periodically monitor the adjacent interior walls.

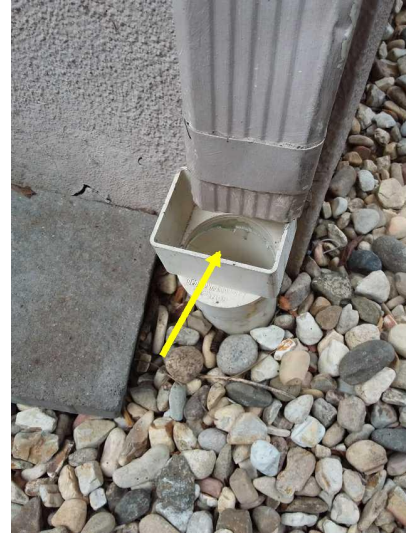
2.9. There are missing or broken area drain covers. This could have allowed leaves and other debris to enter the drain lines and contribute to blockages. Therefore, it would be prudent to have the lines flushed through to the street or to their termination point before the broken covers are replaced.

There are missing or broken area drain covers. This could have allowed leaves and other debris to enter the drain lines and contribute to blockages. Therefore, it would be prudent to have the lines flushed through to the street or to their termination point before the broken covers are replaced.

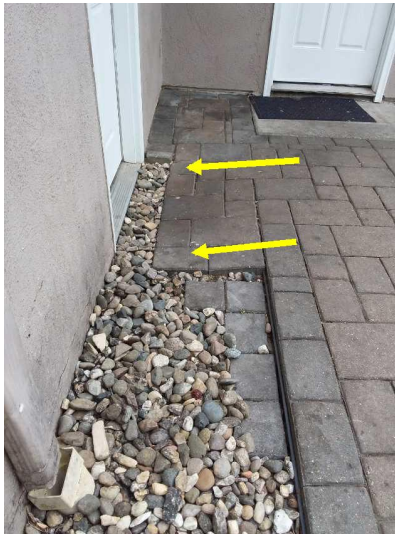
2.3. There are areas at the rear where water will be directed toward the house instead of away from it, as recommended. This not only allows for the possibility of moisture intrusion but also differential settling.

There are areas at the rear where water will be directed toward the house instead of away from it, as recommended. This not only allows for the possibility of moisture intrusion but also differential settling.

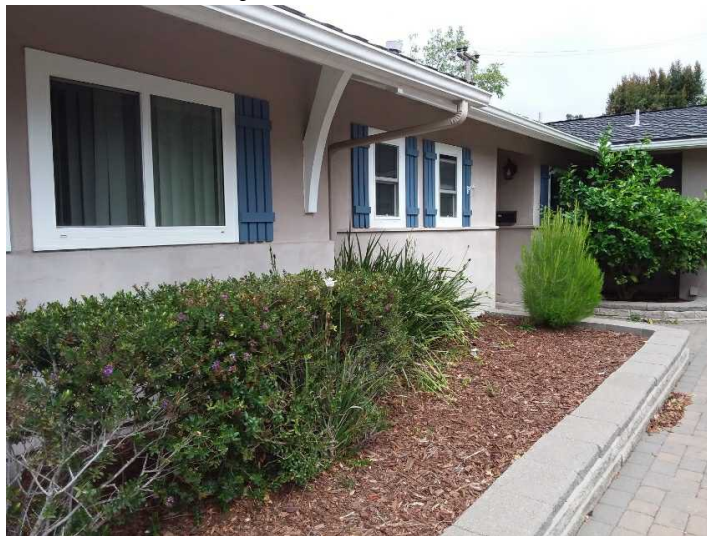
3.2. Vines, shrubs or bushes are growing on the house walls and although they are attractive they can introduce pests and rodents and accelerate deterioration. Therefore, you may wish to consider having them removed or cut back to 12 inches away from the home.

Vines, shrubs or bushes are growing on the house walls and although they are attractive they can introduce pests and rodents and accelerate deterioration. Therefore, you may wish to consider having them removed or cut back to 12 inches away from the home.

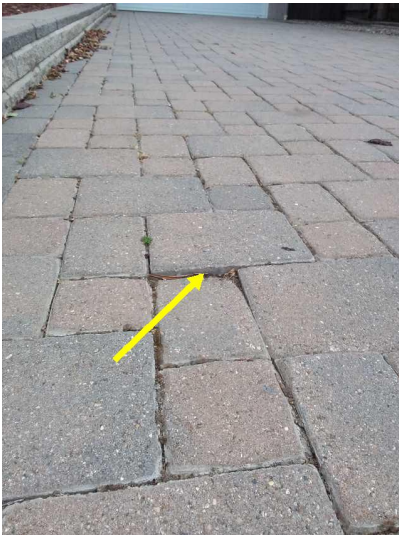
There is one or more offsets in the driveway that could prove to be trip-hazards.

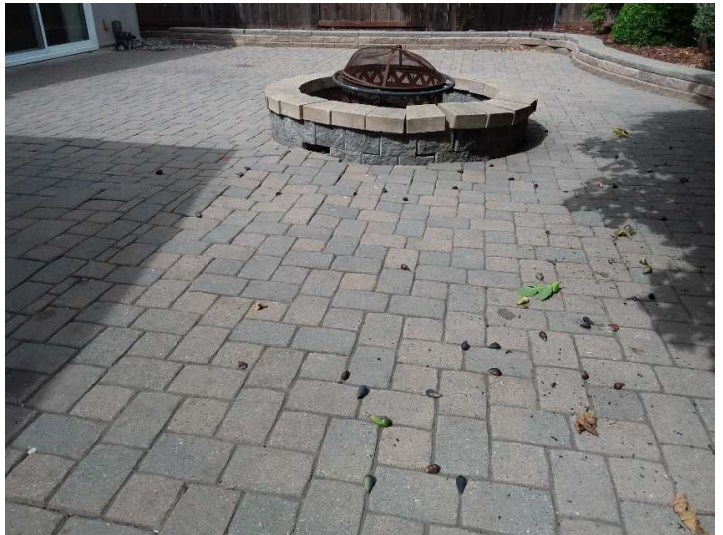
The paver patio or walkway has multiple offsets. This may be due to unsuitable soil below the pavers.

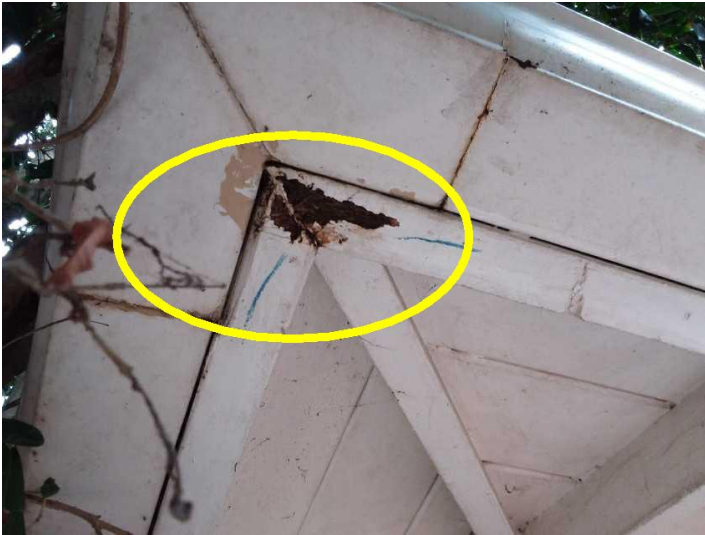
There is damage to the wood trim that should be evaluated by a termite inspector.

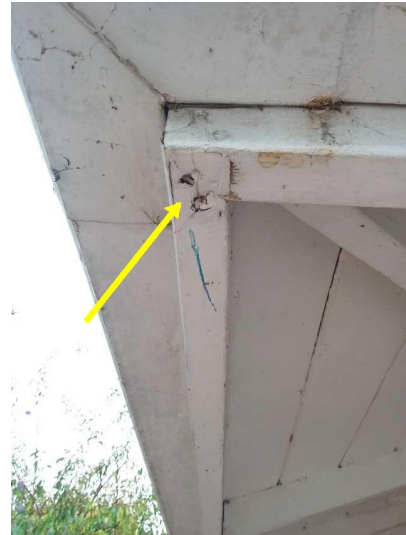
There is damage to the wood trim that should be evaluated by a termite inspector.

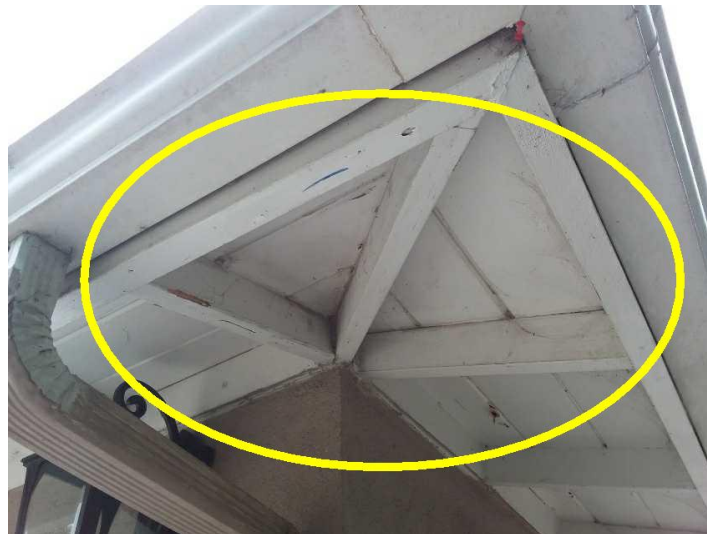
There is damage to the wood trim that should be evaluated by a termite inspector.

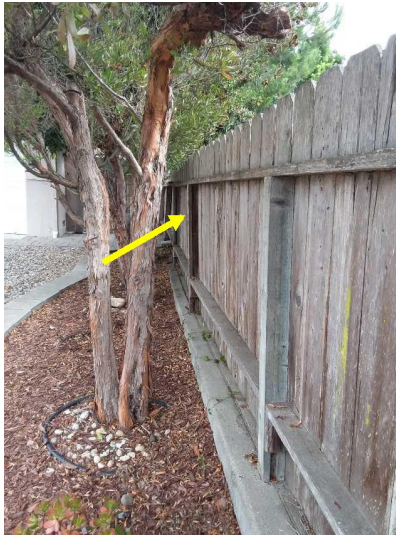
9.3. Sections of the fence are leaning or missing which you may wish to have repaired or replaced.

Sections of the fence are leaning or missing which you may wish to have repaired or replaced.

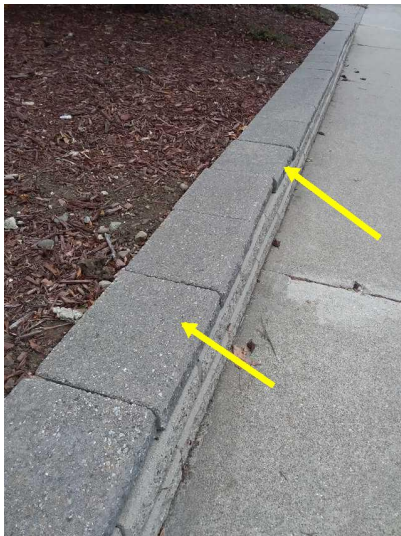
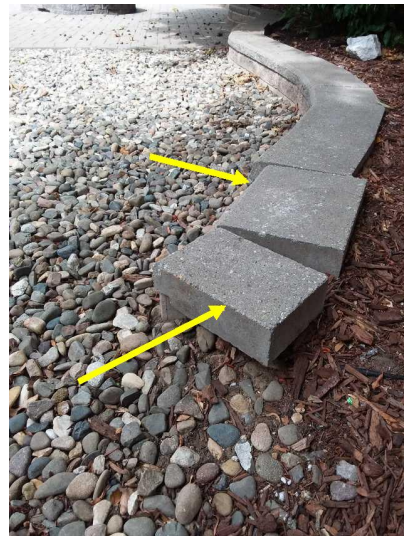
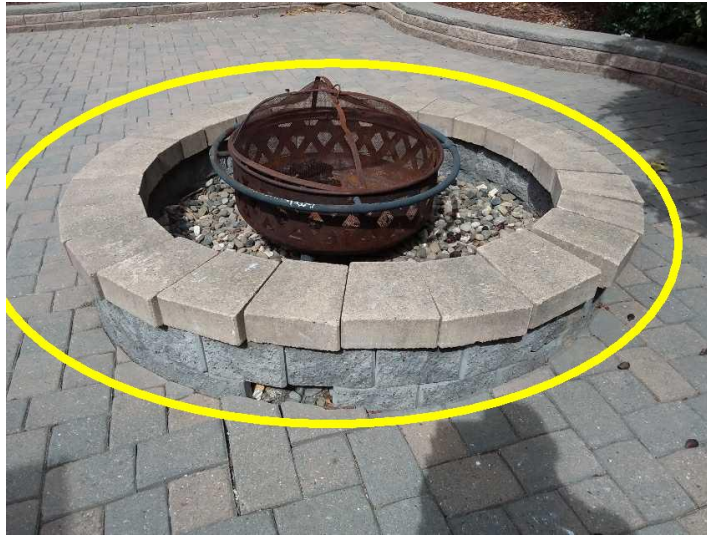
10.2. Some of the planter block-caps are loose or missing and should be serviced.

Some of the planter block-caps are loose or missing and should be serviced.

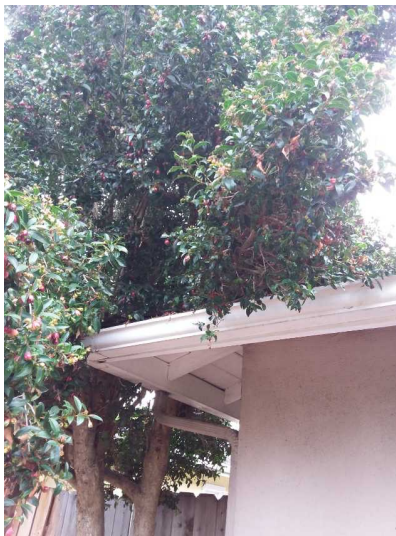
11.2. There are tree limbs over growing the residence that should be trimmed or monitored to insure that they do not impact or damage the roof or its components.

There are tree limbs over growing the residence that should be trimmed or monitored to insure that they do not impact or damage the roof or its components.

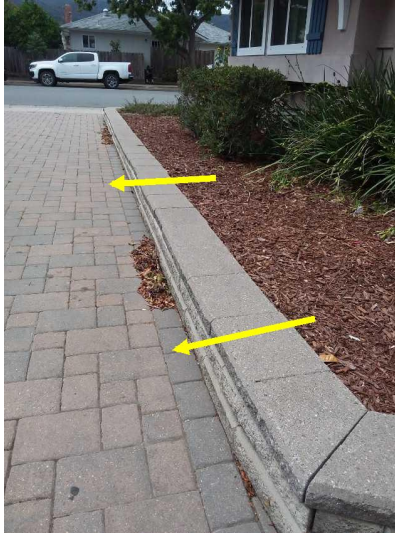
12.2. There are areas of this property that do not have guardrails, which are required for walk-offs greater than thirty inches. While there are walk off's less than 30 inches, appropriate precautions should be taken to safeguard children and the elderly.

There are areas of this property that do not have guardrails, which are required for walk-offs greater than thirty inches. While there are walk off's less than 30 inches, appropriate precautions should be taken to safeguard children and the elderly.

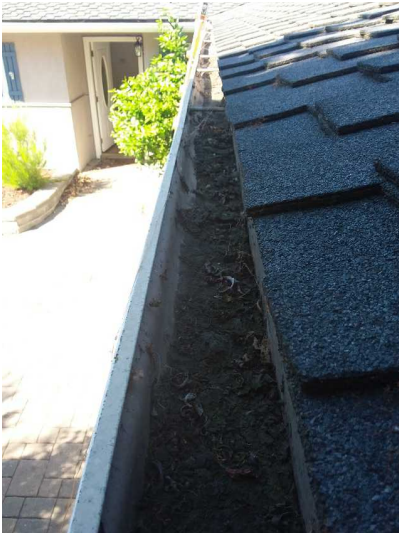
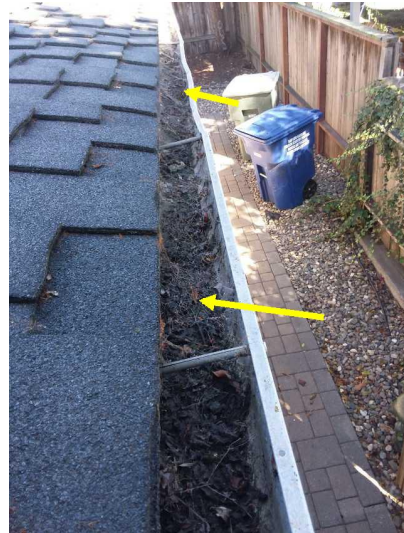
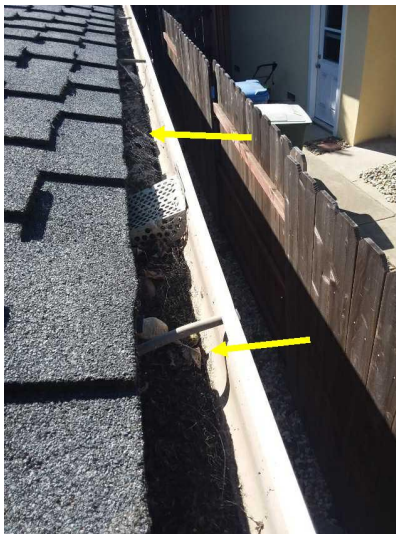
Some of the gutters need to be cleaned to drain properly.

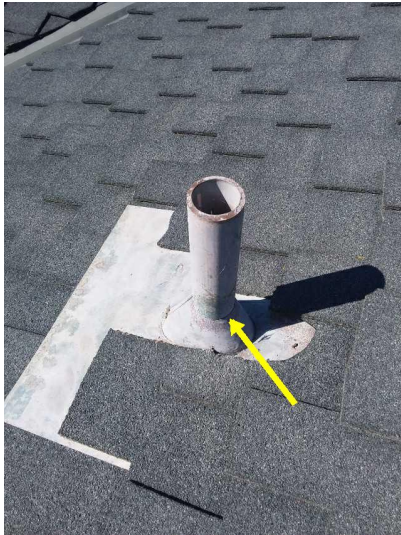
2.7. Some of the roof flashing need to be sealed or serviced. They are comprised of metal that seals valleys and vents and other roof penetrations, and are the most common point of leaks. This is particularly true of the flashing on a layered roof, which are covered by the roofing material and which are even more susceptible to leaks.

Some of the roof flashing need to be sealed or serviced. They are comprised of metal that seals valleys and vents and other roof penetrations, and are the most common point of leaks. This is particularly true of the flashing on a layered roof, which are covered by the roofing material and which are even more susceptible to leaks.

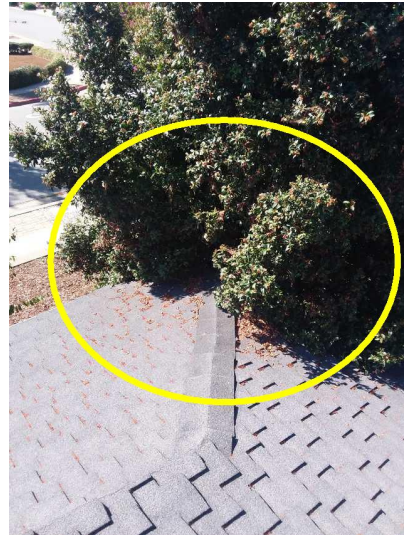
The roof needs to be cleaned and any foliage trimmed away to promote and insure proper drainage.

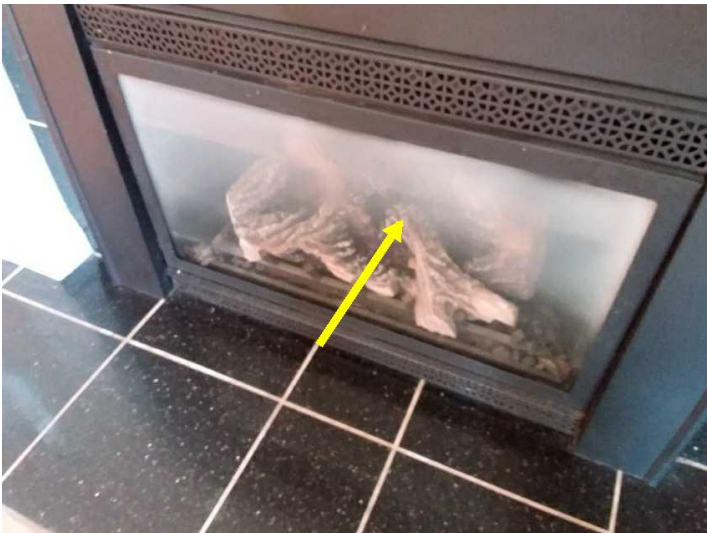
The fireplace glass is functional, however does not have a protective screen, which is required by current standards and should be installed for optimal safety.

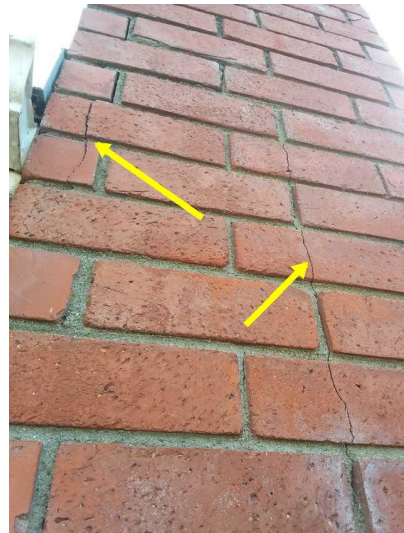
1.10. The chimney wall is cracked and should be evaluated by a specialist.

The chimney wall is cracked and should be evaluated by a specialist.

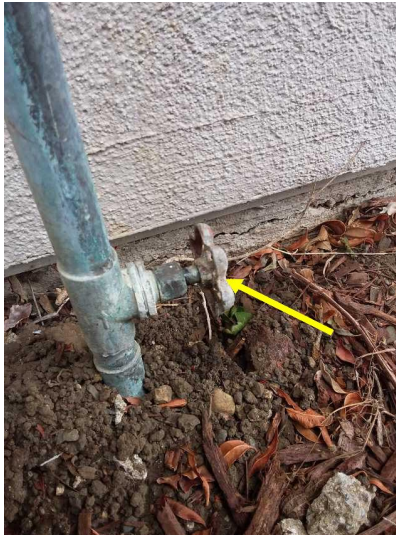
1.5. The main water valve is leaking or dripping and should be repaired.

The main water valve is leaking and should be repaired.

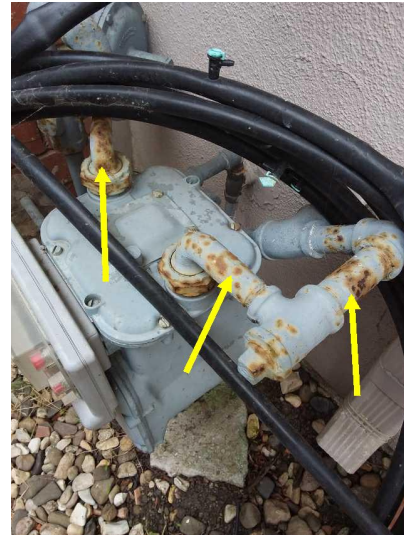
Some of the gas lines at the meter are rusted and should be painted to prevent further corrosion.

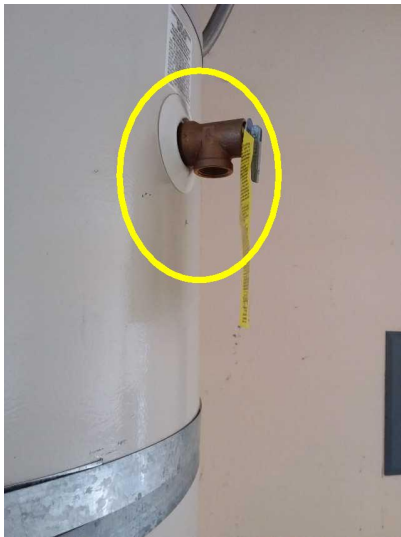
The pressure relief valve on the water heater does not have a discharge pipe. One should be installed to terminate no more than 24 inches above grade and no closer than 6 inches to it and be directed down towards the ground.

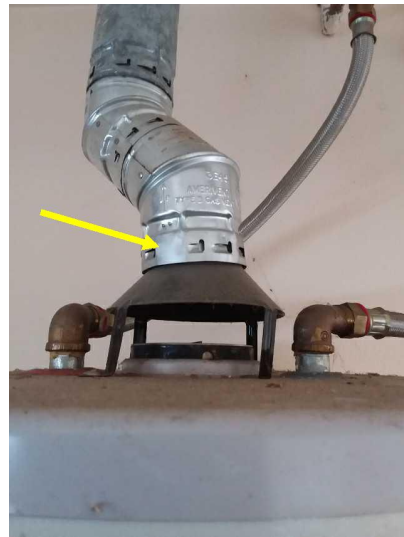
The vent pipe is not properly connected. It is required to have a minimum of 3 fasteners where the pipe connects to the draft hood or other single wall vent pipes.

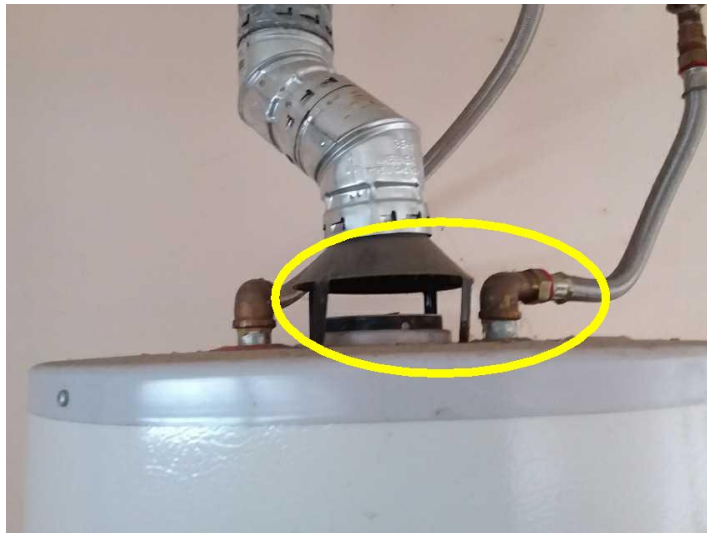
The vent draft hood is not drafting properly and is spilling combusted gases into the garage. We recommend that a licensed plumbing contractor evaluate and service this issue.

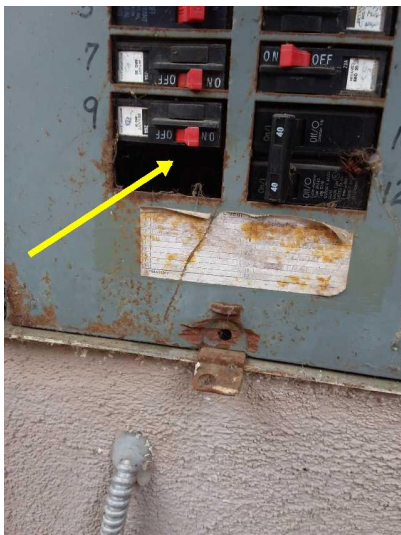
There are voids or open knockouts in the cover of the main electrical panel that should be covered.

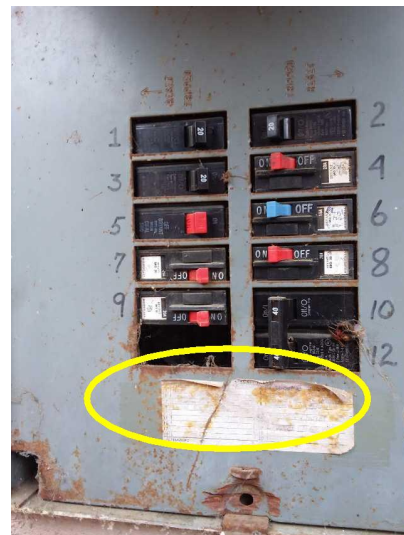
Various circuits are not labeled or legible, which is recommended.

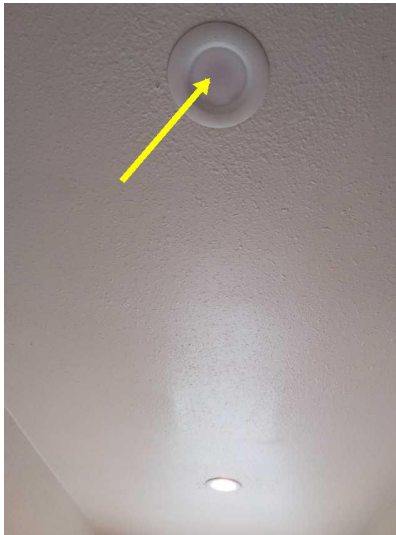
A ceiling light does not respond, and should be serviced.

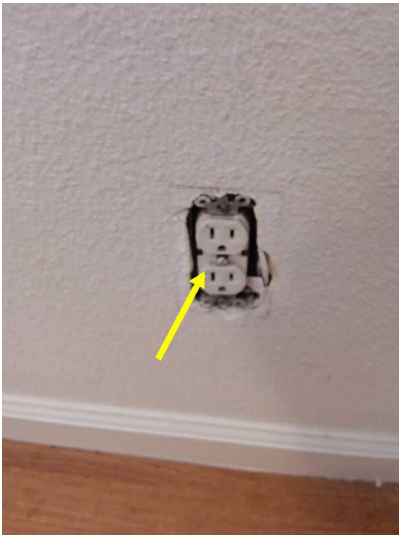
There are outlet or switch covers that are missing and should be replaced.

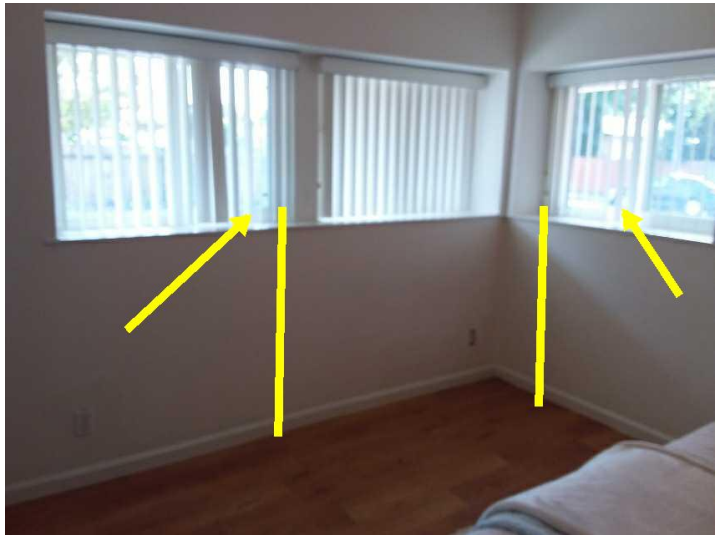
A window is too high or too small to facilitate an emergency exit or egress. Bedroom windows should measure 24" high by 20" wide, with an optimum sill height of 44", to facilitate an emergency exit by the occupant and an emergency egress for a fire person wearing breathing apparatus.

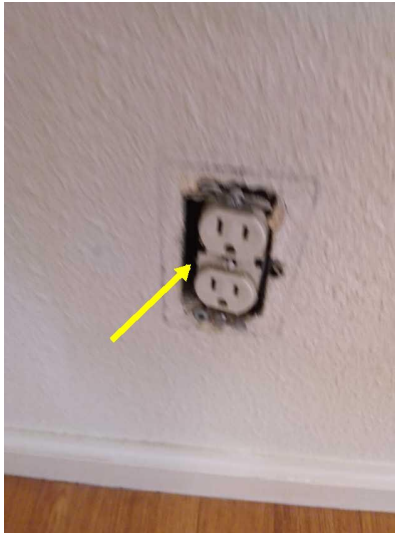
There are outlet or switch covers that are missing and should be replaced.

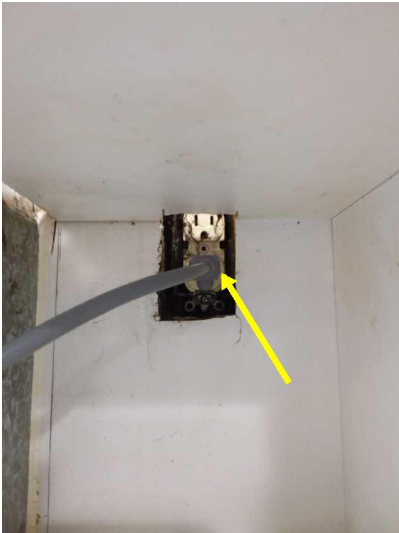
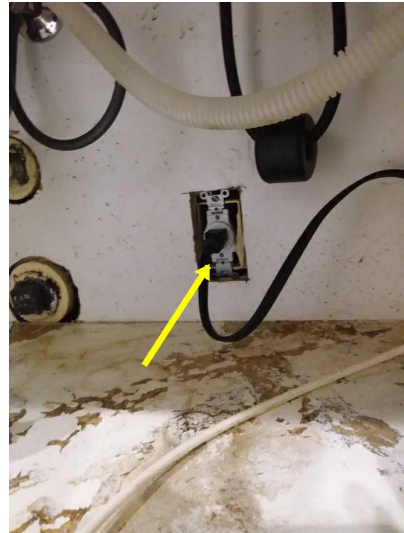
One or more outlet covers is missing or broken and should be serviced.

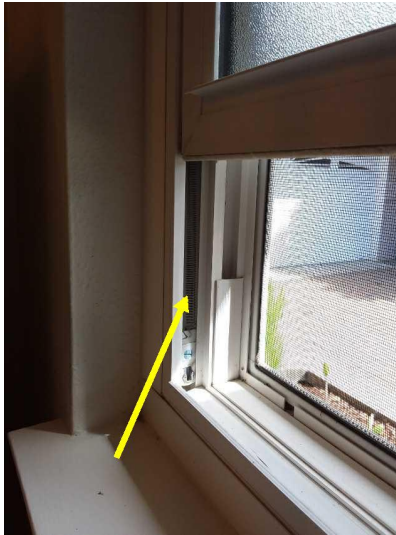
Single or double hung windows do not open smoothly, which could indicate the "balancer" bar needs to be adjusted. We recommend a licensed professional evaluate and service this issue.

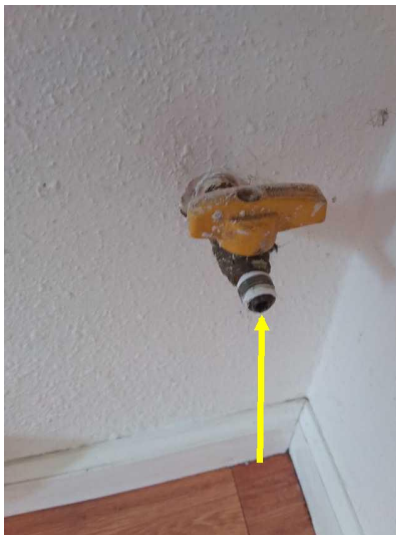
There is no cap on the gas valve. The gas valve should be capped when not in use.

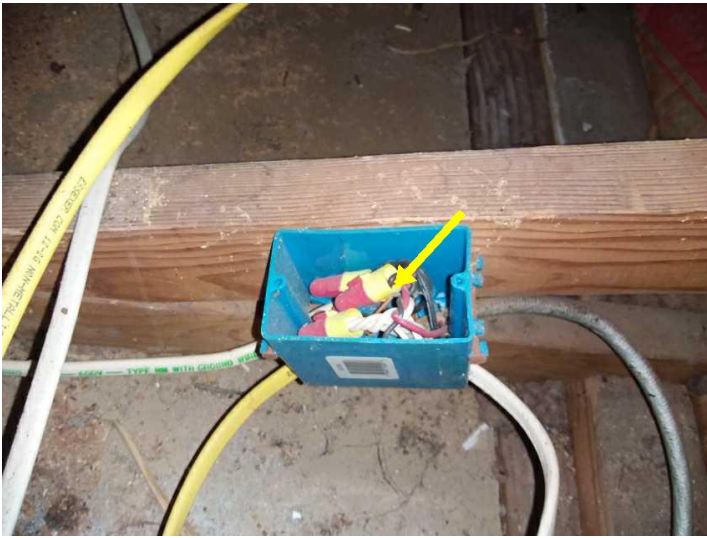
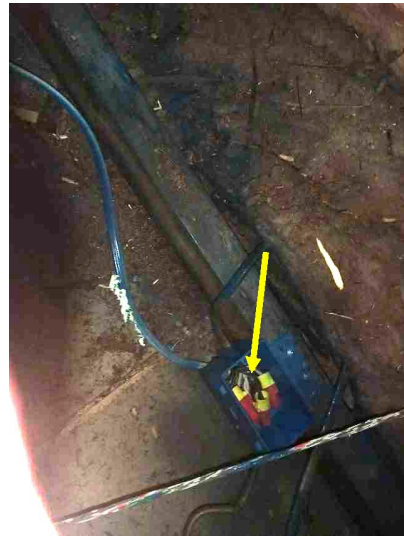
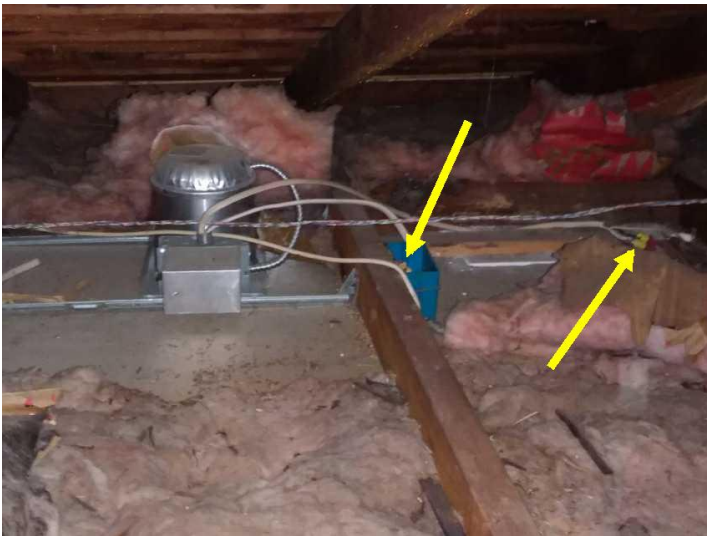
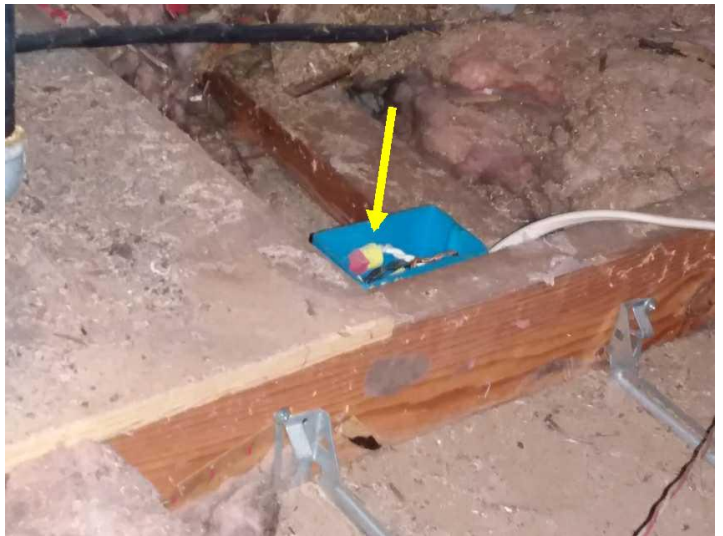
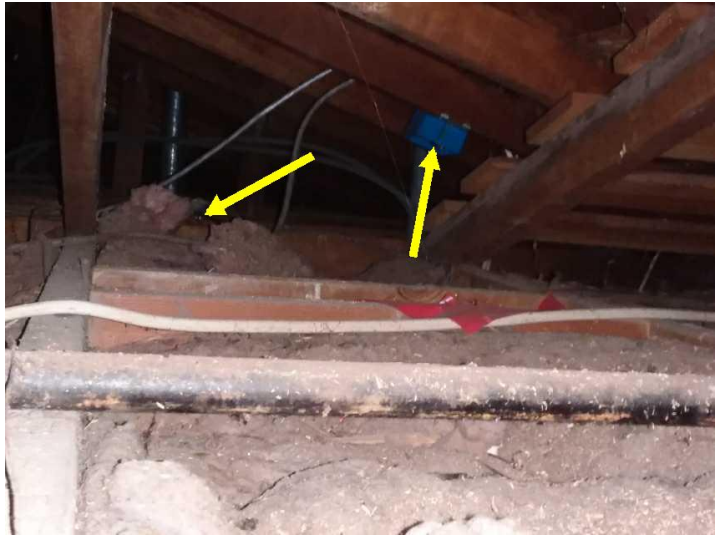
1.17. There are open electrical junction boxes, which should be sealed to contain any arcing or sparking that might occur.

There are open electrical junction boxes, which should be sealed to contain any arcing or sparking that might occur.

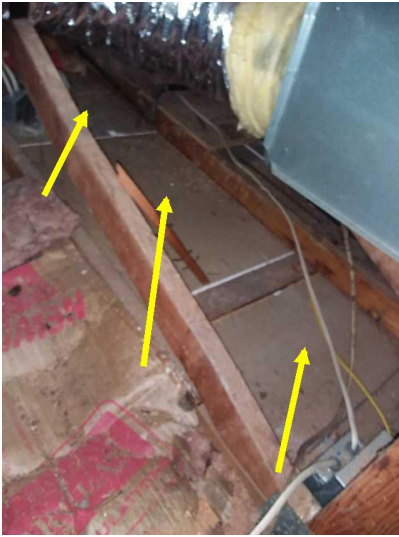
There are areas where the insulation has been moved or improperly installed and should be serviced.

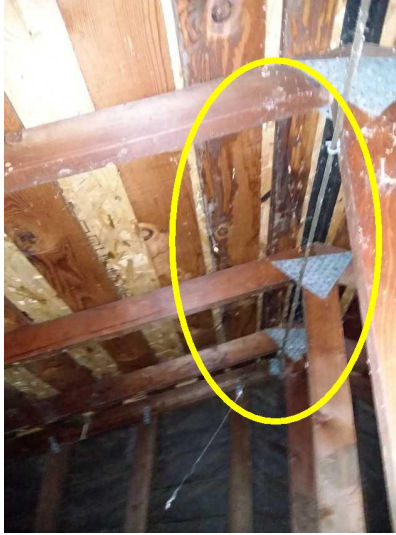
There are water stains on the ceiling that implies that a leak has occurred. Since it was not raining during our inspection, we were unable to determine if the leak is currently leaking, or, it is an old leak that has been repaired. You should ask the sellers for information regarding this issue.

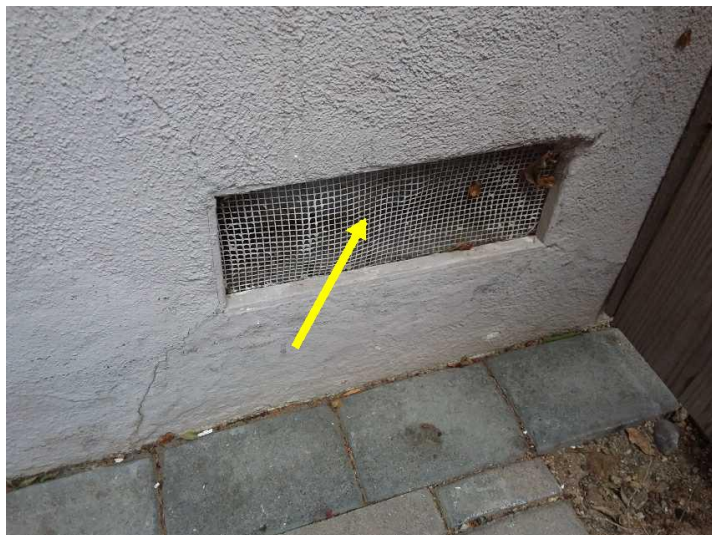
The ventilation ports in the wall have been blocked or covered. If they are not uncovered, vehicle engines and combustion appliances could produce noxious by-products, including deadly, carbon monoxide.

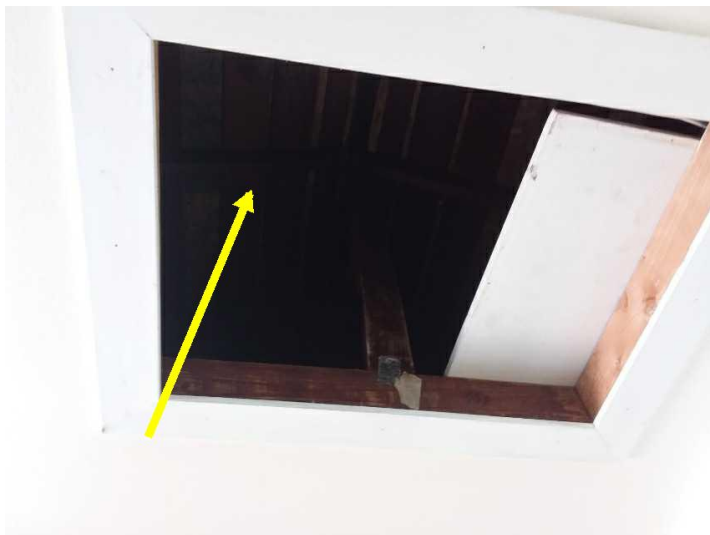
The wooden hatch cover to the attic area should be sheathed with metal or drywall, and made to self close and latch in order to provide a firewall separation between the garage and the residence.

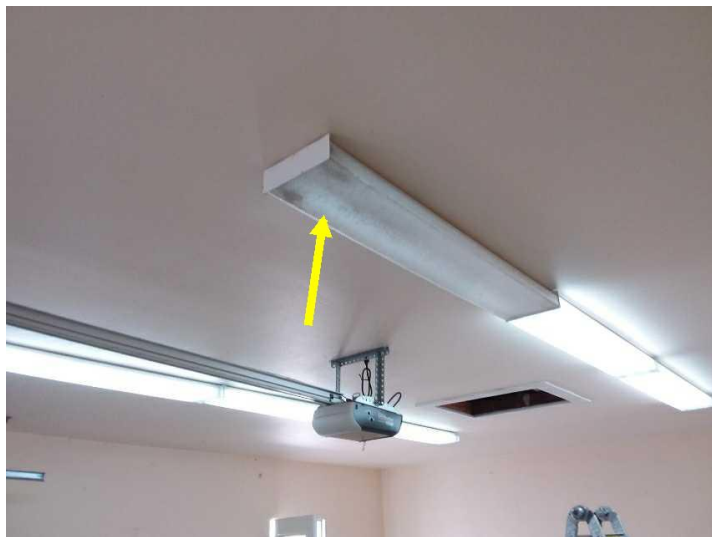
A ceiling light does not respond, and should be serviced.

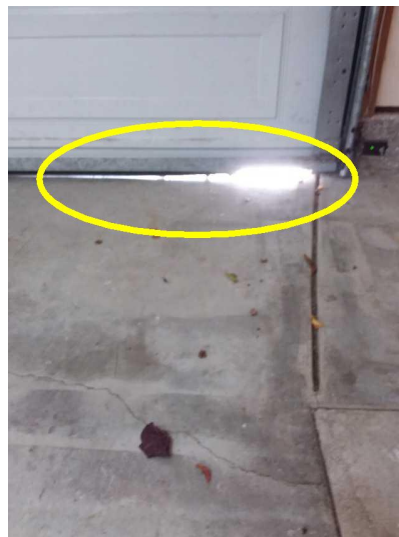
The seal at the base of the garage door is deteriorated and you may wish to have it replaced.
