# INSPECTION REPOTET

1492 Via Coronel, Palos Verdes Estates, CA 90274 Inspection prepared for: Real Estate Agent: Nancy Deperez - Century 21

Date of Inspection: 7/1/2022

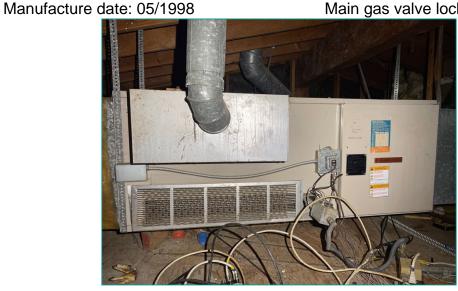
- 1.2. Service shut off; recommend evaluation as needed by a California state licensed HVAC technician when service is restored.
- 1.3. The heating units are approaching their designed life expectancy. We make no warranty, guarantee or estimation as to the remaining useful life of these units.

Main gas valve locked out by Gas Co.

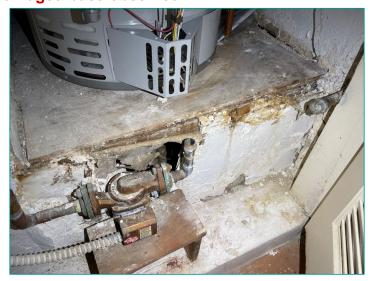
### 1.2. Damaged base observed.

1.1. Recommend evaluation and correction of the following items as needed by a California state contractor.

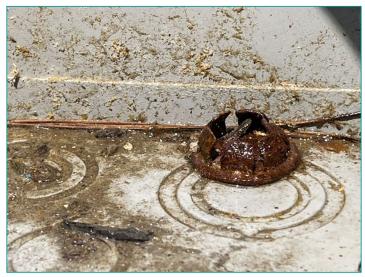
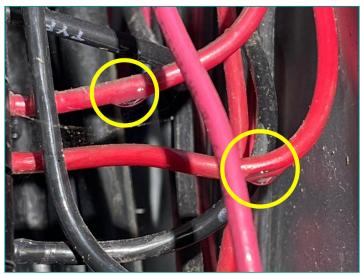
- Evidence of moisture intrusion. Recommend evaluation and correction by a California state licensed electrician.
- Knockouts need snap-in caps inside panel box. Should be installed to panel box to avoid potential electrocution hazard.

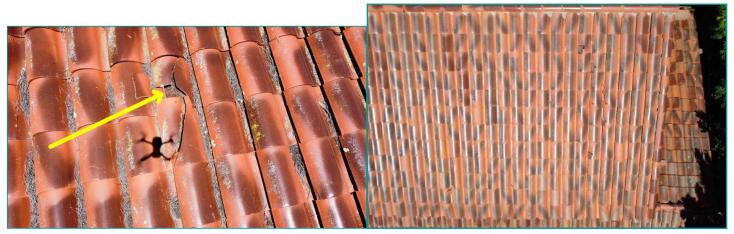
- Clean roof areas: Significant amounts of organic debris evident.
- Recommend trimming tree back away from roof.
- Cracked/broken tiles observed.

Broken tiles

- \*\* Serviceability of roof is questionable; it should be evaluated and repaired as necessary by a California state licensed roofing contractor. \*\*

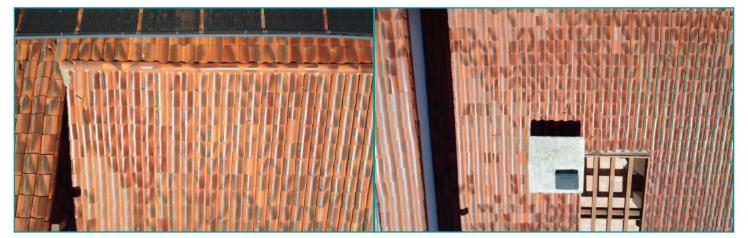
Broken tiles Broken tiles

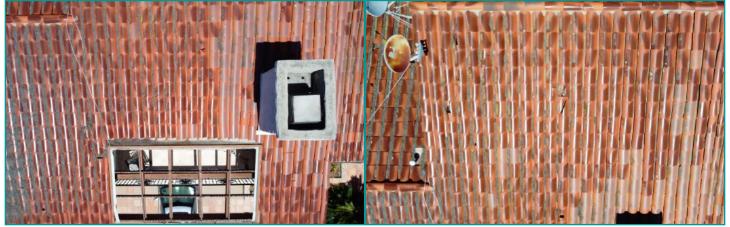
Broken tiles Broken tiles

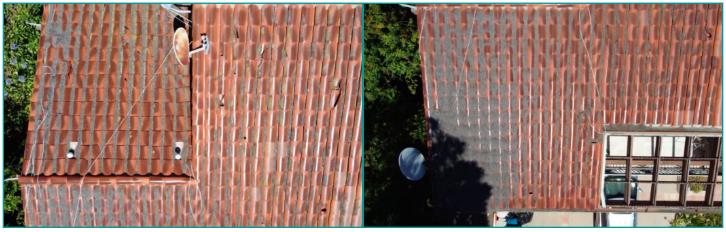
Broken tiles Heavy debris

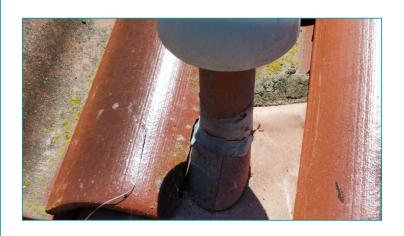
- 4.1. Recommend evaluation and correction of the following items as needed by a California state licensed roofer.
- 4.2. Flashings are mastic covered, recommend re-sealing all through the roof vents and projections as a part of routine maintenance.
- 4.3. Missing kick out flashing. Recommend evaluation and correction by a California state licensed roofer.

Missing kick-out flashing

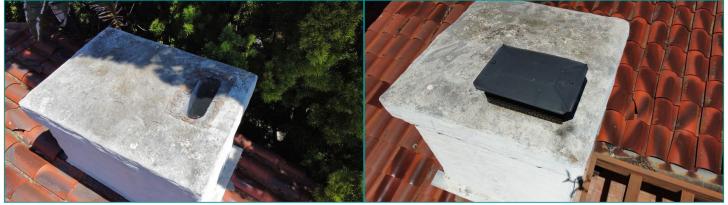
7.1. No rain cap observed. Recommend installation.

No rain cap observed

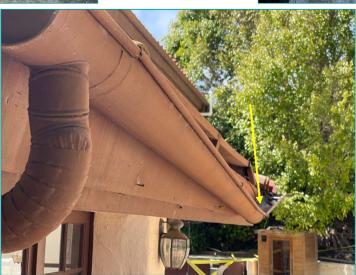
- 8.1. Current gutter/roof drainage system deposits roof runoff against the house which causes accelerated deterioration of the concrete foundation. Recommend evaluation by a licensed drainage specialist to find appropriate ways of diverting water away from the foundation.
- 8.2. All the gutters should be evaluated for correct pitch in installation by a qualified installer.
- 8.3. Downspouts missing; recommend installation.
