### *Inspection Report*

**Address: 1229 Mill St San Luis Obispo, CA 93401**

**07/29/2025**

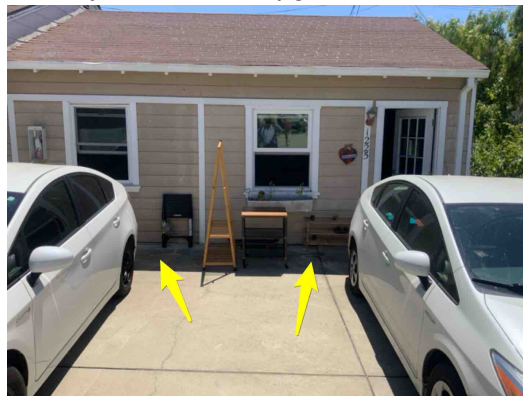
**UPG DS 20:** Disclosure: Due to the height of the DUPLEX driveway at the exterior wall at the garage conversion / living space at UNIT 1225 some water intrusion into the building may occur during certain weather. No visible watershed flashing at the building exterior and driveway connection. Upgrades recommended.

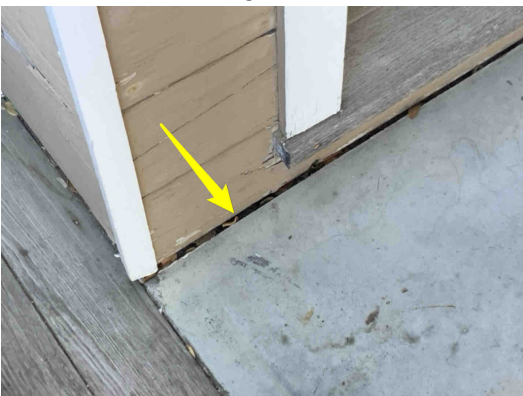
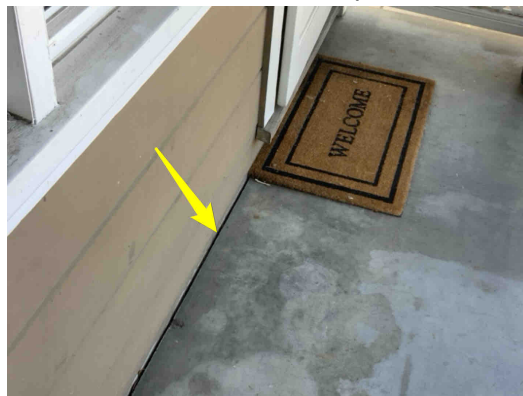
**DS** 31: Areas of the UNIT 1227 front entry porch patio appears to be slightly pulling away from the building. Client should investigate further until satisfied as to the cause, condition and potential future issues.

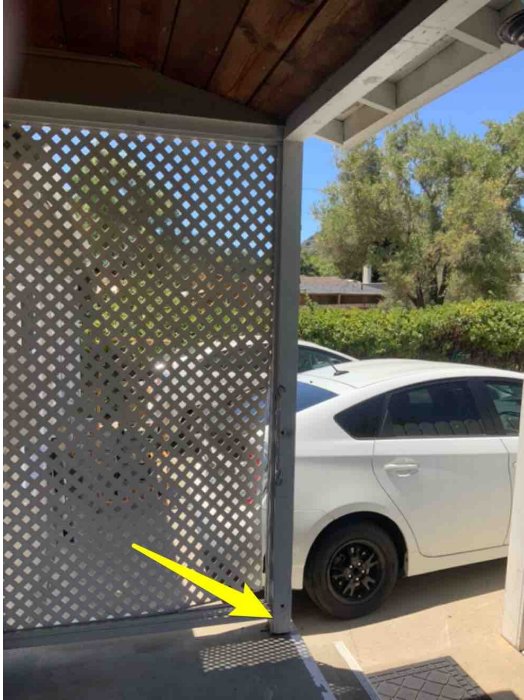
**UPG 32:** The wood support post at UNIT 1227 front entry porch cover found to have a loose connection at the patio. This appears to be from some settling of the concrete porch and the lack of an appropriate metal post base connection. Proper upgrades or repairs are needed to properly support the porch cover roof.

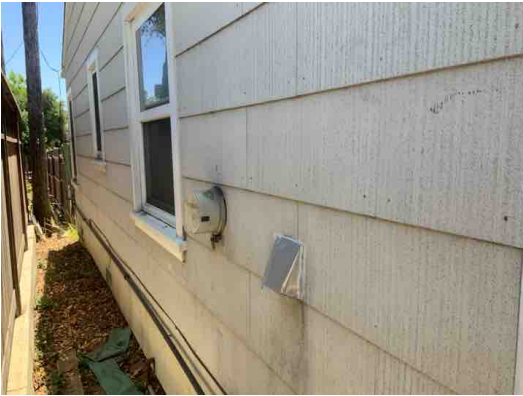
**37:** Asbestos shingle siding found at the DUPLEX

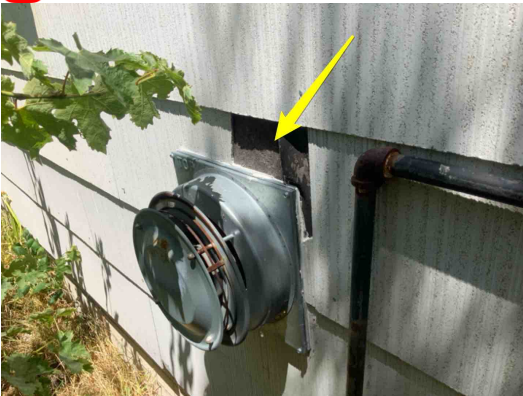
**E&C 40:** Some damaged or missing siding found at UNIT 1225 around the wall heater vent.

Expose tar paper

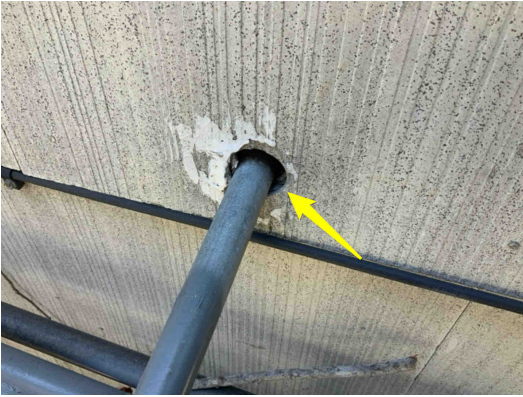
**MR 43:** Recommend sealing holes in exterior walls to prevent water intrusion around areas such as unused open holes in the exterior siding and trim, exterior light fixtures, around exterior electrical boxes, and where utility pipes and/or wires pass through the exterior walls. Have a qualified painter or licensed professional evaluate the entire exterior and seal where needed.

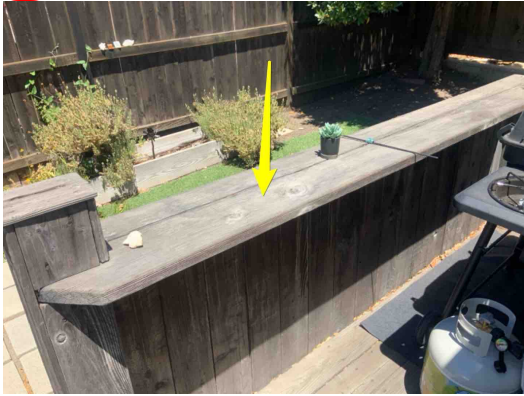
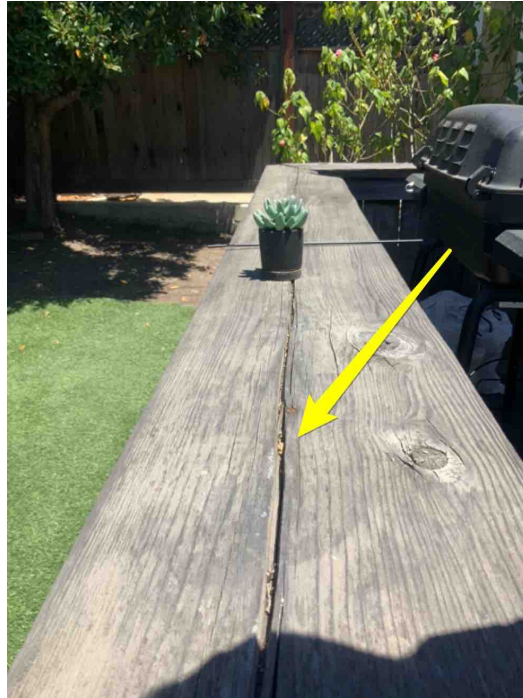
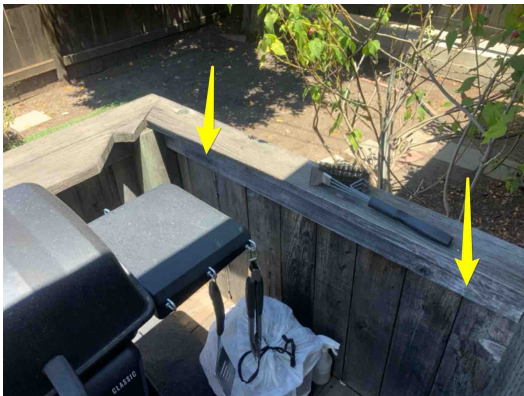
**E&C 52:** A broken 2 x 12 top rail found at the UNIT 1227 FRONT ENTRY DECK railing.

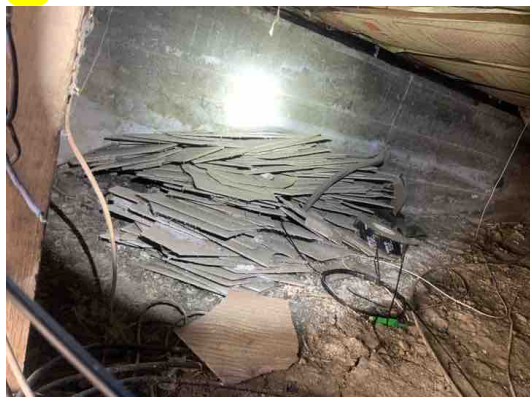
**MR 66:** Some debris noted in areas of the crawlspace. Recommend removal.

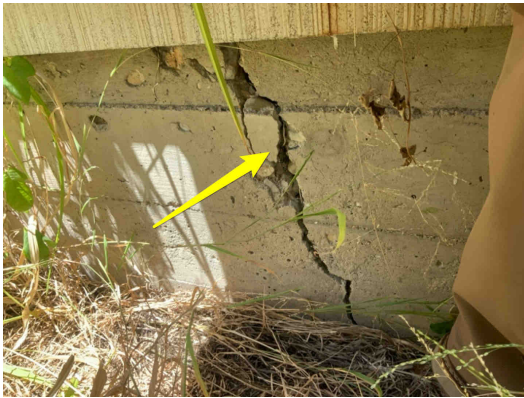
**FI 73:** Some moderate cracks with displacement found at areas of the concrete perimeter foundation stem walls at areas of the DUPLEX FOUNDATION. Evidence of **some** past repairs noted. Unable to verify if the repairs are adequate. Refer to sellers disclosures, or have areas evaluated in appropriate engineer. Recommend additional review by qualified and licensed engineer to evaluate cause, the current conditions and potential future issues.

Some moderate cracks not repaired

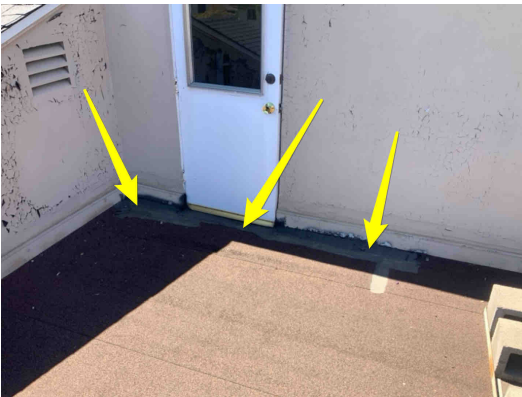
**MR** **UPG** **88:** Areas of past improper or incomplete past repairs found at areas of the UPSTAIRS FLAT ROOF ROLLED COMPOSITION ROOFING. Areas of exposed mastic found not covered by aggregate found deteriorated.

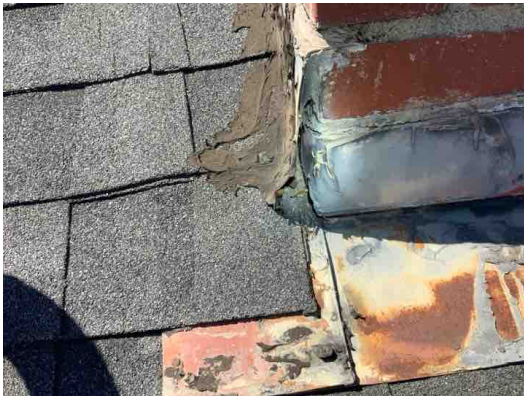
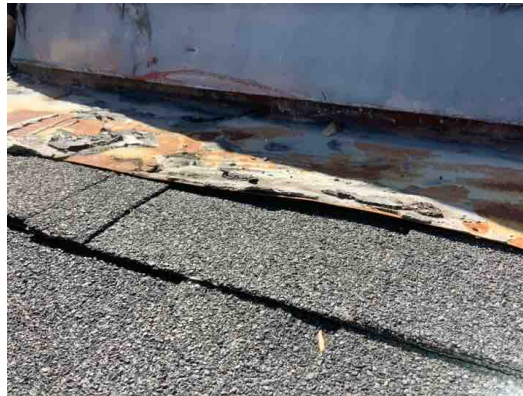
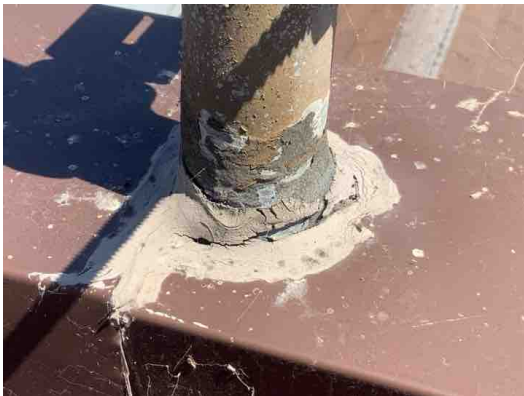
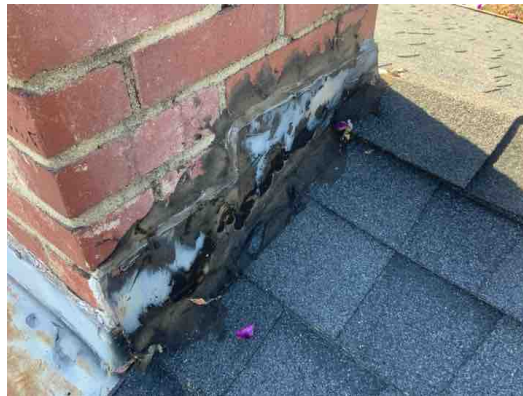
**E&C MR 93: ROOF FLASHING CONDITION:** The flashing at the front house are needing maintenance, servicing and/or repair. Contact a qualified roofing professional to review all roof flashings and provide maintenance and/or repairs as needed.

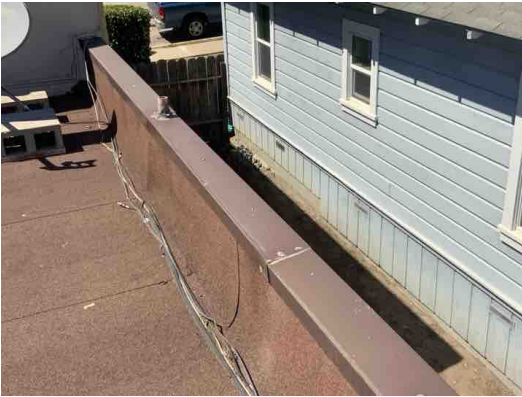
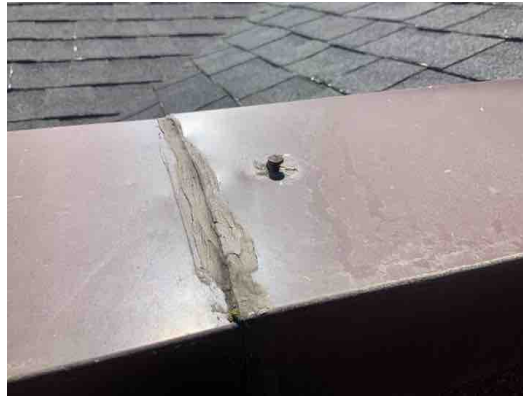
**E&C** **MR** **94:** Deteriorated sealant, Exposed, Loose / Lifting nails at areas of the FRONT UNIT - FLAT ROOF PARAPET CAP FLASHINGS.

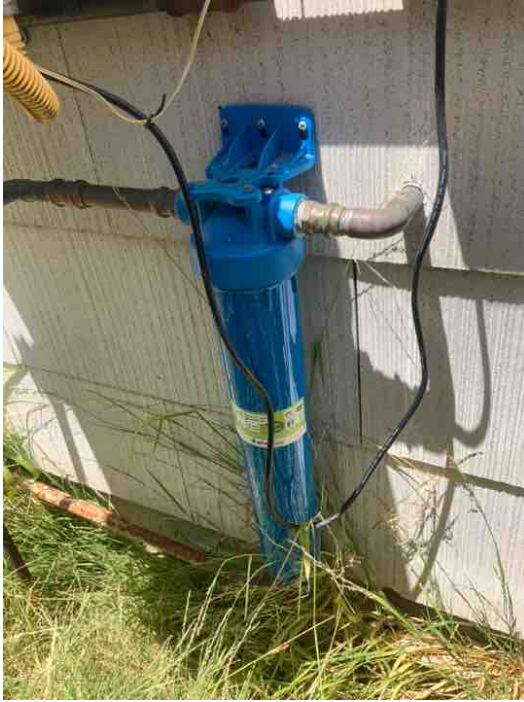
**MR DS 110:** Water filter installed on the EAST SIDE - Exterior at the DUPLEX. *Water quality and filter not inspected or tested. Water filters require continuous and ongoing maintenance. Please read owner's manual for recommendations.*

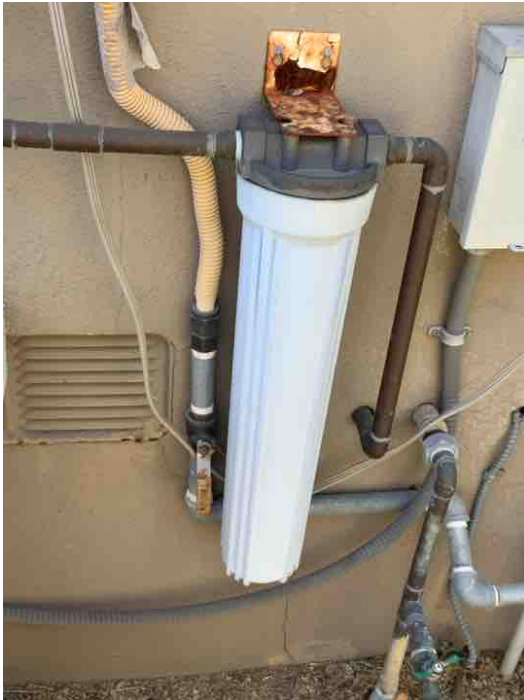
**MR DS 111:** Water filter installed on Exterior on the BACK OF THE FRONT HOUSE. *Water quality and filter not inspected or tested. Water filters require continuous and ongoing maintenance. Please read owner's manual for recommendations.*

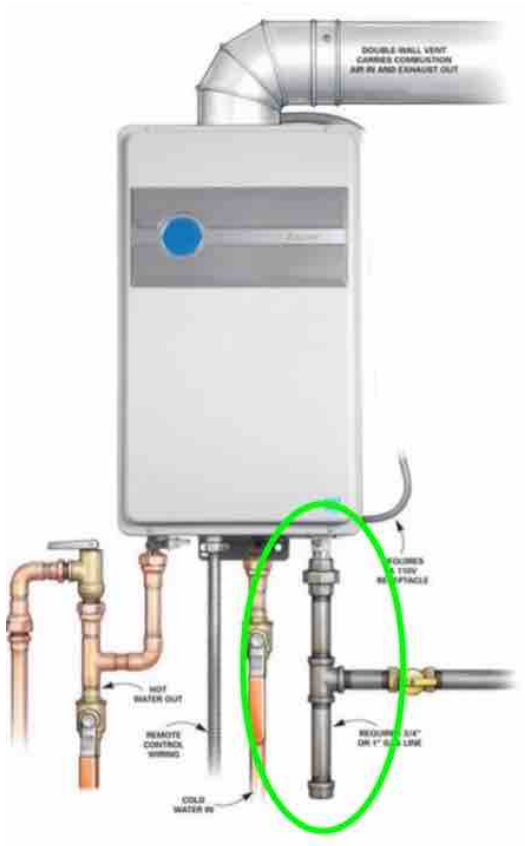
**UPG 127:** Recommend the installation of the missing sediment trap / drip leg at the gas TANKLESS WATER HEATER gas piping at flex connection by a certified or licensed plumbing professional familiar with minimum requirements.

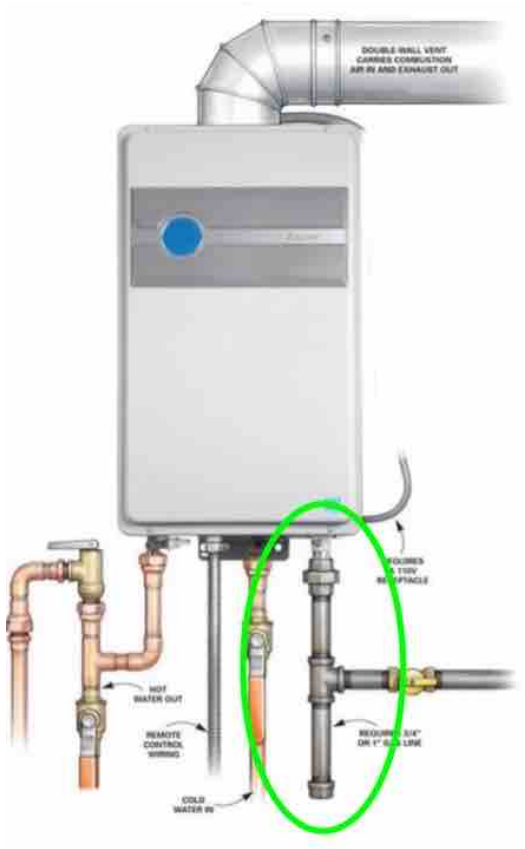
**UPG 137:** Recommend the installation of the missing sediment trap / drip leg at the gas TANKLESS WATER HEATER gas piping at flex connection by a certified or licensed plumbing professional familiar with minimum requirements.

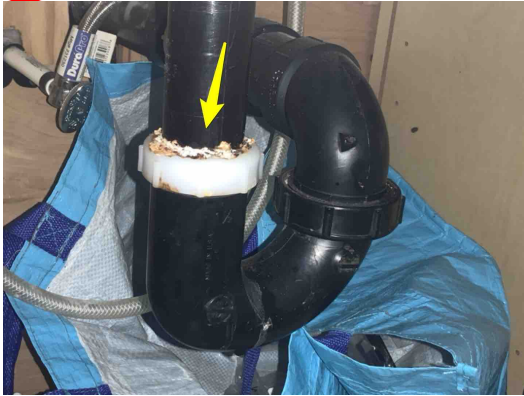
UNIT 1225

**FI 160:** Some corrosion found at waste pipe connections under the kitchen sink / evidence of past leaking.

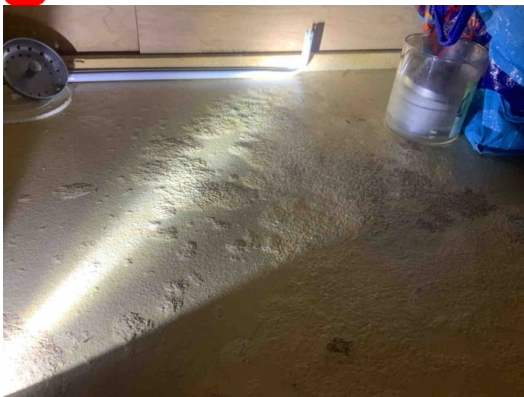
UNIT 1225

**FI 161:** Some dry moisture stains and damage in the cabinetry below the UNIT-1225 kitchen sink.

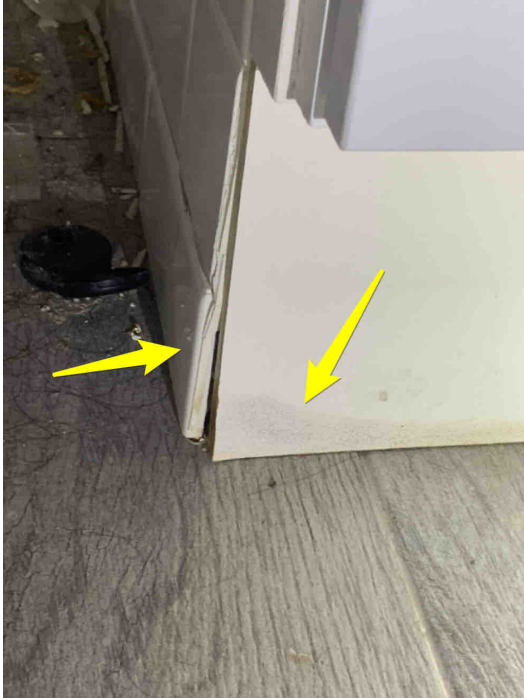
**E&C** **204:** Moisture stains and damage to wood cabinet outside tub: UNIT 1225 BATHROOM

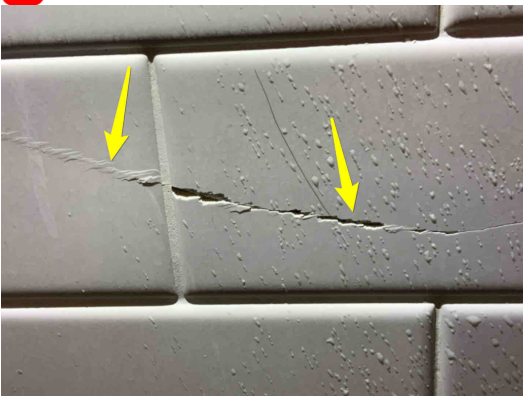
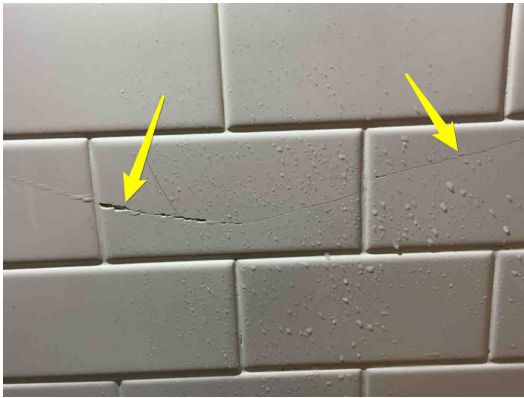
**FI 208:** Some cracked tiles found in areas of UNIT 1225 BATHROOM shower enclosure.

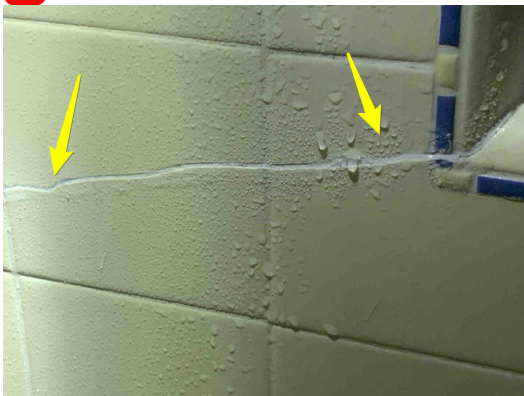
**FI 209:** Some cracked tiles found in areas of UNIT 1227 BATHROOM shower enclosure.

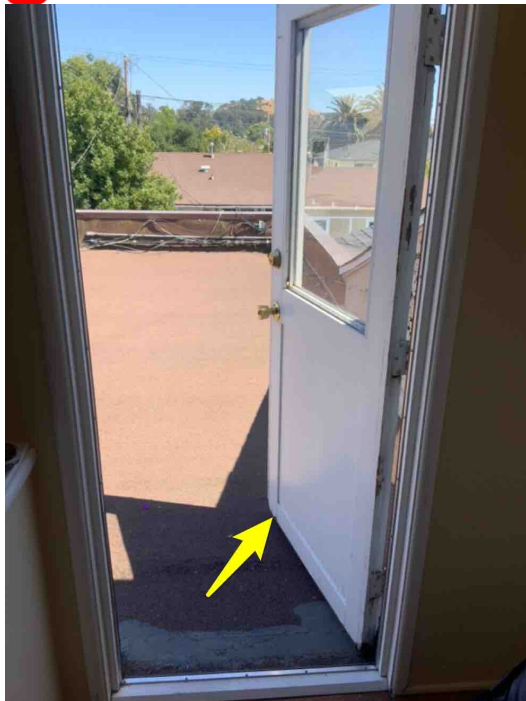
**E&C 220:** Moisture deterioration / damage at the UPSTAIRS WOOD EXTERIOR DOOR

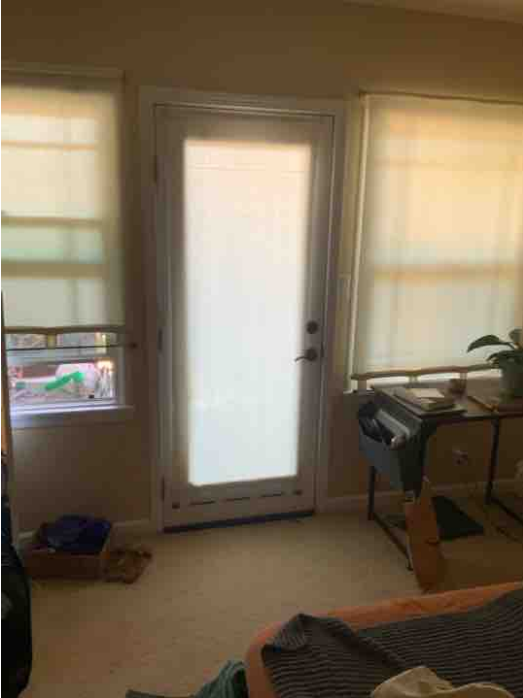
**MR 221:** Some loose weather stripping at the bottom of the MAIN HOUSE BEDROOM-1 EXTERIOR DOOR.

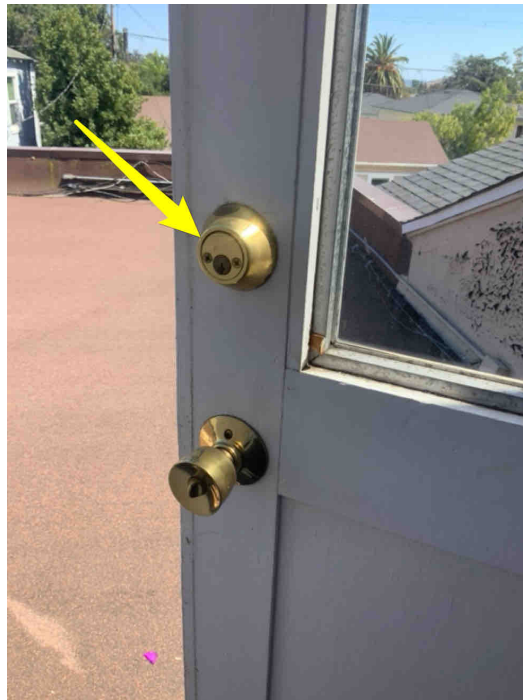
Example. UPSTAIRS WOOD EXTERIOR DOOR

**SC 222:** It is considered unsafe to use of a double-keyed deadbolt at exterior doors which may be used as and exit in an emergency: FRONT HOUSE UPSTAIRS ROOF ACCESS DOOR

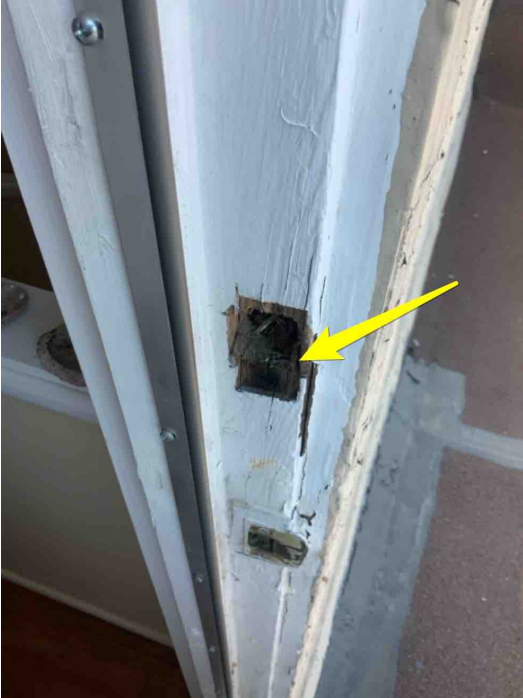
**E&C** **223:** Missing a straight plate for the deadbolt on the door frame at the UPSTAIRS WOOD EXTERIOR DOOR

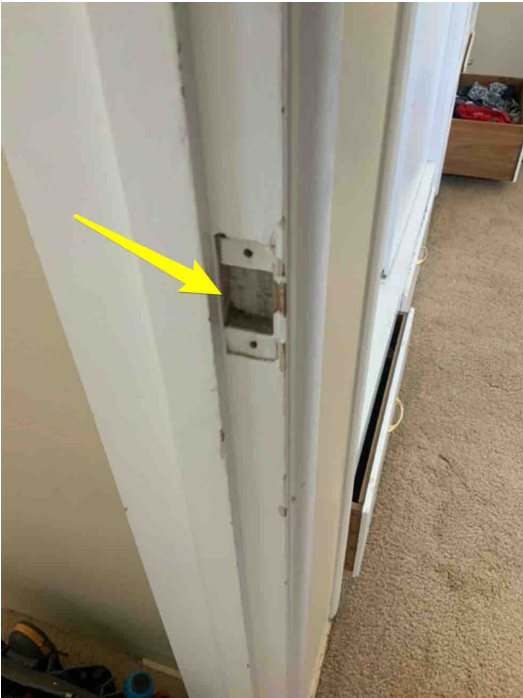
**MR** **UPG** **225:** Interior door rubs & sticks AND is missing the door knob strike plate. Adjustment or repair recommended: FRONT HOUSE - MID-LEVEL BEDROOM

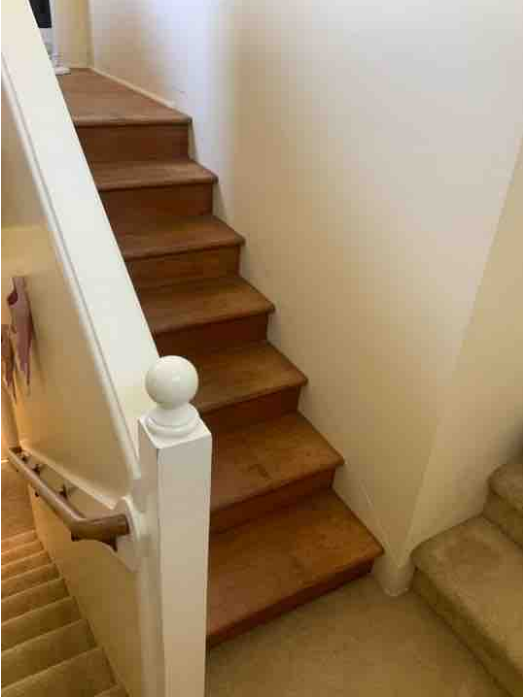
**SC 241:** Missing the GRASPABLE handrail at the FRONT HOUSE - UPPER SECTION of the interior stairway. Repairs warranted.

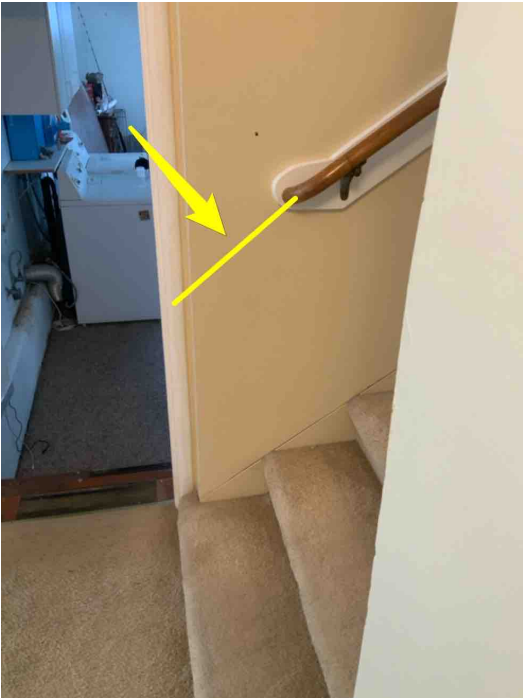
**SC 242:** FRONT HOUSE Interior stairway handrail does not fully extend to the end bottom tread of the interior stairway per standards for safety. Proper upgrades are recommended.

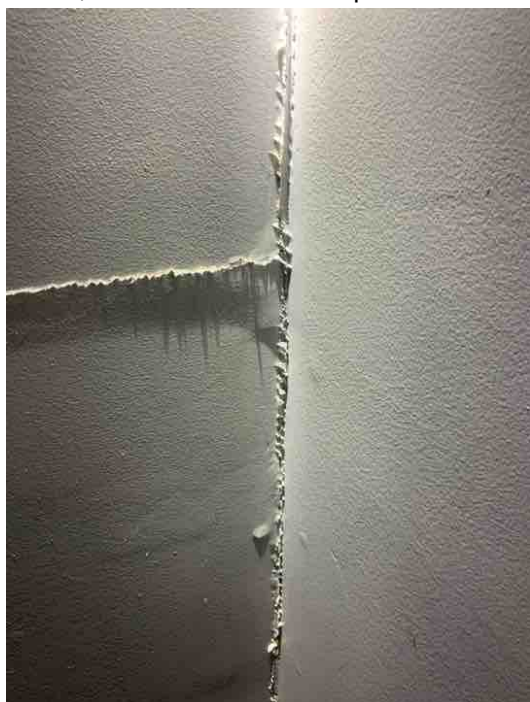
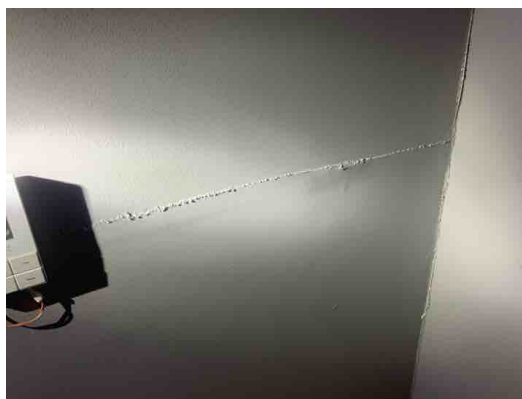
**FI 264:** Some unusual cracks and/or tearing of the drywall at areas of the interior UNIT 1225 BEDROOM-1 CLOSET and BATHROOM. Some cracks are larger than normal. This appears to be from some type of movement or settlement of the framing and/or foundation system. It is advised to have a licensed engineer evaluate the cause, current condition and potential future issues.

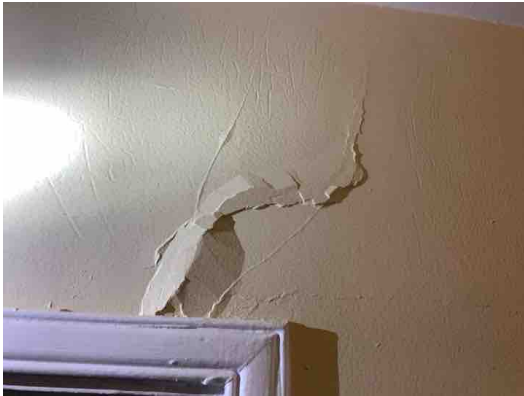
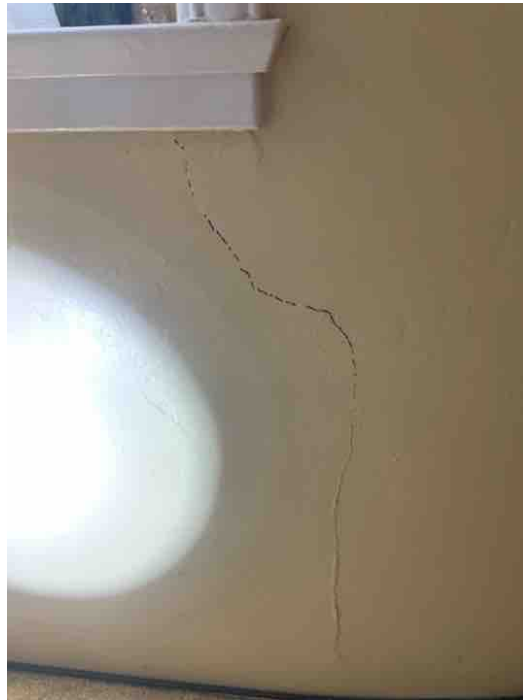
**FI 265:** Evidence of some unusual cracks and/or tearing of the drywall. The visible movement appears more than normal: UNIT 1227. This appears to be from some type of movement or settlement of the framing and/or foundation system. It is advised to have a licensed engineer evaluate the cause, current condition and potential future issues.

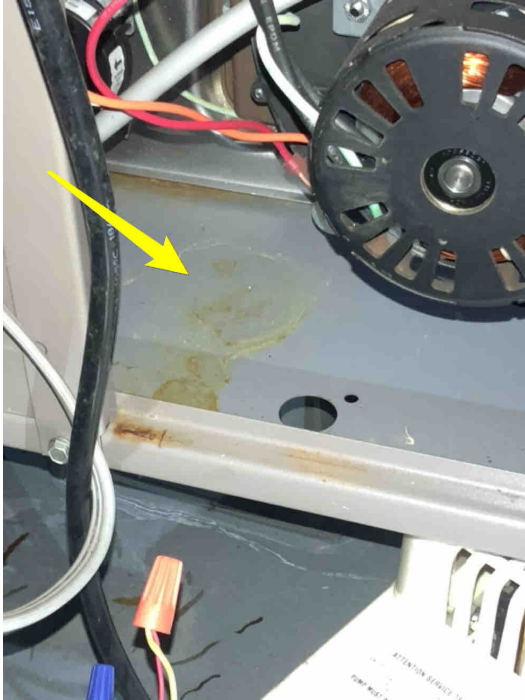
**FI** **MR** 269: Some minor moisture stains inside at furnace enclosure. Suspected condensation leak from the vent pipe.

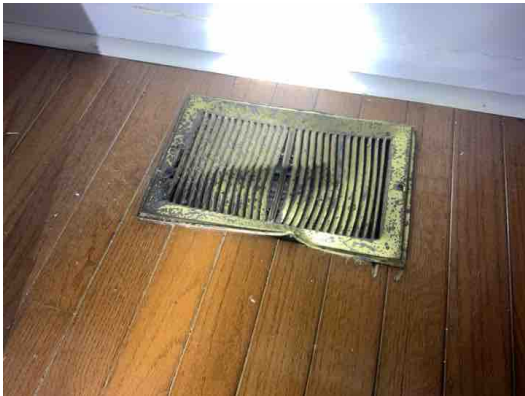
**SC** 271: Improper and unsafe use of a wall or ceiling heating register grill(s) on some of the floor register boxes. Recommend replacement with appropriate floor rated registers to help prevent an accidental falling through the inadequate type of grill.

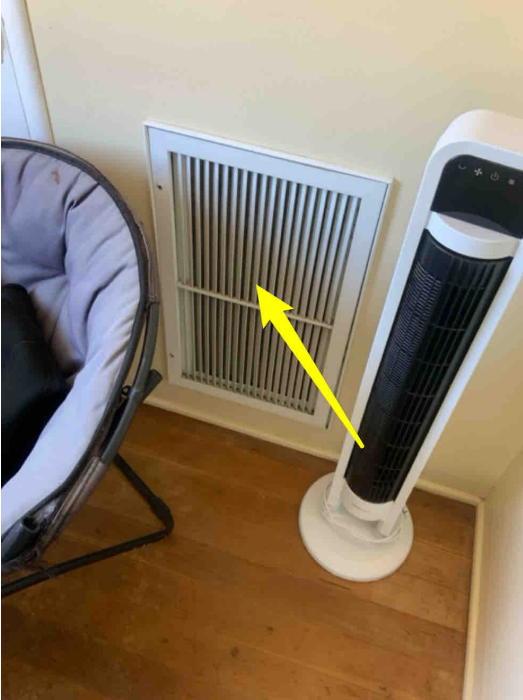
**MR 272:** Dirty Heating air filter found in the return air grill(s). Recommend cleaning or changing the furnace air filters as part of ongoing maintenance.

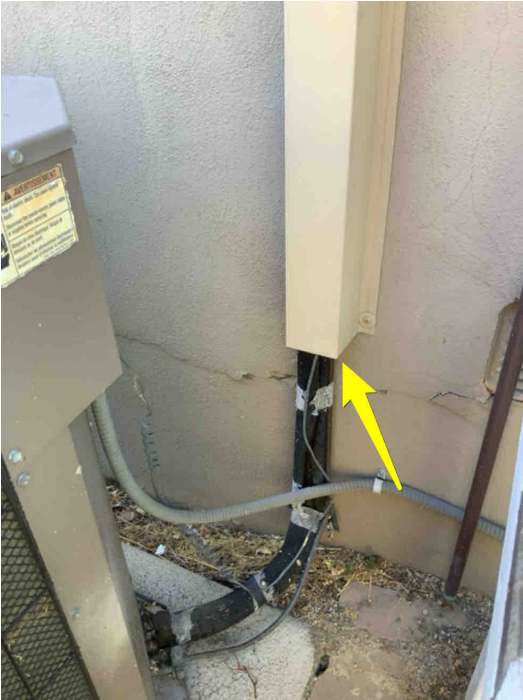
**SU 286:** Recommend sealing the hole or opening through the exterior wall where the Air Conditioner's refrigeration pipes enter the building. This will help prevent rodent, bug and /or water intrusion through this area as need per standards. Recommend filling the opening with rodent resistant expandable foam in a can, which can be purchased at most local hardware store stores.

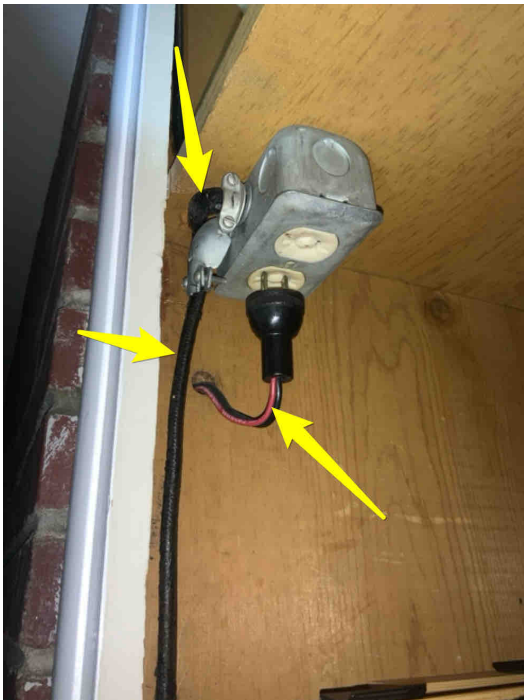
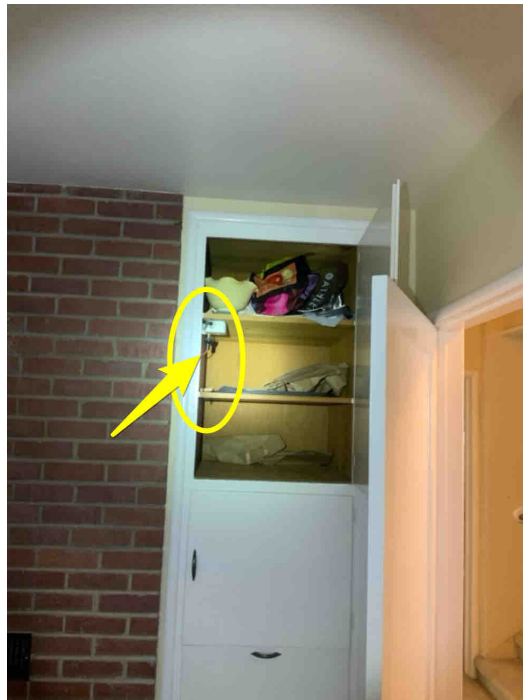
**293:** Improper and unsafe electrical wiring. Exposed electrical wiring, "Romex" improperly installed subject to physical damage, not in a conduit or raceway per standards: FRONT HOUSE - DOWNSTAIRS BEDROOM-1 CABINTRY

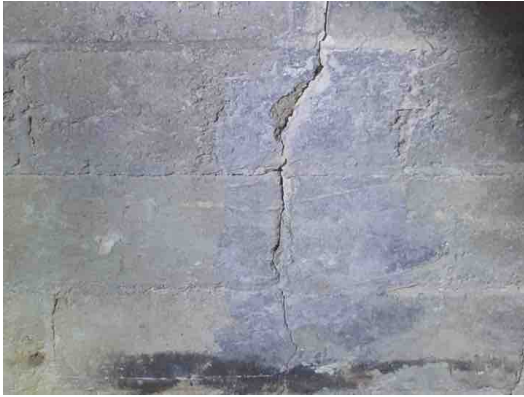
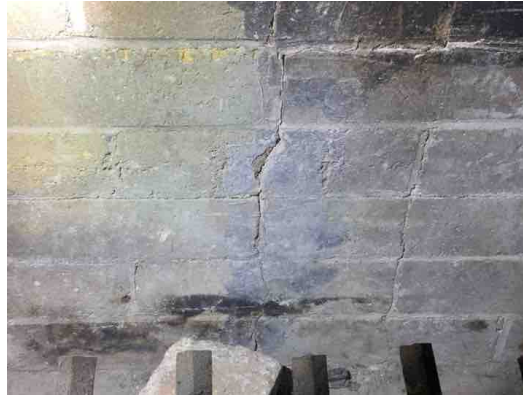
**E&C 321:** Cracked and damaged bricks and/or mortar found at the back wall inside the FRONT UNIT - LIVING ROOM fireplace firebox. General maintenance and/or repairs are warranted as cracks and separations can allow superheated gases to escape through the back wall and collect in the confined spaces of the chimney. Contact a qualified chimney sweep/professional to grind out and re-mortar cracked and separated areas for safety.

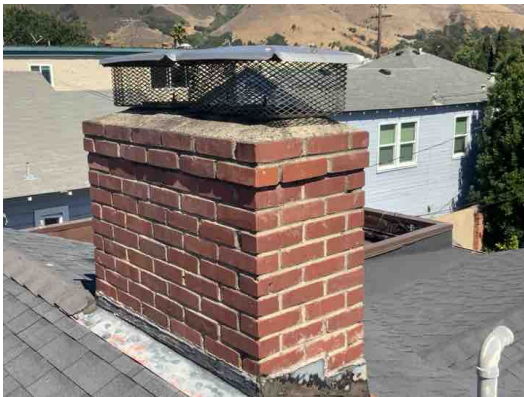
**327:** Photo of the LIVING ROOM Masonry Chimney

**MR 328:** Visible cracks found in the mortar crown located at the top of the LIVING ROOM fireplace chimney. Maintenance / caulking or sealing is recommended to help prevent water intrusion into the confined spaces within the masonry chimney.
