Inspection Report

Property Address:
447 E Hullett St
Long Beach CA 90805

Ferguson Home Inspections

Date: 3/23/2024	Time: 09:00 AM	Report ID: 20240323-447-E-Hullett-St
Property: 447 E Hullett St Long Beach CA 90805	Customer: Kimberly Stewart	Real Estate Professional: Sue Freeman

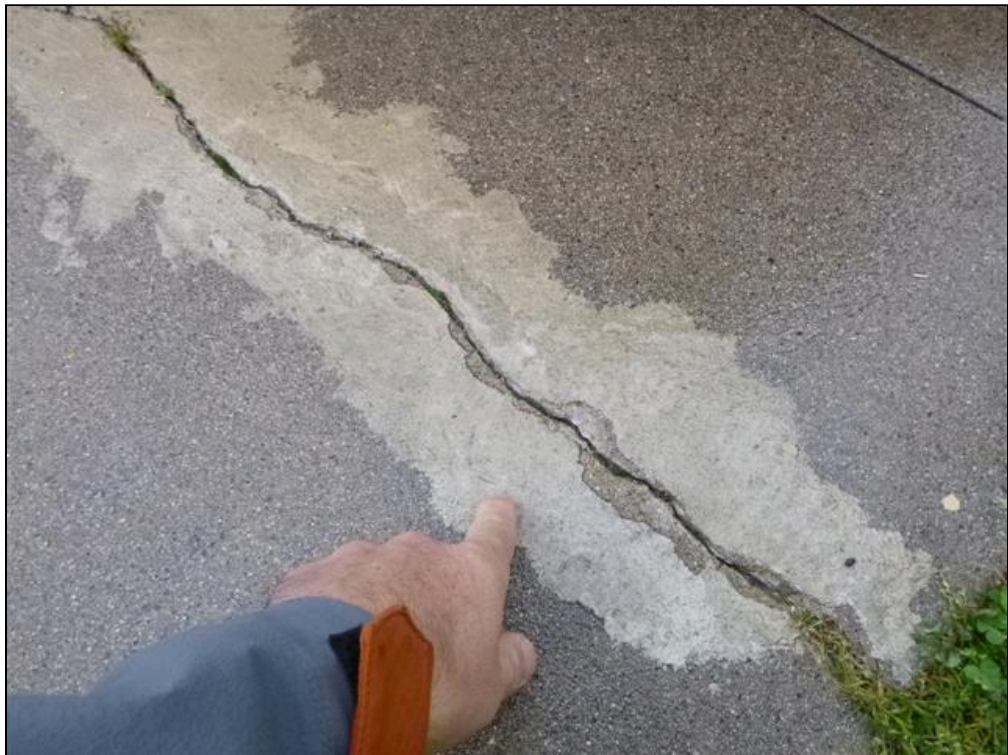
1.0 Item 1(Picture)

1.0 Settling, expansion cracks and heaving noted at various areas, this is a potential trip hazard. Suggest review with a licensed contractor for repair/replacement costs as needed.

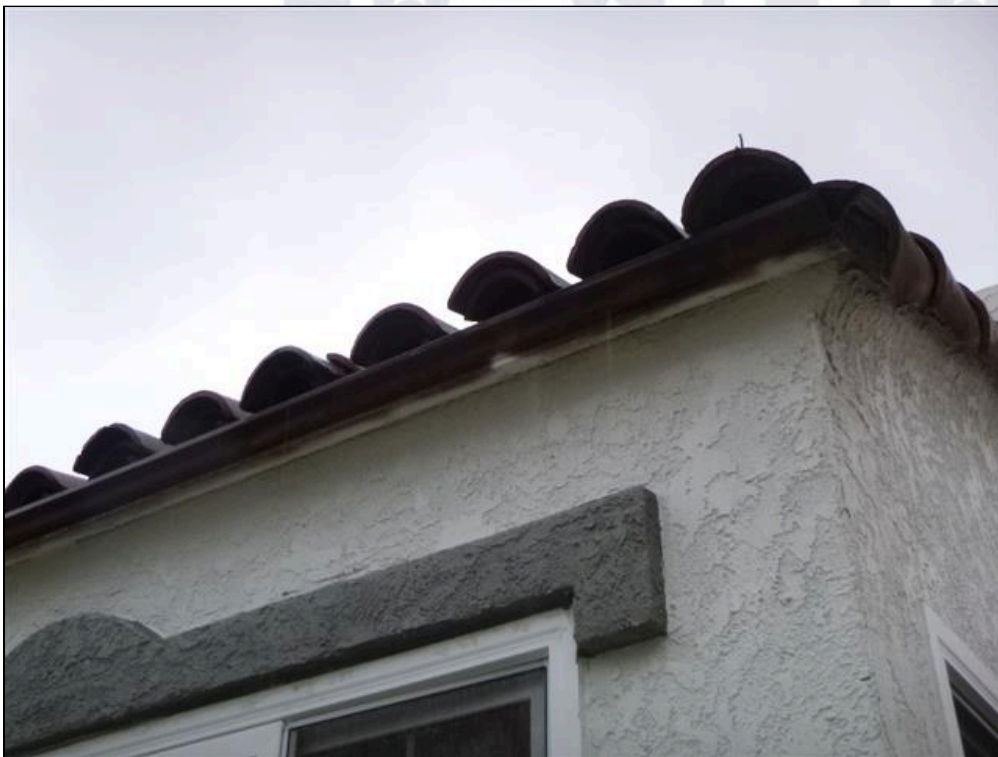
1.9 Item 2(Picture)

1.9 (2) The gutters are rusted and deteriorated at various areas, suggest replacing the gutters as needed.

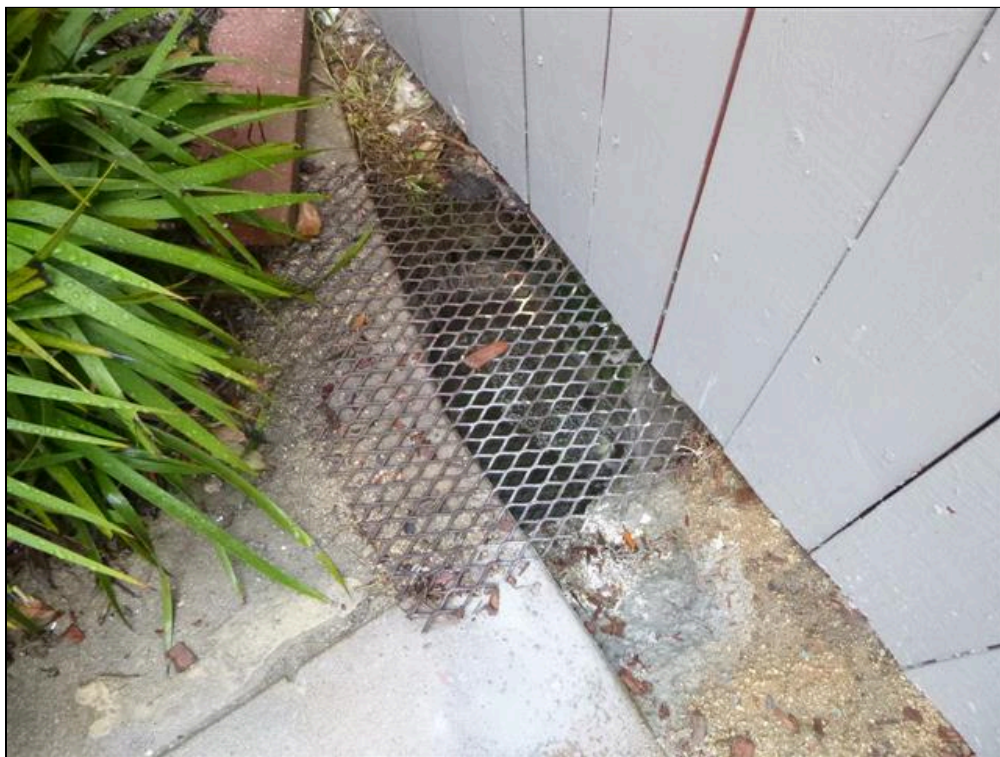
1.11 Item 2(Picture)

1.11 (4) A large hole was noted at the rear of the driveway by the fence/ADU. Suggest review with the seller/neighbor and/or a licensed contractor on this item and any repair/filling/patching costs as needed.

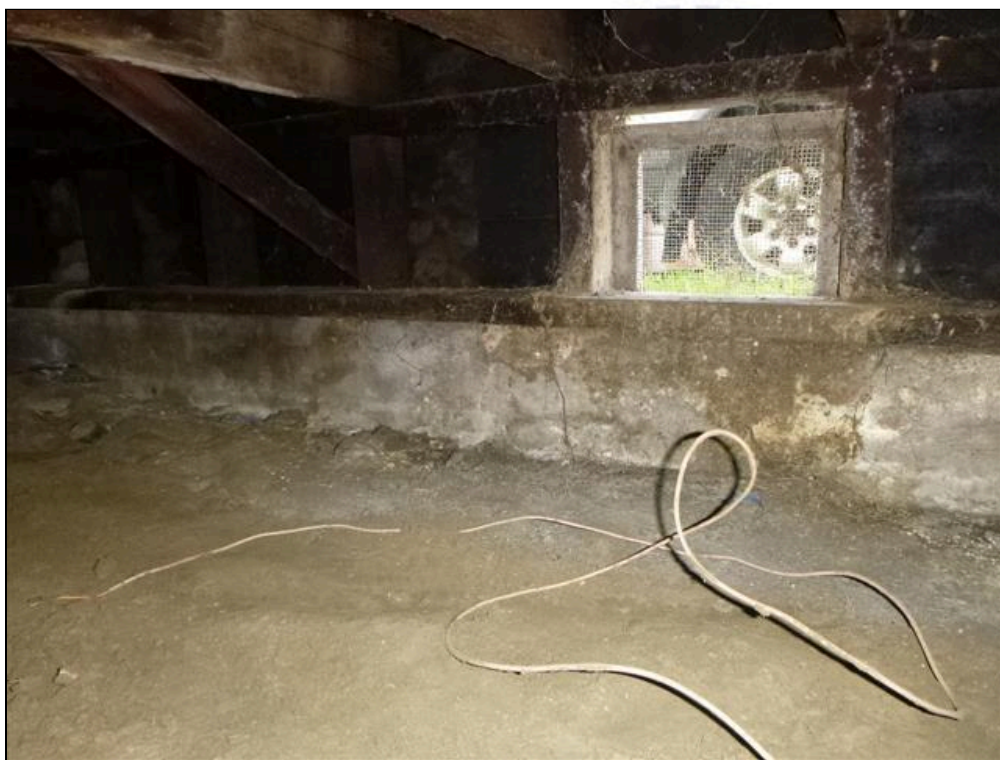
3.0 Item 1(Picture)

3.0 (2) White efflorescence (powder substance) on foundation footings indicates prior, and possibly ongoing, excessive moisture build up at the exterior of the foundation. Ongoing water intrusion at the foundations can, in some cases, cause the steel in the foundations to rust, called spawling, which can lead to horizontal cracking of the foundation (currently there are no major cracks visible at the foundation). Any future cracking/damaged can be an expensive repair as the foundation is now structurally weak and susceptible to horizontal movement. Suggest review of the Lot/Grade and drainage systems, including rain gutters, to reduce and prevent further and future water buildup at the exterior of the dwellings foundations.

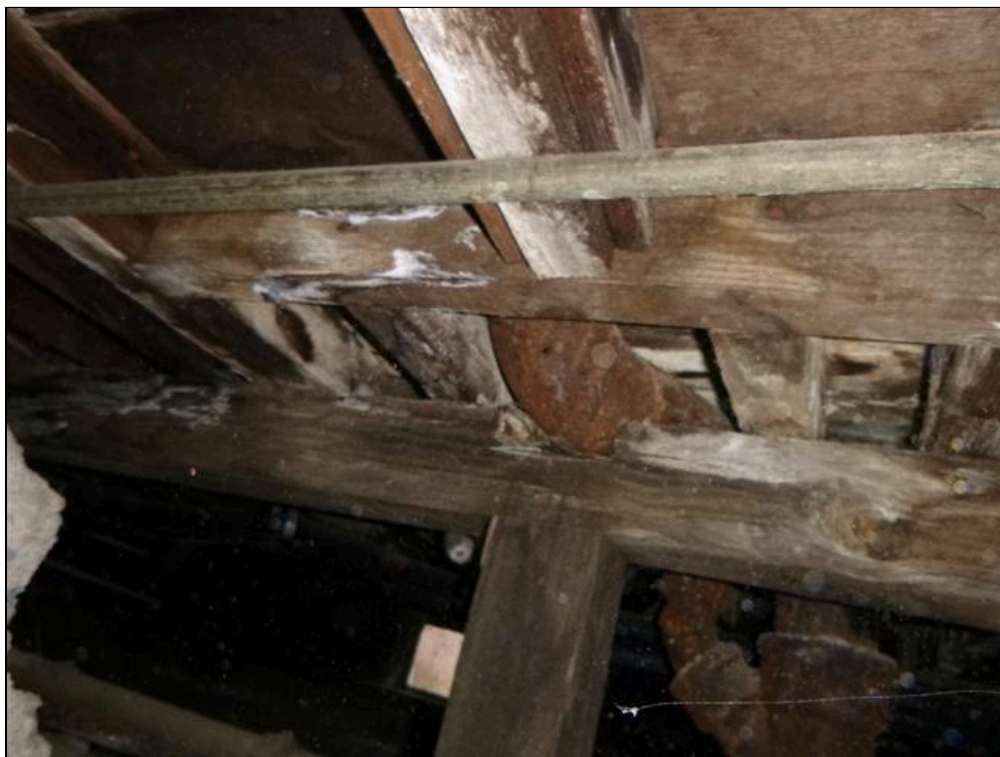
3.1 Item 1(Picture)

3.1 (1) Stains and deterioration noted at various flooring and supports from prior leaks. Suggest review with a termite company and/or a licensed contractor for any repair/replacement costs as needed.

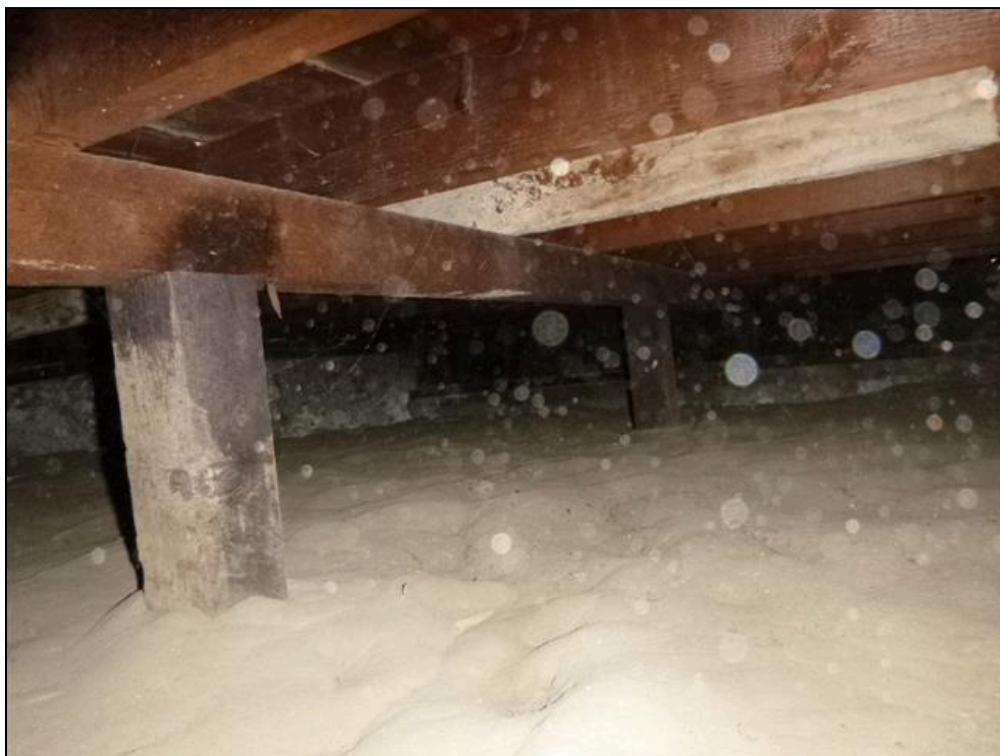
3.1 Item 4(Picture)

3.1 (2) Inadequate support noted at various girder beams due to the excessive span and inadequate support posts, common for the original age of the dwelling. Suggest review by a licensed contractor for costs to add additional supports to prevent possible future structural and floor movement as needed.

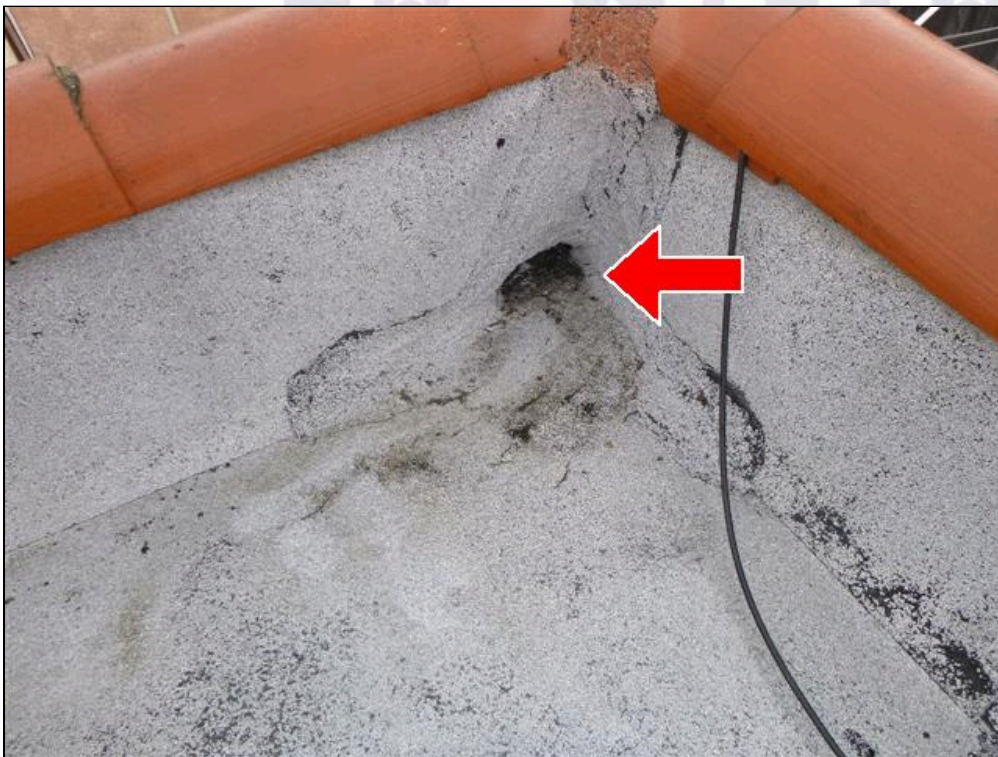
5.0 Item 7(Picture)

5.0 (2) Suggest review with a licensed roofer for installation costs for a scupper/over flow drain to the roof as an upgrade. Any blockages to the roof drain will result in excessive water ponding/flooding at the roof area.

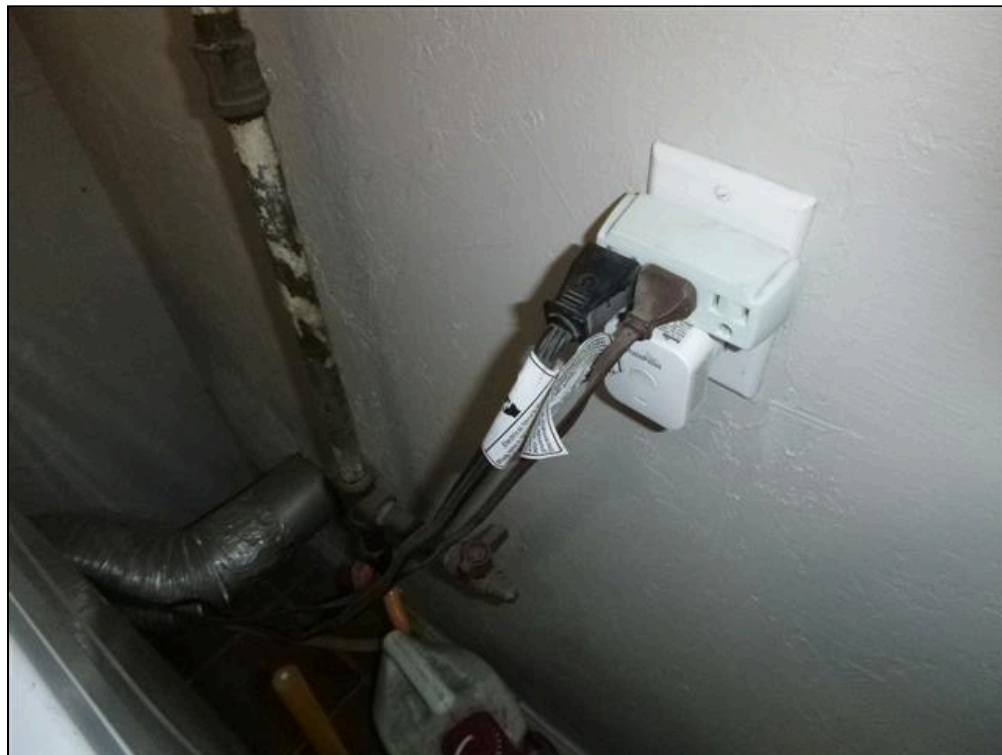
7.6 Item 1(Picture)

7.6 The appliances are currently being powered off a plug strip/extension cord, this is a potential fire hazard. Suggest remove the plug strip/extension cord and review by a licensed electrician for costs to install additional outlets as needed/required for safety.

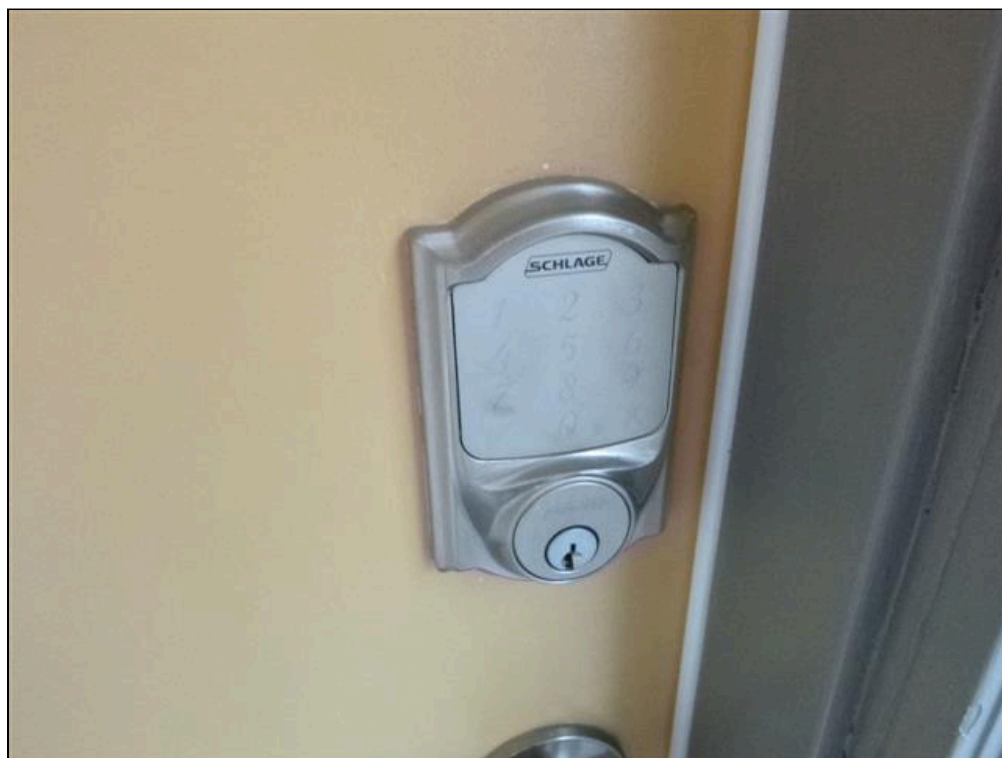
8.5 Item 1(Picture)

8.5 A keypad door lock system was noted. Suggest review with seller for operational brochure, codes for operation and confirm correct operation as needed.

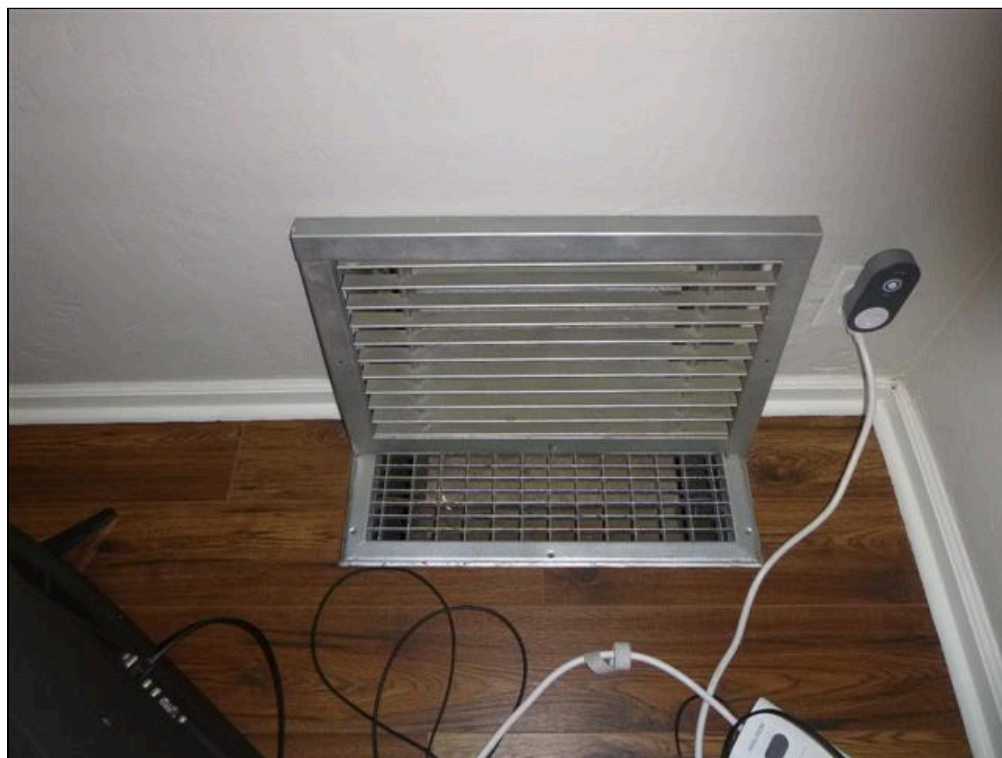
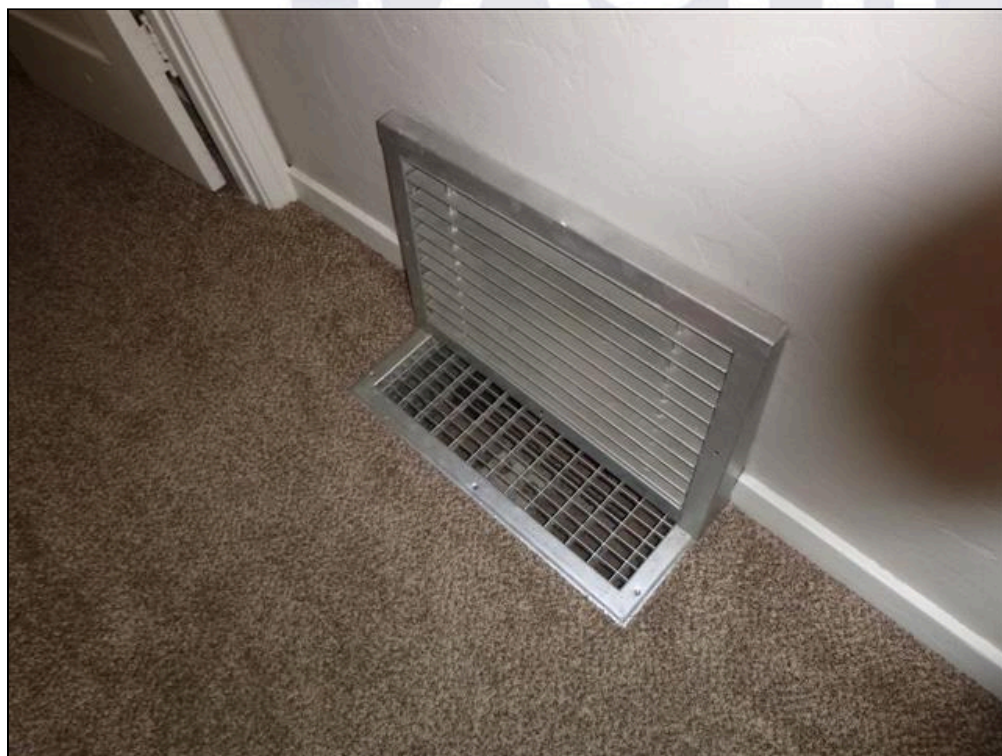
10.0 (1) The heater/furnace is very old but did work at the time of inspection. The inspector is unable to determine remaining life expectancy of this system. Due to the age and style of this system, suggest review with the Gas company and/or a licensed heating company for further review to determine the remaining life expectancy of the unit and any repair/replacements costs as needed

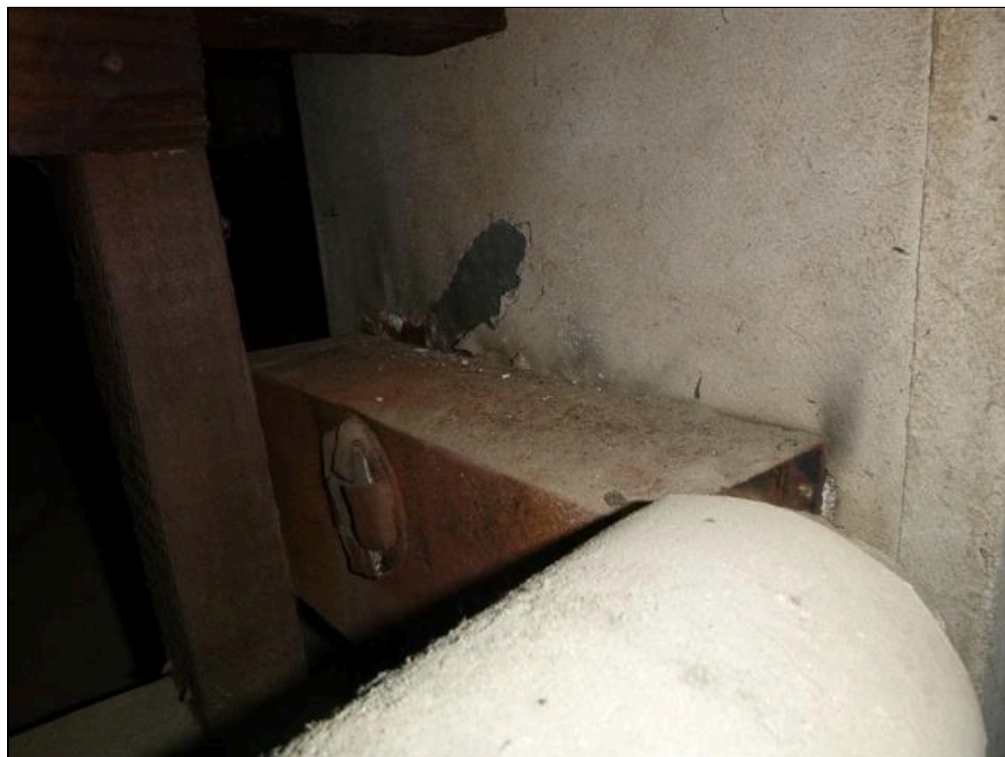
10.1 Item 1(Picture)

10.1 Potential safety hazard due to the heater draft diverter is rusted, deteriorated and large holes were noted. This will allow heater fumes/carbon monoxide to escape into the crawl area and possibly into the dwelling. Suggest review with a licensed heater company for replacement costs as required for safety.

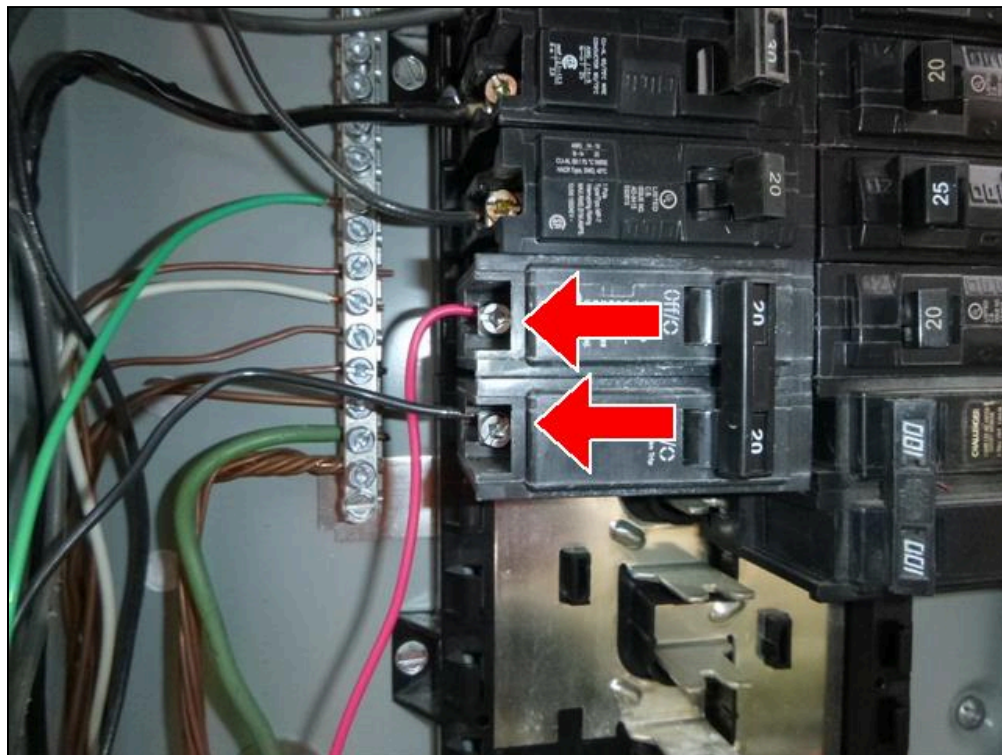
12.2 Item 1(Picture)

12.2 (2) A potential fire/safety hazard was noted due to the incorrect sized wiring connected to the breakers. 14 gauge wiring is currently connected to 20 amp breaker(s) in the sub panel, 15 amp breakers are required. Suggest review by a licensed electrician for any repair/replacement costs as needed.

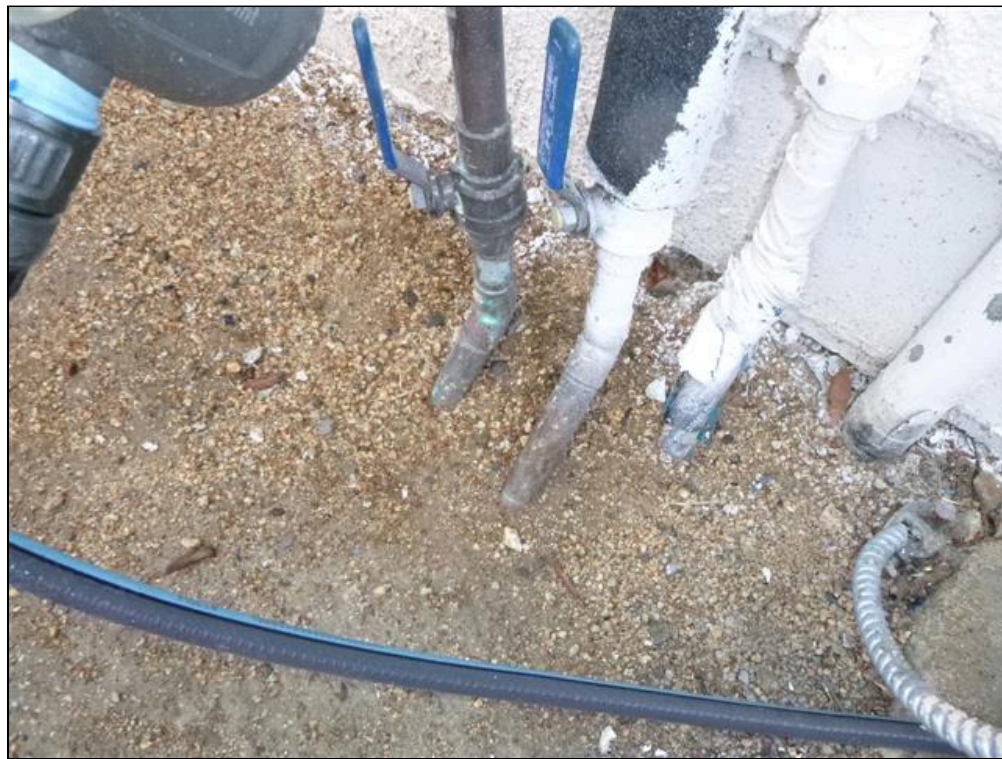
13.0 Item 1(Picture)

13.0 (1) The copper plumbing that transfers from the dwelling to the guest house/ADU area does not appear to be wrapped or insulated below grade. Suggest review by a licensed plumber and repair/replace as needed.

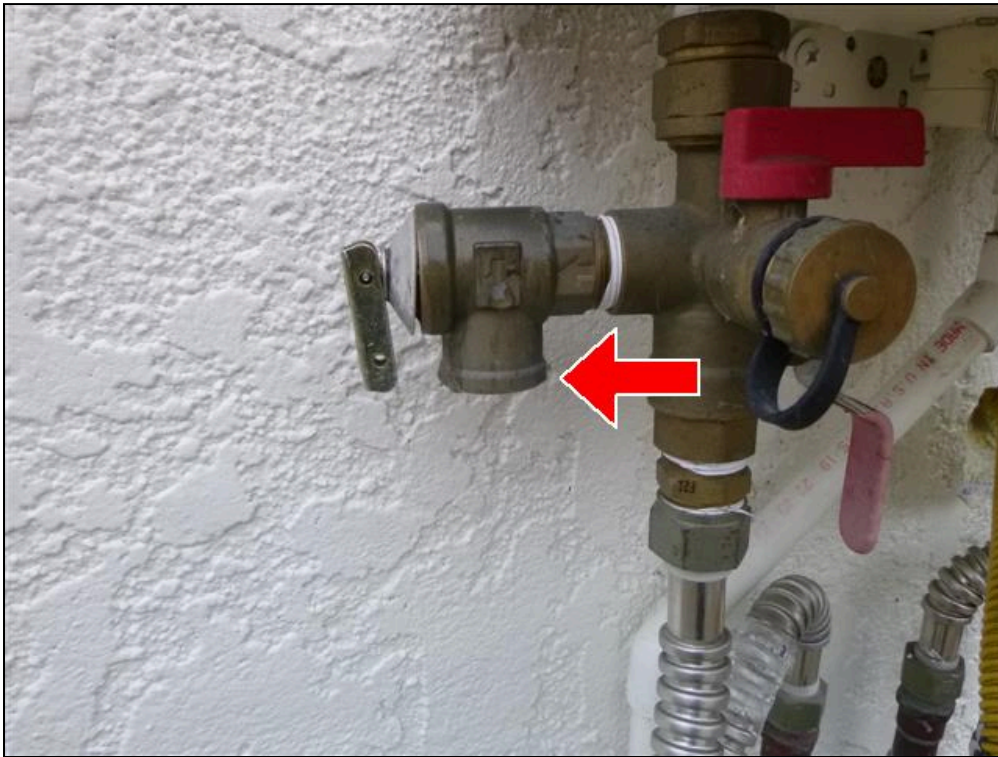
15.0 Item 3(Picture)

15.0 (4) No discharge pipe connected to the TP&R valve, this is a potential safety hazard. Suggest review by a licensed plumber for costs to install the TP discharge drain down to within 4-6 inches of the exterior grade/deck as required for safety.

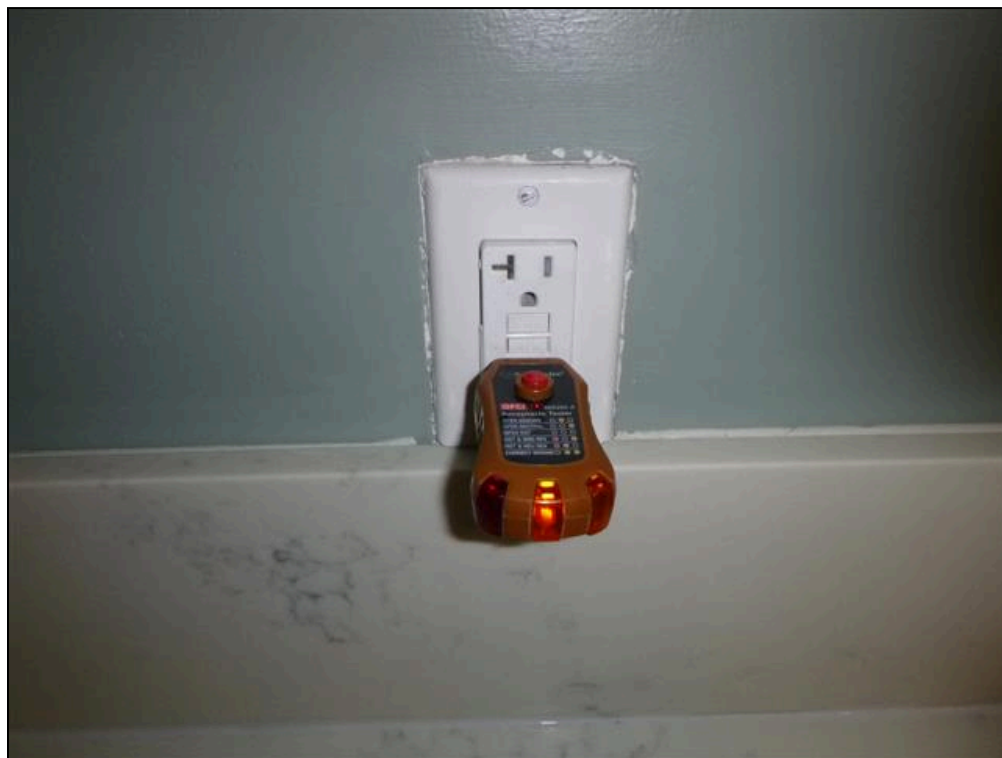
16.7 Item 3(Picture)

16.7 (3) The GFCI outlet(s) at this area are not grounded. The GFCI should still provide GFCI protection but the outlet should generally be grounded. Suggest review by a licensed electrician for repair/grounding cost as needed and required for safety.

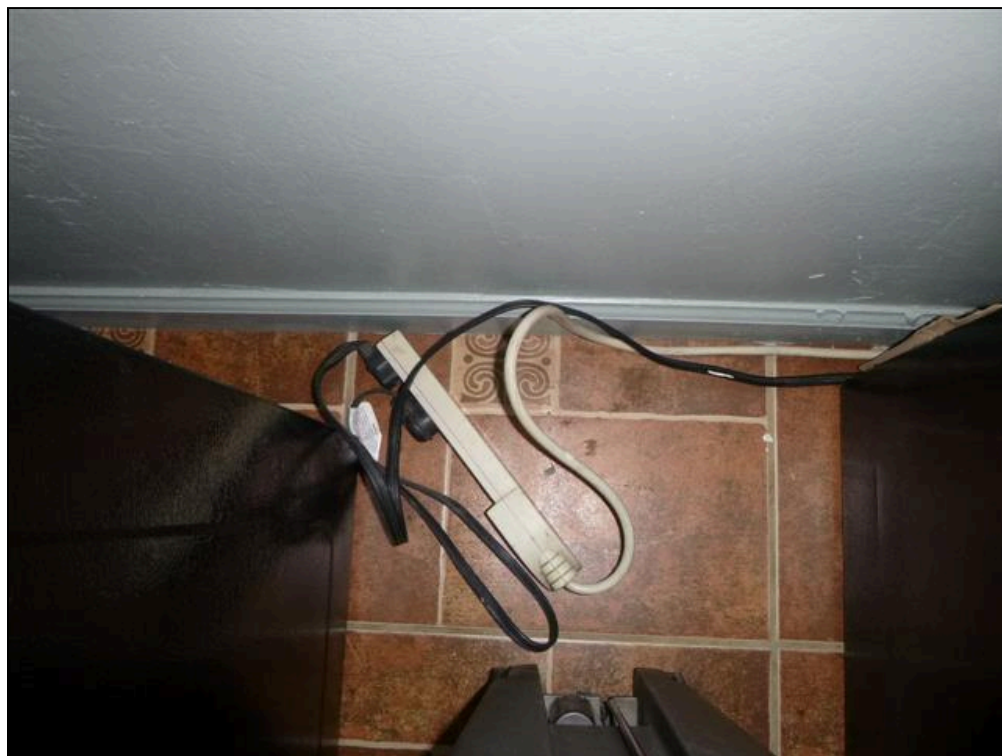
16.7 Item 4(Picture)

16.7 (4) Excessive use of electrical plugs strips/extension cords used at this area, this is a potential fire safety hazard. Suggest review with a licensed electrician for additional electrical circuits/outlets costs as needed for safety.

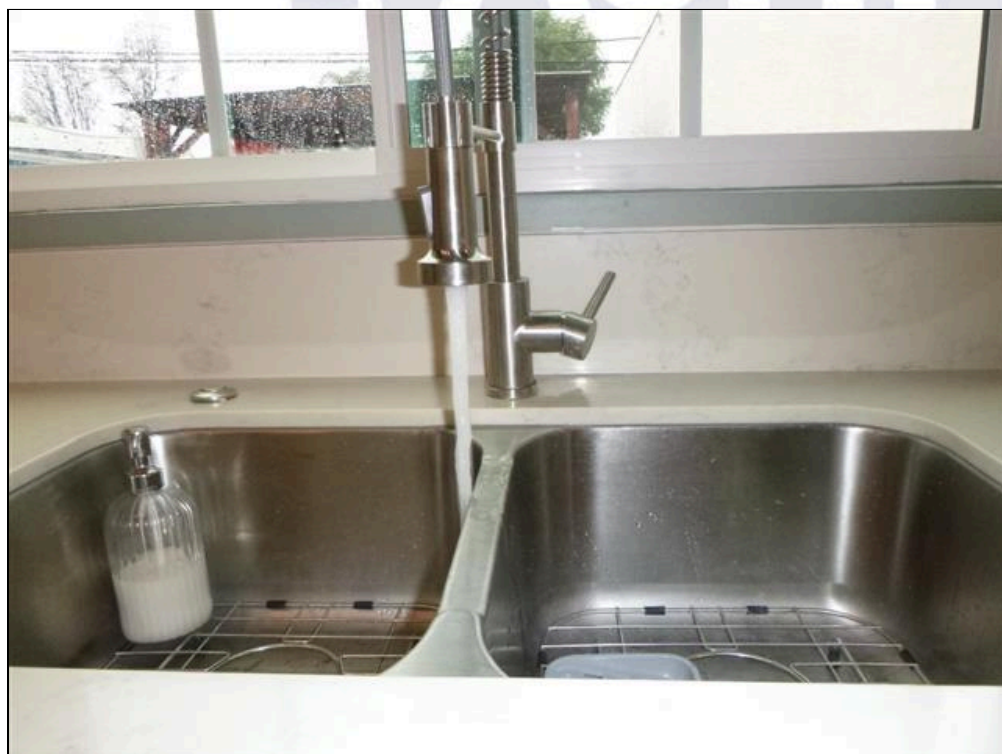
16.9 Item 1(Picture)

16.9 The sink faucet is loose at the countertop, suggest repair as needed.

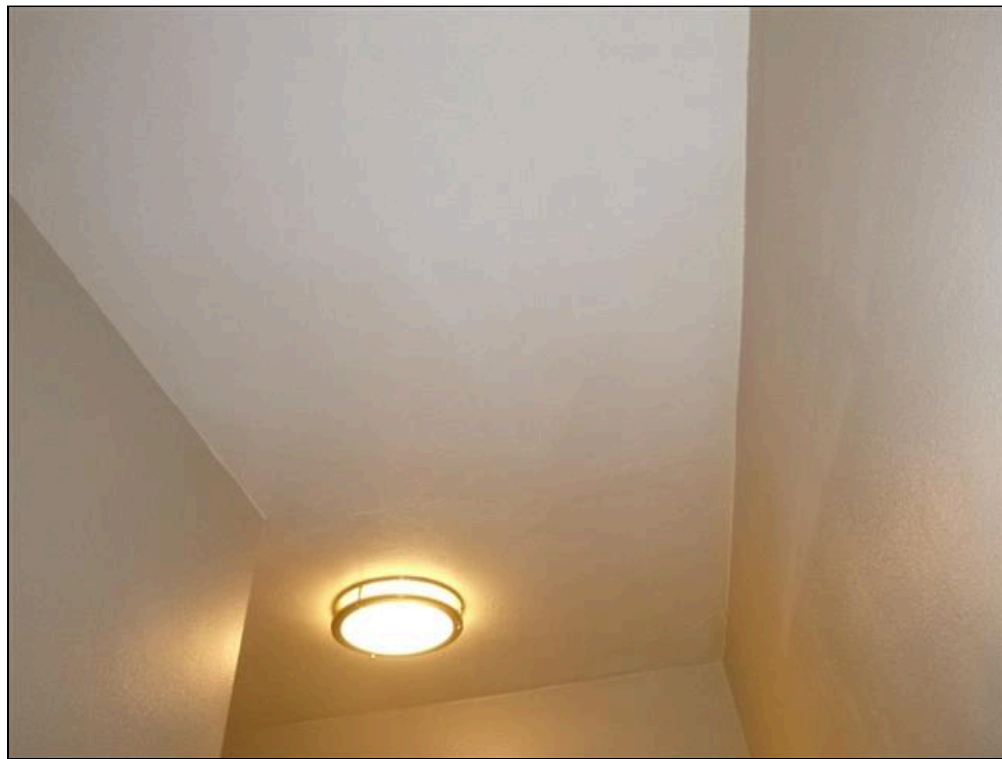
17.2 Item 1(Picture)

17.2 Patched and uneven areas of the ceiling was noted, suggest review with the seller on the cause and any repairs needed. Suggest review with a licensed contractor for any repair/removal/replacement costs as needed.

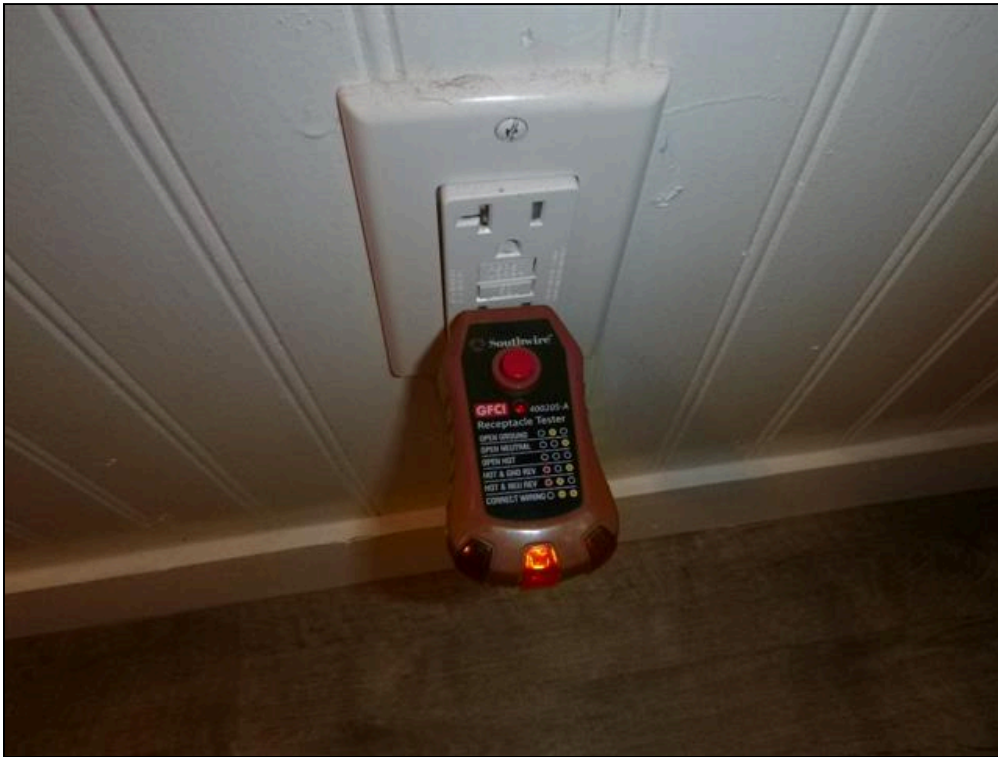
17.6 Item 1(Picture)

17.6 The GFCI outlet(s) at this area are not grounded. The GFCI should still provide GFCI protection but the outlet should generally be grounded. Suggest review by a licensed electrician for repair/grounding cost as needed and required for safety.

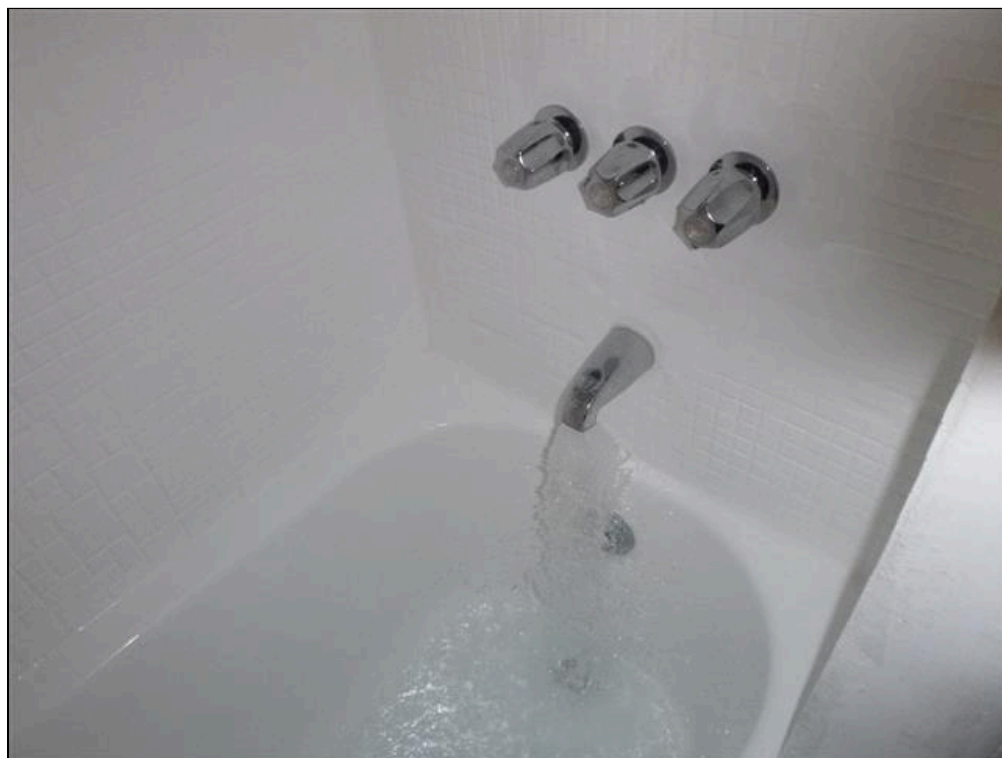
17.9 Item 1(Picture)

17.9 (1) The existing tub faucet is not a low-flow system as required. Suggest review with a licensed plumber for costs to replace the existing tub faucet with a low flow faucet (2.2 gallons per minute) as required by the State of California as of January 1st, 2017. See the plumbing system comments for further details and a link to the State of California plumbing ordinance. Most retrofit companies/cities do not enforce the low flow tub faucet requirements due to it can take an excessive amount of time to fill the tub (you will use the same amount of water irrelevant of how long it takes to fill the tub).

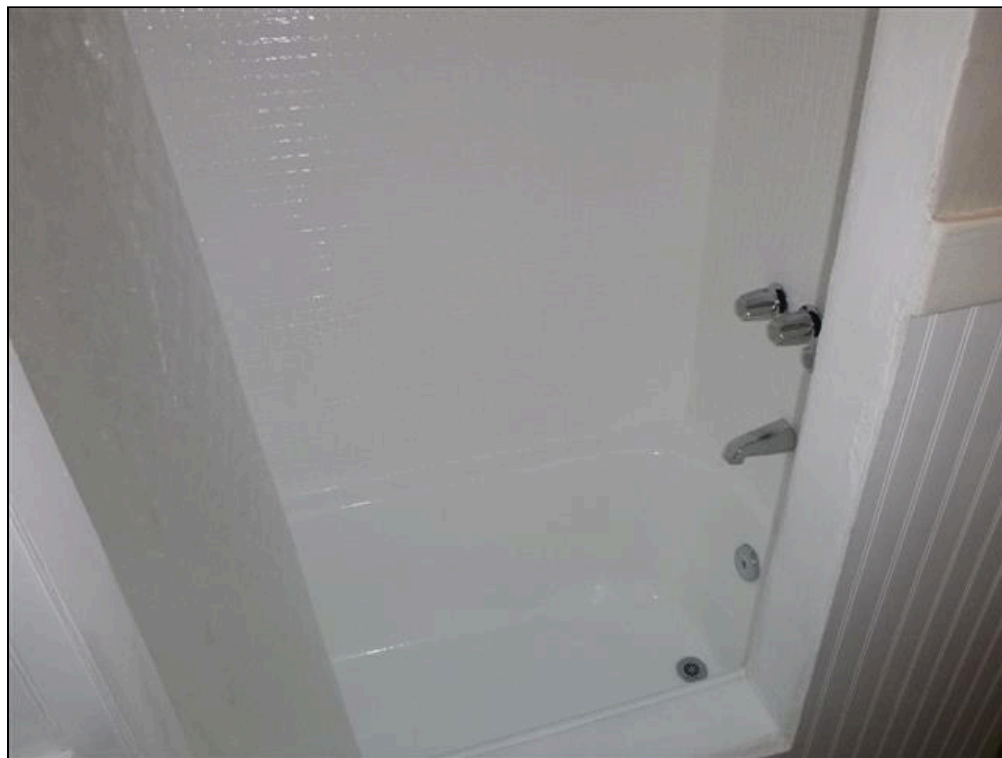
17.10 Item 1(Picture)

17.10 Reglazing noted at the shower wall tiles. Suggest review with the seller and/or installation company for care and maintenance requirements.

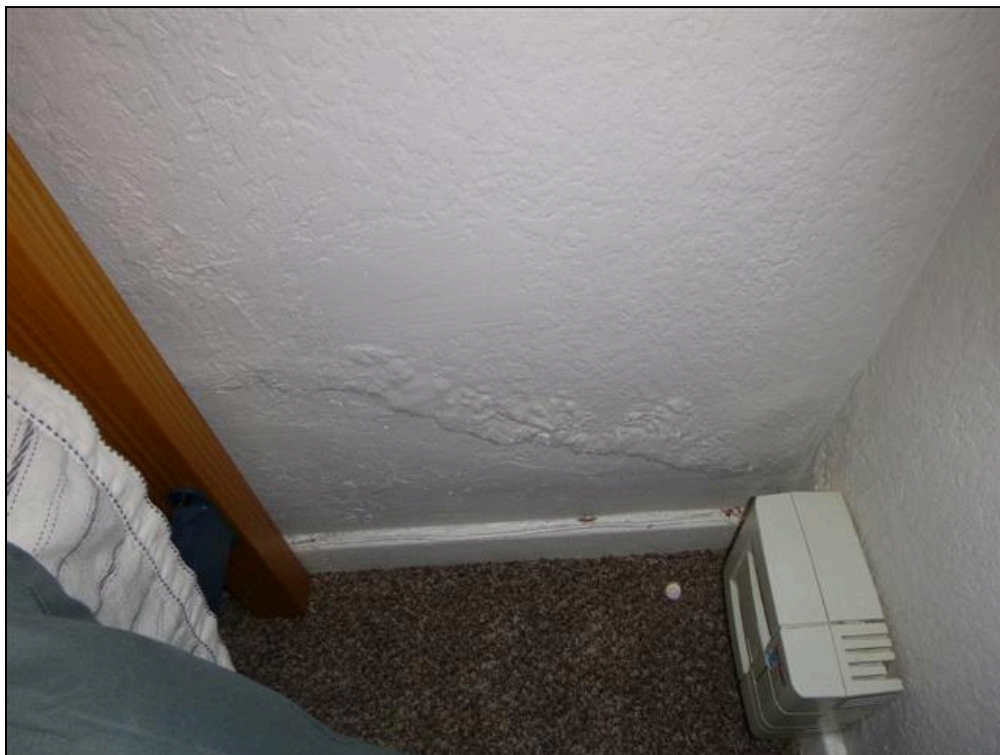
17.18 Item 1(Picture)

17.18 Excessive deterioration/damaged areas of the wall in bedroom #2 was noted noted which is adjacent to the tub/shower area. Suggest review with the seller and/or a licensed contractor for any repair/removal/replacement costs as needed.

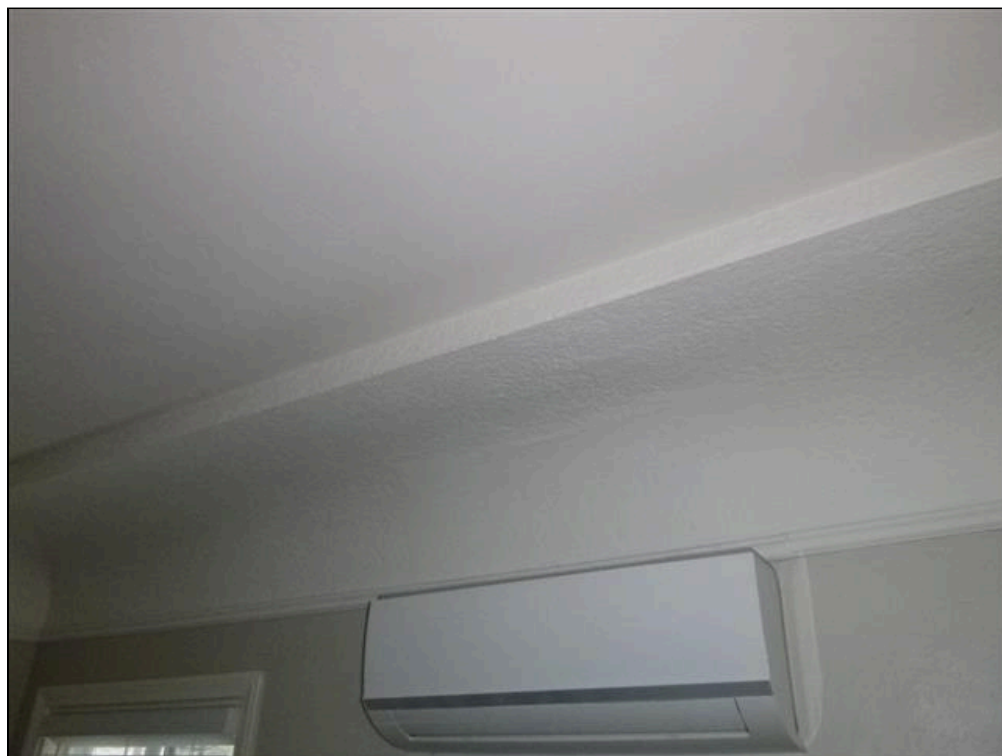
19.1 Item 1(Picture)

19.1 Patched areas of the walls was noted, suggest review with the seller for the cause and any repairs needed. Suggest repair as needed.

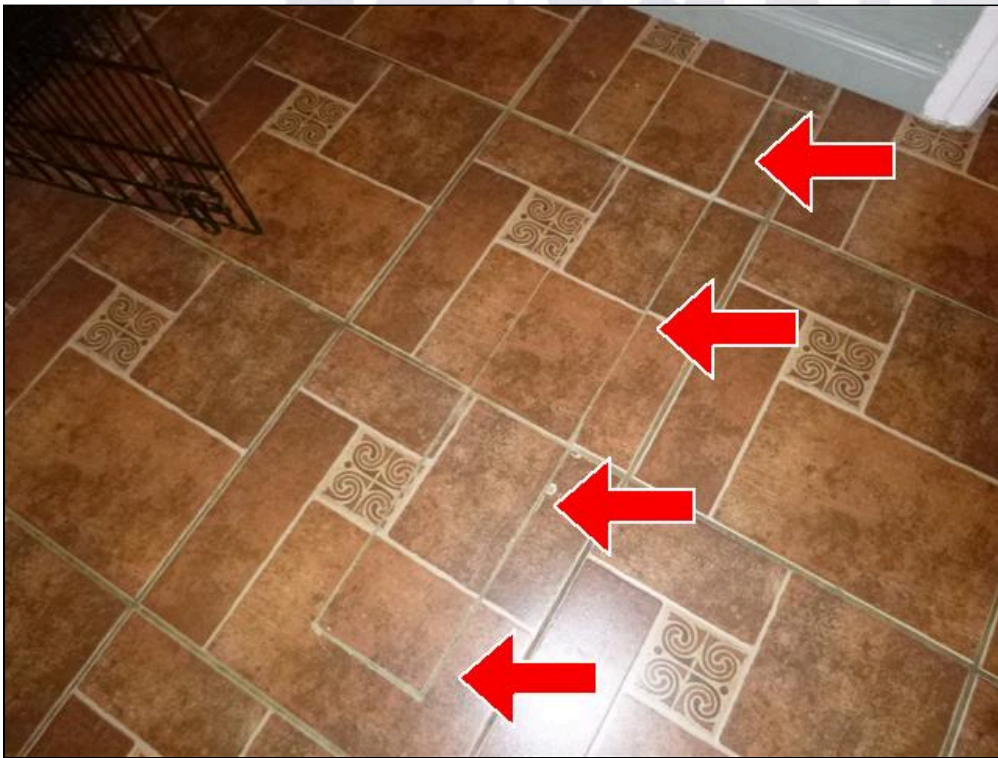
21.0 Item 1(Picture)

21.0 Patched repaired areas of the tile flooring was noted (this appears to be from a removed wall). Suggest review with the seller and/or a licensed contractor on this item as needed.

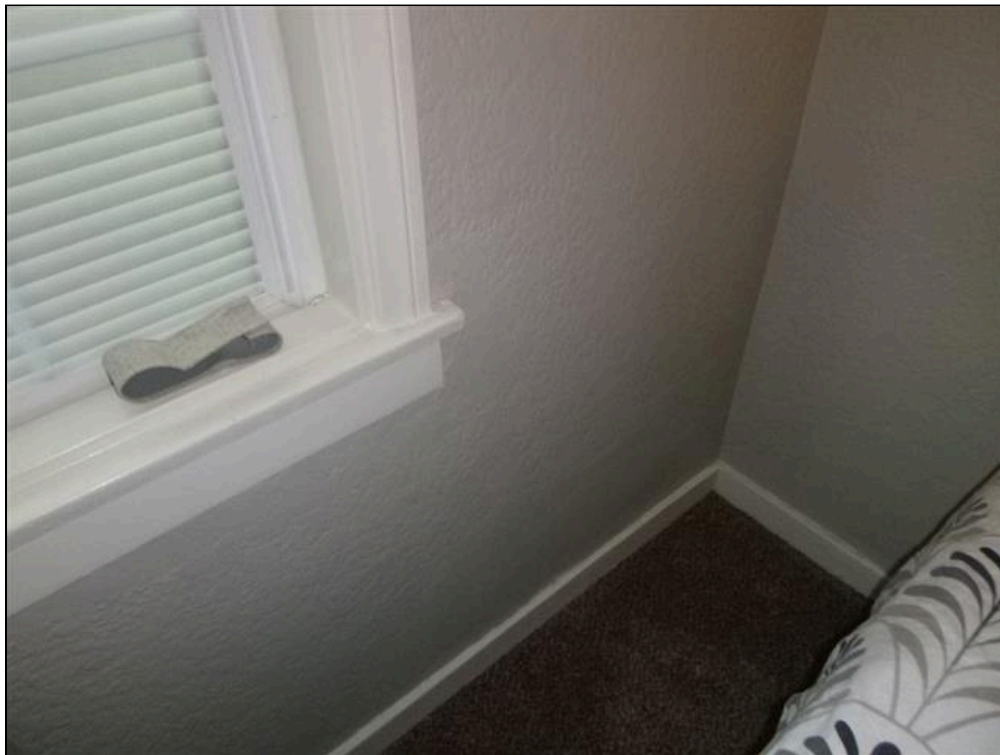
23.1 Item 1(Picture)

23.1 Patched areas of the walls was noted, suggest review with the seller for the cause and any repairs needed. Suggest repair as needed.

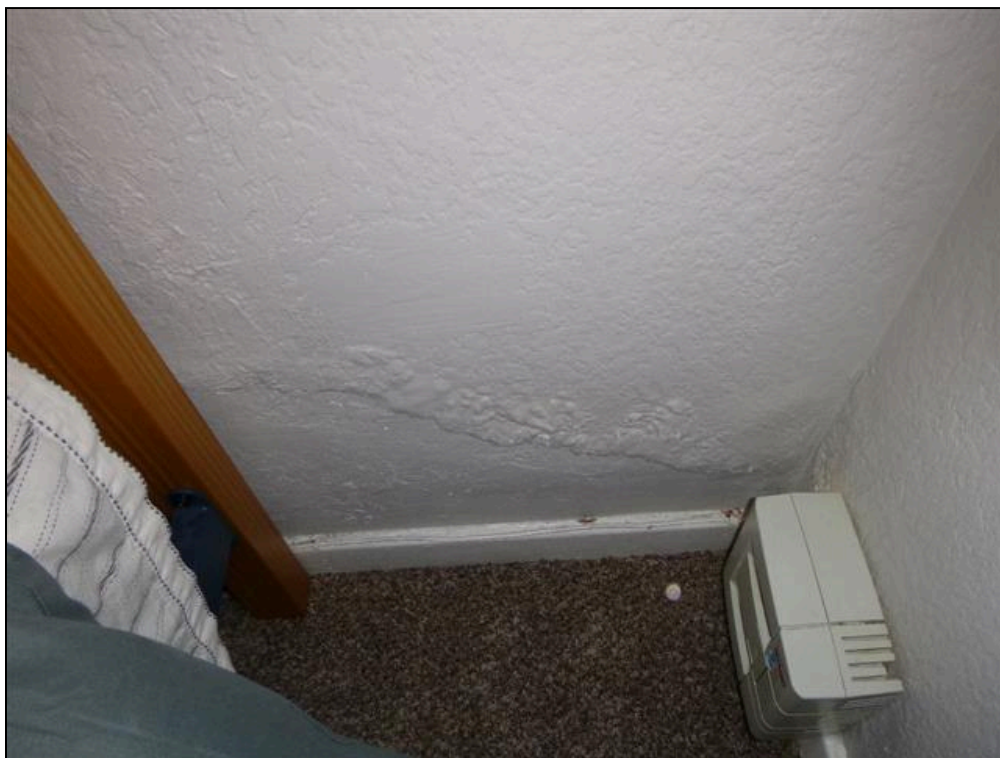
24.1 Item 2(Picture)

24.1 (2) Deteriorated/blistered/damaged areas of the front wall were noted (this area tested dry at the time of the inspection). This area is adjacent to the bathroom tub/shower area. Suggest review with the seller and/or a licensed contractor for any repair/removal/replacement costs as needed.
