Inspection Report

Property Address:
447 E Hullett St
Long Beach CA 90805

Ferguson Home Inspections

Date: 3/23/2024	Time: 09:00 AM	Report ID: 20240323-447-E-Hullett-St
Property: 447 E Hullett St Long Beach CA 90805	Customer: Kimberly Stewart	Real Estate Professional: Sue Freeman

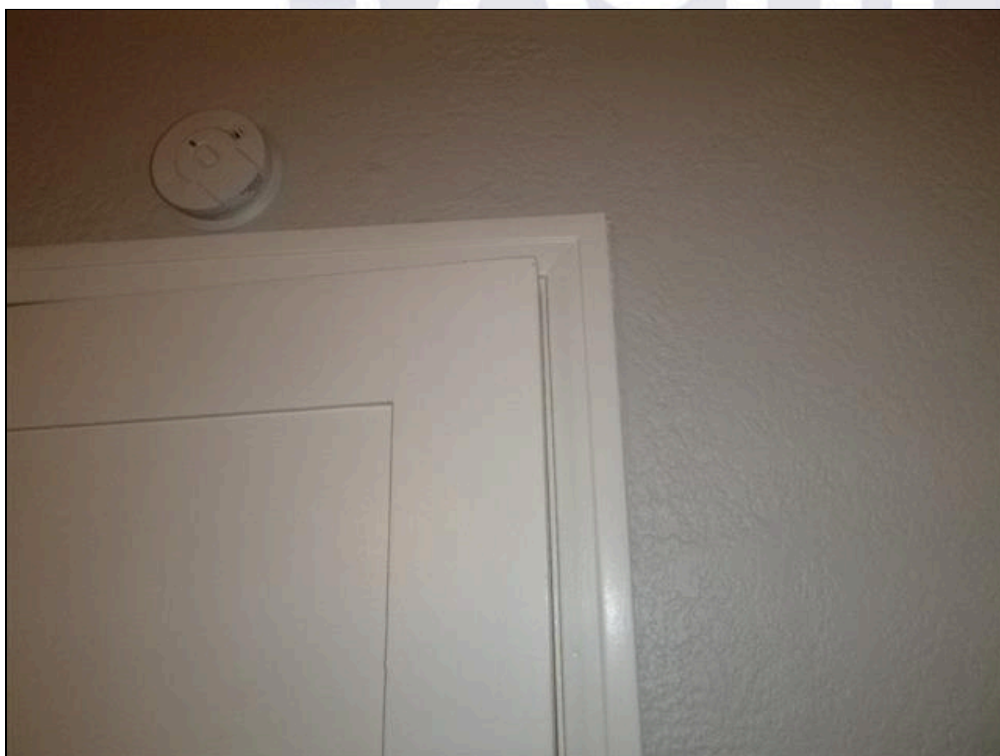
24.3 Item 1(Picture)

24.3 The door sticks/impacts on the jamb when operating, suggest repair as needed.

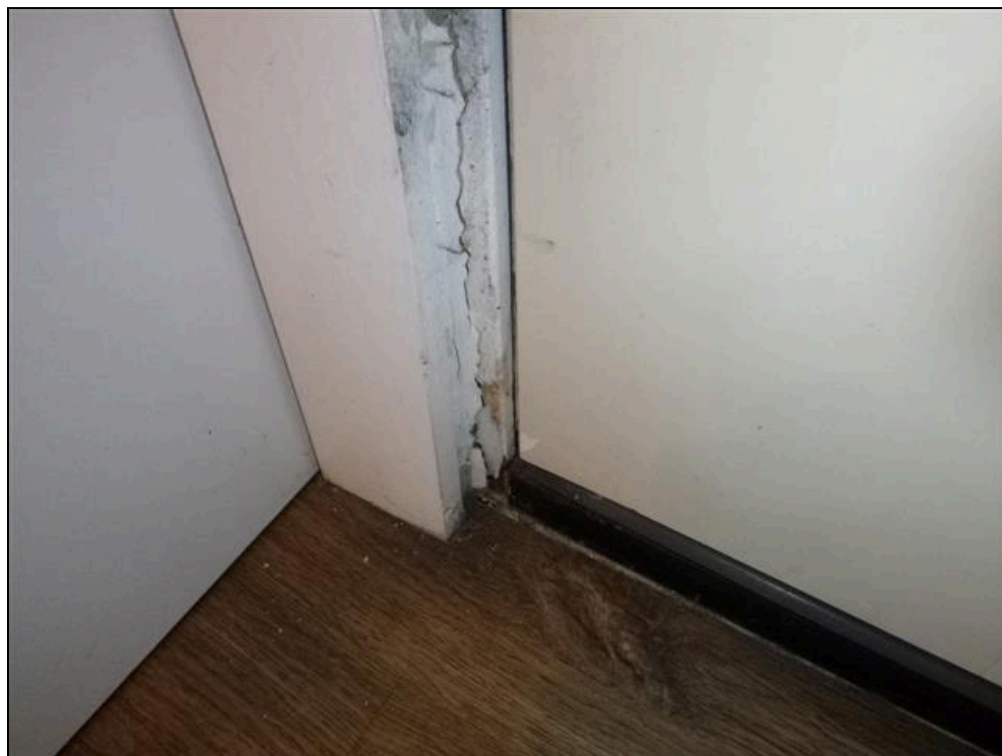
28.3 Item 3(Picture)

28.3 (3) Evidence of previous and ongoing water intrusion noted at the door(s) to the interior. Deteriorated and loose door trim/casings were noted. Suggest review with a licensed contractor for any repair/replacement costs as needed to prevent further and future water intrusion at this area.

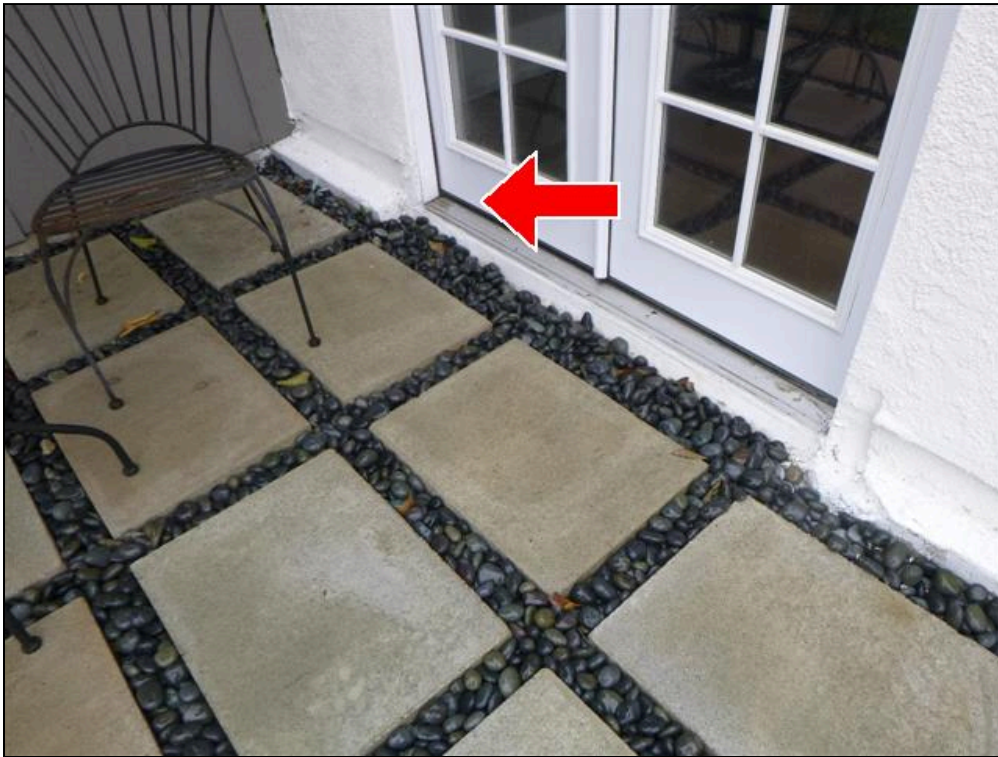
29.2 Item 1(Picture)

29.2 Evidence of previous and ongoing water intrusion noted at the door(s) to the interior. Deteriorated and stained flooring/baseboards noted. Suggest review with a licensed contractor for any repair/replacement costs as needed to prevent further and future water intrusion at this area.

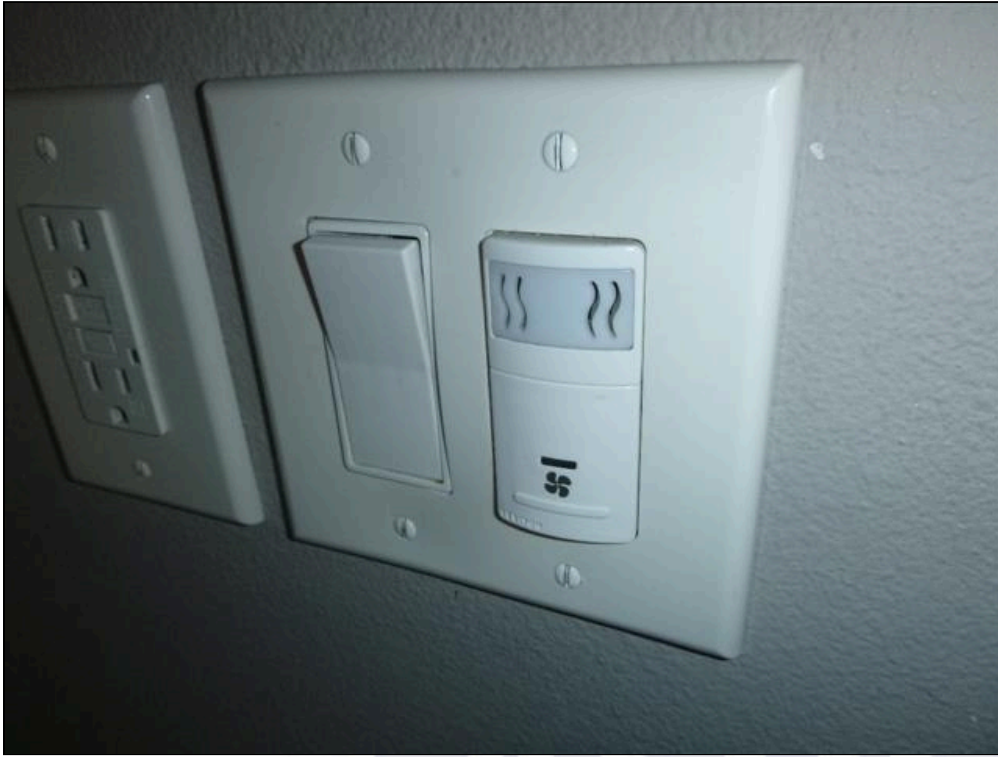
34.7 Item 1(Picture)

34.7 The exhaust fan is equipped with a motion and humidity sensor system.

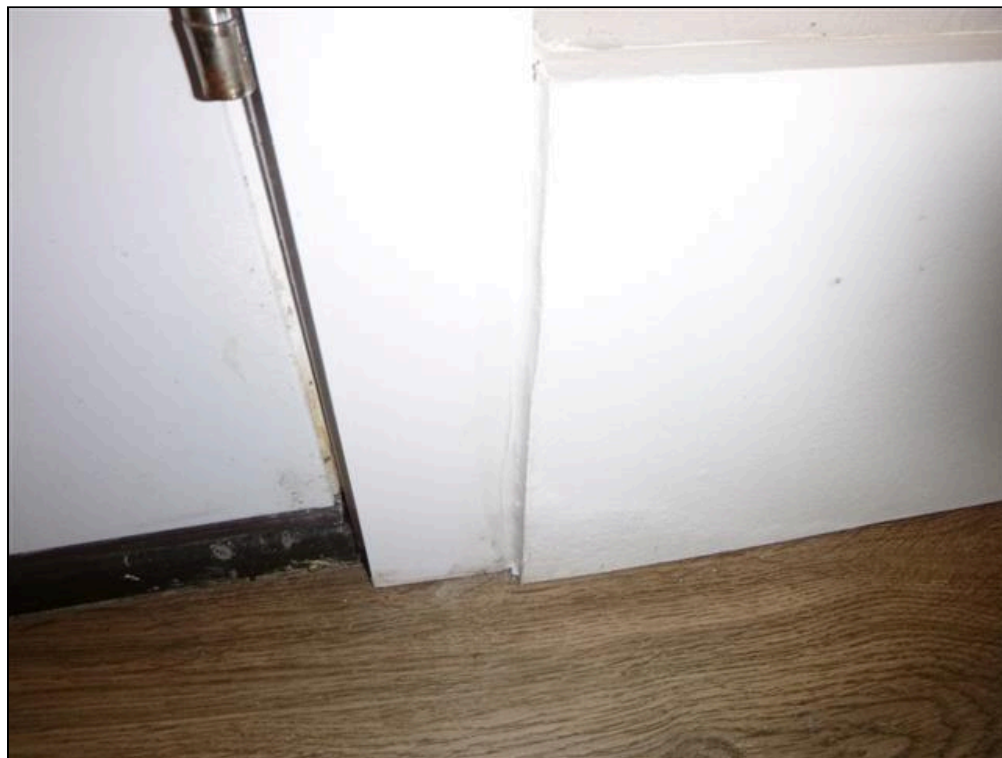
35.3 Item 1(Picture)

35.3 (2) Evidence of previous and possible on-going water intrusion was noted at the door(s) to the exterior (this area tested positive for moisture at the time of the inspection). Suggest review with a licensed contractor for any repair/removal/replacement costs as needed.

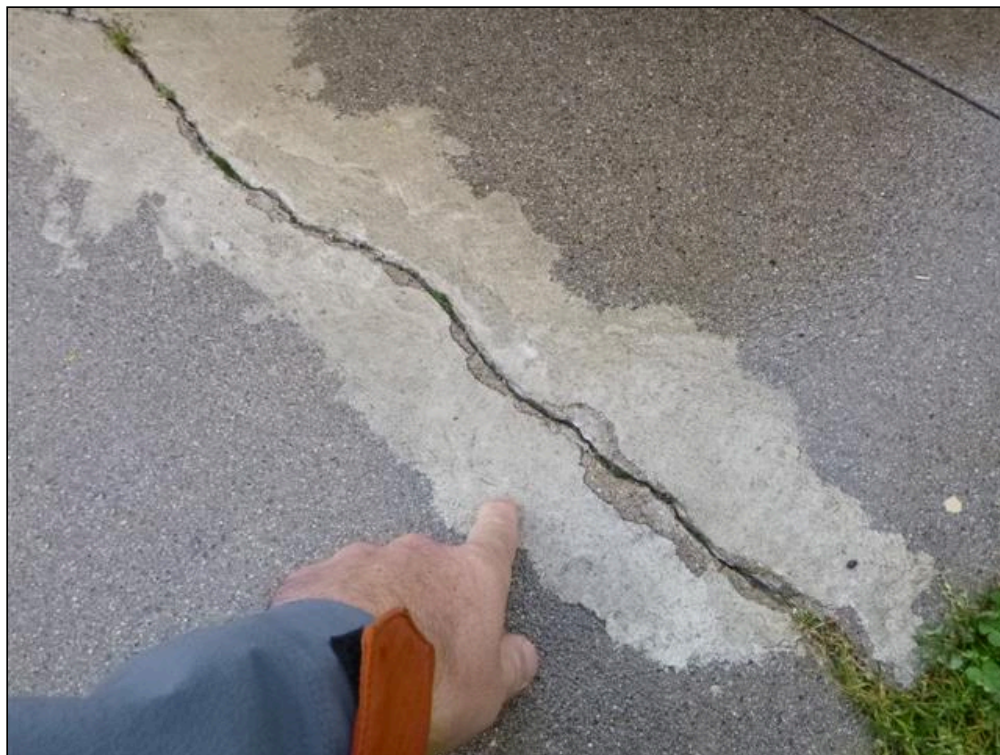
1.0 Item 1(Picture)

Settling, expansion cracks and heaving noted at various areas, this is a potential trip hazard. Suggest review with a licensed contractor for repair/replacement costs as needed.

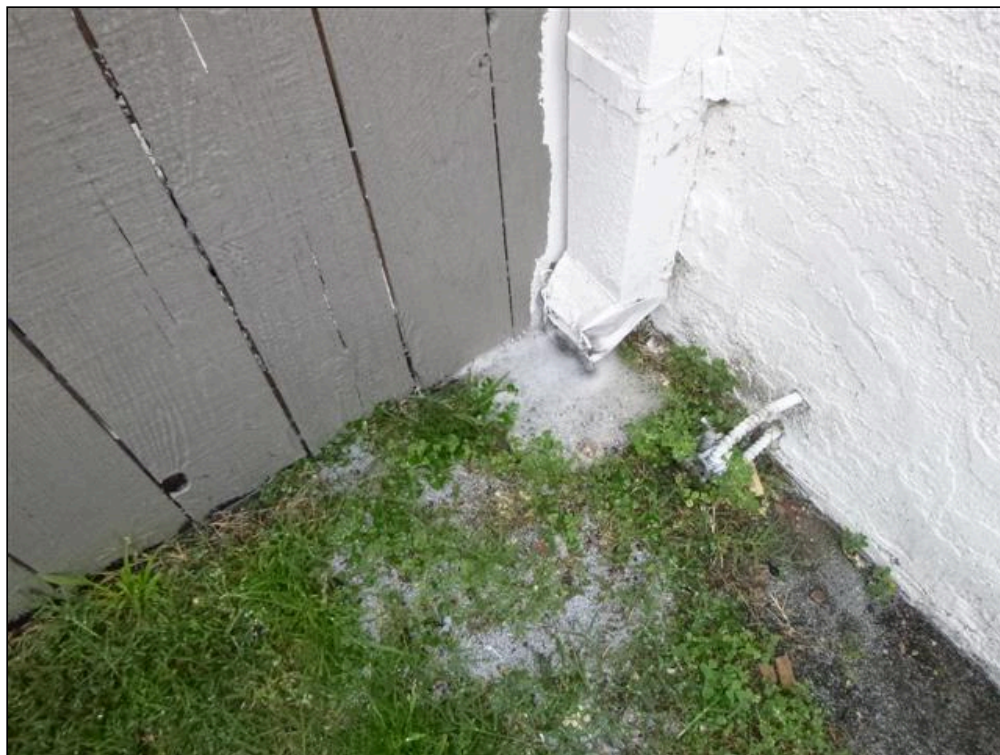
1.9 Item 1(Picture)

(1) Suggest review by a licensed contractor for possible installation of an area drainage system to divert drainage away from the foundation.

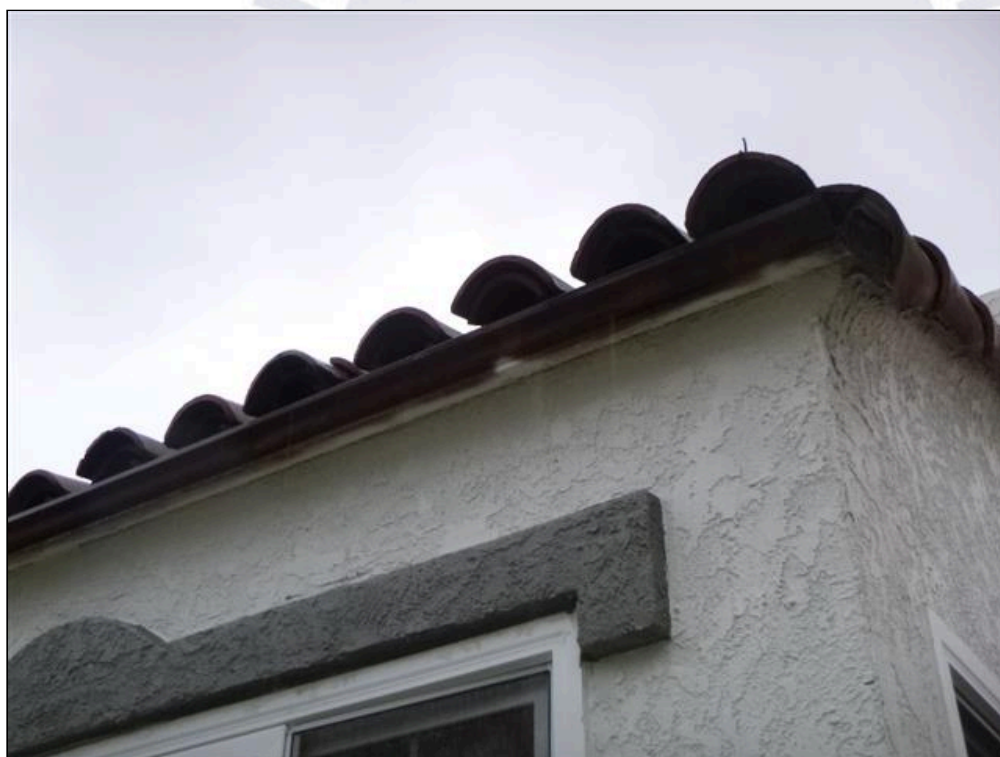
1.9 Item 2(Picture)

(2) The gutters are rusted and deteriorated at various areas, suggest replacing the gutters as needed.

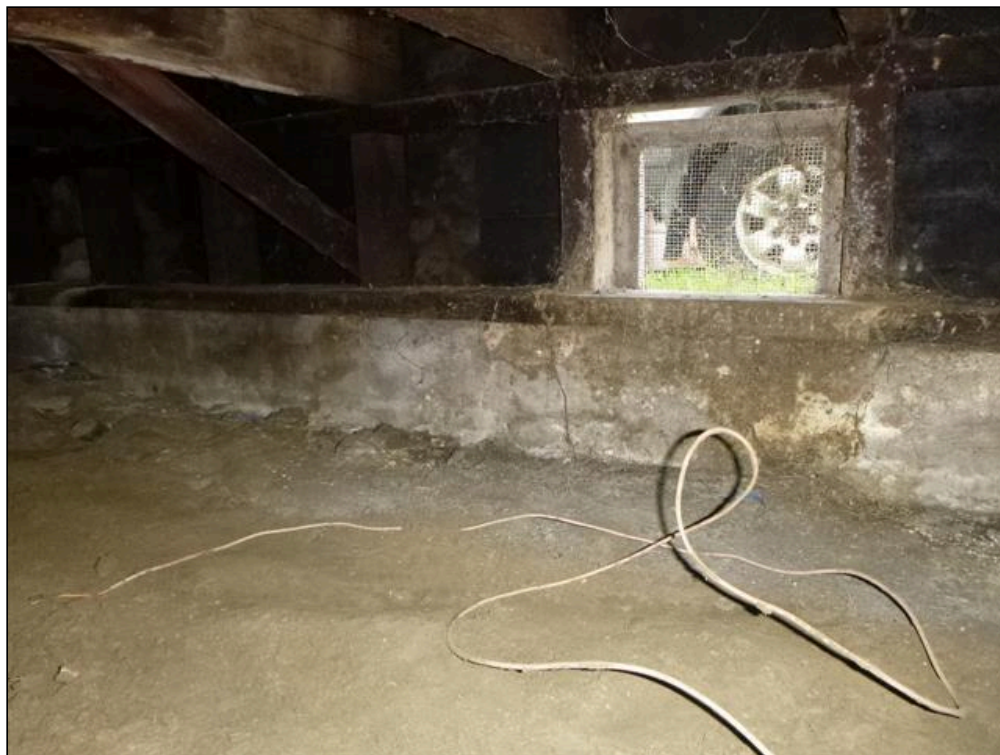
2.0 Item 1(Picture)

Re-grading where needed is recommended to assure all water drains away from the home's foundation. The inadequate drainage has caused the excessive moisture buildup at the foundation and intrusion into the crawl area. Suggest review with a licensed contractor for installation of concrete walkways/barriers, water proofing membranes, rain gutters and an area drainage/sump pump system to divert all the water away from the foundation/structure.

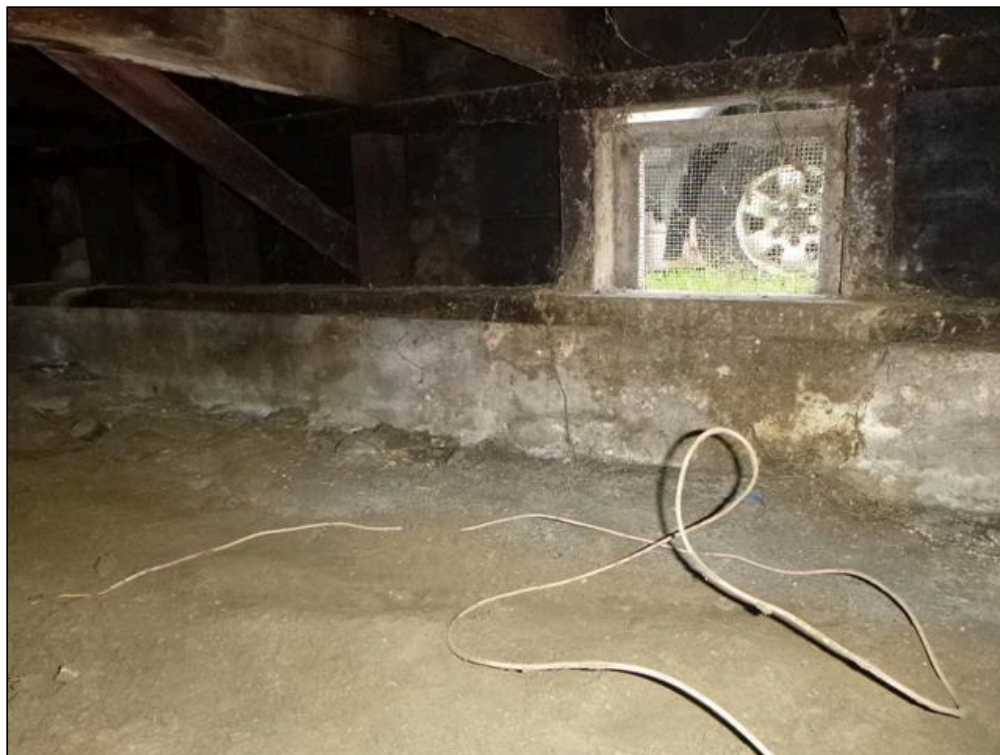
3.0 Item 1(Picture)

(2) White efflorescence (powder substance) on foundation footings indicates prior, and possibly ongoing, excessive moisture build up at the exterior of the foundation. Ongoing water intrusion at the foundations can, in some cases, cause the steel in the foundations to rust, called spawling, which can lead to horizontal cracking of the foundation (currently there are no major cracks visible at the foundation). Any future cracking/damaged can be an expensive repair as the foundation is now structurally weak and susceptible to horizontal movement. Suggest review of the Lot/Grade and drainage systems, including rain gutters, to reduce and prevent further and future water buildup at the exterior of the dwellings foundations.

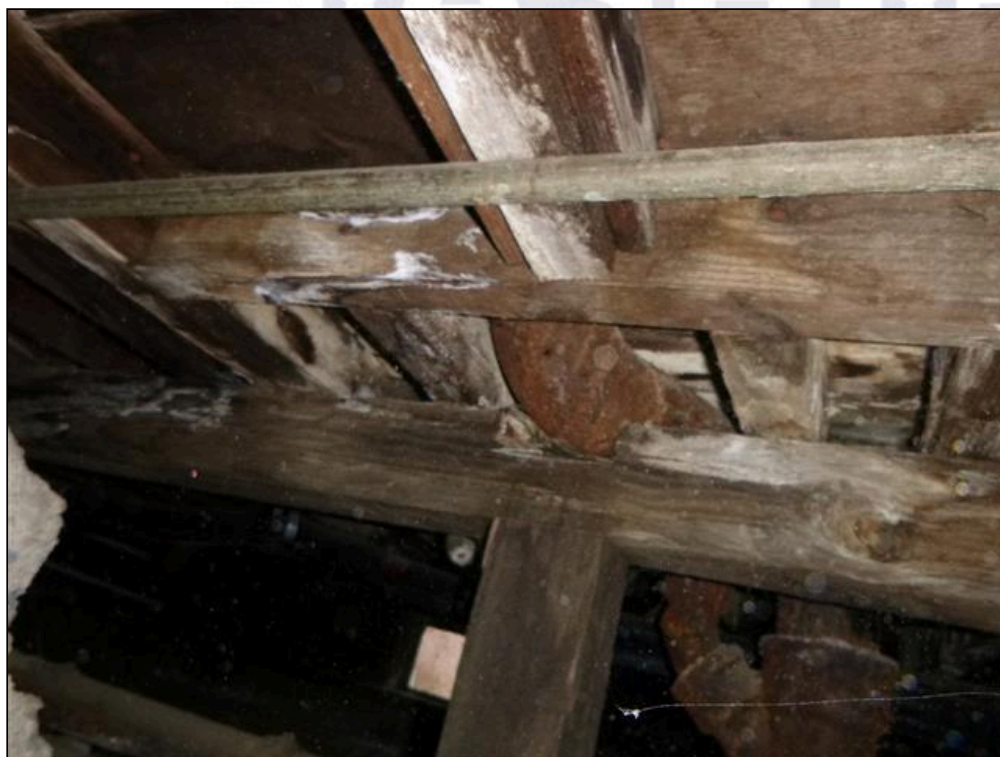
3.1 Item 1(Picture)

(1) Stains and deterioration noted at various flooring and supports from prior leaks. Suggest review with a termite company and/or a licensed contractor for any repair/replacement costs as needed.

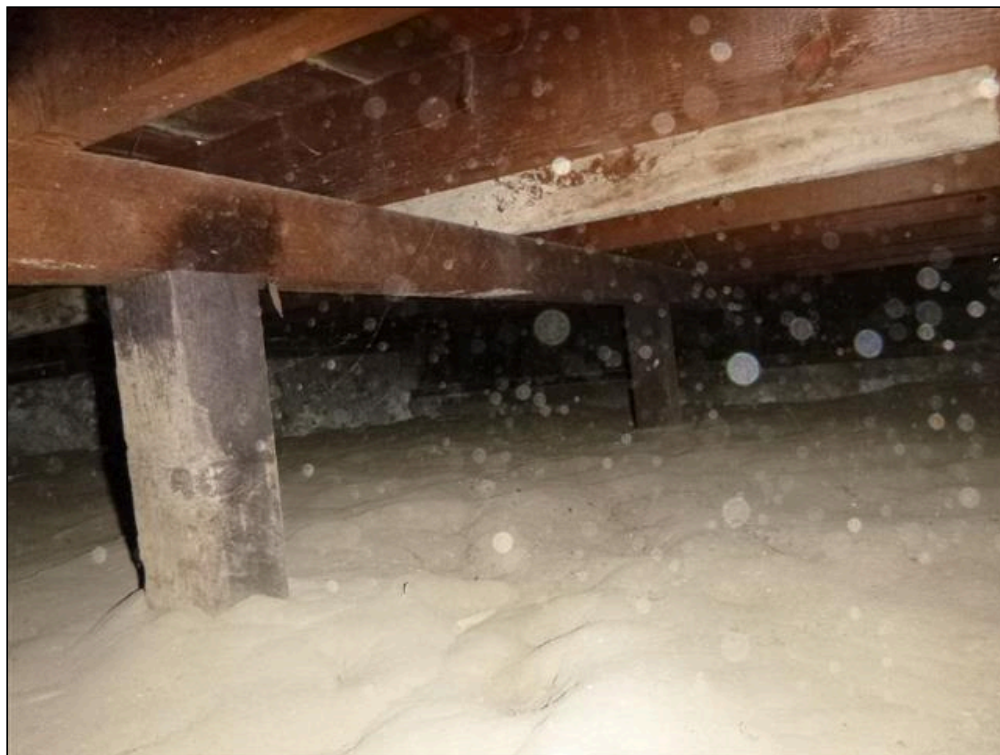
3.1 Item 4(Picture)

(2) Inadequate support noted at various girder beams due to the excessive span and inadequate support posts, common for the original age of the dwelling. Suggest review by a licensed contractor for costs to add additional supports to prevent possible future structural and floor movement as needed.

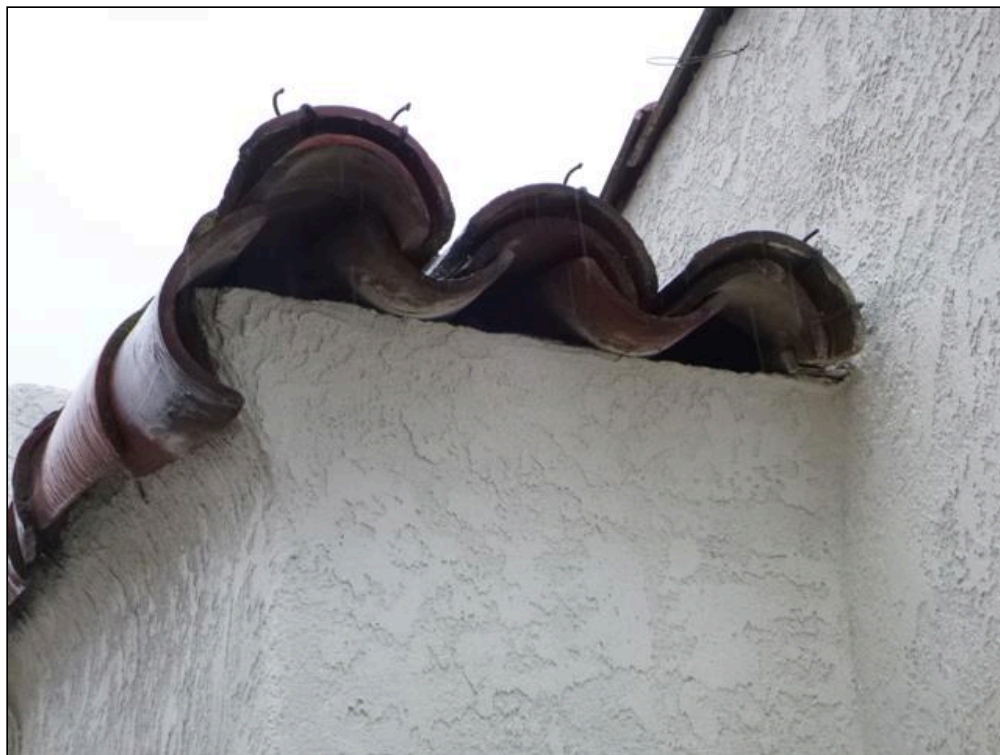
5.0 Item 16(Picture)

(6) No 'bird stops' were installed at the tile roof time of the inspection. Suggest review with a licensed roofer for installation costs as needed.

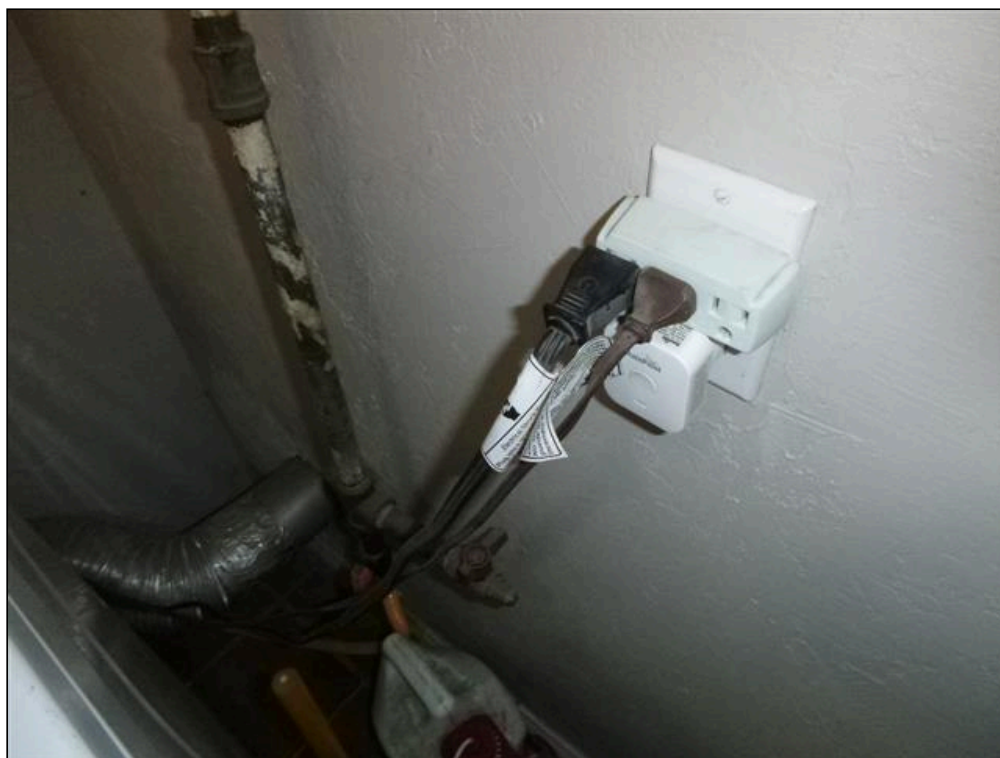
7.6 Item 1(Picture)

The appliances are currently being powered off a plug strip/extension cord, this is a potential fire hazard. Suggest remove the plug strip/extension cord and review by a licensed electrician for costs to install additional outlets as needed/required for safety.

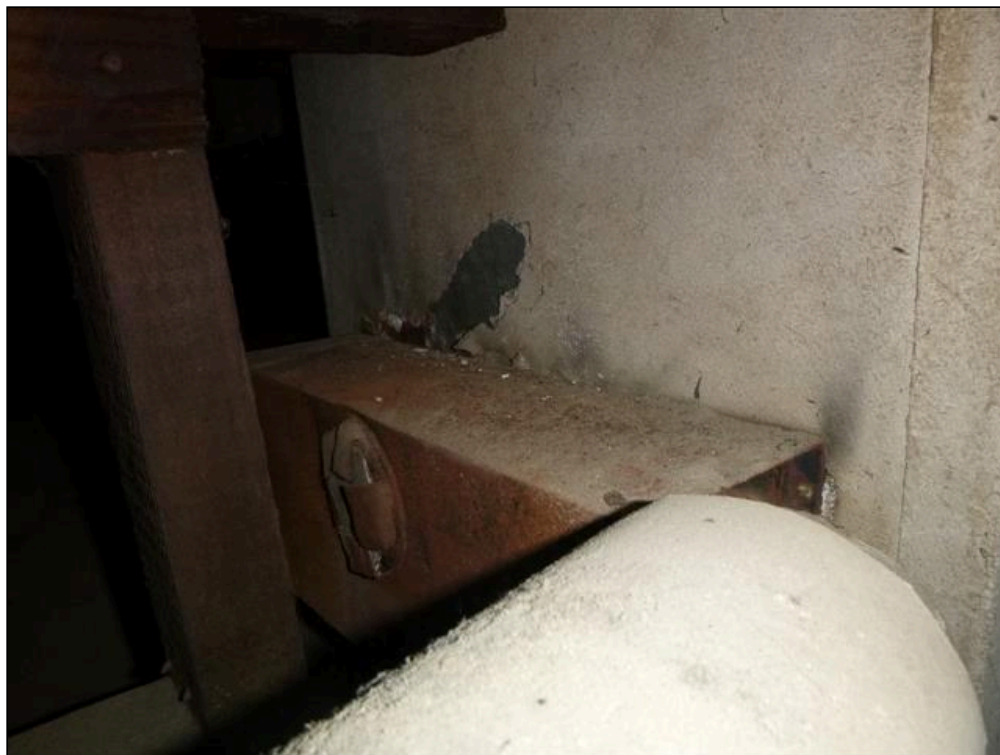
10.1 Item 1(Picture)

Potential safety hazard due to the heater draft diverter is rusted, deteriorated and large holes were noted. This will allow heater fumes/carbon monoxide to escape into the crawl area and possibly into the dwelling. Suggest review with a licensed heater company for replacement costs as required for safety.

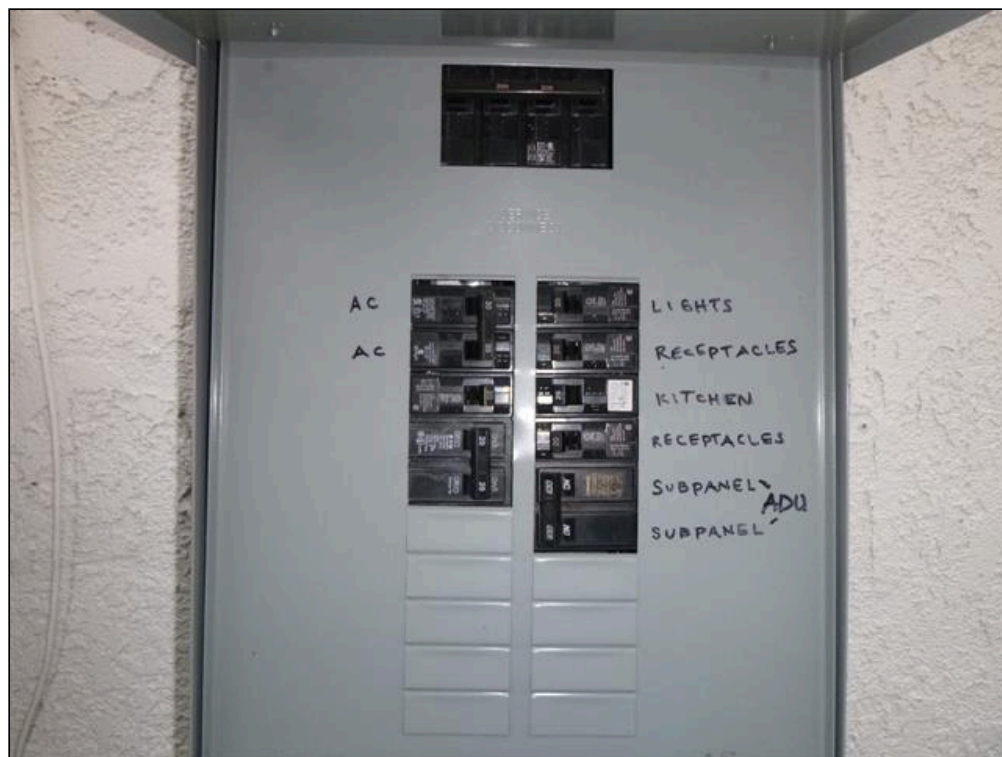
12.1 Item 1(Picture)

Suggest adding correct/complete indexing/labelling to all breakers for identification of each circuit for safety.

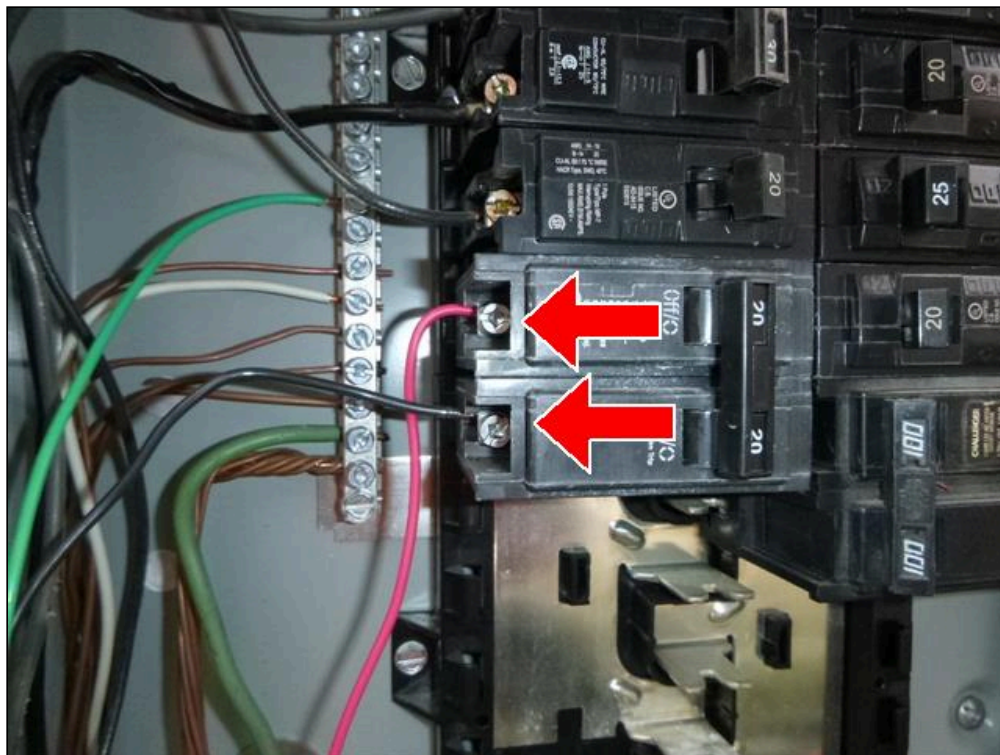
12.2 Item 1(Picture)

(2) A potential fire/safety hazard was noted due to the incorrect sized wiring connected to the breakers. 14 gauge wiring is currently connected to 20 amp breaker(s) in the sub panel, 15 amp breakers are required. Suggest review by a licensed electrician for any repair/replacement costs as needed.

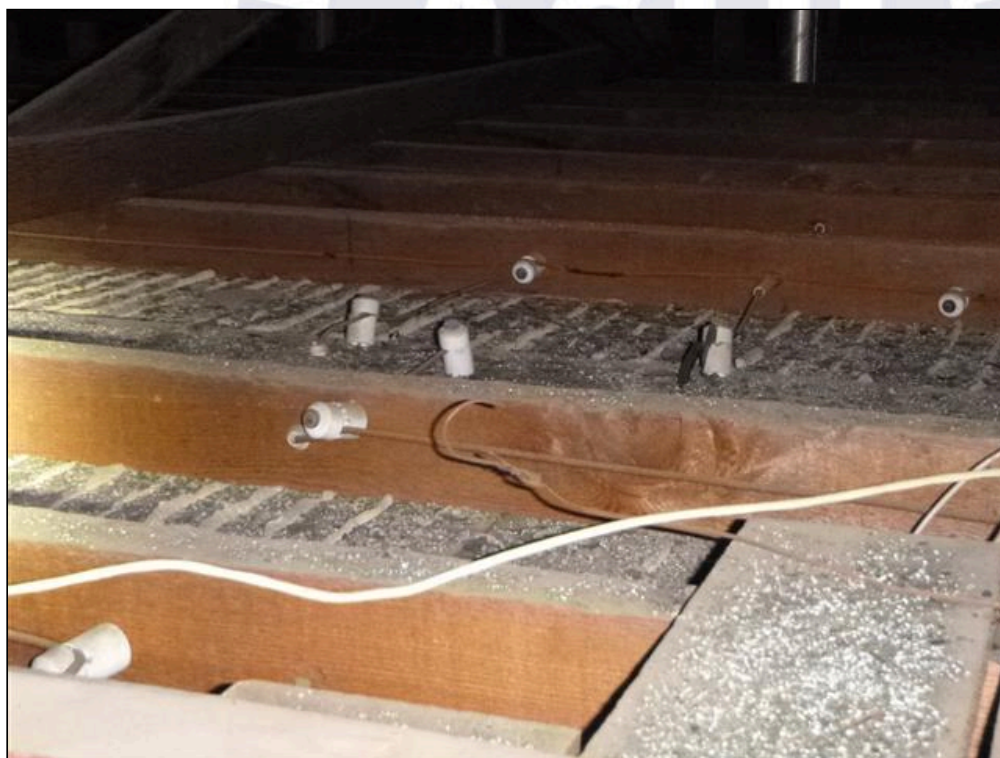
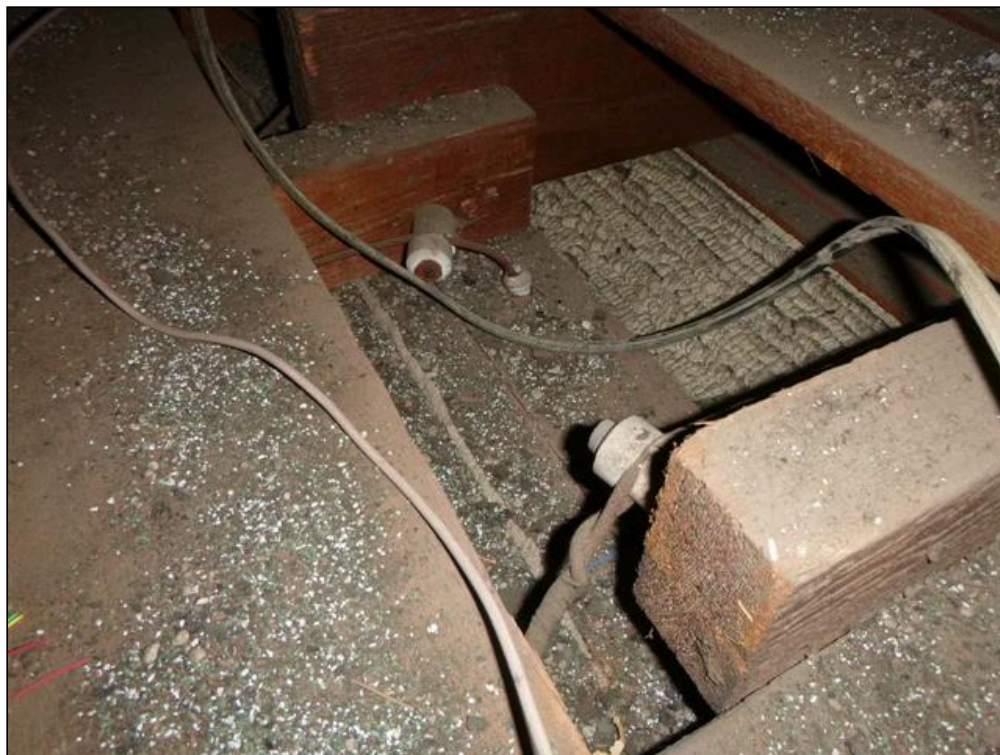
(3) Knob & Tube wiring noted throughout the attic area, this is common for the original age of the dwelling. Suggest review by a licensed electrician for replacement costs to upgrade the wiring to todays standards for safety.

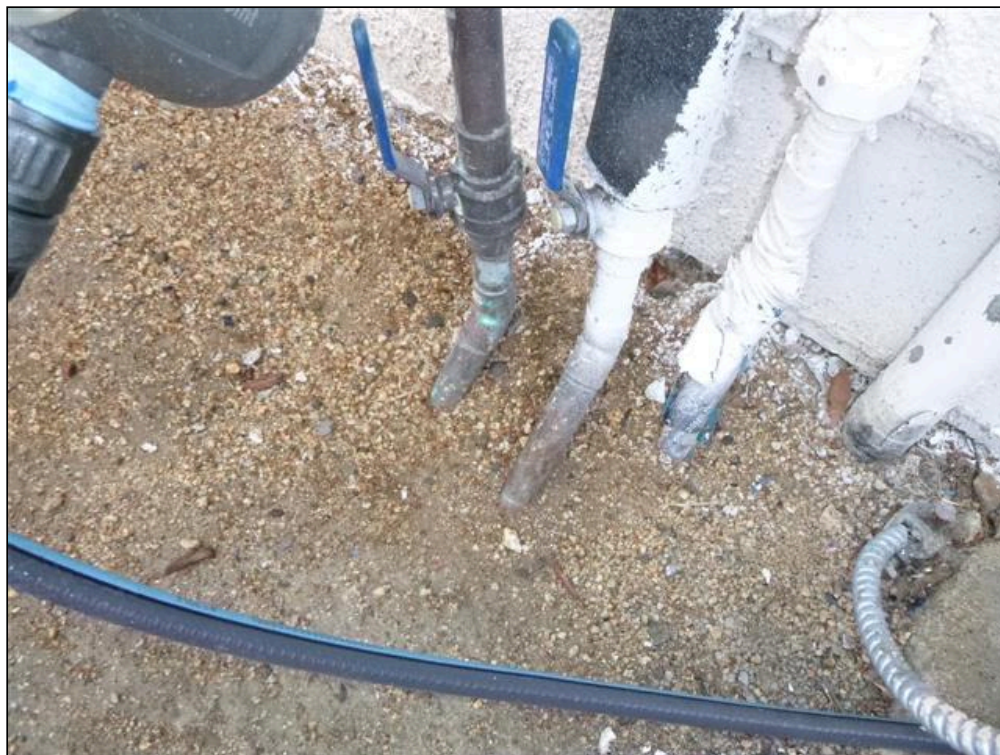
13.0 Item 1(Picture)

(1) The copper plumbing that transfers from the dwelling to the guest house/ADU area does not appear to be wrapped or insulated below grade. Suggest review by a licensed plumber and repair/replace as needed.

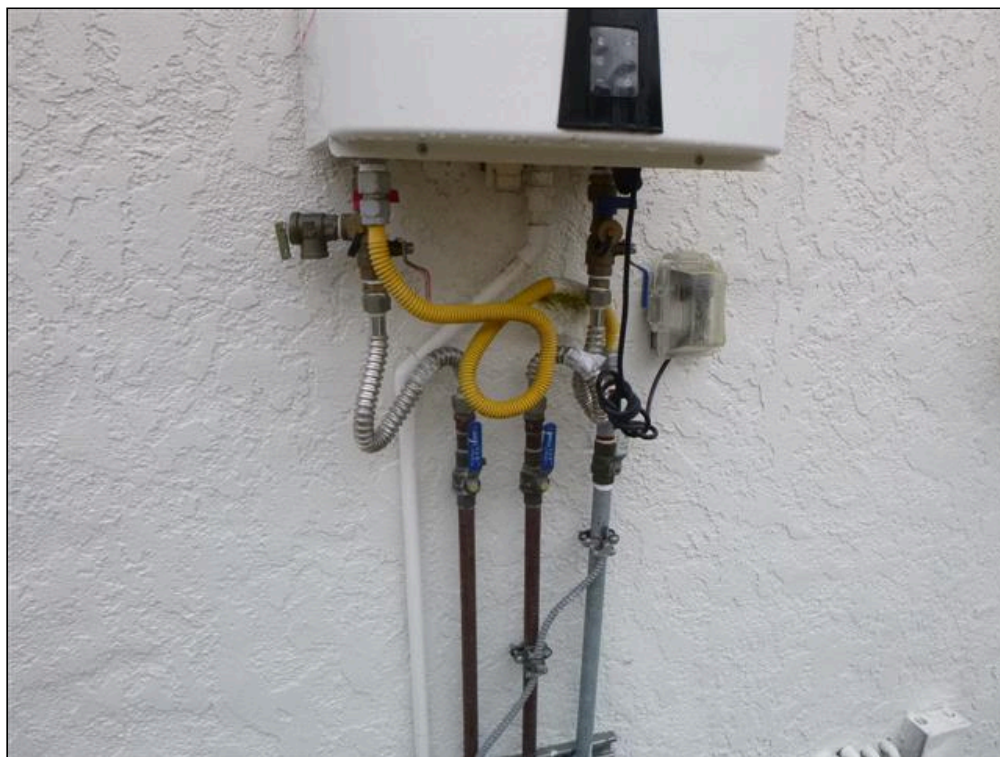
15.0 Item 2(Picture)

(3) The current water heater does not have a "Thermal Expansion tank" which is generally installed to prevent a possible leak at the T&P or "pop-off" valve and/or excessive pressure build-up at the internal plumbing, fixtures and joints. Recent changes (2012) require one when a new water heater is installed, but various cities do not enforce this installation for multiple reasons (the home is not on a closed system and various tankless units do not require it) . There were no leaks or drips at the T&P valve during inspection. If your water heater does begin to drip or leak, then a thermal expansion tank may be needed. Suggest review with the city and/or a licensed plumber to determine if this installation is required and install as needed.

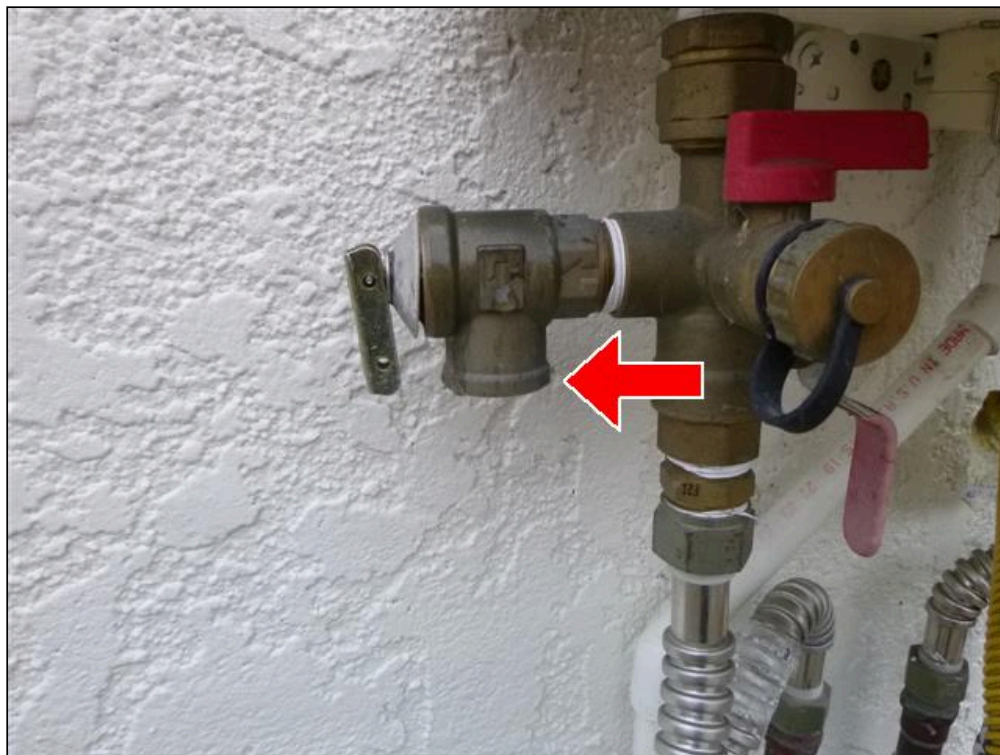
15.0 Item 3(Picture)

(4) No discharge pipe connected to the TP&R valve, this is a potential safety hazard. Suggest review by a licensed plumber for costs to install the TP discharge drain down to within 4-6 inches of the exterior grade/deck as required for safety.

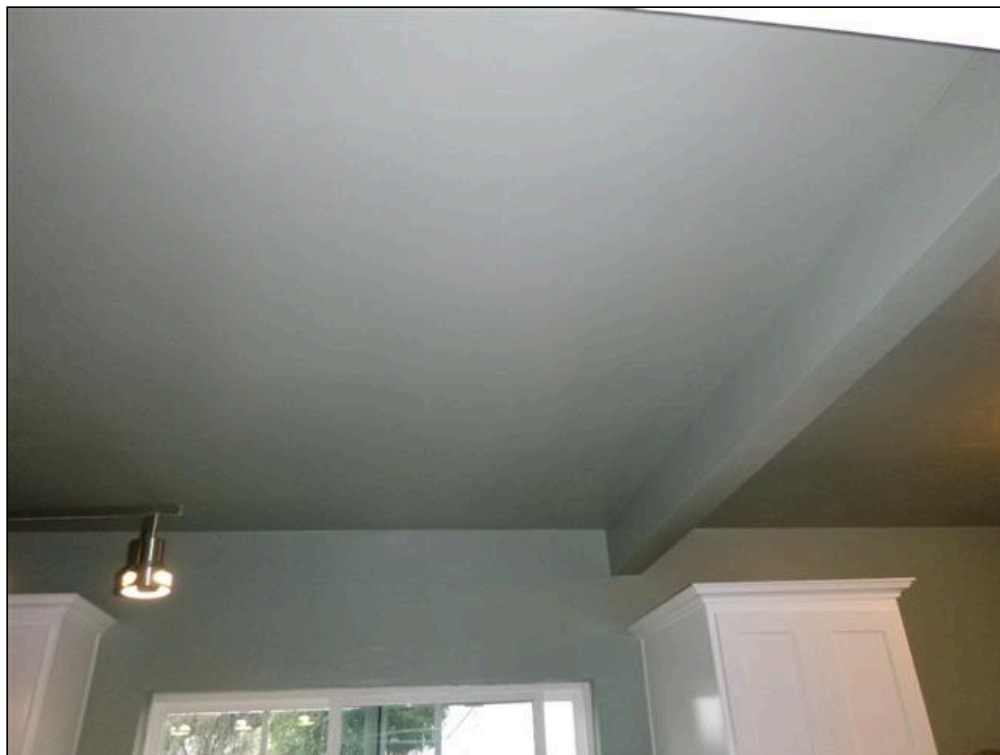
16.2 Item 1(Picture)

Patched and uneven areas of the ceiling was noted, suggest review with the seller on the cause and any repairs needed. Suggest review with a licensed contractor for any repair/removal/replacement costs as needed.

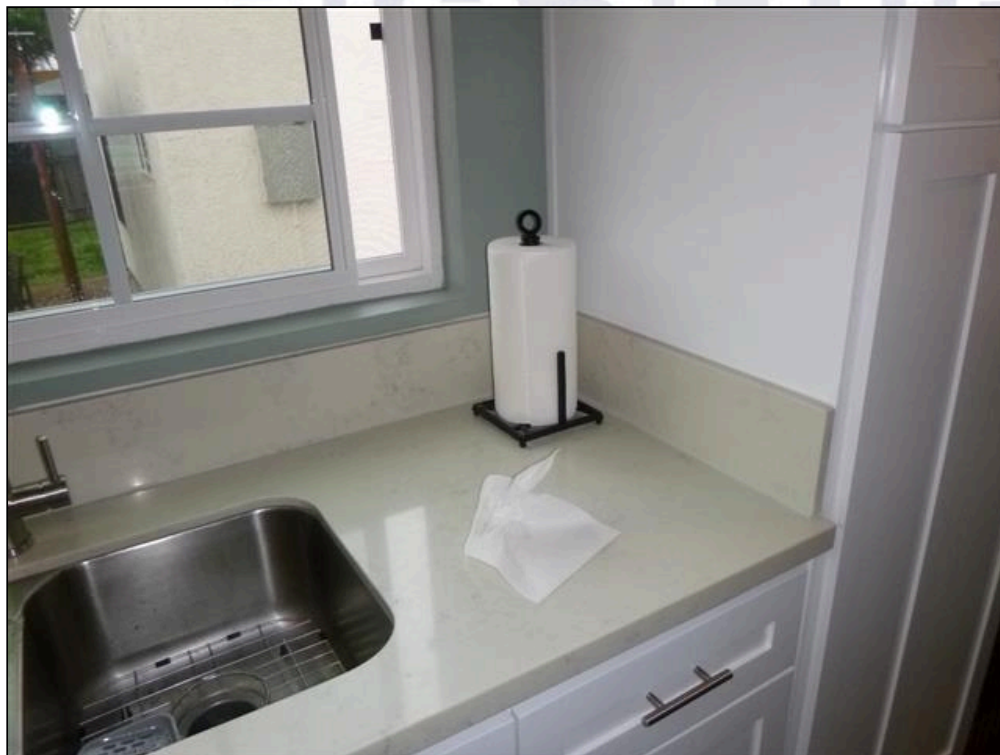
16.7 Item 1(Picture)

(1) Inadequate/incorrectly installed countertop/appliance outlets/circuits were noted, suggest review with a licensed electrician for installation costs as needed/required.
