Summary Only

Property Address:
11102 Whitebark Ln
Corona CA 92883

**A New Day Home Inspections
Chris Johnson**

This is not the complete home inspection report. It is only the Summary Items.

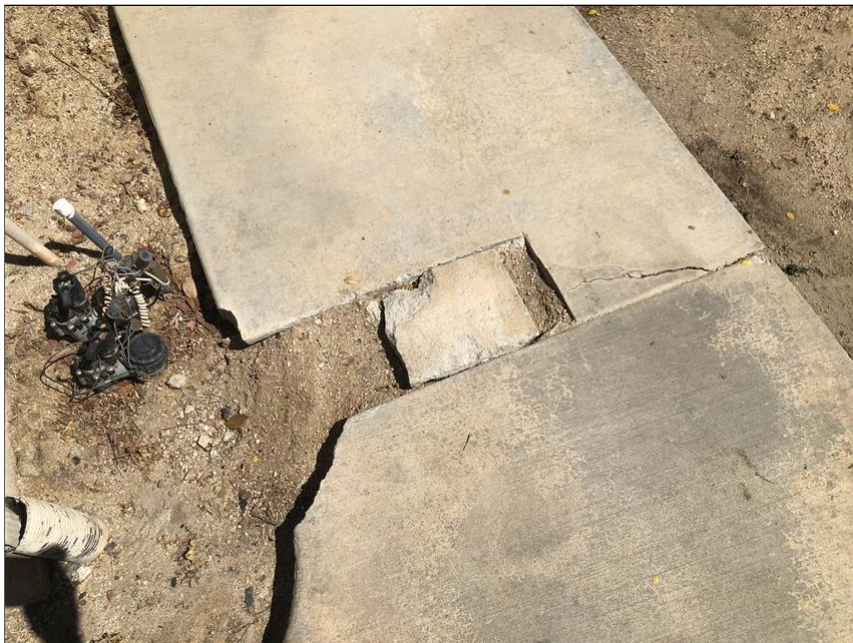
3.3 Item 1(Picture)

- ➔ Damage to the right side walkway has created trip hazards. The damaged areas should be replaced or repaired as needed.

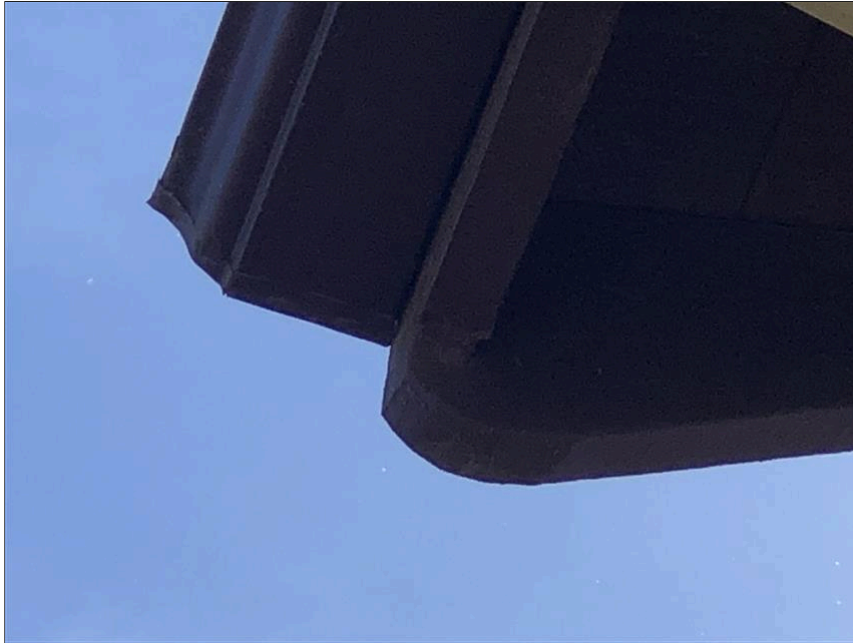
3.8 Item 1(Picture)

- ➔ Conditions associated with wood-destroying organism activity are present in several areas.
 - A qualified, licensed pest control operator should evaluate these conditions, and determine what further steps are necessary.
 - NOTE: Observations by a building inspector, who is not otherwise specially qualified to inspect for evidence of pests, is not a substitute for inspection by a licensed Pest Inspector or exterminator. This report includes comments on current visible conditions only. (Rear left side)

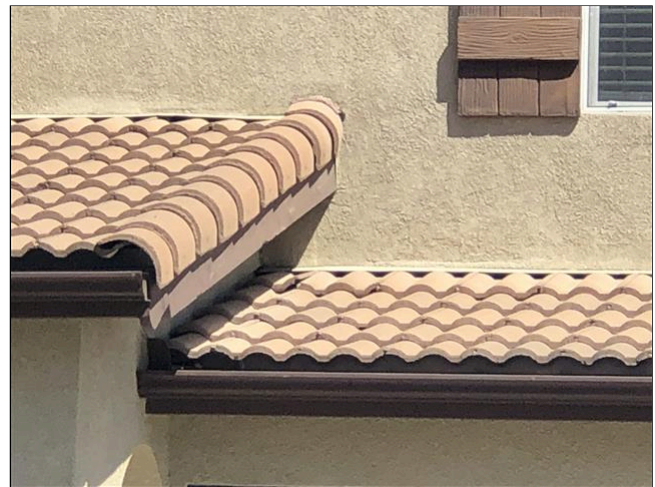
- ➔ (1) Two concrete tiles are cracked and/or broken at the front of the home. A qualified roofing contractor should inspect further and make any needed repairs.

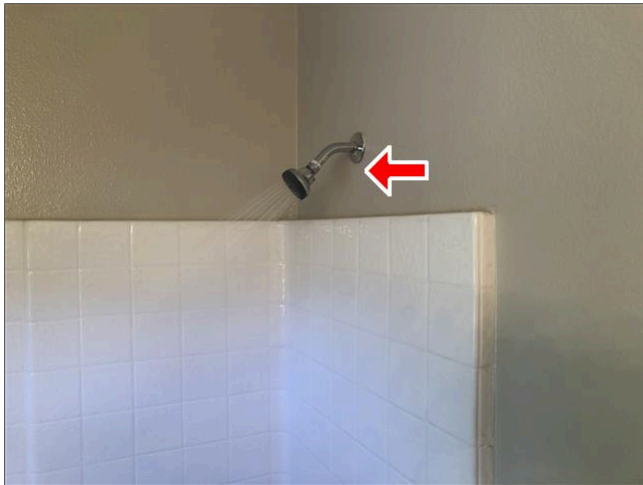
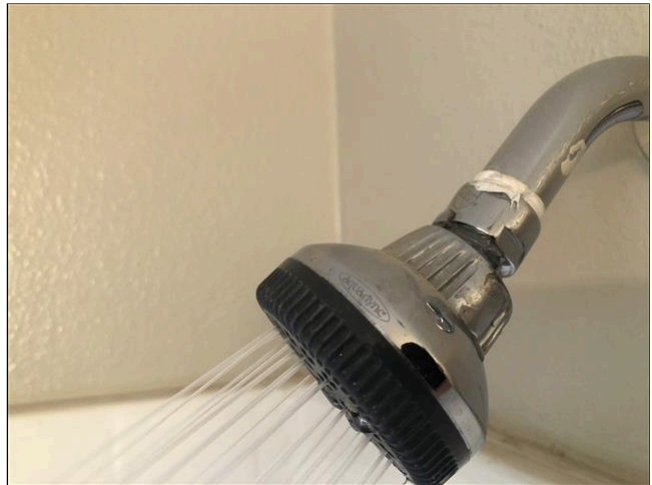
- ➔ The shower head leaks at its base at the hall bathroom. A qualified technician should repair or correct as needed.

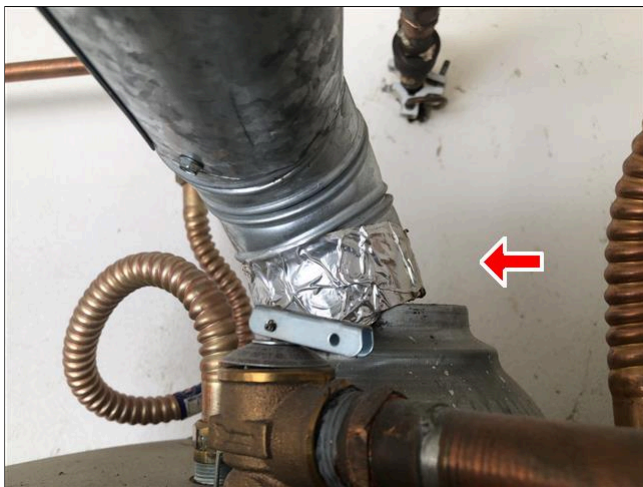
5.10 Item 1(Picture)

- ➔ The water heater vent is separated allowing the vent gasses to mix with the household air supply. A qualified technician should effect repairs as needed.

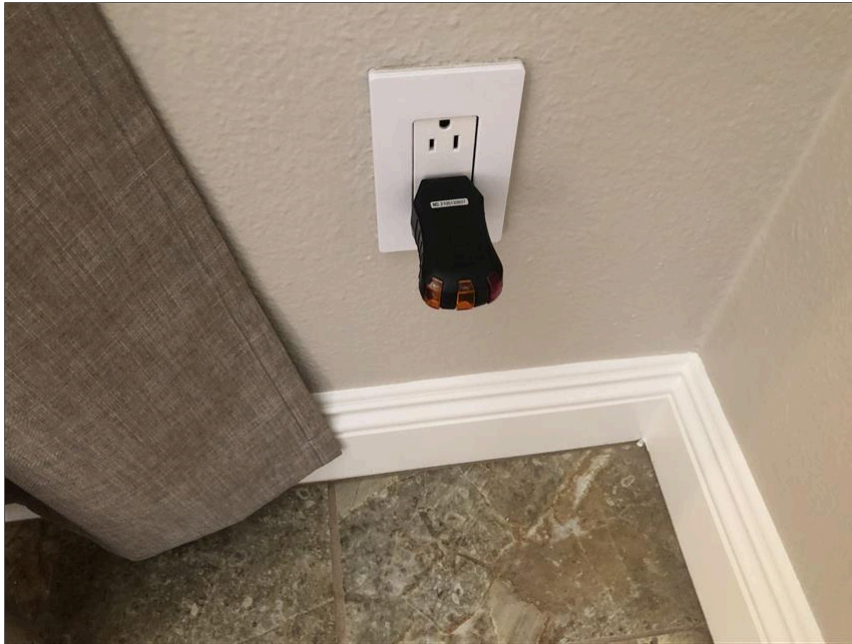
➔ (3) One outlet are does not have power at living room. A qualified electrician should make any needed repairs.

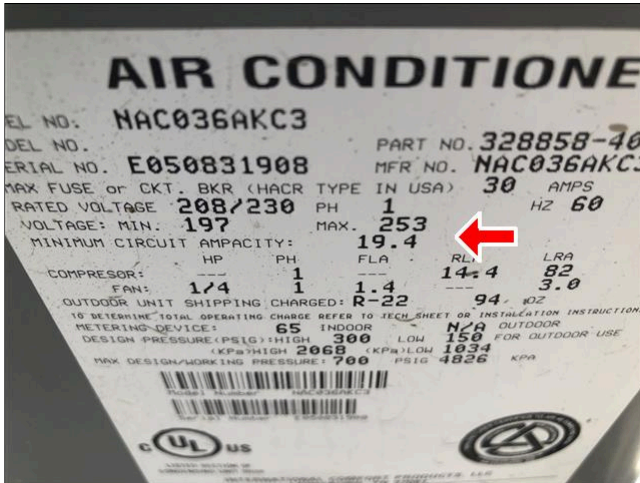
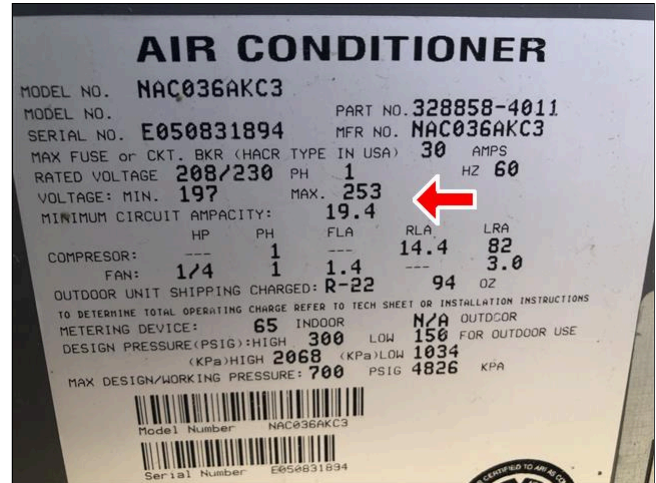
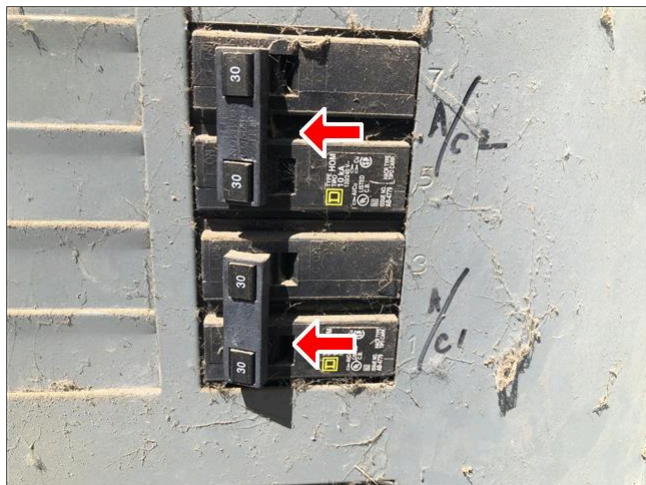
➔ The local disconnect is over fused. Have a licensed electrician install a breaker/fuse that meets the manufacturer's installation instructions.

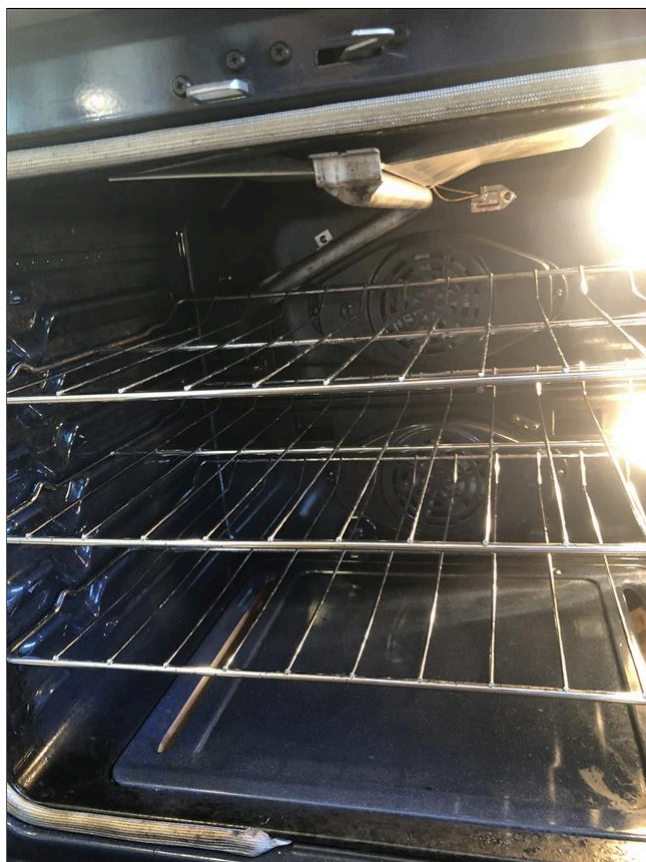
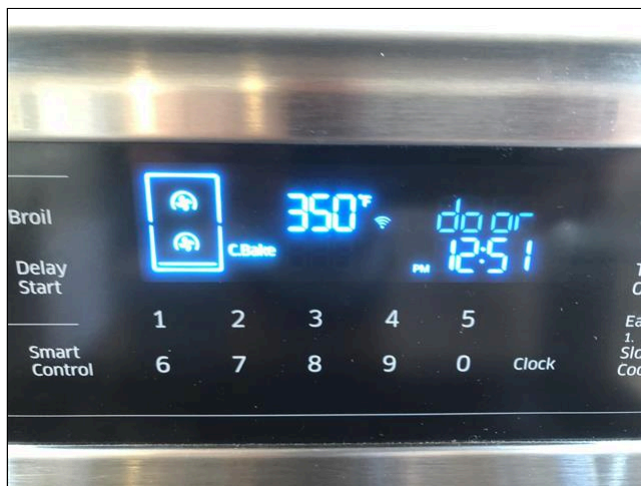
- ➔ (2) The convection fans did not work when tested. A qualified technician should repair as needed.

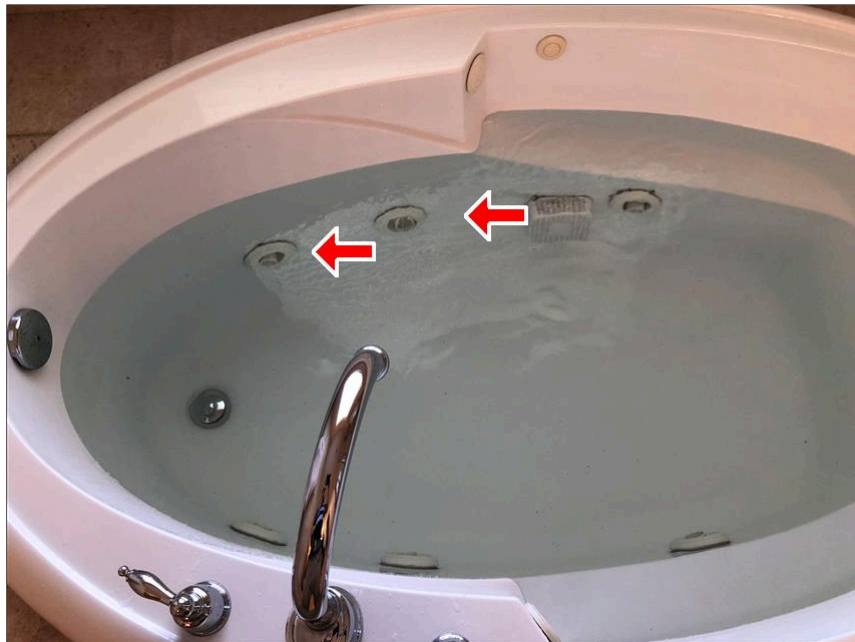
12.11 Item 1(Picture)

- ➔ One or more of the whirlpool tub jets are not functional. A qualified technician should evaluate the system and make repairs or modifications as necessary.

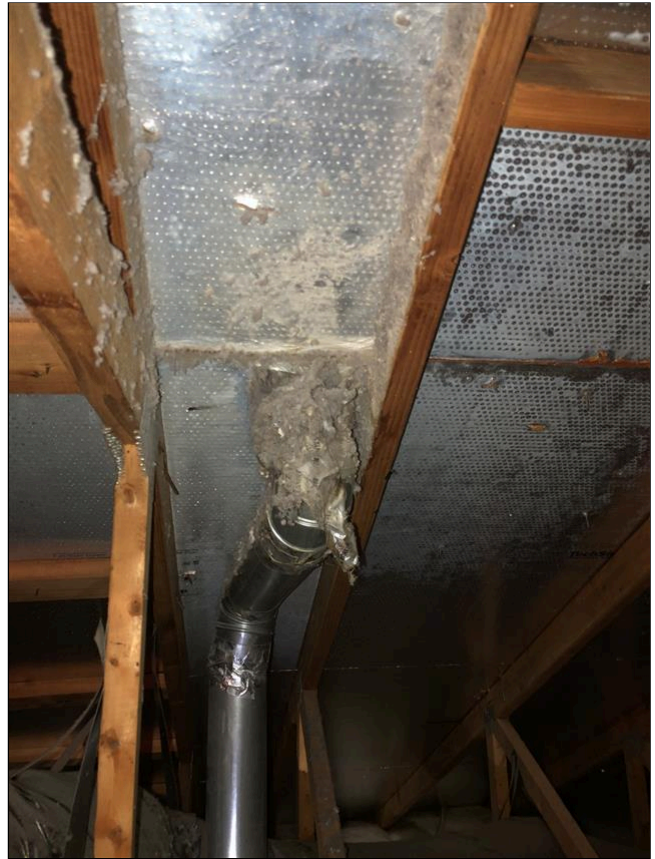
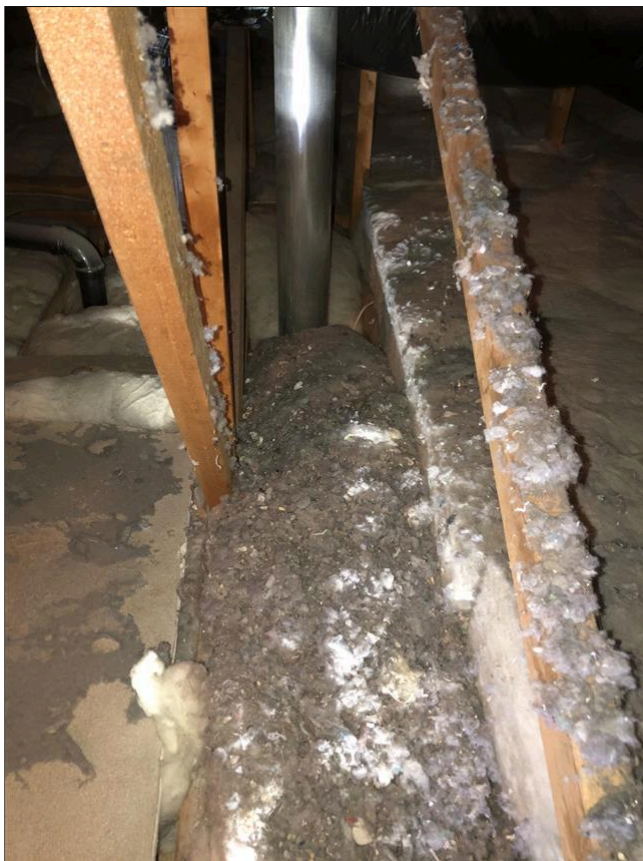
- ➔ The dryer vent in the attic is loose and is leaking lint in the attic space near the furnaces. This is a significant fire hazard. A qualified technician should fix this leak and clean the lint from the attic space.

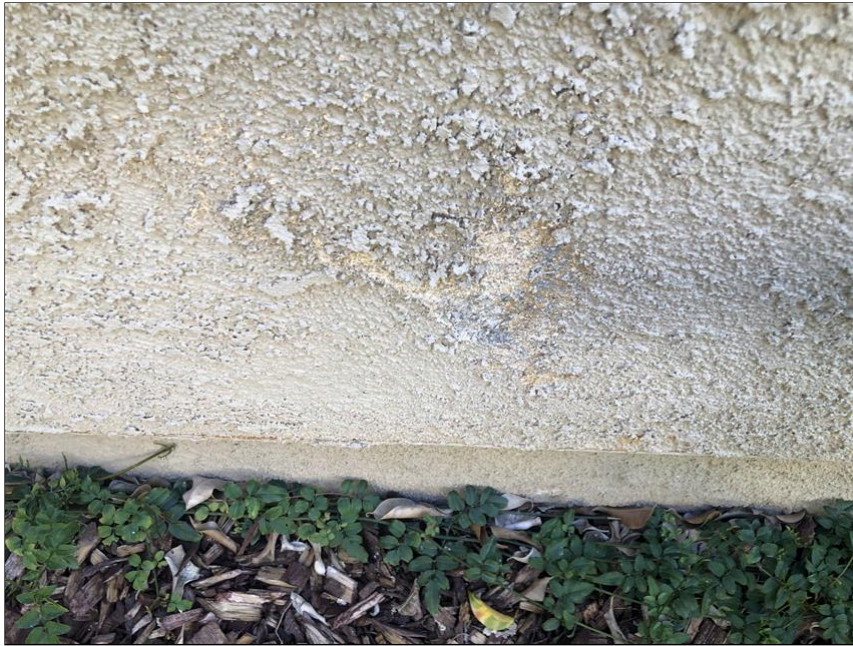
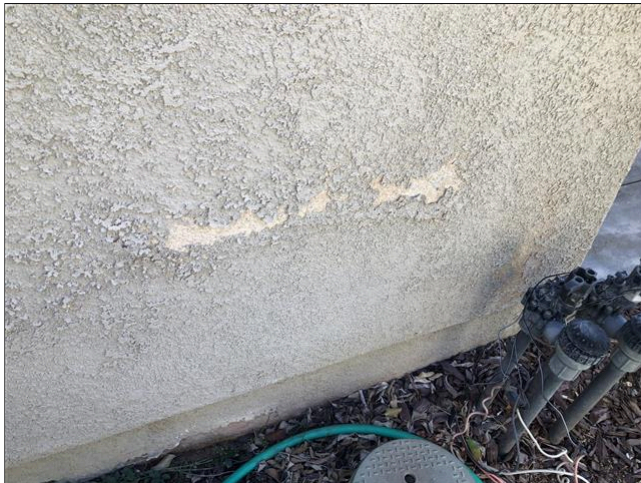
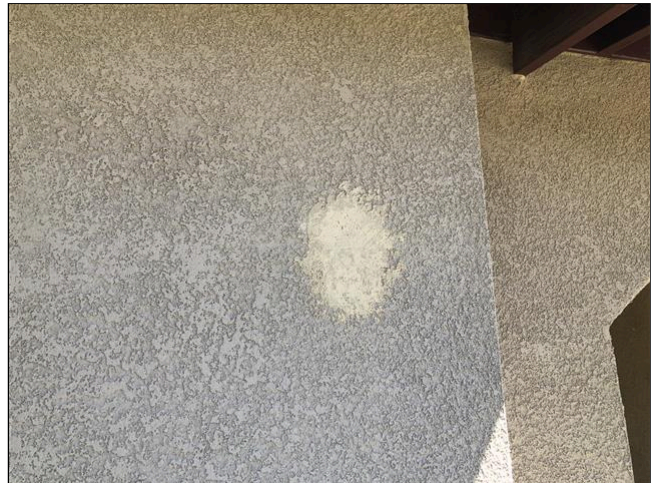
Sections of the stucco at the front & left side of the building are deteriorated.
- A qualified plastering technician should evaluate the stucco and make repairs or modifications as necessary.

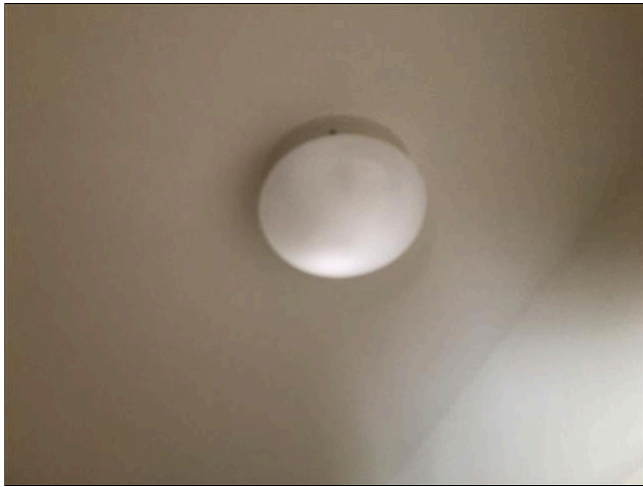
6.10 Item 1(Picture)

(1) One or more lights are not functional at the interior. Some bulbs are missing and other bulbs may have burned out. Try replacing the bulbs, and test the fixtures. If a new bulb does not correct the problem, a qualified electrician

should make repairs or modifications as necessary.

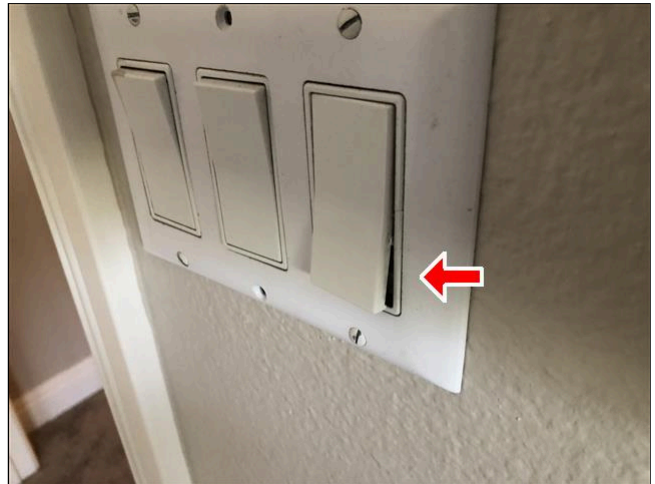
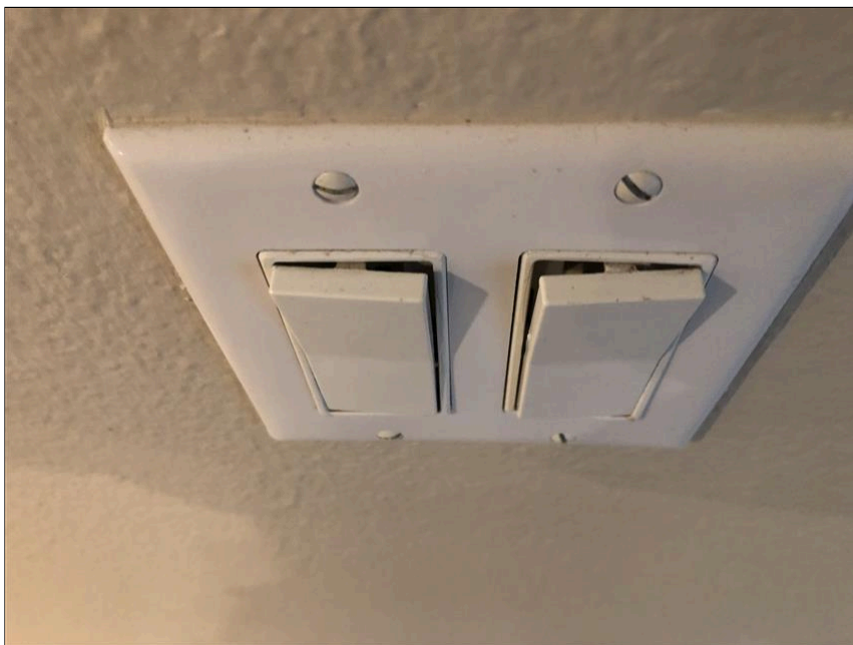
(2) Two light switched are loose to the wall and are damaged. A qualified technician should make this repair. (Master bedroom and second floor halfway)

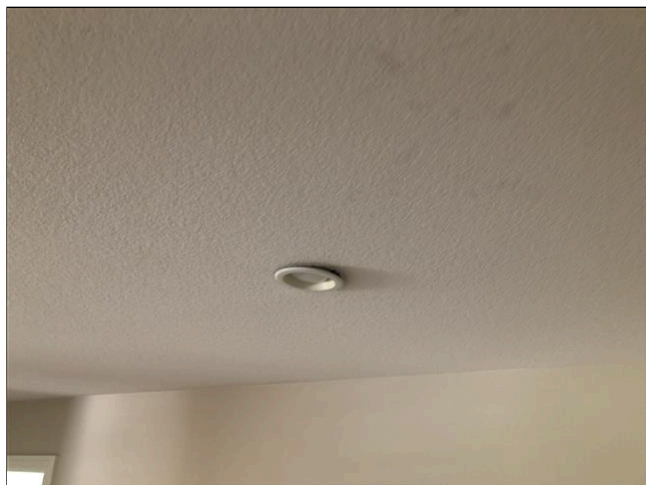
6.10 Item 7(Picture)

- ➔ (4) The can light at the second floor landing is not sealed to the ceiling. A qualified technician should make this repair.

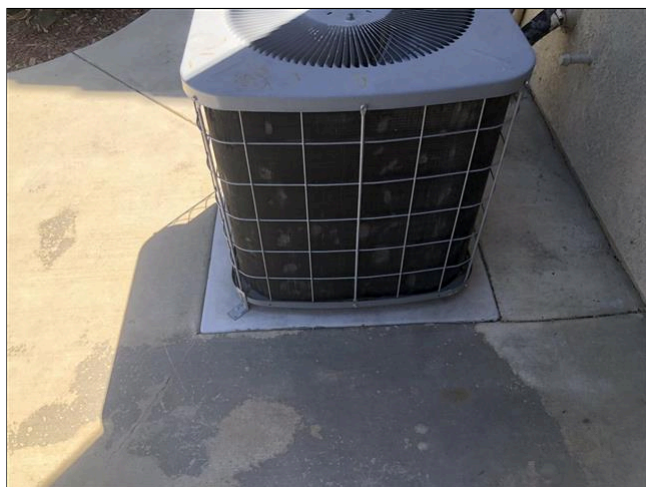
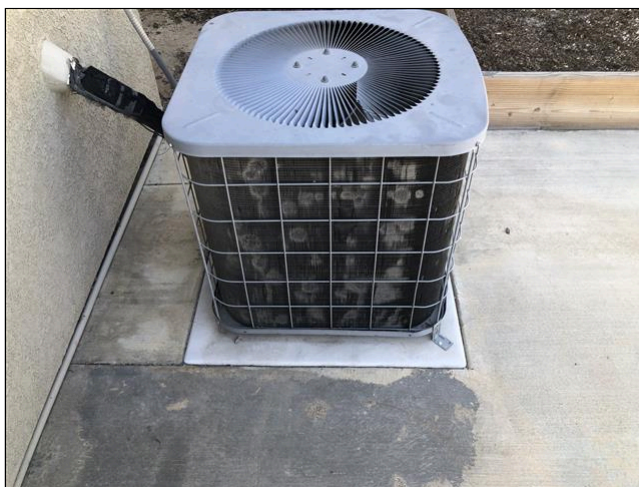
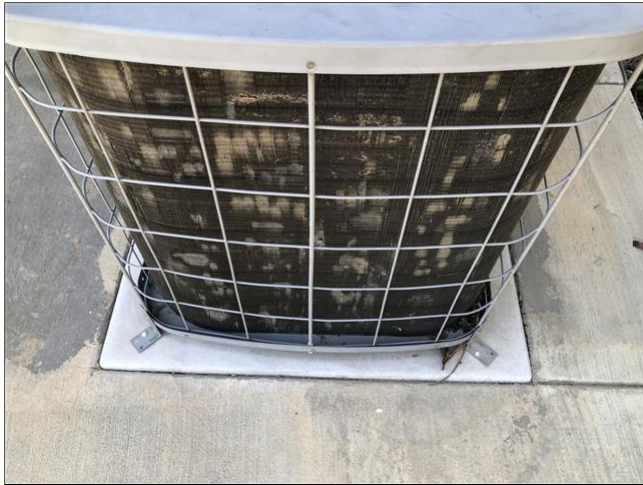
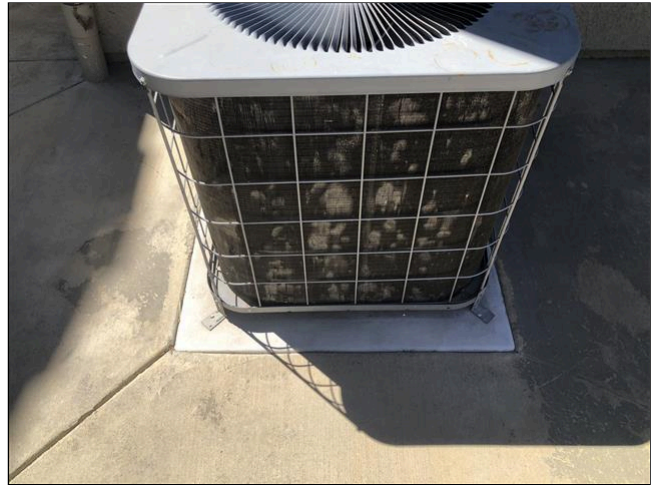
- ➔ (1) The cooling fins on the compressor are damaged and degraded. This could shorten the life of the unit. A qualified HVAC contractor should make any needed repairs or modifications. (both units)

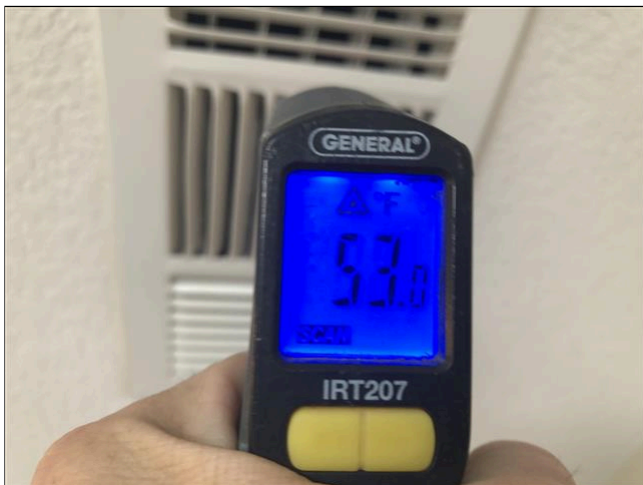
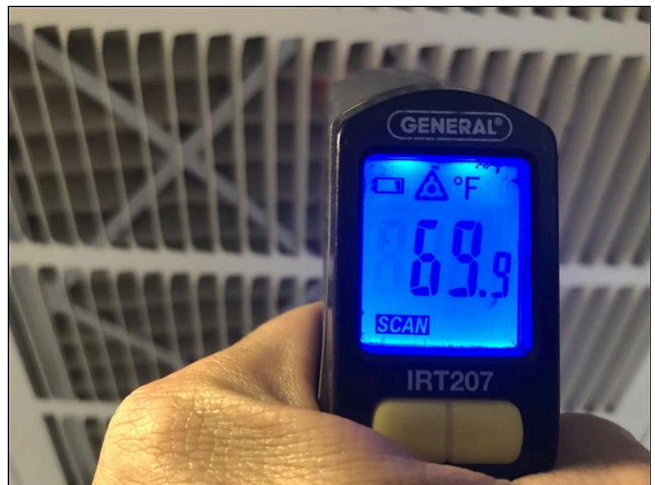
➔ (5) An ambient air test was performed by using a thermometer on the air handler of air conditioner to determine if the difference in temperatures of the supply and return air are between 14 degrees and 22 degrees which indicates that the unit is cooling as intended. The supply air temperature on your system read 53 degrees, and the return air temperature was 69 degrees. This indicates **the range in temperature drop is normal.** (second floor)

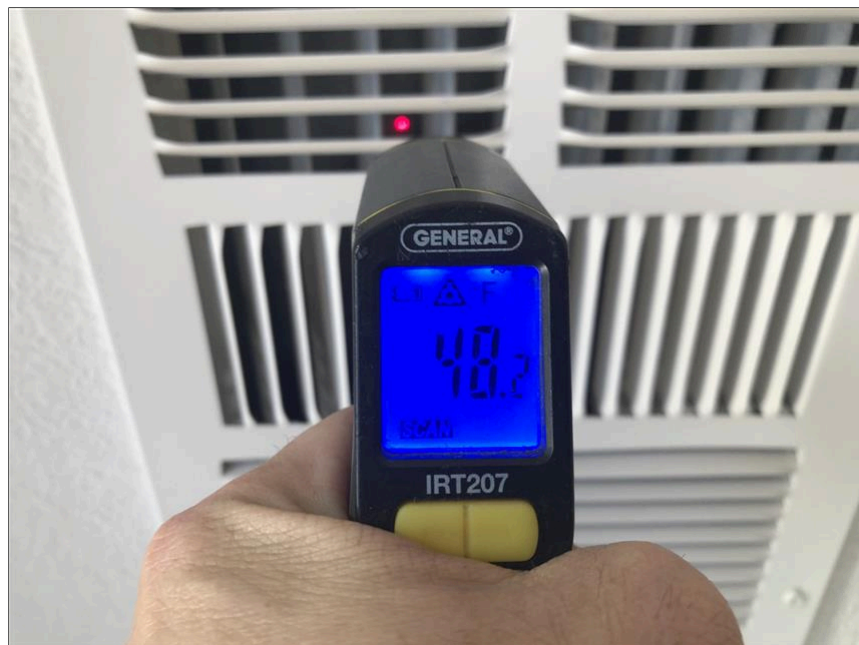
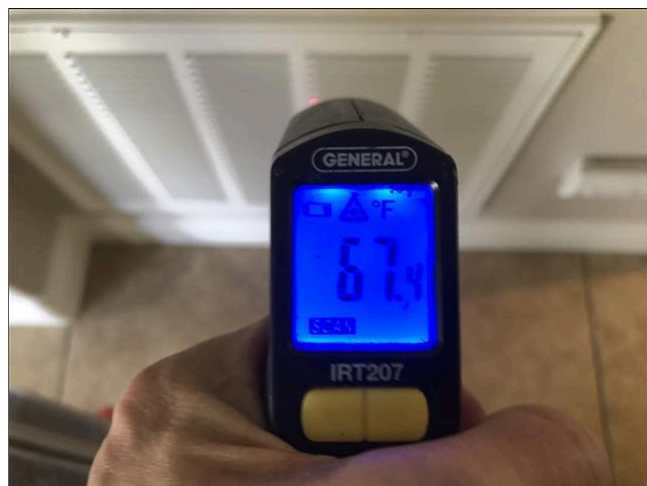
➔ (6) An ambient air test was performed by using a thermometer on the air handler of air conditioner to determine if

the difference in temperatures of the supply and return air are between 14 degrees and 22 degrees which indicates that the unit is cooling as intended. The supply air temperature on your system read 48 degrees, and the return air temperature was 67 degrees. This indicates **the range in temperature drop is normal.**

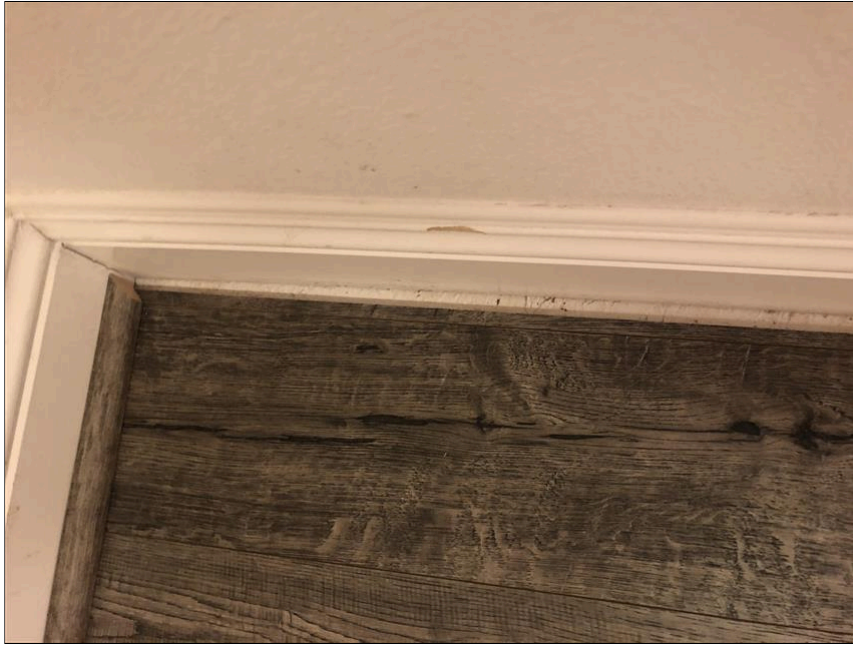
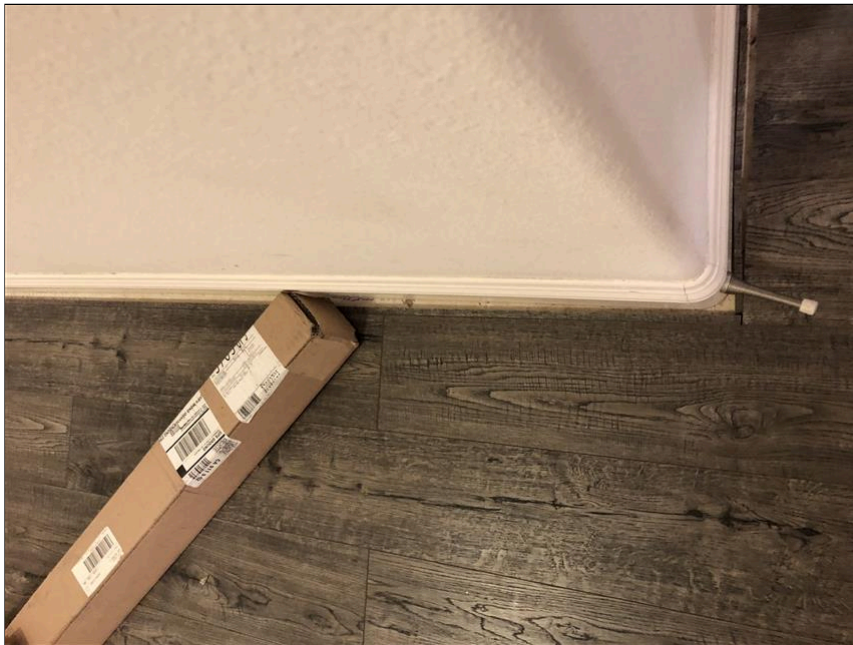
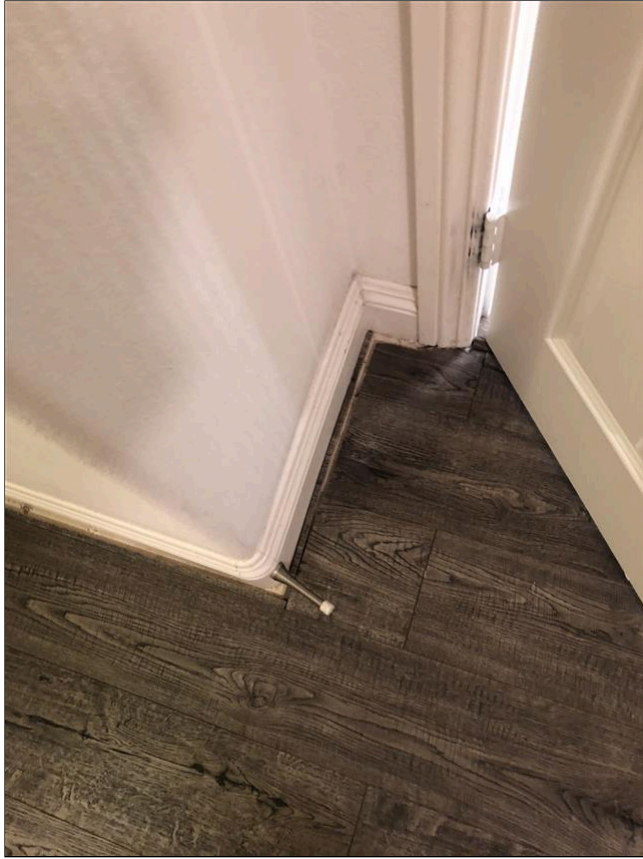
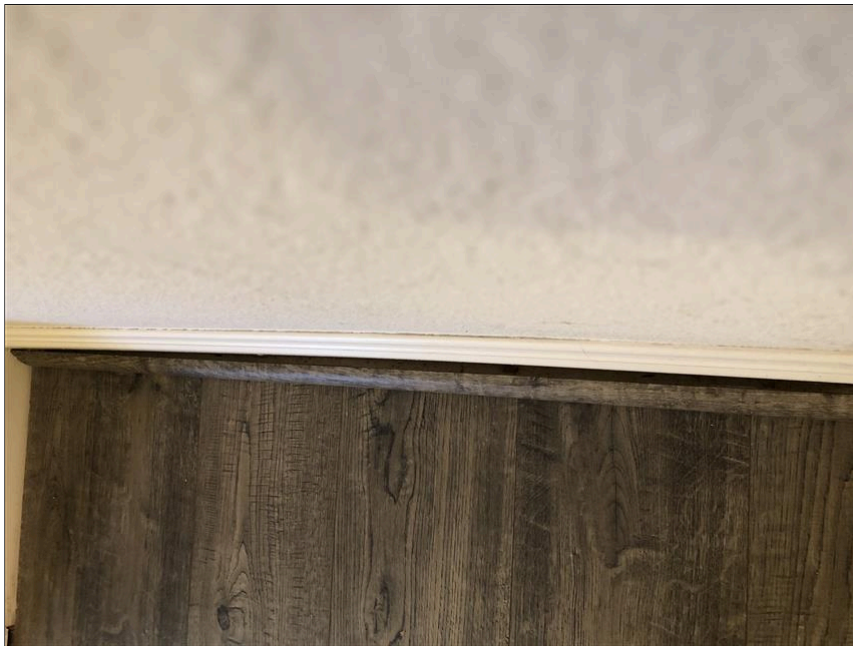
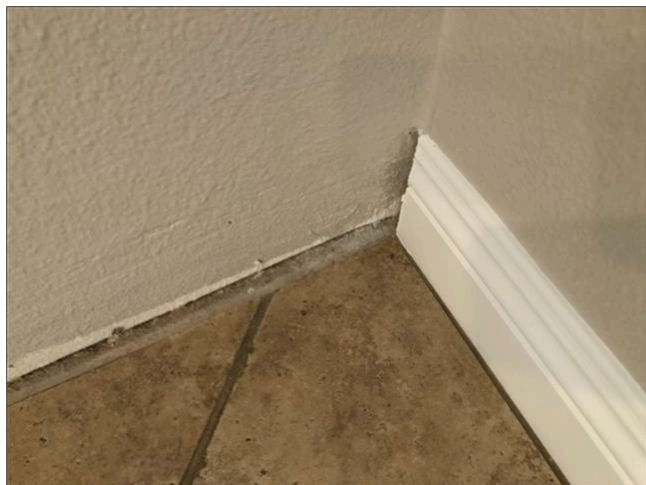
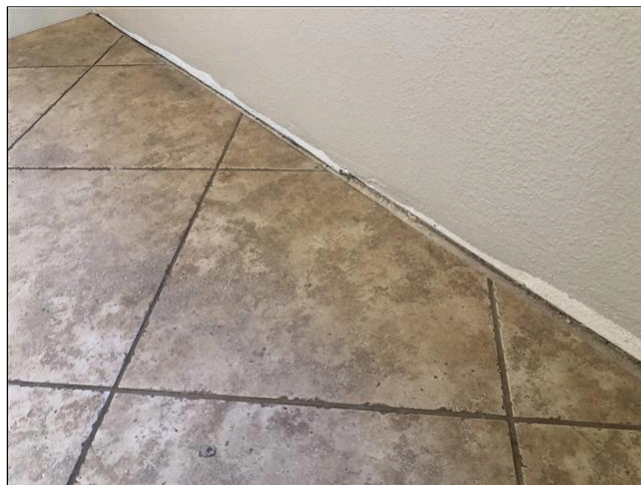
- ➔ The base board has not been installed in the master bedroom closet and the kitchen dining room. A qualified

technician should make this repair.

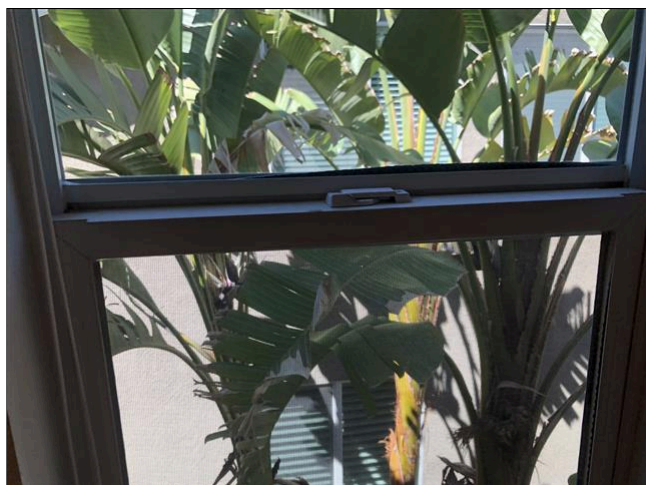
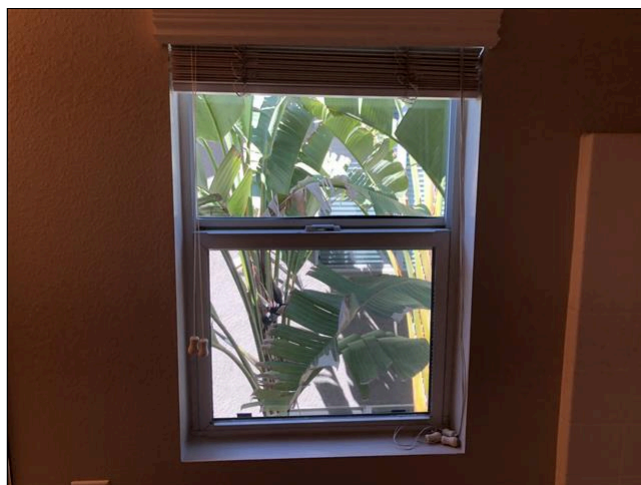
(1) The interior insulation for the window in the jack and jill bathroom has become loose. This is a cosmetic issue. A qualified technician should make this repair.

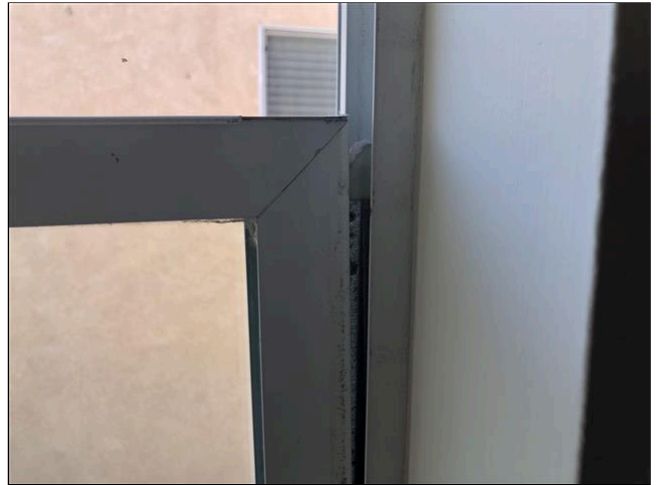
(2) One or more windows do not operate smoothly, are difficult to latch or are in need of adjustment. All poorly or non-operating windows and their associated hardware should be cleaned, lubricated, and adjusted for smoother operation. Where needed, essential hardware, such as operator cranks, sash balances and latches should be replaced with compatible components. (MAster bedroom)

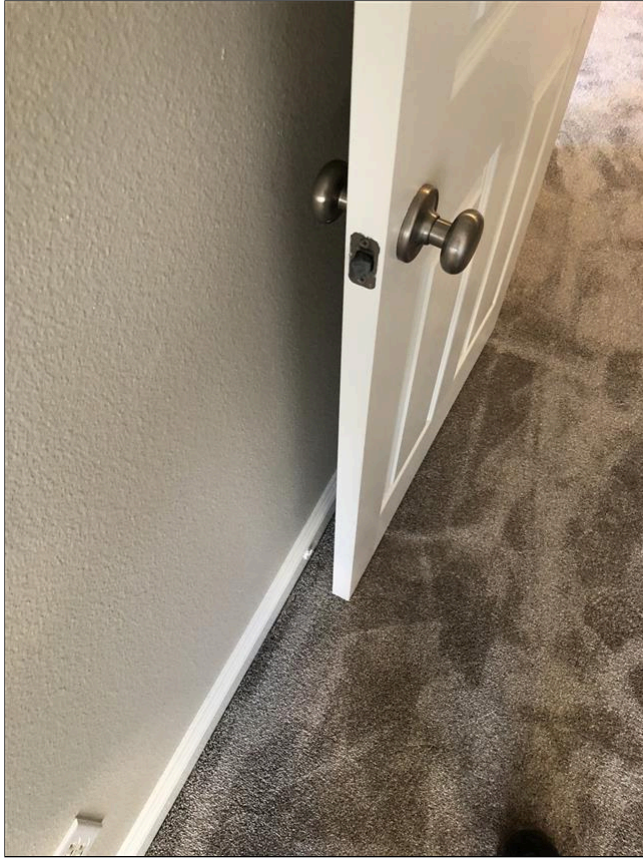
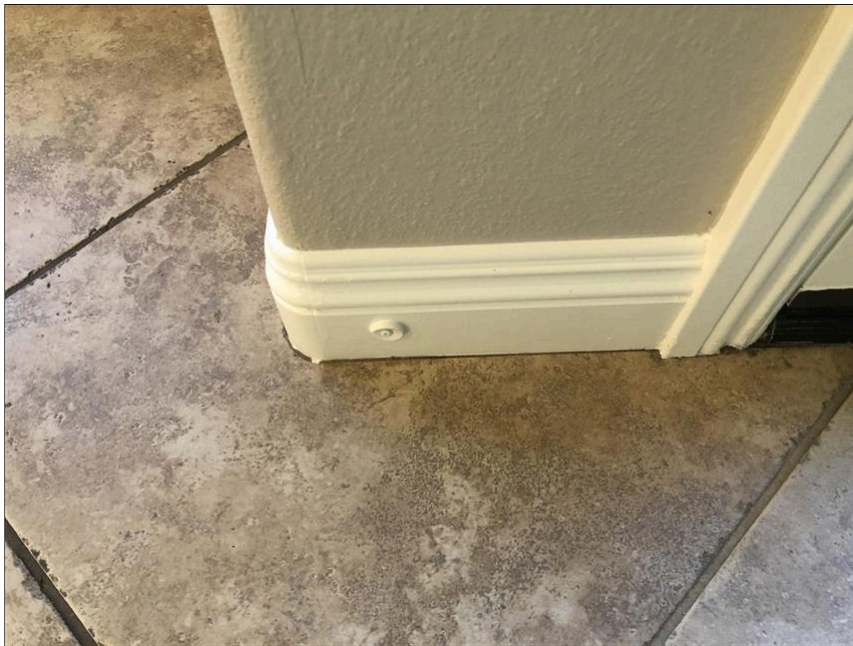
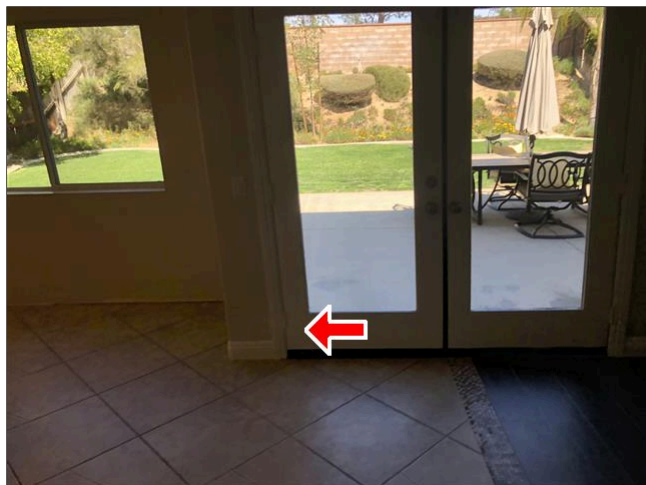
One or more interior doors have no door stop. A stop or bumper should be installed on each door to help prevent damage to the surfaces behind the door.

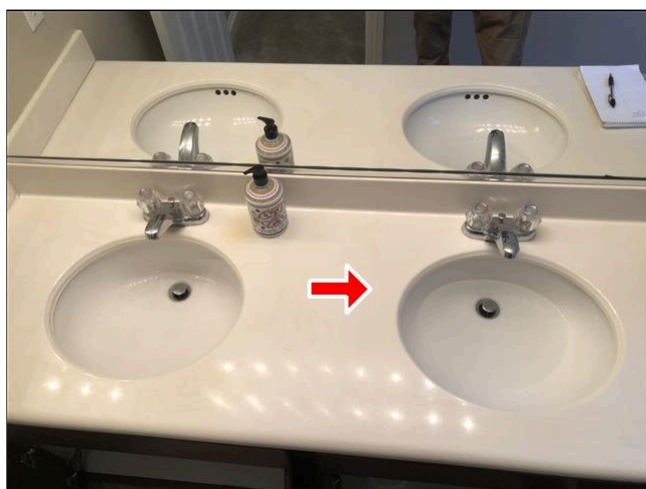
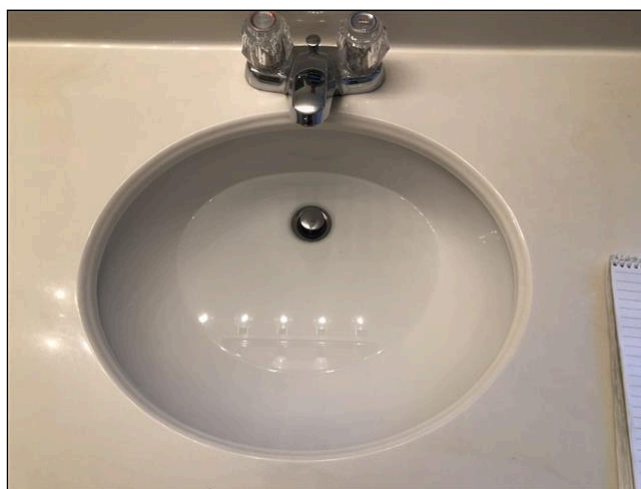
➔ The drain at the hall bathroom sink is slow. The trap on the wash basin should be cleaned or snaked. A qualified technician should do the work. (Right sink)

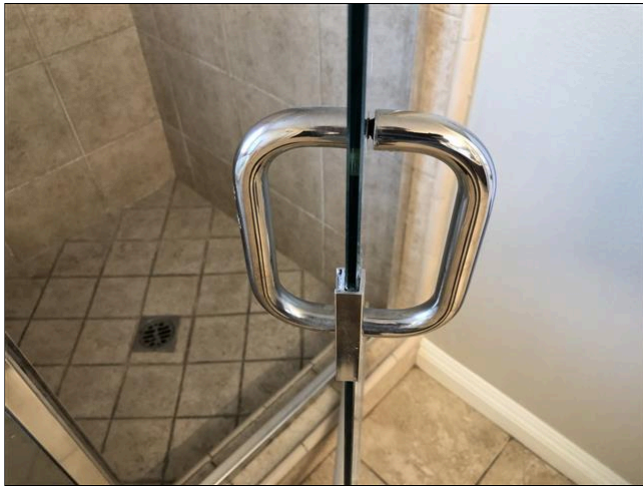
12.6 Item 1(Picture)

➔ The shower door handle is very loose and should be secured. A qualified technician should make this repair. (

Master Bathroom)

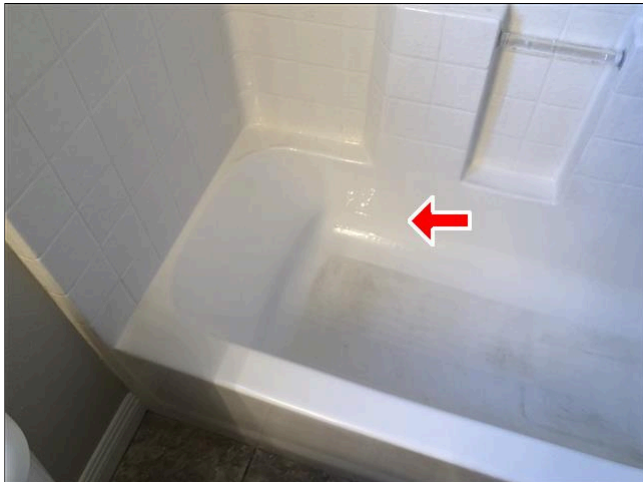
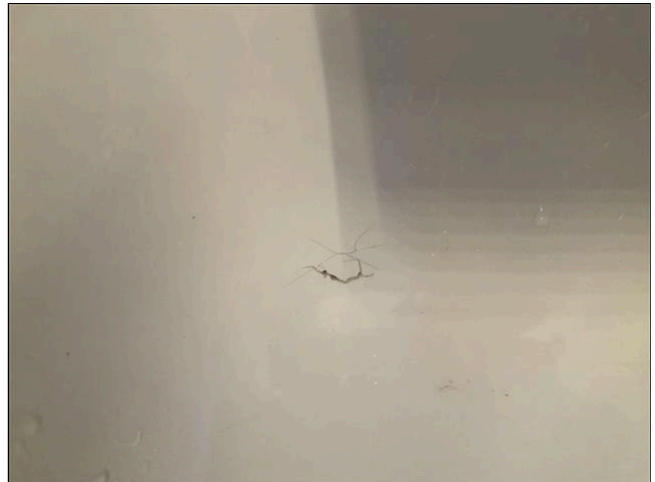
➔ The bathtub at the hall bathroom is chipped. A qualified technician should make any needed repairs.
