# ***Cornerstone Inspection***

## **Property Inspection Report**

***1045 Tiburon Way, San Luis Obispo, CA 93401***

***Date of Inspection: 11/10/2025 Time: 9:00 AM***

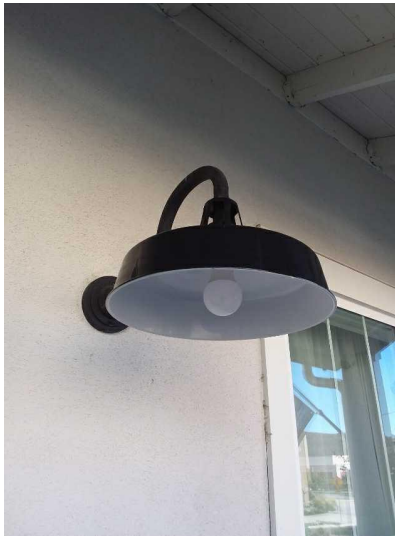
6.4. We were not able to activate some of the exterior lights which may be operated on a timer, sensors, or a light bulb that is burned out. Nonetheless, they should be demonstrated as functional by the seller.

We were not able to activate some of the exterior lights which may be operated on a timer, sensors, or a light bulb that is burned out. Nonetheless, they should be demonstrated as functional by the seller.

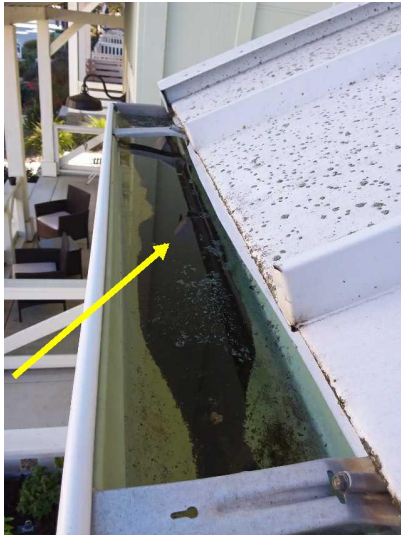
1.4. We observed standing water in some sections of the gutters which implies that it may not be properly sloped and should be evaluated and serviced.

We observed standing water in some sections of the gutters which implies that it may not be properly sloped and should be evaluated and serviced.

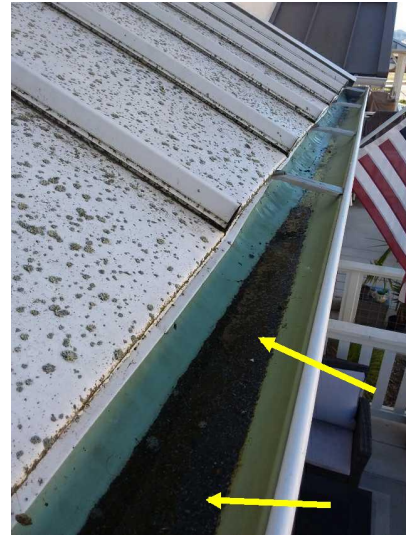
Some of the gutters need to be cleaned to drain properly.

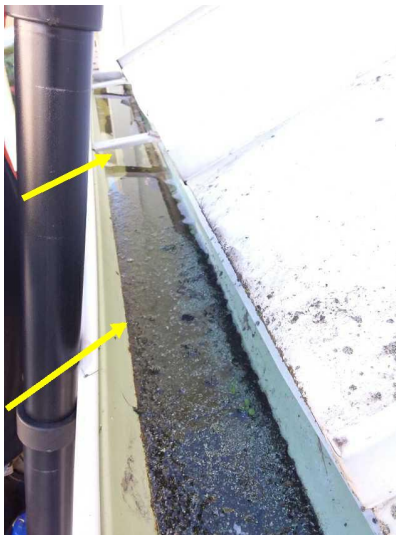
Some of the gutters need to be cleaned to drain properly.

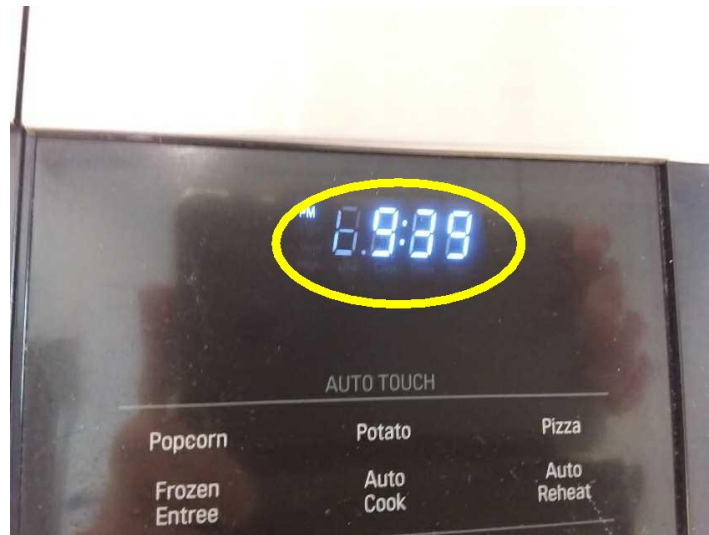
5.2. The LED readout is hard to see or does not work properly which you may wish to have serviced.

The LED readout is hard to see or does not work properly which you may wish to have serviced.

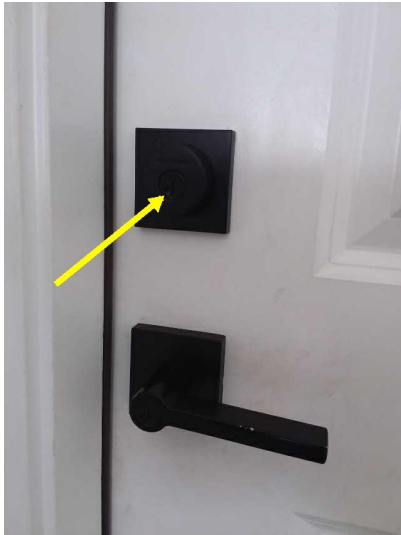
1.2. The keyed deadbolt could prevent or impede an emergency exit, and should be replaced with a safer latch type.

The keyed deadbolt could prevent or impede an emergency exit, and should be replaced with a safer latch type.

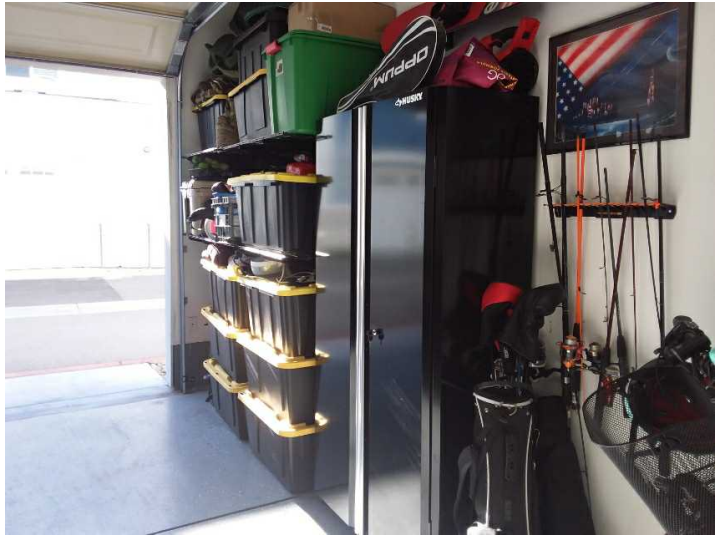
The garage walls are too full or covered to provide a clear view of them and other components of the garage.

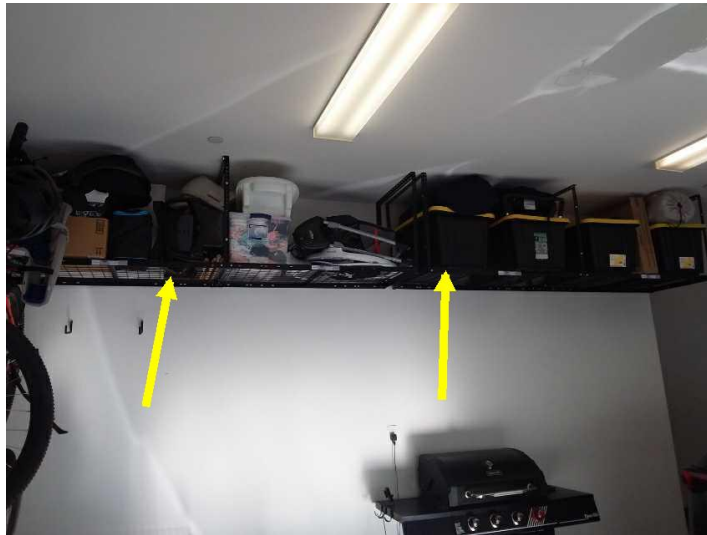
The storage space may have been added without the benefit of a permit, which could stress the roof framing. You may wish to verify this with the sellers. Regardless, you should limit the storage to lightweight items.
