# Golden State Plumbing And Heating

## Sewer Inspection Report

**401 Yarmouth Road  
Palace Verdes Estates, California 90274**

**Friday, June 5, 2026 8:50 PM**

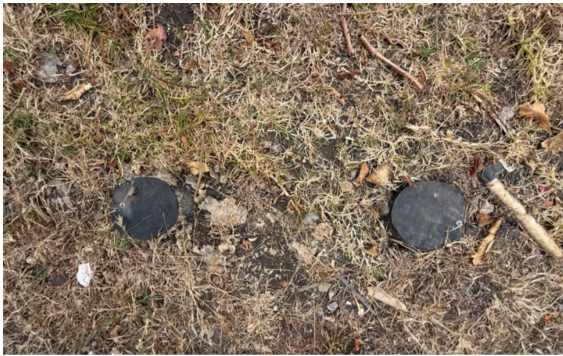
West side of the garage.

Three inch abs plastic clean outs. The camera would not go back upstream under the house.

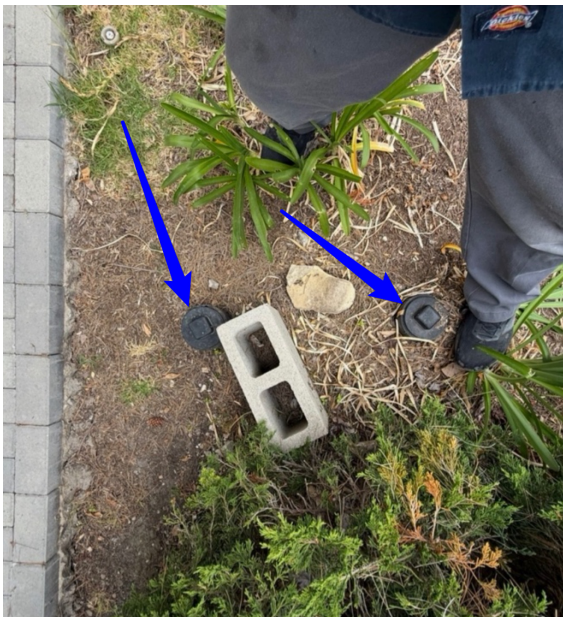
Front yard near the front door.

Four inch abs plastic clean outs.
