WOOD DESTROYING PESTS AND ORGANISMS INSPECTION REPORT

Building No. 906	Street Junipero	City Long Beach	ZIP 90804	Date of Inspection 10/02/2024	Number of Pages 7
---------------------	--------------------	--------------------	--------------	----------------------------------	----------------------

GENERAL DESCRIPTION:
 One Story Stucco Wood Sided Residence Vacant and Unoccupied with a Composition Roof and Wood Shake Roof on a 2 Car Detached Garage on a Raised Foundation

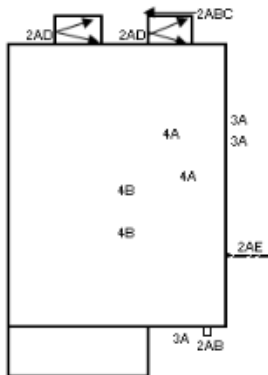
Diagram Not To Scale

Evidence of drywood termite infestations at HOUSE AND GARAGE FRAMING as indicated on the diagram.

Evidence of termite damaged wood members noted at time of inspection at BEAM ENDS, RAFTERS as indicated on the diagram..

Evidence of termite damaged wood members noted at time of inspection at PORCH HEADER as indicated on the diagram..

Evidence of termite damaged wood members noted at time of inspection at BACK PORCH OVERHANGS WOOD SHAKE SHINGLE ROOFS as indicated on the diagram..

Evidence of termite damaged wood members noted at time of inspection at SIDE GATE WOOD FRAMING, SIDING as indicated on the diagram..

Evidence of termite damaged wood members noted at time of inspection at GARAGE DOOR JAMBS as indicated on the diagram..

Evidence of termite damaged wood members noted at time of inspection at GARAGE STUCCO MOLDINGS as indicated on the diagram..

Evidence of termite damaged wood members noted at time of inspection at POST as indicated on the diagram..

Evidence of termite damaged wood members noted at time of inspection at GARAGE PATIO HEADER as indicated on the diagram..

Dry-rot wood members found at time of inspection at WOOD SIDING as indicated on the diagram.

Earth-wood contacts visible at time of inspection at SUBAREA as indicated on the diagram.

We recommend fumigation (tenting) the structure with Surfuryl Floride as our primary method of control. This gas requires occupants to vacate the structure for 3 days and 2 nights. Fumigations come with a two (2) year warranty against drywood termites. Remove or cover all accessible Drywood termite pellets. See fumigation details later on in this report for terms, liabilities, and procedures.

Replace, or patch repair (bondo) drywood termite damaged as necessary in order to eliminate this deficiency. Prime and or, paint wood members. If paint, we ask that owner provide paint at time of work, for color matching purposes

Replace the drywood termite damaged structural wood members identified in the above finding. Prime and or, paint wood members. If paint, we ask that owner provide paint at time of work, for color matching purposes.

Patch repair drywood termite damaged areas with bondo. Probe and clean out damaged areas to wood members. Repair damaged areas with bondo, sand , prime and or, paint wood members. If paint, we ask that owner provide paint at time of work, for color matching purposes

Replace the dryrot damaged structural wood members identified in the above finding. Prime, and or, paint wood members. If paint, we ask that owner provide paint at time of work, for color matching purposes.

Lower dirt to break earth to wood contact.
