# Duration Plumbing

## Sewer Inspection Report

**2139 Mac Arthur Street  
Rancho Palos Verdes, California 90275**

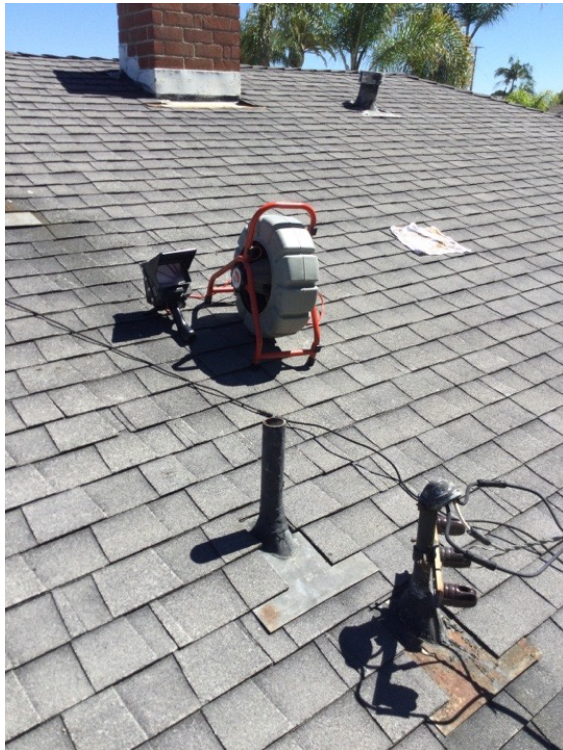
No external clean out was located, the sewer line was accessed through a roof vent.
