# WOOD DESTROYING PESTS AND ORGANISMS INSPECTION REPORT

| Building No.<br>1150 | Street<br>3rd St | City<br>Gilroy | ZIP<br>95020 | Date of Inspection<br>03/30/2026 | Number of Pages<br>5 |
| <b>Western Way Termite &amp; Pest Services</b><br>8505 Church St STE 7<br>Gilroy CA 95020<br>(408) 837-7734<br>Info@westernwayservices.com<br>Fax (408) 837-7734 | | | | Report # : 17746<br>Registration # : PR8572<br>Escrow # :<br><input type="checkbox"/> CORRECTED REPORT | |

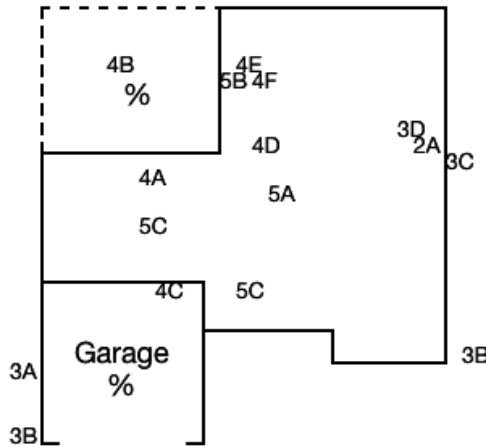
**Diagram Not To Scale**

DRYWOOD TERMITE pellets as indicated by 2A on the diagram. Pellets appear old and infestation appears inactive. There was a fumigation tag posted by Best Care Fumigation dated 3/26/21 for Drywood Termites.

Remove or cover pellets in visible and accessible areas. NOTE: It is common for additional pellets to sift down over a period of time due to normal household vibrations. This estimate is to cover or remove the pellets one time only.
