**Archive Property Inspection**

**Report ID# :**

**06182026-276-32**

**29619 Camino Pepita**

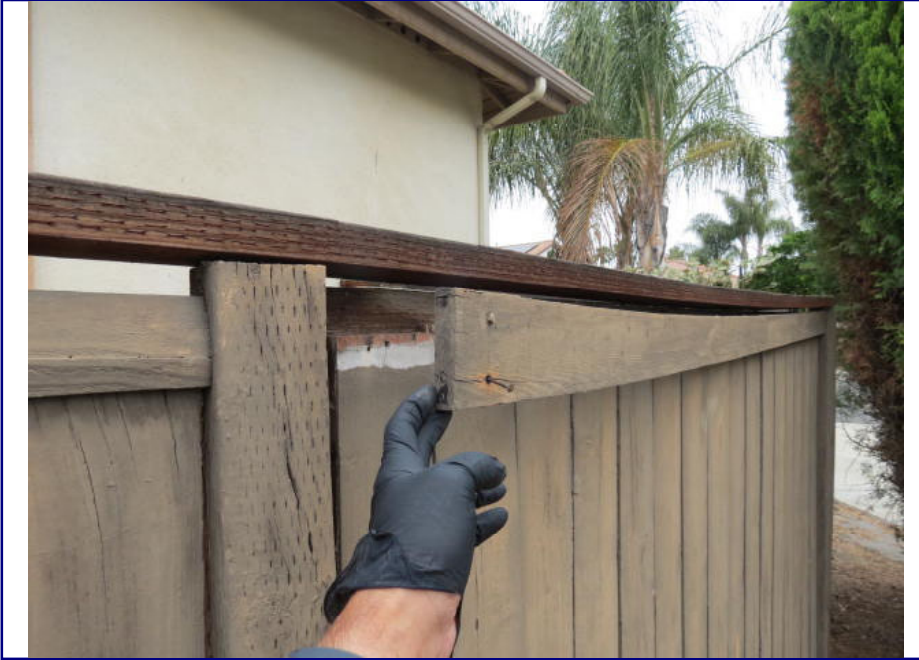
**Picture 1**

The wood fencing shows general weathering and age/wear, some damaged or deteriorating boards noted. Repair as needed and paint for weather protection. Recommend further evaluation and correction by a fencing professional.

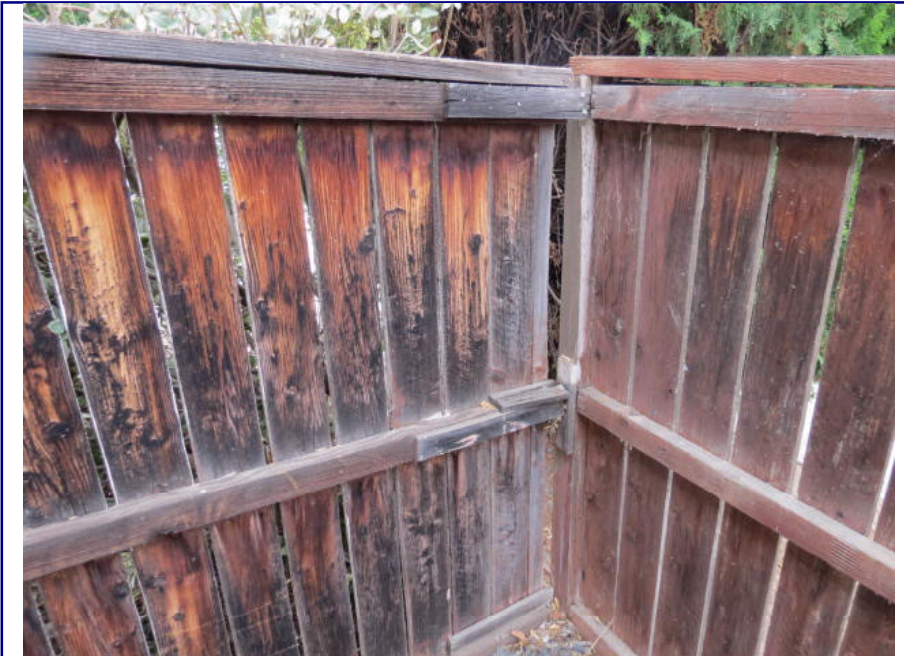
**Picture 2**

Another sample photo of the general condition of the wood fencing.

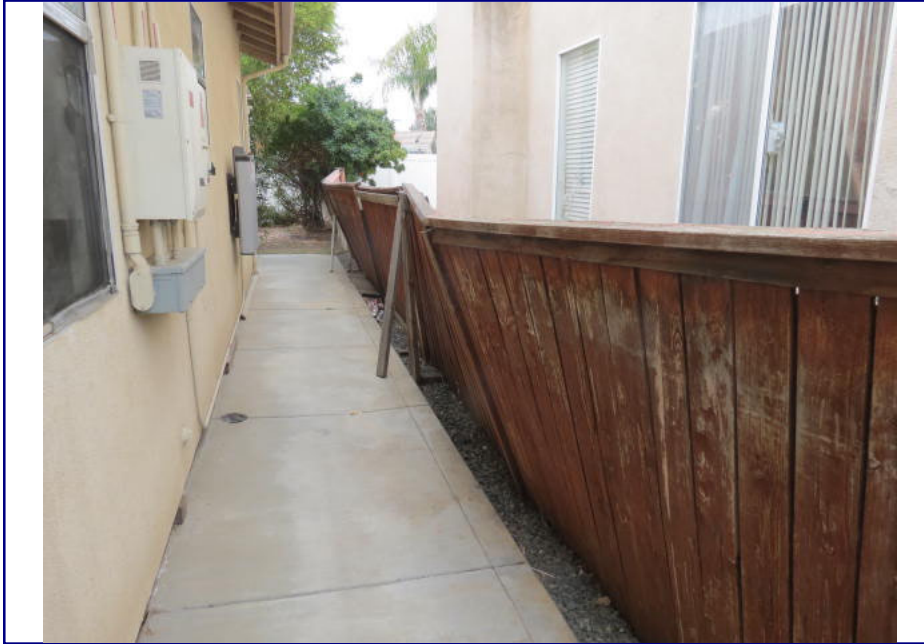
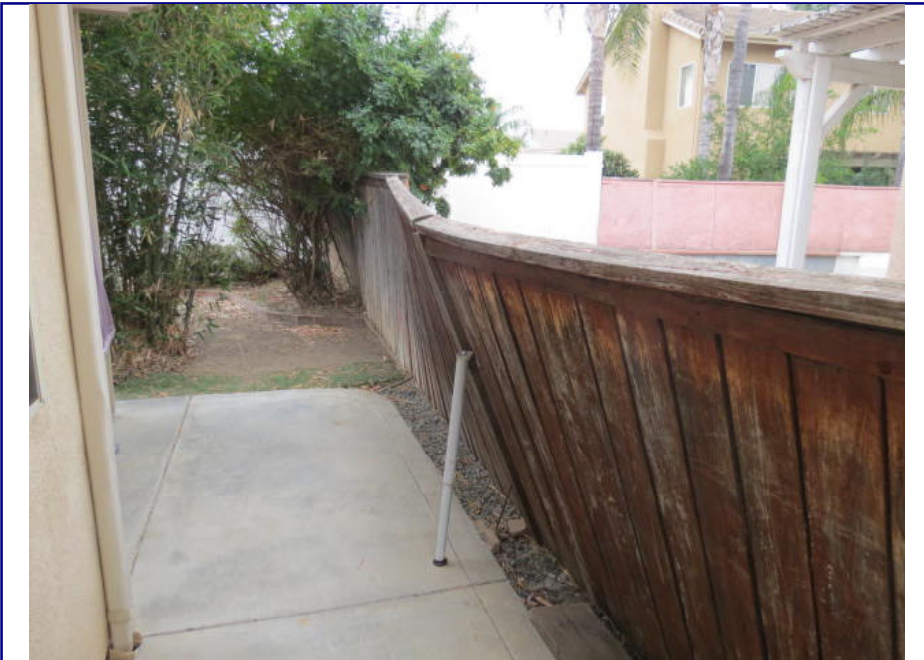
**Picture 3**

North fence line was falling over (both photos), support posts compromised. Recommend further evaluation and correction by a fencing professional.

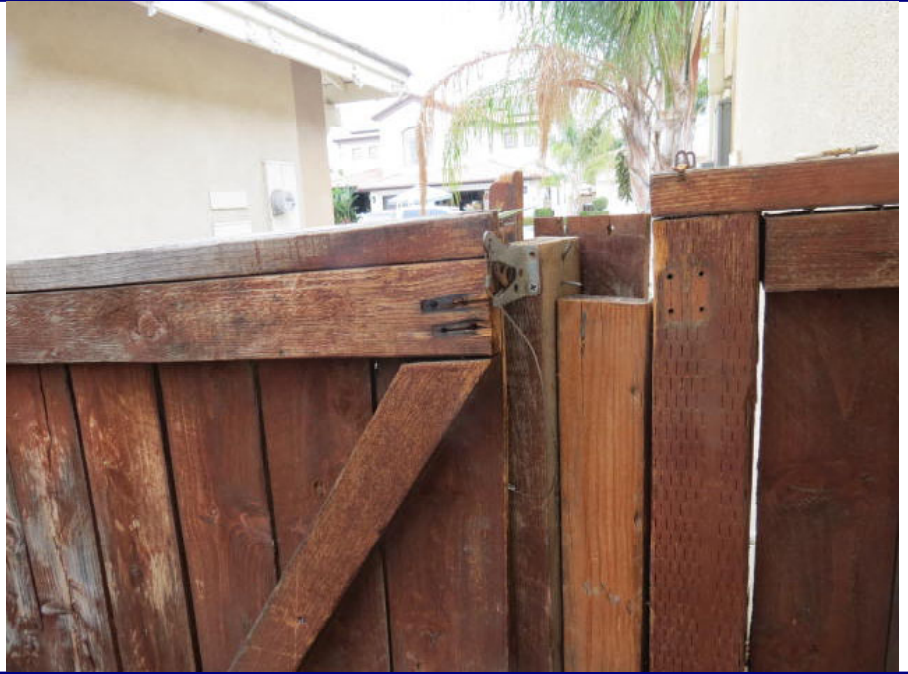
**Picture 5**

Latching mechanism was disabled at the entry gate, and gate was blocked off, not operational. Recommend further evaluation and correction by a fencing professional.

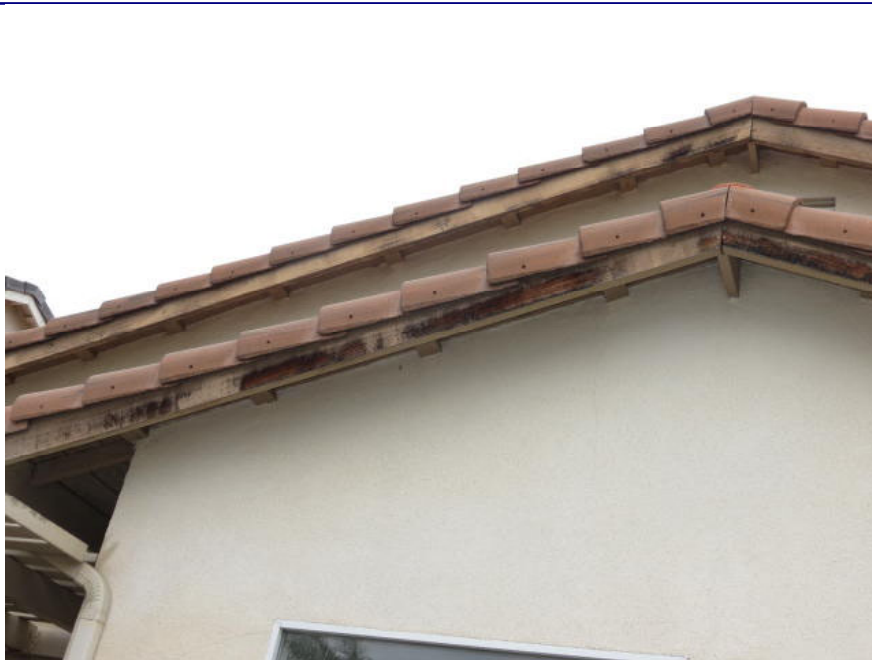
**Picture 6**

Paint deterioration noted in a few areas around the exterior wood trim and finish. Recommend further evaluation and correction by a professional paint contractor to prevent weathering and deterioration to the wood.

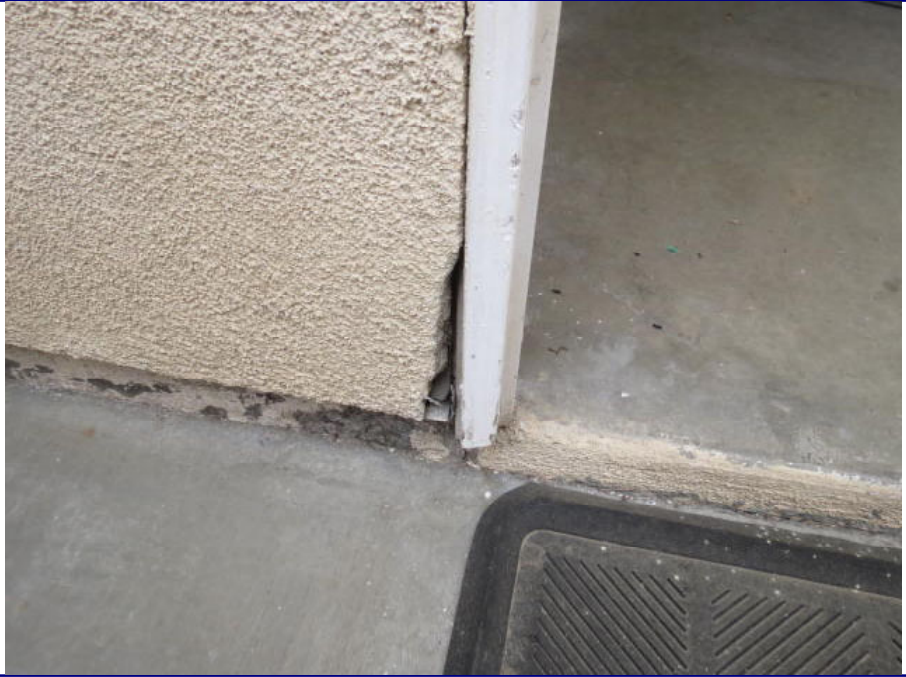
**Picture 7**

Minor stucco damage noted at the lower corner off the side garage passage door. This should be sealed up to prevent moisture intrusion. Recommend further evaluation and correction by a stucco professional.

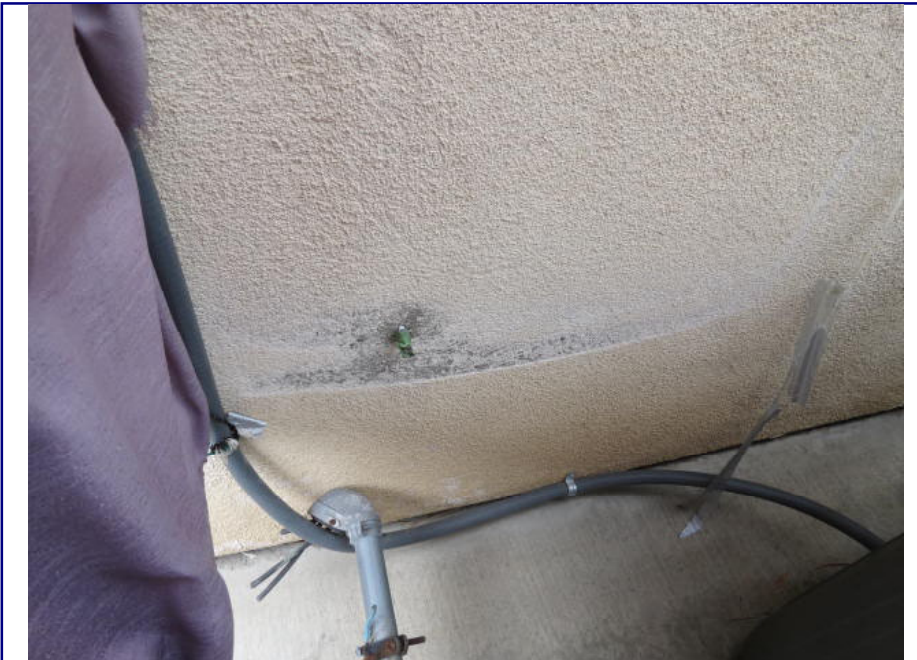
**Picture 8**

Stucco deterioration finish noted at the NW corner of the house. Further exposure to moisture will continue to expound the deterioration. Recommend further evaluation and correction by a stucco professional.

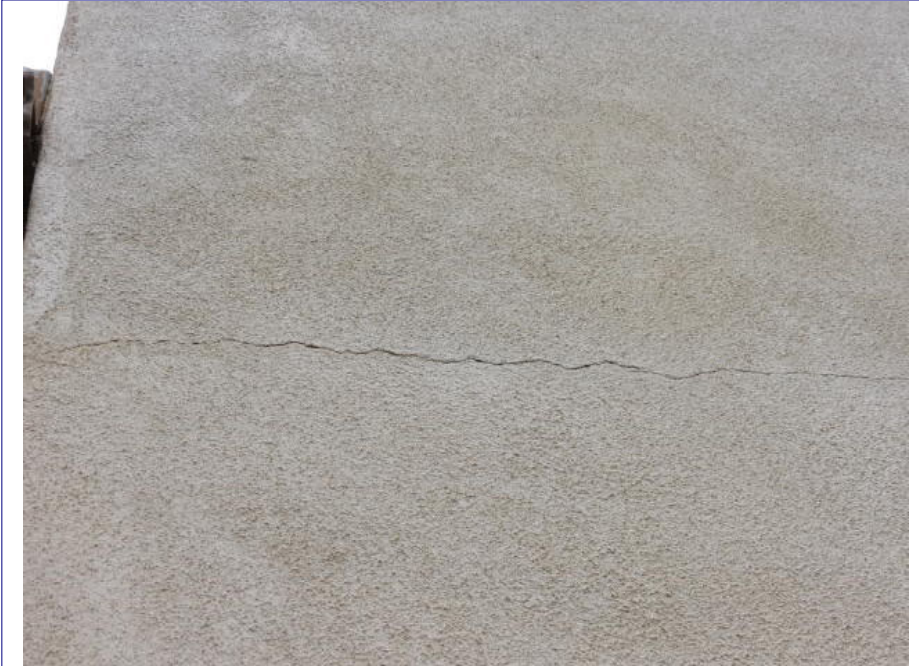
**Picture 9**

Minor stucco deterioration noted along a couple of the cracks on the south facing exterior wall. These should be filled/sealed to prevent moisture exposure/intrusion which can further expound the deterioration.

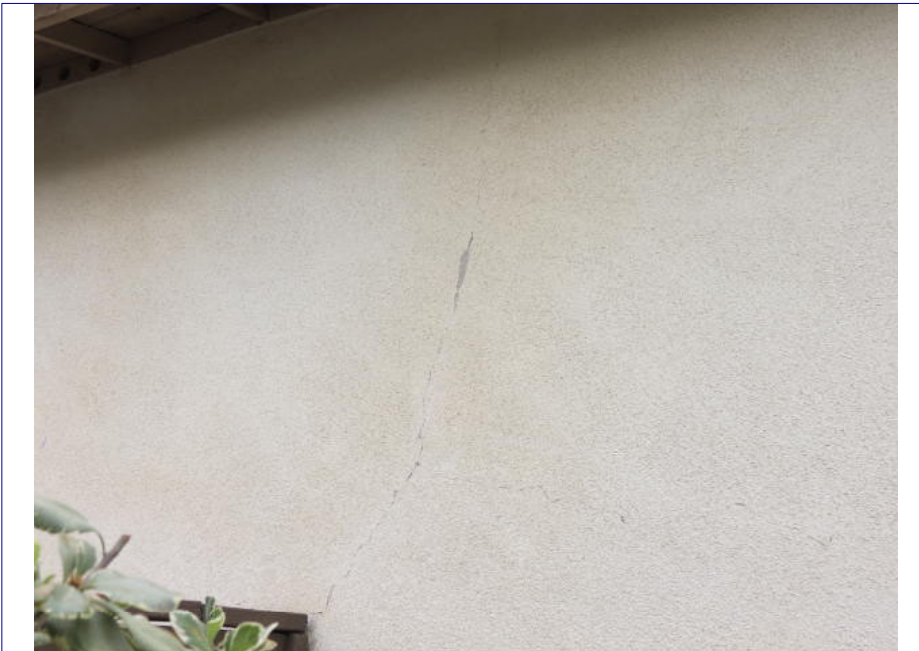
**Picture 10**

Another sample photo of the stucco deterioration along the stucco cracking on the south facing exterior wall.

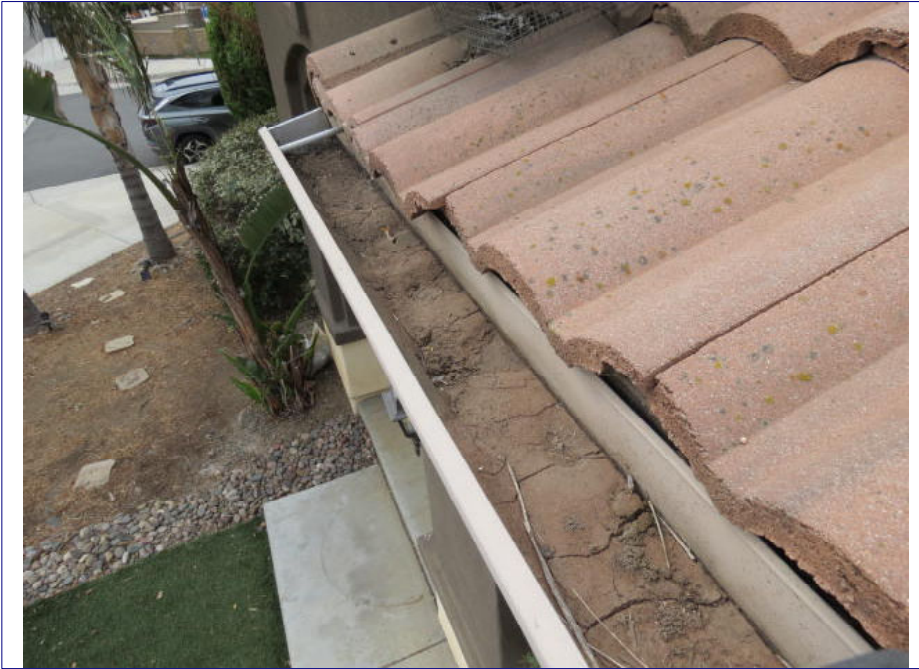
**Picture 11**

Recommend cleaning of the debris build up in the rain gutters, needed to allow for effective drainage. Recommend further evaluation and correction by a gutter professional.

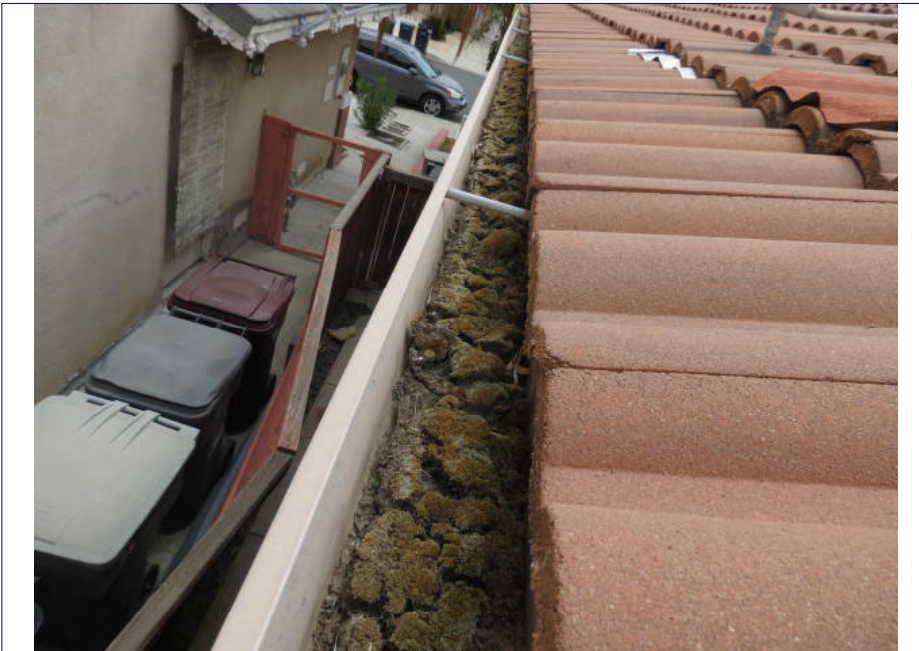
**Picture 12**

Another sample photo of the debris build up in the rain gutters needing cleaning.

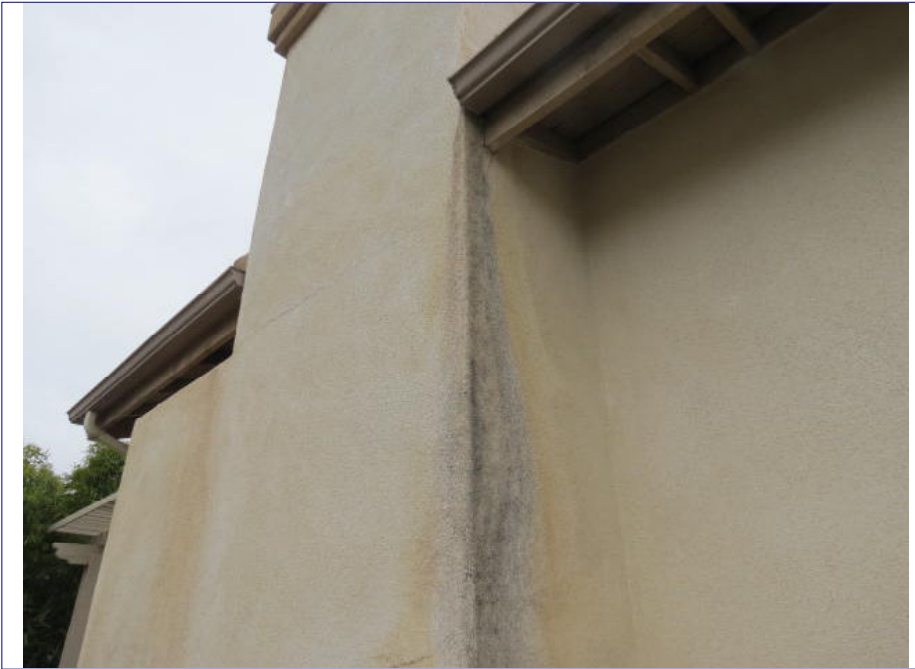
**Picture 13**

Staining noted on the south facing exterior wall, a result of water run-off from the roof line, possible leaking from the rain gutter. Recommend cleaning/power wash by a qualified professional and assessment of the gutter by a qualified professional.

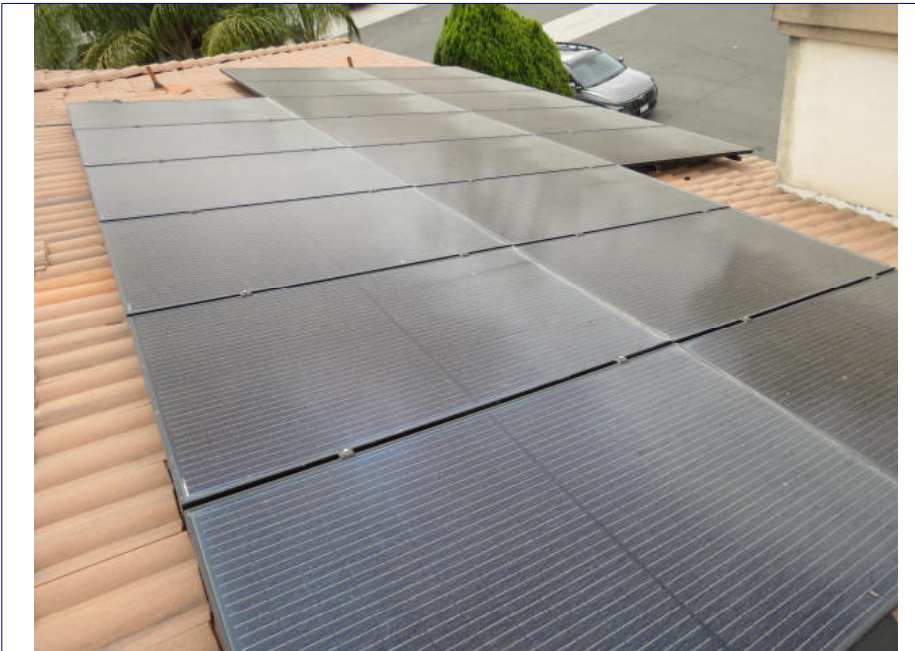
**Picture 14**

Recommend periodic cleaning of the build up off the solar panels, this allows the panels the best opportunity to produce and perform at peak efficiency. Recommend assessment by a qualified professional.

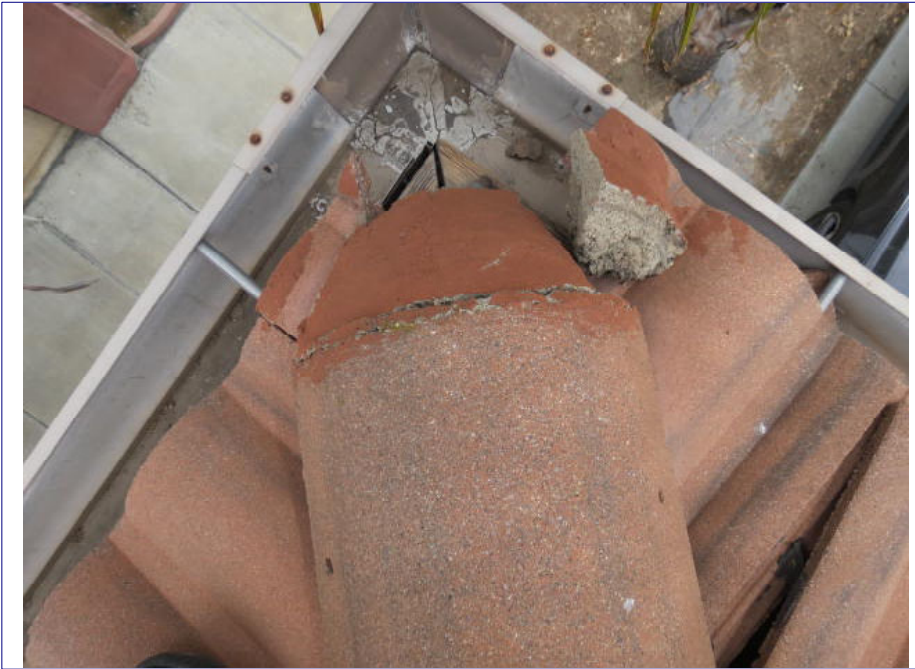
**Picture 15**

Roof material was cut short at the NE and SE corners of the house. This is exposing the fascia boards to moisture exposure and long-term deterioration. Recommend further evaluation and correction by a licensed roofer.

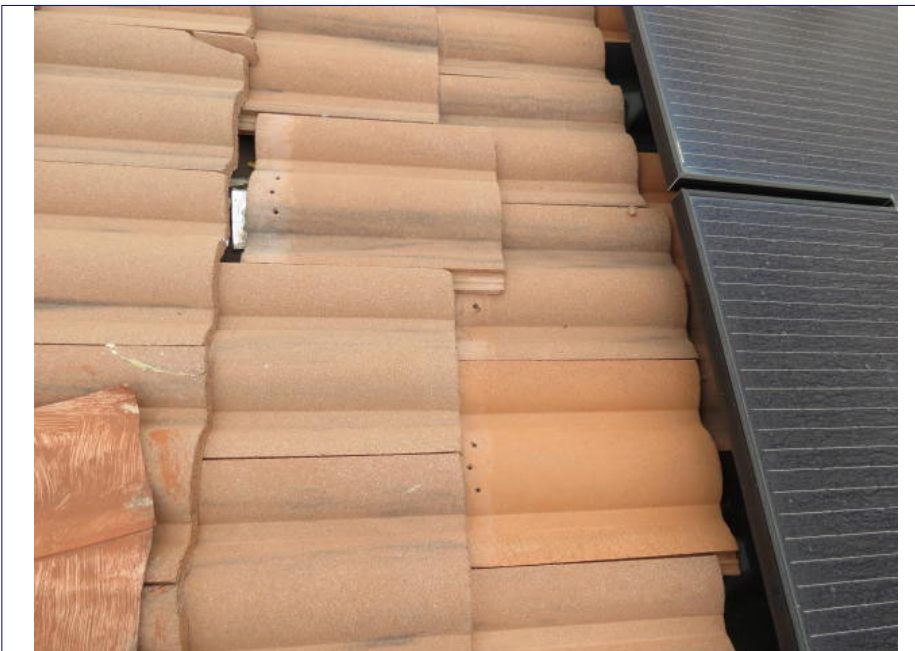
**Picture 16**

Displaced roof tiles noted at a few areas along the south facing roof lines. Recommend further evaluation and correction by a licensed roofer to prevent potential water intrusion.

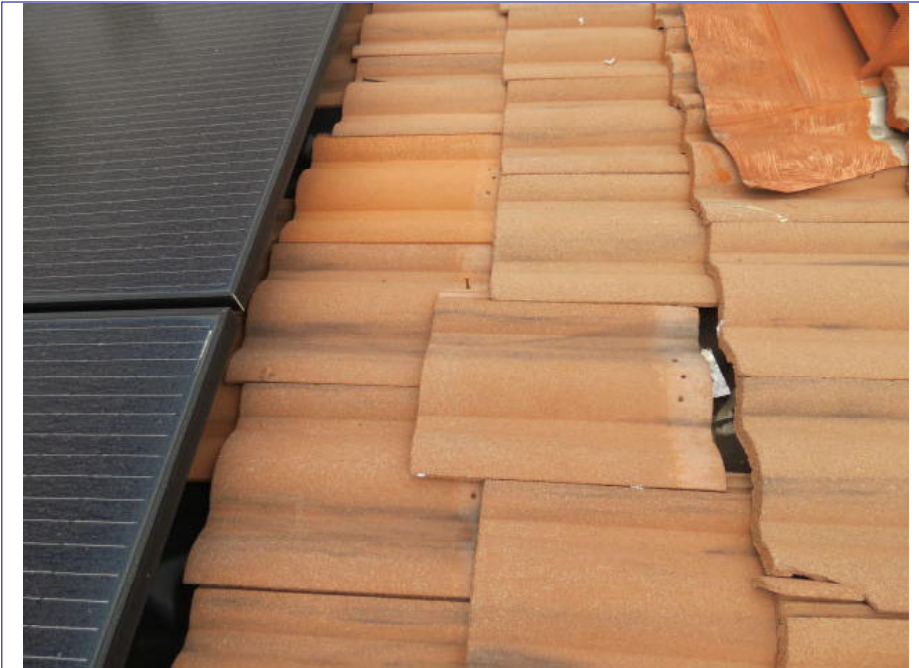
**Picture 17**

Another sample photo of the loose roof tiles on the south facing roof line.

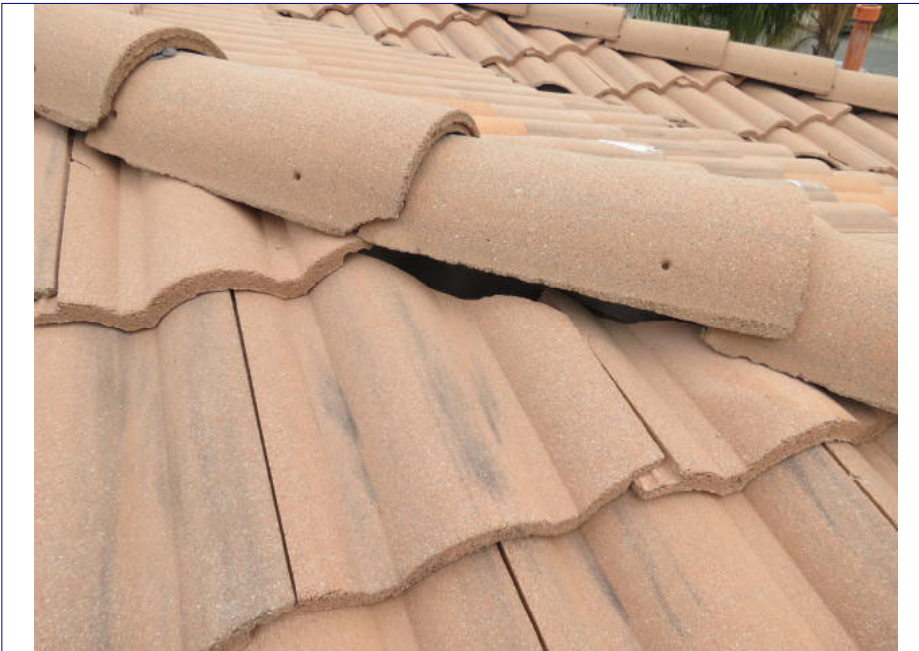
**Picture 18**

Another sample photo of the loose roof tiles on the south facing roof line.

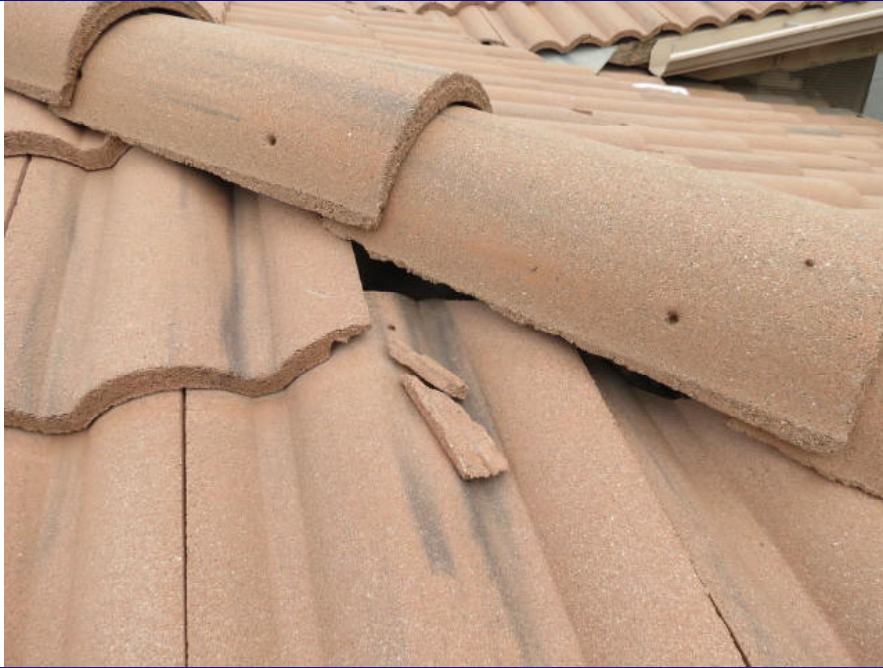
**Picture 19**

Another sample photo of the loose roof tiles on the south facing roof lines.

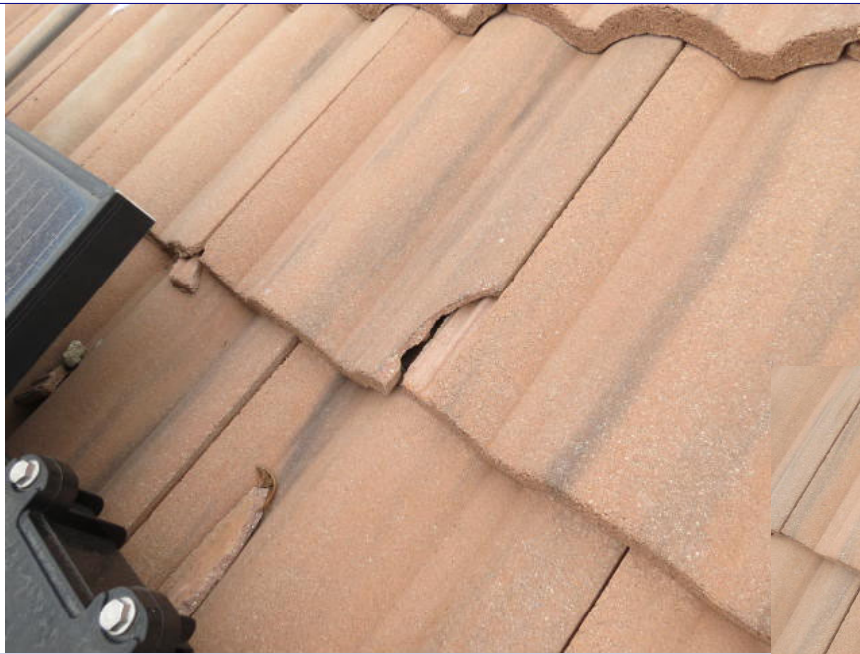
**Picture 20**

Broken corners noted at multiple roof tiles in various areas, primarily the south facing roof line. Small gaps can allow for water intrusion. Recommend further evaluation and correction by a licensed roofer.

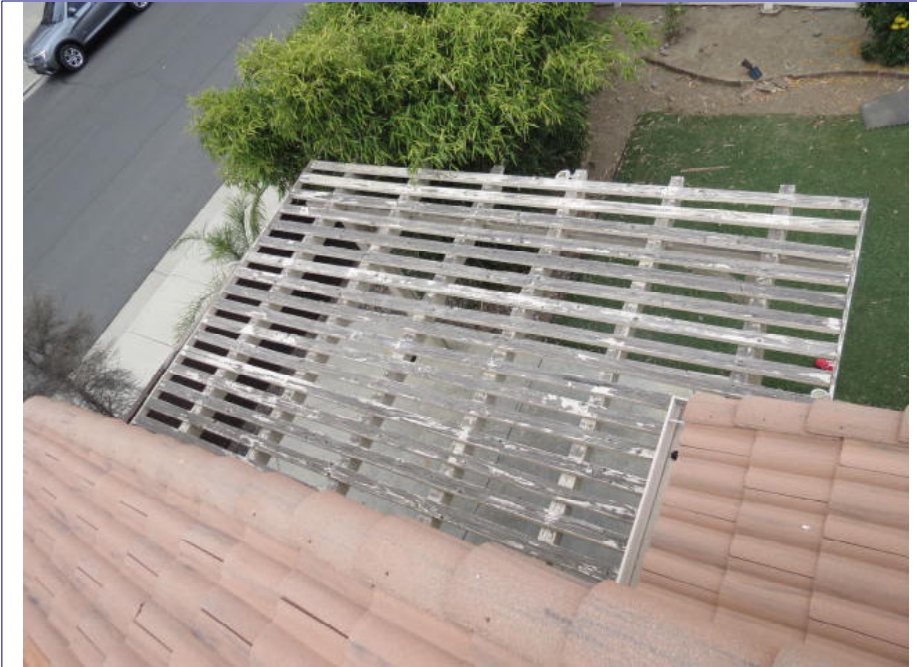
**Picture 21**

Paint deterioration noted on the topside of the patio covers, which can hasten weathering and deterioration of the wood. Recommend new coat of paint for weather protection.

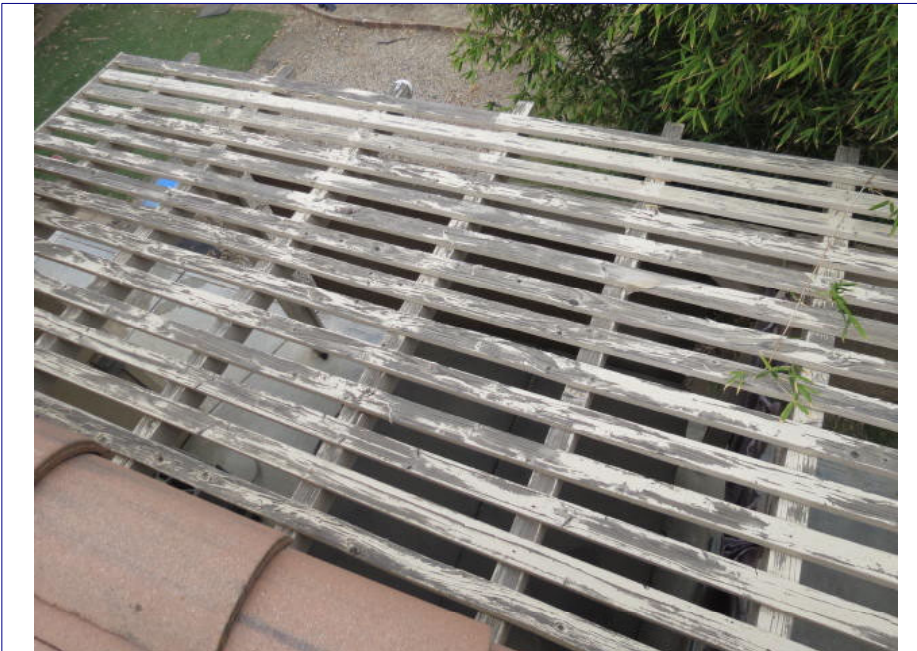
**Picture 22**

Sample photo of the 2nd patio cover with deteriorated paint finish.

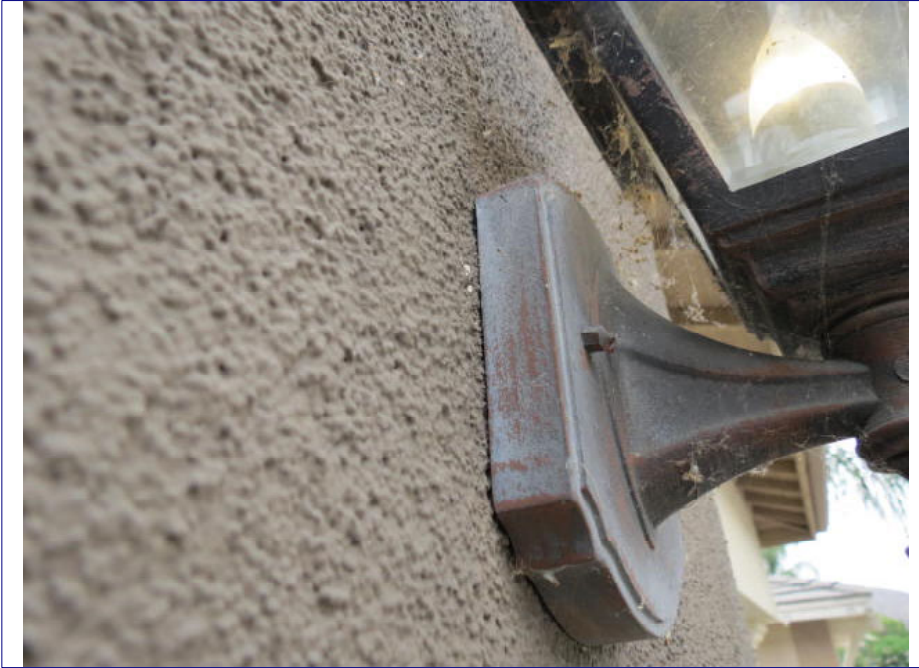
**Picture 23**

Recommend caulking around the open seams between the stucco walls and exterior wall mounted light fixtures. This is to prevent potential moisture intrusion into the wiring box. Recommend further evaluation and correction by a licensed electrician.

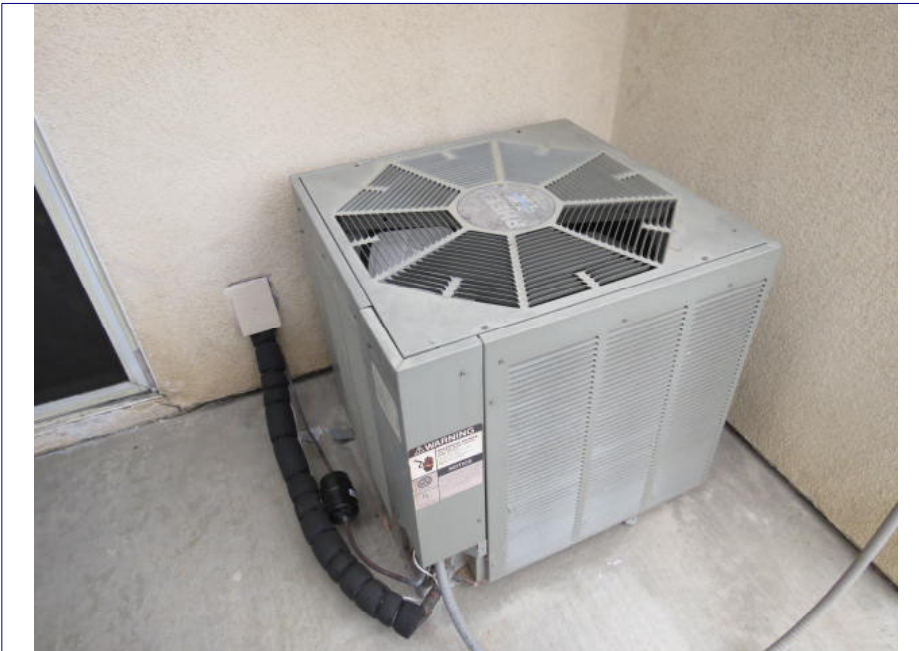
**Picture 24**

Based on the age of the HVAC units (furnace and ac), recommend having the units serviced by an HVAC professional to ensure safe and most efficient operation of the system.

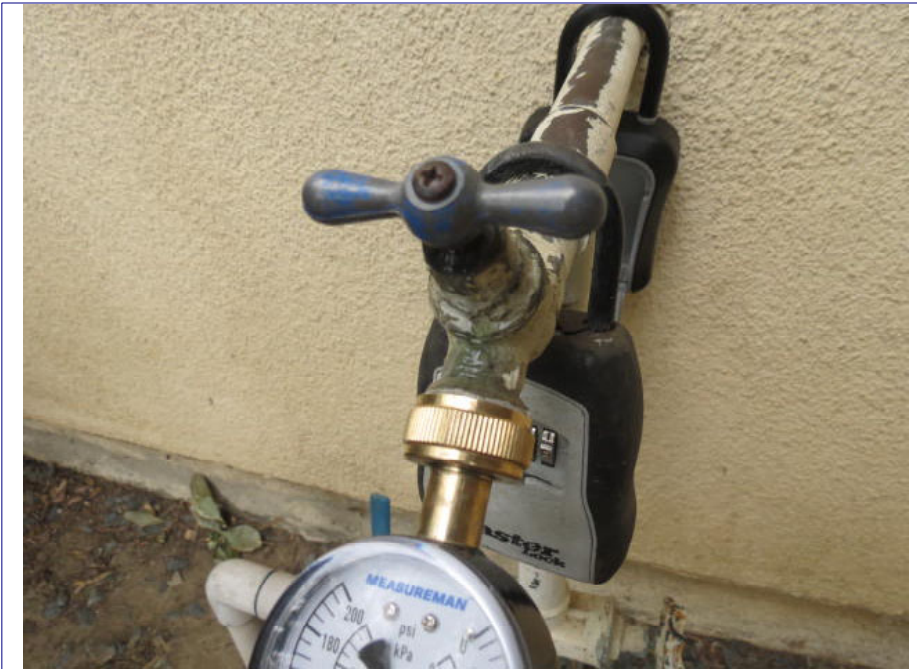
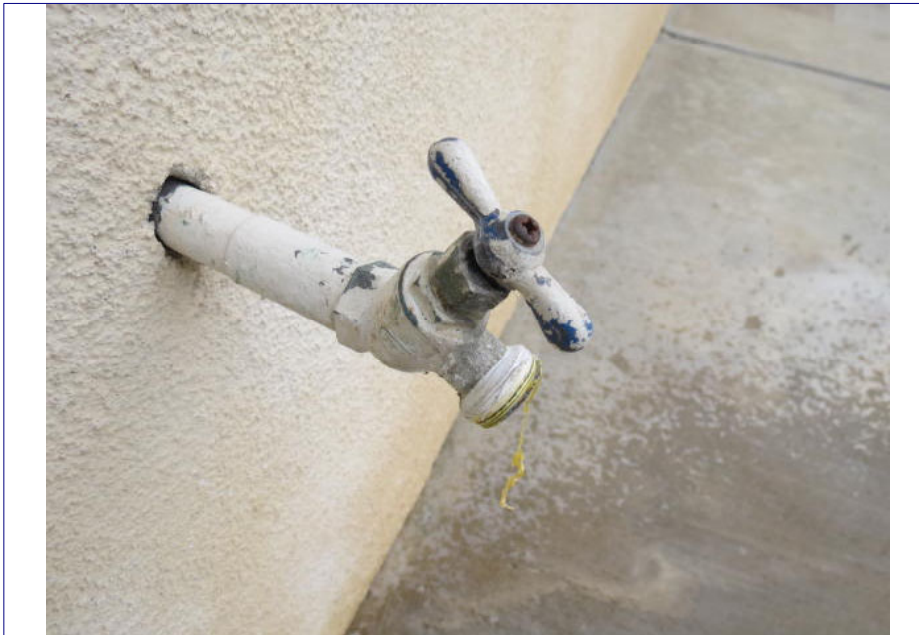
**Picture 25**

Handle leaks noted at hose faucets during operation (both photos). Recommend further evaluation and correction by a licensed plumber.

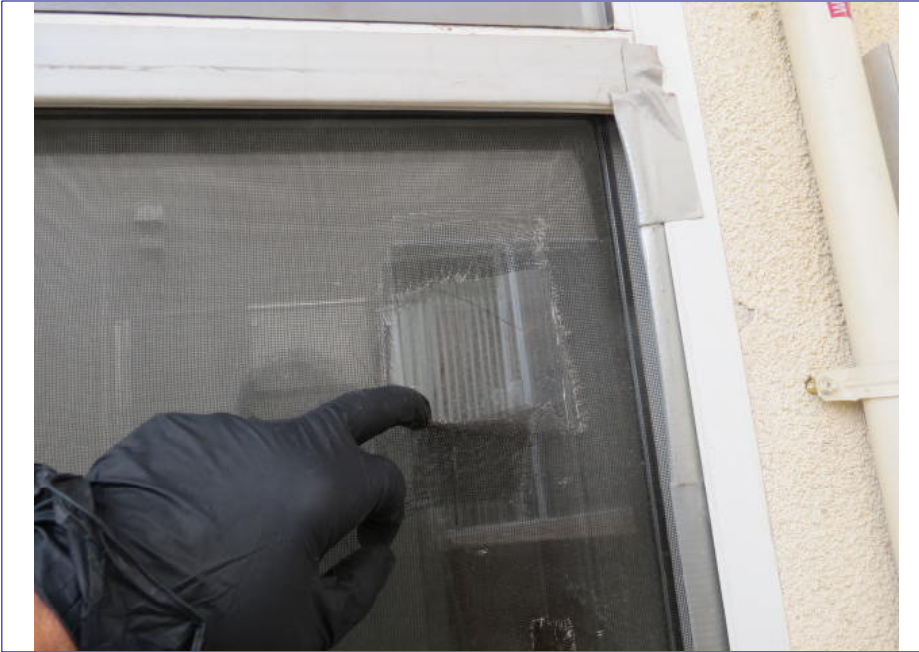
**Picture 27**

Worn/weathered/damaged screens noted at a few windows around the house, primarily the windows with the most exposure to the sun. Recommend further evaluation and correction by a screen professional.

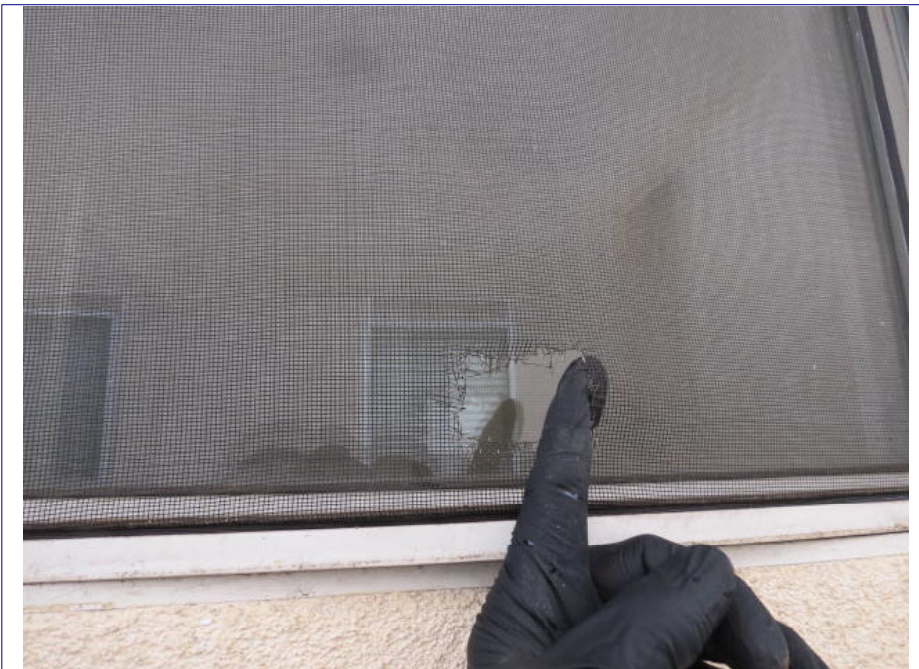
**Picture 28**

Another sample photo of the worn/weathered/damaged window screens.

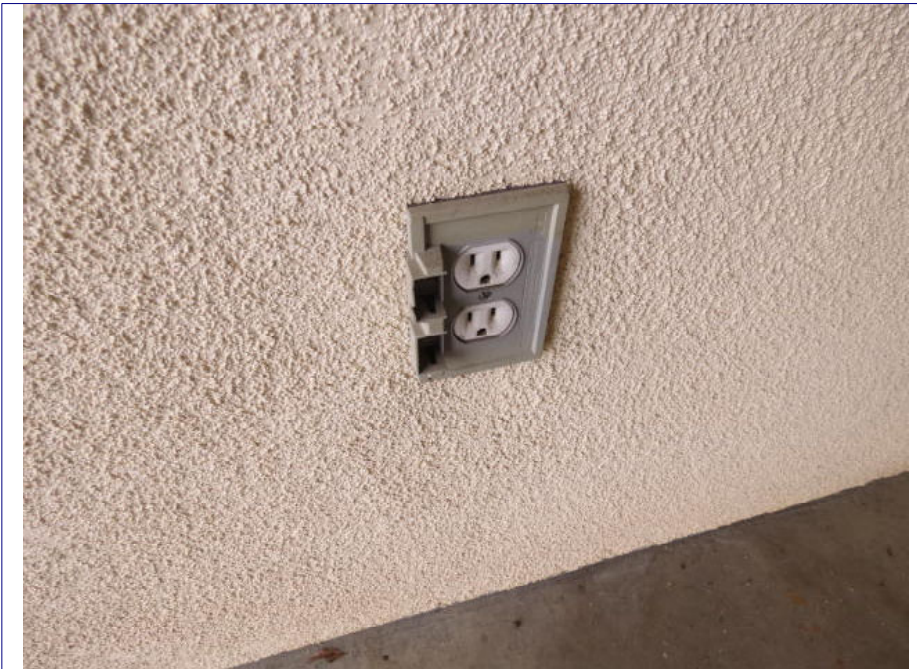
**Picture 29**

Missing/broken weather-proof cover plate noted at the electrical outlet at the front porch area. This can allow for moisture intrusion into the receptacle. Recommend further evaluation and correction by a licensed electrician.

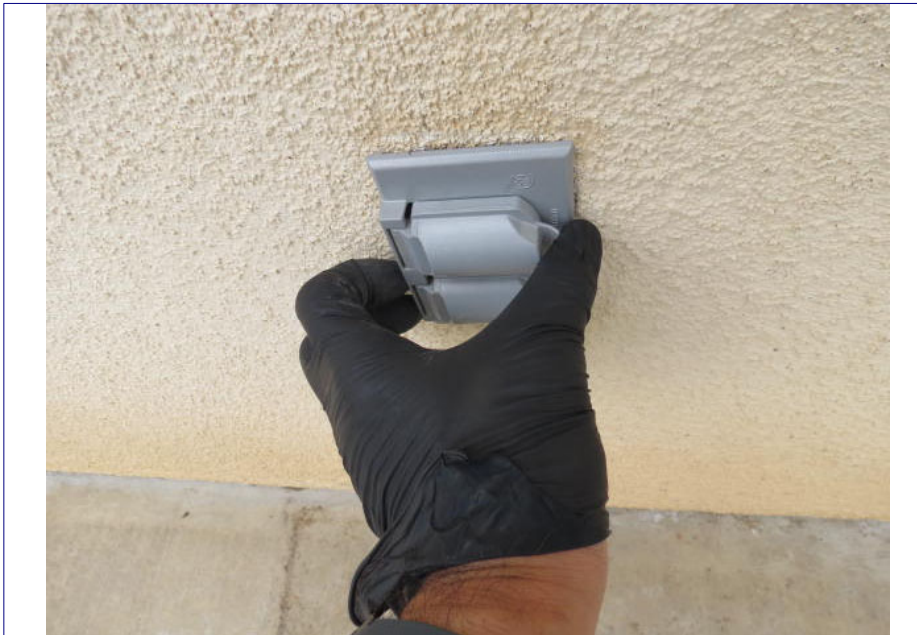
**Picture 30**

Electrical receptacle/outlet was loose in the wall junction box at the rear patio area, needs to be resecured before it becomes a hazardous condition. Recommend further evaluation and correction by a licensed electrician.

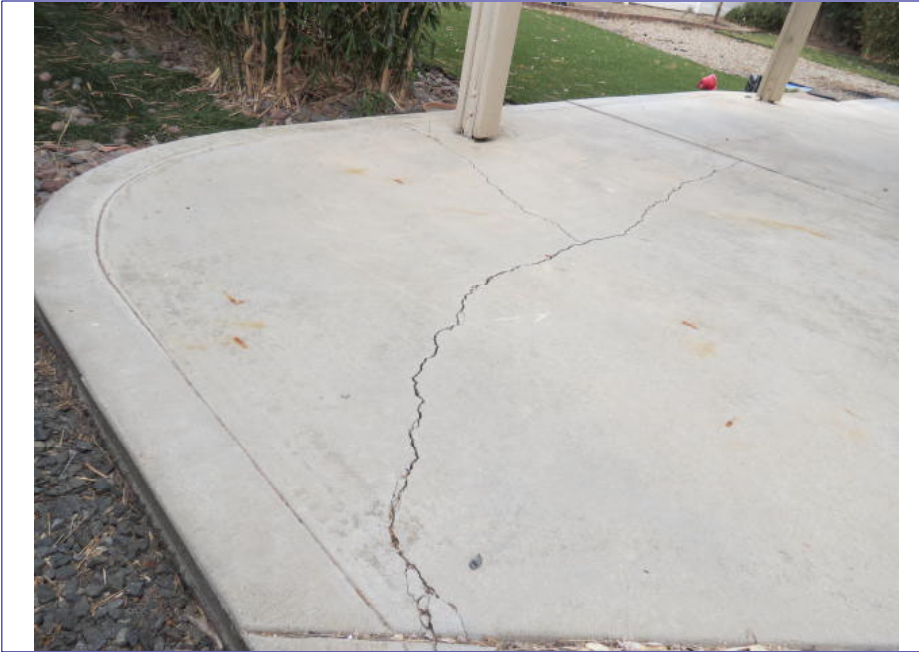
**Picture 33**

Comments: Common cracks up to 1/4" were noted in the patio slab. Settling noted at SW section of patio. (2) See photo

Displacement crack and slight settling noted at the south corner of the concrete slab at the rear patio. Crack should be filled/sealed to prevent potential water intrusion which can expound the cracking and displacement. Recommend further evaluation and correction by a concrete professional.

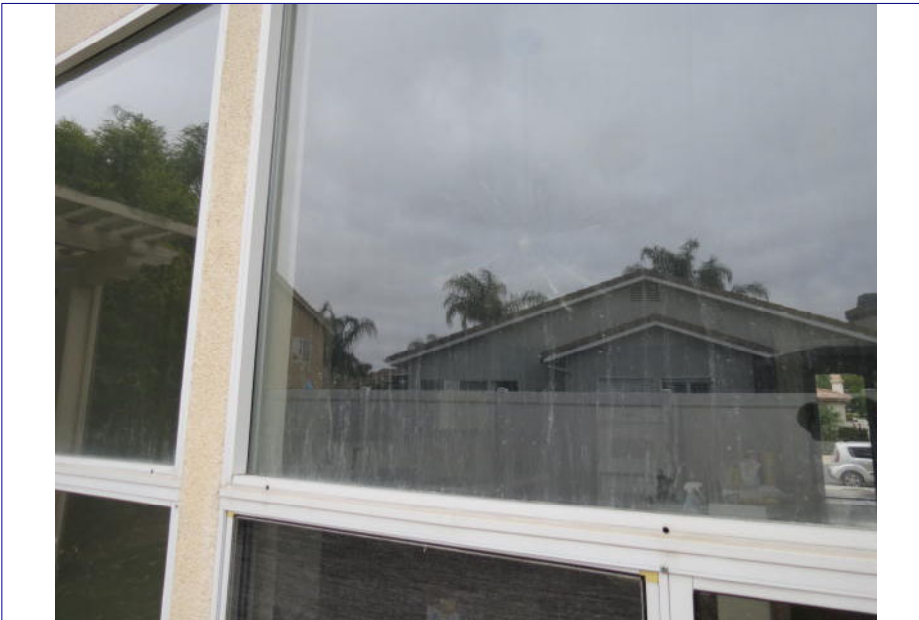
**Picture 34**

Condensation stains noted between the glass panes at the rear facing window off the kitchen niche area. Recommend further evaluation and correction by a window professional.

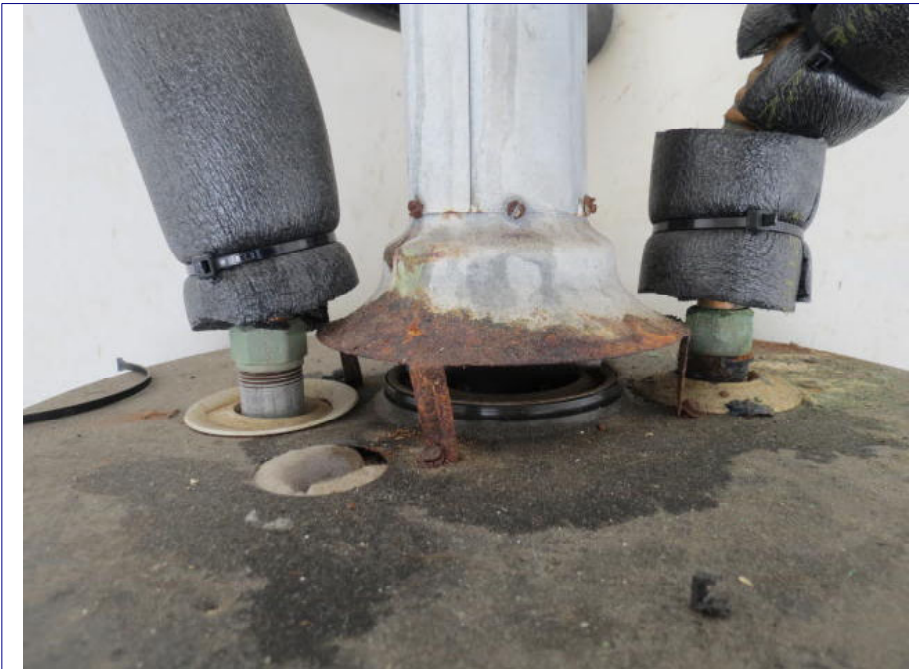
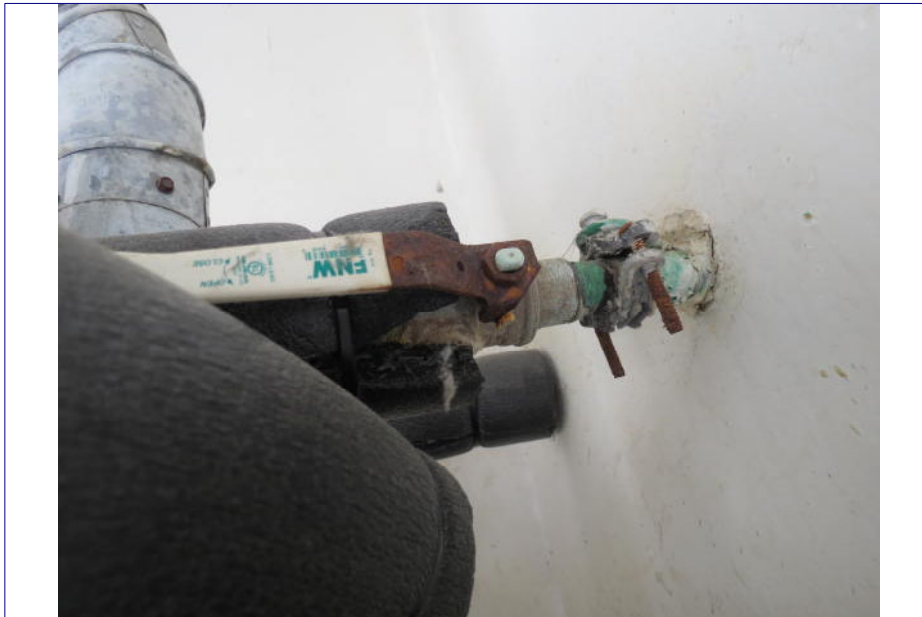
**Picture 35**

Rusting noted on the draft hood, water line connections, and the water shut off valve and bonding wire clamp (both photos). Unknown cause but possible there could be an issue with the combustion vent pipe allowing the combustion air to vent into the area. Check seller's disclosures for any repair history or have assessed by a licensed plumber for any necessary corrections.
