**Archive Property Inspection**

**Report ID# :**

**06182026-276-32**

**29619 Camino Pepita**

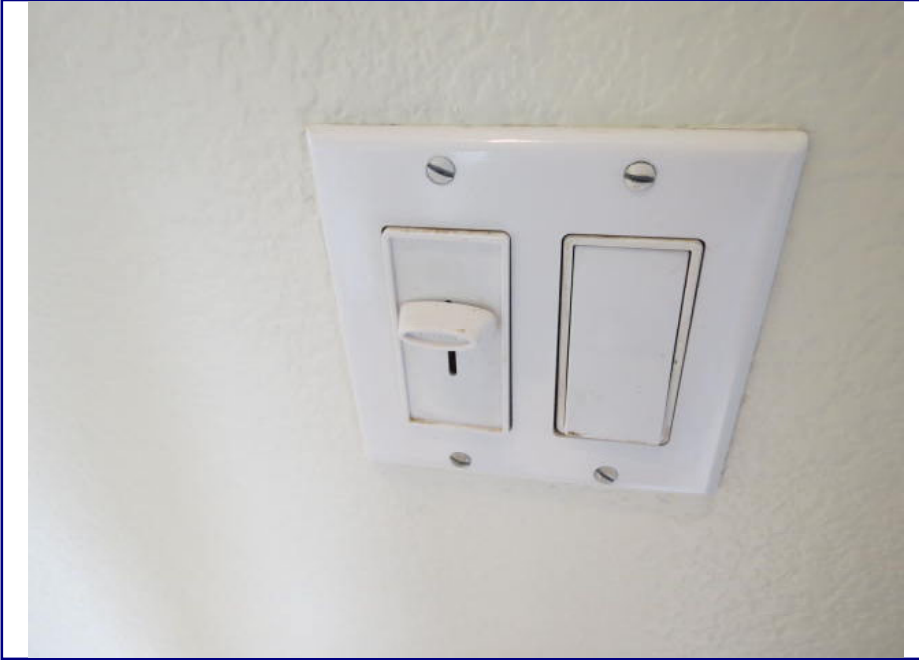
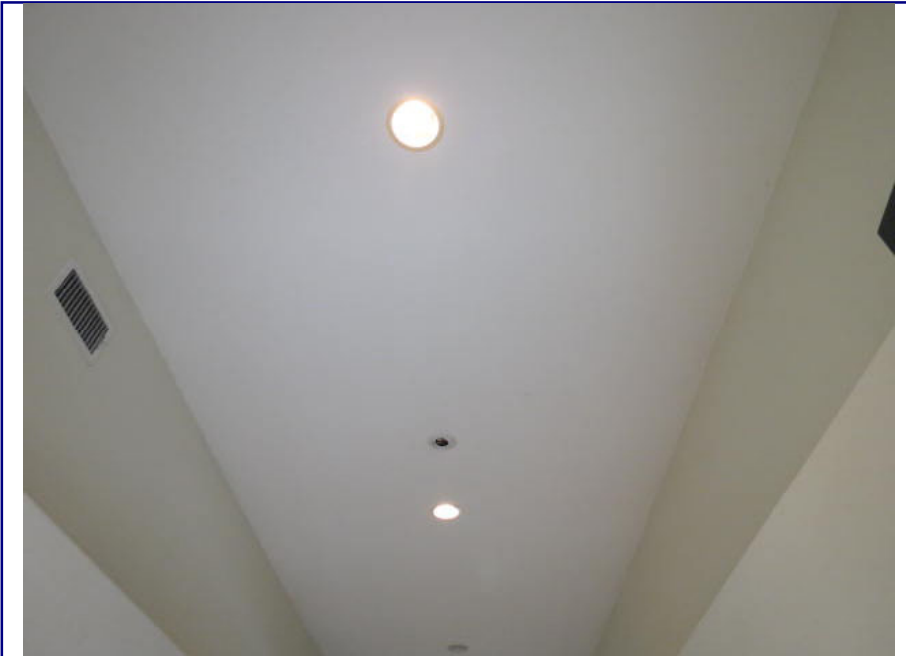
**Picture 1**

The dimmer switch at the front entry door (this photo), used to control the overhead lights at the front entry hallway (lower photo), is not a 3-way controllable device. This is preventing the other 3-way switch in this circuit to function properly. Recommend further evaluation and correction by a licensed electrician.

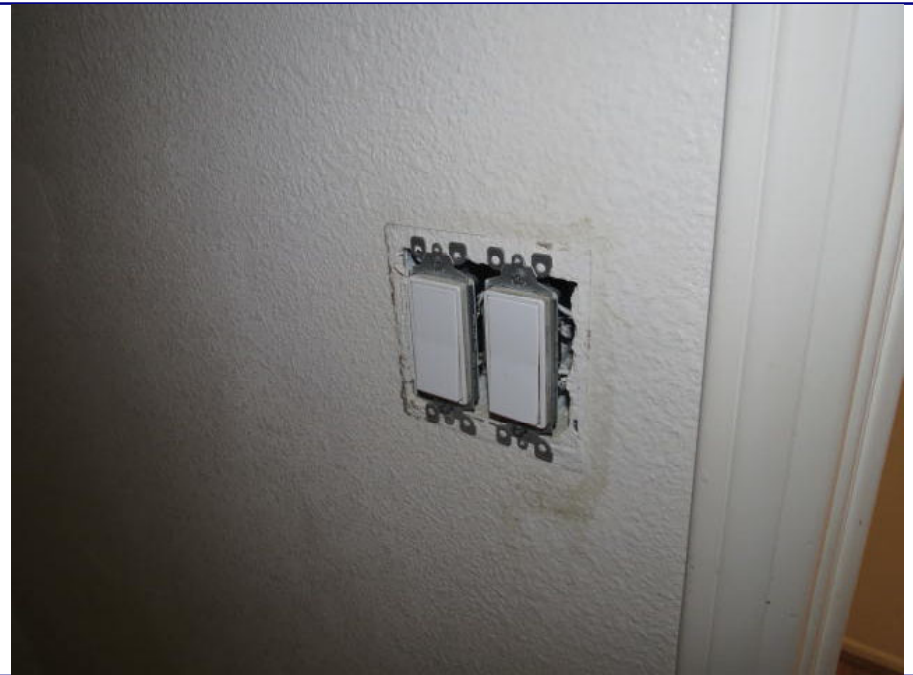
**Picture 5**

Missing cover plates noted at the electrical wall switches and outlets in multiple locations throughout the house. Recommend further evaluation and correction by a licensed electrician.

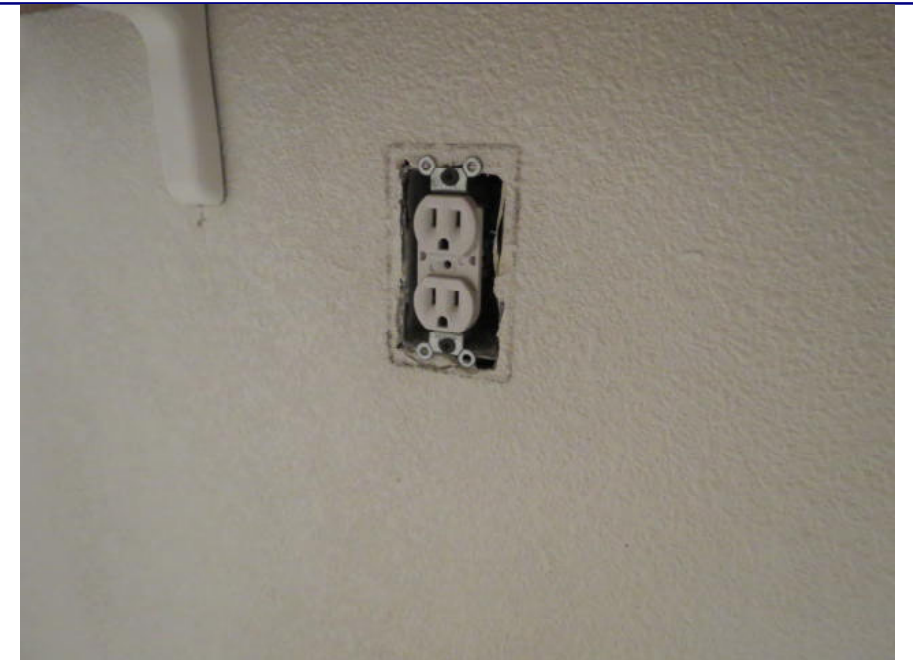
**Picture 6**

Another sample photo of the missing cover plates at the various electrical outlets and wall switches.

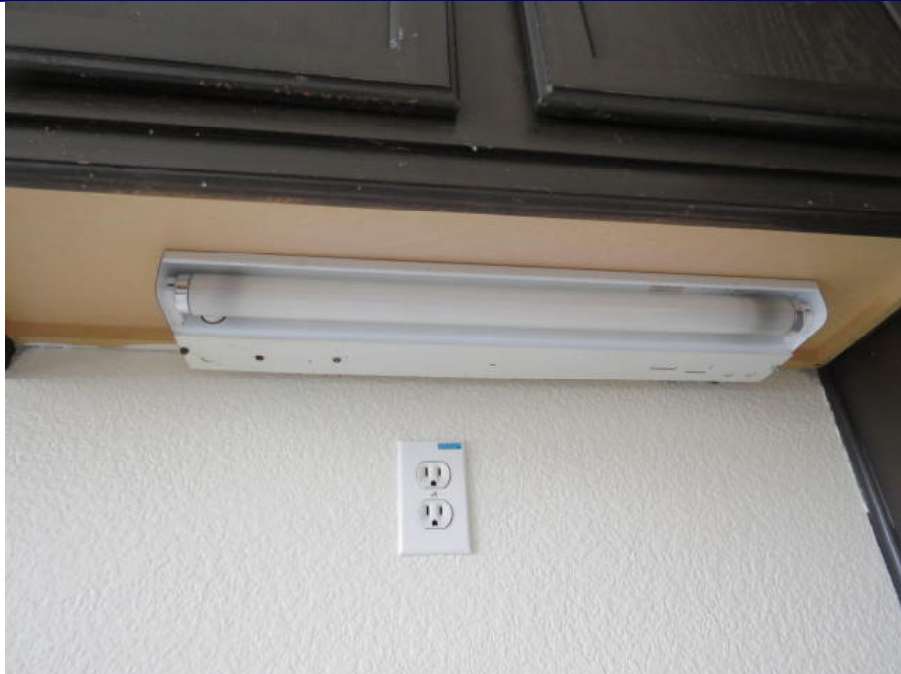
**Picture 7**

Unable to determine operation of the undercabinet lights in the kitchen, lights did not respond to the control switch. Recommend bulb replacements, and if still not operational have assessed by a licensed electrician.

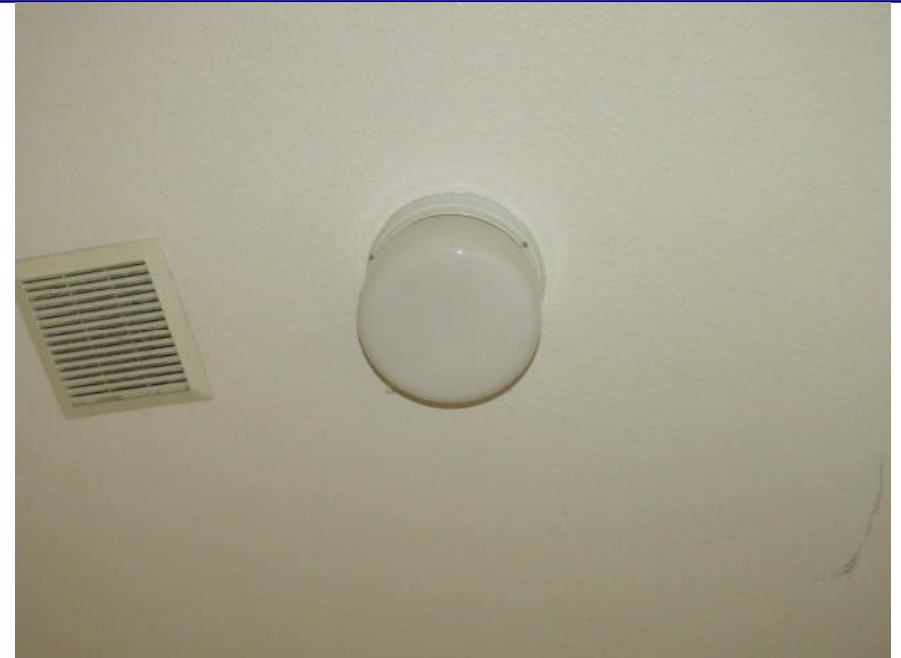
**Picture 8**

Unable to determine operation of the light at the laundry room, light did not respond to the control switch. Recommend bulb replacement, and if still not operational have assessed by a licensed electrician.

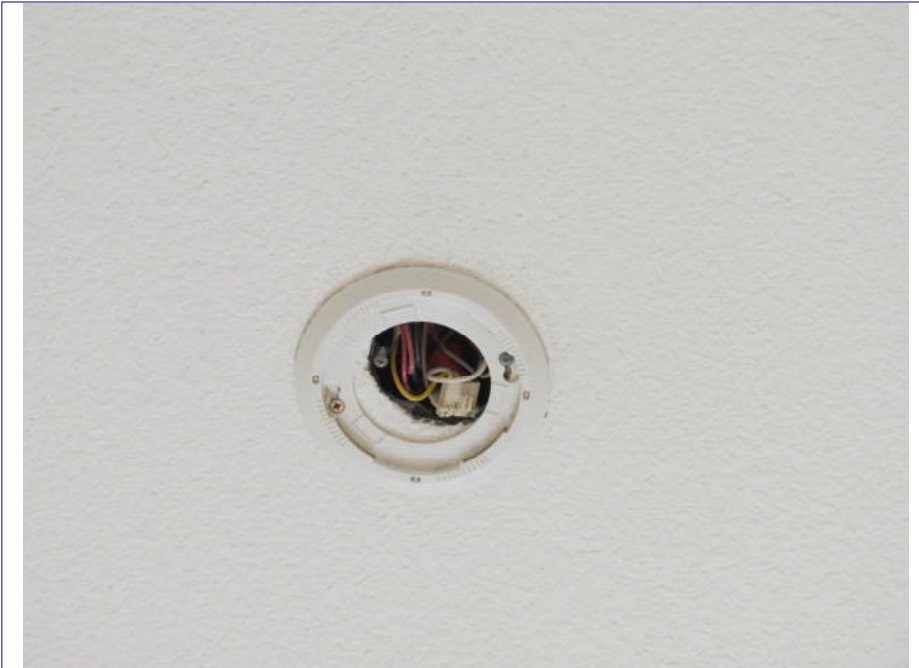
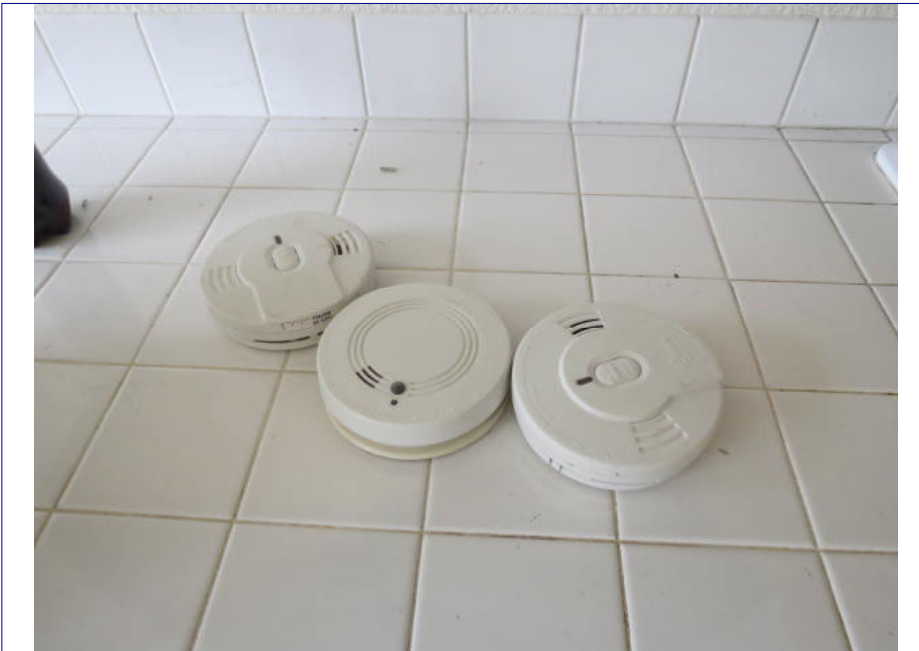
**Picture 9**

Smoke detectors were removed at the main hall common areas and carbon monoxide detector was missing (both photos). These must be in place and operational to comply with state requirements. Recommend corrections prior to occupancy or transfer of property.

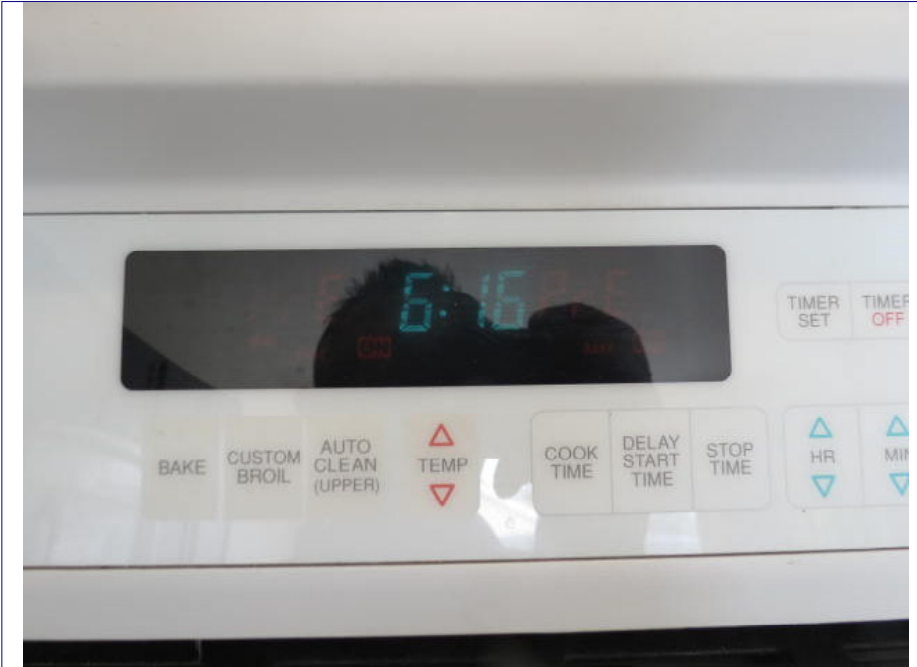
**Picture 11**

The LED read-out at the kitchen oven appliance was dim, difficult to read to assess the operational settings. Recommend assessment by an appliance professional for any needed corrections.

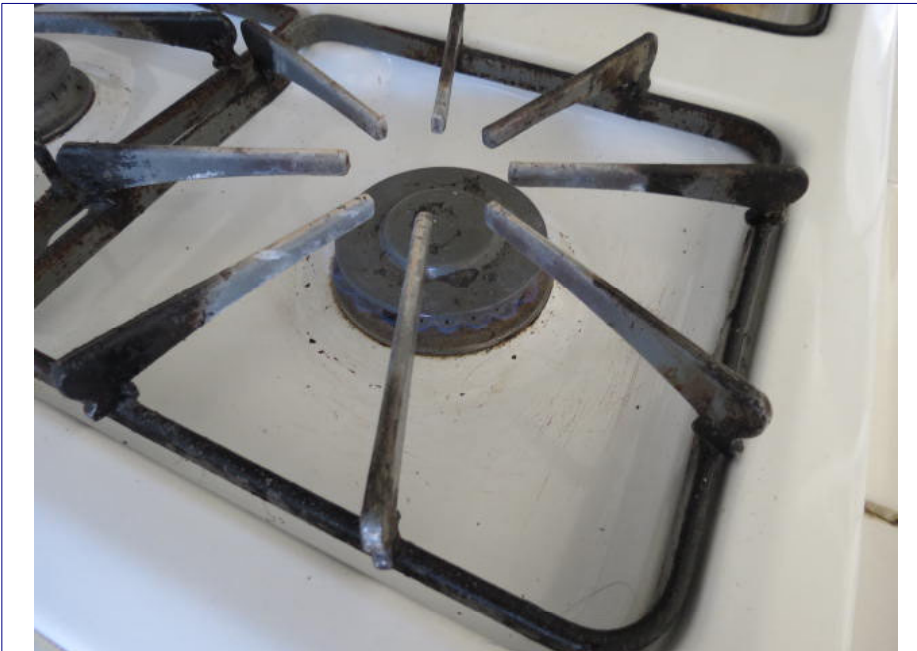
**Picture 12**

The flame at the lower left burner at the kitchen range was low, appears to be restricted. Recommend further evaluation and correction by an appliance professional.

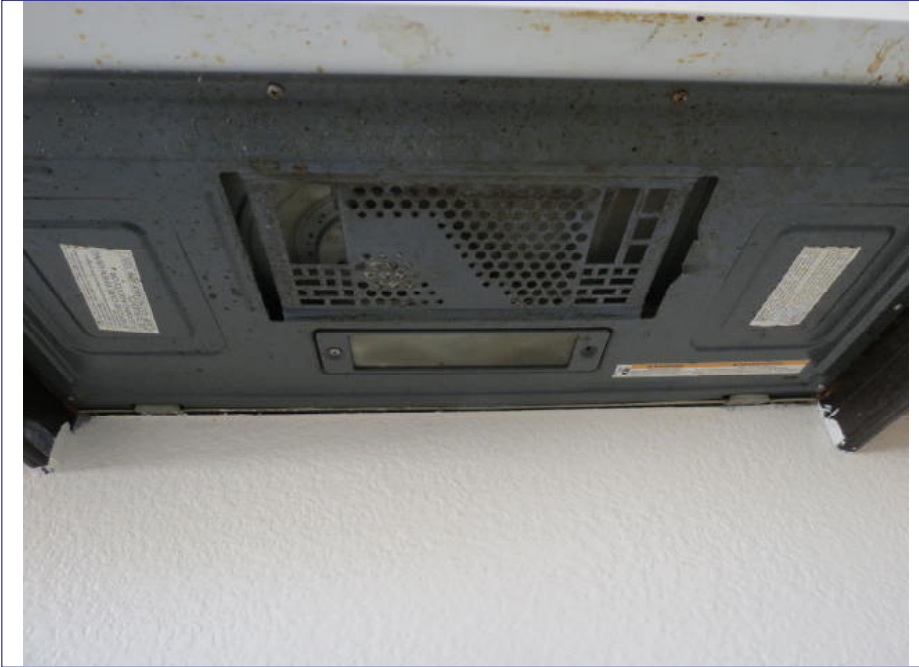
**Picture 13**

The light above the kitchen cooktop/below the microwave was not operational and the filter was missing for the exhaust fan operation. Recommend bulb replacement and if still not operational have evaluated by an appliance professional.

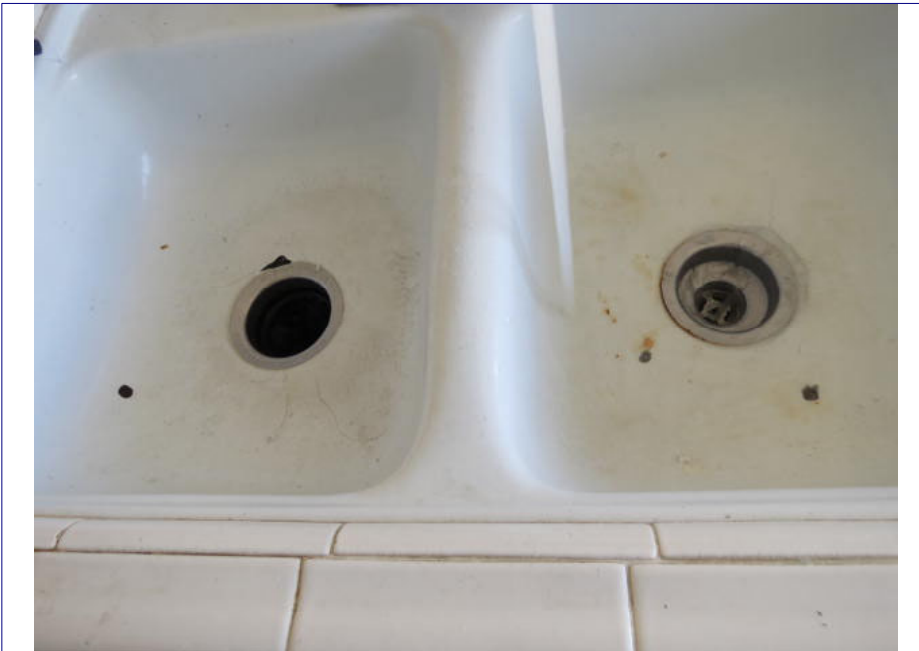
**Picture 14**

Chips noted in the finish of the kitchen sink. These should be refinished to prevent moisture intrusion and further erosion. Recommend further evaluation and correction by a fiberglass refinishing professional.

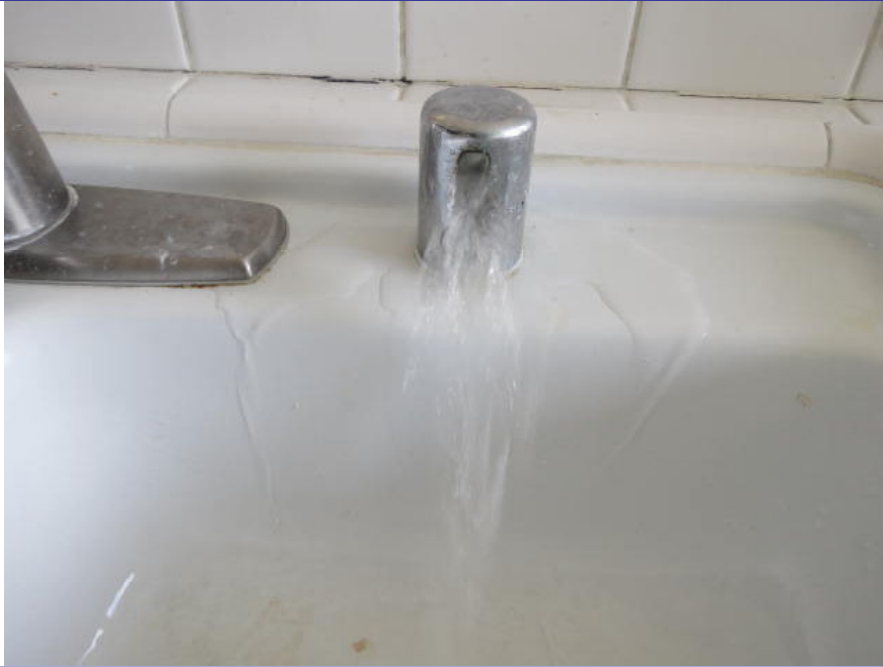
The dishwasher was draining through the airgap device, indicating clogging or blockage in the primary drain line between the air gap and disposal unit. Recommend further evaluation and correction by a licensed plumber.

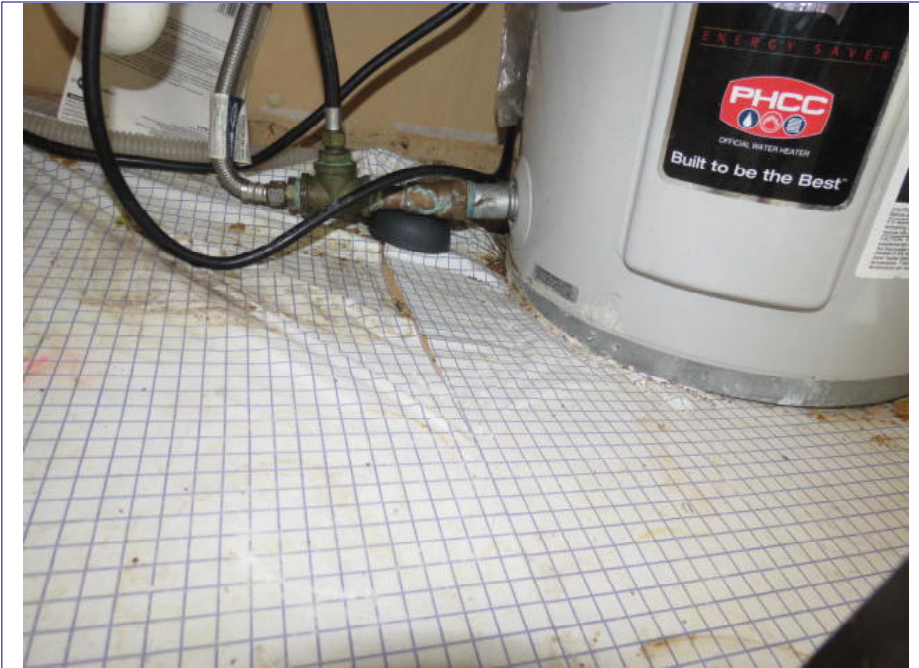
Water damage noted to the platform below the kitchen sink, likely due to the leaking noted on the previous page. Recommend further evaluation and correction by a cabinet professional.

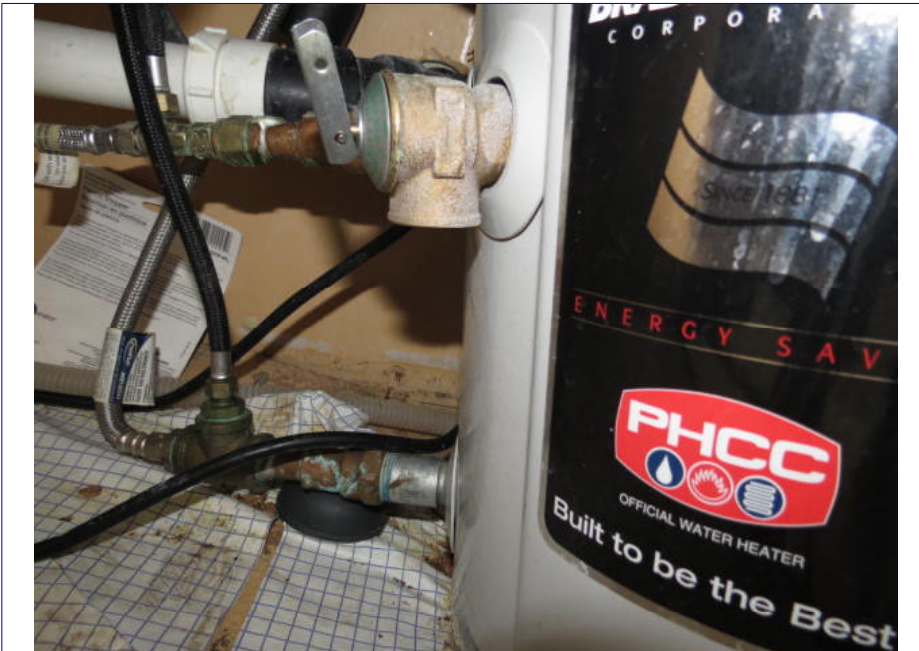
TPR overflow pipe was missing off the kitchen water heater. This is needed to safely dissipate water should the valve open. This is a safety hazard. Recommend further evaluation and correction by a licensed plumber.

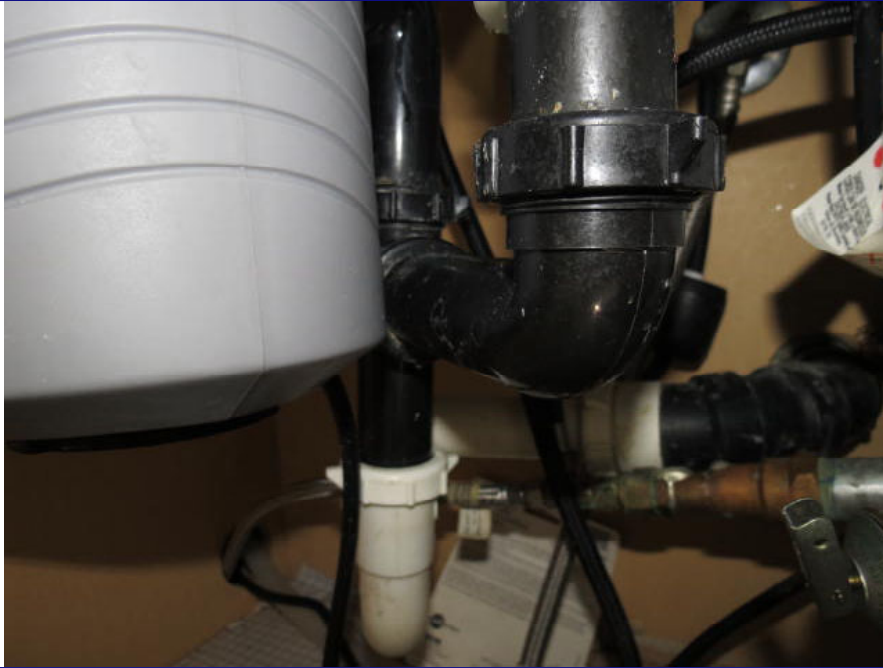
Horizontal waste line below the kitchen sink has improper angle, should be downward instead of upward to aid in proper drainage. Recommend further evaluation and correction by a licensed plumber.

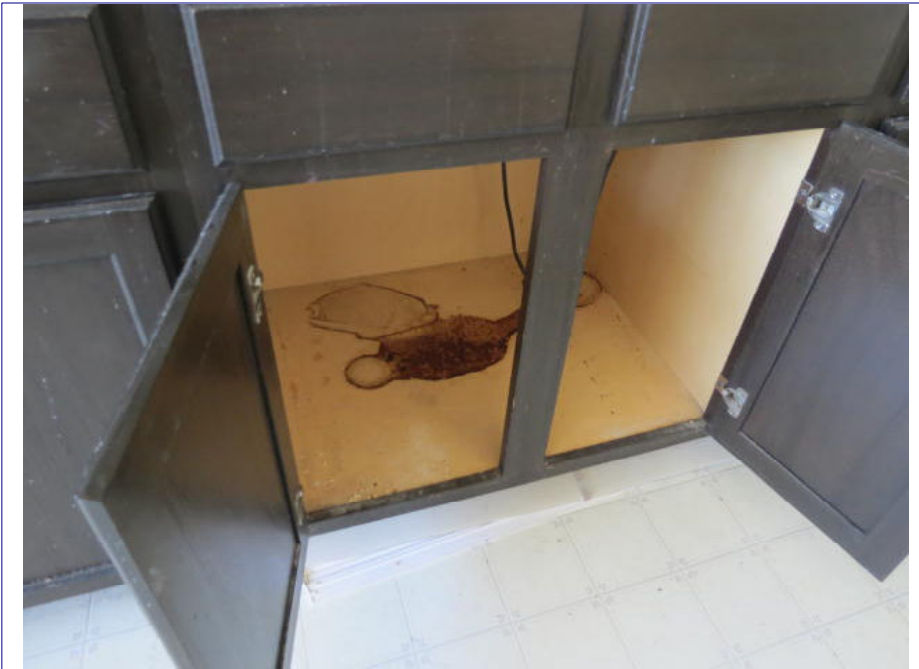
Moderate wear/use noted to the cabinetry in the bathrooms and kitchen. Consult with a cabinet professional for refinishing options.

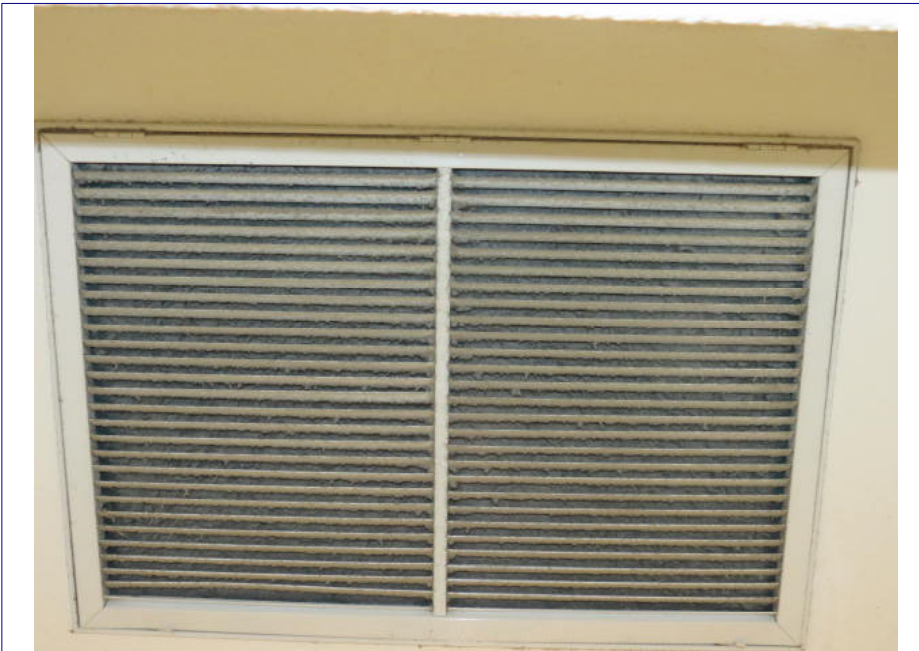
Air filter at the HVAC return vent was dirty/clogged. Recommend replacing prior to occupanc

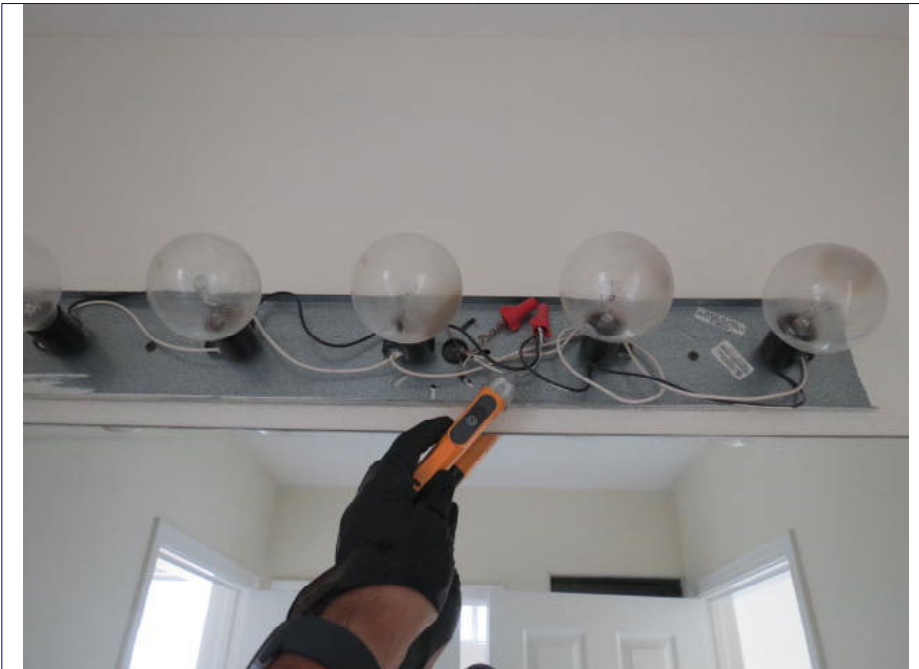
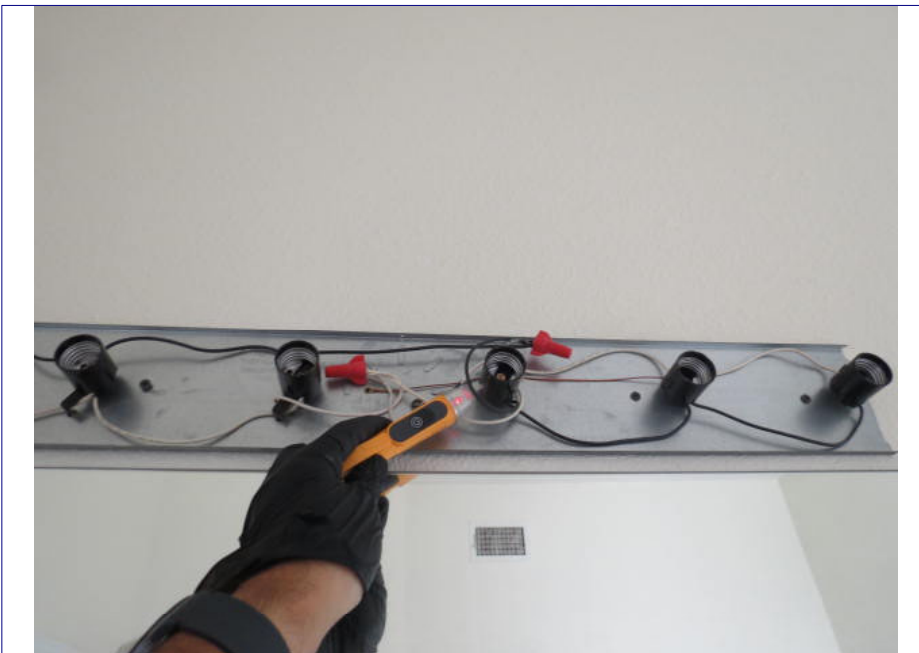
Unable to determine operation of the vanity lights in both bathrooms (both photos). Lights were not responding but the wiring was showing to have power. Recommend further evaluation and correction by a licensed electrician.

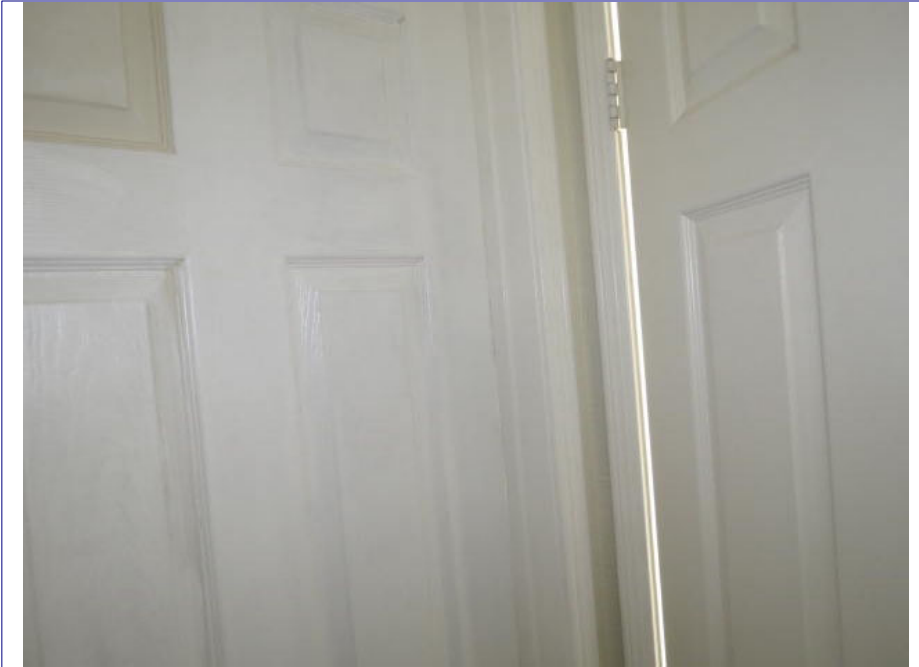
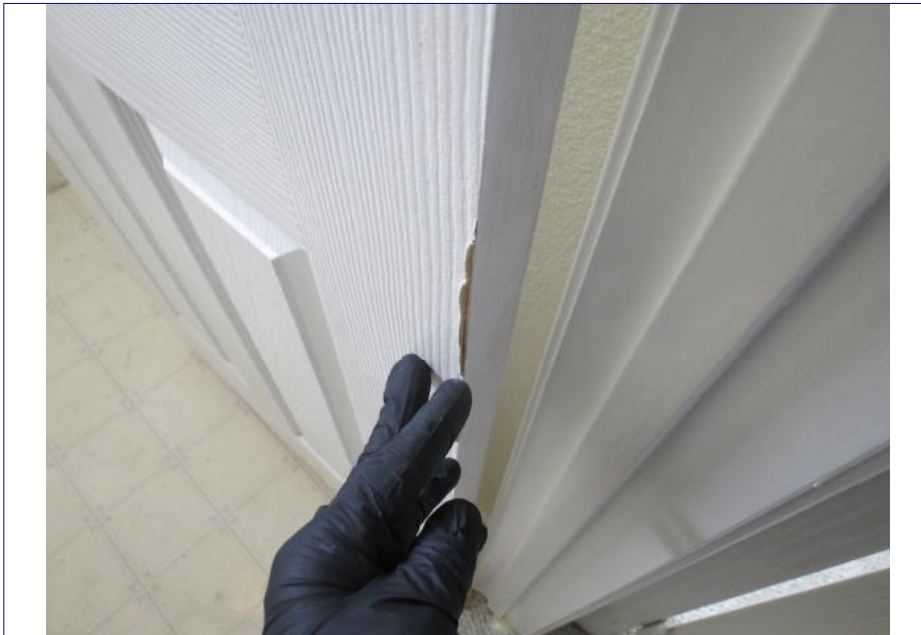
The interior door to the Jack&Jill bath toilet/shower closet was difficult to close (this photo). The edge of the door is rubbing on the jamb (lower photo), preventing the door from easily closing. Recommend further evaluation and correction by a door professional.

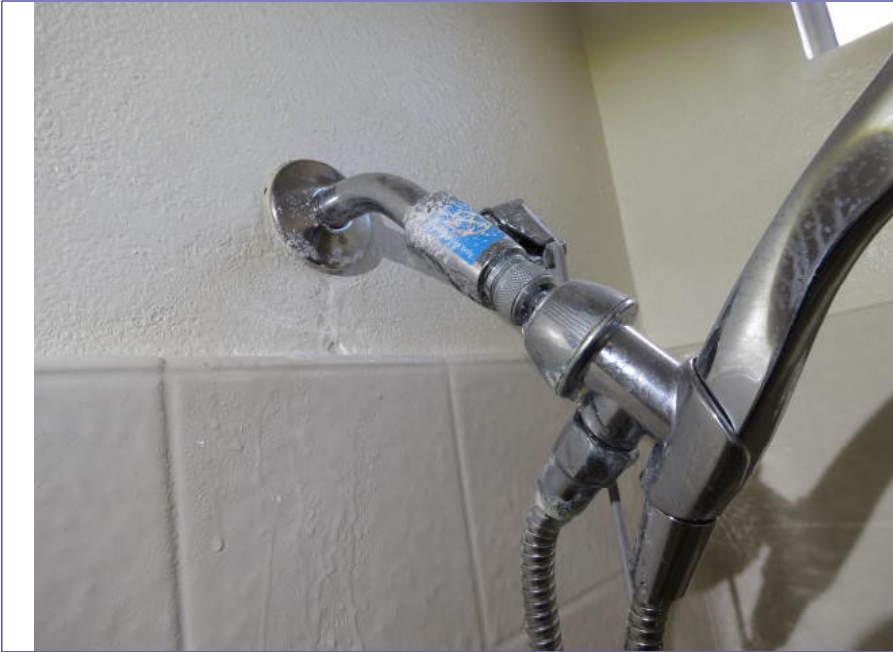
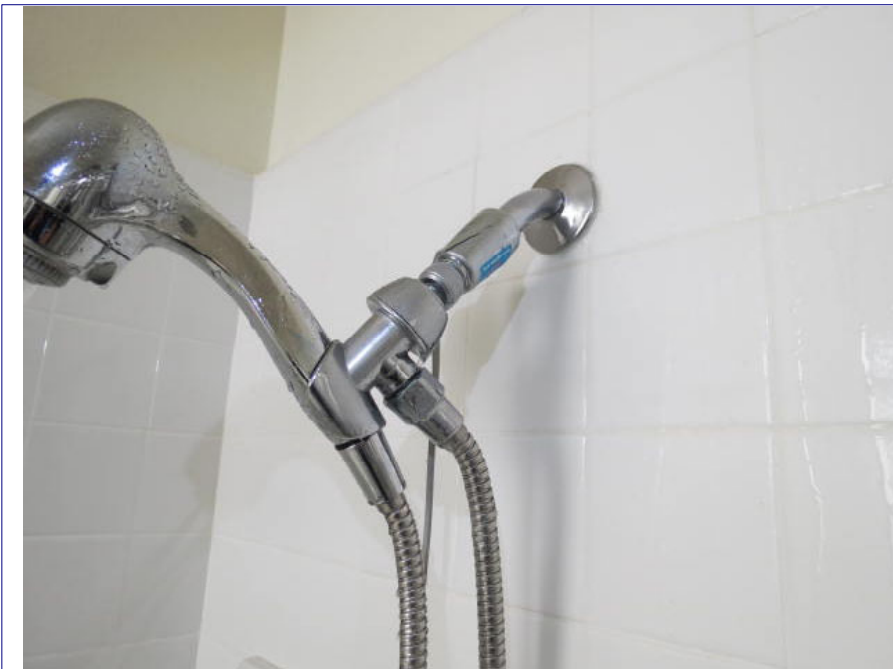
Shower heads leak from the connectors at both bathroom showers (both photos). Recommend further evaluation and correction by a licensed plumber.

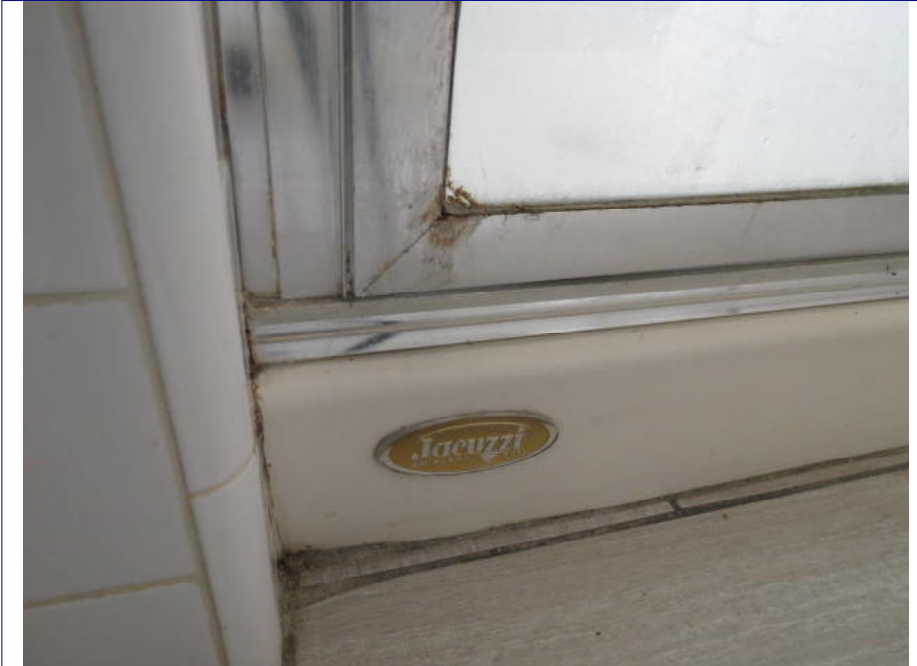
The lower edge of the primary bathroom shower door was rubbing on the lower frame, making door cumbersome to close. Recommend further evaluation and correction by a glass professional.

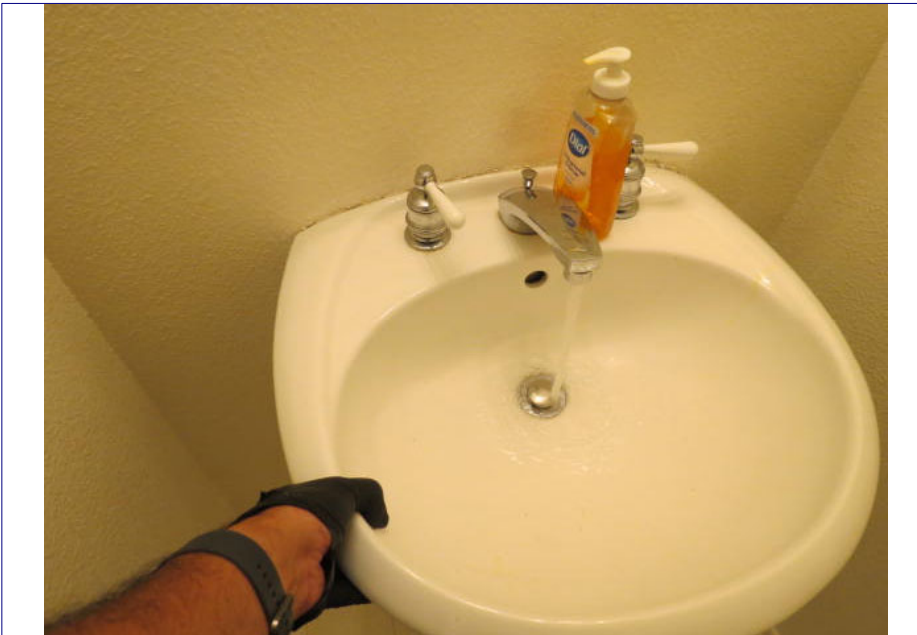
The pedestal sink in the powder bathroom was slightly loose from the wall, should be resecured to prevent further detachment. Recommend further evaluation and correction by a licensed plumber.

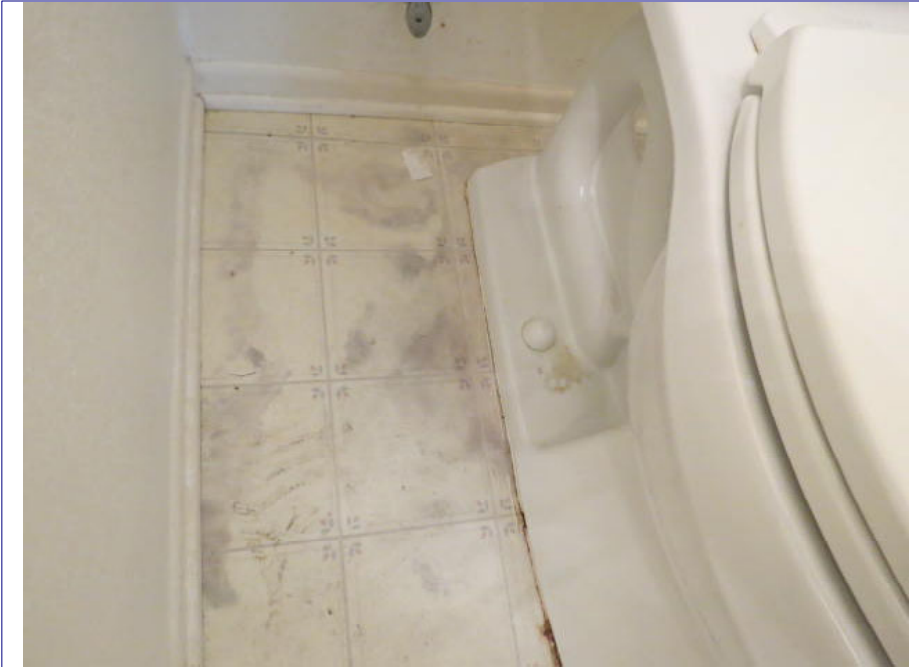
Moisture stains noted at the vinyl flooring around the toilet in the powder bathroom. No active leaks noted at the time of the inspection. Recommend assessment by a licensed plumber for any needed correction.

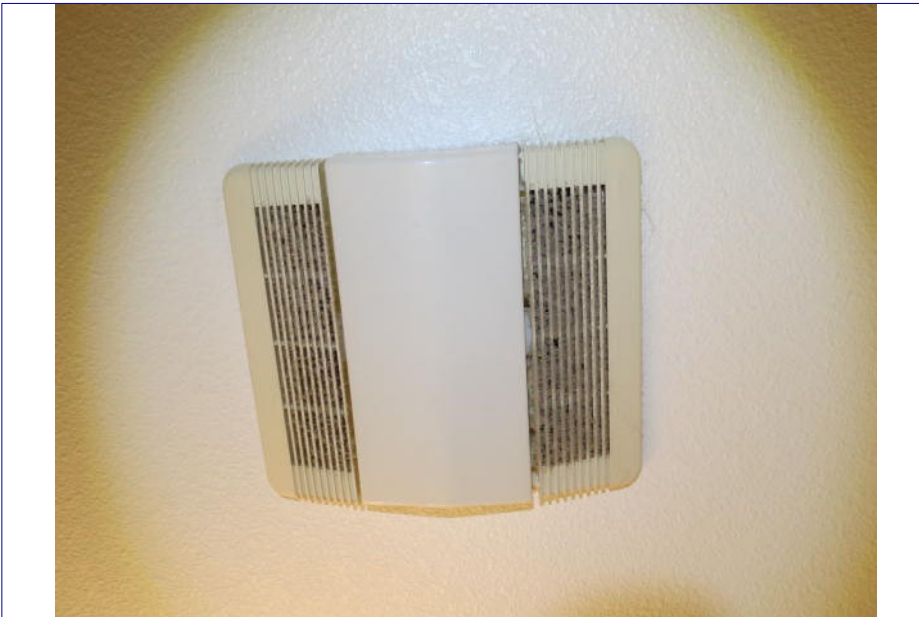
The vent covers to the exhaust fans in the bathrooms and laundry room were clogged with debris, need to be cleaned before the fan motors choke off and burn out. Recommend correction upon occupancy.

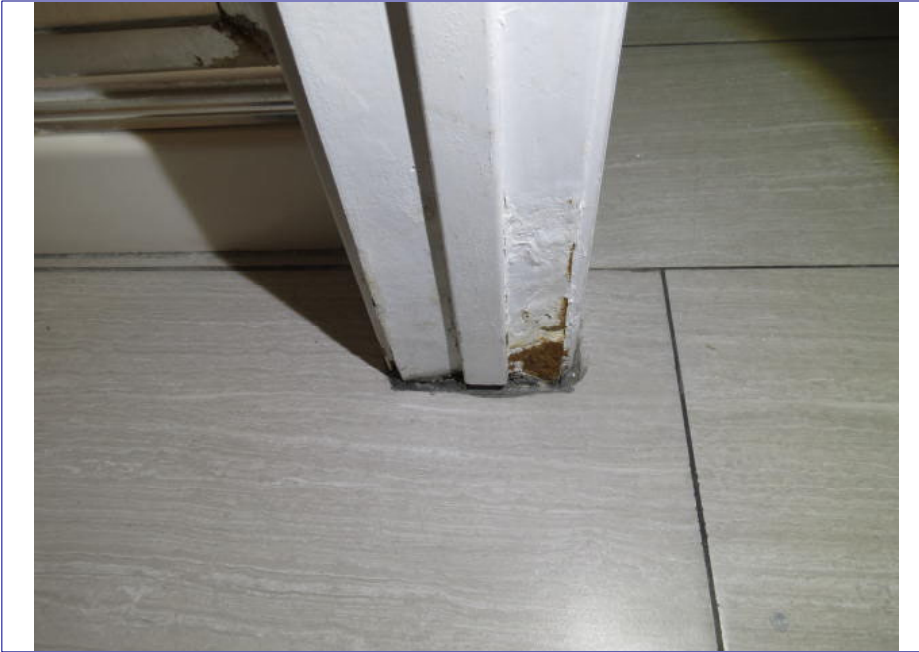
Moisture stains/minor damage noted to the lower edges of the door jambs in the primary bathroom, unable to determine the cause. Recommend assessment by a finish carpenter for potential solutions.

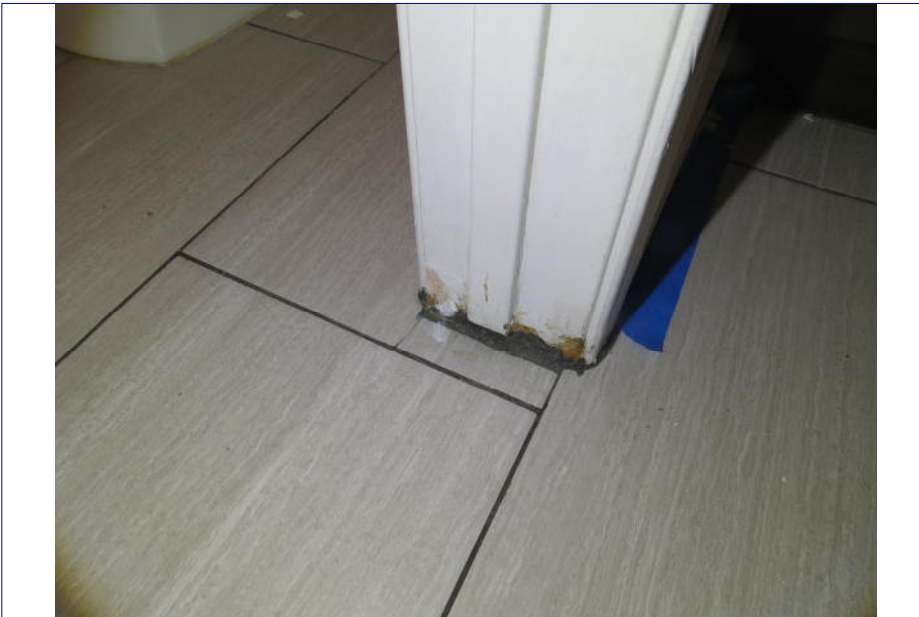
Another sample photo of the moisture stains/minor damage to the lower edges of the door jambs in the primary bathroom.

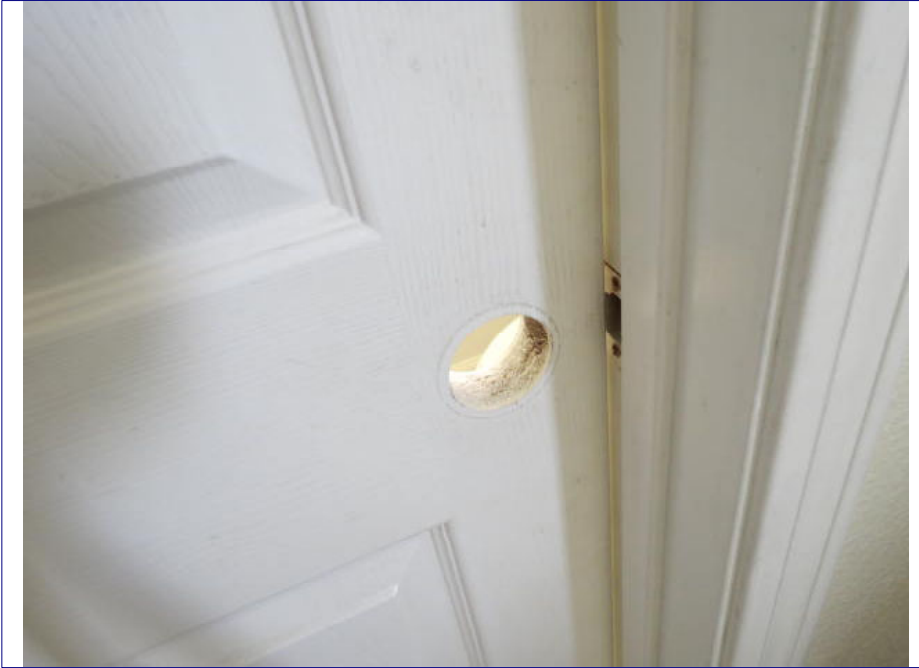
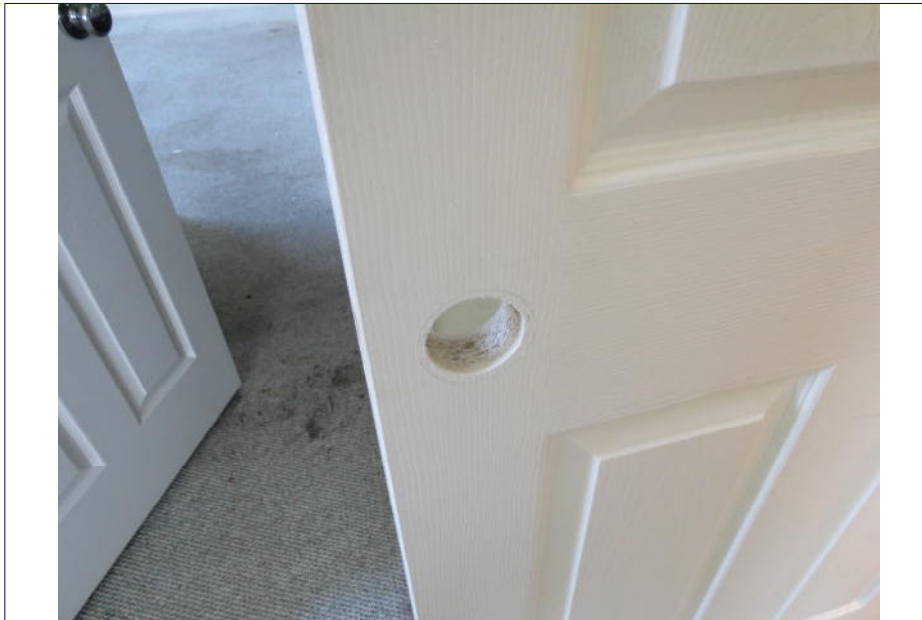
Doorknob hardware was missing at the primary bathroom toilet (this photo) closet and bedroom 1 entry (lower photo). Recommend further evaluation and correction by a door professional.

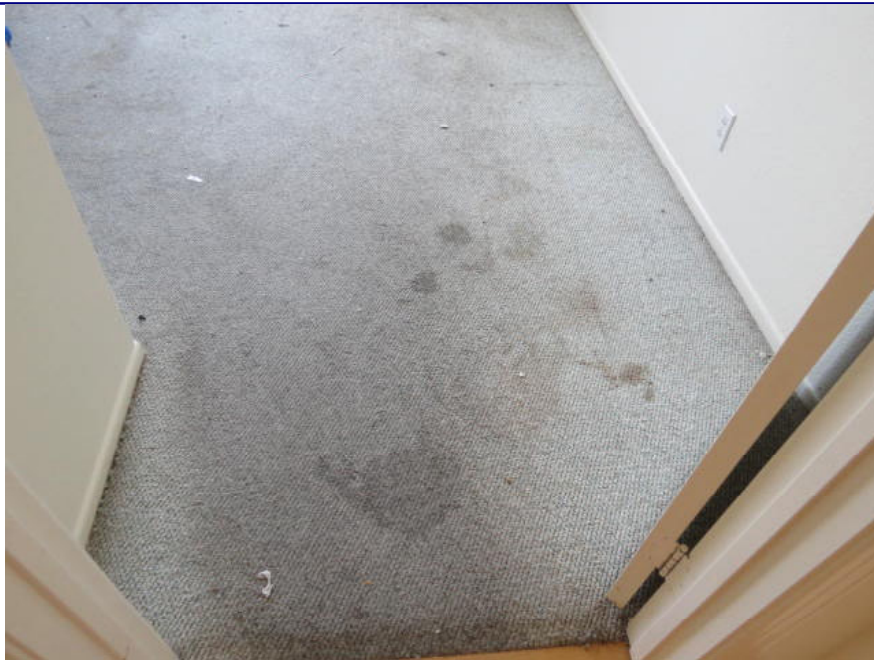
Stained carpet noted in various areas throughout the house. Consult with a carpet professional for cleaning or replacement options.

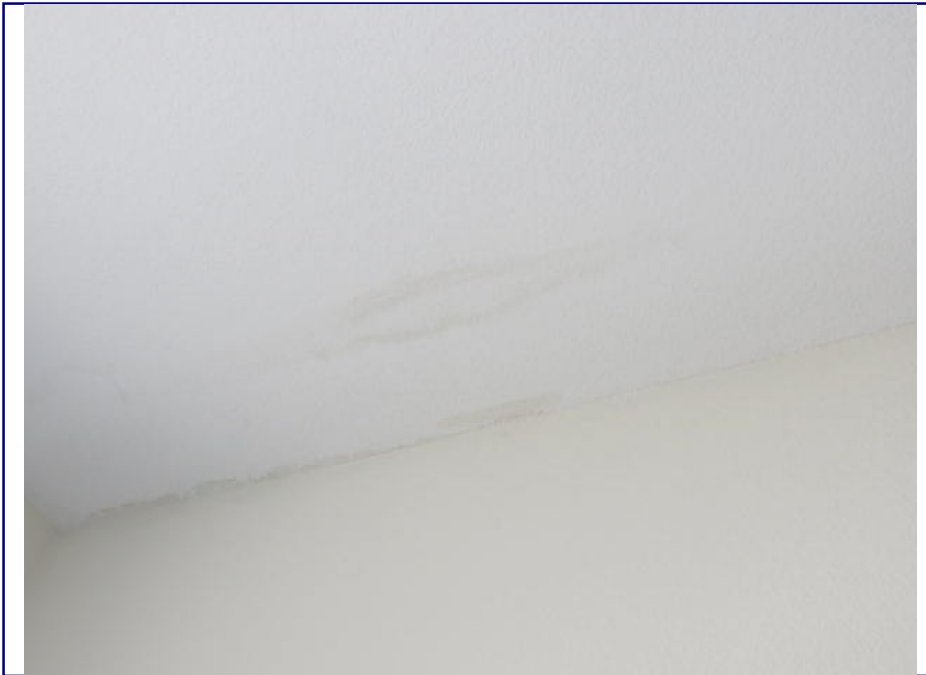
Moisture stains noted in the ceiling of bedroom 2, unable to determine if this is an active or old leak. Recommend assessment by a licensed roofer for any needed corrections.

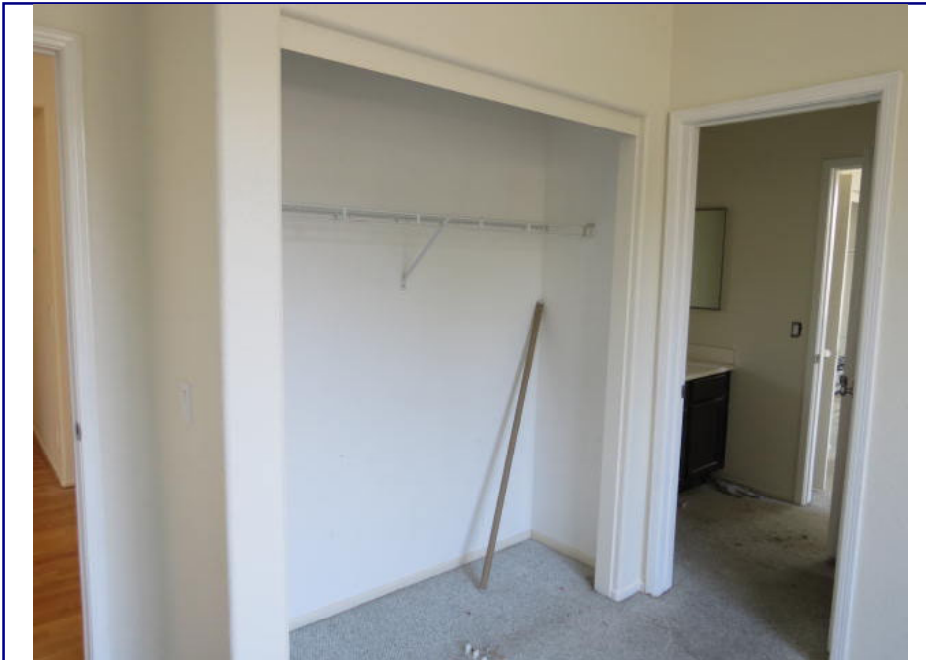
Closet doors were removed in the guest bedrooms. Recommend reinstalling to confirm operation and serviceability.
