# Inspection Report

**Property Address:**  
6402 Seabryn  
Rancho Palos Verdes CA 90275

**Home Inspection Detection Services**

<b>Date:</b> 3/26/2025	<b>Time:</b> 11:00 AM	<b>Report ID:</b> KI032625-116-116
<b>Property:</b> 6402 Seabryn Rancho Palos Verdes CA 90275	<b>Customer:</b> Carol Manligas-Kishler Kevin Kishler	<b>Real Estate Professional:</b> Steve Gutierrez-Kovner John Hart Real Estate

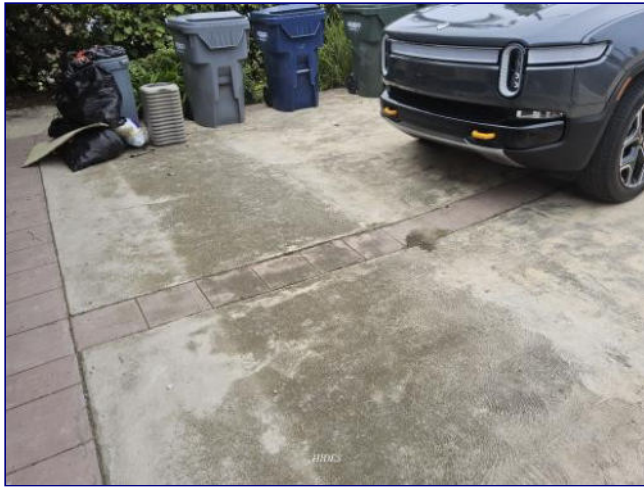
1.0 Item 1(Picture)

Moderate to large size cracks were noted to the driveway. Regular maintenance and or inspection is advised. Driveway show evidence of inadequate drainage and or ponding. Regular maintenance and or inspection is advised. Driveway appears to be sloped towards the home / garage. Further evaluation is recommended by a licensed general contractor.

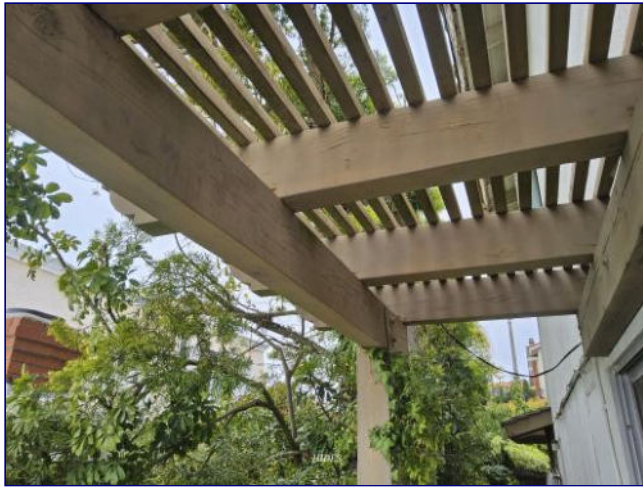
1.4 Item 1(Picture)

- 🔧 Substandard / non professional installation, support methods used along with heavy moisture stains were noted to the patio area structure. Further evaluation, consultation, and inspect, is recommended by a licensed general contractor. Extensive moisture damage and dry rot was noted to the open design patio covers. Further evaluation, consultation, and inspection, is highly recommended by a licensed pest control / termite company and or licensed general contractor.

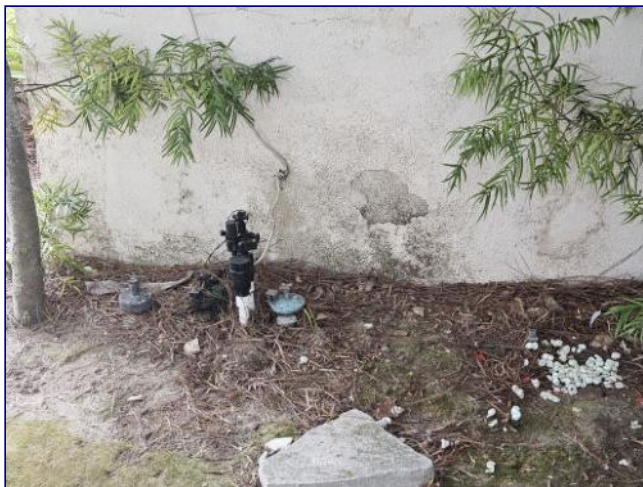
2.1 Item 1(Picture)

- Moderate cracks were noted to the exterior walls. Regular maintenance and or inspection is advised. Large size cracks were noted to the exterior walls. Regular maintenance and or inspection is advised. Stucco to the exterior walls is worn / deteriorated. Regular maintenance and or inspection is advised. Moisture stains were noted to the exterior walls. Although stains are dry, regular maintenance and or inspection is advised. Holes, openings, and or exposed framing was noted to the exterior walls. These holes, openings, and or exposed framing areas must be sealed / patched to help eliminate any moisture intrusion and or penetration. Further evaluation is recommended by a licensed general contractor.

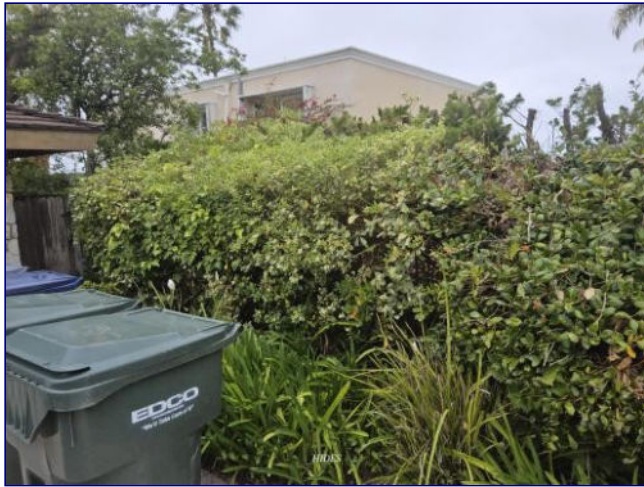
3.0 Item 1(Picture)

Large size trees and or tree trunks were planted on the property. Regular maintenance and or inspection is advised as large size trees can pose issues with various aspects of construction. The tree limbs that are in contact with the roof or hanging near roof should be trimmed. Overgrown vegetation was noted. Removal of overgrown vegetation is recommended as this can pose issues with various aspects of construction. Evidence of inadequate drainage / ponding was noted around the perimeter of the home near foundation. Regular maintenance and or inspection is advised. Due to the overgrown vegetation, many perimeter block walls were not visible for inspection. Use caution High soil level was noted at exterior walls at various perimeter locations. Regular maintenance and or inspection is advised.

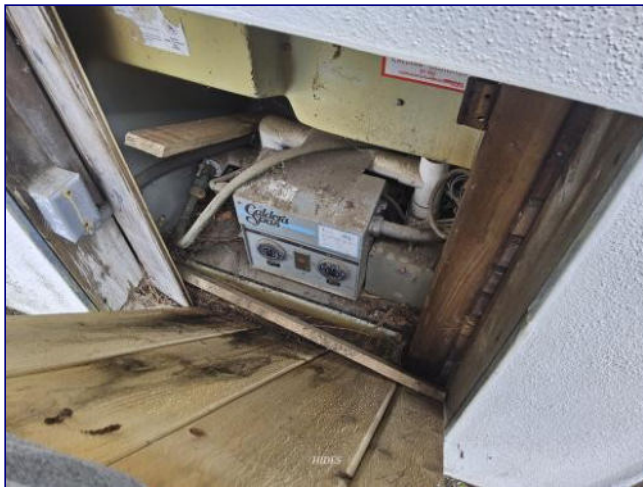
3.1 Item 1(Picture)

A portion of the raised foundation was not accessible due to the installation of indoor spa at the left side of the home. Raised foundation portion inspection is limited. The other access point inside the home (downstairs office area) to the raised foundation shows evidence of possible moisture intrusion and or penetration along with inadequate ventilation. Further evaluation, consultation, and inspection, is highly recommended by a licensed general contractor. There is an active leak to the supply lines and or waste / drain lines st upstairs hallway bathroom resulting in the extensive moisture damage, mold like substance to the ceiling below at family room. Further evaluation, consultation, and inspection, is highly recommended by a licensed plumber for the leak issues and subsequent general contractor, drywall contractor, mold abatement company, and possibly a structural engineer.

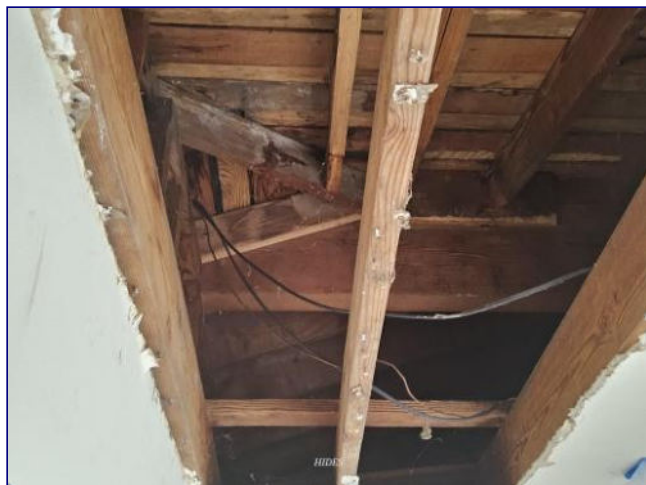
3.6 Item 1(Picture)

Moisture stains were noted in the attic area at various locations. Although stains are dry, regular maintenance and or inspection is advised. Evidence of possible rodent droppings were noted all throughout the attic area. Further evaluation is recommended by a licensed pest control company. Attic access hatch remains partially open is damaged / defective. Correction is needed. Further evaluation is recommended by a licensed drywall contractor. Asbestos type materials was installed in the attic. Further evaluation is recommended by a licensed general contractor. Poor insulation coverage was noted in the attic. Further evaluation is recommended by a licensed general contractor.

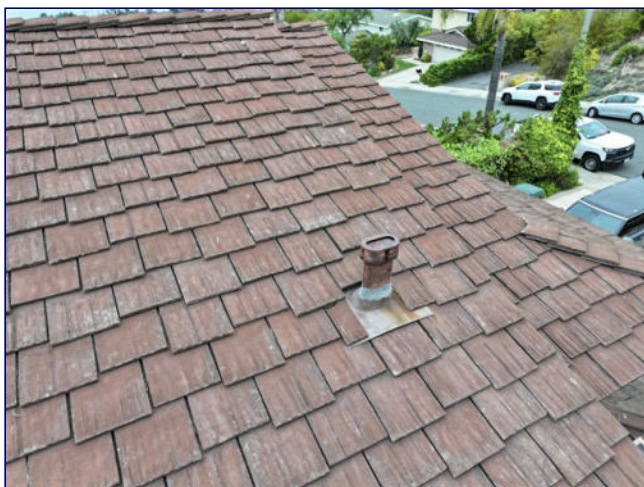
4.1 Item 1(Picture)

The roofing system is in a heavily worn / deteriorated condition, and quite simply is approaching the end of its lifespan with improper installation of flashing, rusted flashing, cracked tiles, loose tiles, dislodged tiles, and no roof underlayment noted. Further evaluation, consultation, and inspection, is highly recommended by a licensed roofer.

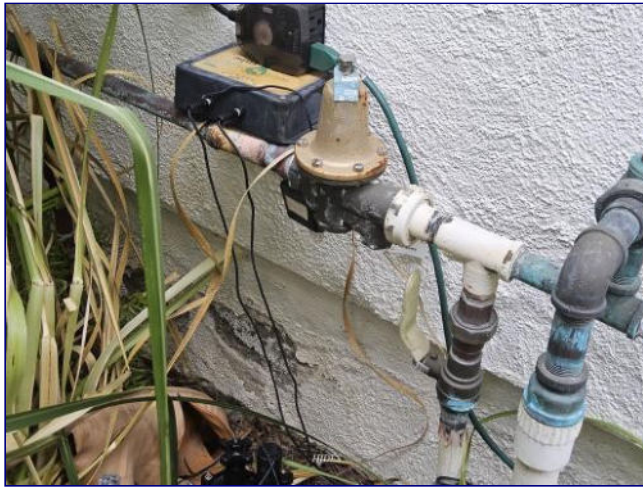
5.0 Item 1(Picture)

- Moderate corrosion was noted to the main water supply line and regulator. Further evaluation is recommended by a licensed plumber.

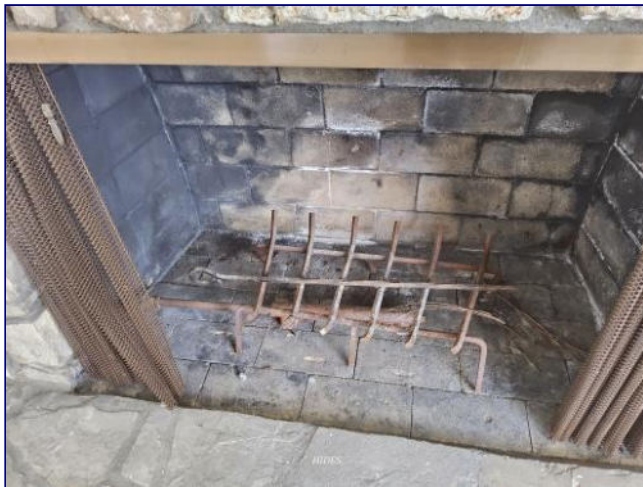
5.4 Item 1(Picture)

Gas line fireplace entry line is not sealed inside the firebox. This is a safety hazard and correction is needed. Further evaluation is recommended by a licensed general or licensed fireplace / chimney contractor.

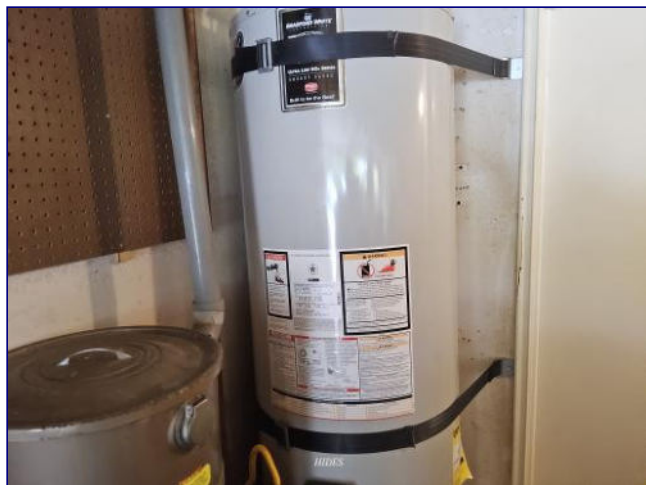
5.5 Item 1(Picture)

Please note that the supply lines have moderate major restriction of water pressure and or volume primarily when using multiple fixtures. Further evaluation, consultation, and inspection is highly recommended by a licensed plumber. Please note that the downstairs supply lines leading to the kitchen area have been capped / no water provided in this area, as told to the inspector by the client. As a result, supply lines and drain lines as well as components and systems related to the supply lines were unable to be inspected. Further evaluation, consultation, and inspection, is highly recommended by a licensed plumber. Substandard, non-professional installations and routing methods used was noted to the supply lines. Further evaluation is recommended by a licensed plumber. Improper installation of seismic straps, improper termination of TPR overflow pipe, and major corrosion to the outlet line and or connector, were all deficiencies noted to the water heater. Further evaluation, consultation, and inspection, is highly recommended by a licensed plumber. Please note that the water heater platform has a hole / opening and has been compromised and as a result, adjacent garage firewall has been compromised. This is a safety hazard and correction is needed. Further evaluation is recommended by a licensed general contractor and or licensed drywall contractor.

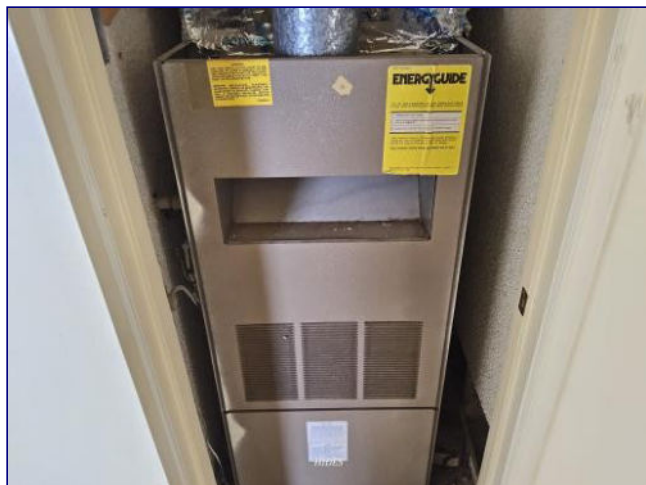
6.0 Item 1(Picture)

- 🔧 Heating system turns on and off sporadically, had detached vent at ceiling collar, vent is in contact with combustible material in the attic area, has low air volume to its distribution system (due to damaged and disconnected ducting in the attic). These deficiencies are safety hazards and correction is needed. Further evaluation, consultation, and inspection, is highly recommended by a licensed HVAC contractor.

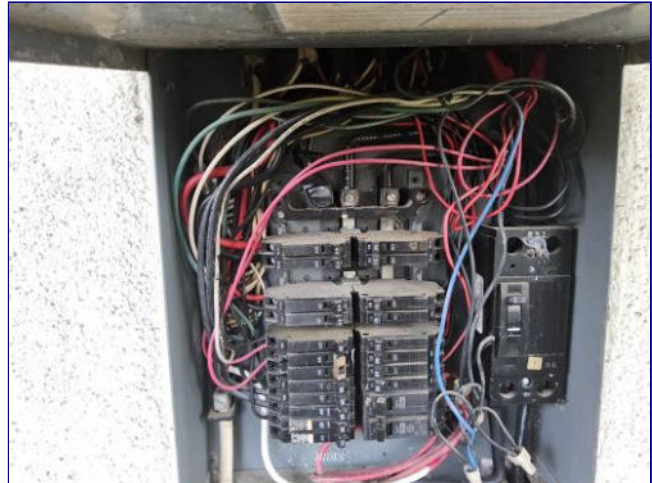
7.2 Item 2(Picture)

- 🔧 Main electrical panel has unprotected openings. Further evaluation, consultation, and inspection, is recommended by a licensed electrician. Breakers are not fully labeled for circuit designation. This is a safety hazards and correction is needed. Further evaluation, consultation, and inspection, is recommended by a licensed electrician. Improper wiring / two wires connected to a breaker was noted

to the main electrical panel. This is a safety hazard and correction is needed by a licensed electrician. The 125 amp main electrical may be undersized by today's electrical standards due to the size of the home as well as the pool installation. Further consultation is recommended by a electrician.

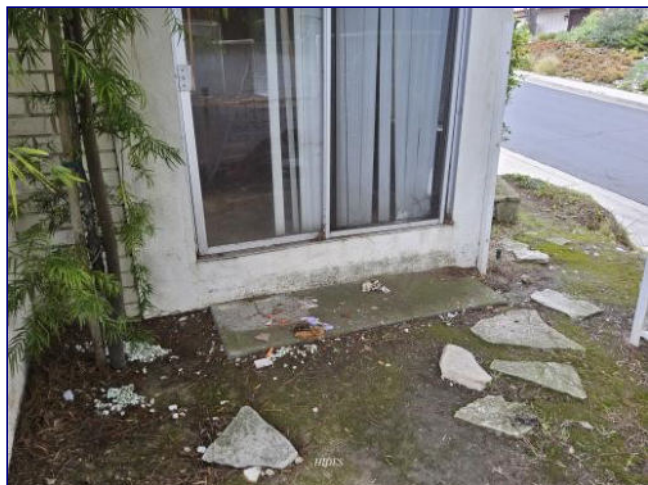
8.0 Item 1(Picture)

- Rear exterior sliding door does not have a landing. This is a safety hazard and correction is needed. Further evaluation is recommended by a licensed door contractor. All exterior sliding doors were difficult to operate, in need of adjustment / lubrication, have damaged or missing exterior sliding screen doors and do not appear to be tempered. Further evaluation, consultation, and inspection, is highly recommended by a licensed door contractor and or licensed general contractor. Please note that many interior doors had some sort of defect (missing hardware, non functional hardware, trim damage, door damage, doors not square to frame). Further evaluation, consultation, and inspection, is highly recommended by a licensed door contractor.

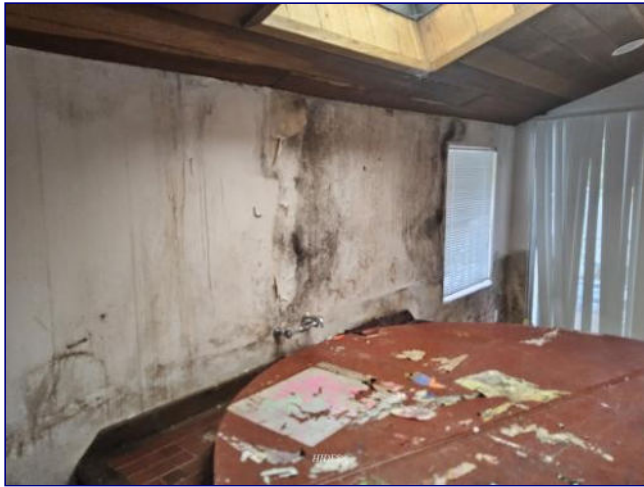
8.2 Item 1(Picture)

Due to the many areas of excessive moisture stains, excessive moisture damage, excessive mold like substance, holes, openings / exposed framing noted all throughout the property, the structural integrity of the walls and ceilings and possible slab / floors may and or have been compromised. Further evaluation, consultation, and inspection, is highly recommended by a licensed general contractor, drywall contractor, mold abatement company, and a structural engineer.

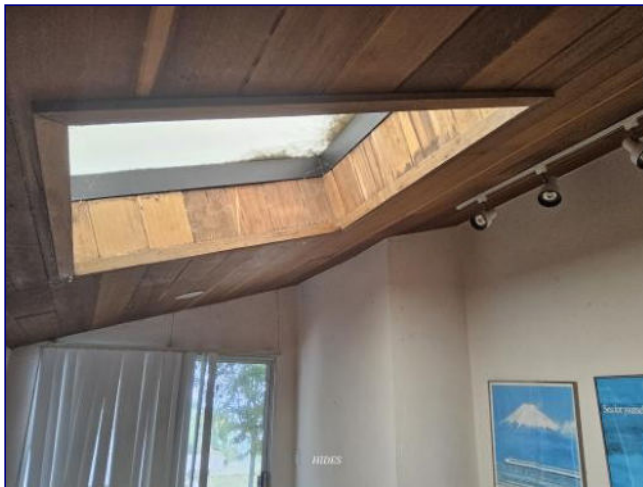
8.3 Item 1(Picture)

Due to the many areas of excessive moisture stains, excessive moisture damage, excessive mold like substance, holes, openings / exposed framing noted all throughout the property, the structural integrity of the walls and ceilings and possible slab / floors may and or have been compromised. Further evaluation, consultation, and inspection, is highly recommended by a licensed general contractor, drywall contractor, mold abatement company, and a structural engineer. There is an active leak to the supply lines and or waste / drain lines st upstairs hallway bathroom resulting in the extensive moisture damage, mold like substance to the ceiling below at family room. Further evaluation, consultation, and inspection, is highly recommended by a licensed plumber for the leak issues and subsequent general contractor, drywall contractor, mold abatement company, and possibly a structural engineer.

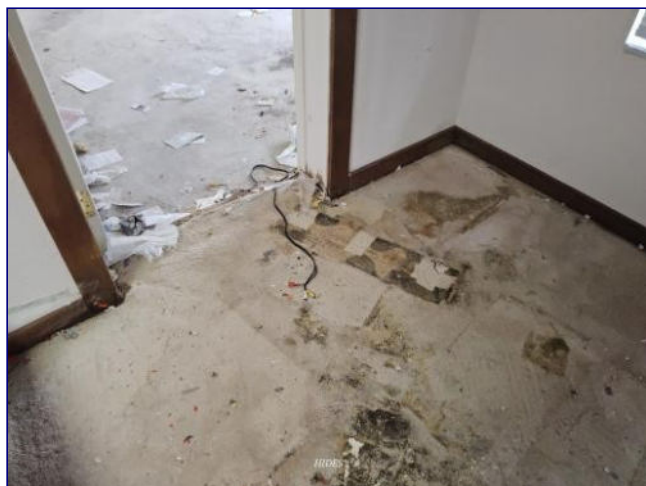
8.4 Item 1(Picture)

Due to the many areas of excessive moisture stains, excessive moisture damage, excessive mold like substance, holes, openings / exposed framing noted all throughout the property, the structural integrity of the walls and ceilings and possible slab / floors may and or have been compromised. Further evaluation, consultation, and inspection, is highly recommended by a licensed general contractor, drywall contractor, mold abatement company, and a structural engineer. There is an active leak to the supply lines and or waste / drain lines st upstairs hallway bathroom resulting in the extensive moisture damage, mold like substance to the ceiling below at family room. Further evaluation, consultation, and inspection, is highly recommended by a licensed plumber for the leak issues and subsequent general contractor, drywall contractor, mold abatement company, and possibly a structural engineer. Missing floor coverings were noted at many locations with heavy stains and damage to floor coverings. Further evaluation is highly recommended by a licensed flooring contractor.

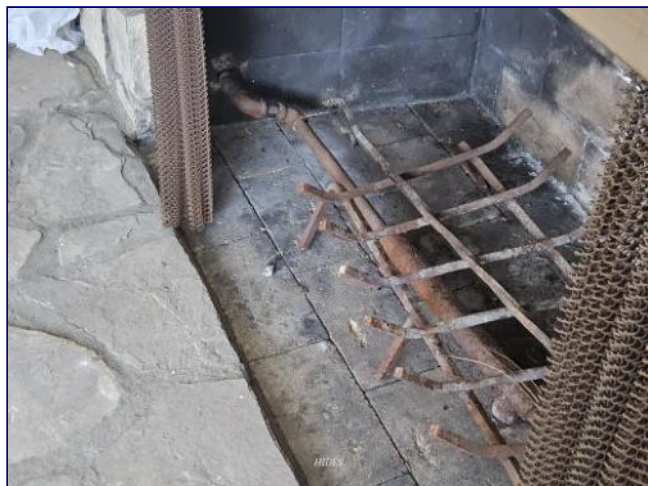
8.5 Item 1(Picture)

Gas entry line inside the fireplace is not sealed and line has excessive rust / corrosion. The rust / corrosion to the gas line inside the firebox is a direct result of moisture intrusion and or penetration of the chimney / fireplace. This is a safety hazard and correction is needed. Further evaluation is recommended by a licensed general or licensed fireplace / chimney contractor. Fireplace appears to have not been serviced or swept for some time. Further evaluation, consultation, and inspection, is highly recommended by a licensed fireplace / chimney contractor.

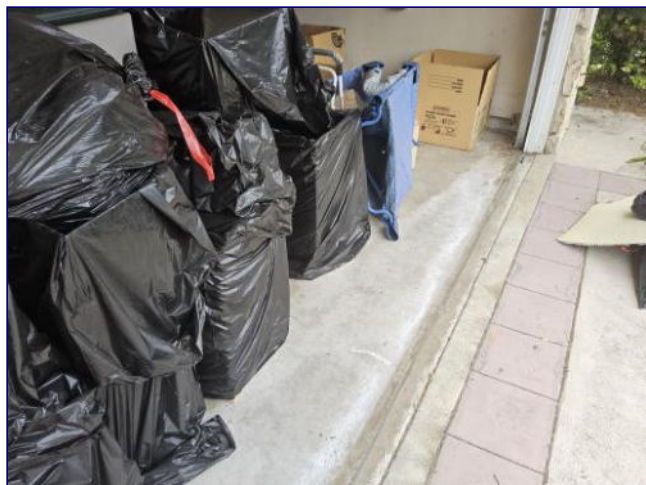
10.0 Item 1(Picture)

Moderate cracks were noted to the garage floor / slab. Regular maintenance and or inspection is advised. Evidence of moisture intrusion and or penetration was noted to the garage floor, resulting in efflorescence, was noted. Further evaluation is recommended by a licensed general contractor.

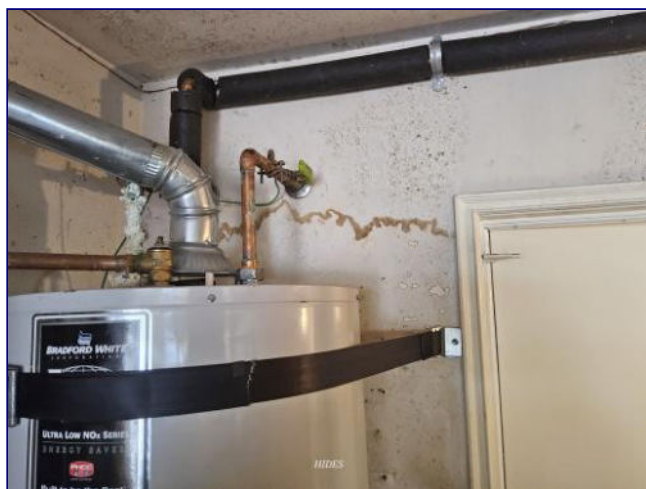
10.1 Item 1(Picture)

- 🔧 Moisture stains were noted to the garage wall(s). Although stains are dry, regular maintenance and or inspection is advised. Holes, openings were noted to to the garage firewall / firewall ceiling. This is a safety hazard and correction is needed. Further evaluation is recommended by a licensed drywall contractor. Please note that the water heater platform has a hole / opening and has been compromised and as a result, adjacent garage firewall has been compromised. This is a safety hazard and correction is needed. Further evaluation is recommended by a licensed general contractor and or licensed drywall contractor.

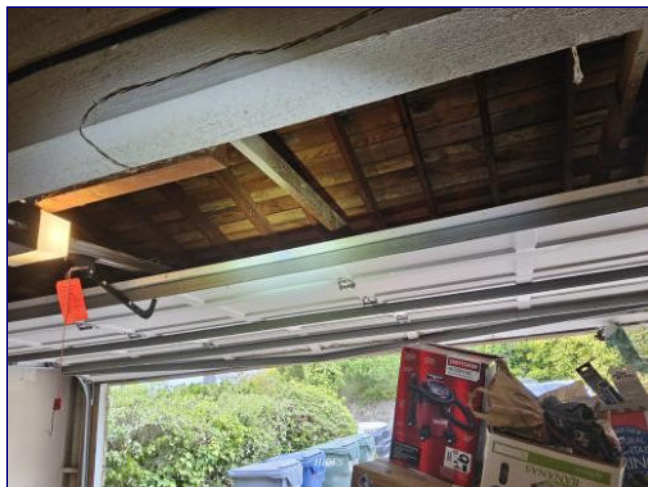
10.2 Item 1(Picture)

- 🔧 Moisture stains were noted to the garage ceiling(s). Although stains are dry, regular maintenance and or inspection is advised.

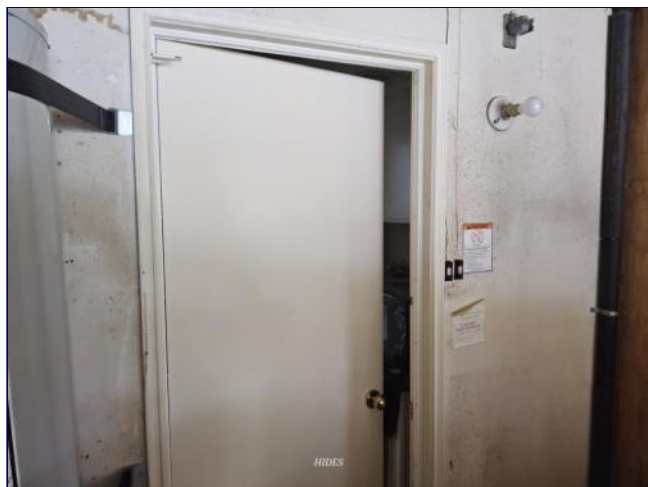
10.4 Item 1(Picture)

🔧 The garage door to living space is missing its self closing device. This is a safety hazard and correction is needed. Further evaluation is recommended by a licensed door contractor.

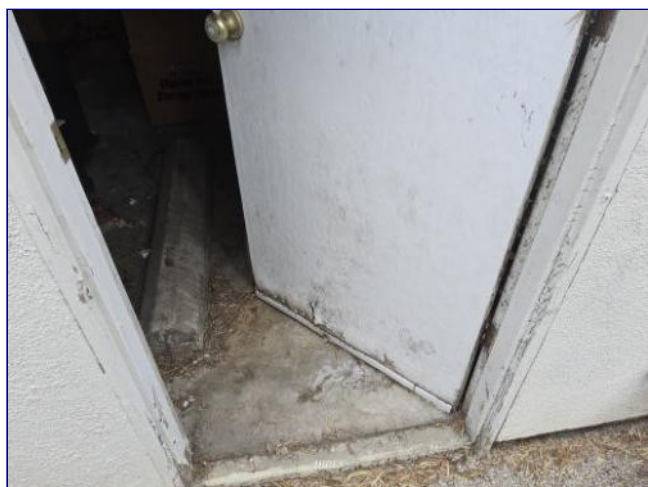
10.5 Item 1(Picture)

🔧 Garage exterior door is moisture damaged. Correction is needed. Further evaluation is recommended by a licensed door contractor and or licensed pest control / termite company.

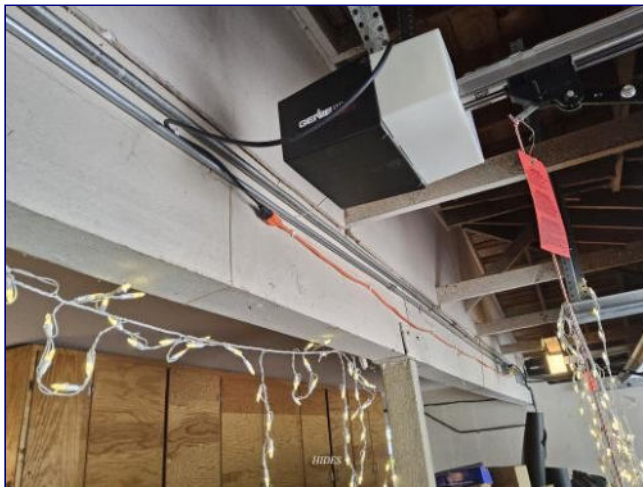
10.8 Item 1(Picture)

- 🔧 Improper light fixture wiring noted in the garage. This is as a safety hazard and correction is needed. Further evaluation is recommended by a licensed electrician. Missing outlet and or switch covert plates were noted in the garage. This is a safety hazard and correction is needed. Further evaluation is recommended by a licensed electrician. Unprotected / exposed wiring was noted in the garage. This is a safety hazard and correction is needed. Further evaluation is recommended by a licensed electrician.

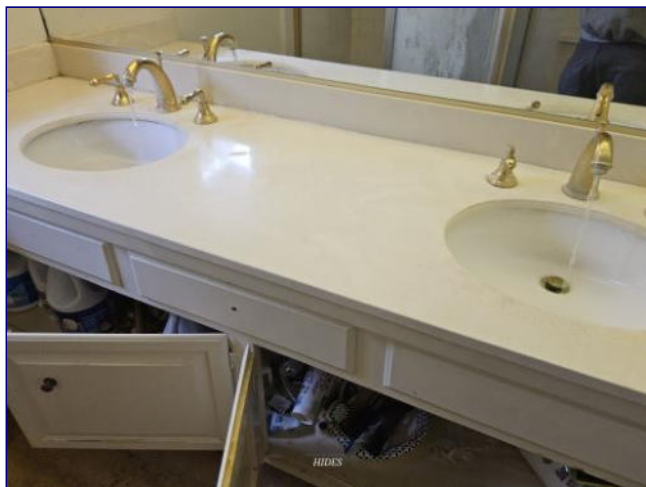
12.1.A Item 1(Picture)

- 🔧 Extremely low water pressure was observed to master bathroom sinks and shower. Correction is needed. Further evaluation is recommended by a licensed plumber.

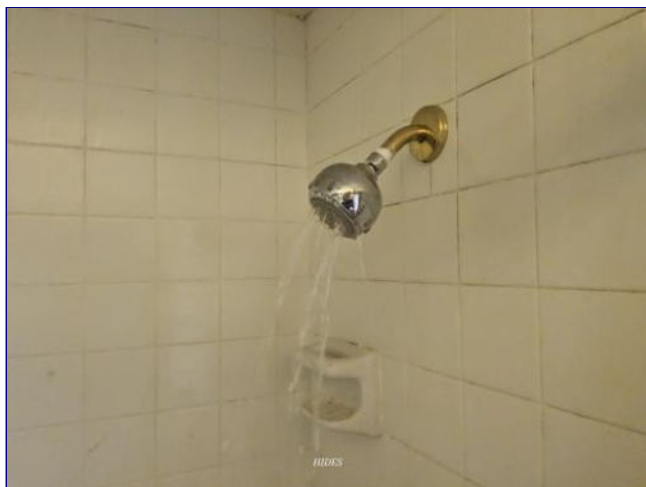
12.4.A Item 1(Picture)

- Extremely low water pressure was observed to master bathroom sinks and shower. Correction is needed. Further evaluation is recommended by a licensed plumber.

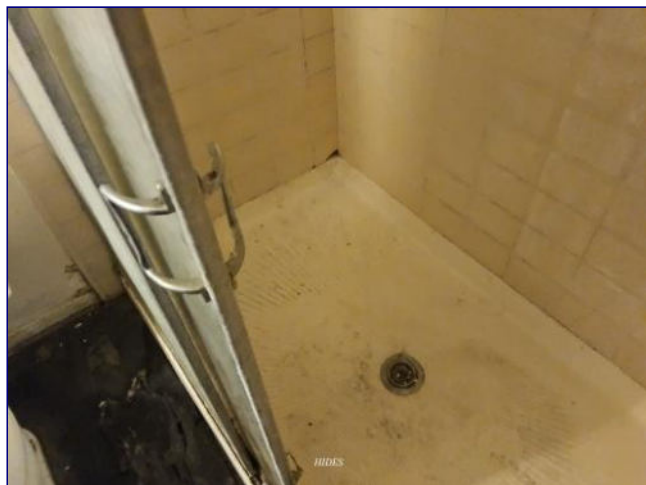
12.4.C Item 1(Picture)

- Heavy deterioration, mildew, and possible mold like substance was observed at downstairs bathroom, shower enclosure. Further evaluation is highly recommended by a licensed mold abatement company. Downstairs bathroom shower head leaks. Correction is recommended by a licensed plumber.

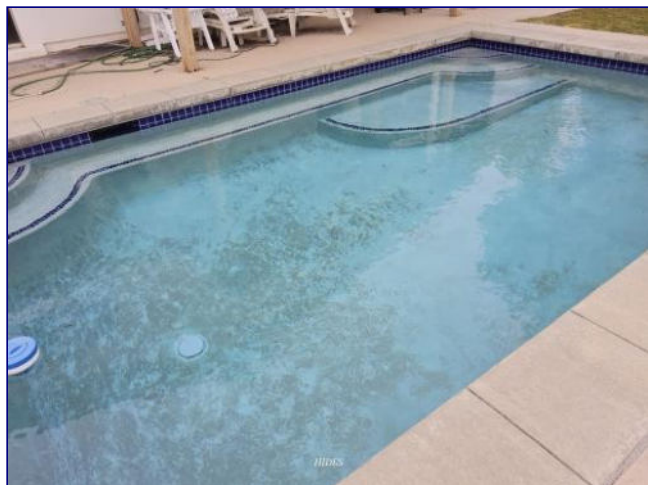
13.0 Item 1(Picture)

- 🔧 Surface deterioration was noted to the pool. Regular maintenance and or inspection is advised. Please note that the edge of the pool towards the rear of the property is quite close to an embankment and may have inadequate support of adjacent soil and embankment. This may also and or is impacting the adjacent deck as well. Further evaluation, consultation, and inspection, is highly recommended by a licensed geo-technical contractor as to soil in this area.

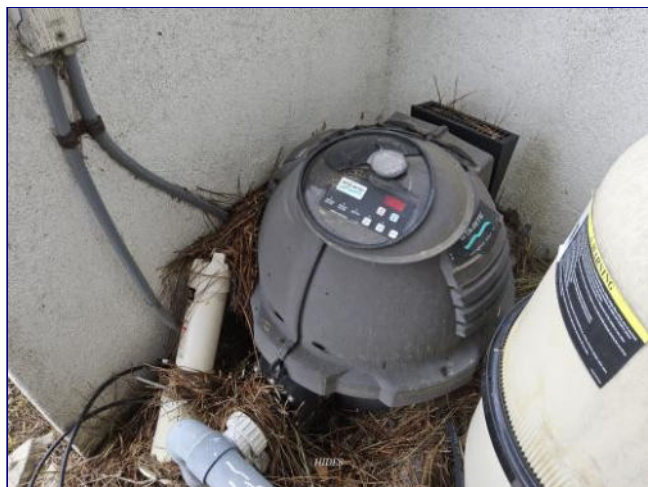
13.1 Item 1(Picture)

🔧 Pool heater was not responsive / currently functional. Further evaluation is recommended by a licensed pool contractor.

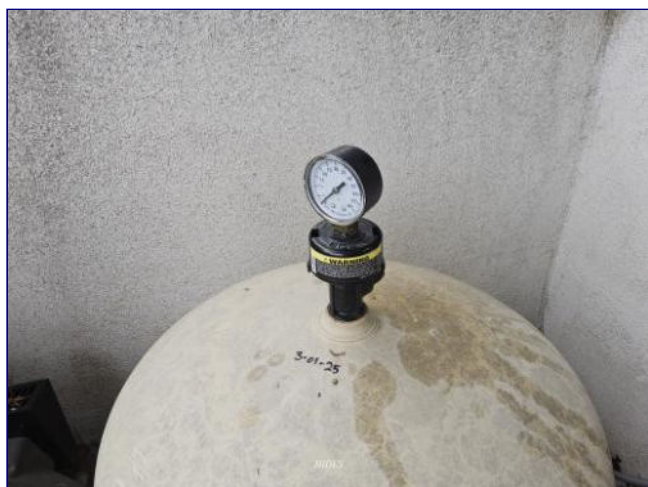
13.2 Item 1(Picture)

🔧 Diatomaceous pool filter pressure gage shows no reading when in operation. Correction is needed. Further evaluation is recommended by a licensed pool contractor.

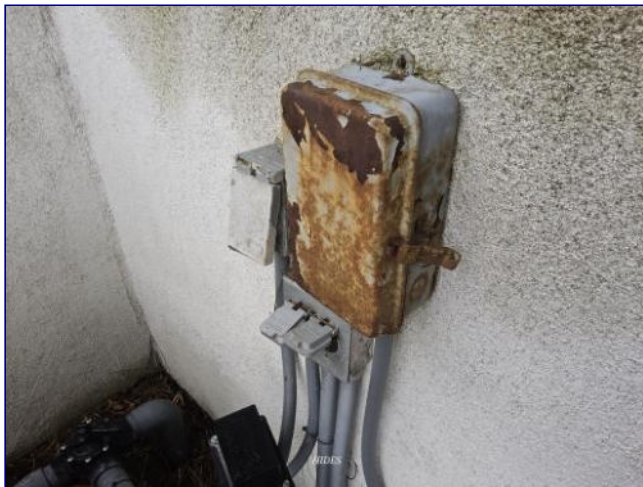
13.5 Item 1(Picture)

- 🔧 Pool equipment GFCI is missing its exterior rated cover plates as well as various other outlets throughout the property. This is a safety hazard and correction is needed. Further evaluation is recommended by a licensed electrician. Pool time box is heavily corroded and replacement is needed. Further evaluation is recommended by a licensed pool contractor and or licensed electrician. Electronic pool cover is not functional, as mentioned to the inspector from client. Further evaluation is recommended by a licensed pool contractor as to its functionality and issues.

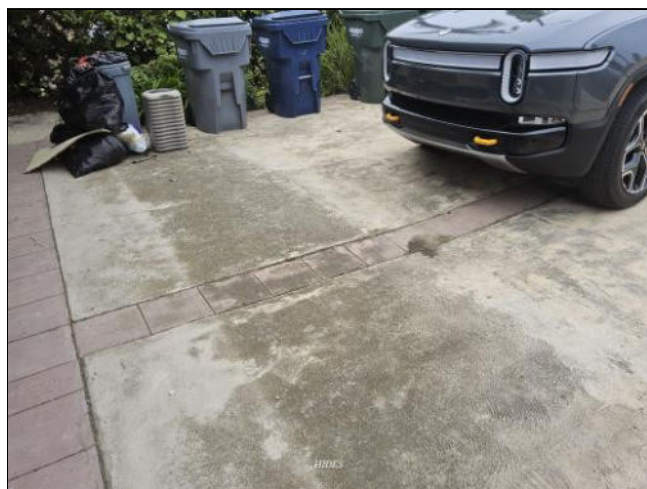
1.0 Item 1(Picture)

🔧 **1.0** Moderate to large size cracks were noted to the driveway. Regular maintenance and or inspection is advised. Driveway show evidence of inadequate drainage and or ponding. Regular maintenance and or inspection is advised. Driveway appears to be sloped towards the home / garage. Further evaluation is recommended by a licensed general contractor.

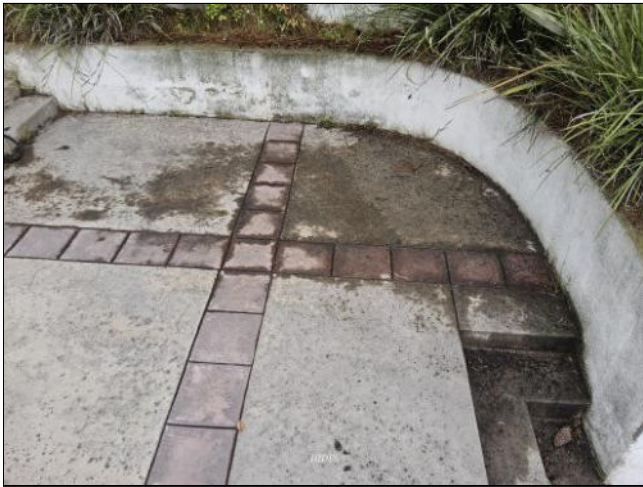
1.1 Item 1(Picture)

**1.1** Common to moderate cracks as well as evidence of ponding and or inadequate drainage was noted to the sidewalks. Regular maintenance and or inspection is advised. Uneven areas were noted to the sidewalks. Regular maintenance and or inspection is advised. Trip hazards were noted to the sidewalks. This is a safety hazard and correction is needed. Further evaluation is recommended by a licensed general contractor.

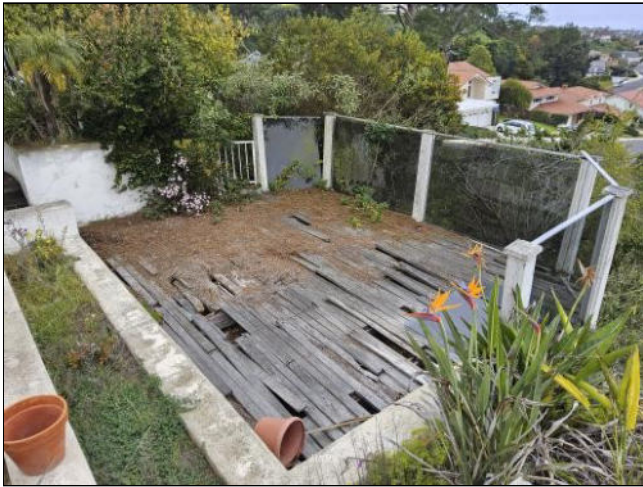
1.7 Item 1(Picture)

sound and has damaged glass railings. Considering the location of the deck, its damage, and the lack of structural integrity, this is an extreme safety hazard. Deck should not be walked on. Immediate attention is needed. Further evaluation, consultation, and inspection, is highly recommended by a licensed general contractor, structural engineer, and possibly a geo-technical contractor.

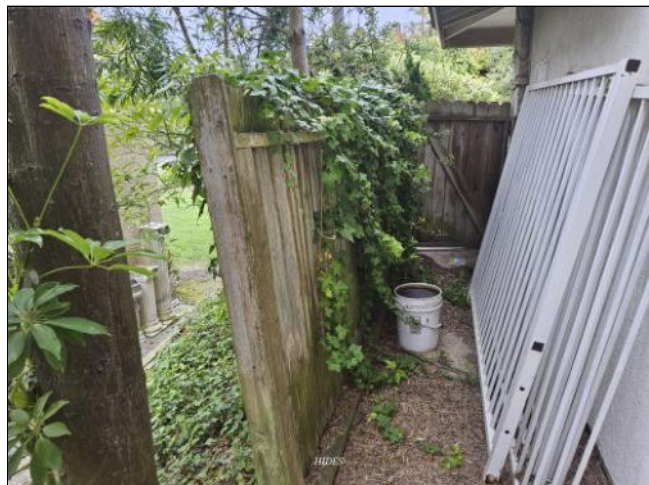
1.8 Item 1(Picture)

**1.8** Perimeter fencing and gates are worn, rusted, deteriorated. Also, gates leading to the pool area are in need of self closing device and or device is not functional. The self closing device issue is a safety hazard. Further evaluation, consultation, and inspection, is highly recommended by a licensed gate installation company / contractor.

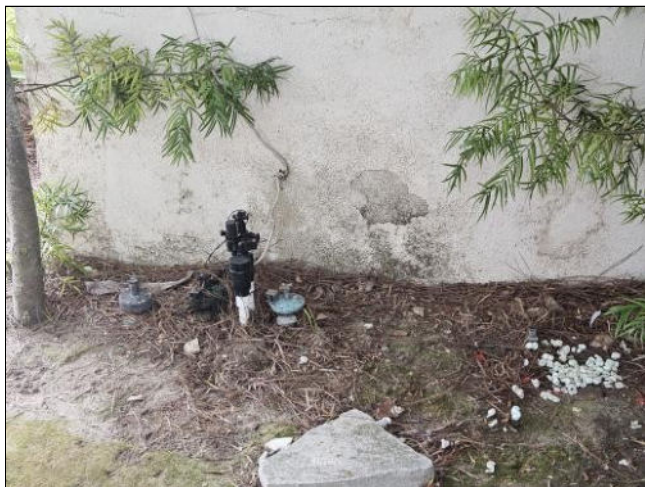
2.1 Item 1(Picture)

**2.1** Moderate cracks were noted to the exterior walls. Regular maintenance and or inspection is advised. Large size cracks were noted to the exterior walls. Regular maintenance and or inspection is advised. Stucco to the exterior walls is worn / deteriorated. Regular maintenance and or inspection is advised. Moisture stains were noted to the exterior walls. Although stains are dry, regular maintenance and or inspection is advised. Holes, openings, and or exposed framing was noted to the exterior walls. These holes, openings, and or exposed framing areas must be sealed / patched to help eliminate any moisture intrusion and or penetration. Further evaluation is recommended by a licensed general contractor.

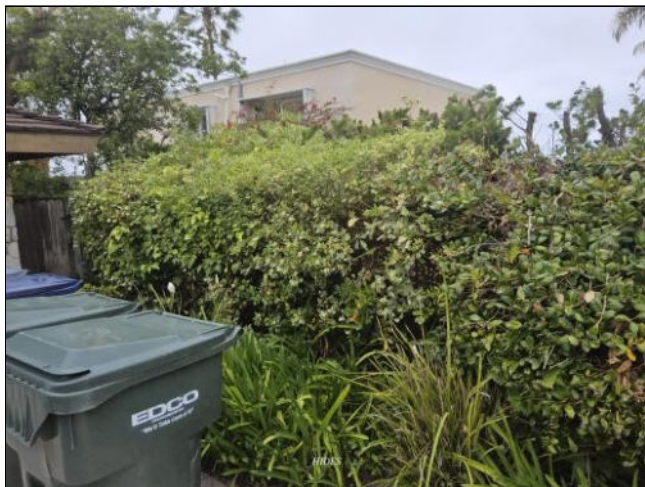
3.0 Item 1(Picture)

**3.0** Large size trees and or tree trunks were planted on the property. Regular maintenance and or inspection is advised as large size trees can pose issues with various aspects of construction. The tree limbs that are in contact with the roof or hanging near roof should be trimmed. Overgrown vegetation was noted. Removal of overgrown vegetation is recommended as this can pose issues with various aspects of construction. Evidence of inadequate drainage / ponding was noted around the perimeter of the home near foundation. Regular maintenance and or inspection is advised. Due to the overgrown vegetation, many perimeter block walls were not visible for inspection. Use caution High soil level was noted at exterior walls at various perimeter locations. Regular maintenance and or inspection is advised.

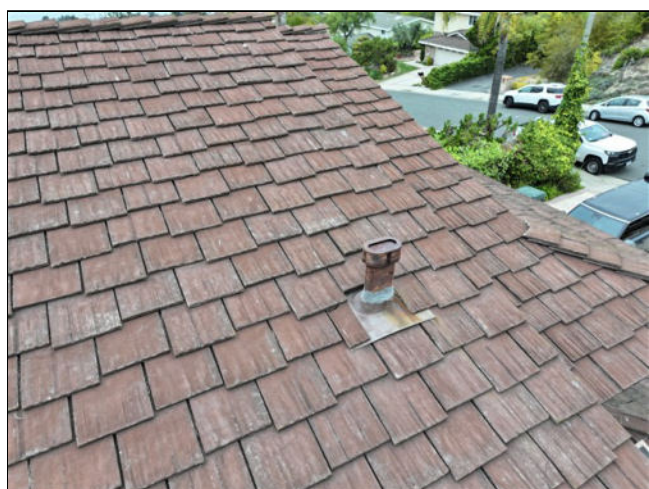
4.1 Item 1(Picture)

**4.1** The roofing system is in a heavily worn / deteriorated condition, and quite simply is approaching the end of its lifespan with improper installation of flashing, rusted flashing, cracked tiles, loose tiles, dislodged tiles, and no roof underlayment noted. Further evaluation, consultation, and inspection, is highly recommended by a licensed roofer.

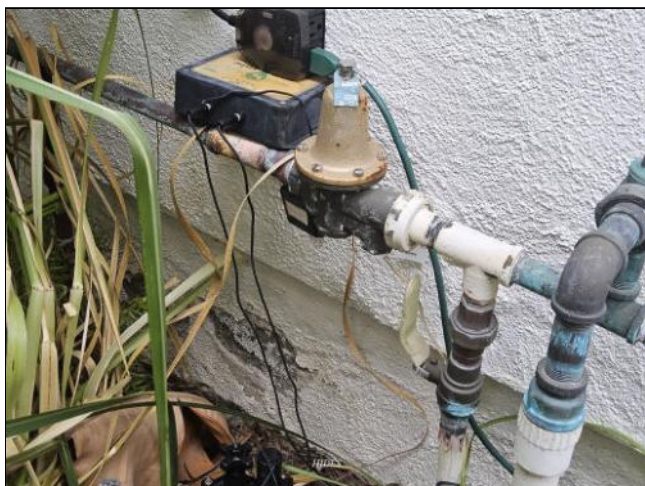
5.0 Item 1(Picture)

**5.0** Moderate corrosion was noted to the main water supply line and regulator. Further evaluation is recommended by a licensed plumber.

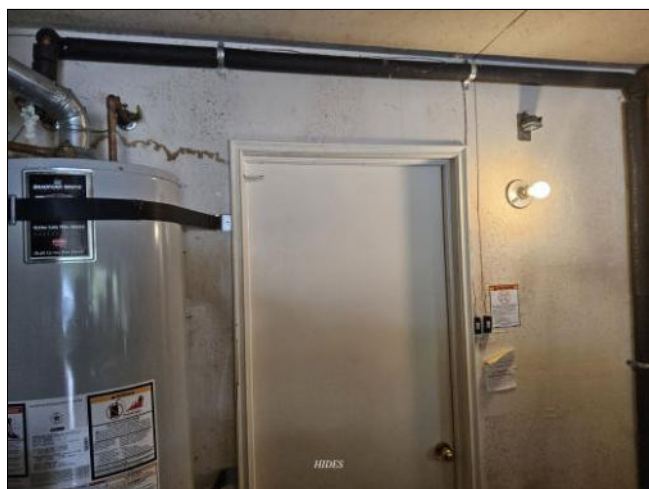
5.1 Item 1(Picture)

**5.1** Please note that the supply lines have moderate major restriction of water pressure and or volume primarily when using multiple fixtures. Further evaluation, consultation, and inspection is highly recommended by a licensed plumber. Please note that the downstairs supply lines leading to the kitchen area and laundry room area have been capped / no water provided in this area, as told to the inspector by the client. As a result, supply lines and drain lines as well as components and systems related to the supply lines were unable to be inspected. Further evaluation, consultation, and inspection, is highly recommended by a licensed plumber. Substandard, non-professional installations and routing methods used was noted to the supply lines. Further evaluation is recommended by a licensed plumber. There is an active leak to the supply lines and or waste / drain lines st upstairs hallway bathroom resulting in the extensive moisture damage, mold like substance to the ceiling below at family room. Further evaluation, consultation, and inspection, is highly recommended by a licensed plumber for the leak issues and subsequent general contractor, drywall contractor, mold abatement company, and possibly a structural engineer.

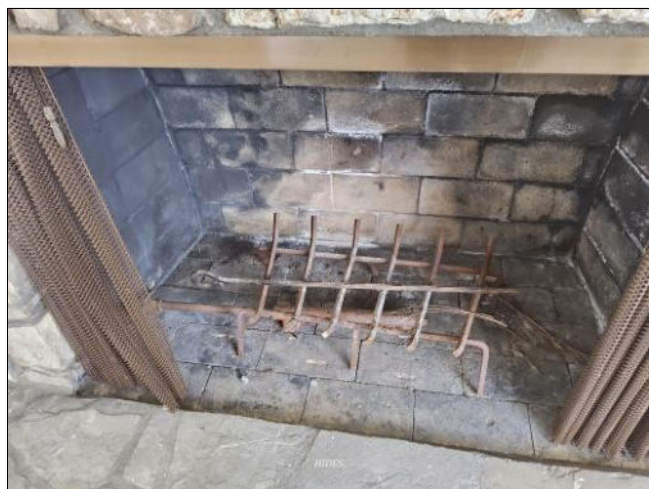
5.4 Item 1(Picture)

**5.4** Gas line fireplace entry line is not sealed inside the firebox. This is a safety hazard and correction is needed. Further evaluation is recommended by a licensed general or licensed fireplace / chimney contractor.

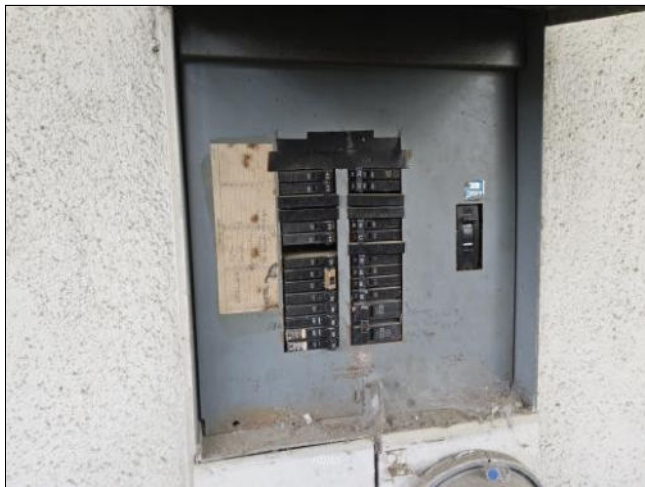
7.2 Item 1(Picture)

**7.2** Main electrical panel has unprotected openings. Further evaluation, consultation, and inspection, is recommended by a licensed electrician. Breakers are not fully labeled for circuit designation. This is a safety hazards and correction is needed. Further evaluation, consultation, and inspection, is recommended by a licensed electrician. Improper wiring / two wires connected to a breaker was noted to the main electrical panel. This is a safety hazard and correction is needed by a licensed electrician. The 125 amp main electrical may be undersized by today's electrical standards due to the size of the home as well as the pool installation. Further consultation is recommended by a electrician.

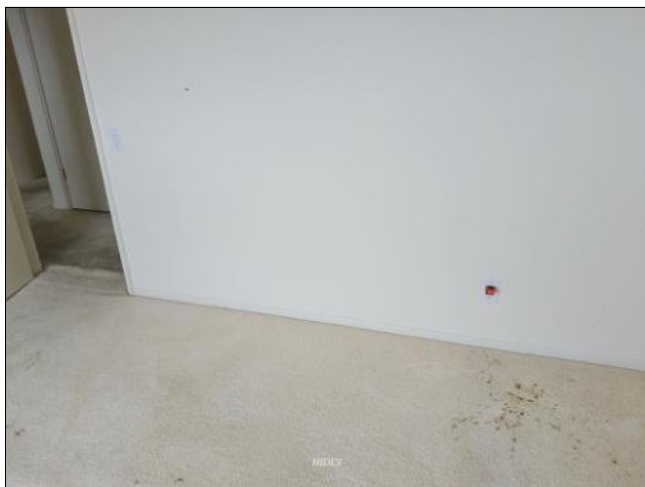
7.3 Item 1(Picture)

**7.3** Wall switch powers / controls both the upper and lower receptacles at all bedrooms. Switch should on power / control lower receptacle. This is a wiring deficiency and correction is needed. Further evaluation is recommended by a licensed electrician. Improper wiring / splicing / extension cord use as permanent wiring, were all electrical deficiencies noted in the kitchen inside cabinetry. This is a safety hazard and correction is needed. Further evaluation is recommended by a licensed electrician.
