### *Inspection Report*

Address: 2649 Vine St Paso Robles, CA 93446

2/11/23

Inspector: Keith Vreeken, MCI, FCI  
P.O. Box 415 Templeton, CA 93465 O: 805.462.1978 C: 805.440.5050

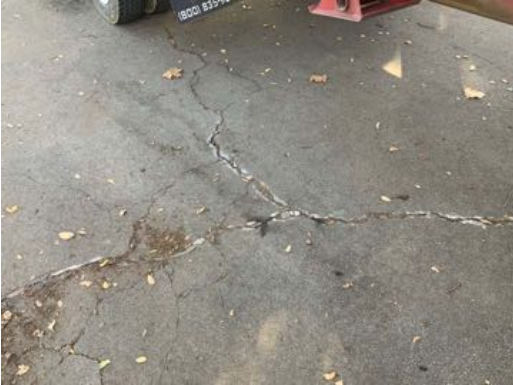
**FI** 19: Some typical, common and moderate cracks with some damaged concrete found in areas of the driveway.

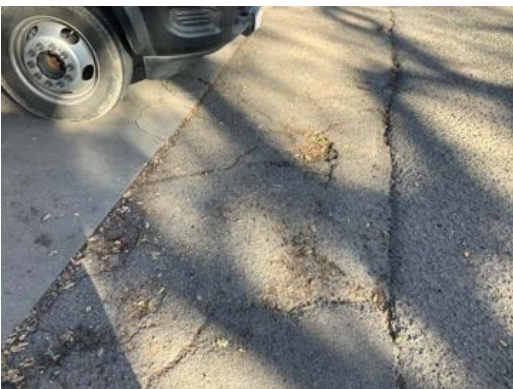
**MR** **FI** 23: Eroded or damaged asphalt found in some areas of the driveway. Maintenance or repairs are recommended.

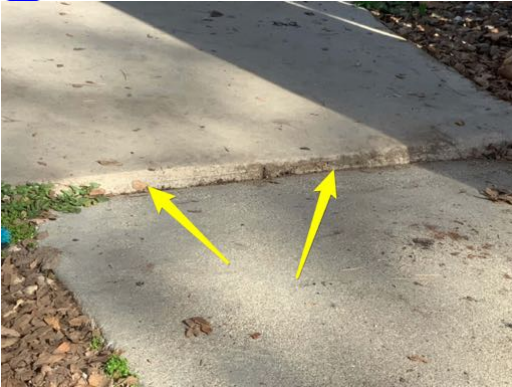
Example

**SU 27:** Areas of the walkways are uneven with potential trip hazards.

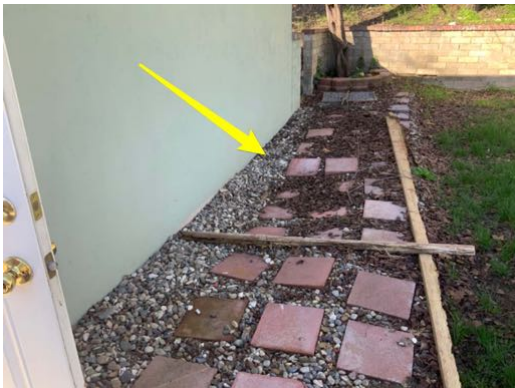
Example at the garage

**MR 41:** Soil level found high at areas of the exterior. Soil should be a minimum of 6 inches from the top of the garage and house concrete stem wall to the exterior dirt, rock, mulch or wood chips.

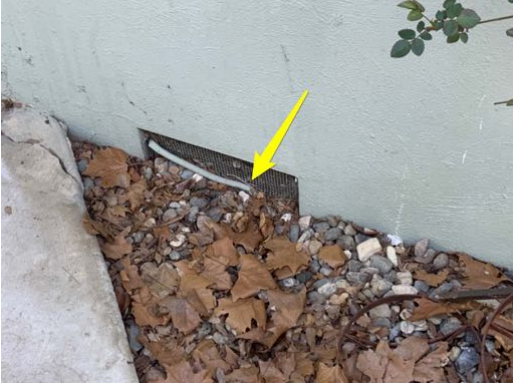
Example

**MR 44:** Areas of the surrounding soil areas found higher or above the crawlspace ventilation opening. This can allow water to flow unrestricted into the crawlspace. Upgrades recommended.

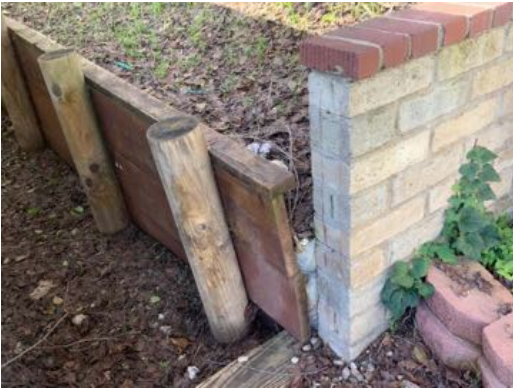
**E&C 47:** Some moisture damage, deterioration, and/or leaning of the wood retaining walls. *Be aware that wood retaining walls have a limited lifespan and will warrant eventual replacement. Monitor all wood walls and upgrade or repair as needed.*

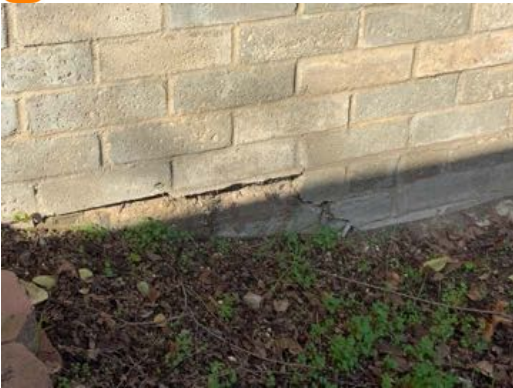
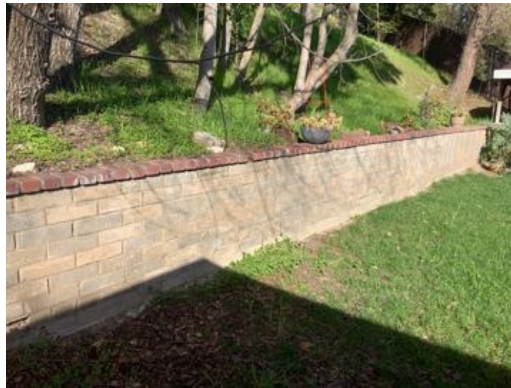
**FI 48:** Some Moderate cracks and leaning noted at the backyard masonry retaining wall.

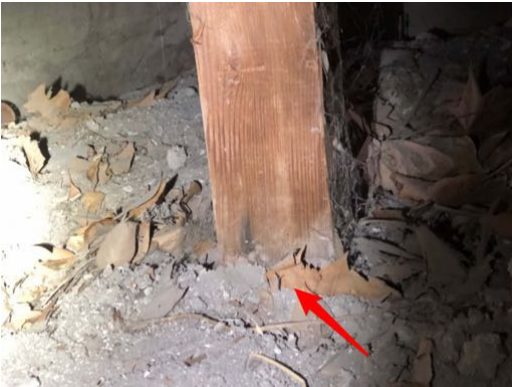
**MR 57:** Earth-to-wood contact found in areas of the crawlspace. Upgrades recommended. Refer to termite report for locations.

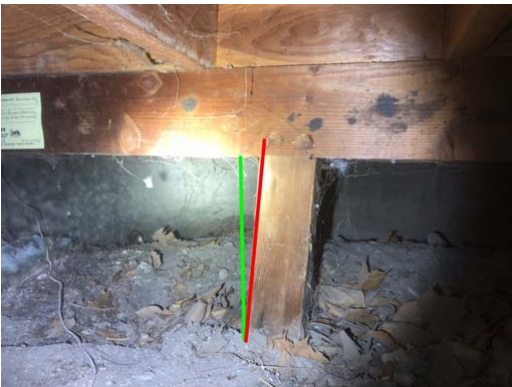
Example

**E&C SU 58:** Many of the posts under the home at the foundation system found to be leaning with one post that had fallen over near the crawlspace opening. Recommend further review of all piers, posts and girder connections with Upgrades and Repairs by qualified contractor.

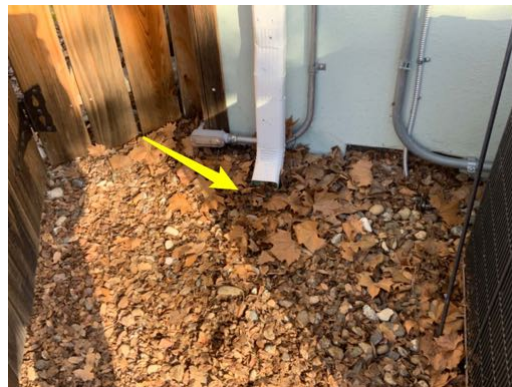
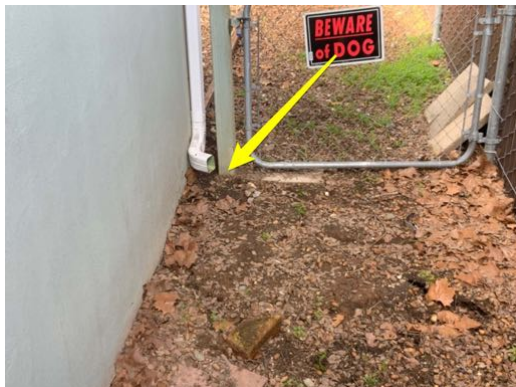
**MR 68:** Recommend splash blocks and diverting the rain gutter downspouts at the bottom to assist in proper flow of roof water away from the house and to help prevent soil erosion where not installed.

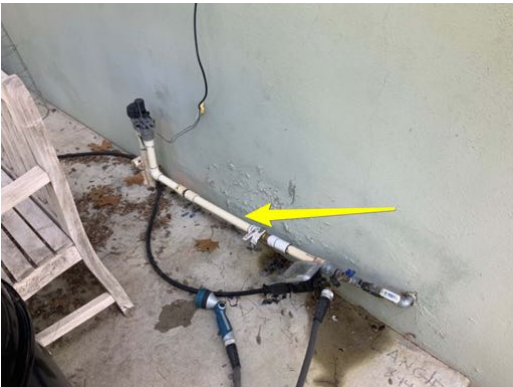
Example

**DS 77: Disclosure:** *The Plastic PVC pipe used above ground for faucet or supply piping is fragile, not UV rated, and can break easily. Upgrades are recommended to help prevent future damage or water leakage.*

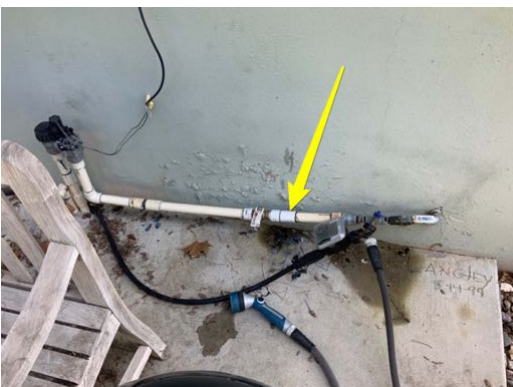
Example

**MR 78:** Exposed plumbing pipes subject to freezing are not insulated well or have deteriorated insulation in areas on the EXTERIOR.

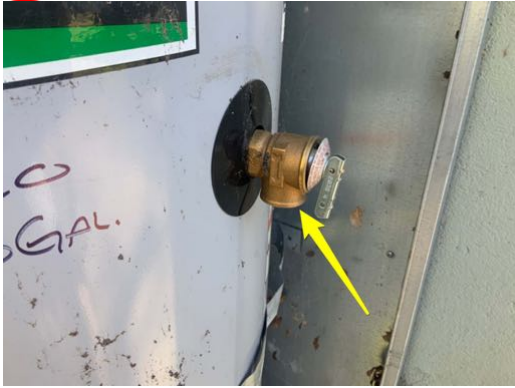
**SC 88:** Water heater TPR (temperature pressure relief) pipe is missing / not installed.

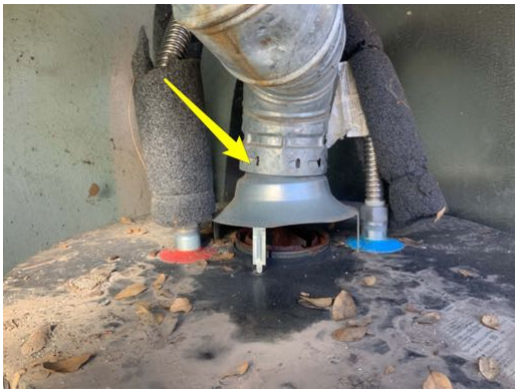
**SC 89:** Water heater vent connector pipe (single wall) is not properly fastened with the required 3-fasteners at the draft hood per standards.

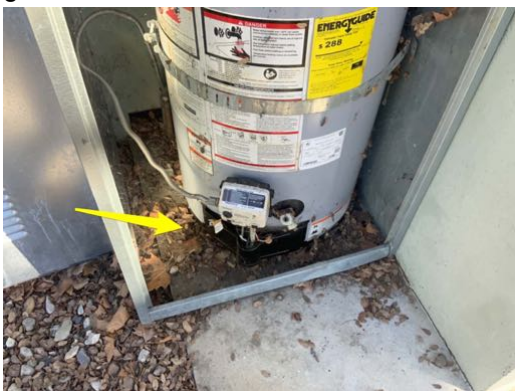
**SU 90:** Water heater should be a minimum of 3 1/2 inches to 4 inches above the surrounding grade to help prevent rust and corrosion at the bottom of the water heater. Recommend lifting water heater above surrounding grade.

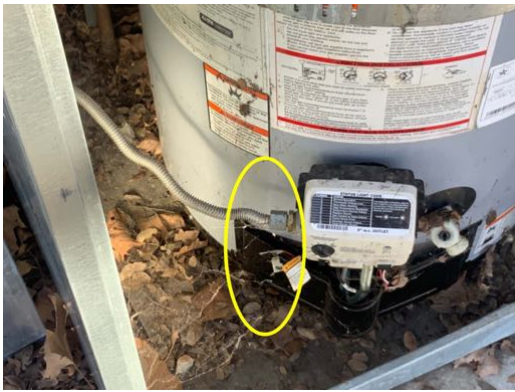
**E&C 91:** Recommend the installation of the missing sediment trap / drip leg at the WATER HEATER gas piping at flex connection by a certified or licensed plumbing professional familiar with minimum requirements.

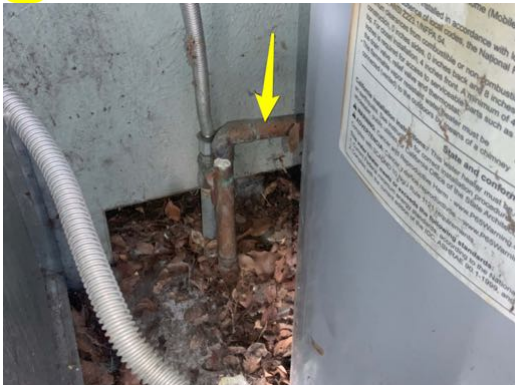
Example

**MR 92:** Recommend insulation on all HOT and COLD water supply pipes at the water heater.

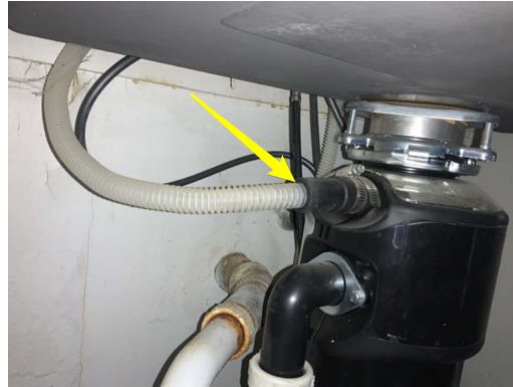
**SU 97:** Recommend an Air Gap Device at the dishwasher drain.

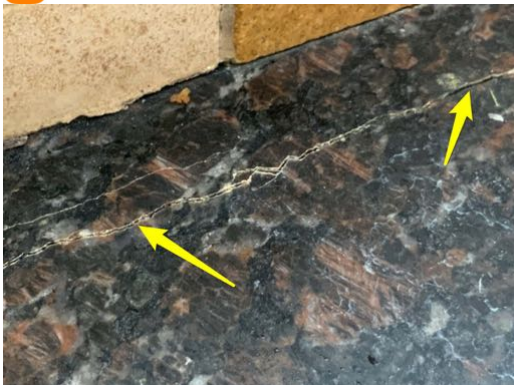
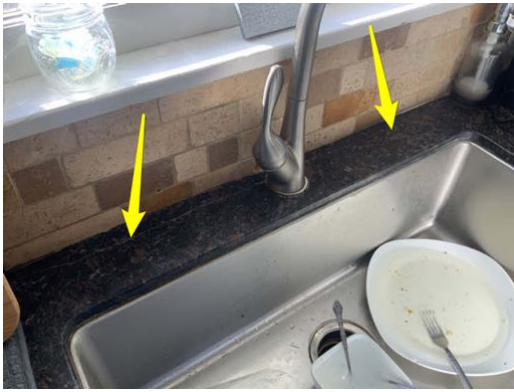
**FI 102: Disclosure:** Some cracks noted at the kitchen counter: Ex. Behind the kitchen sink faucet.

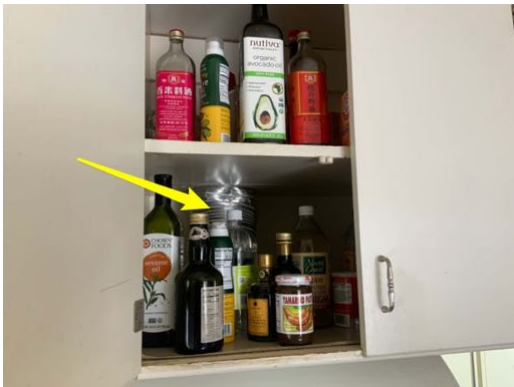
**SC 107:** Improper installation and use of a non-fire rated corrugated flexible pipe through kitchen cabinet above the cook top for the cook top exhaust vent pipe, (ridged metal is required for fire safety). Contact a qualified professional to correct as needed.

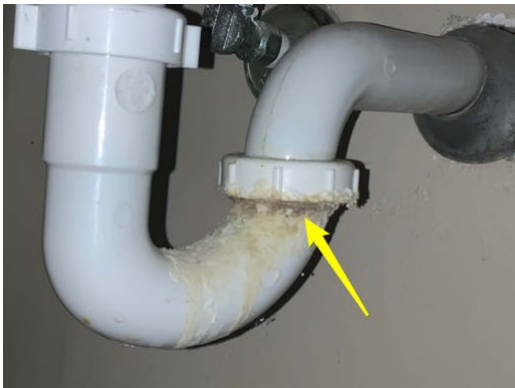
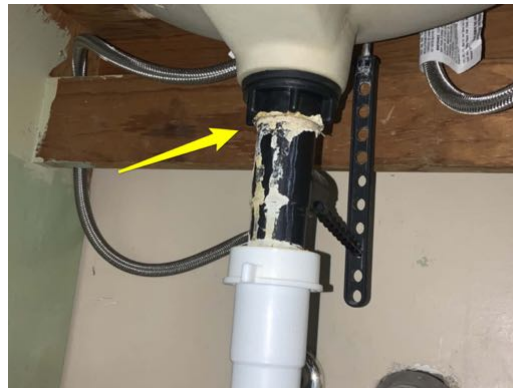
**E&C 123:** Some corrosion found at waste pipe connections under the bathroom sink / evidence of past leaking:  
HALLWAY BATHROOM

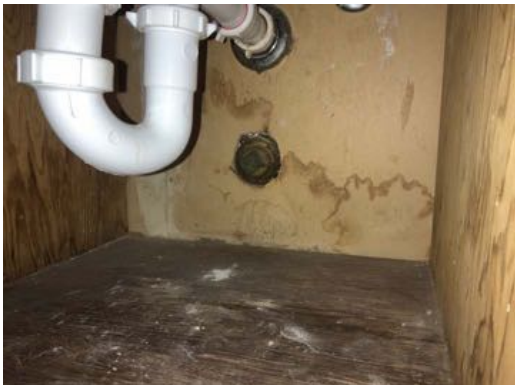
**FI 124:** Some dry moisture stains and / or damage noted in the cabinetry below the sink in the: PRIMARY BEDROOM BATHROOM

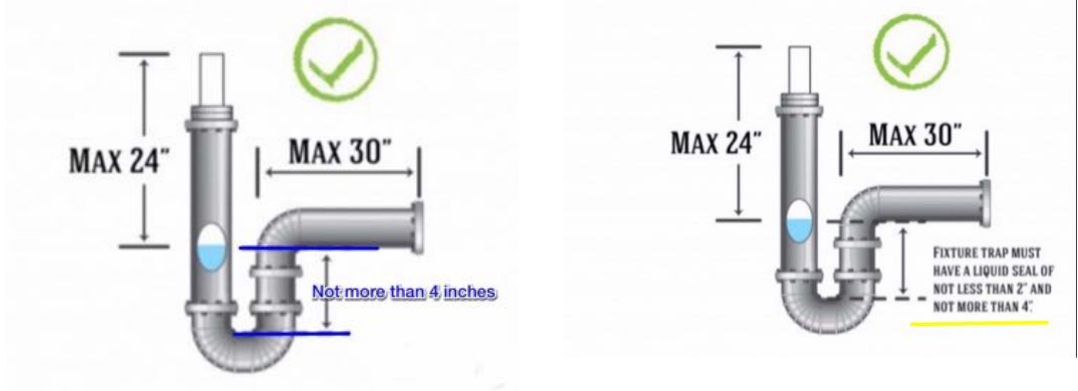
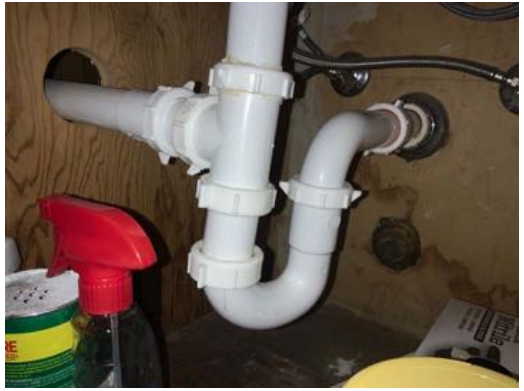
**E&C 125:** Improper drain piping under the PRIMARY BEDROOM BATHROOM bathroom sink. P-trap installed backwards. The maximum height between the top of the P-trap and the bottom of the trap arm cannot exceed 4 inches

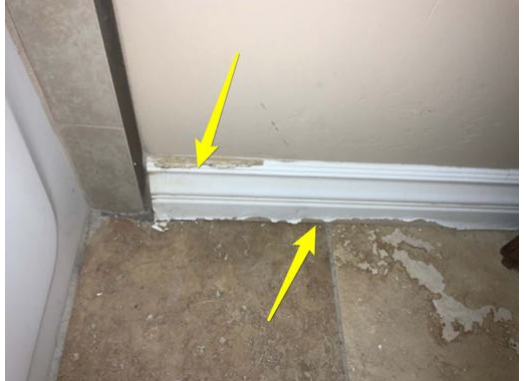
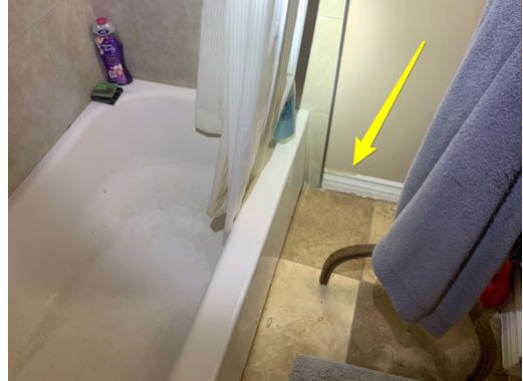
**FI 129:** Moisture stains and damage to wall, baseboards and/or floor outside tub: HALLWAY BATHROOM

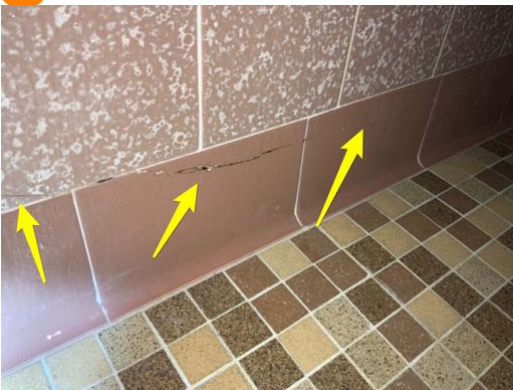
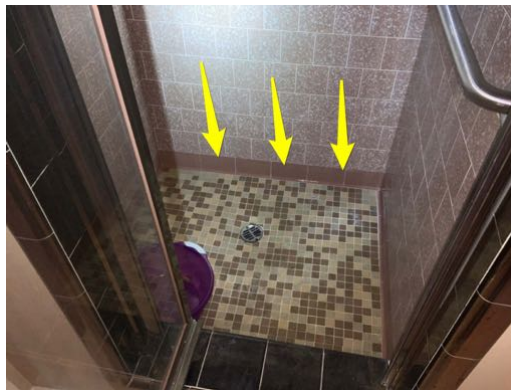
Example

**FI 134:** Some Cracked tiles found in areas of the PRIMARY BEDROOM BATHROOM shower enclosure.

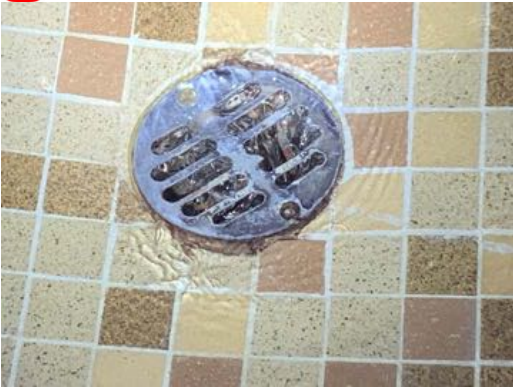
**SC 135:** Damaged shower floor, drain, cover, found in the PRIMARY BEDROOM BATHROOM SHOWER

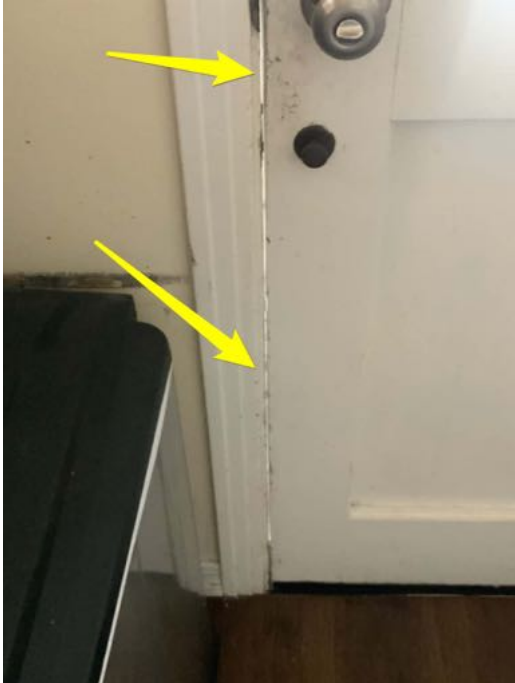
Example

**MR 139:** Visible daylight noted around some of the exterior doors. Adjustment and/or repair of the weather stripping is recommended to help prevent water and critter intrusion.

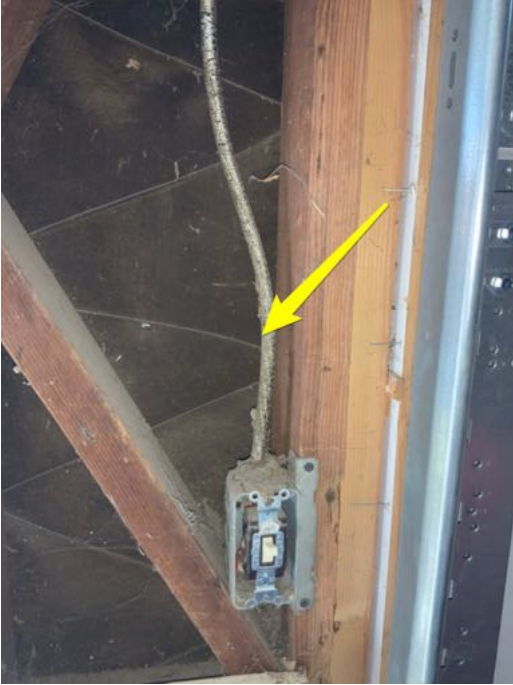
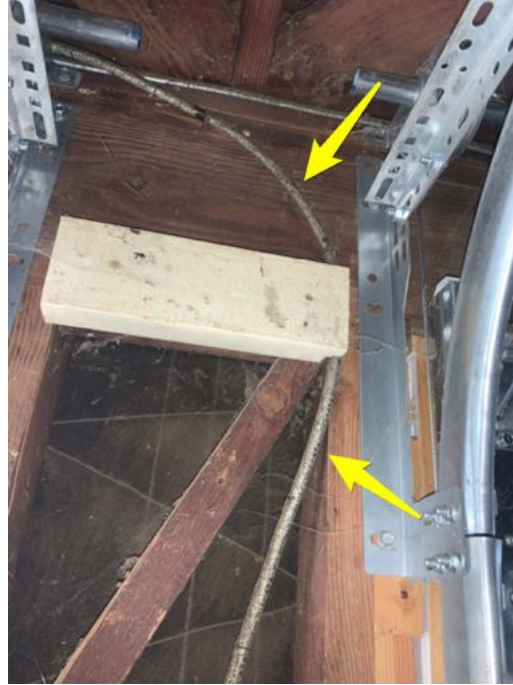
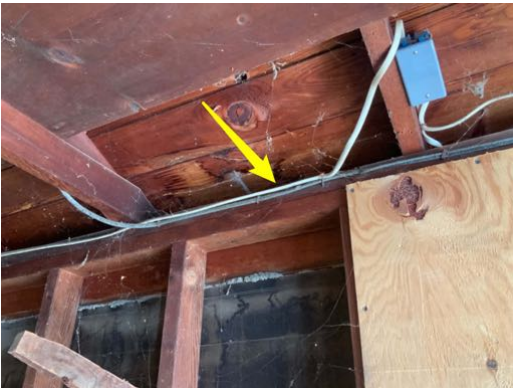
**SC 177:** Improper and unsafe electrical wiring, missing, electrical, cover plates and outlets, or switches, reverse polarity, some ungrounded, three prong outlets, etc., at some electrical outlets and exposed electrical wiring, "Romex" improperly installed subject to physical damage, not in a conduit or raceway per standards: GARAGE.

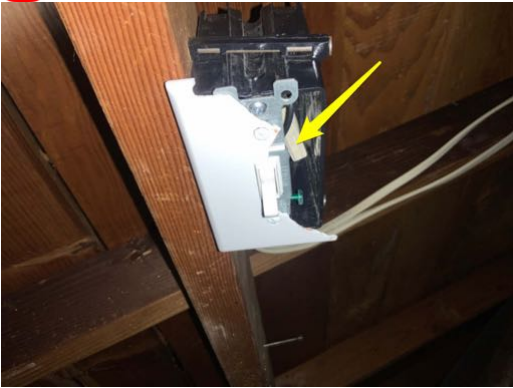
Example. Attic light switch.

**SC 179:** Damaged electrical cover plates that switches and outlets: At a few throughout the house and attic.

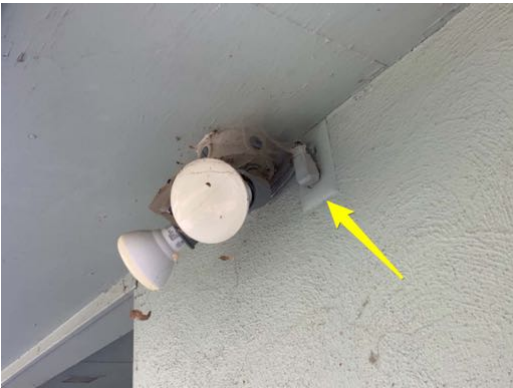
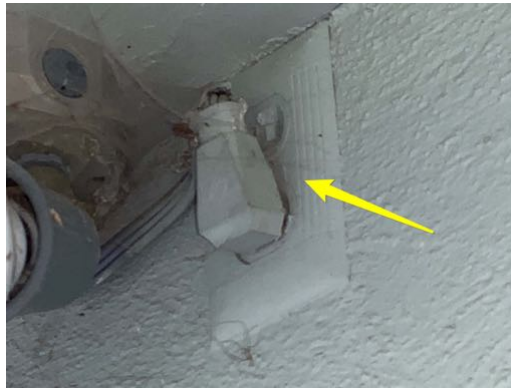
**SC 180:** Exterior electrical outlet found without a proper weather tight box or cover: Example. At the added exterior light fixture on the back of the house.

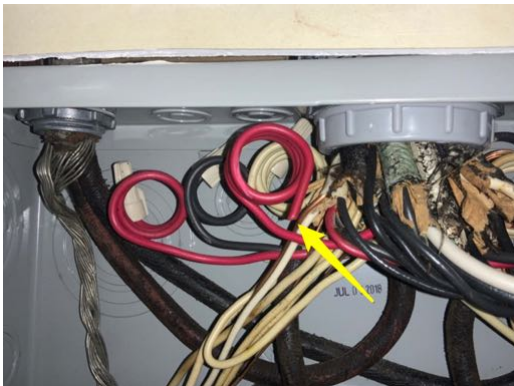
Example

**SC 187:** A couple of unused wires in the ELECTRICAL SUB PANEL found missing proper wire nuts. Repairs are recommended for safety to help prevent a short or shock. Contact a qualified professional.

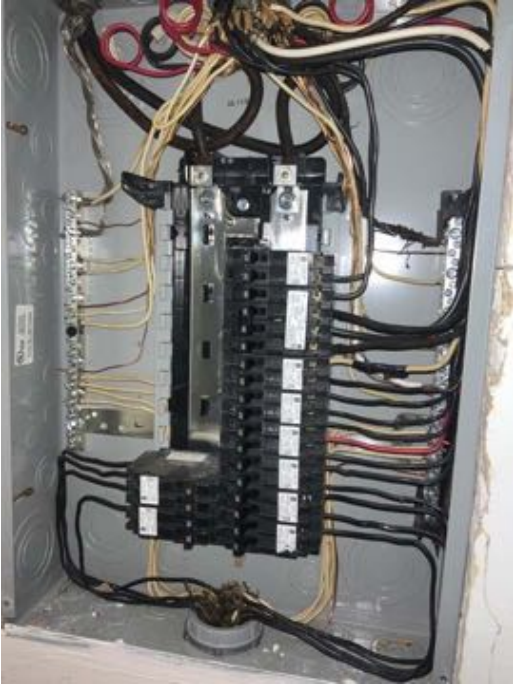
**SU 188:** Electrical system and wiring appears to be older and ungrounded at many circuits throughout the home.

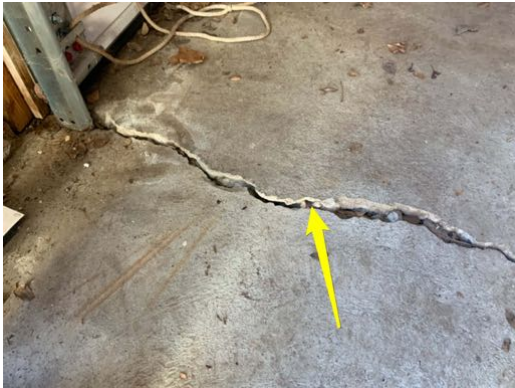
Example

**FI DS 191:** Some common and moderate cracks with visible displacement and/or settlement found in the garage concrete floor and/or foundation system. The concrete floor is raised, settled and/or uneven. Client should contact a qualified engineer to evaluate the cause, current condition and potential future issues.

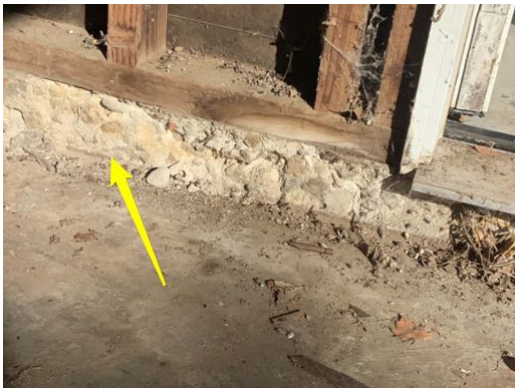
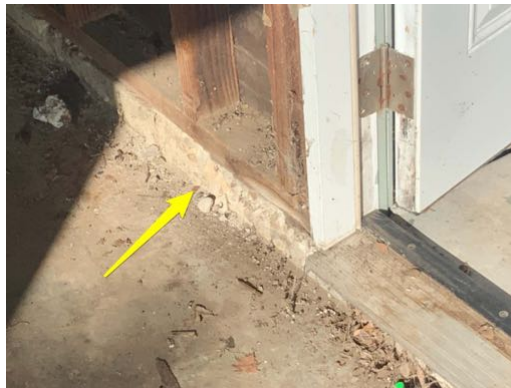
Example

**DS 195:** Some deterioration / spalling of the concrete perimeter stem wall at the foundation noted. This appears typical of the age. However, upgrades are recommended to help prevent additional deterioration of the concrete. Contact a licensed concrete foundation specialist to evaluate and make recommendations.

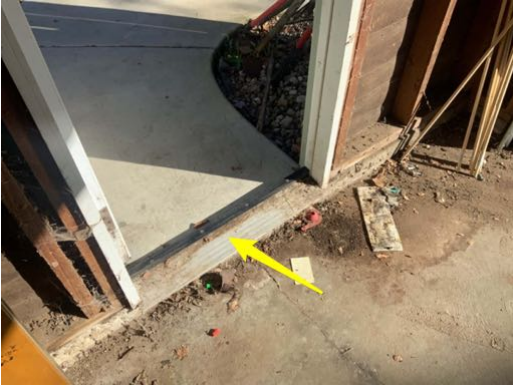
**MR 197:** Loose and/or Unsupported threshold found at the GARAGE PEDESTRIAN DOOR.

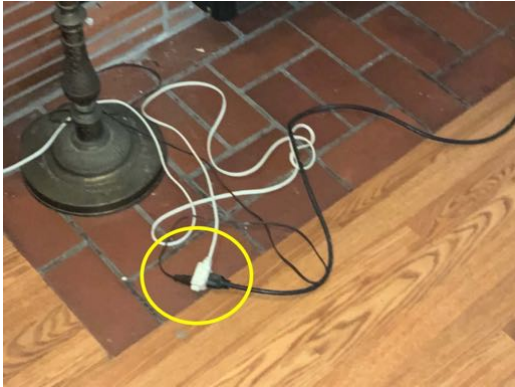
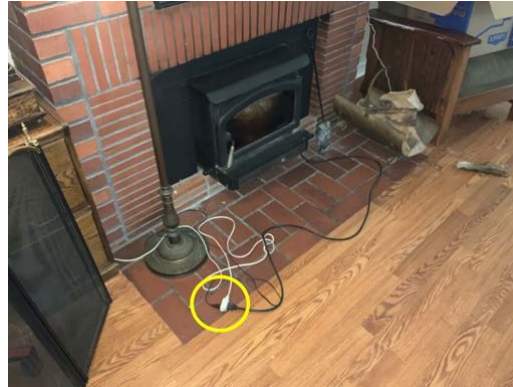
**SU 208:** Improper use of an ungrounded extension cord with the ground lug snapped off of the fireplace fan appliance cord. This is considered a safety hazard and warrants correction. Contact a licensed electrician.
