# Inspection Report

**Jeff Tse**  
**3960 S. Higuera #176**  
**San Luis Obispo, CA 93401**

Report Date: 10/6/2025

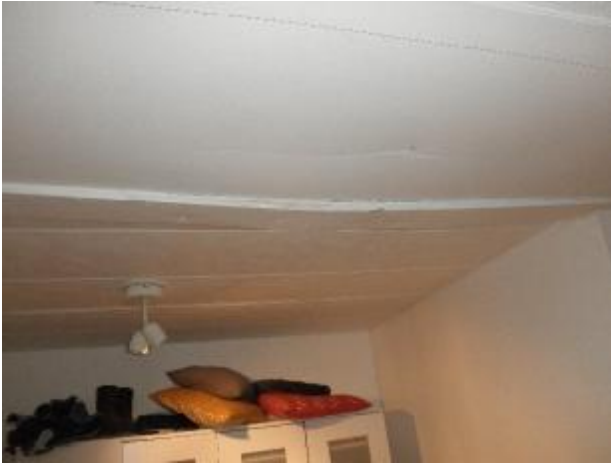
1.) The roof is original with the applied coating worn away. This has resulted in rust damage to the metal roofing in numerous locations. The waste vent pipes do not extend far enough and the furnace/water heater exhaust flues have patching around them. The sealant at the perimeter of the roof is deteriorated and there is a large patch due to a past leak above the SW bedroom. This leak has caused the interior ceiling to partially collapse.

Ceiling sloped due to leak in the master bedroom.

**Special Note:** Based on the observations above, it is recommended to have the entire roofing system further evaluated by a qualified and licensed Roofing Contractor to determine the full extent of repairs needed and the associated costs of these repairs prior to close of escrow.

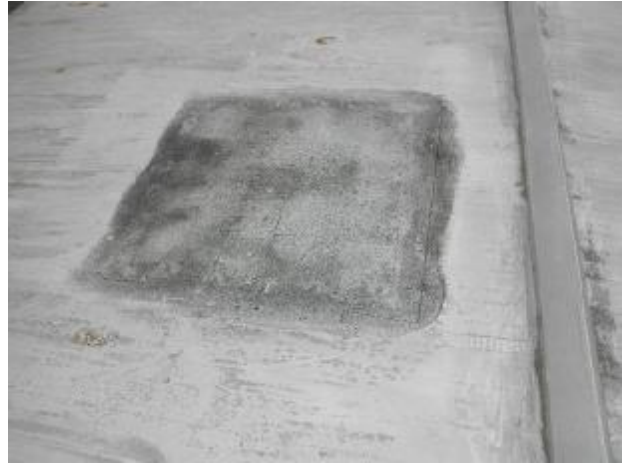
Large patch on the roof above the master bedroom.

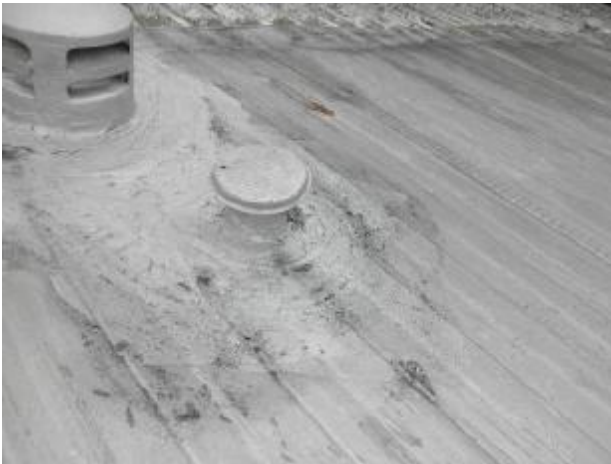
Waste vent pipes do not extend past the roof line.

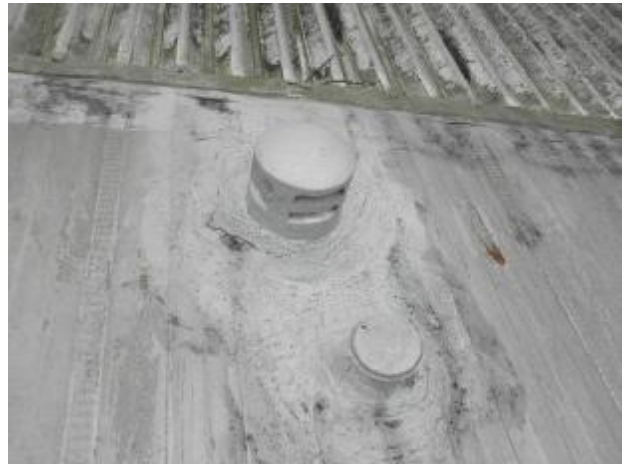
Sealant around the furnace exhaust flue.

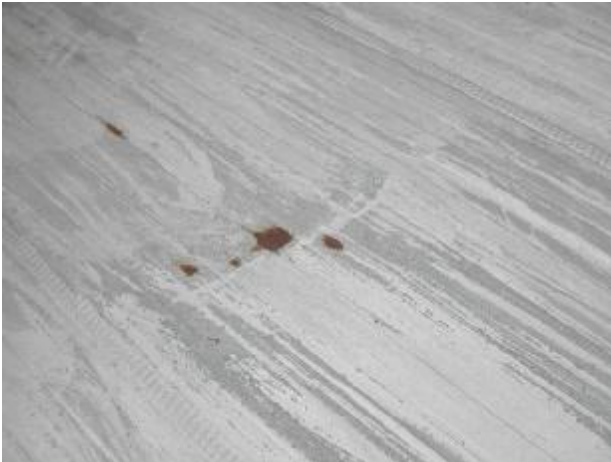
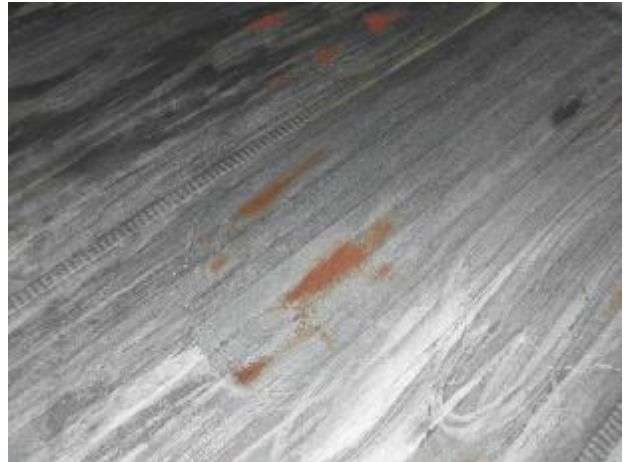
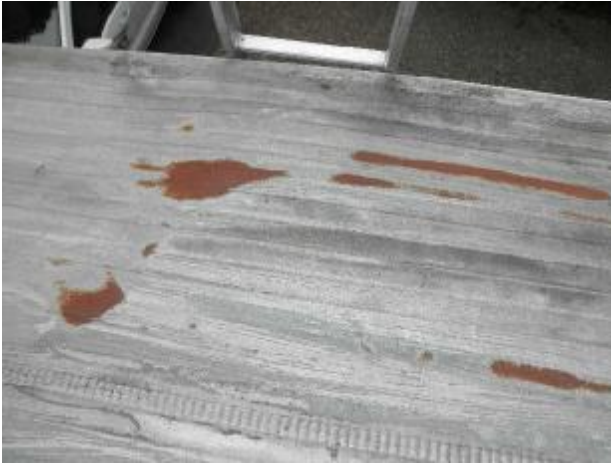
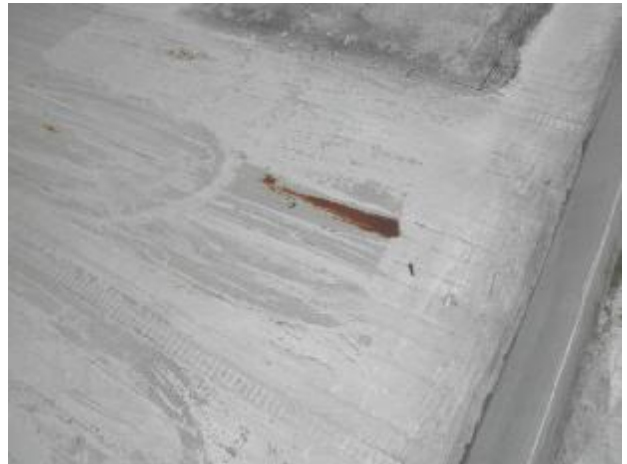
Example of rust damage to the metal roof.

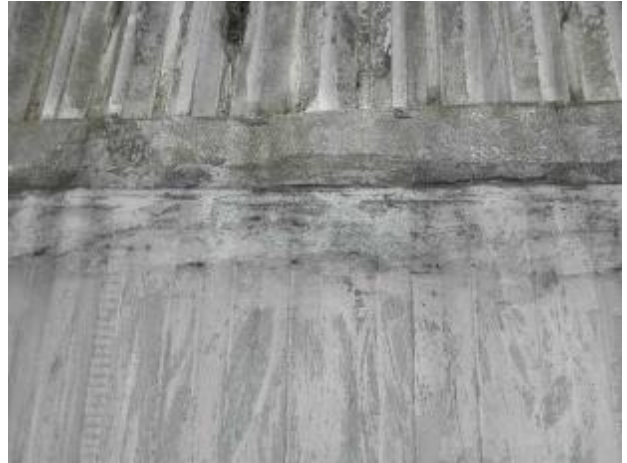
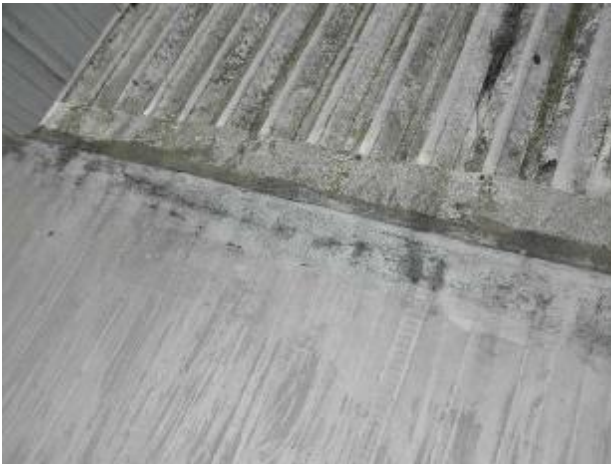
Deteriorated sealant at the perimeter.

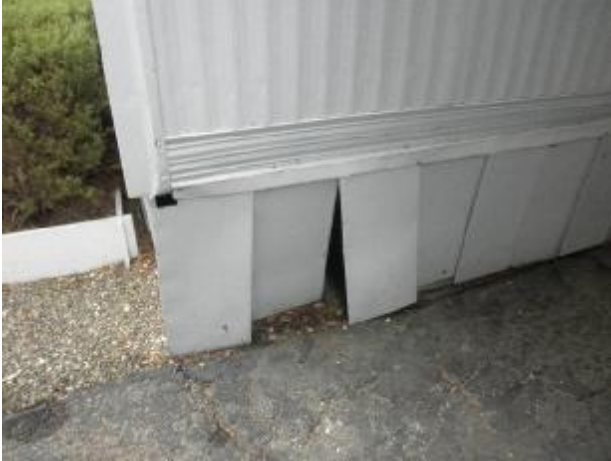
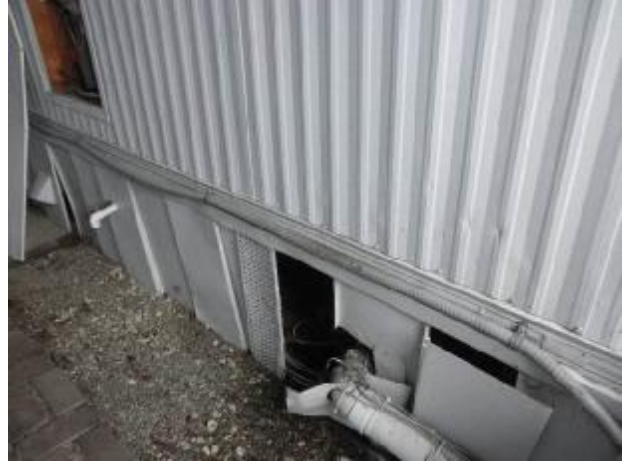
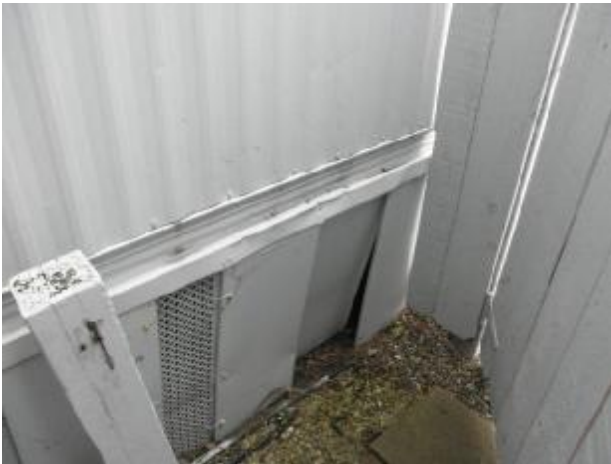
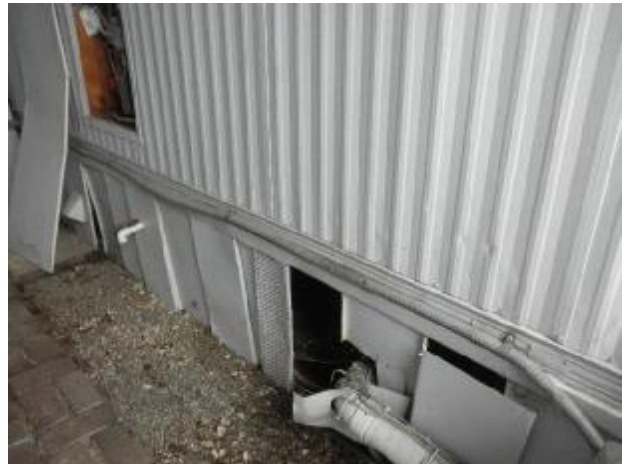
Example of the damaged skirting at the perimeter of the home.

3.) The metal skirting is dented/damaged/missing in several places.

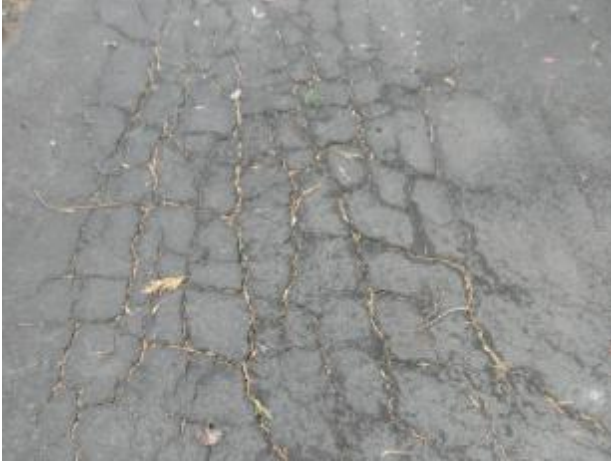
**Maintenance Note:** The asphalt driveway appears to be in reasonable condition but needs sealant. Cracks and general deterioration were observed.

General cracking in the asphalt driveway.

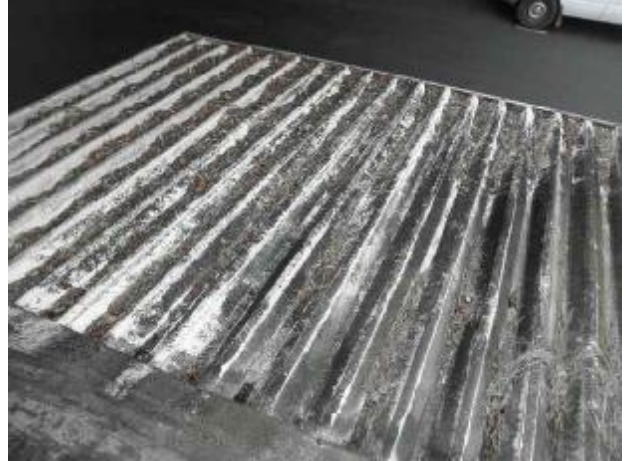
The patio roof is covered in debris.

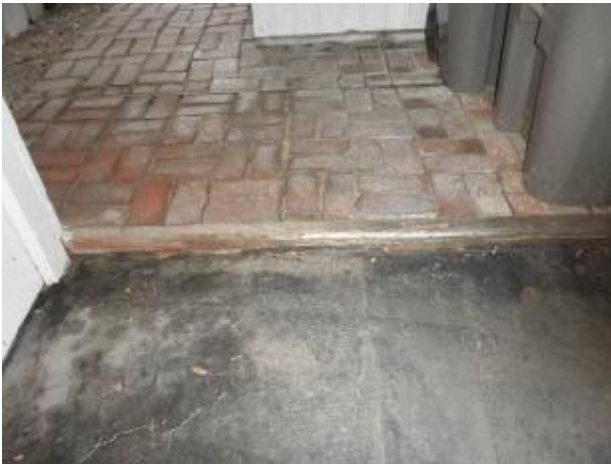
**Safety Hazard Note:** There is a tripping hazard at the interface of the asphalt and the bricks at the west end of the carport.

Tripping hazard at the interface of the carport asphalt and the brick walkway.

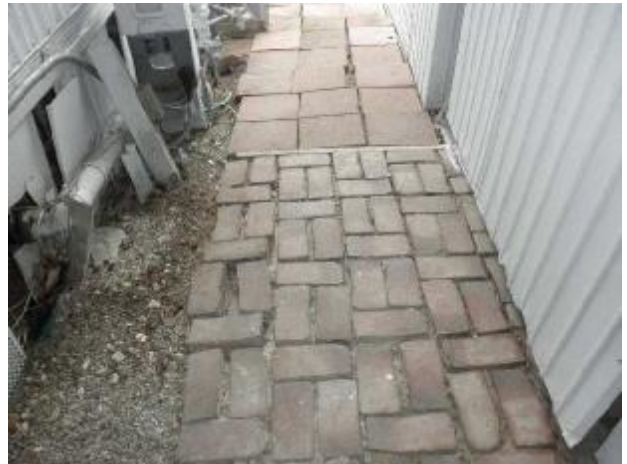
**Safety Hazard Note:** There are loose/dislodged bricks at the front yard walkway and the NW yard. This can be a tripping hazard.

Dislodged bricks in the NW yard.

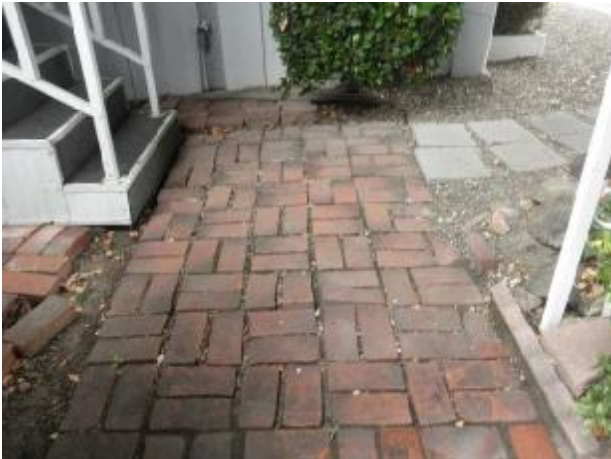
Dislodged bricks at the front entry walkway.

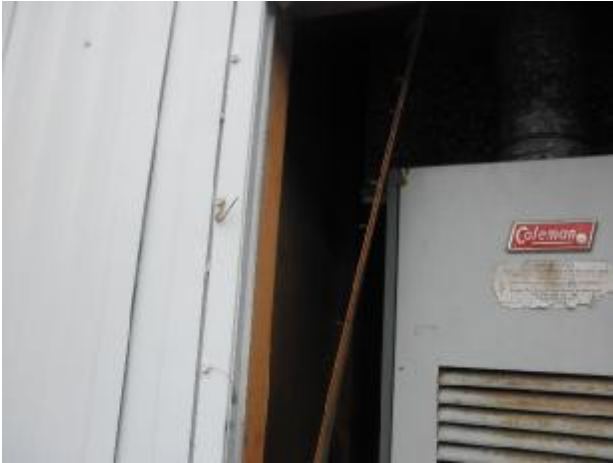
Maintenance Note: Part of the wall paneling is loose inside the furnace closet.

Loose wood paneling inside the furnace closet.

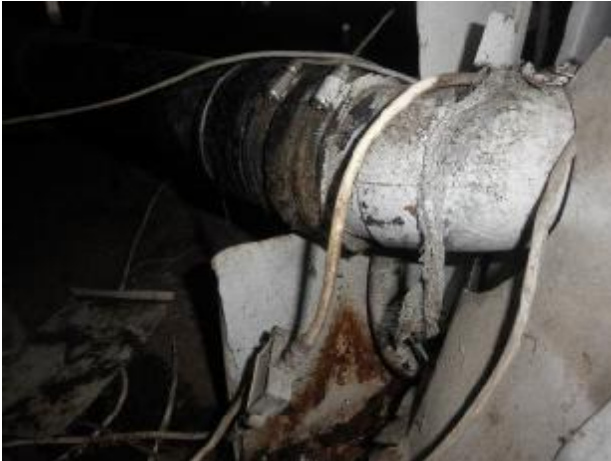
Leak at the 4" drain waster line.

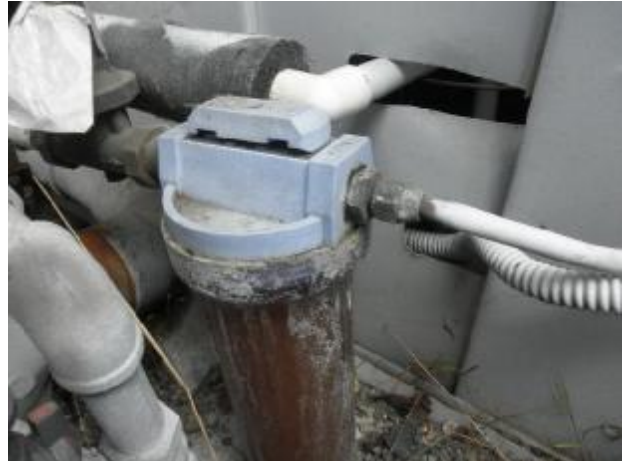
The cartridge filter needs to be replaced.

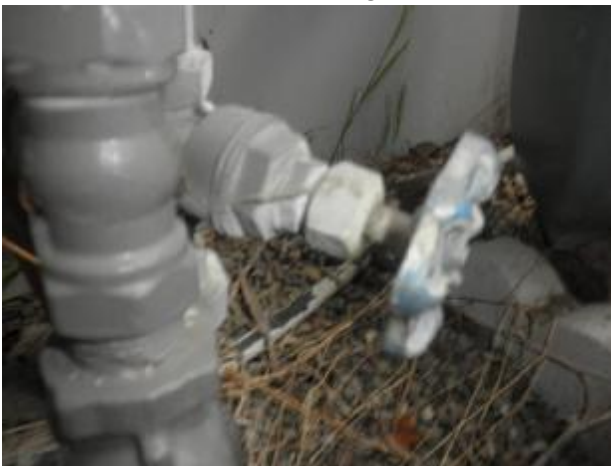
Leak at the main water shut off valve.

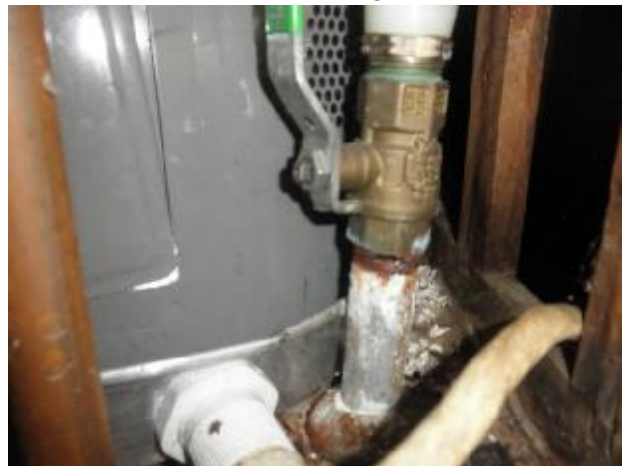
Leak at the cold water line connection to the water heater.

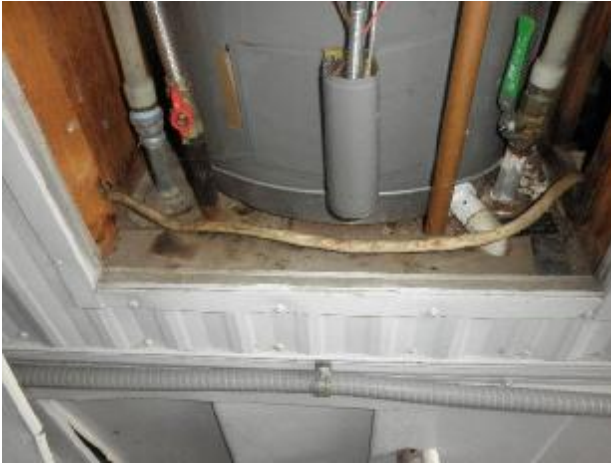
Exposed wiring in the water heater closet should be installed in conduit.

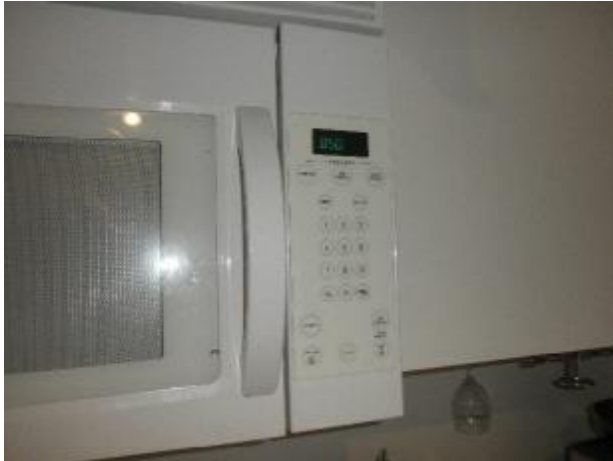
- 1.) The microwave control panel cover is loose.

**Control panel is loose at the microwave.**

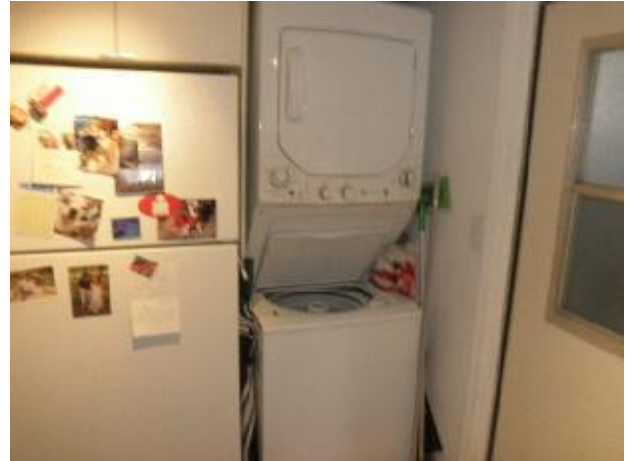
**utility connection for the laundry units are blocked.**

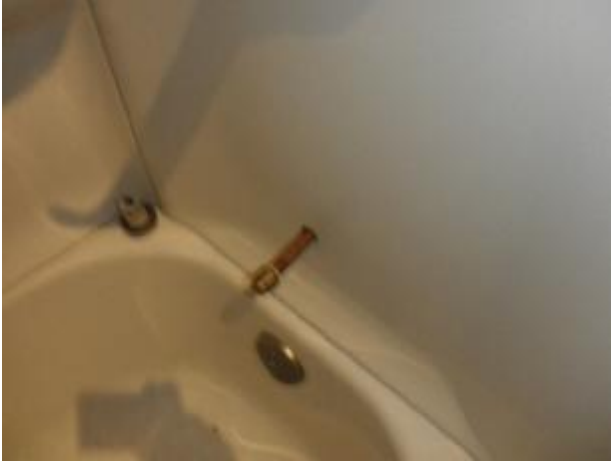
1.) The tub spout is missing at the bathroom tub/shower.

Tub spout missing in the bathroom.

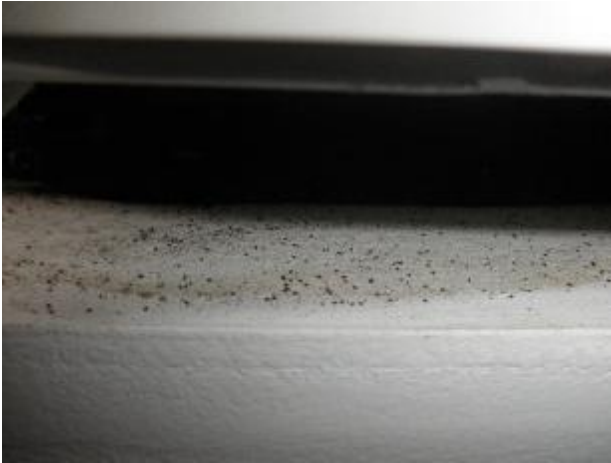
**1.)** There is evidence of possible drywood termite infestation at the window sill on the west wall in the west bedroom. Recommend further evaluation by a qualified and licensed Pest Control Inspector prior to the close of escrow.

Possible termites at the window sill in the west bedroom.

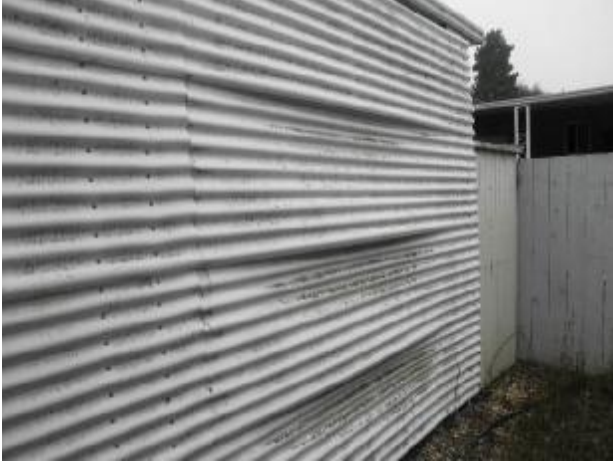
Parts of the Filon panels at the carport are warped.

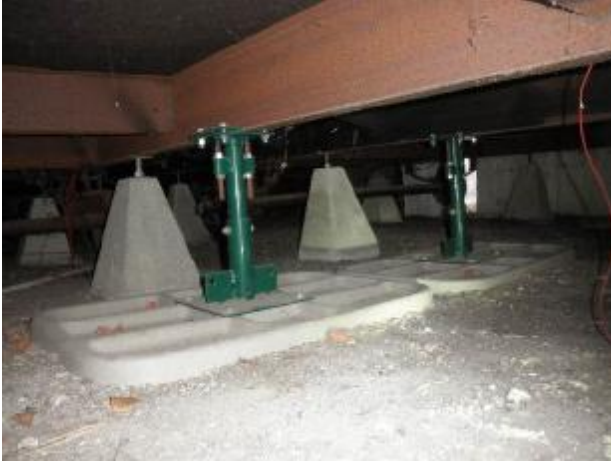
**Information Note:** Specialty mobile home permanent foundation jacks system have been installed.

Example of the permanent foundation jacks.
