WOOD DESTROYING PESTS AND ORGANISMS INSPECTION REPORT

Building No. 26669	Street Modoc	City Lake Arrowhead	ZIP 92352	Date of Inspection 09/29/2023	Number of Pages 5
-----------------------	-----------------	------------------------	--------------	----------------------------------	----------------------

Empire Termite Solutions

Report # : 16233
Registration # : PR7434
Escrow # :
 CORRECTED REPORT

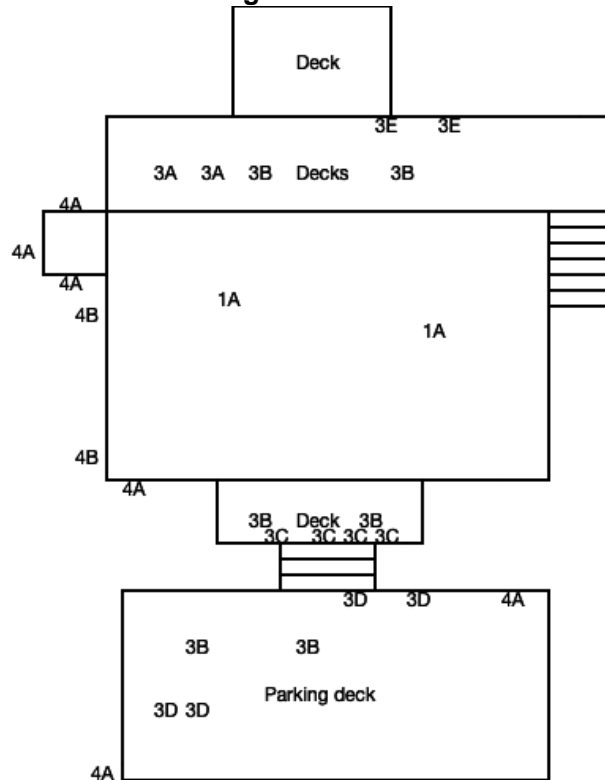
Diagram Not To Scale

FINDING: Evidence of subterranean termites noted at the tree stumps under the house.

FINDING: Dry rot noted at three cantilevered joists under the back lower deck. This repair will require new concrete piers and posts, which are included in this quote. This repair may reveal additional findings.

FINDING: Surface fungus was noted on the joists and deck planks under the front and back deck.

FINDING: Dry rot noted at four joists under the entry deck.

FINDING: Dry rot noted at about four parking deck joists, two parking deck planks and the base of one 6x6 post under the parking deck.

FINDING: Dry rot noted at two joists under the back top deck.

FINDING: Earth to wood contact noted at the wood box at the left side of house, the joist and post under the parking deck and the siding at the front of house.

FINDING: Wood pecker holes were noted at siding at the left side of the house. Wood pecker holes can lead to water intrusion into the house causing an excessive moisture condition.

RECOMMENDATION: Chemically treat the soil with Termidor (Fipronil), and/or Dragnet (Permethrin), and/or Timbor (Disodium Octabrate Tetrahydrate), all products registered with the State of California for the control of subterranean termites. Remove shelter tubes, where accessible.

RECOMMENDATION: Remove the damaged wood member(s). Replace the damaged wood with new material. (This bid excludes priming, painting, or staining. If any party to the transaction wants the wood primed, painted, or stained, they should contact Empire Termite Solutions for a bid to prime, paint, or stain repaired wood. Empire Termite Solutions is not responsible for damage to bare wood.) This repair might reveal additional findings.

RECOMMENDATION: Scrape away surface fungus and treat the area with Timbor (Sodium Borate) a chemical registered with the state of California, Department of Agriculture, in accordance with the label for the control of fungus.

RECOMMENDATION: Remove the damaged area. Repair the damaged area with new material. (This bid excludes priming, painting, or staining. If any party to the transaction wants the wood primed, painted, or stained, they should contact Empire Termite Solutions for a bid to prime, paint, or stain repaired wood. Empire Termite Solutions is not responsible for damage to bare wood.) This repair might reveal additional findings.

RECOMMENDATION: Remove earth from wood contact and further inspect. This repair may reveal additional findings.

RECOMMENDATION: Repair the damaged siding. Empire Termite Solutions does not guarantee nor take responsibility for wood peckers or new damage caused by wood peckers. Empire Termite Solutions recommends hiring a licensed pest control company for the removal of the woodpeckers. Please contact Empire Termite Solutions for any questions or recommendations.
