## Home Inspection Report

26584 Oak Terrace Pl  
Stevenson Ranch, CA 91381

Inspected On Thu, Oct 1, 2026 at 10:00 AM

Secure Home And Property Inspections LLC

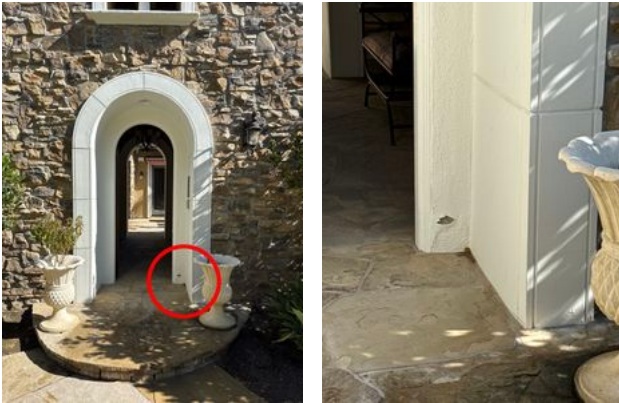
Peeling paint and stucco was noted on the right exterior side of the front door.

Recommend further evaluation and repair by a qualified licensed contractor.

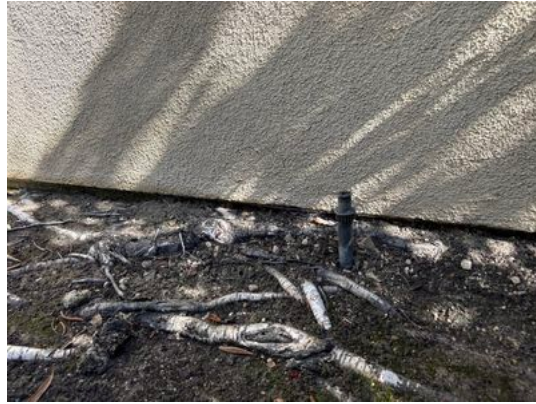
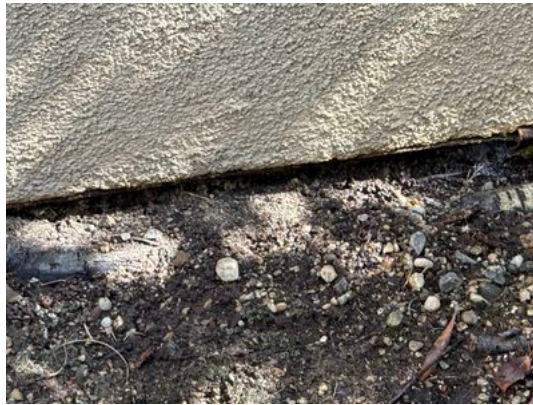
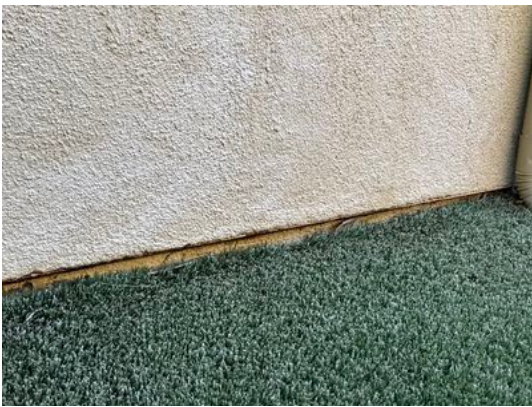
Sprinkler over spray was noted around the exterior of the home in many areas. Soil is built up against and above the weep screed. Damaged and rusted sections of the stucco weep screeds were observed.

Recommend adjustment of sprinklers

Recommend further evaluation and repair by a qualified licensed contractor.

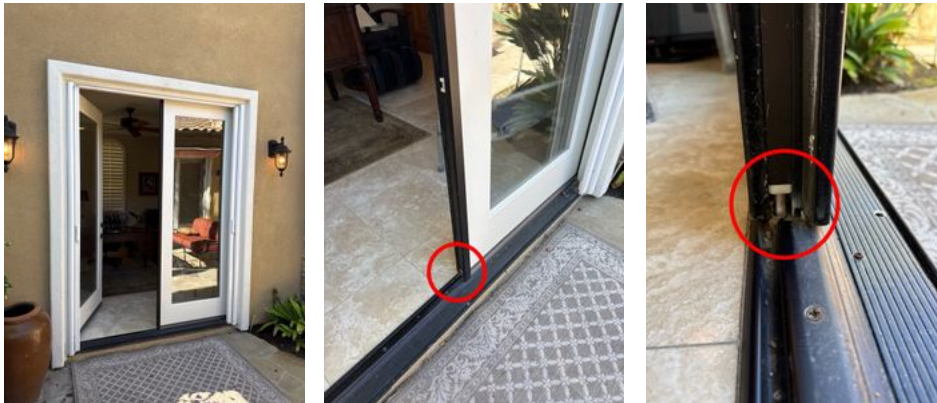
The front office patio french door on the stationary side needs adjustment. The pin latch does not fit into the frame.

Recommend further evaluation and repair by a qualified licensed contractor.

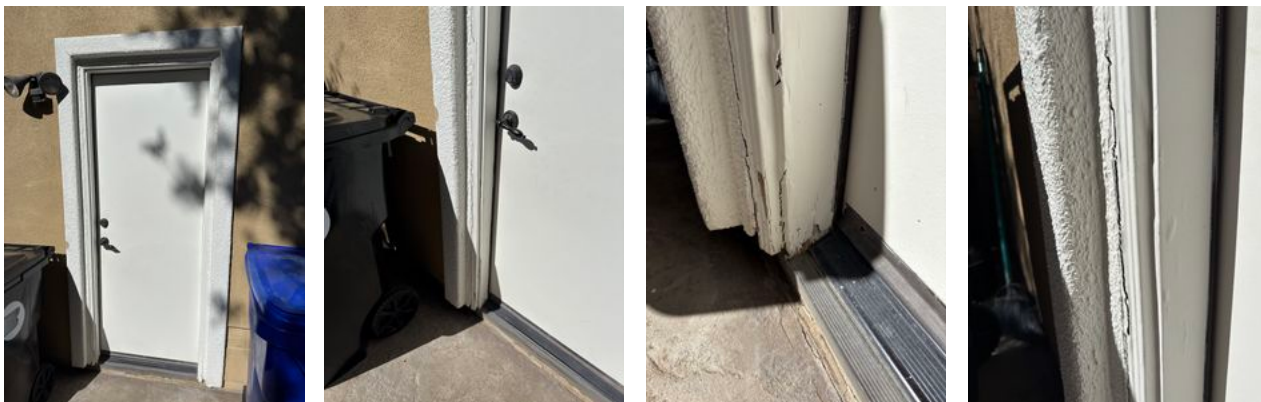
Peeling paint and stucco was observed around the side pedestrian garage door frame and casing.

Recommend further evaluation and repair by a qualified licensed contractor.

Recommend further evaluation by a qualified licensed termite contractor.

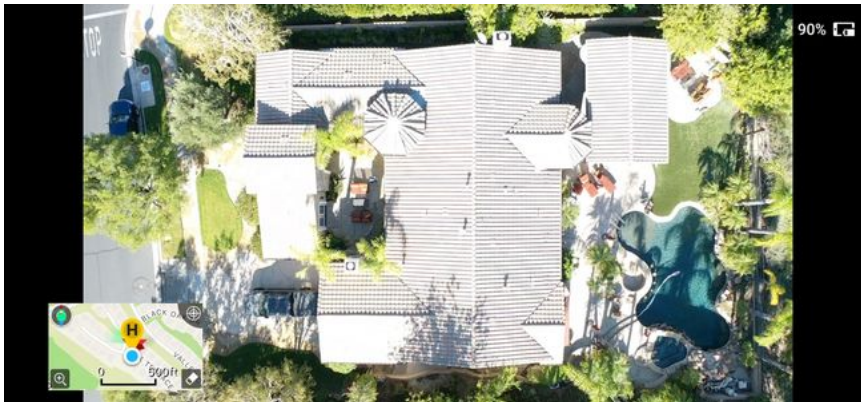
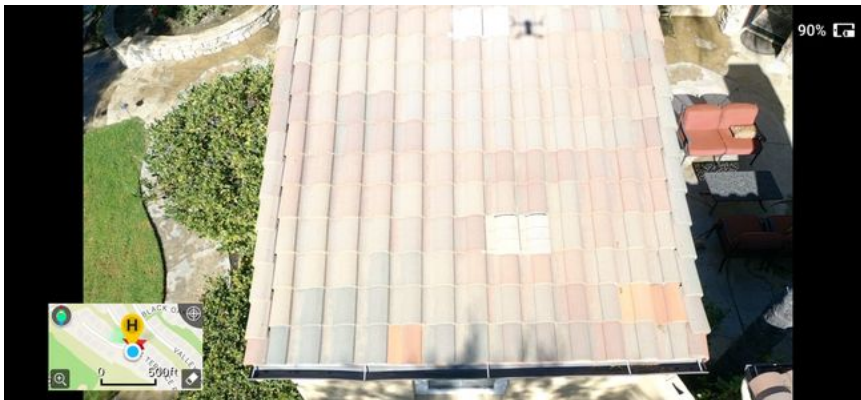
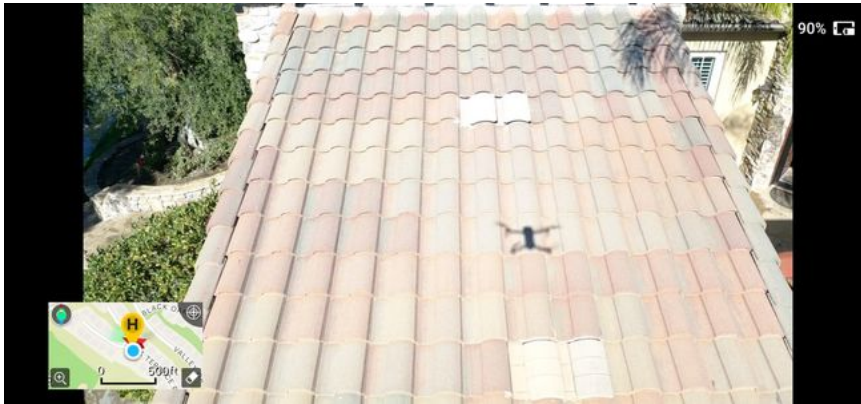
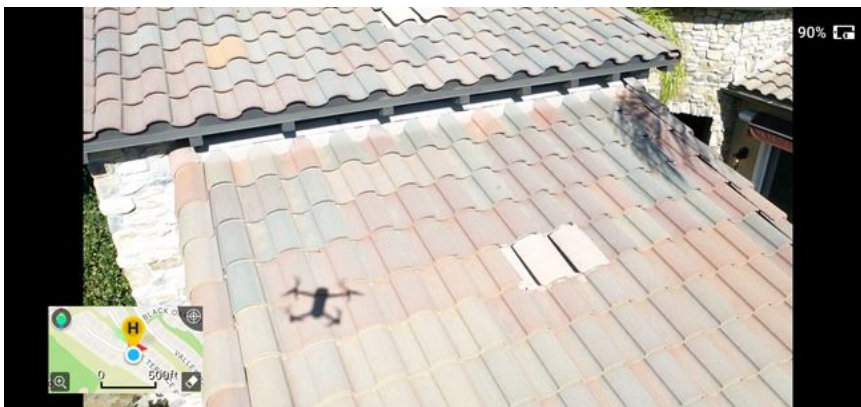
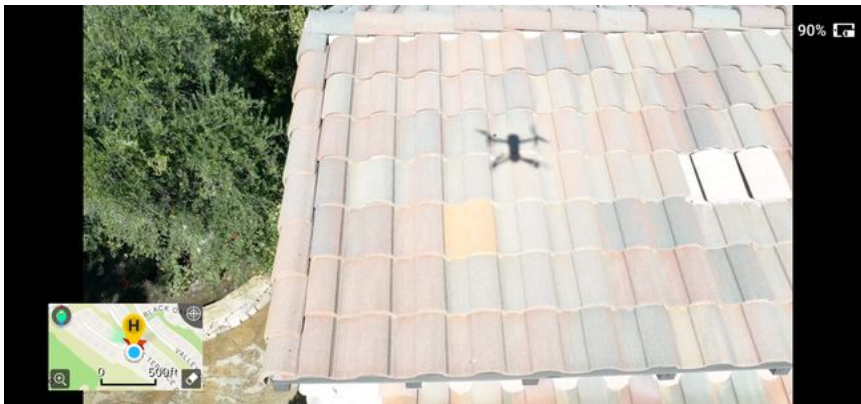
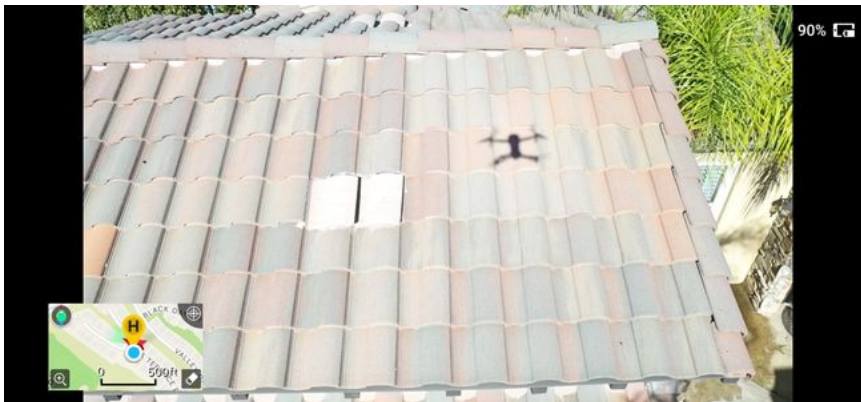
Cracked and slipped tiles were observed during the roofing inspection. Previously repaired and or replaced tiles were noted in some locations. Vent flashing sealant in a few locations is in need of maintenance work, gaps and cracks are beginning to form. Valleys and rain gutters were noted to have a buildup of debris and should be cleaned.

Recommend further evaluation and repair by a qualified licensed roofing contractor.

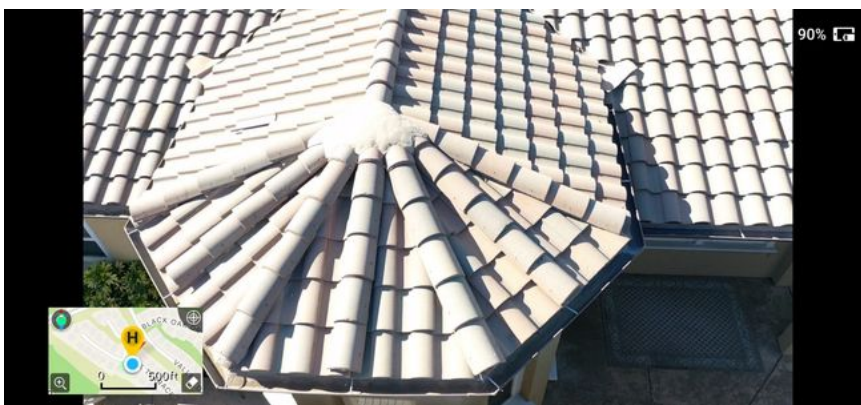
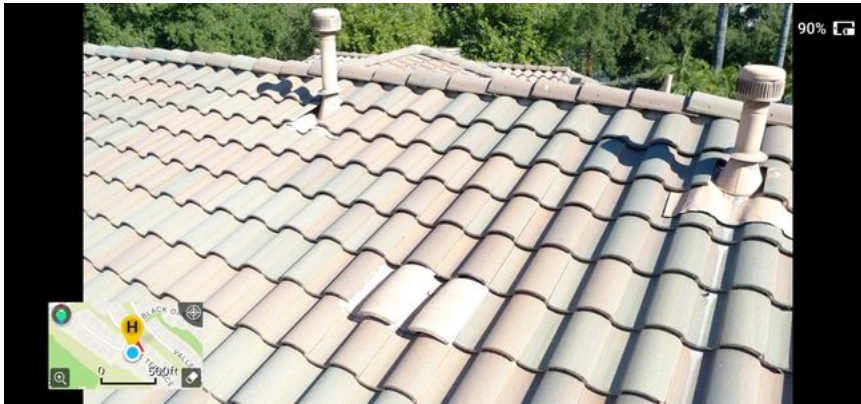
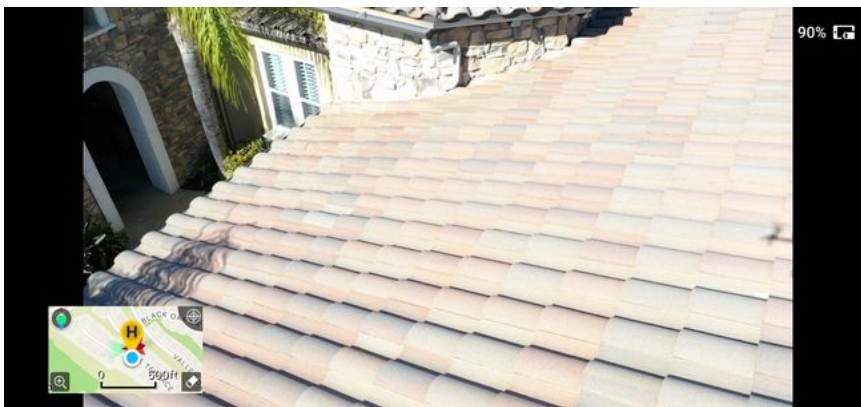
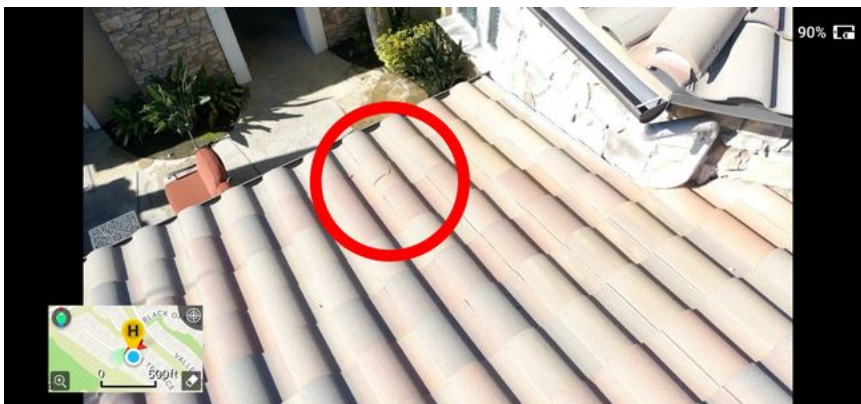
Continuation of roofing pictures.

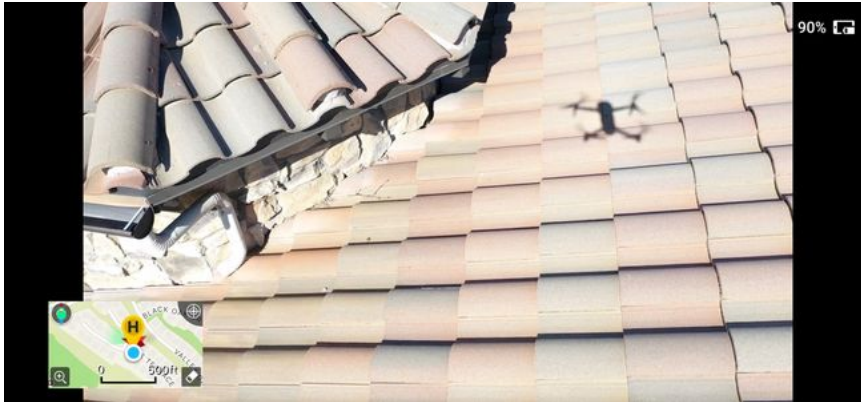
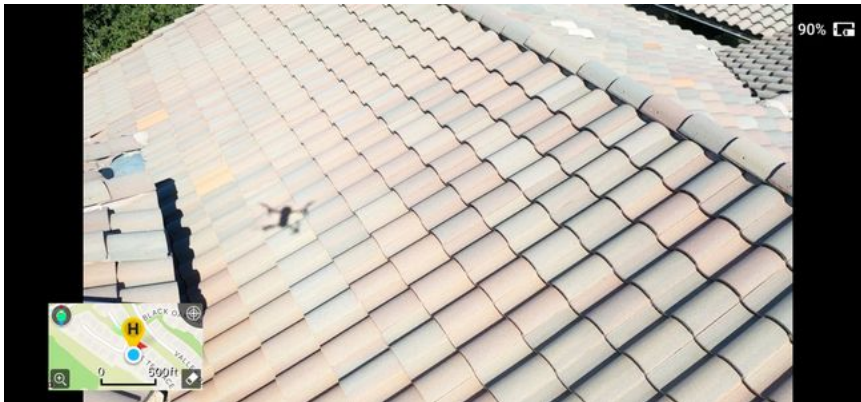
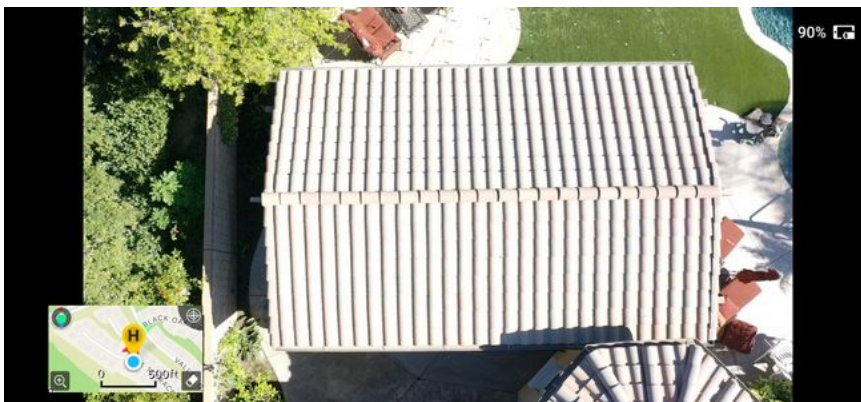
Continuation of roofing pictures.

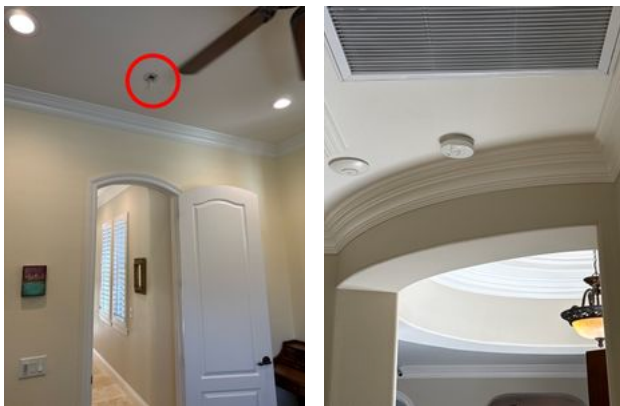
A missing and partially removed smoke detector was noted in the home. Smoke detectors are beyond 10 years old and should be replaced. A carbon monoxide detector was not located inside of the home.

Recommend further evaluation and repair by a qualified licensed contractor.

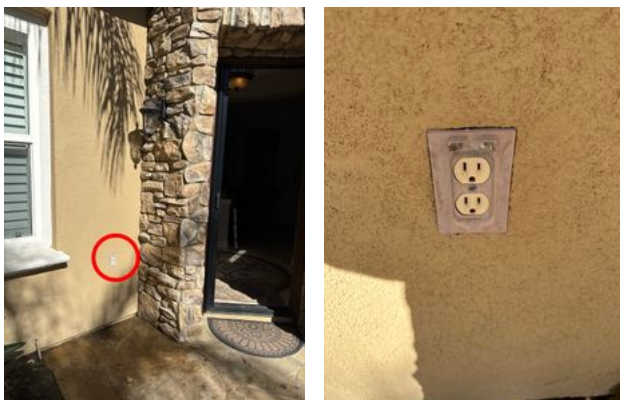
Front patio electrical outlet did not have power. Also the weatherproof cover is missing.

Recommend further evaluation and repair by a qualified licensed contractor.

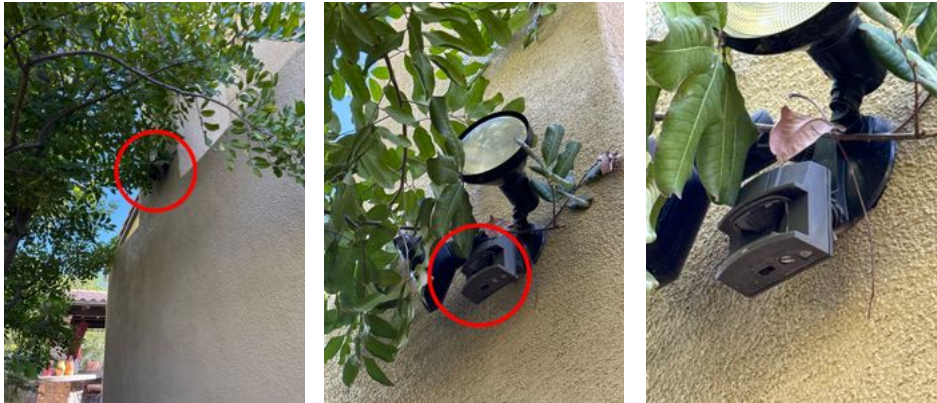
Lighting fixture on the left exterior side of the home did not function. Motion sensor/photo cell appears to be damaged.

Recommend further evaluation and repair by a qualified licensed contractor.

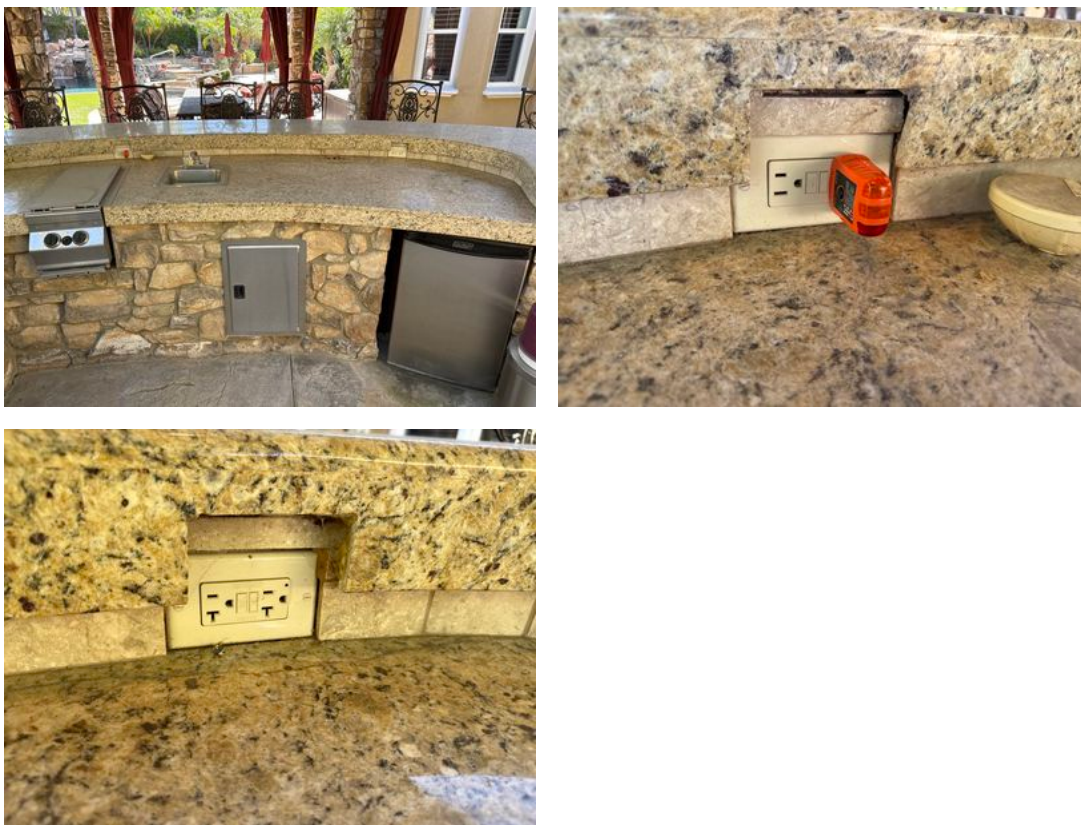
Patio countertop electrical outlets do not have power and do not reset.

Recommend further evaluation and repair by a qualified licensed contractor.

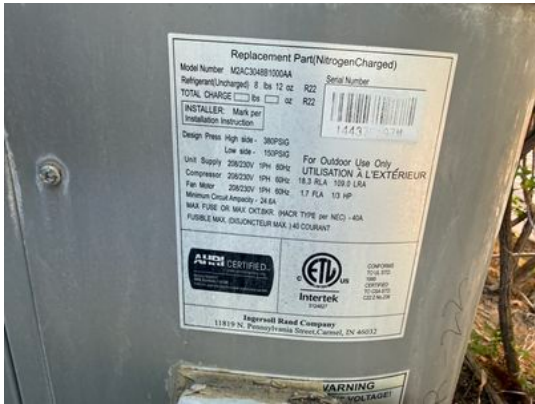
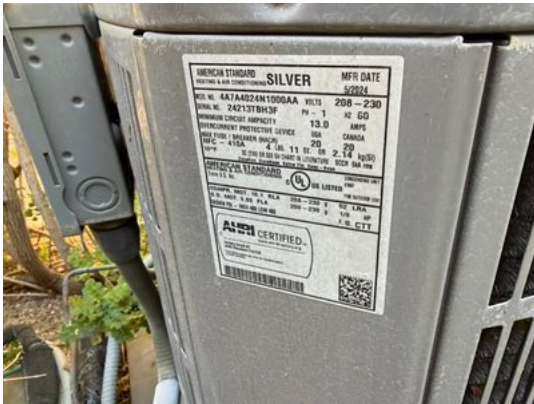
The master bedroom side air-conditioning system was only lowering the incoming air temperature by approximately 10°.

Dirt, dust, and debris are noted inside both of the air conditioning condensers.

Due to the age and build up of debris inside, recommend servicing/cleaning by a qualified licensed HVAC contractor.

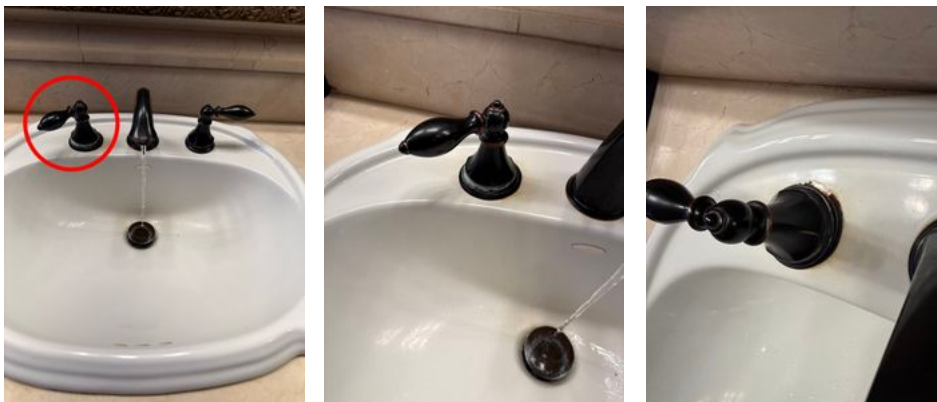
The right side master bathroom sink hot side water valve is damaged.

Recommend further evaluation and repair by a qualified licensed contractor.

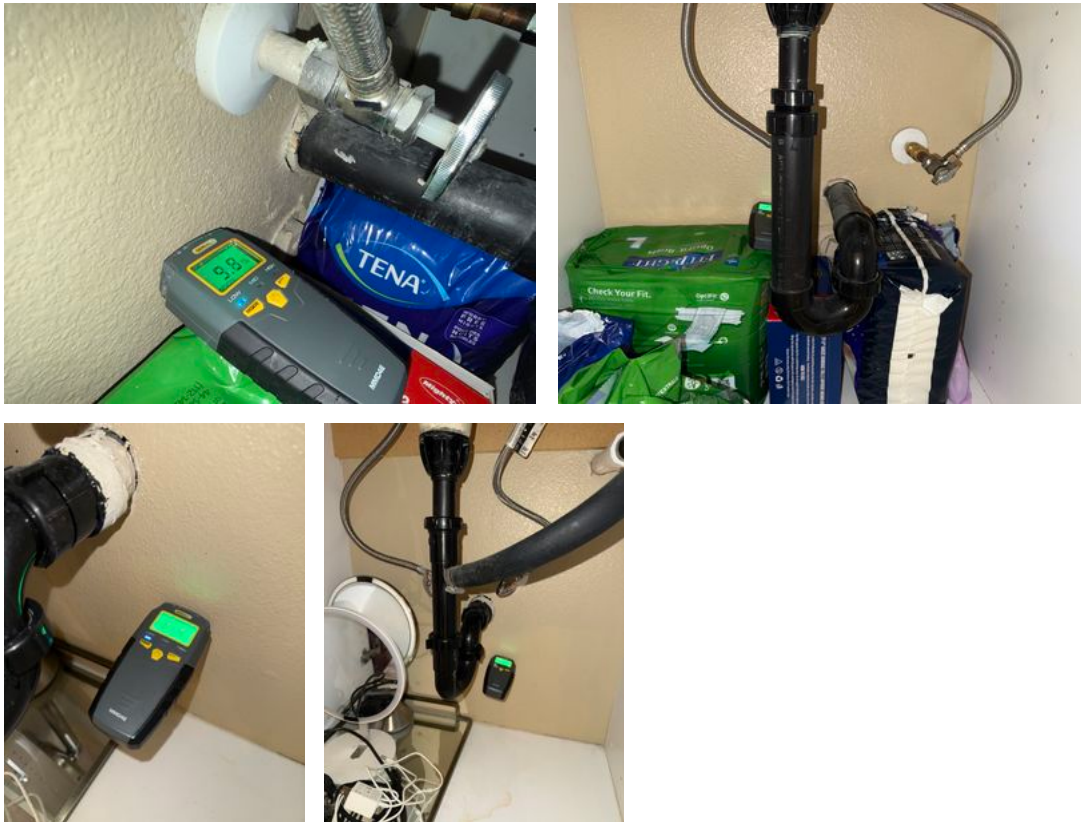
The drywall under both master bathroom sinks was tested for moisture. Moisture was noted at 9.8% and 11.4%

Drywall under 15% moisture in this area is considered normal.

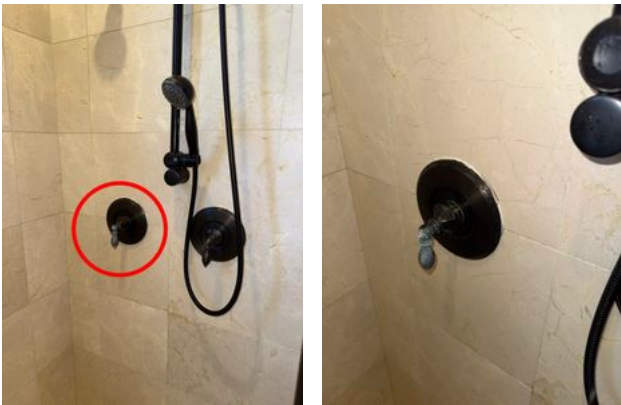
One of the master bathroom shower stall water valve plate covers is loose.

Recommend further evaluation and repair by a qualified licensed contractor.

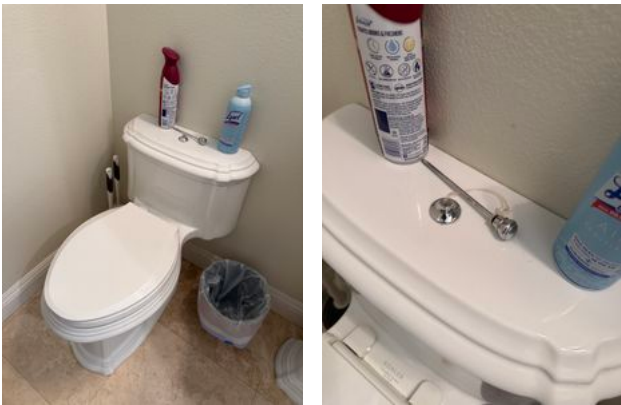
The hallway bathroom toilet flush valve has separated from the toilet.

Recommend further evaluation and repair by a qualified licensed contractor.

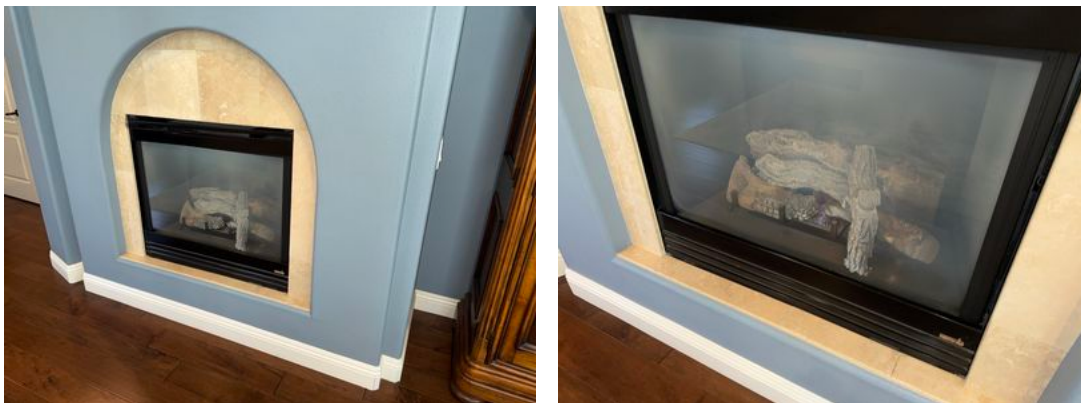
Informational only, master bedroom gas push button/light switch button fireplace is functional.

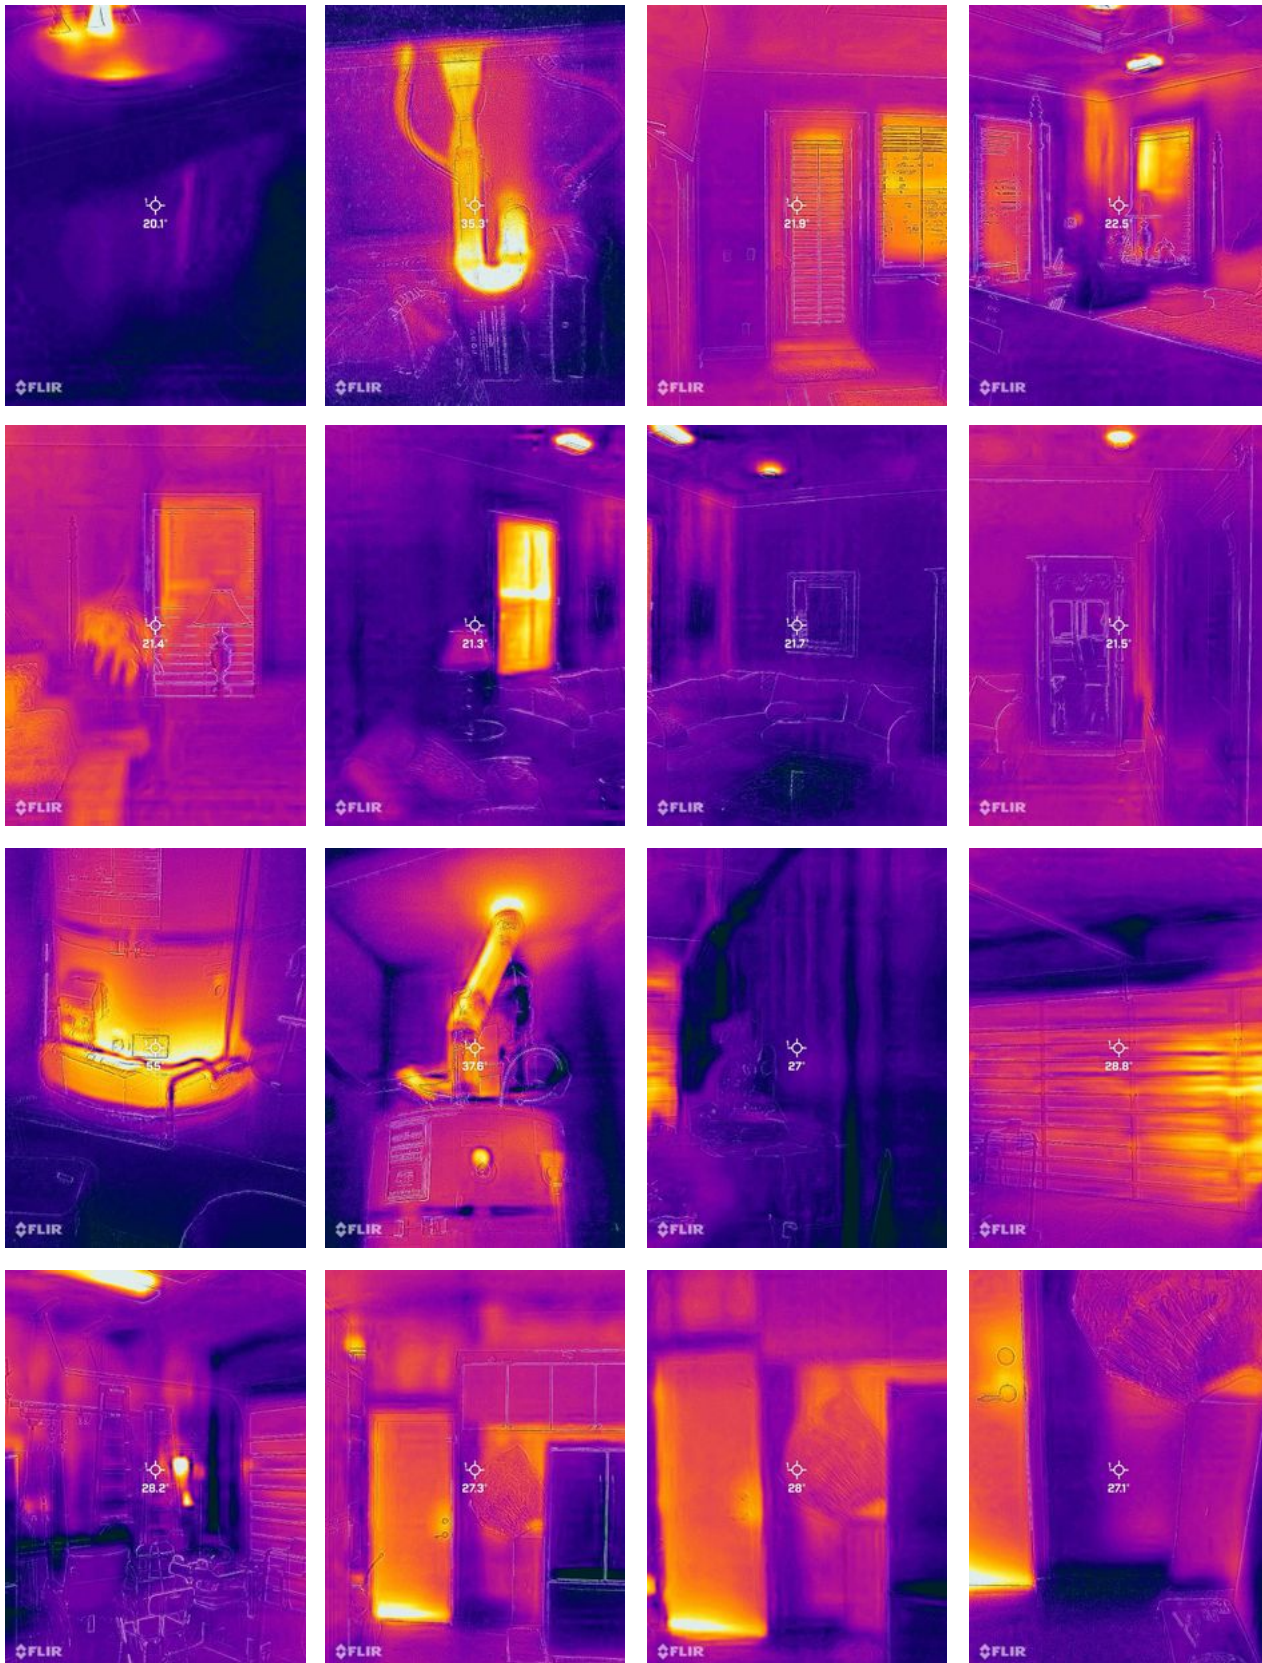
Walls and ceilings throughout the home were observed using a FLIR infrared camera. No abnormalities noted at this time.

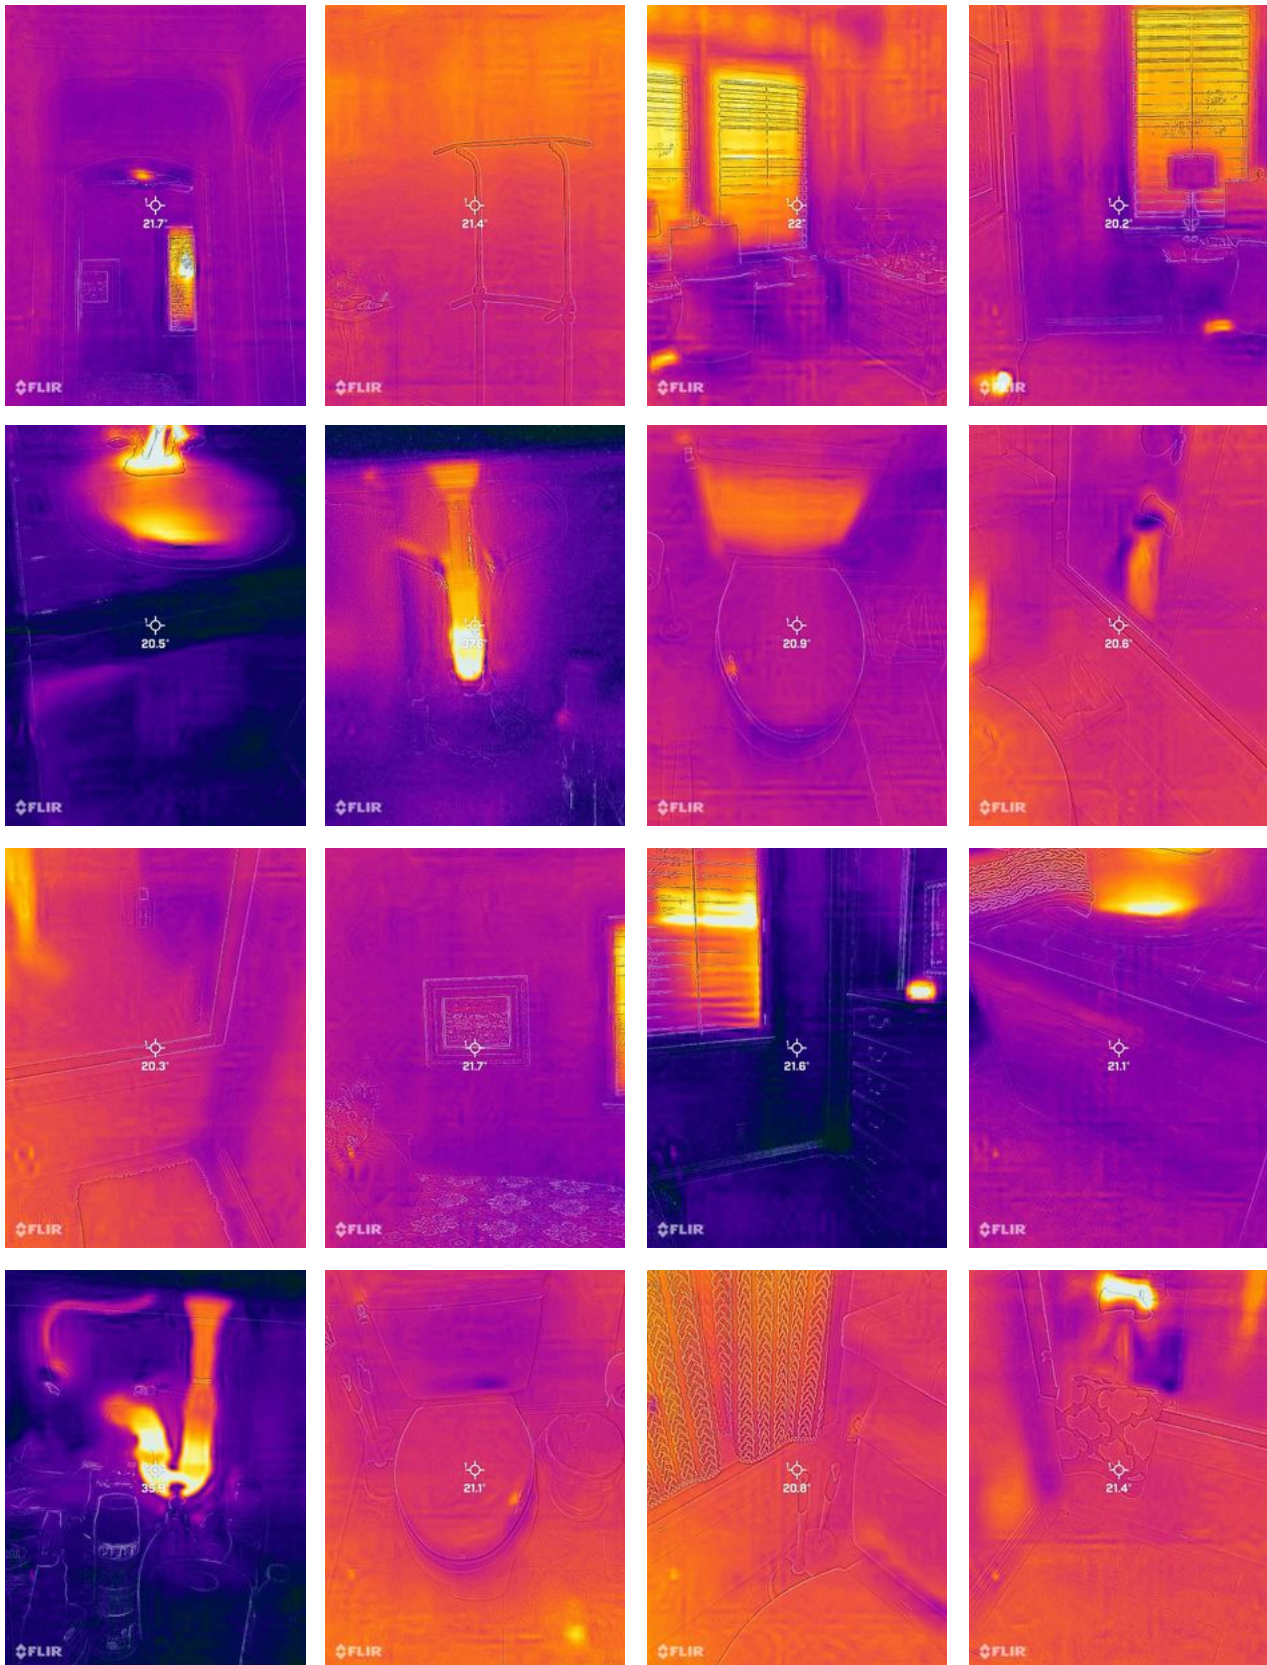
Continuation of FLIR pictures.

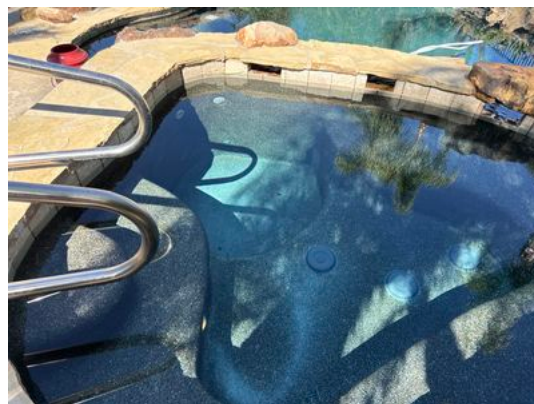
Spa interior finish appears to be in generally good condition. A buildup of material was observed on the steps and bottom of the spa which appears to be related to the degrading stone surrounding the coping.

Recommend further evaluation and repair by a qualified licensed pool contractor.

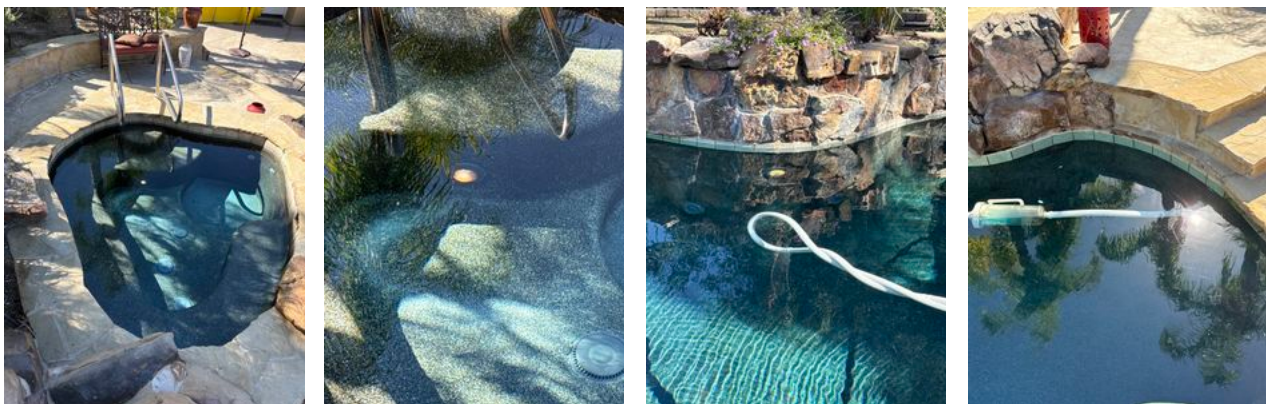
The spa and pool lights were functional however the GFCI outlet attached to the control panel was found in the tripped position at the start of the inspection. GFCI outlet was reset to allow for testing. GFCI outlet appears to be in need of replacement. Outlet appeared to be corroded.

Recommend further evaluation and repair by a qualified licensed pool contractor.

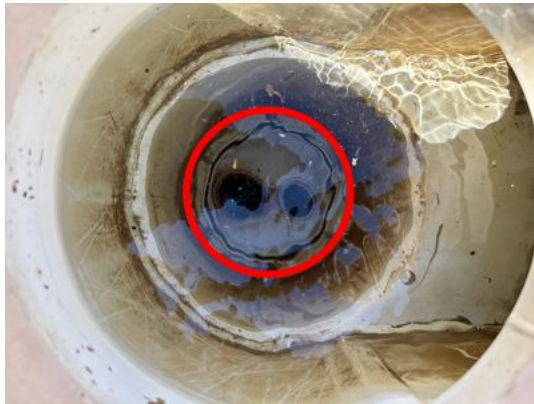
Float valve assembly appears to have been removed from the skimmer basket intake piping. Recommend further evaluation and repair by a qualified licensed pool contractor.

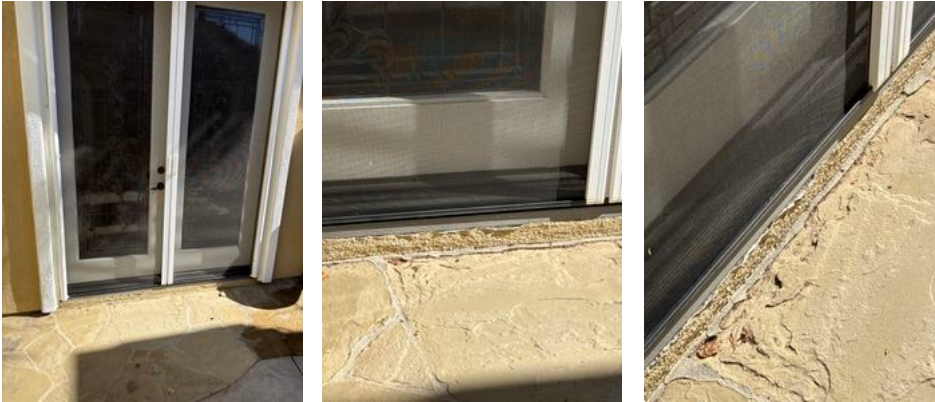
Peeling paint was observed beneath the front patio french doors.

Recommend further evaluation and repair by a qualified licensed contractor.

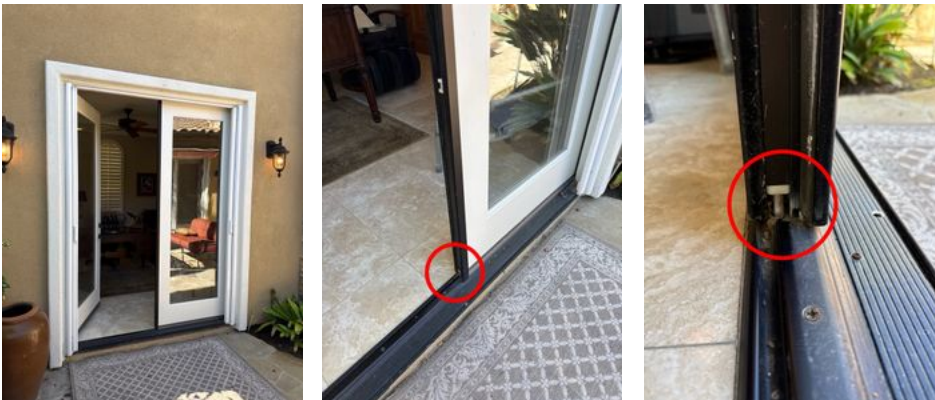
The front office patio french door on the stationary side needs adjustment. The pin latch does not fit into the frame.

Recommend further evaluation and repair by a qualified licensed contractor.

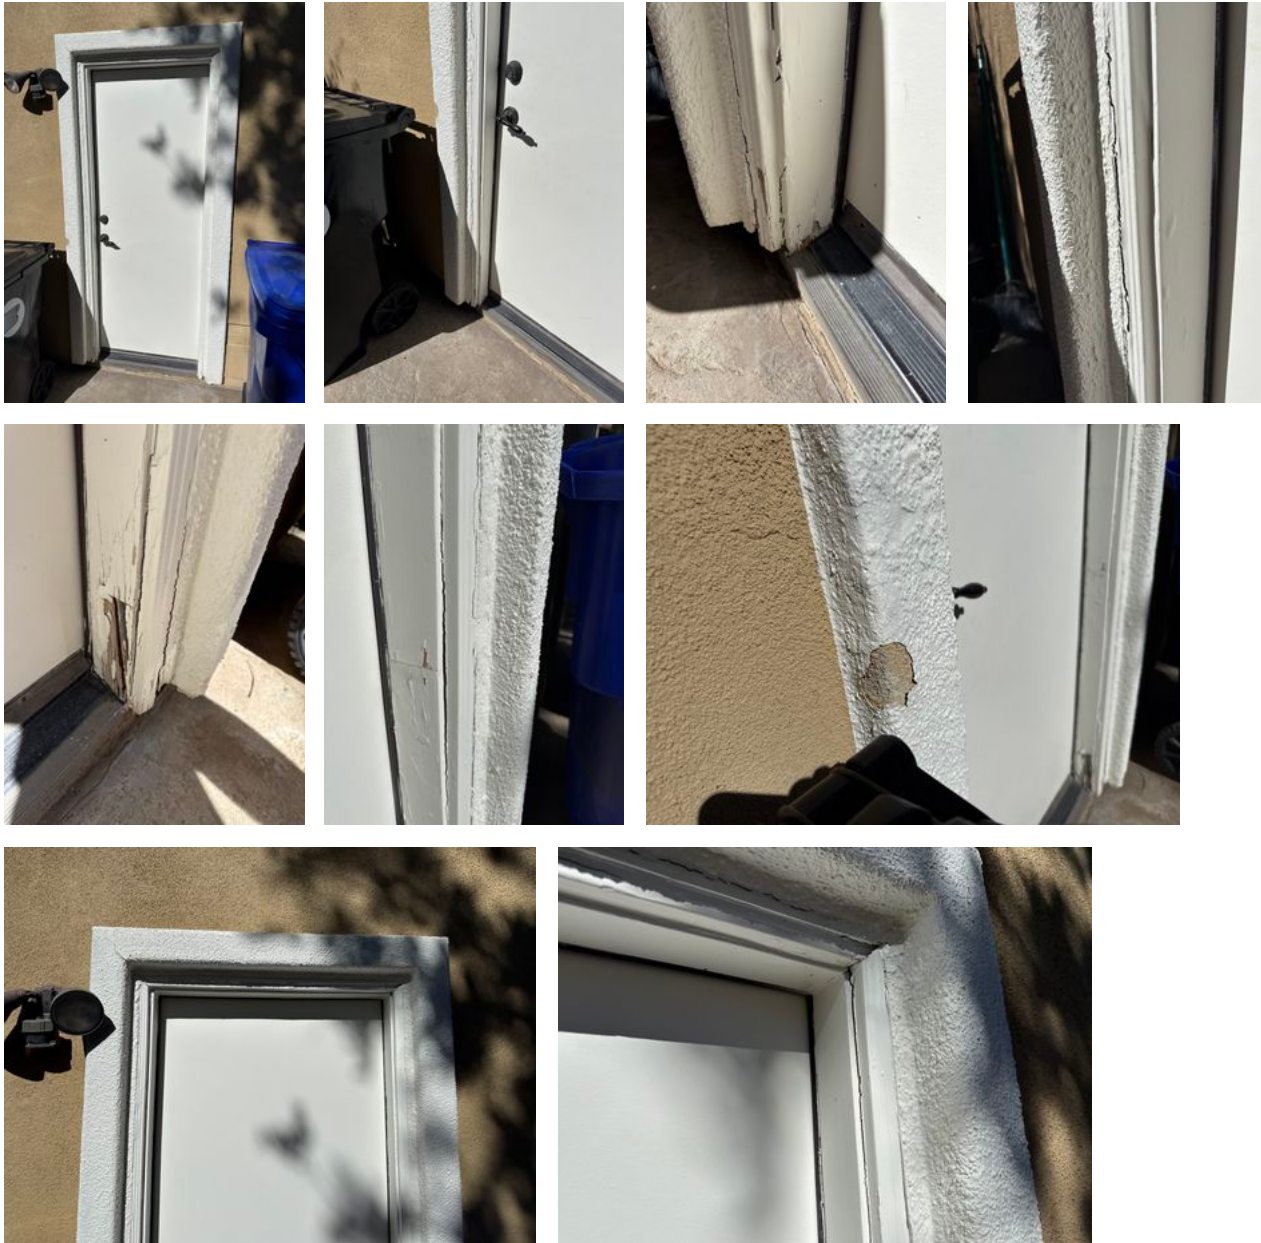
Peeling paint and stucco was observed around the side pedestrian garage door frame and casing.

Recommend further evaluation and repair by a qualified licensed contractor.

Recommend further evaluation by a qualified licensed termite contractor.

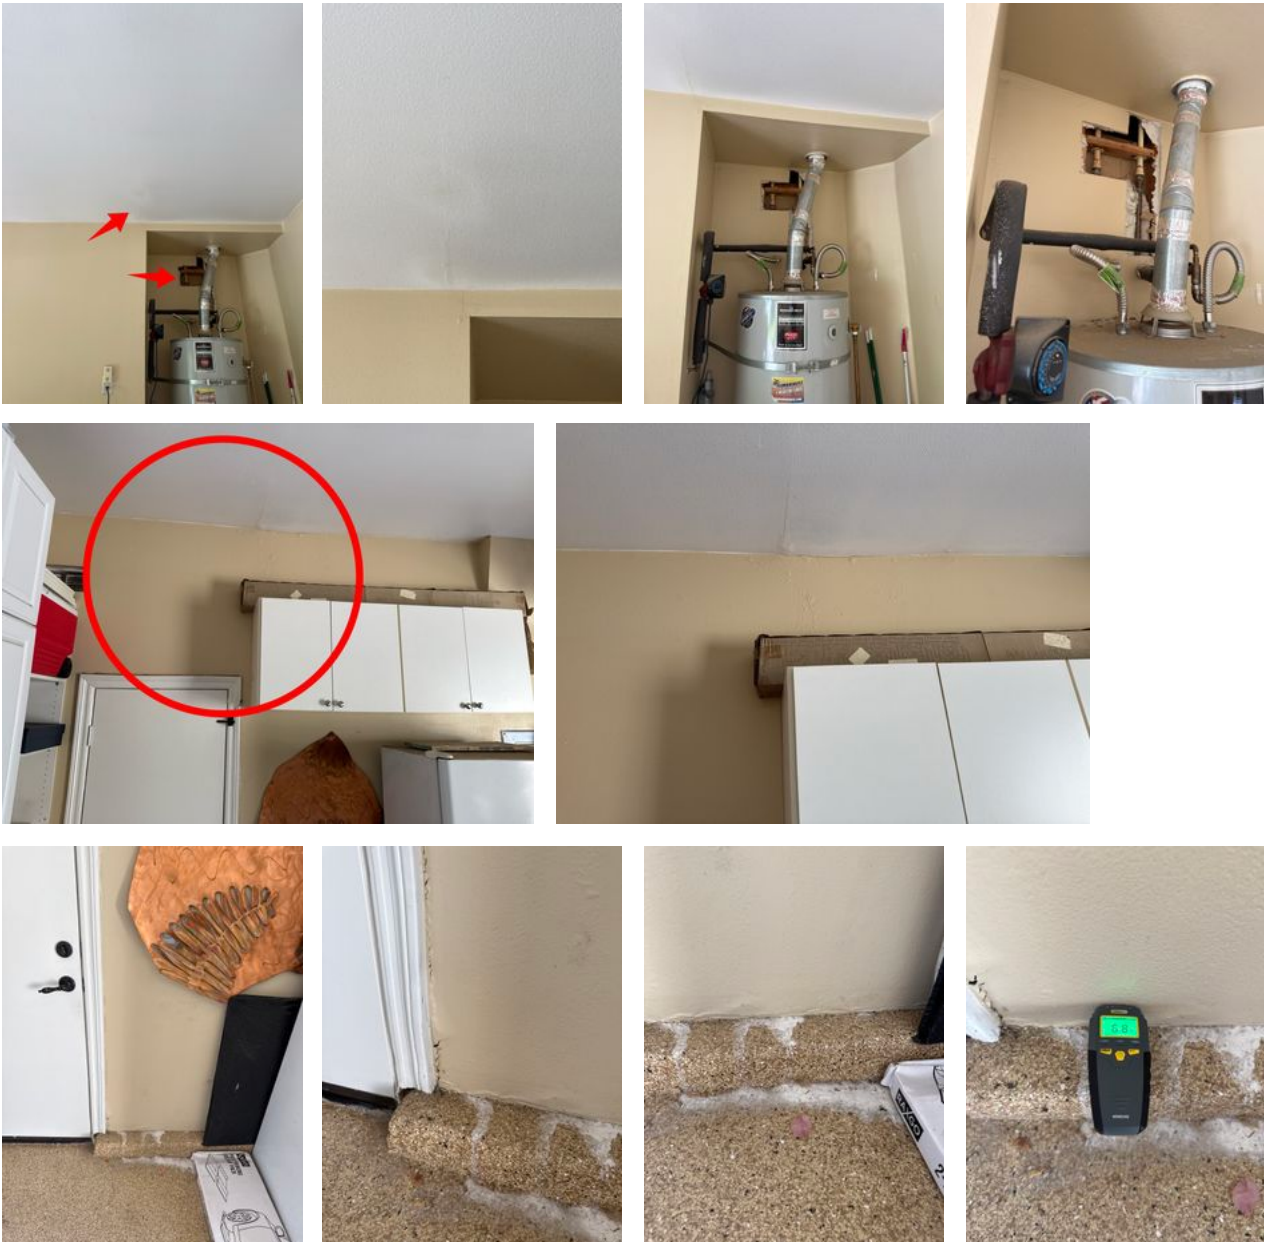
Damaged drywall repair was noted in the garage . Behind water heater drywall was found removed. Damaged drywall above side garage pedestrian door. Staining and efflorescence with swollen drywall was noted next to the door frame.

Recommend further evaluation and repair by a qualified licensed contractor.

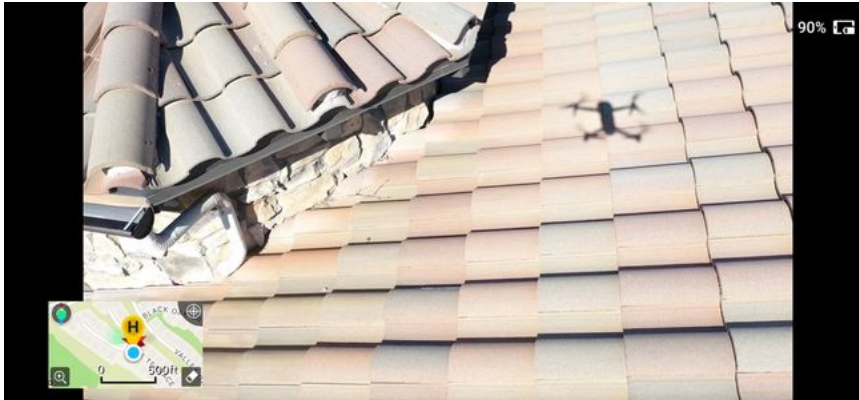
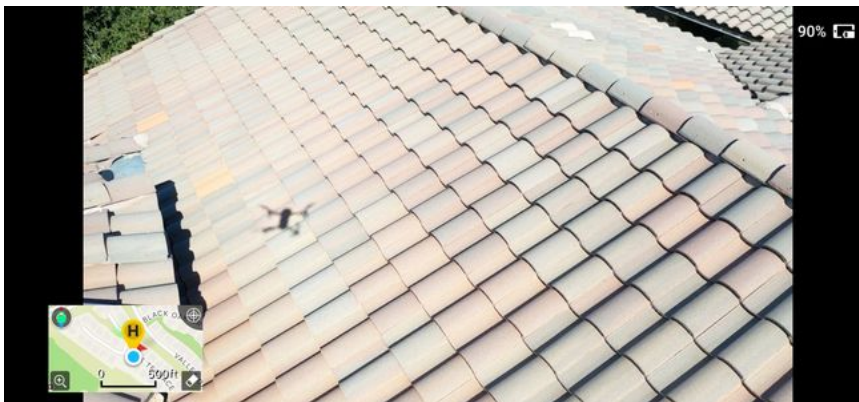
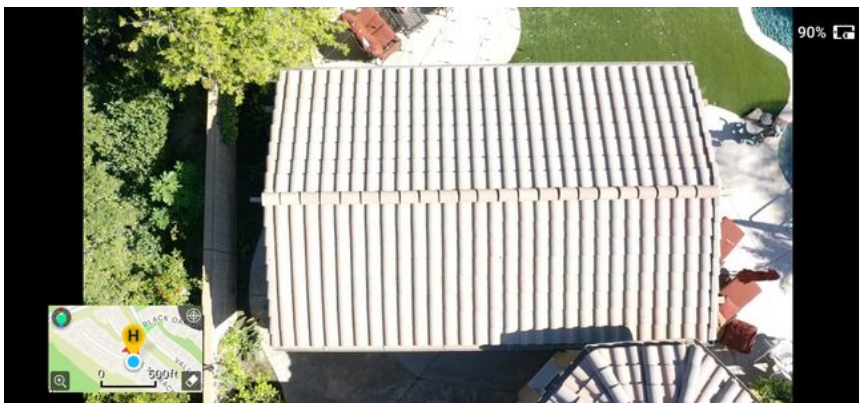
Continuation of roofing pictures.

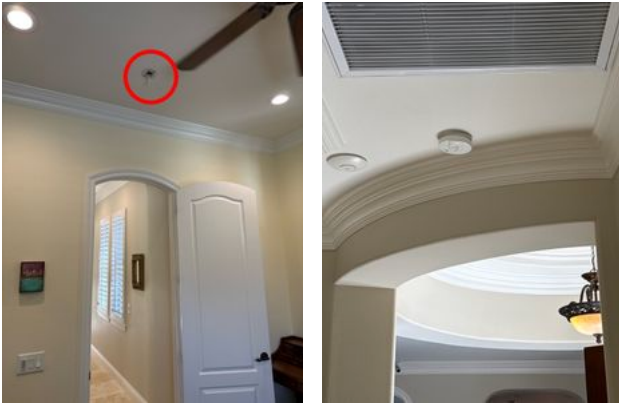
A missing and partially removed smoke detector was noted in the home. Smoke detectors are beyond 10 years old and should be replaced. A carbon monoxide detector was not located inside of the home.

Recommend further evaluation and repair by a qualified licensed contractor.

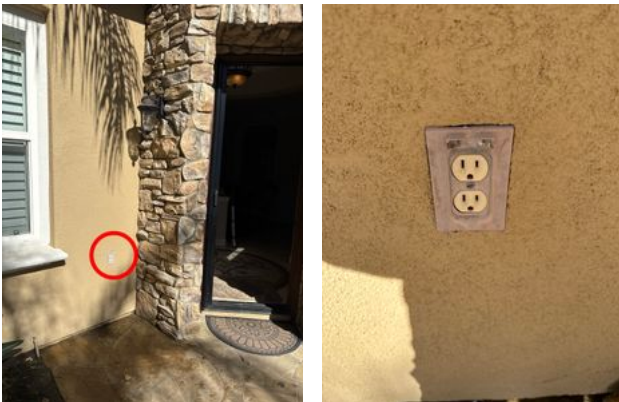
Front patio electrical outlet did not have power. Also the weatherproof cover is missing.

Recommend further evaluation and repair by a qualified licensed contractor.
