## Home Inspection Report

26584 Oak Terrace Pl  
Stevenson Ranch, CA 91381

Inspected On Thu, Oct 1, 2026 at 10:00 AM

Secure Home And Property Inspections LLC

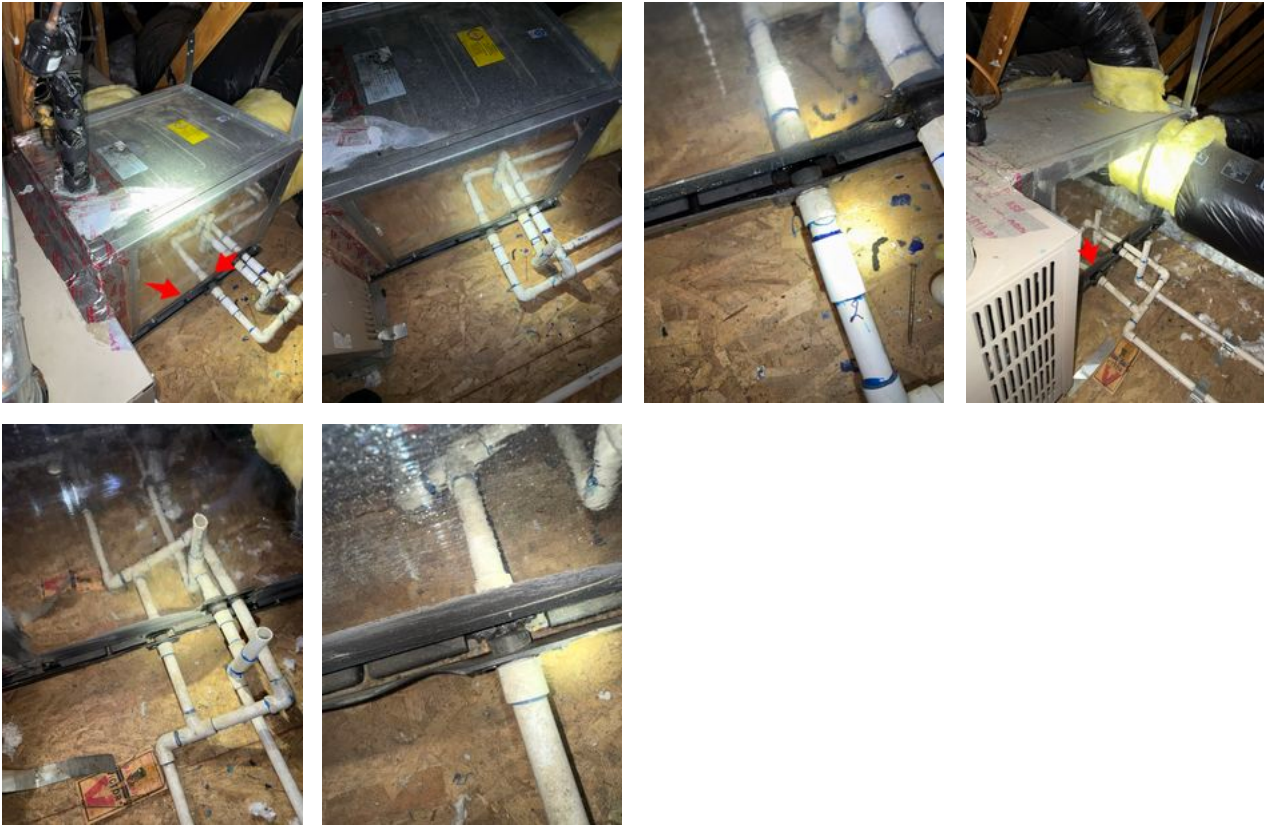
Both air-conditioning condensation catch pans or noted to have water built up.

Recommend further evaluation and repair by a qualified licensed HVAC contractor.

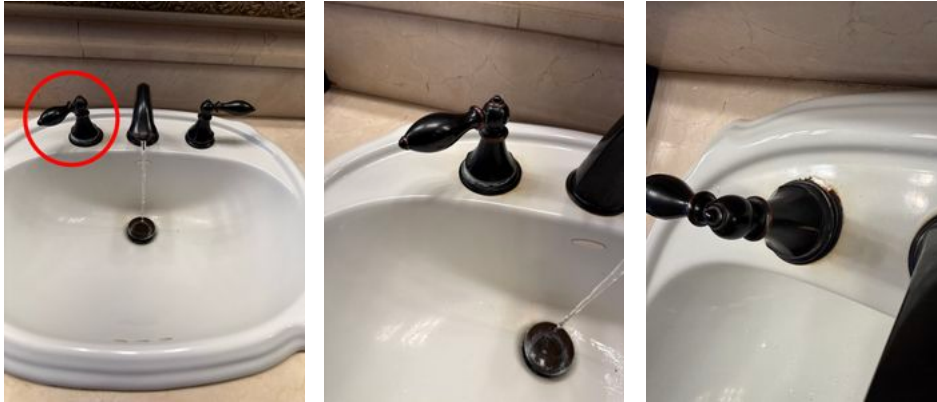
The right side master bathroom sink hot side water valve is damaged.

Recommend further evaluation and repair by a qualified licensed contractor.

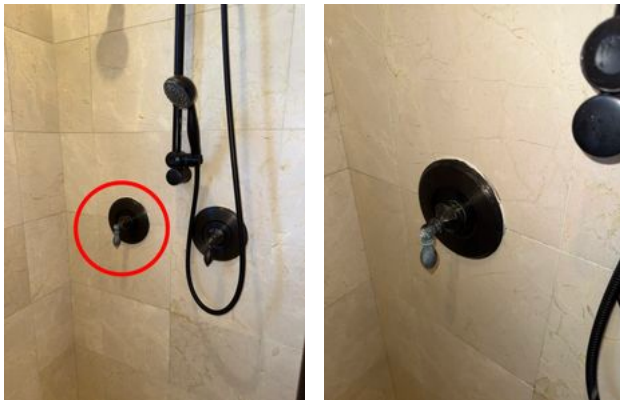
One of the master bathroom shower stall water valve plate covers is loose.

Recommend further evaluation and repair by a qualified licensed contractor.

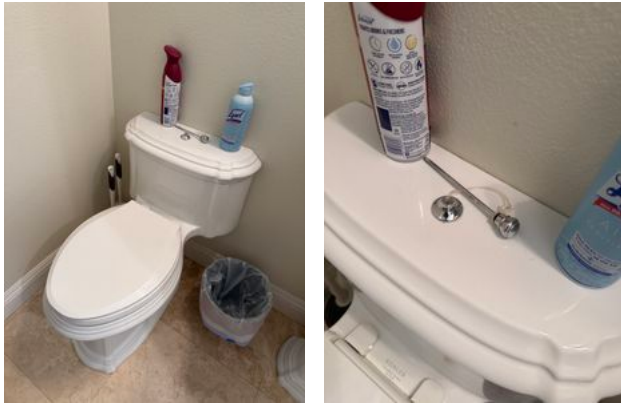
The hallway bathroom toilet flush valve has separated from the toilet.

Recommend further evaluation and repair by a qualified licensed contractor.

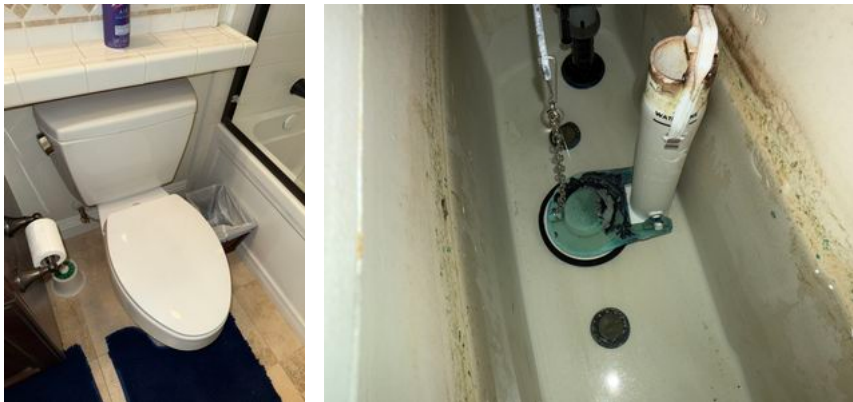
Bathroom toilet flapper appears to be in need of replacement. Water leaks past the flapper.

Recommend further evaluation and repair by a qualified licensed contractor.

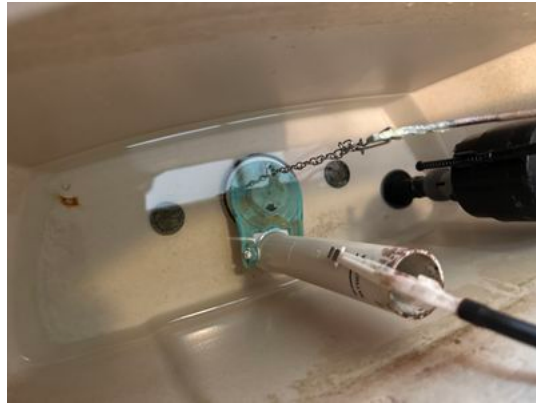
Bathroom toilet flapper appears to be in need of replacement. Water leaks past the flapper.

Recommend further evaluation and repair by a qualified licensed contractor.

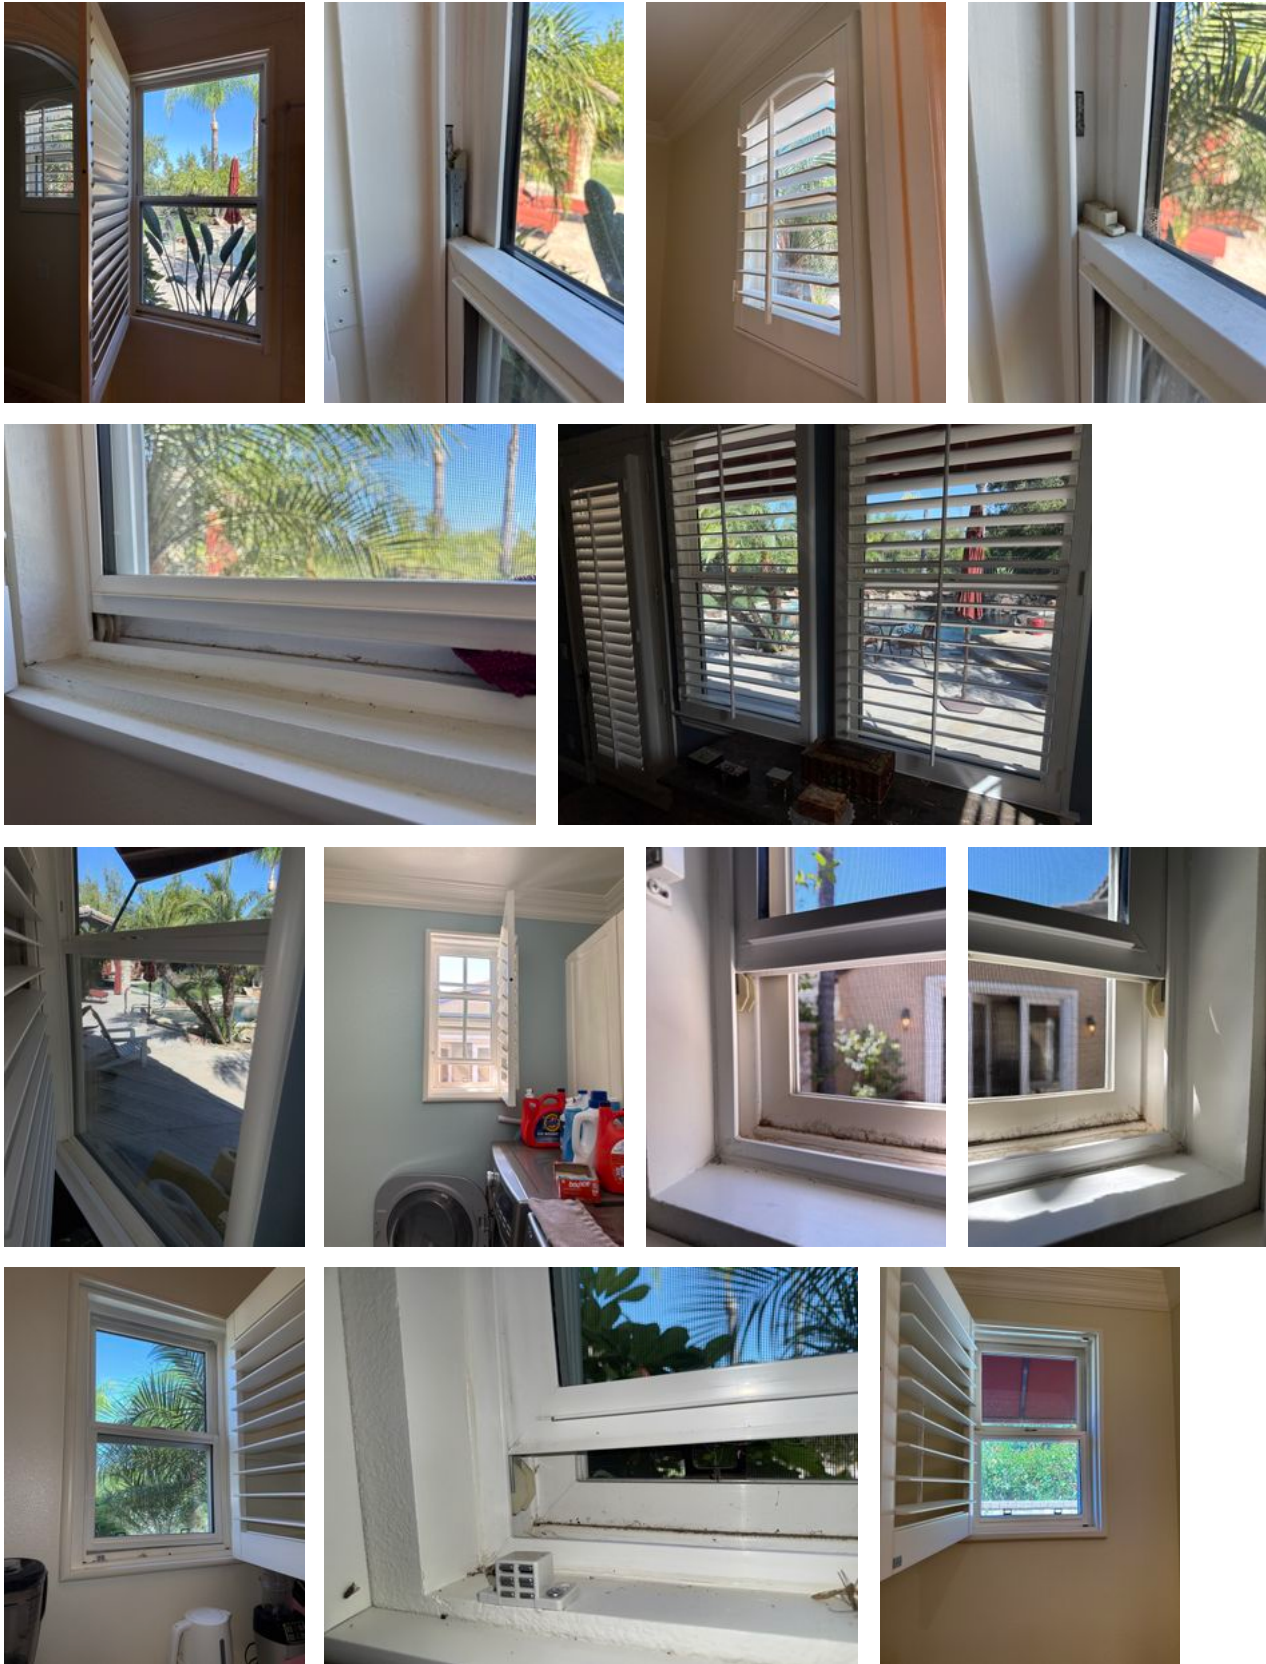
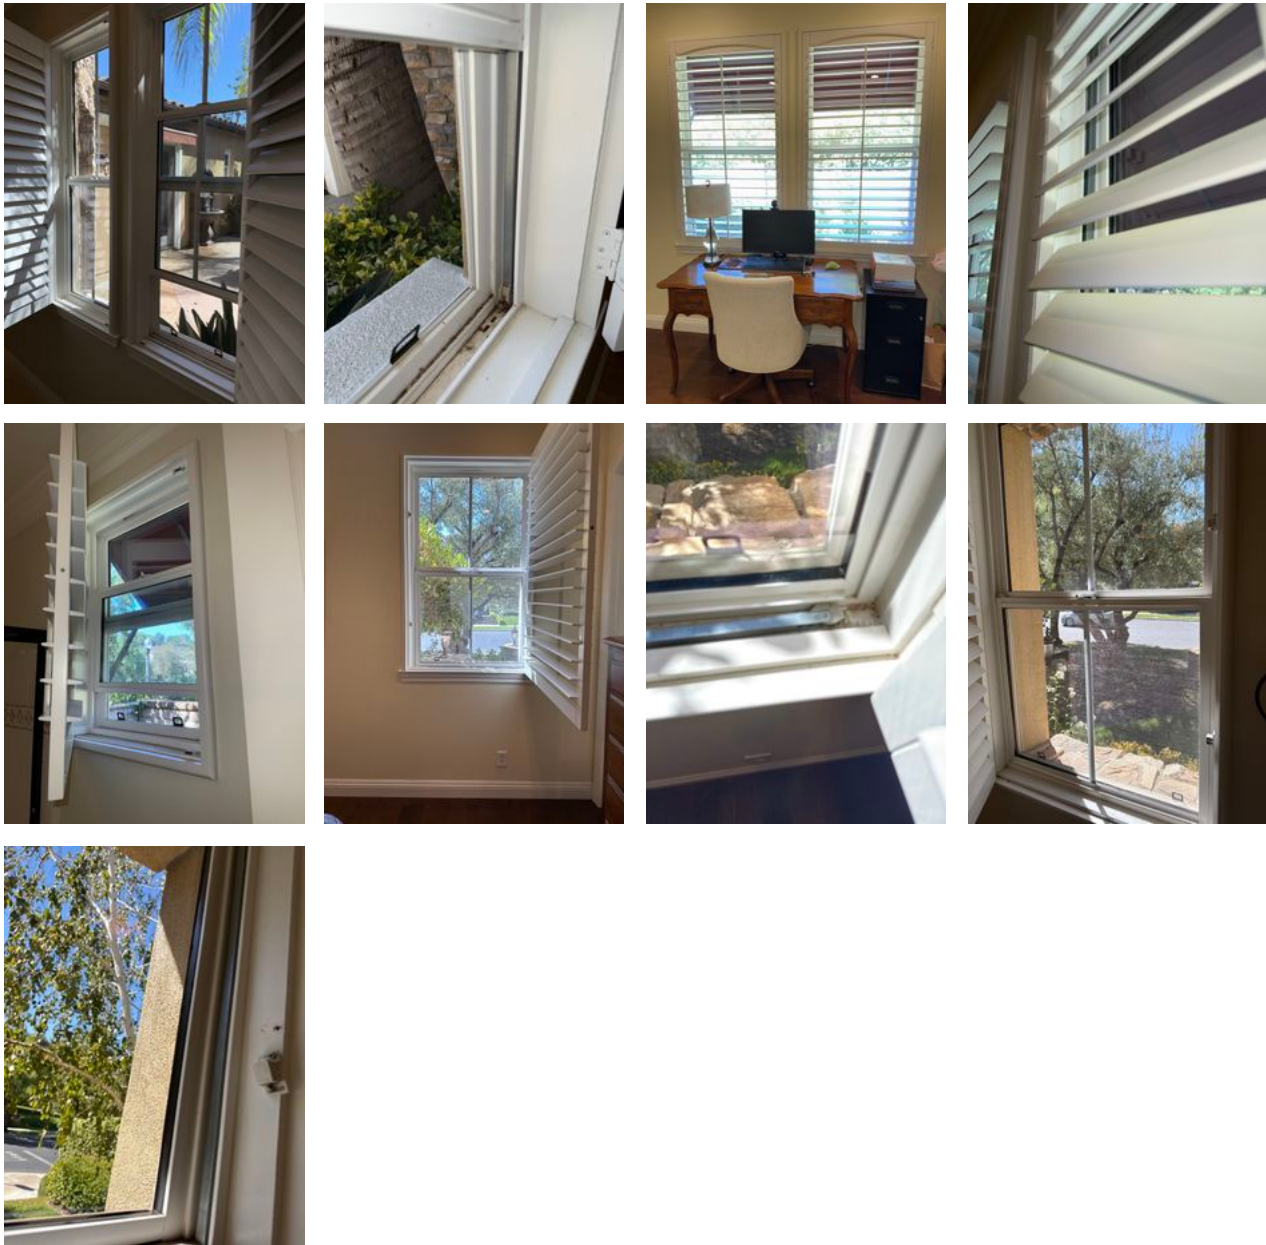
Broken window springs were noted throughout the master bedroom and bathroom, laundry room, pantry, hallway bathroom, bedroom hallway, center and front bedroom bathrooms.

Recommend further evaluation and repair by a qualified licensed contractor.

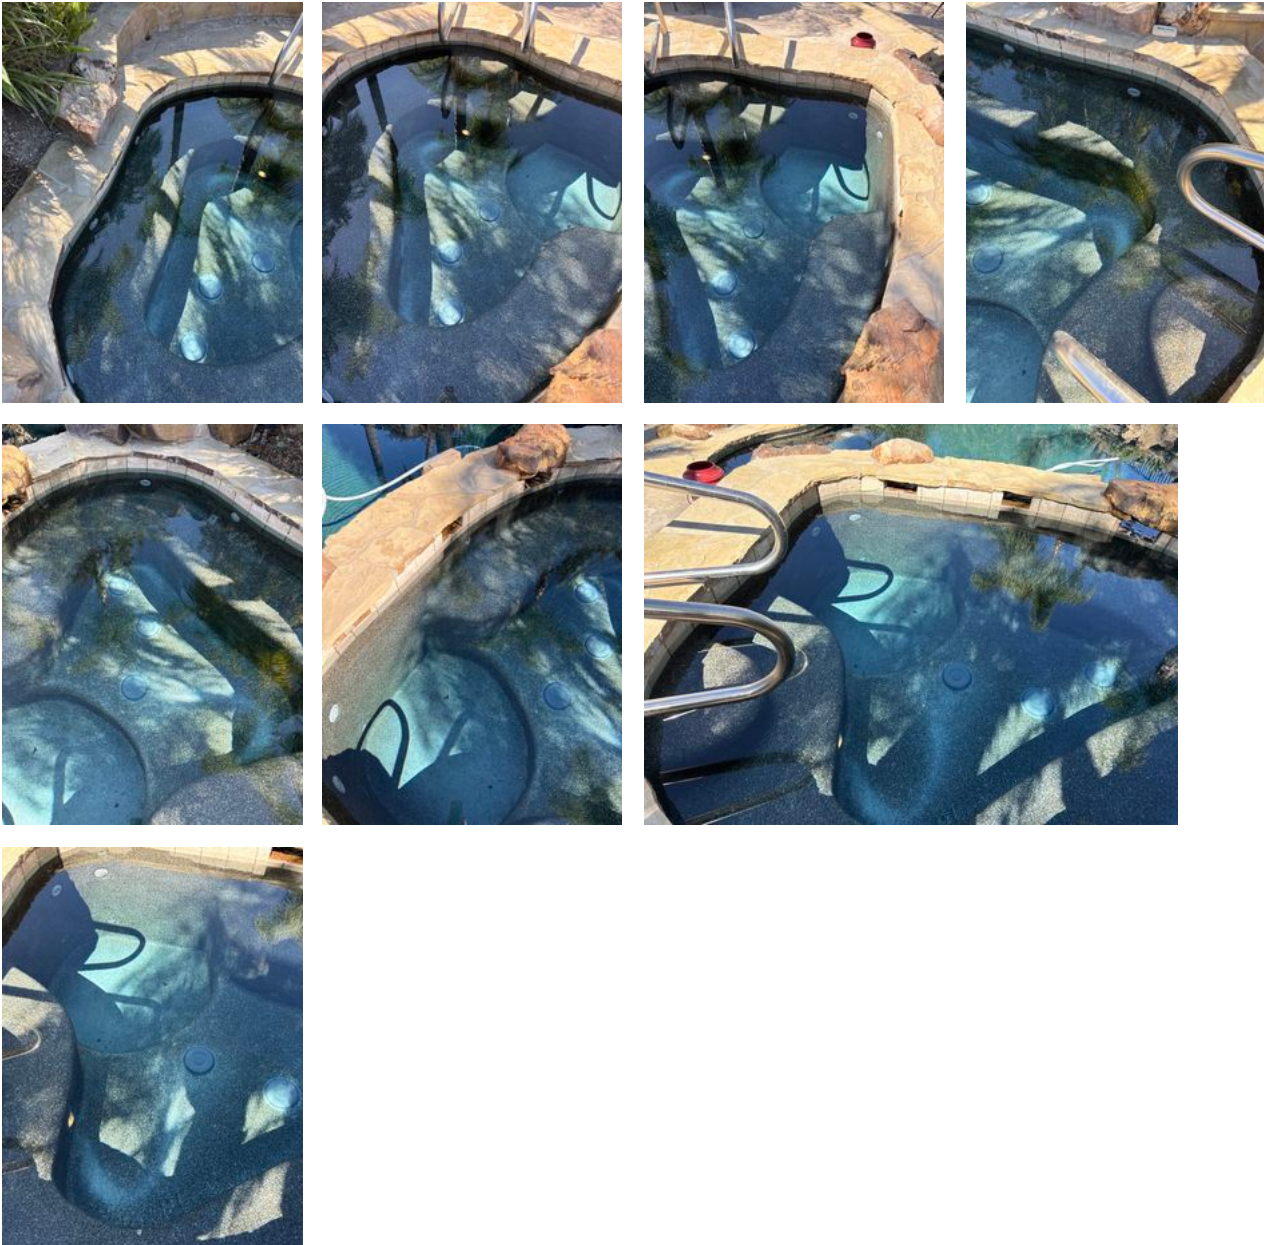
Spa interior finish appears to be in generally good condition. A buildup of material was observed on the steps and bottom of the spa which appears to be related to the degrading stone surrounding the coping.

Recommend further evaluation and repair by a qualified licensed pool contractor.

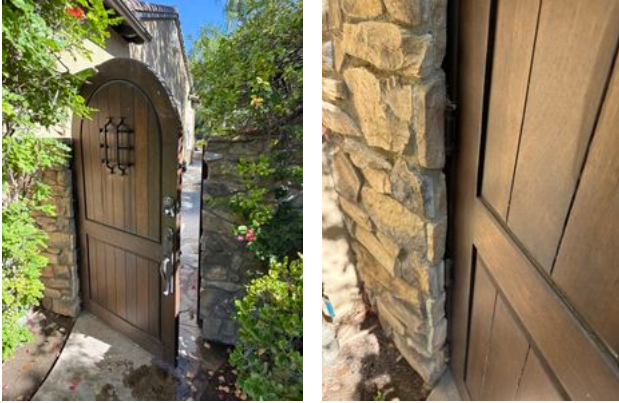
Side entry gate leading to the backyard is not self-closing. The self closing spring hinges are not strong enough to close the gate.

Recommend installation of window and door alarms on all rear yard accessible areas to prevent young children from entering the pool. Recommend installation of a water sensor alarm.

Recommend requesting documentation of final approved city/county permits prior to the close of escrow. General home inspections are not building code inspections.
