## Inspection Services

### *Inspection Report*

Address: 2015 Calle Pattito Templeton, CA 93465

09/26/2025

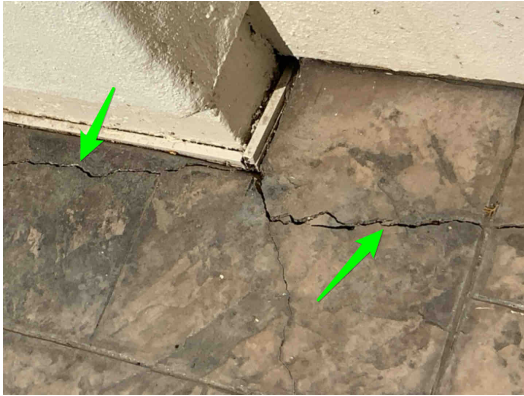
**28:** Typical and common cracks found.

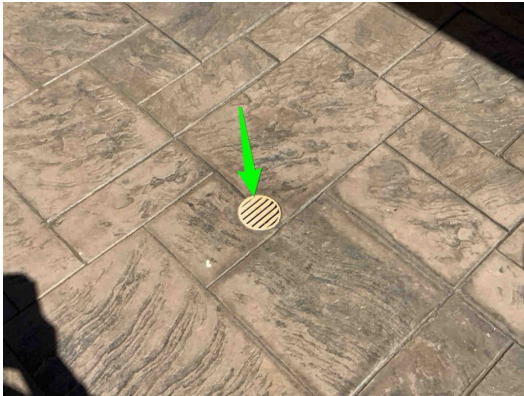
**MR DS 29: Disclosure:** Some surface drains noted in areas of the patio. Drains not tested. The condition of the underground piping and terminations are unknown. Recommend having drains and terminations cleaned, tested and inspected by a qualified landscape contractor to determine the proper flow. Keep drains clean and free of debris regularly.

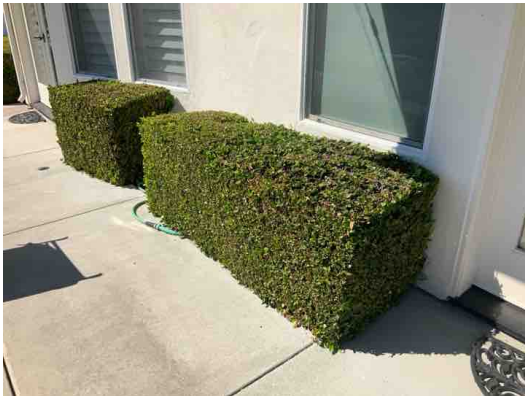
**MR** **35:** Areas of the exterior are not fully visible and not inspectable due to overgrown foliage. Conditions behind the foliage in areas not visible are unknown. Client is advised to have the overgrown foliage removed and to have the areas reinspected.

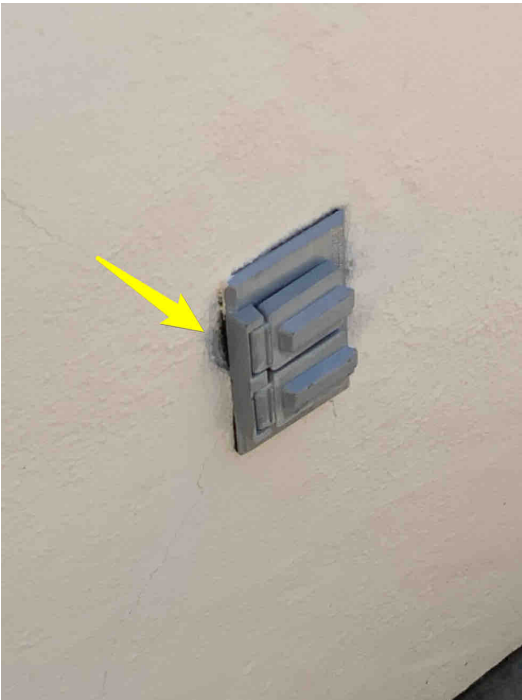
**MR 38:** Recommend sealing holes in exterior walls to prevent water intrusion around areas such as unused open holes in the exterior siding and trim, exterior light fixtures, around exterior electrical boxes and covers, and where utility pipes and/or wires pass through the exterior walls. Have a qualified painter or licensed professional evaluate the entire exterior and seal where needed.

Example. Around an exterior outlet.

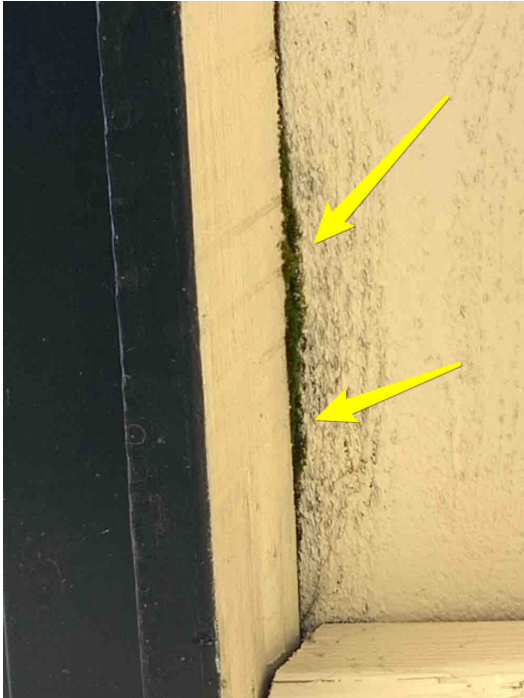
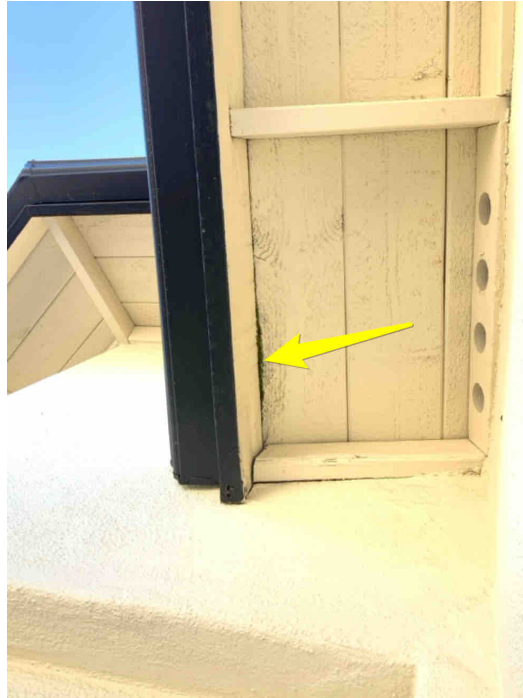
**FI 53:** Evidence of some roof leakage with visible moisture stains and/or damage at areas of the roof overhang: OVER THE FRONT ENTRY AREA WHERE A TILE HAS IMPROPERLY SLIPPED OUT OF POSITION. Recommend further review of the roof by qualified roofer to determine the cause, the current conditions and to determine if other areas of concern exist. Proper repairs are recommended.

A loose and displaced roof tile above the water damaged area.

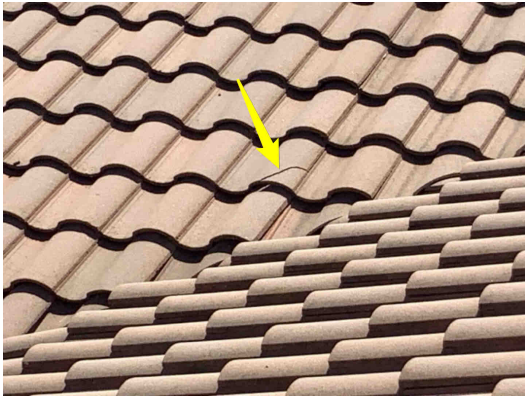
**E&C 54:** Multiple cracked, damaged roof tiles needing repair or replacement. Contact a licensed roofing contractor for further evaluation of the roof and to determine location(s) and quantity of the roof tiles needing repair or replacement.

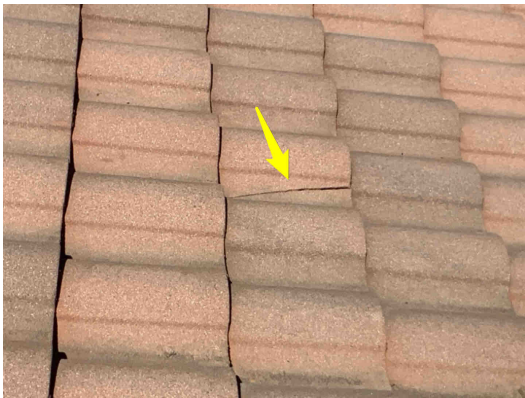
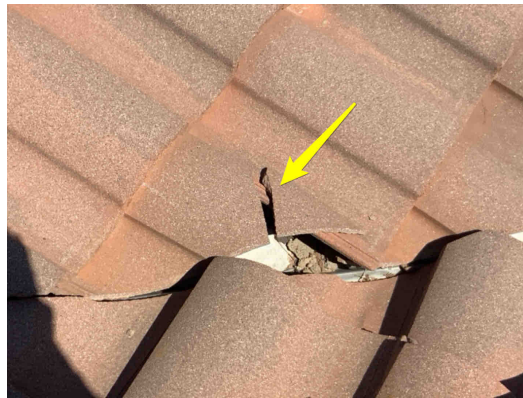
**E&C MR 55:** Some loose roof tiles needing repair or maintenance found missing the required approved fastener, nail, or batten extender at areas of the tile roof. Recommend further review of the roof by a qualified / licensed roofing contractor to determine quantity of repair or maintenance needed.

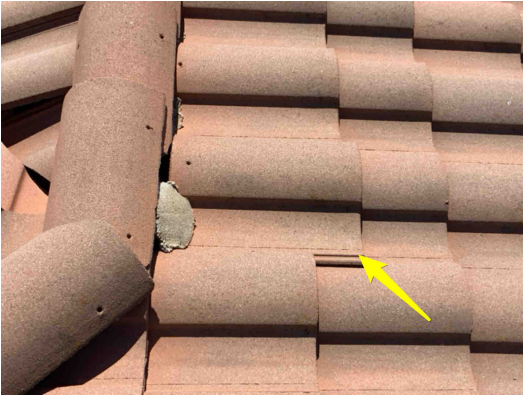
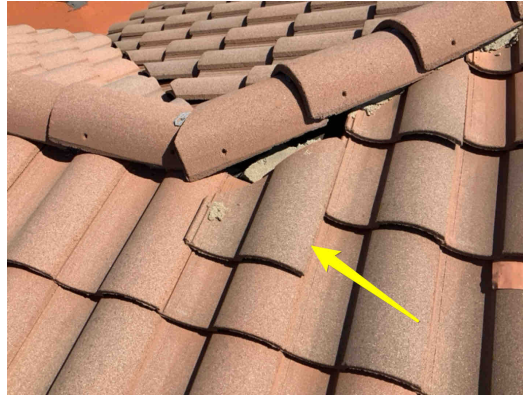
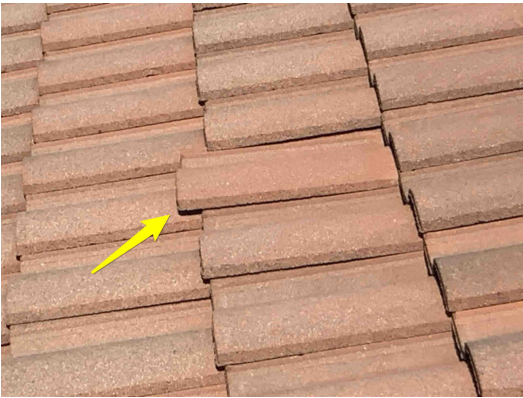
**E&C 56:** Some loose / LIFTING roof tiles found improperly installed at areas of the tile roof. Recommend further review and repairs by a qualified / licensed roofing contractor.

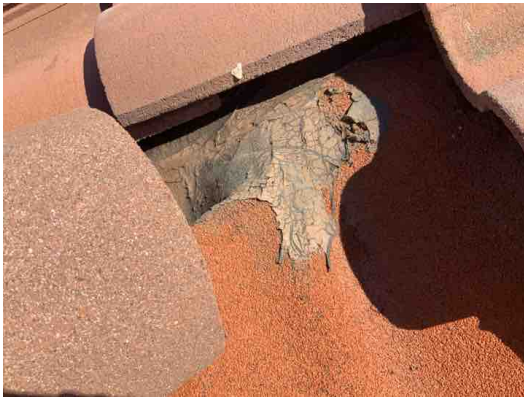
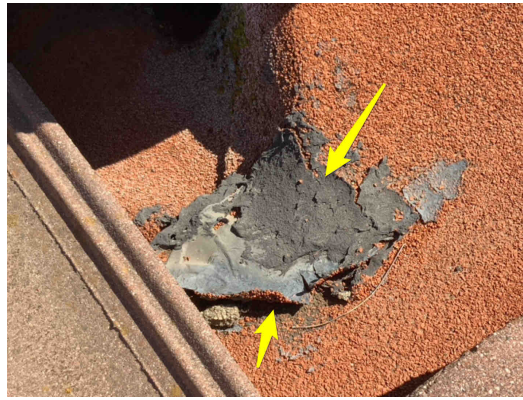
**FI 58:** Areas of past improper or incomplete past repairs found at areas of the ROLLED COMPOSITION ROOFING. Areas of exposed mastic found not covered by aggregate found deteriorated. These areas covered by mastic may be indicative of previous roof, deterioration or roof leakage. Recommend additional review with maintenance or repair by a licensed roofer.

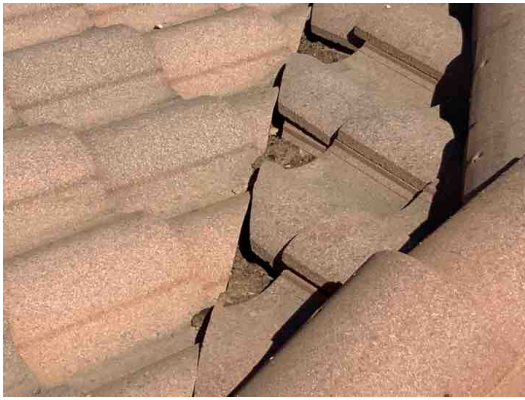
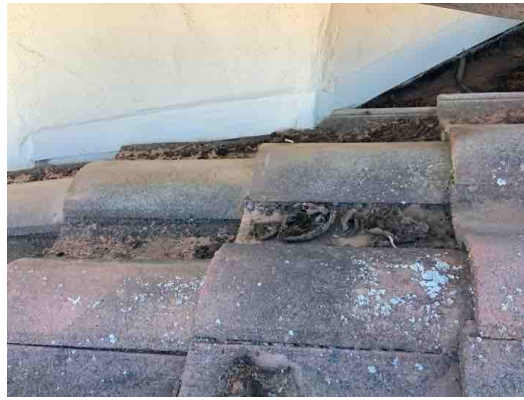
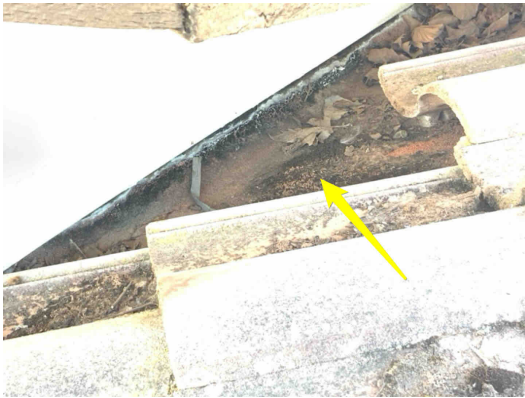
**MR 63:** Some debris buildup on areas of the roof and/or roof valley flashings. Areas not fully visible. Continuous maintenance / cleaning warranted to help prevent roof leakage.

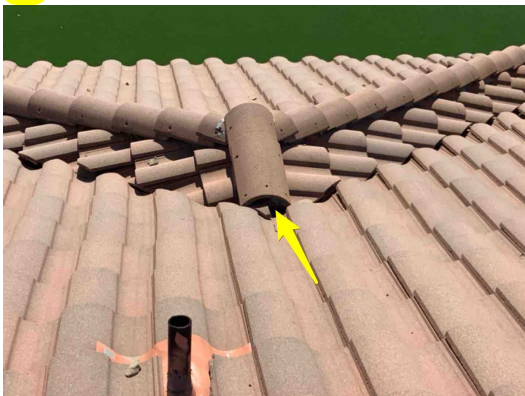
**MR 64:** Recommend re-sealing or sealing all the roof ridge 3-ways and/or hip/ ridge transitions.

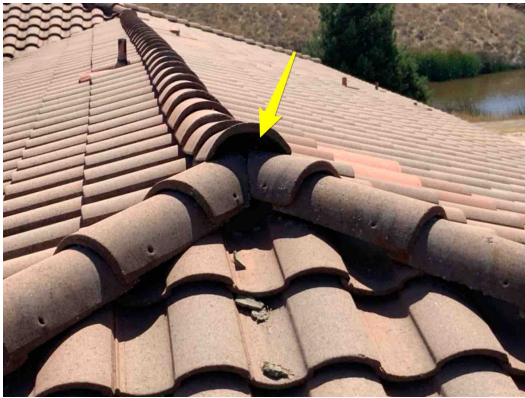
Areas should be filled with mortar

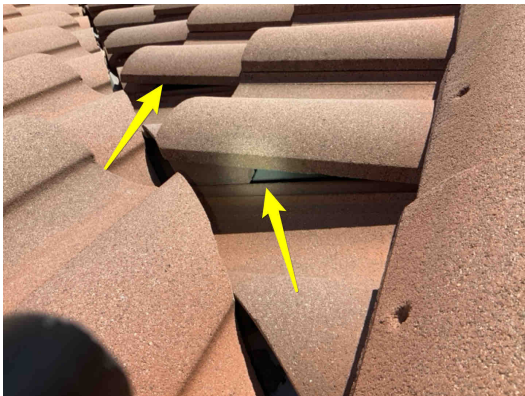
**E&C 66:** Evidence of some loose roof tiles improperly installed in the roof valley flashings (Missing the required batten extenders with the use of a single crown valley flashing). This allows the tile to drop onto the valley flashing causing damming of the water and may create a roof leak.

Tiles are lifted and separated

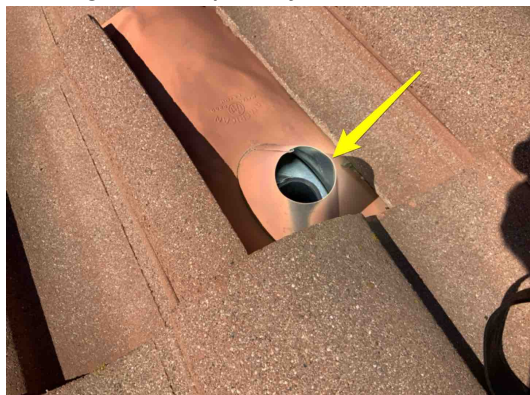
**FI 67:** Plumbing vent pipe has slipped or is improperly installed and does not properly pass through the roof. Jack flashing over the primary bedroom bathroom area. Recommend a licensed plumber to evaluate and correct.

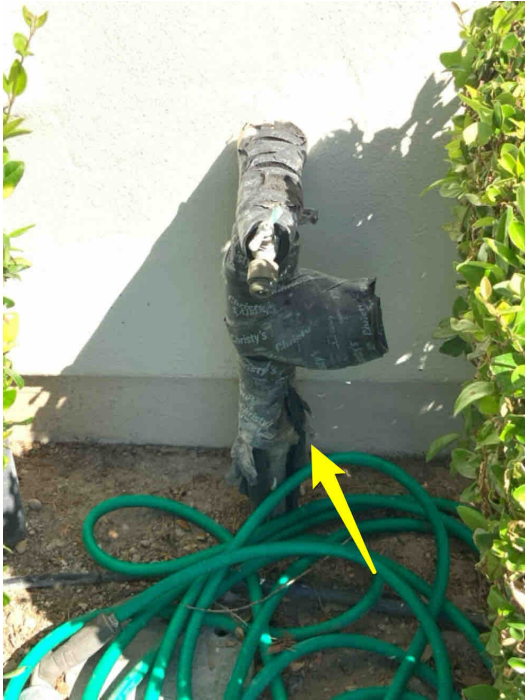
Main water shut off handle is broken, missing

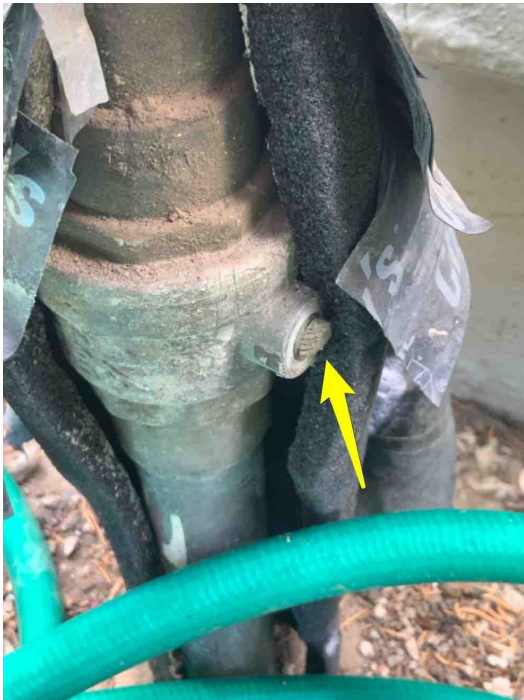
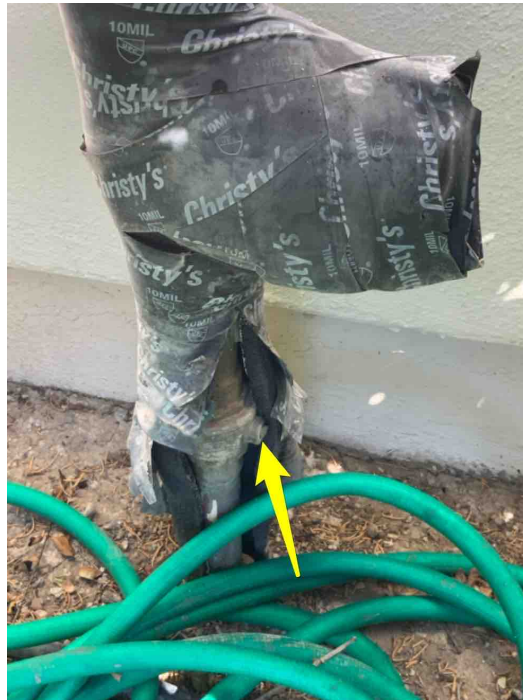
**80:** The MAIN WATER shut off handle is broken, missing at the main water supply. Recommend contacting a plumber to evaluate and correct.

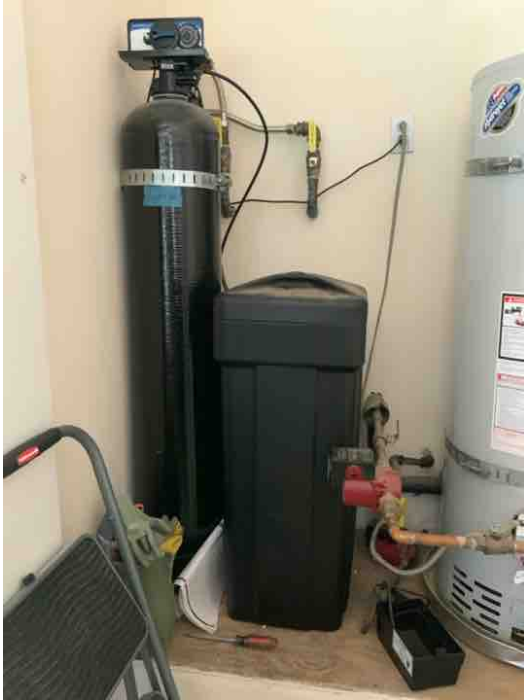
**SC 89:** Improper installation of the water softener drain hose. Missing the required air gap at water softener drain hose at waste connection. Refer to the manufacturer's installation requirements and plumbing code.

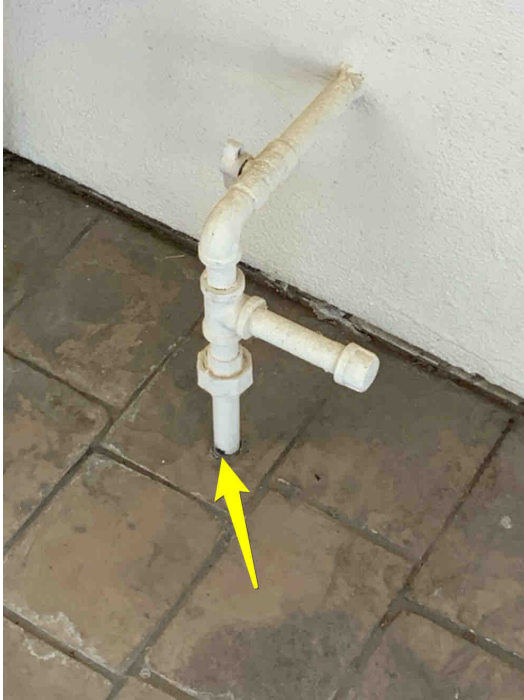
**UPG 95: Disclosure:** Gas pipe not protected / sleeved through concrete on the east side of the house for the added backyard gas fire pit. No visible deterioration or damage found at this time. Continue to monitor.

Not sleeved through the concrete

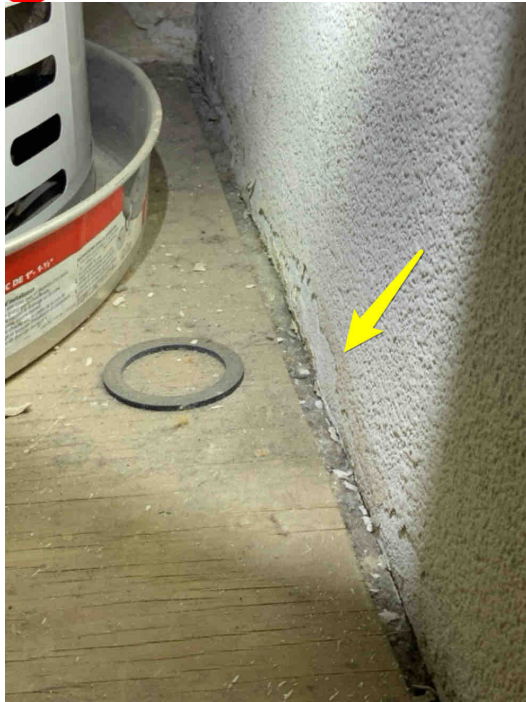
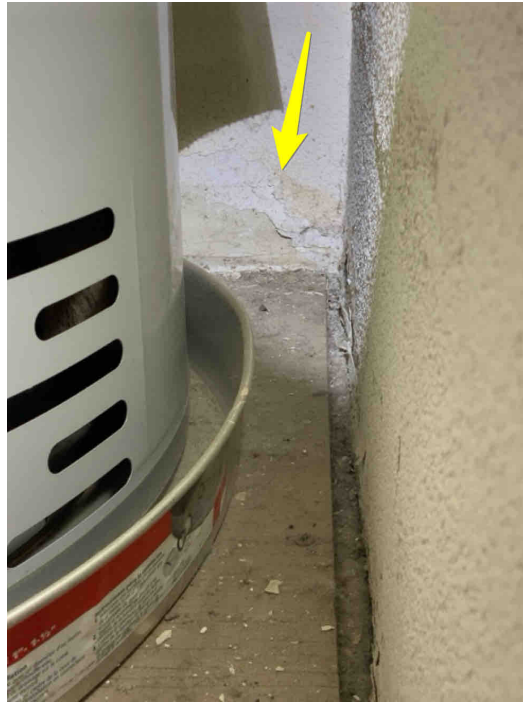
**FI 104: Disclosure:** Dry Moisture stains noted at areas around the water heater at the platform and/or enclosure.

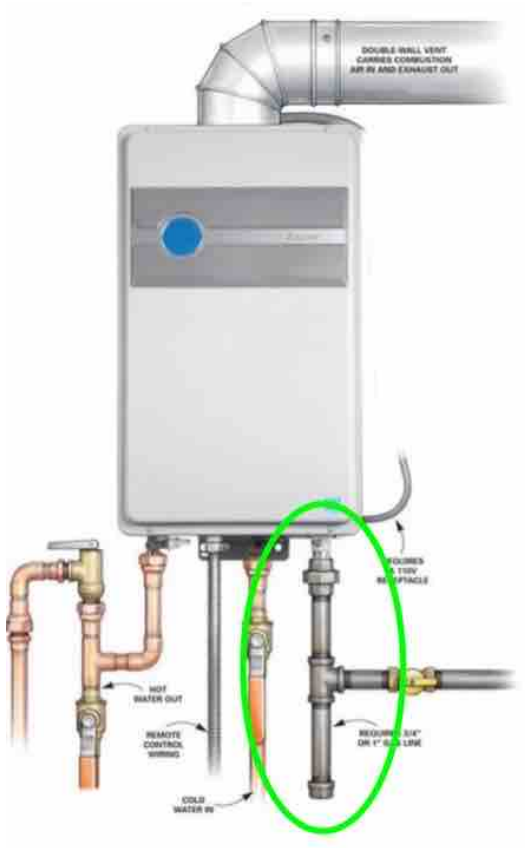
**UPG 105:** Recommend the installation of the missing sediment trap / drip leg at the gas TANKLESS WATER HEATER gas piping at flex connection by a certified or licensed plumbing professional familiar with minimum requirements.

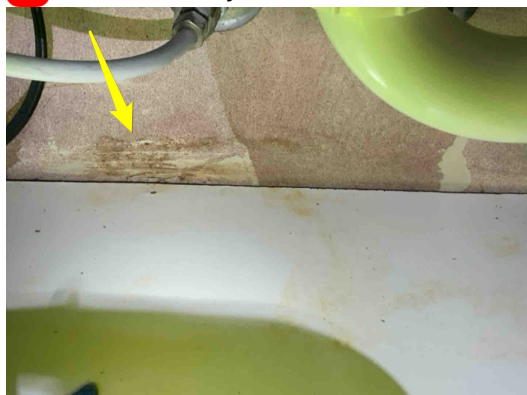
**FI** 114: Some dry moisture stains and damage in the cabinetry below the kitchen sink.

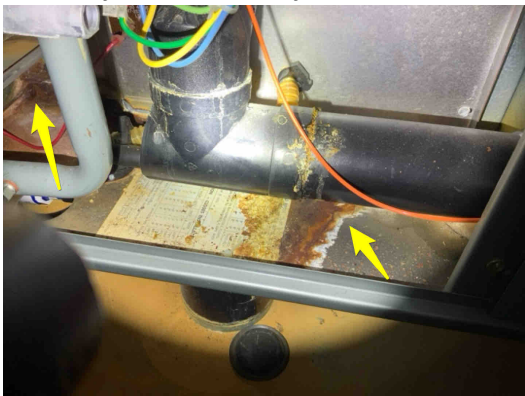
**FI MR 189:** Evidence of past dripping and leaking of condensation at the BEDROOM-2 CLOSET ATTIC high efficiency furnace vent system. Recommend further review, servicing or repairs by qualified HVAC professional.

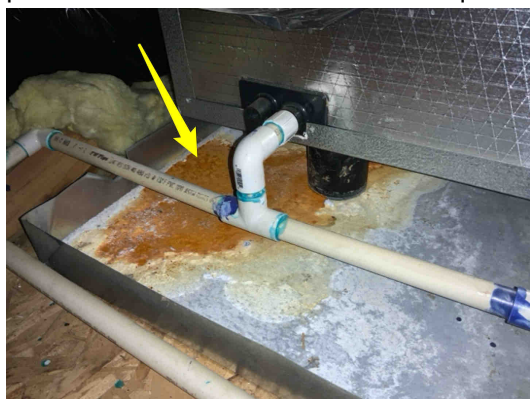
**FI 201:** Evidence of past water with some visible rust deterioration found in the secondary safety overflow catch pan under the air conditioner coil in the Hall 1/2 Bathroom Hallway attic. This is indicative of some defect in the coil and/or primary condensate drain system. Recommend further review and/or repairs by a certified or licensed HVAC professional familiar with minimum requirements.

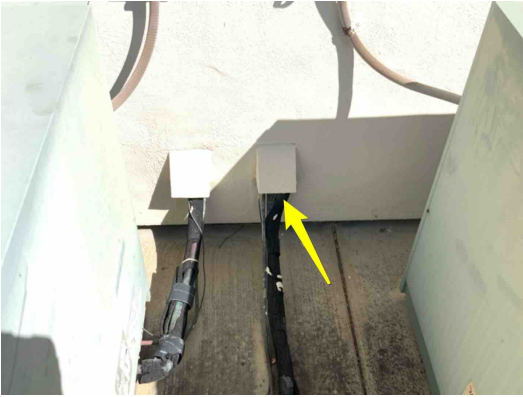
**SU 206:** Recommend sealing the hole or opening through the exterior wall where the Air Conditioner's refrigeration pipes enter the building. This will help prevent rodent, bug and /or water intrusion through this area as need per standards. Recommend filling the opening with rodent resistant expandable foam in a can, which can be purchased at most local hardware store stores.

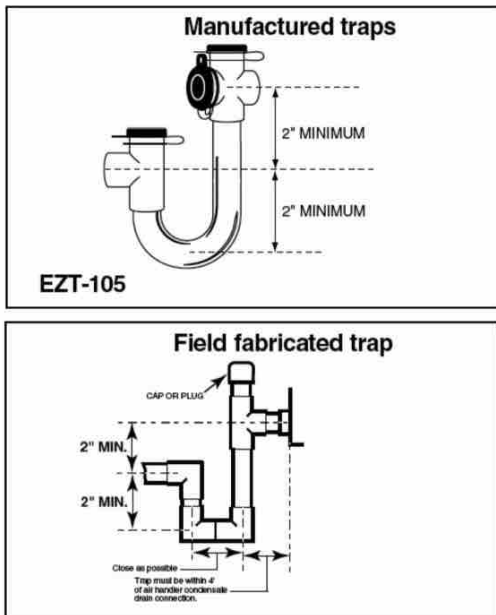
**E&C 208:** Missing the vent/clean-out and trap at the Air Conditioner's condensate drip pipe at the coil. Upgrades / repairs recommended per minimum installation standards.

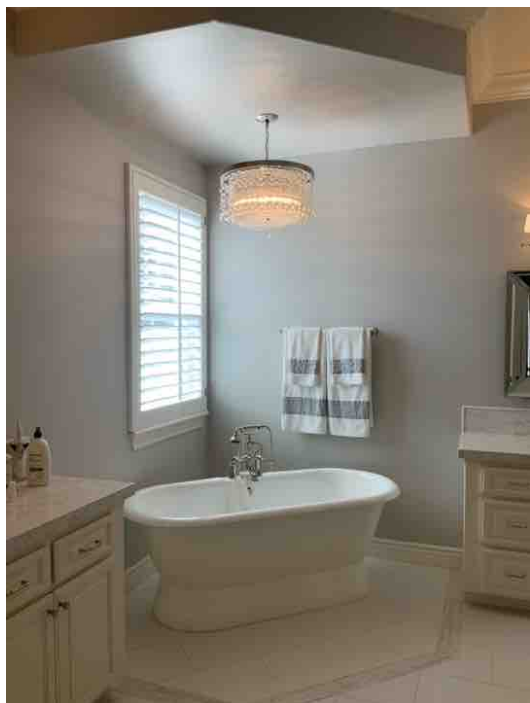
**SC 216:** It is improper to have a chandelier hanging over a bathtub below 10-feet as this is considered a safety hazard: PRIMARY BEDROOM BATHROOM.

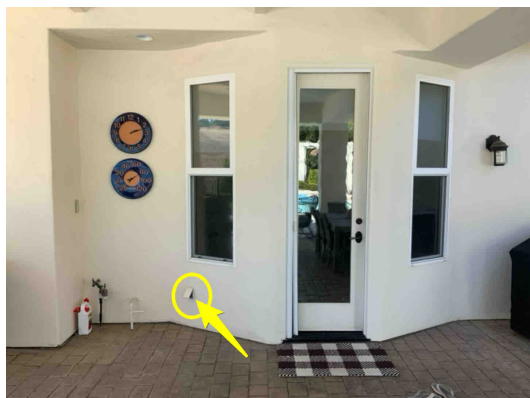
**SC 217:** GFCI protection at a GFCI outlet found defective / non-operational. Recommend replacement of the defective outlet: EXTERIOR OUTLET ON THE EAST SIDE OF THE HOUSE OFF THE KITCHEN EXTERIOR DOOR

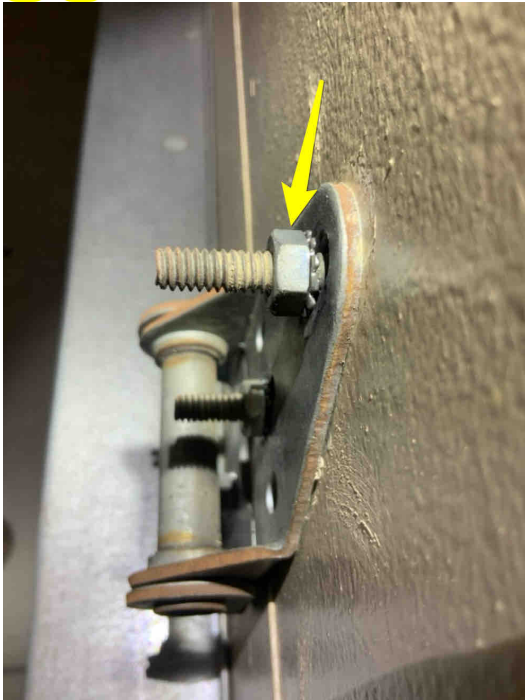
**MR SU 236:** Some loose nuts and bolts noted at the wood roll-up door hinges. Maintenance recommended.

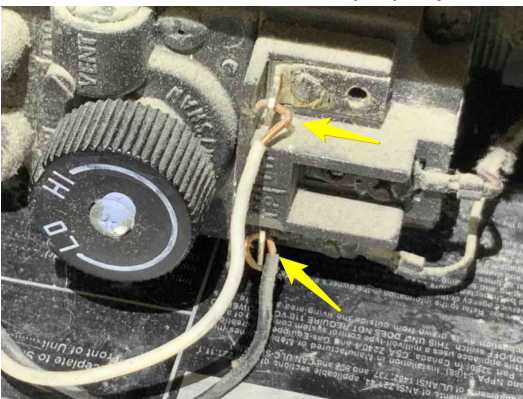
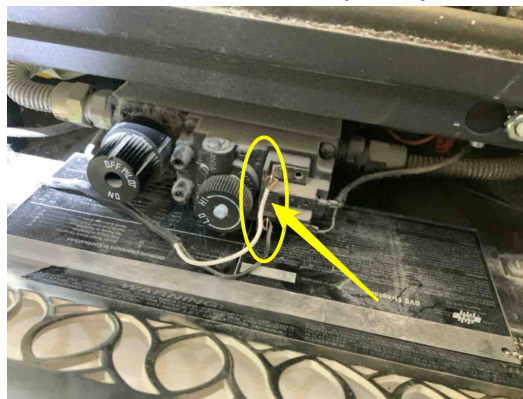
248: Thermostat wires are improperly connected to the controller inside the primary bedroom fireplace.
